# St Mary's Church Lower Heyford Oxfordshire

## Archaeological Watching Brief Report

**Document Type:** Watching Brief

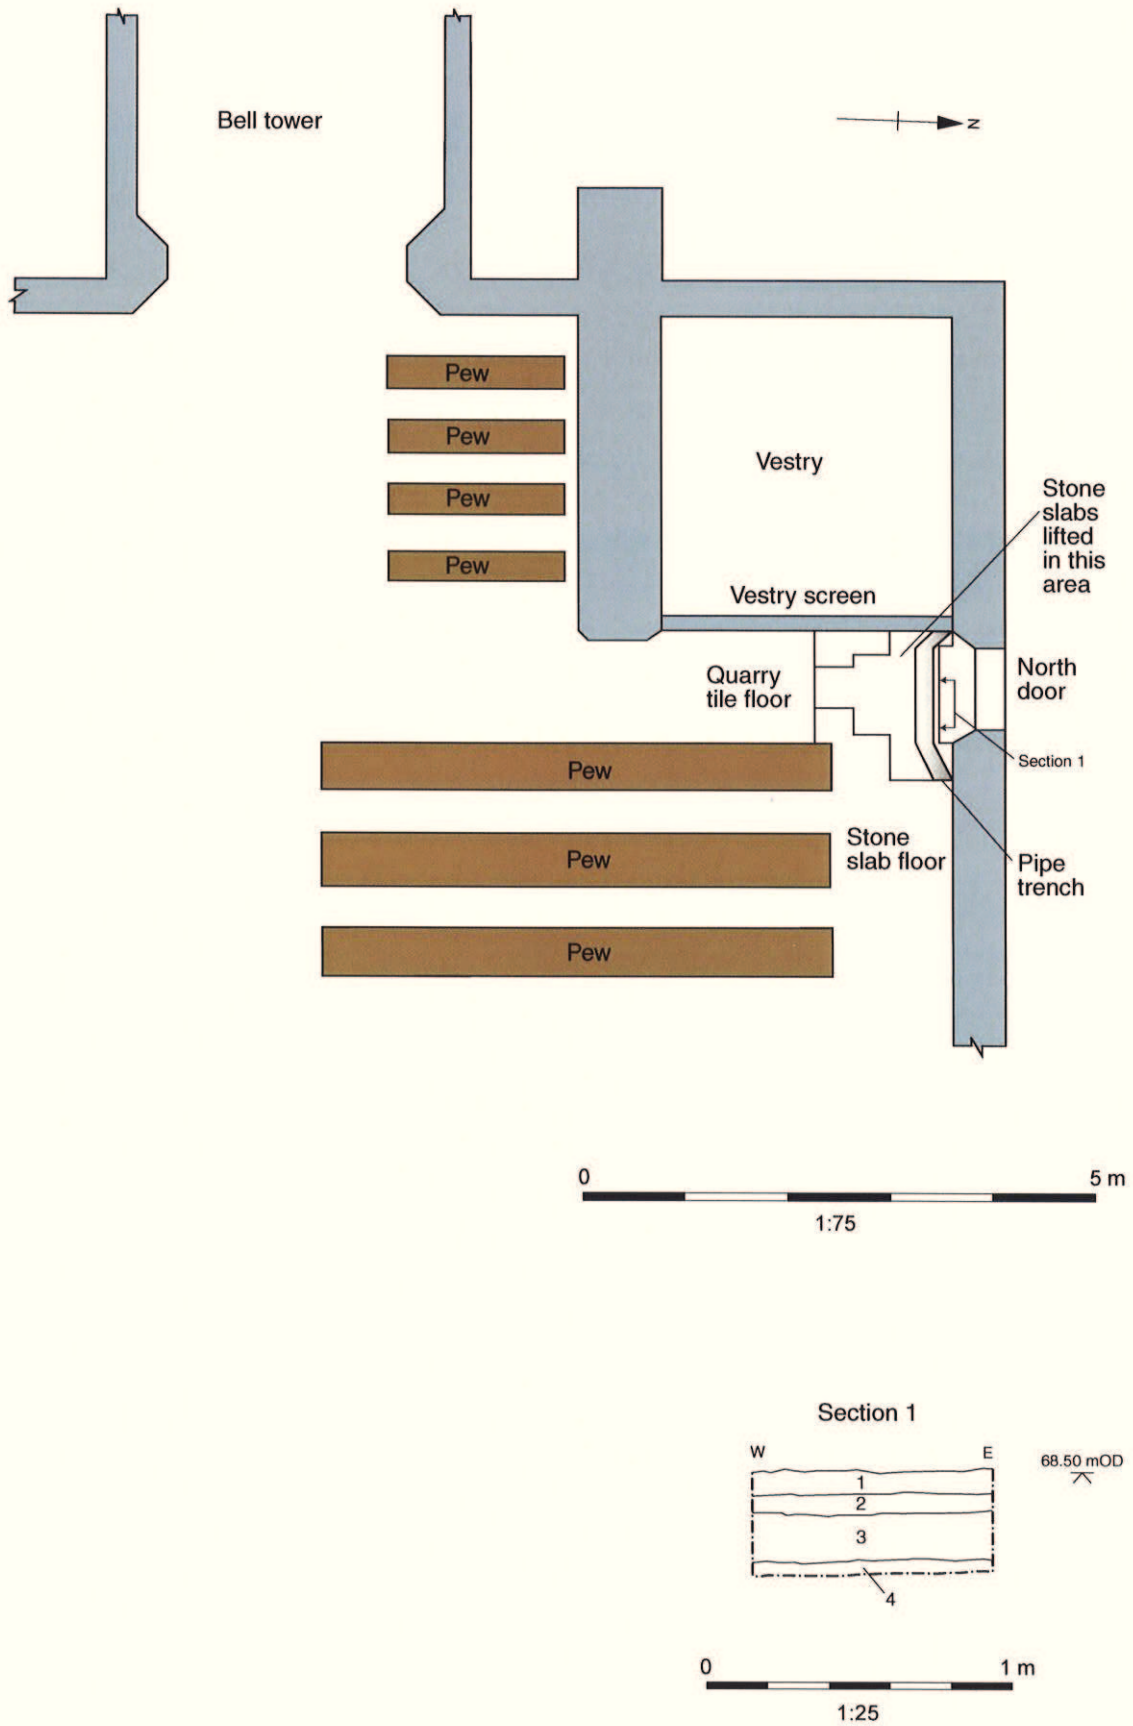
Figure 2: Plan showing area of watching brief and section 1

- 3.1.1 The base of the trench cut 0.1 m deep into the top of a layer of friable dark yellow-brown sandy silt (4). This produced small stone fragments, fragments of white wall plaster and inclusions of a pinkish lime mortar. Overlying this was a 0.16 m thick layer of friable, pale yellow-brown sandy silt (3). This context also contained small stone fragments and fragments of white wall plaster. This was sealed by a 0.08 m thick layer of grey lime mortar (2), which formed the bed for the 19th century stone slab floor (1) (Fig. 2, section 1).

- 4.1.1 The depth of the excavation was such that only construction levels relating to the 19th century renovation of the church were encountered, and that no evidence for earlier deposits or structures was observed.
