AXWELL HALL, GATESHEAD PHASE 2

**Archaeological
Building
Investigation**

Oxford Archaeology North

June 2006

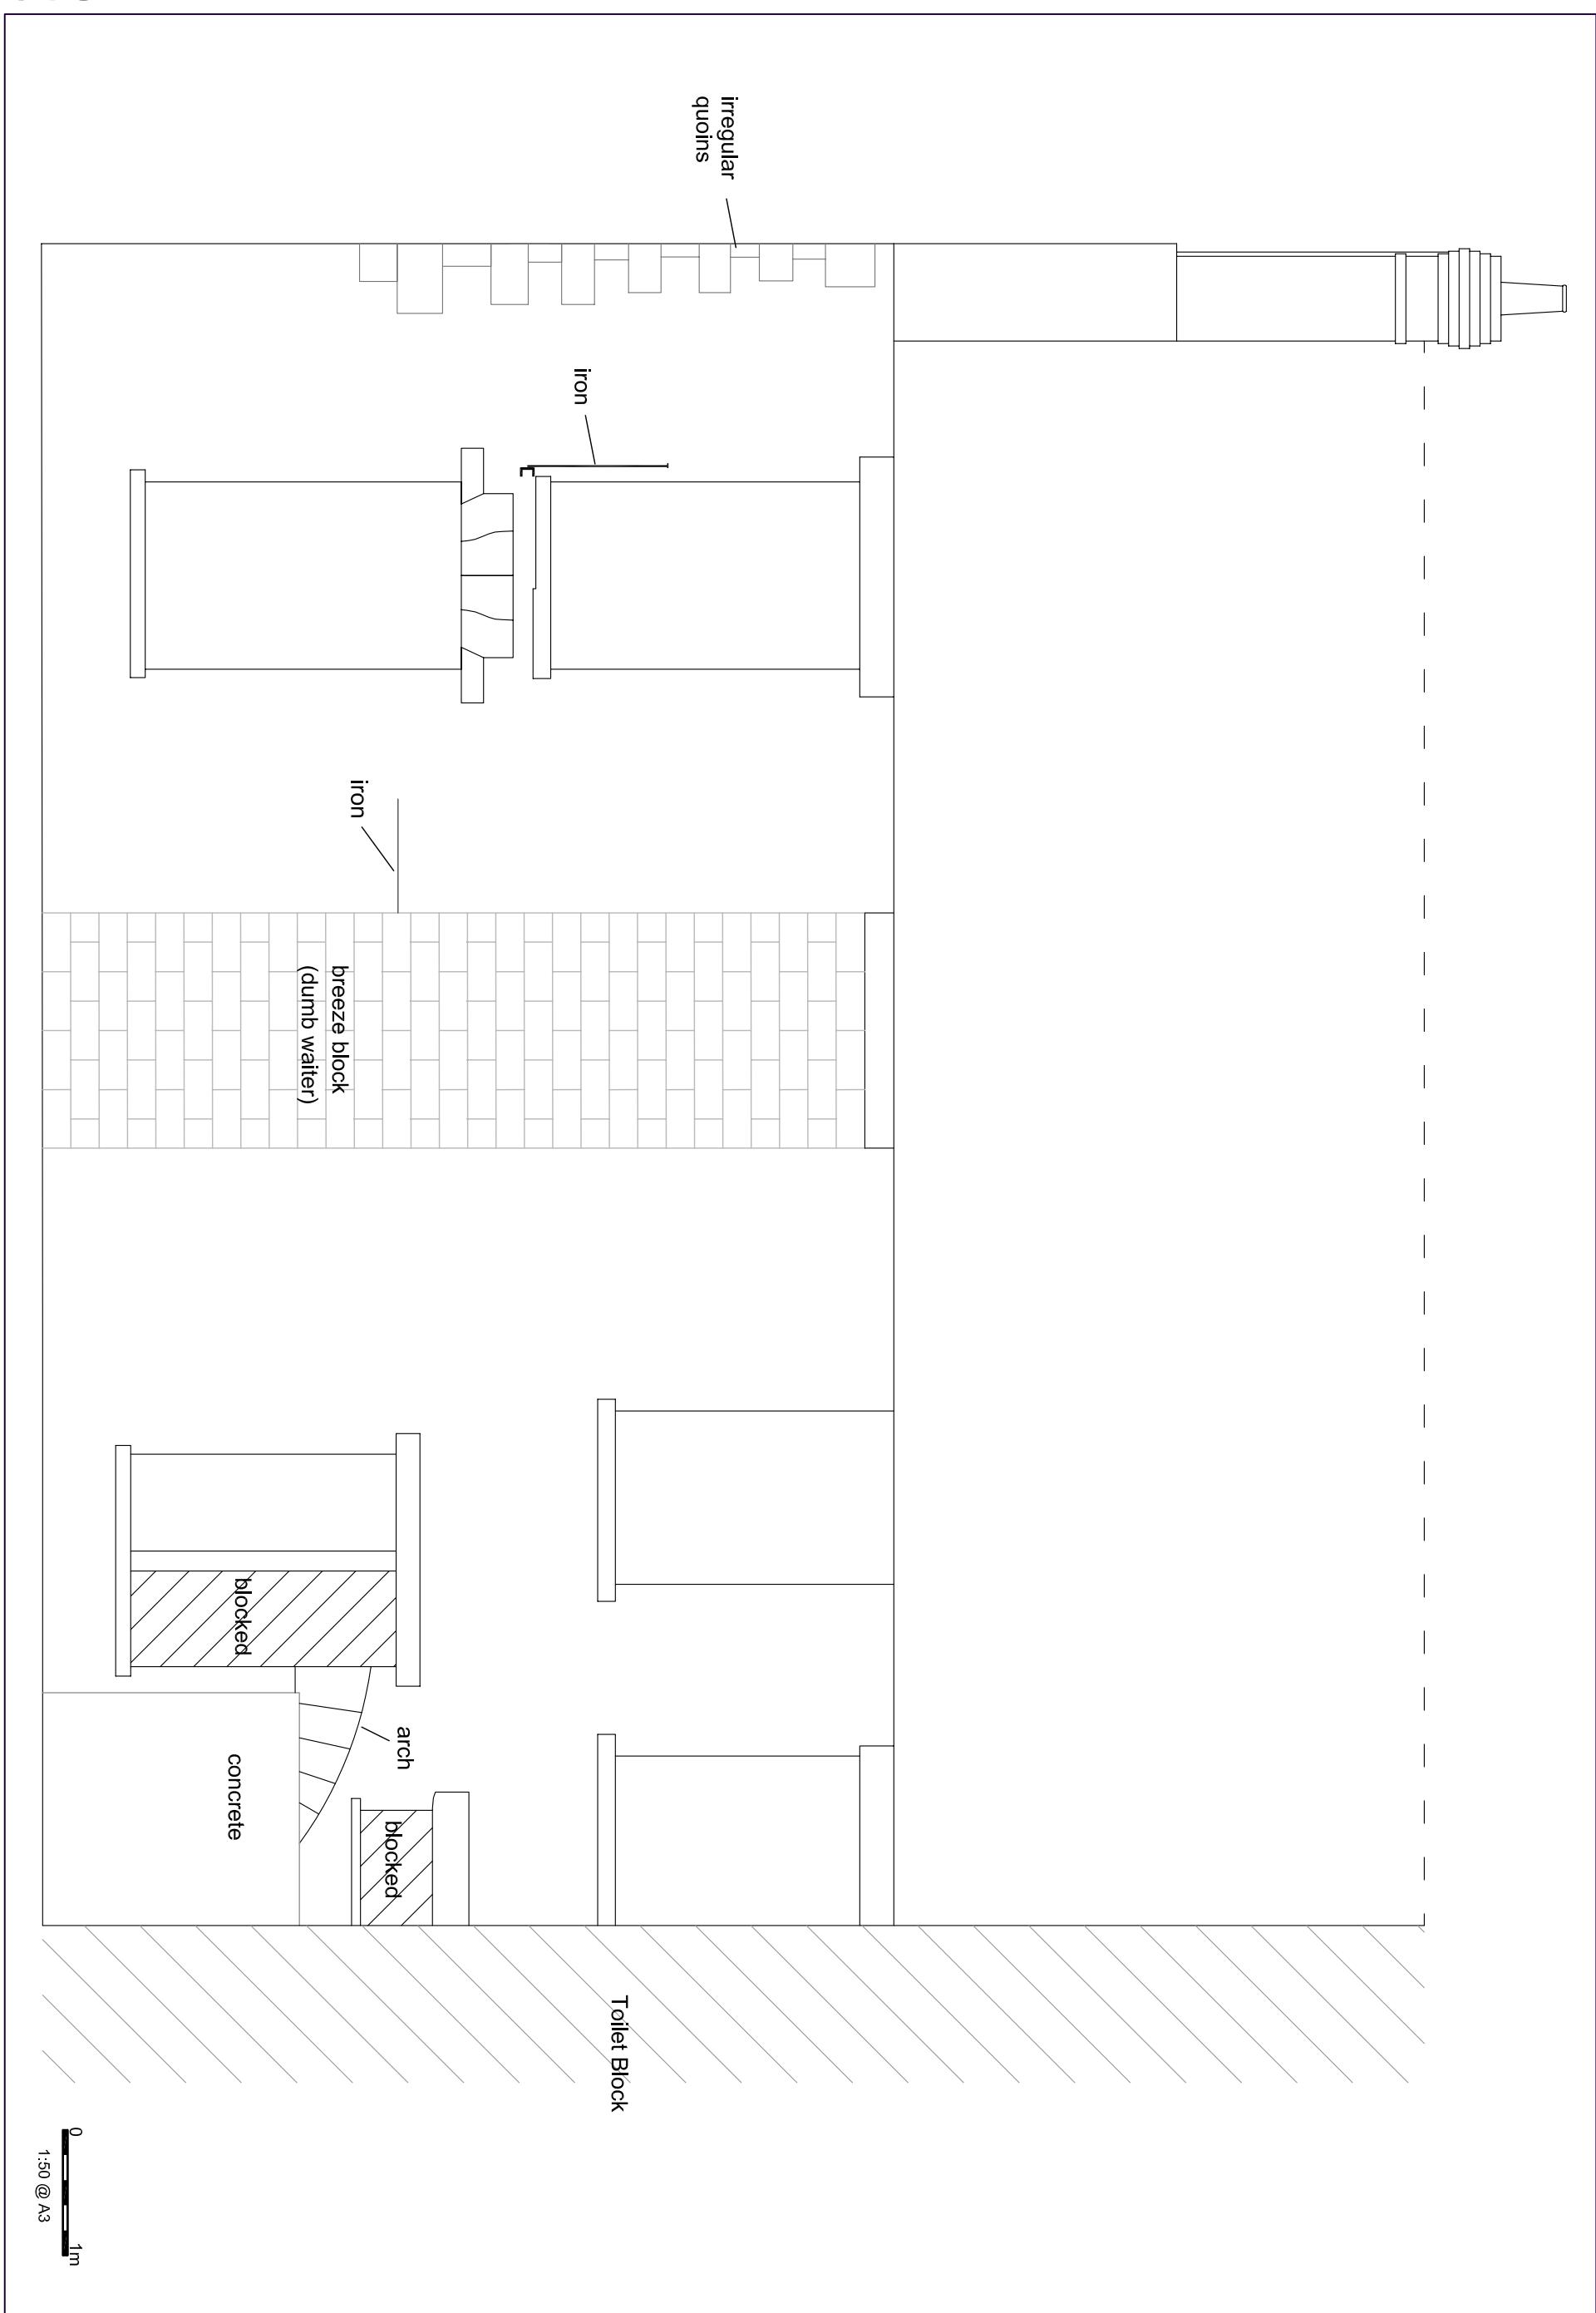
Figure 2: South elevation of the Annex at Axwell Hall

- 3.1.9 **Annexe – South Elevation:** this elevation is constructed using both the same stone and the vernacular style employed on the rest of the building (Plate 9). In the centre of the elevation, there is a tall, narrow extension, which houses the dumb-waiter between the kitchen on the ground floor and the canteen above. It is constructed from cinder block with a flat bitumen roof, and it is obvious that its upper limits have been repaired or extended. This is evident from the courses of cement-rendered brick, which have been scored to suggest continuity with the cinder blocks below. In addition, the windows feature the same flush lintels and projecting sills of sandstone as their counterparts on the north elevation. Likewise, there is a suggestion that the windows on the first floor have been reduced in height in a similar fashion to their aforementioned counterparts. The window lying to the east of the dumb-waiter would appear to be an earlier feature, which has had a later sandstone mullion and lintel inserted, whilst the sill appears to be contemporary with the rest of the windows on the elevation. To the west, there is a small window, again with lintel and sill, which straddles the ground and first floors. In addition, at the west end of the elevation, a few scraps of iron denote the extent of the fire escape from the canteen door on the first floor. Towards the opposite end of the elevation, there is a substantial voussoir round-arch, which appears to be either an original or early feature of the building. There are now only five stones visible as the mullioned window cuts the arch, whilst the later extension leading to the cellar has obscured the rest of it.

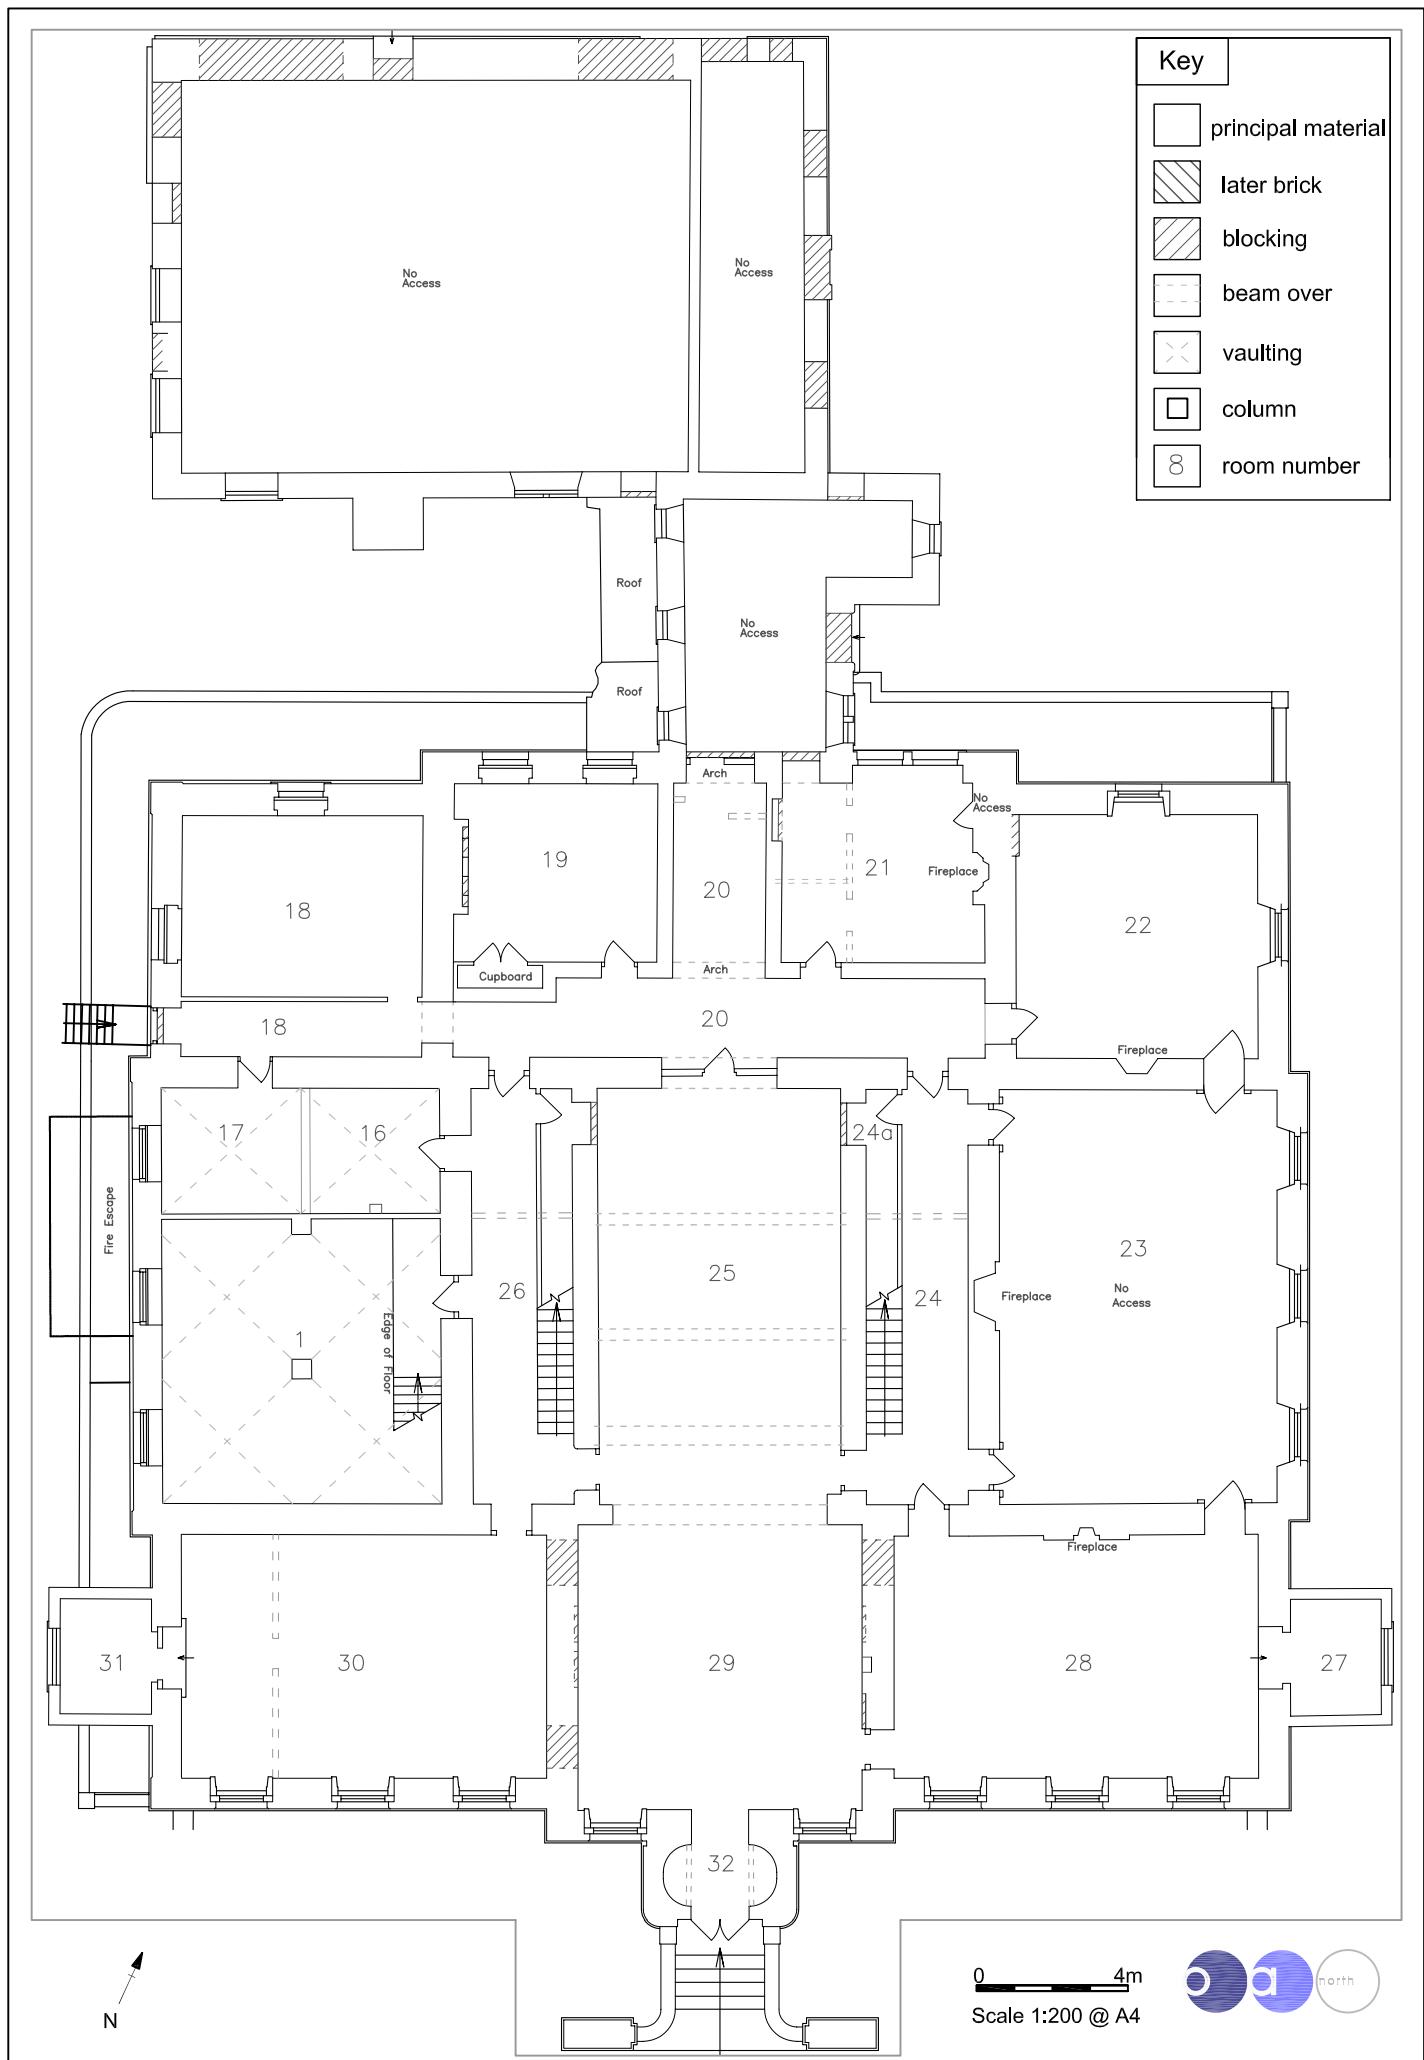
Figure 3: Ground floor plan featuring reception rooms included in plaster survey

- 4.1.1 The plasterwork within Axwell Hall is mainly confined to the grand reception rooms on the ground floor at the front (south) of the building, and would appear to fit into two broad phases of development. Room numbers referred to in the text relate to Figure 3.

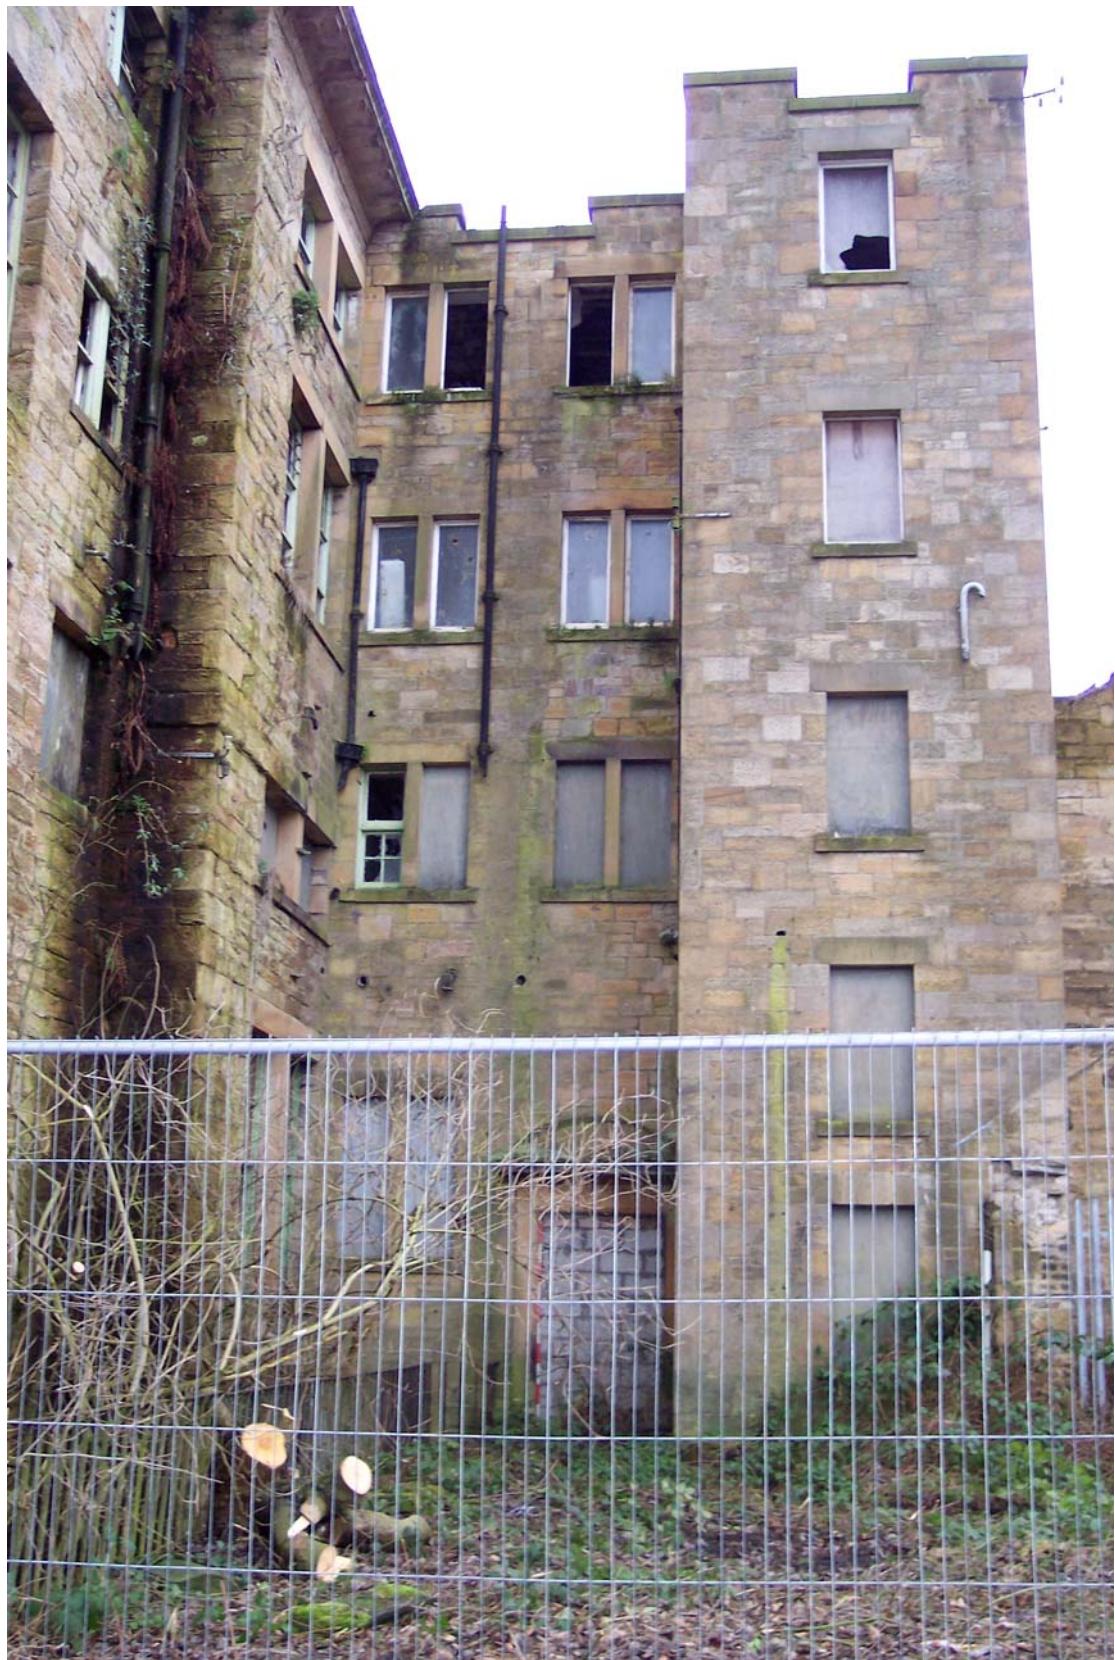
Plate 1: The east elevation of the Toilet Block

- 3.1.2 **Toilet Tower – East Elevation:** as with all other elevations of the toilet tower this elevation is composed of yellow random uncoursed sandstone decorated with pick marks. All three elevations are finished with stepped coping stones. The northern section of the east elevation projects out from the southern section (Plate 1). The windows in the southern section of the block are stone-mullioned double windows with flat vertically-furrowed lintels and slightly projecting sills. These are similar in style to the windows on the rear elevation and most of them are blocked or unglazed. There is a blocked door (with cinder block) at the base of the tower, which has a moulded stone surround with horizontally-furrowed jambs. The door has a projecting hood with what appears to be the remains of a segmental pediment. A cast iron down pipe is located in the south corner. The northern section of the elevation has five single window apertures with the same flat lintels and projecting sills as noted above. The quoins are decorated with pick marks. The roof of the toilet tower is evidently flat with a castellated parapet with plain sandstone coping.

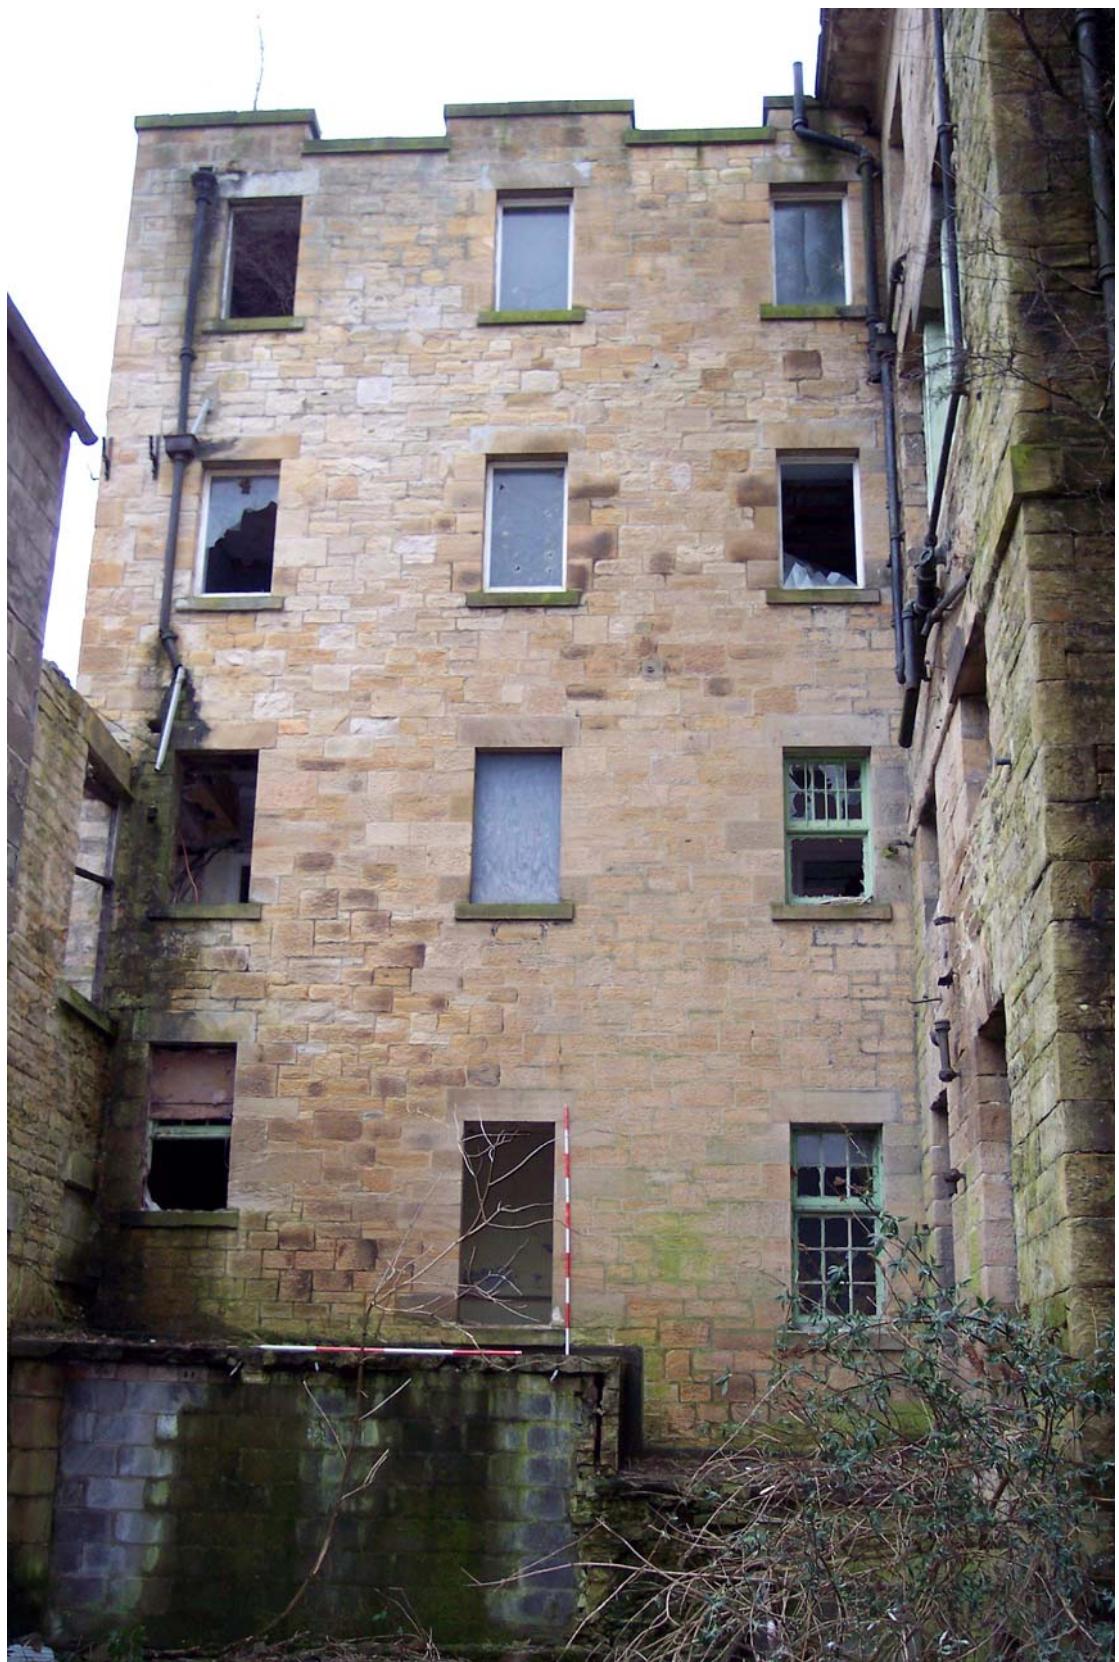
Plate 2: The west elevation of the toilet block

- 3.1.3 **Toilet Tower - West Elevation:** the west elevation of the toilet block is much the same as the east elevation (Plate 2). The windows are all single apertures, some glazed with mesh-reinforced glass. At the base of the elevation, there is a low roofed structure constructed from brick and featuring a reinforced concrete roof. Although this extension is now infilled with cinder blocks, it originally provided access to the cellar under the main house (Mr David Best, local resident, pers comm). There is a blocked window situated low down on the elevation and is only accessible from the sunken walkway; it is similar to the other windows on the elevation. The sunken walkway continues along the base of the elevation.

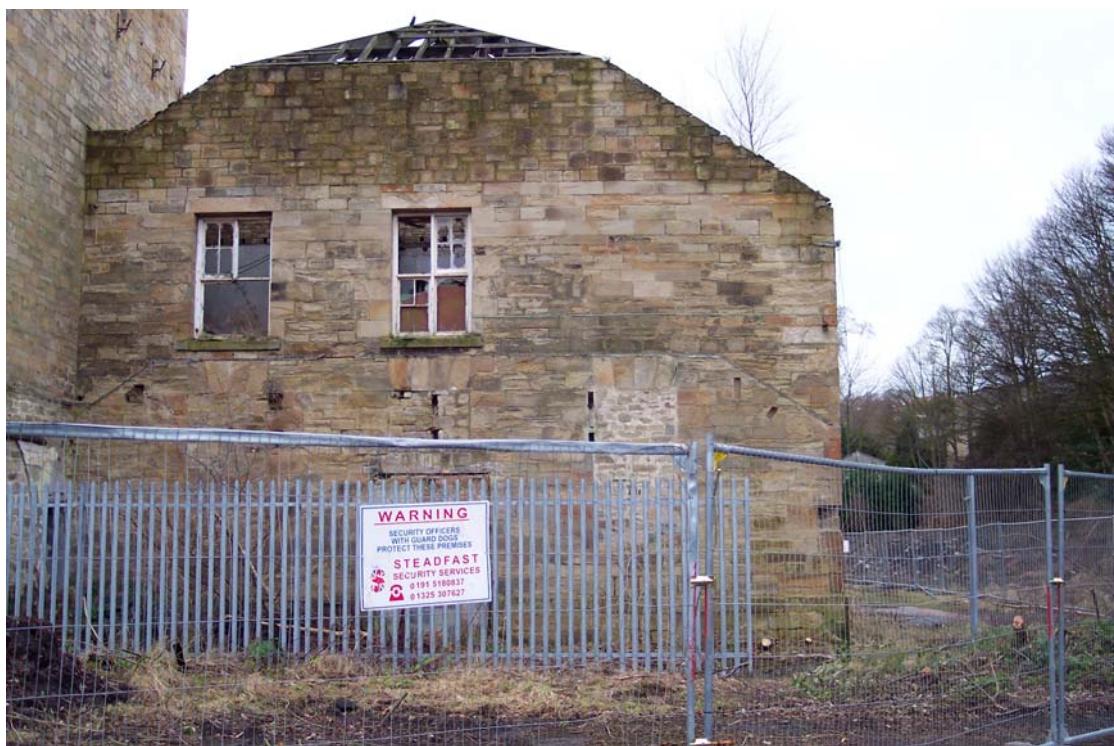
Plate 3: The east elevation of the Annex

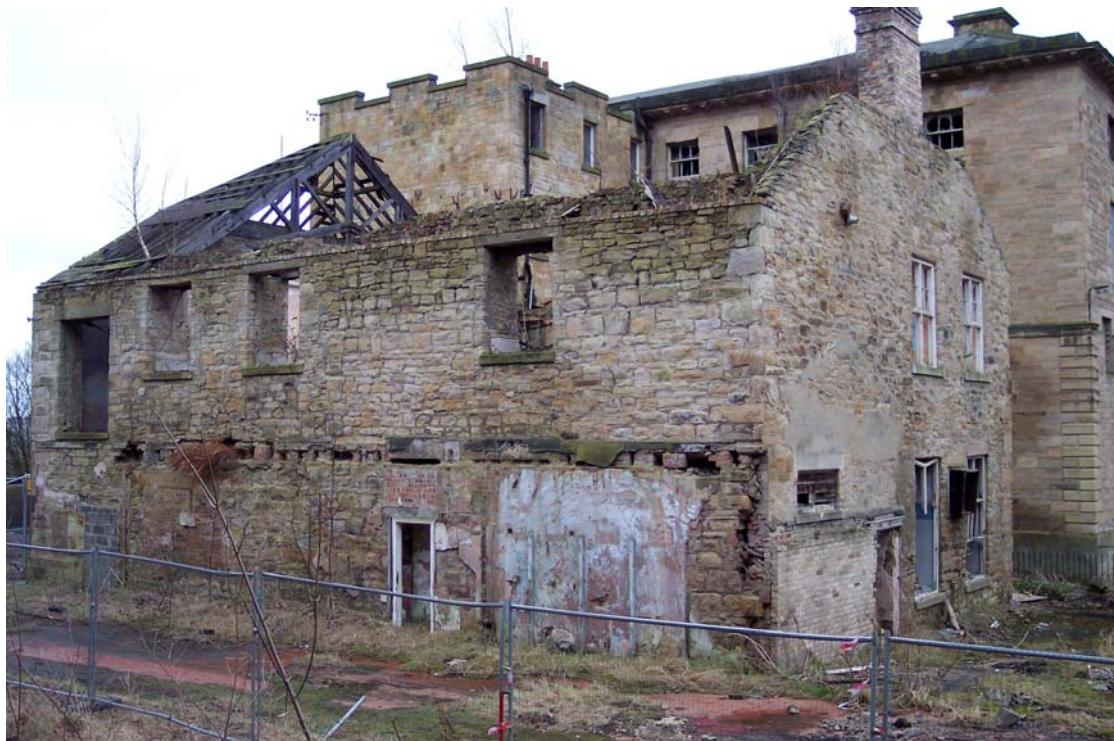
Plate 4: The north elevation of the Annex, west end

- 3.1.7 ***Annexe – North Elevation:*** the north elevation of the rear annexe has been much modified and is in a poor general state of repair (Plates 4-6). It is largely composed of random coursed stone, which is patched in places with modern brick. There are four upper windows, all of which are unglazed and have flat lintels and slightly projecting sills. The easternmost window is twice as large as the other three windows, which are all the same size. All of the latter appear to have been reduced by the infilling of the lower half. A smaller lintel above the large window may be the remains of a small window. Above the windows at eaves level is a row of brick headers. Below the three small windows, a line of missing stones and the remains of some roofing material, together with brick infilling alludes to the presence of a lean-to or outshut which extended north. To the east of this, and below the large window, a timber lintel is present within the wall. Below this is a small blocked (with modern brick) aperture with a stone sill and lintel, which was probably a window. To the right of this is a blocked (with cinder block) doorway. West of this a cast iron down pipe has been built into the wall. The remains of a brick arch are visible above a wide blocked (with brick) doorway that has a sandstone lintel. This blocked aperture has a stone sill. A further doorway is situated approximately 6m east of the western end of the wall, which has a timber lintel with some brick infilling above. This door has been blocked on its interior, approximately 0.5m back from the elevation To the west of this there are the remains of plaster adhering to the wall. The extreme western corner of the elevation has been patched with brick.

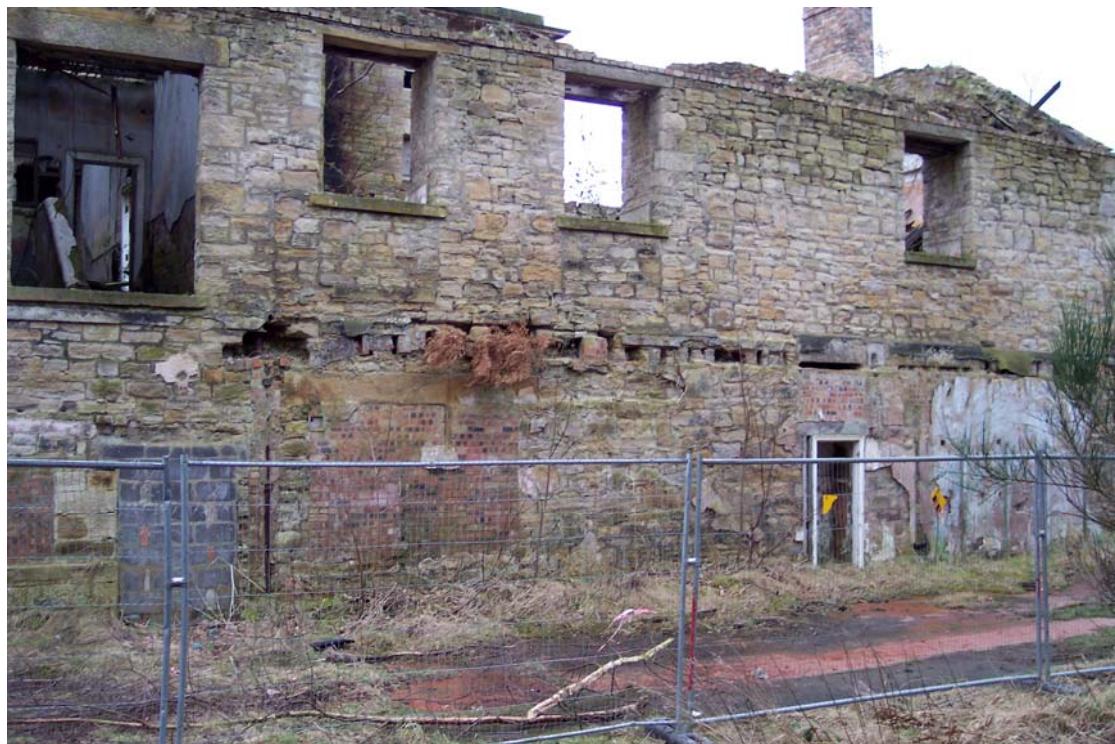
Plate 5: The north elevation of the Annex, east end

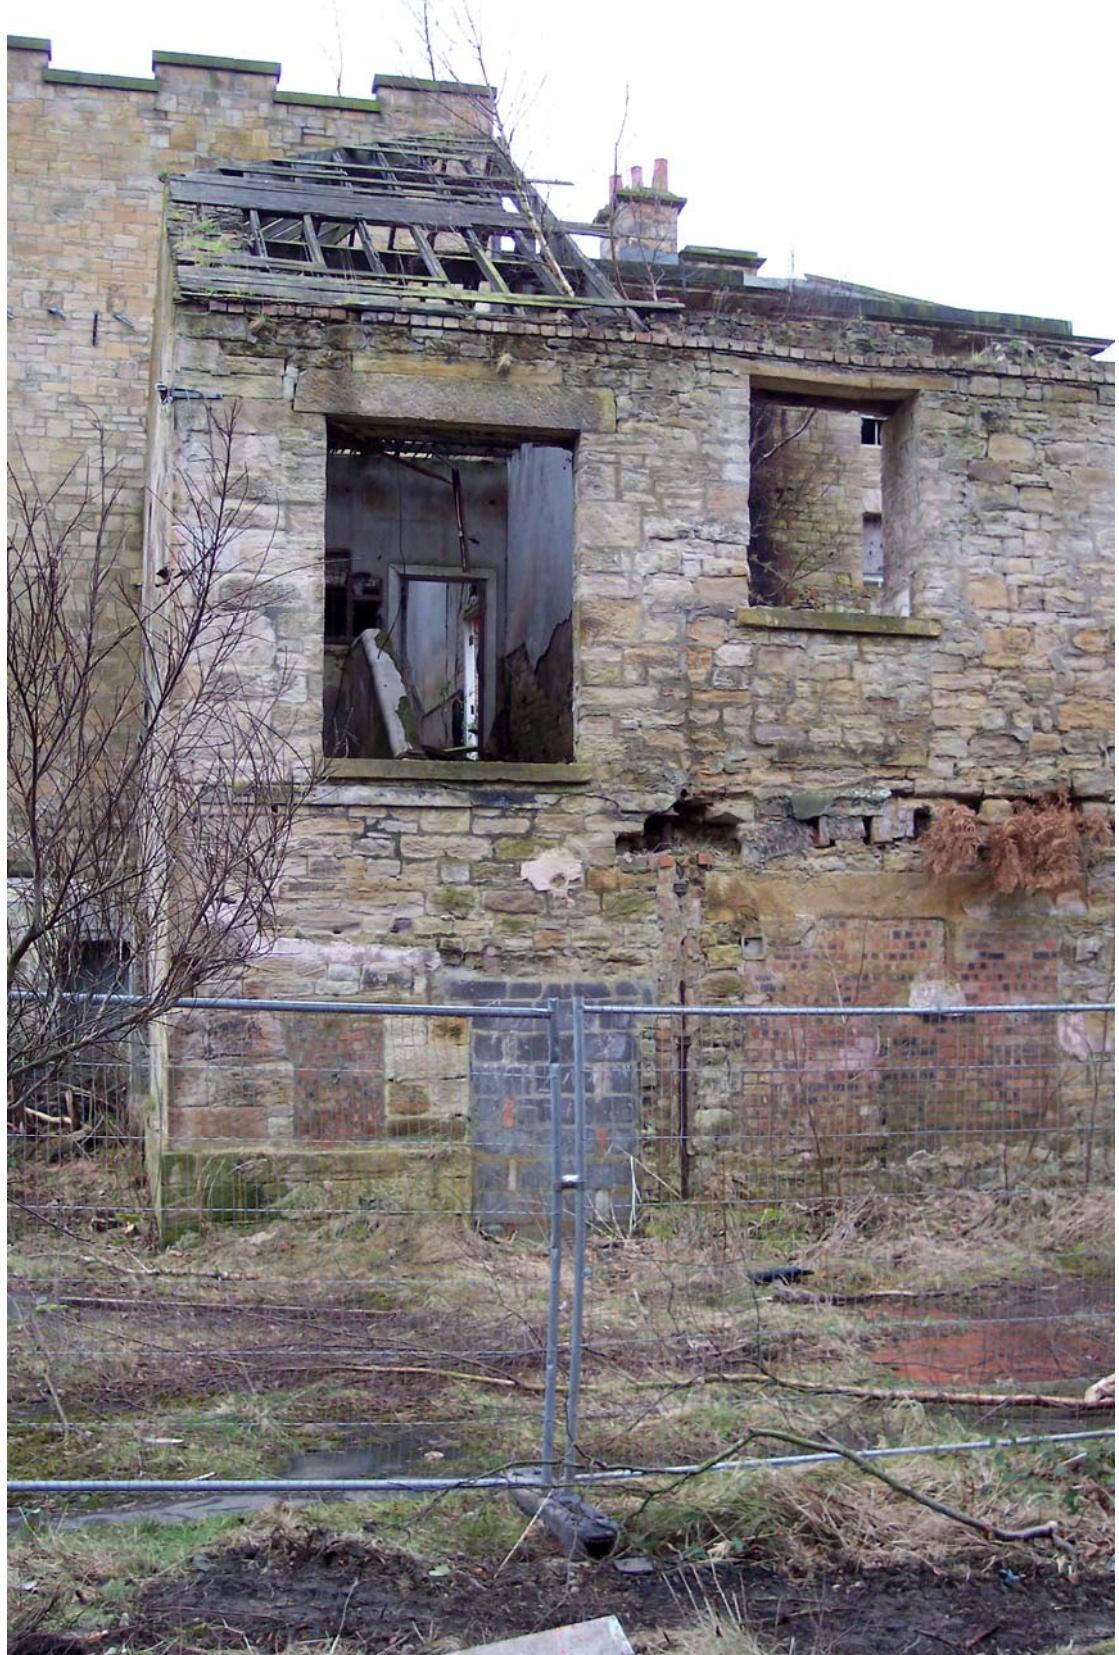
Plate 6: Detail of the north-east corner of the Annex

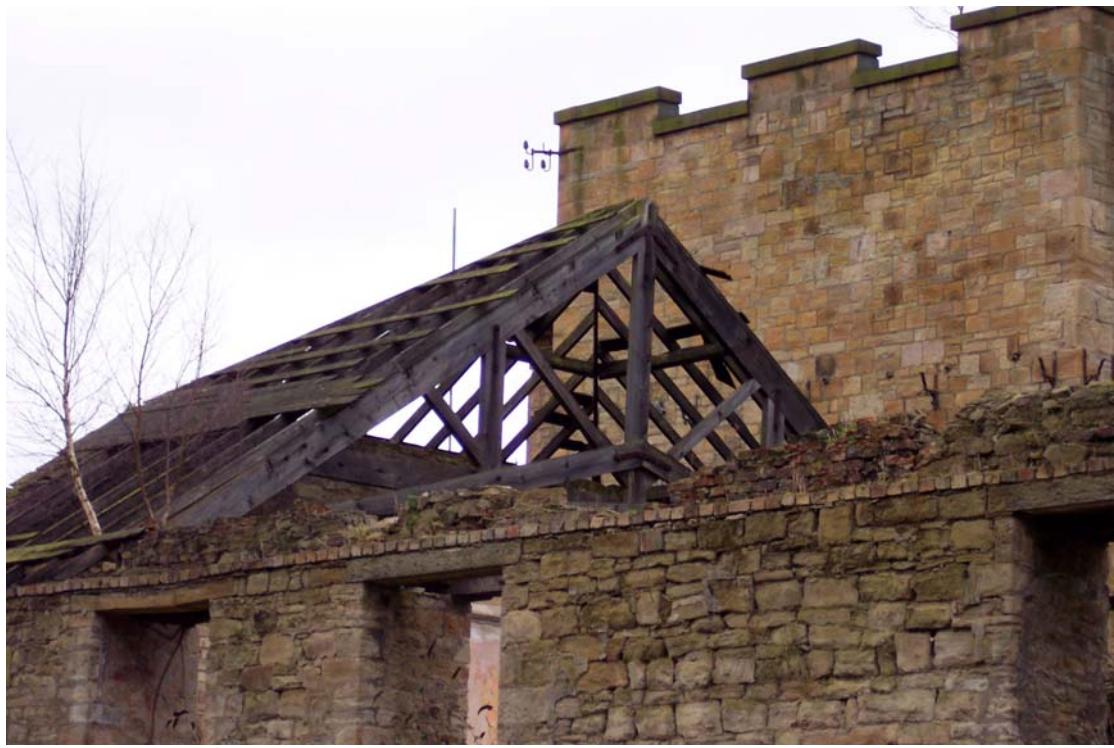
Plate 7: Detail of the roof-truss at the east end of the Annex roof showing surviving roof detail

- 3.1.8 Although, most of the roof is collapsed and now lies on the first floor, sufficient evidence remains from the surviving timbers and truss that lie on the internal cross-partition at the east of the building. The roof was originally hipped with a composite truss of king-post design with queen struts added (Plate 7). Both the king post and the queen struts have diagonal braces, and

there is also a pair of shallow angled braces, which run from the end of the tie-beam to the king-post. As a later roof structure, all of the timbers are fixed with iron bolts and three way straps/plates.

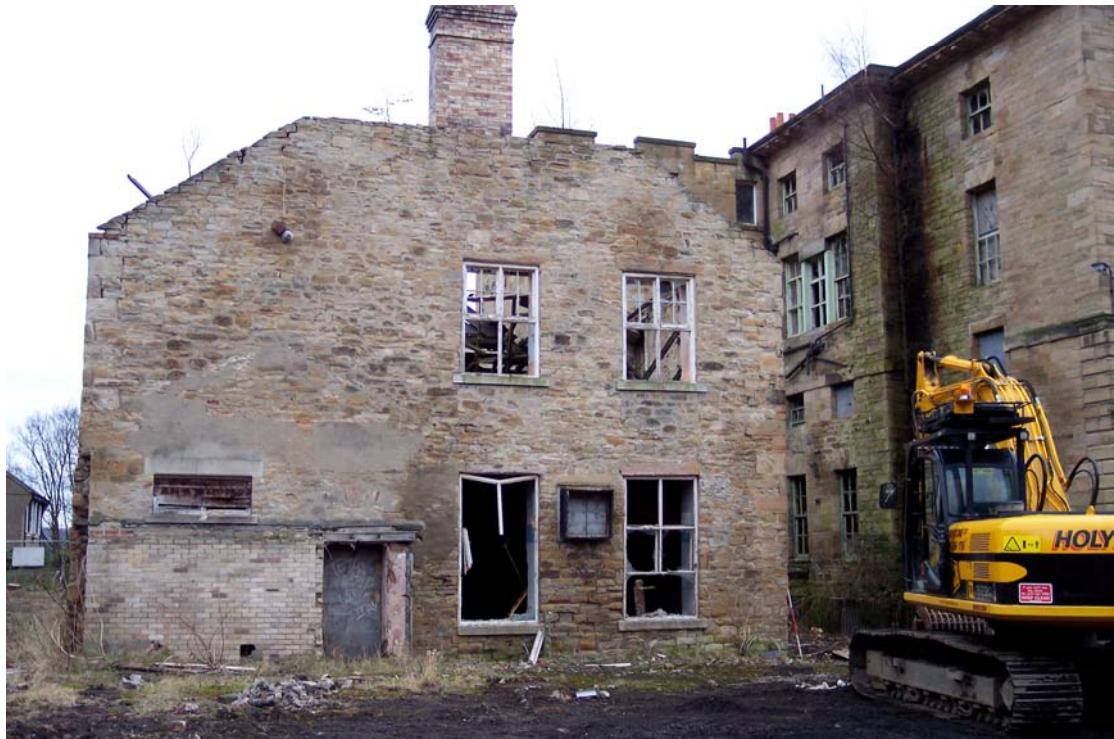
Plate 8: The west elevation of the Annex

- 3.1.6 ***Annexe – West Elevation:*** the general proportions of this elevation are similar to the east elevation (Plate 8). There are four windows, the upper two of which are similar to those on the east elevation. The lower two are also similar and are without glazing. There is a pitched roof scar on the northern half of the elevation below which is a blocked door (blocked in a similar fashion to that on the north elevation) and a partially blocked window with a concrete sill and lintel. A large area of brick blocking is present here below what could be an outshut or lean-to roof scar. Sitting atop the gable is a pale yellow brick chimney with three cylindrical terracotta pots.

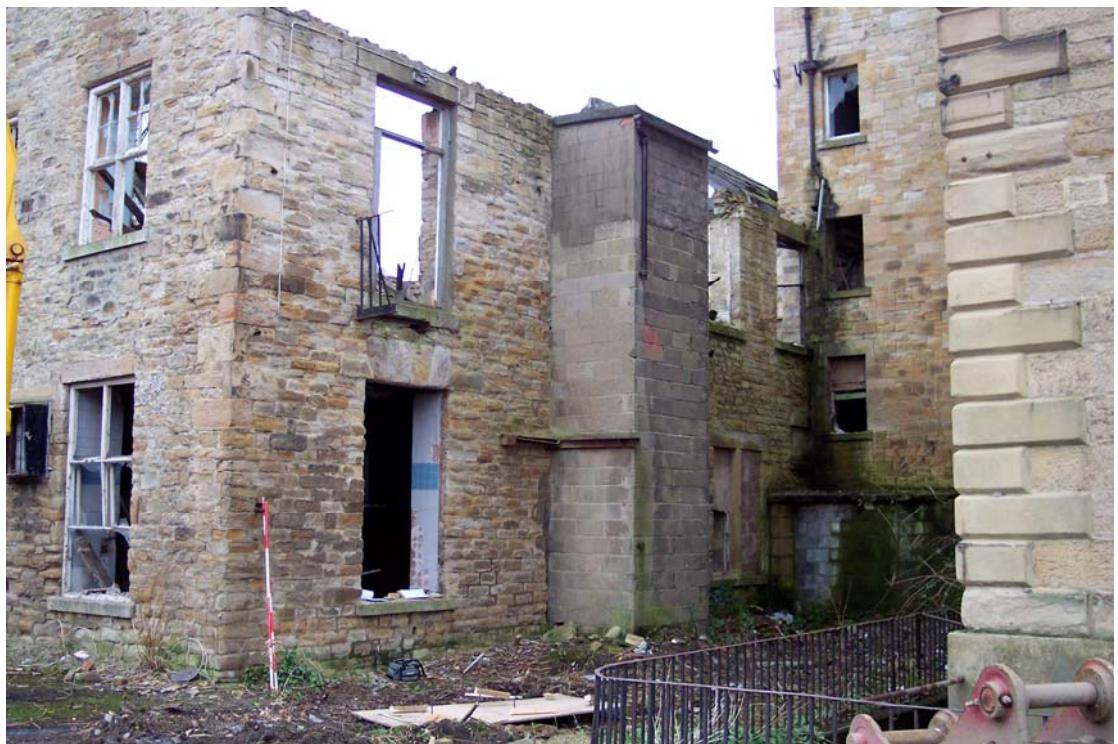
Plate 9: The south elevation of the Annex

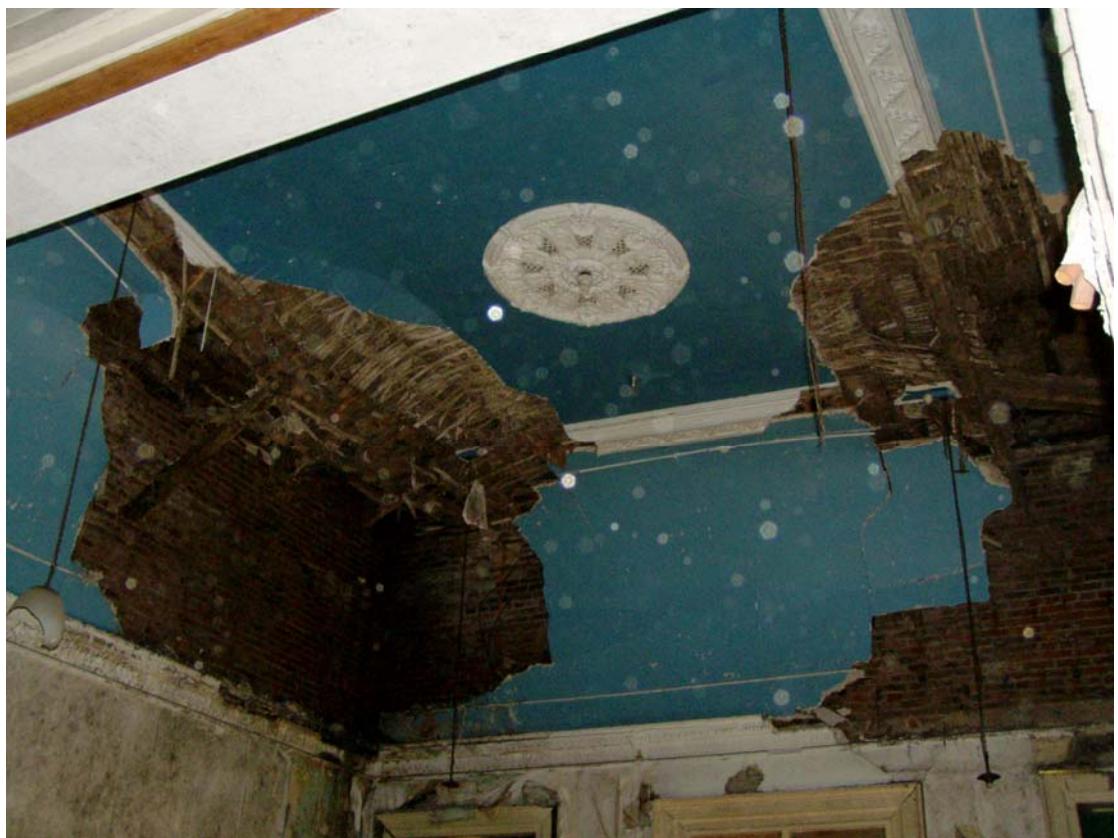
Plate 10: General view of the ceiling plasterwork in the Entrance Hall (29)

- 4.1.9 **Room 29 Entrance Hall:** this room has a coved ceiling (Plate 10) with an elaborate cornice, stringing to the coving, a moulded ceiling panel and central rose (Plate 11). The cornice rail has a decorated astragal moulding at the base with deep band of elongated acanthus leaf above that followed by a band of egg and dart (Plate 12). Above the egg and dart is a plain band with a narrow decorative band above.

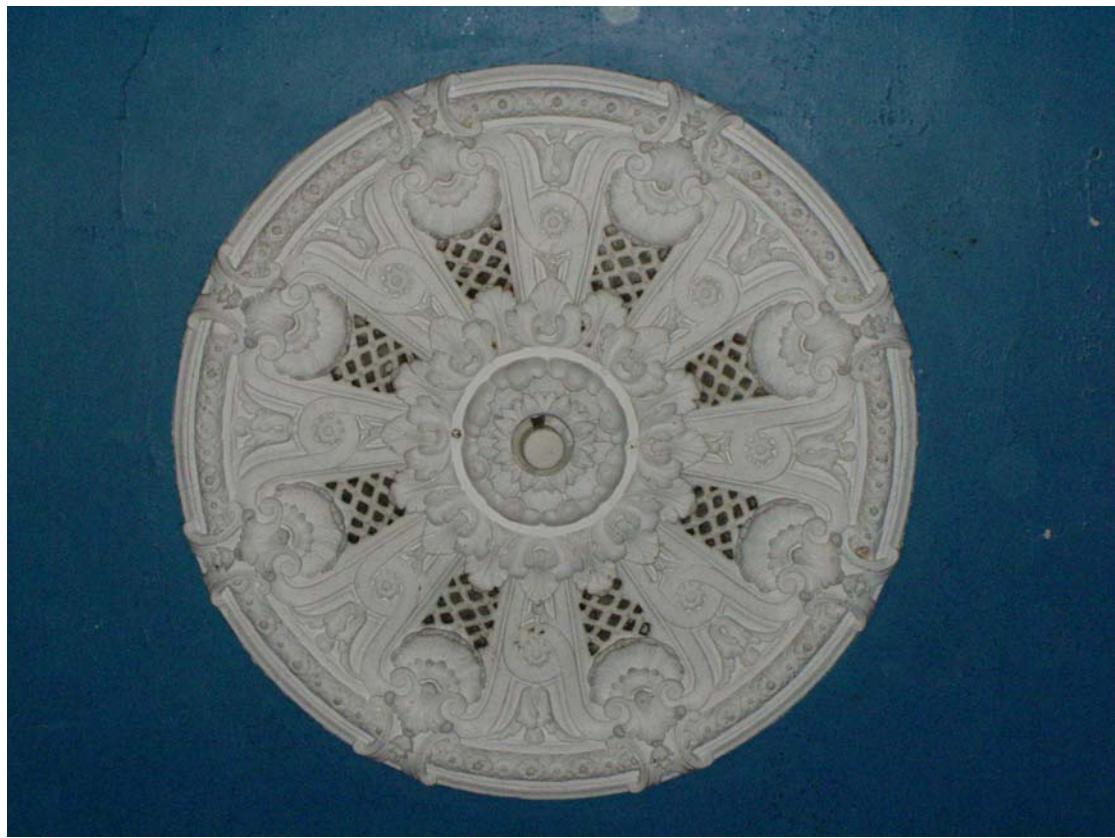
Plate 11: Detail of the ceiling rose in the Entrance Hall (29)

- 4.3.1 There may have been some modification of the ceilings in the Victorian period, as in the case of the ceiling rose in the entrance Hall (Room 29) (Plate 11), which may have been renewed or adapted for gas lighting.

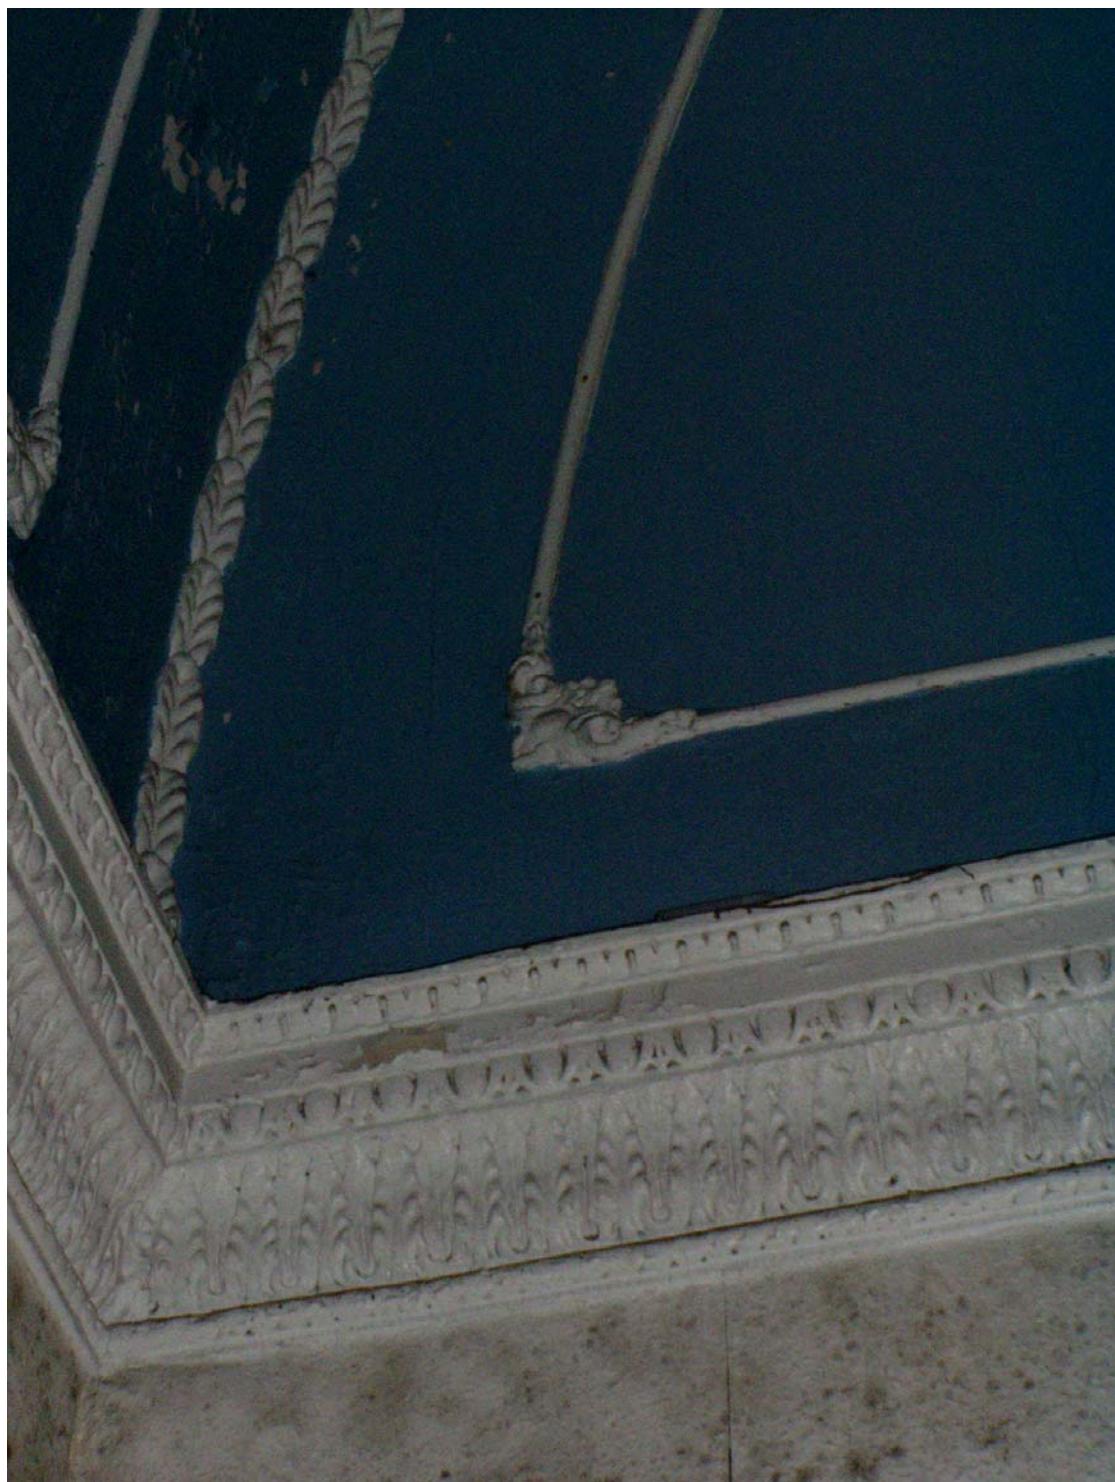
Plate 12: Detail of the cornice in the Entrance Hall (29)
