AXWELL HALL, GATESHEAD PHASE 2

**Archaeological
Building
Investigation**

Oxford Archaeology North

June 2006

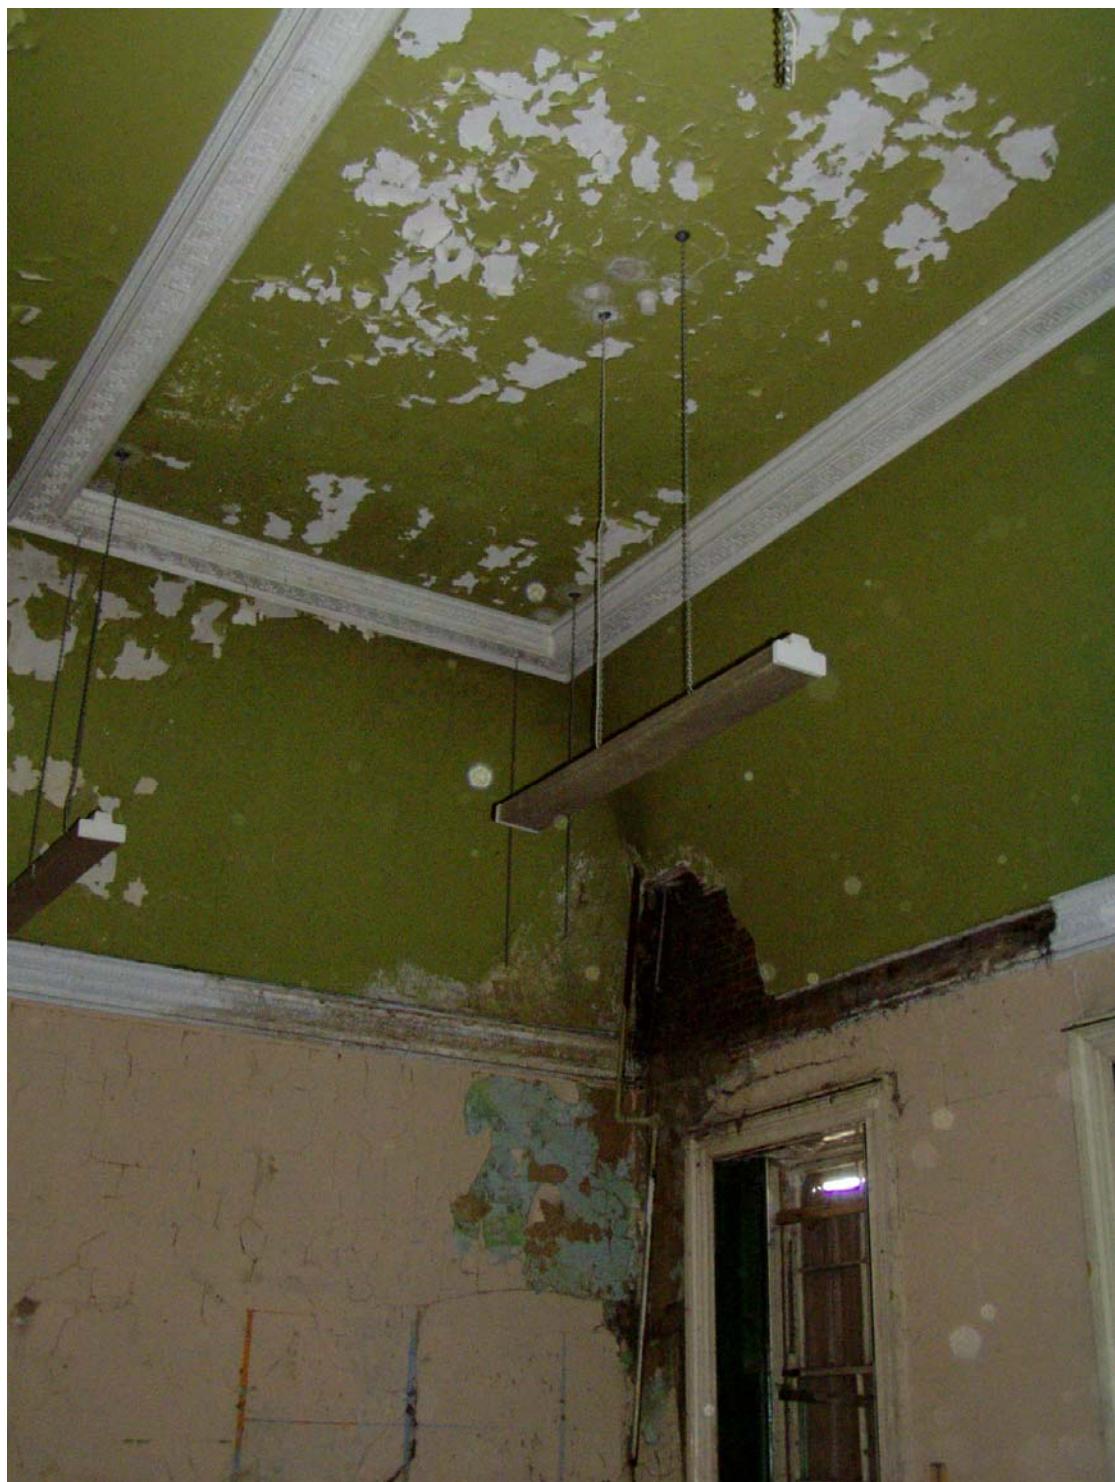
Plate 13: General view of the ceiling plasterwork in the Drawing Room (30)

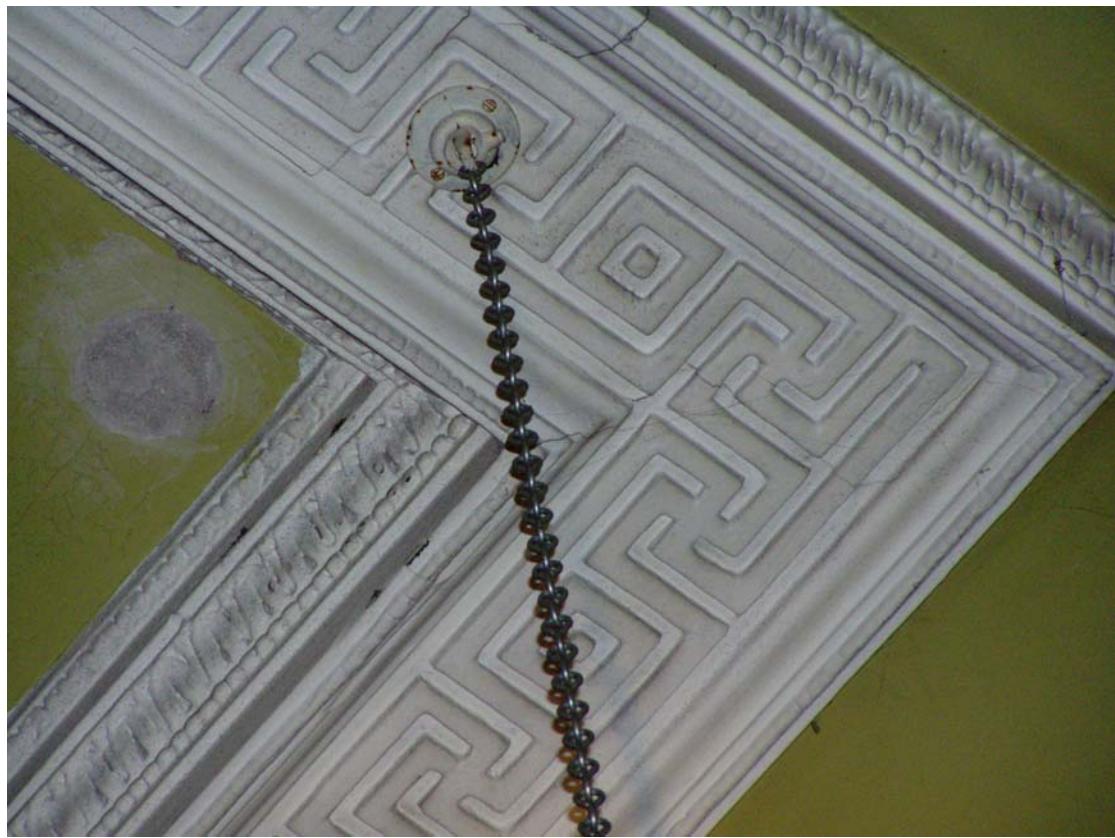
Plate 14: Detail of the ceiling moulding in the Drawing Room (30)

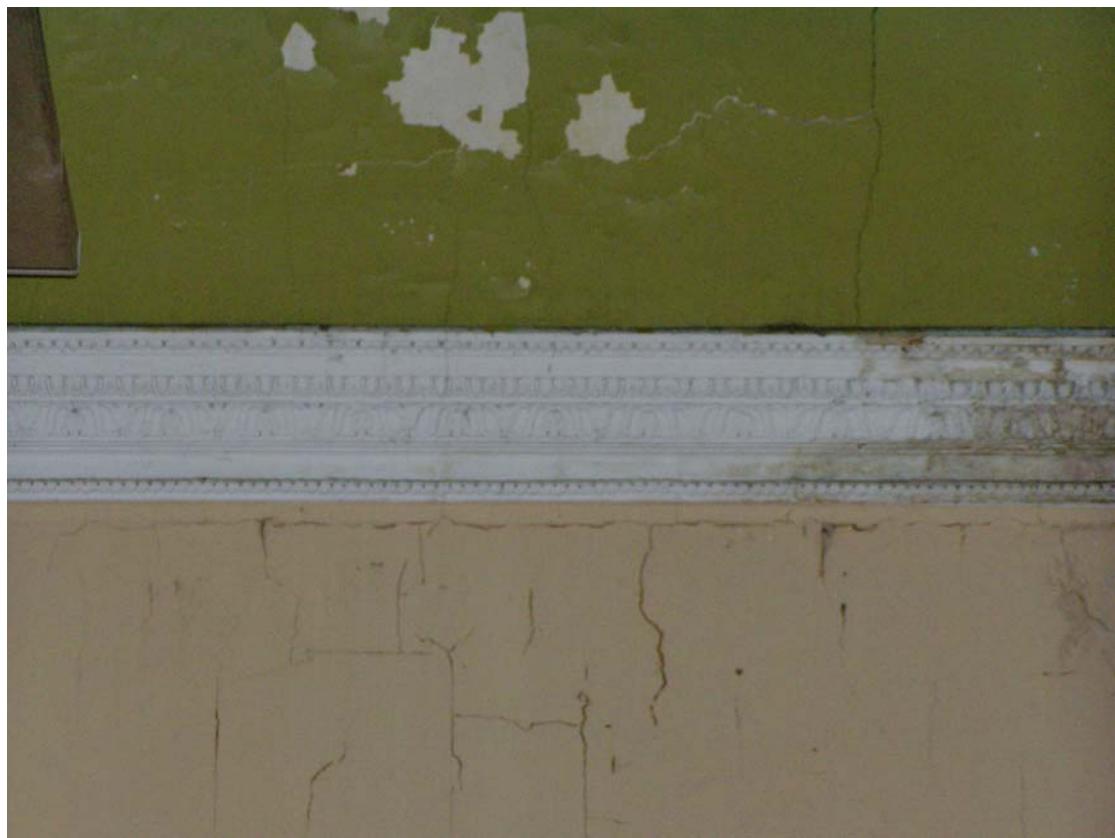
Plate 15: Detail of the cornice in the Drawing Room (30)

- 4.1.12 **Room 30, The Withdrawing Room:** this room has a cornice (Plate 15) enriched with a band of egg and dart moulding and a narrow upper decorative moulding. The ceiling is coved with a central rectangular moulded panel, which has a bands of beaded moulding and what appears to be waterleaf moulding (Plates 13 and 14). The soffit is decorated with a wide band of Greek key moulding.

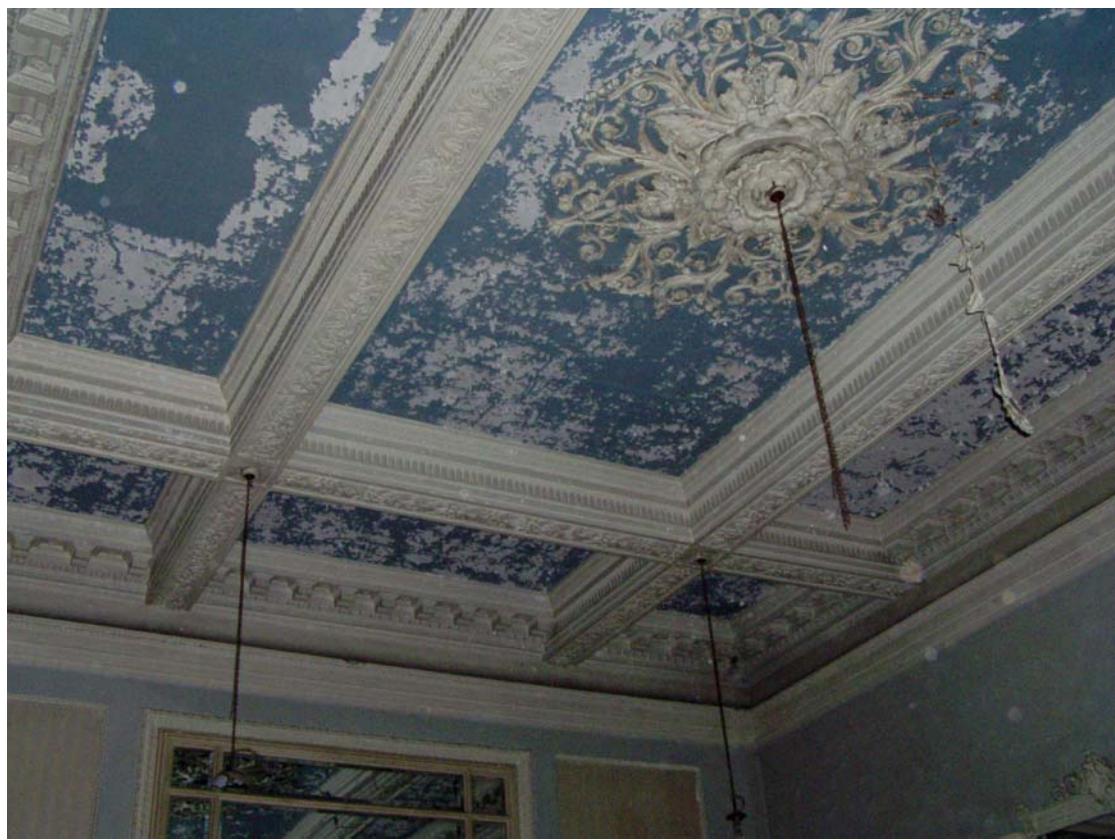
Plate 16: General view of the ceiling plasterwork in the Best Dining Room (23)

- 4.1.2 **Room 23, The Best Dining Room:** thick layers of paint obscure the detail of the mouldings and make recognition of some of the decorative forms difficult (Plates 16 to 19).

restraint. The Best Dining Room (Room 23) (Plates 16-19) has a fine rose of Augustan design, with associated decoration continuing on the wall panels and over-door, whilst the Common Dining Room (Room 28) (Plates 20-22) is more sophisticated, with its oval ceiling compartment and deep decorated frieze of swags and urns.

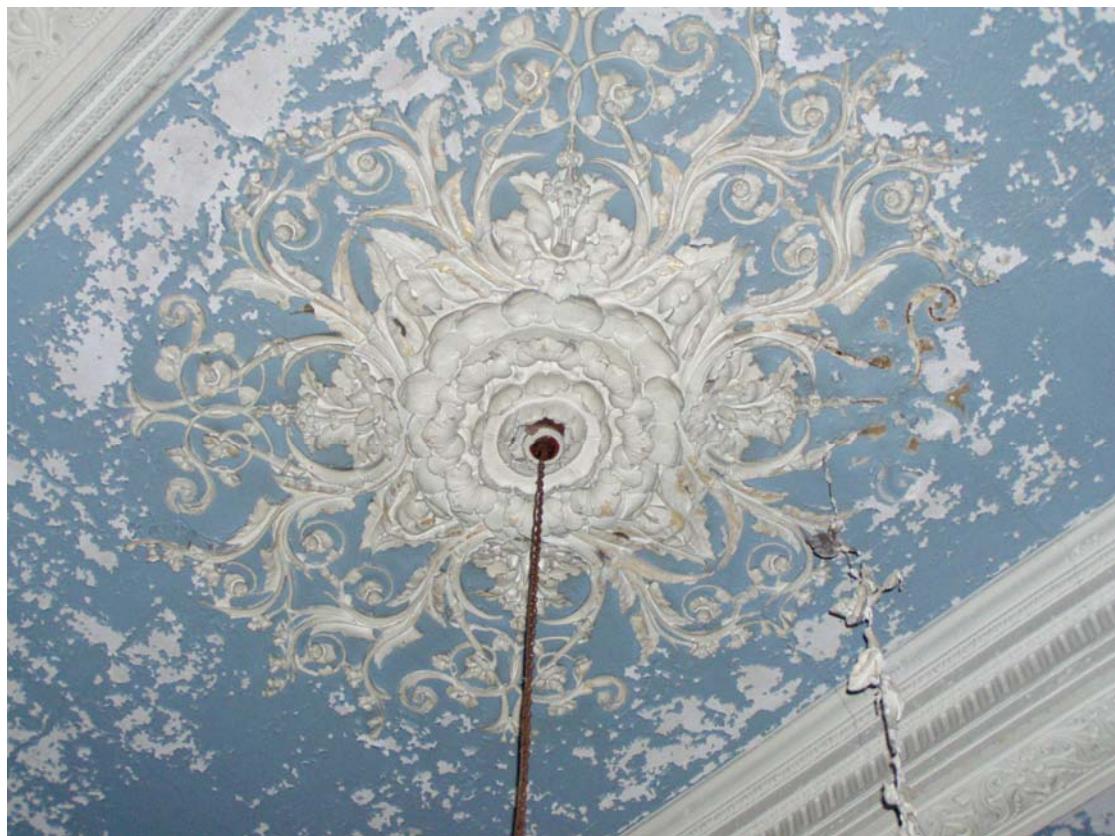
Plate 17: Detail of the ceiling rose in the Best Dining Room (23)

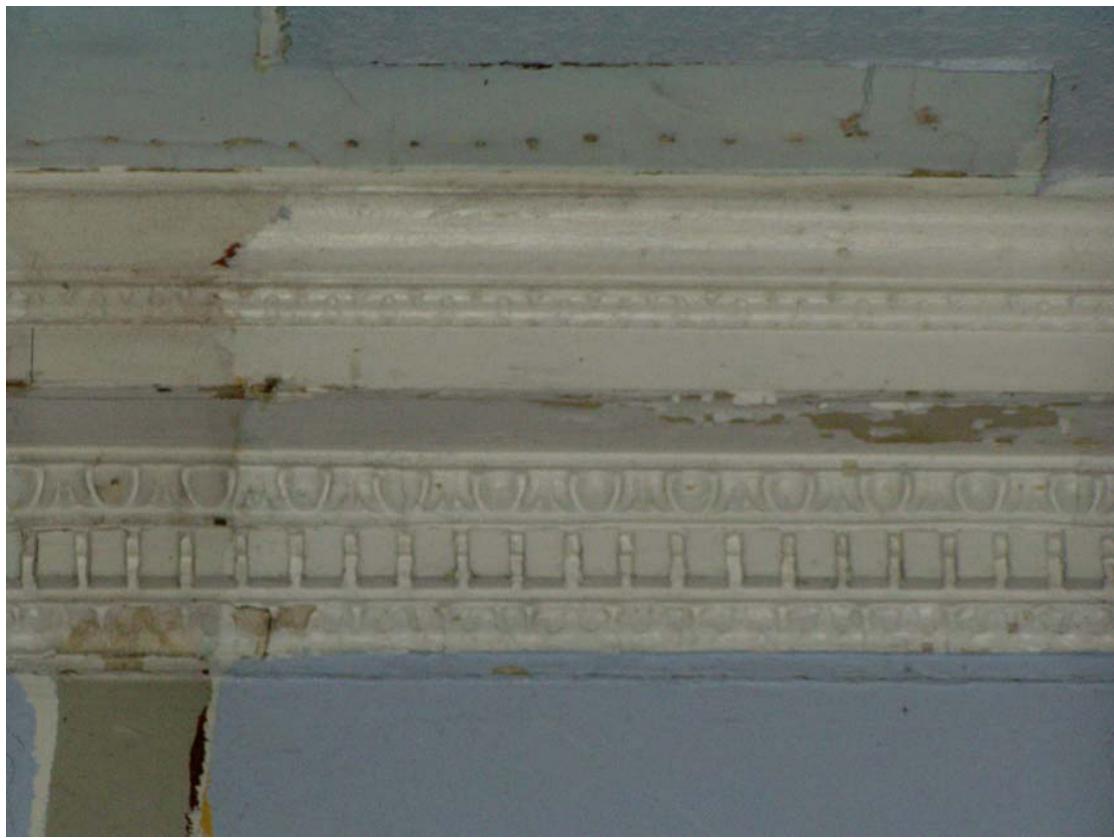
Plate 18: Detail of the cornice in the Best Dining Room (23)

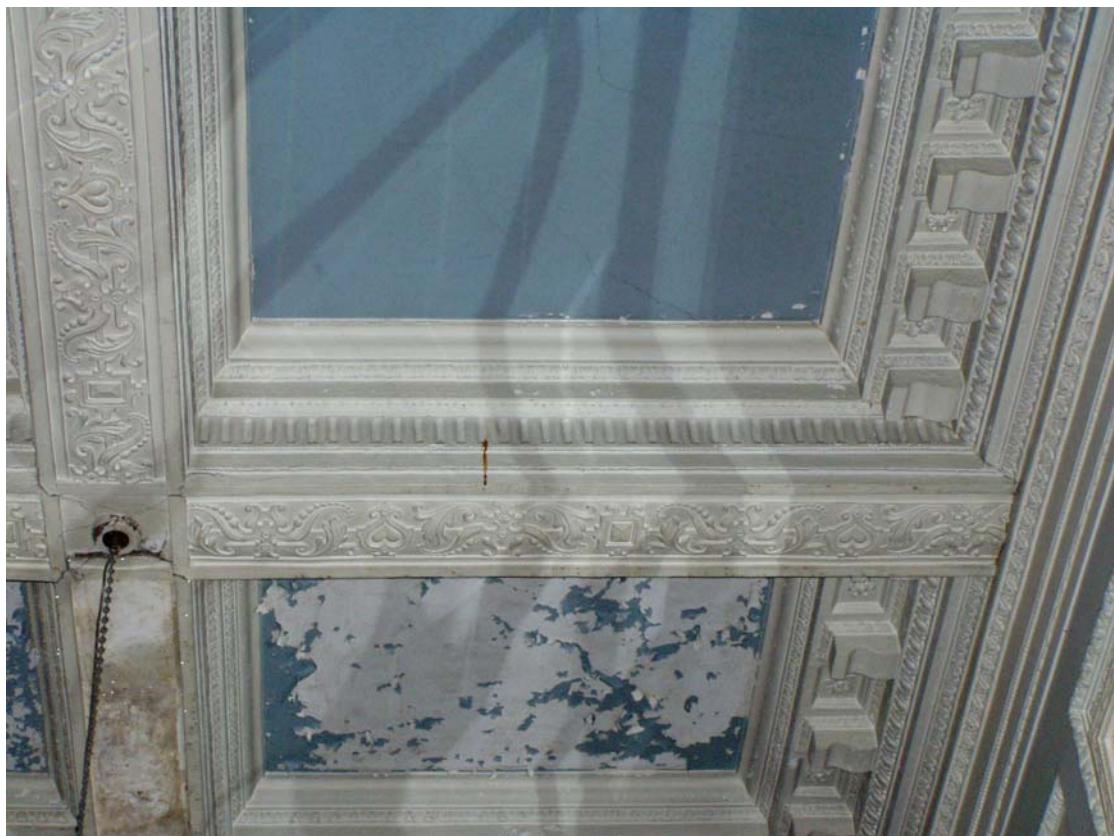
Plate 19: Detail of the ceiling compartments in the Best Dining Room (23)

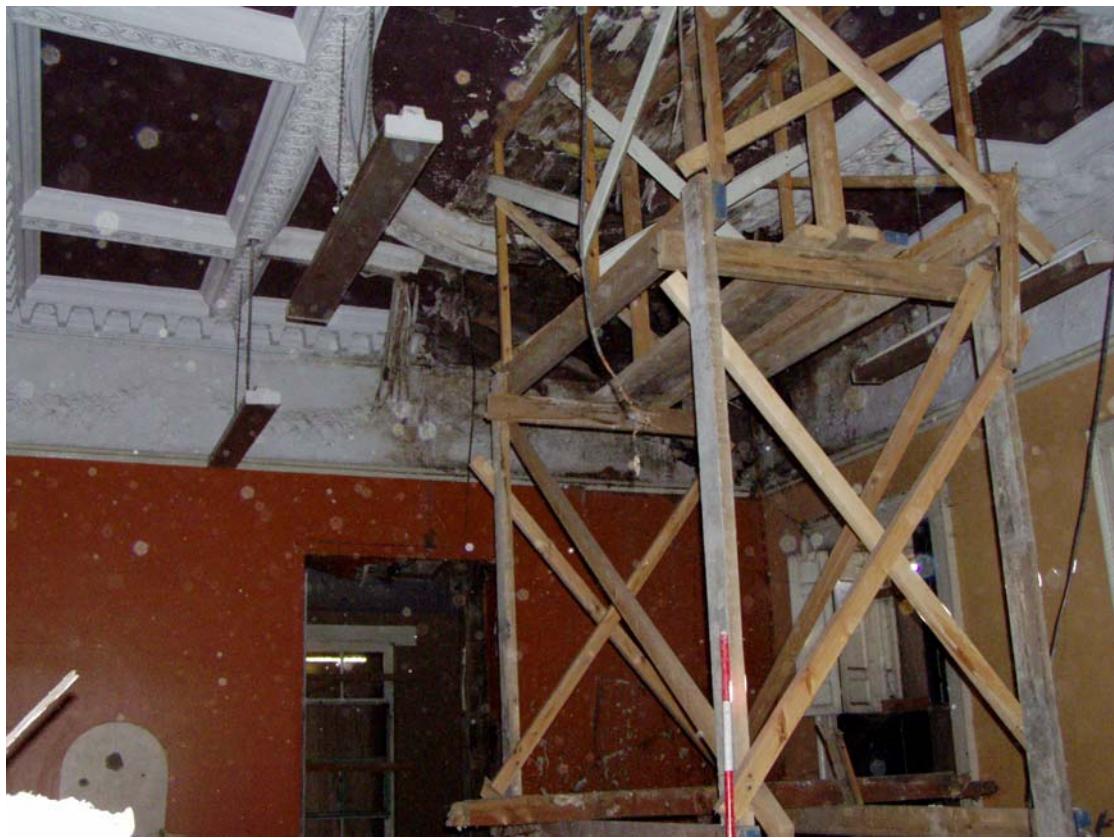
Plate 20: General view of the ceiling plasterwork in the Common Dining Room (28)

- 4.1.7 **Room 28, The Common Dining Room:** the ceiling is divided into panels consisting of a large central oval with surrounding square and rectangular panels (Plates 20 to 22). The cornice projects below the soffit of the panel mouldings and has a bead moulding below modillions alternating with paterae. This is similar to Room 23 although here the modillions have plain soffits. The upper cornice and panel mouldings have a cyma recta moulding at the top with a band of bead or bead and reel moulding below it. The soffits are decorated

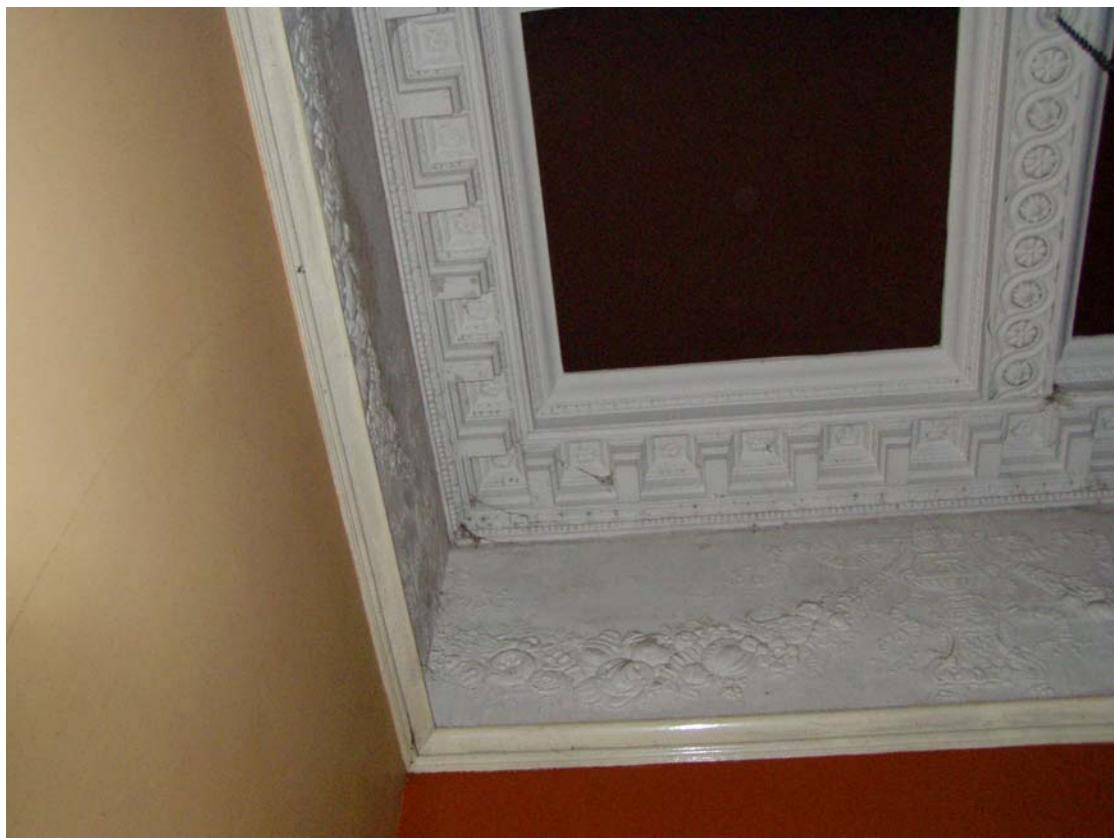
Plate 21: Detail of the frieze and cornice in the Common Dining Room (28)

- 4.1.8 Below the cornice is a deep frieze with low relief decoration of heavy floral swags suspended from urns on decorative stands (Plate 21). Below the frieze is a plain wooden picture rail.

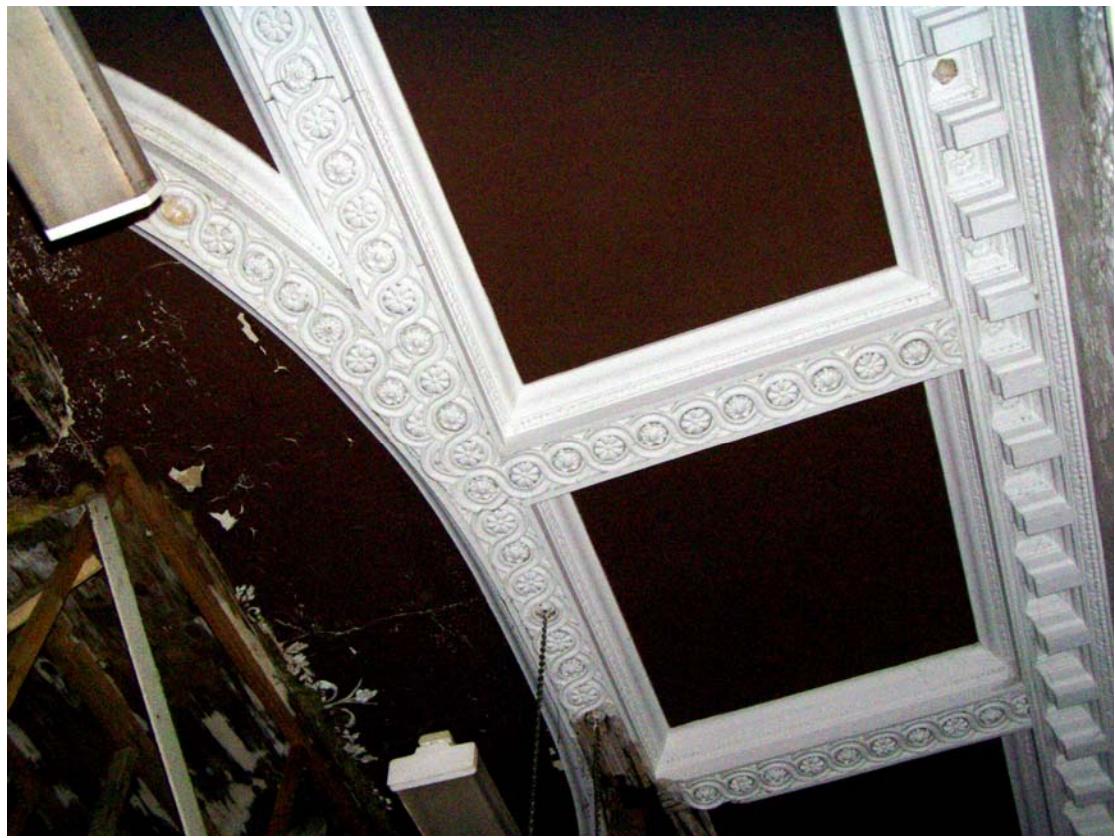
Plate 22: Detail of the ceiling compartments in the Common Dining Room (28)
