Albion Mill, Factory Hill, Lancaster, Lancashire

Archaeological Building Investigation

Oxford Archaeology North

October 2013

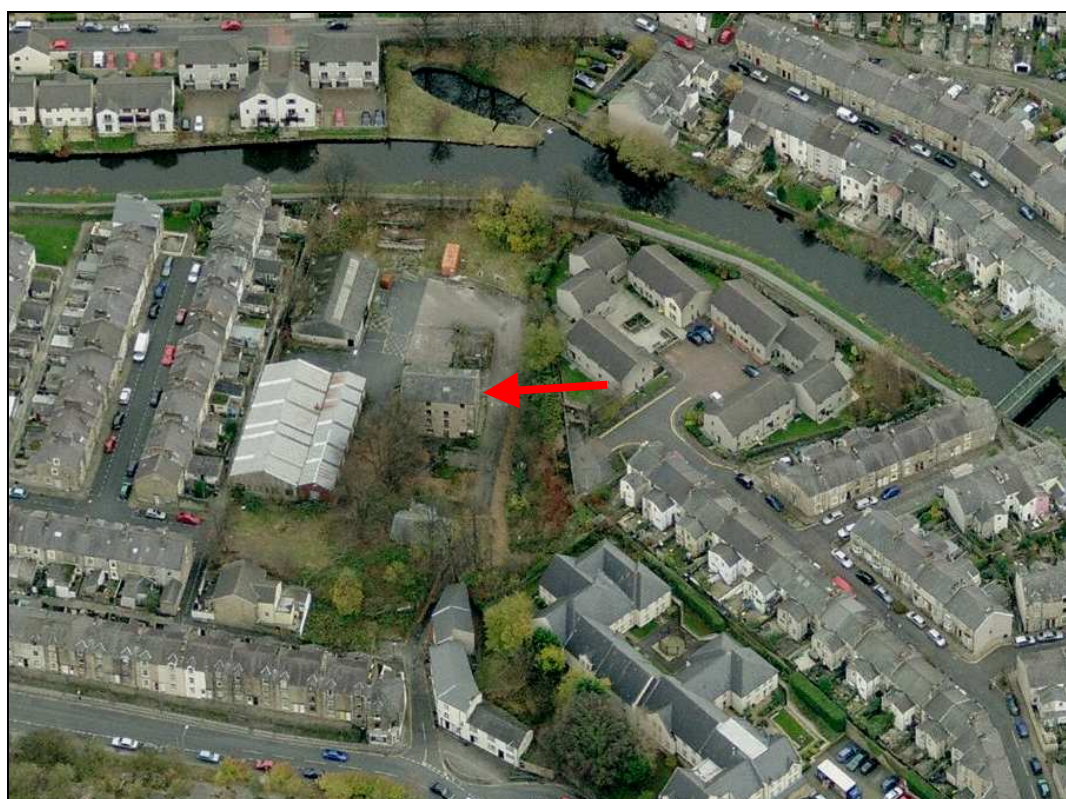
Plate 1: Aerial view looking east across the site, with arrow marking the subject building

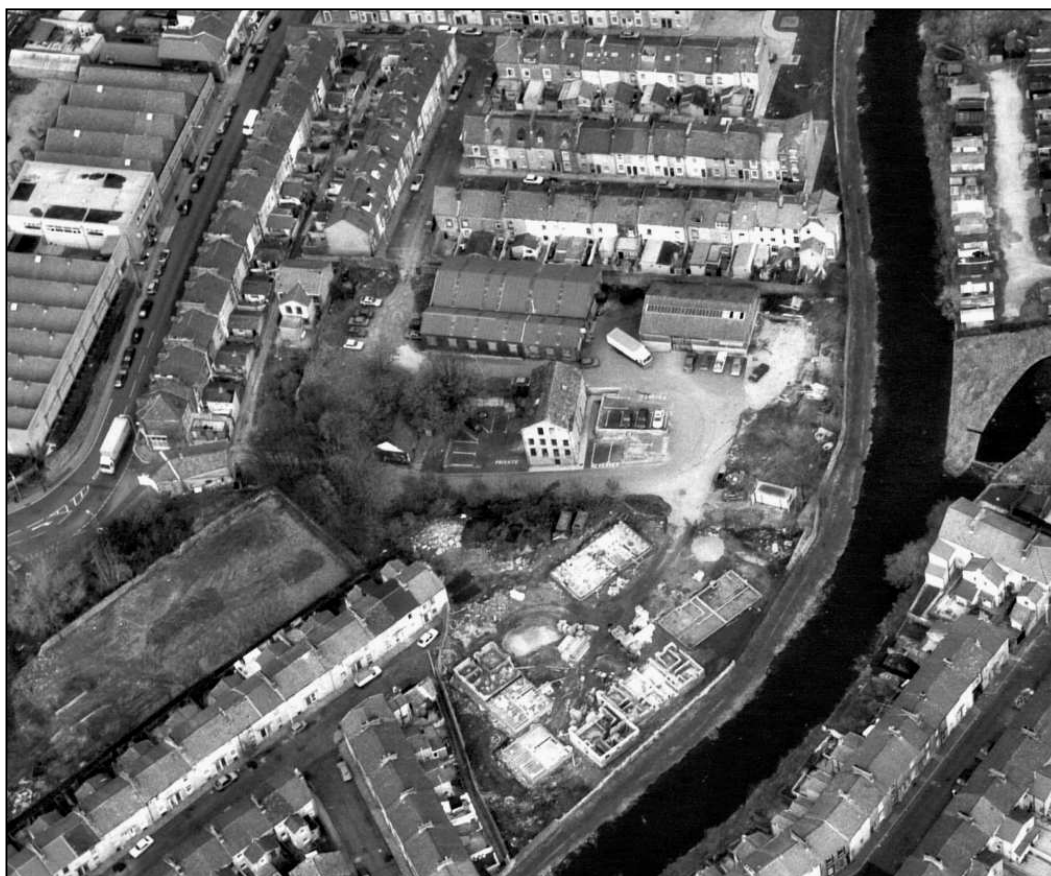
Plate 4: Aerial view across the site of Albion Mill taken in 1988

- 1.3.6 The mill was taken over by William Goodacre & Sons (also of Holme and Kendal) sometime between 1915 and 1924. The Ordnance Survey 1:2500 map of 1956-7 annotates the mill complex as a weaving and dyeing factory. This firm continued the production of coconut matting, and later rugs and carpets, at Albion Mill. The firm ceased trading in 1963 (CA/WDB 64), and the site was converted for use as a small industrial estate. The main buildings adjacent to the Lancaster Canal were eventually demolished to enable the residential development of Albion Mews in the late 1980s (Plate 4).

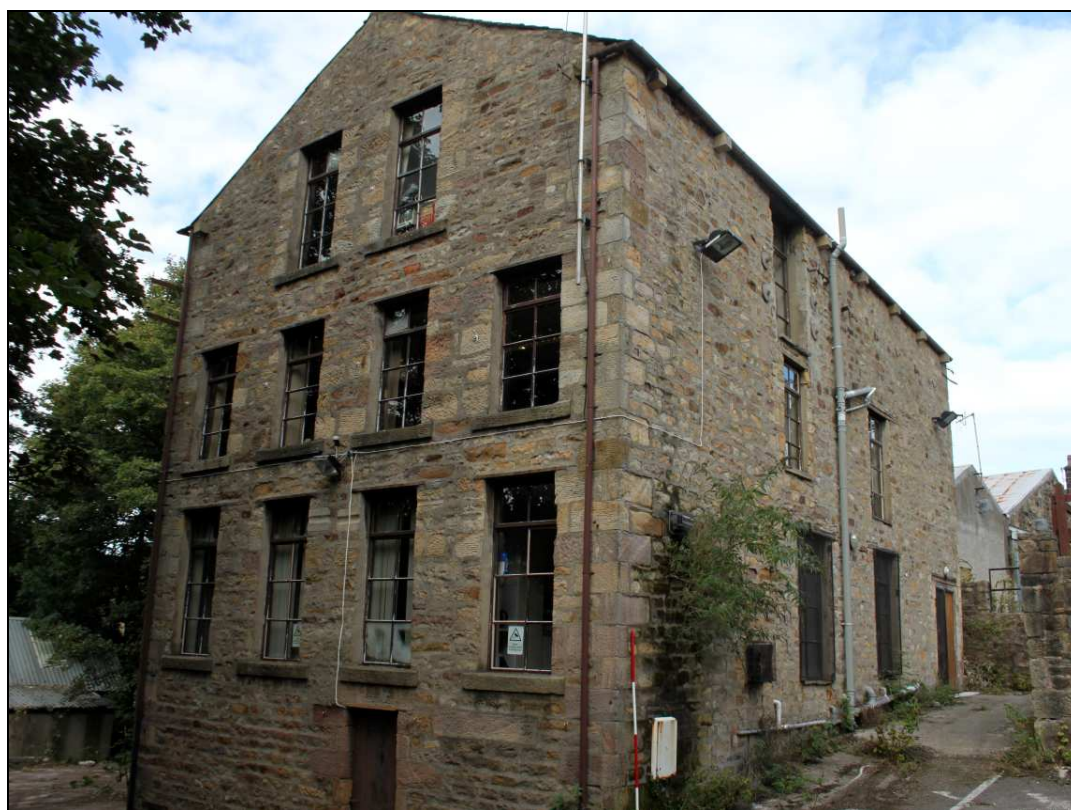
Plate 5: General view of the multi-storey block, looking north-west from Factory Hill

- 3.1.1 The former Albion Mill complex comprises two historic buildings: a multi-storey block, which formed the focus of the archaeological building investigation (Plate 5); and a single-storey range immediately to the north. The multi-storey block comprised a four-storey, stone structure occupying the north-western part of the site, fronting Factory Hill. Internally, the building above the ground floor measures 12.9 x 7.48m, with the wall having a thickness of 0.46m.

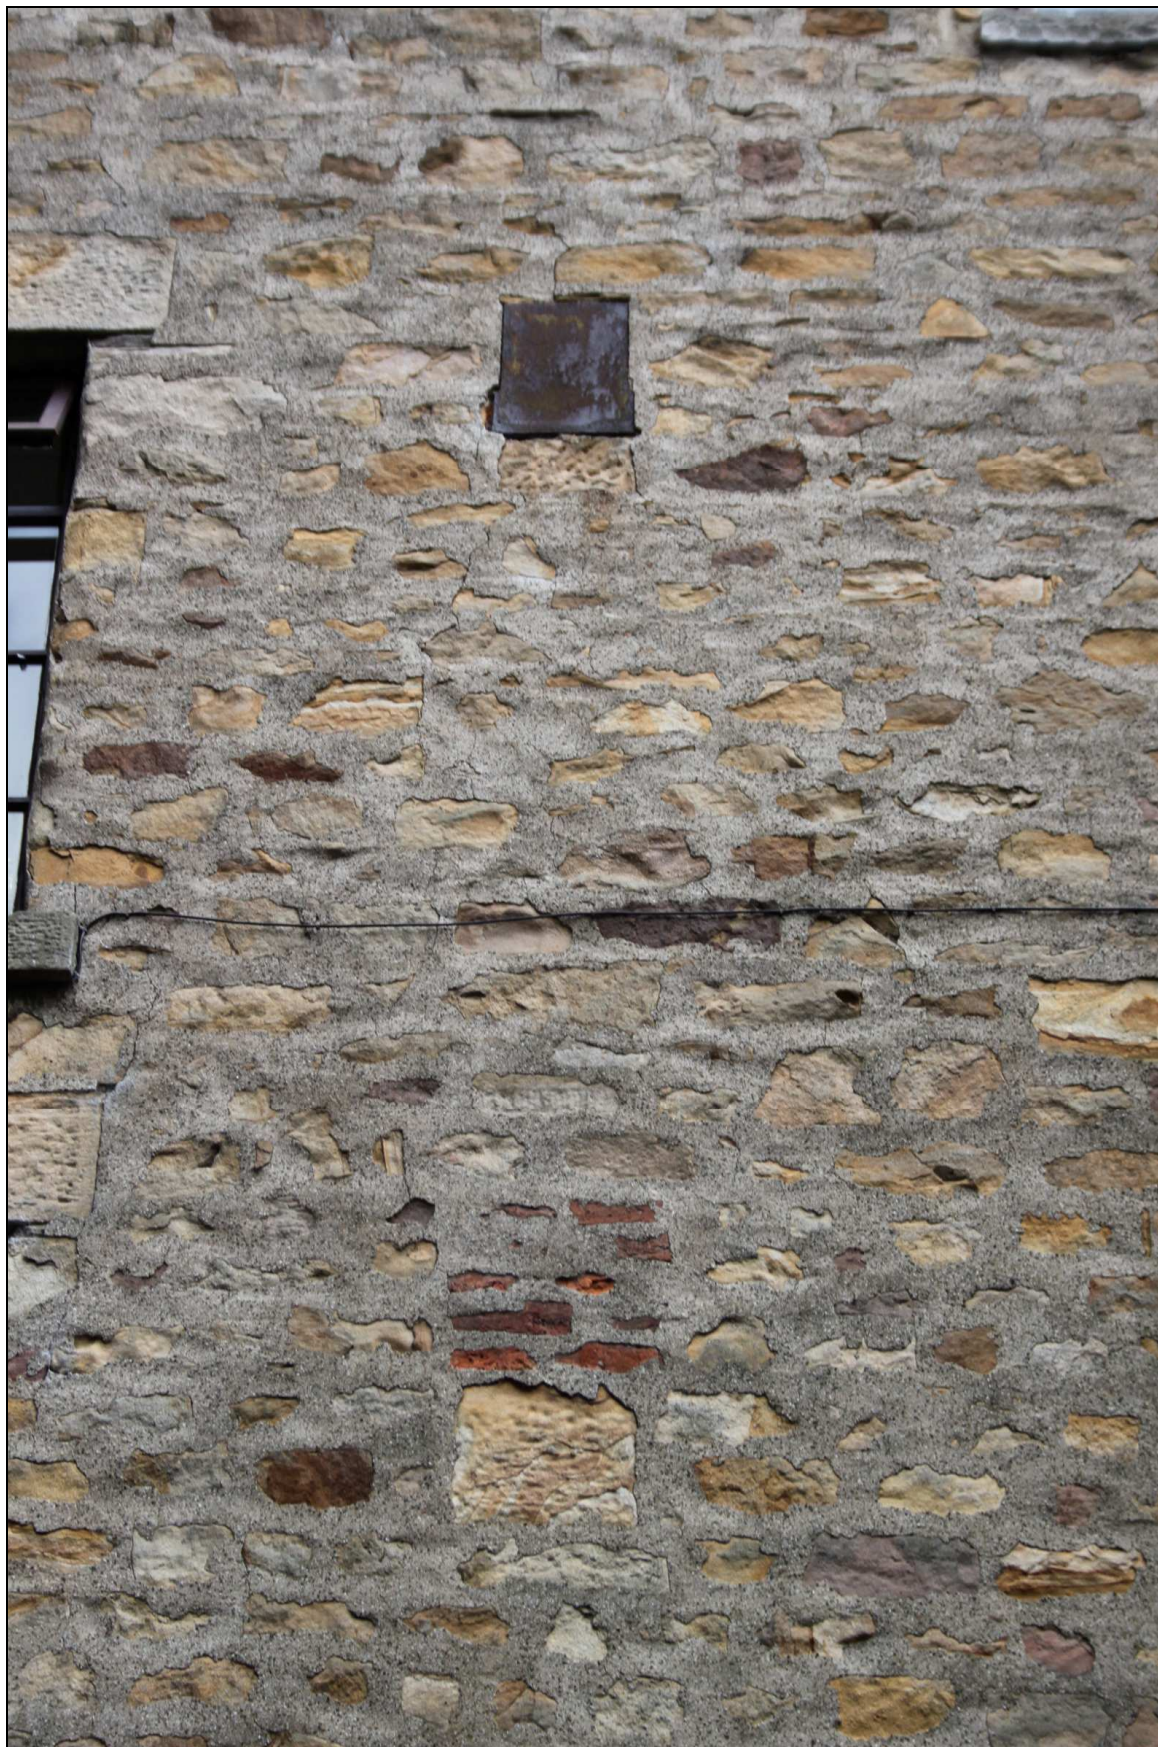
Plate 6: Brick blocking above a stone corbel at first-floor level in the west elevation of the building

- 3.1.2 The original building, erected prior to the Ordnance Survey map of 1849 (Plate 2), was bounded on its northern side by a curving retaining wall, forming an asymmetrical structure. This curving wall survives extant within the ground floor of the existing building. Late re-pointing / partial rendering of the external walls obscured detail which may have demonstrated whether the upper stories of the extant structure formed part of the original construction, or were added when the building was extended by up to 6.2m on its northern side, adding a further bay, and creating a uniformly rectangular structure. Brick blocking in the east and west long walls above stone corbels carrying the ceiling beams at first-floor level (Plate 6), and the use of cast-iron brackets for the ceiling beams at second-floor level, suggest that the original structure was possibly of two-storey height, with the ceiling beams being replaced when the structure was extended to its present four-storey height.

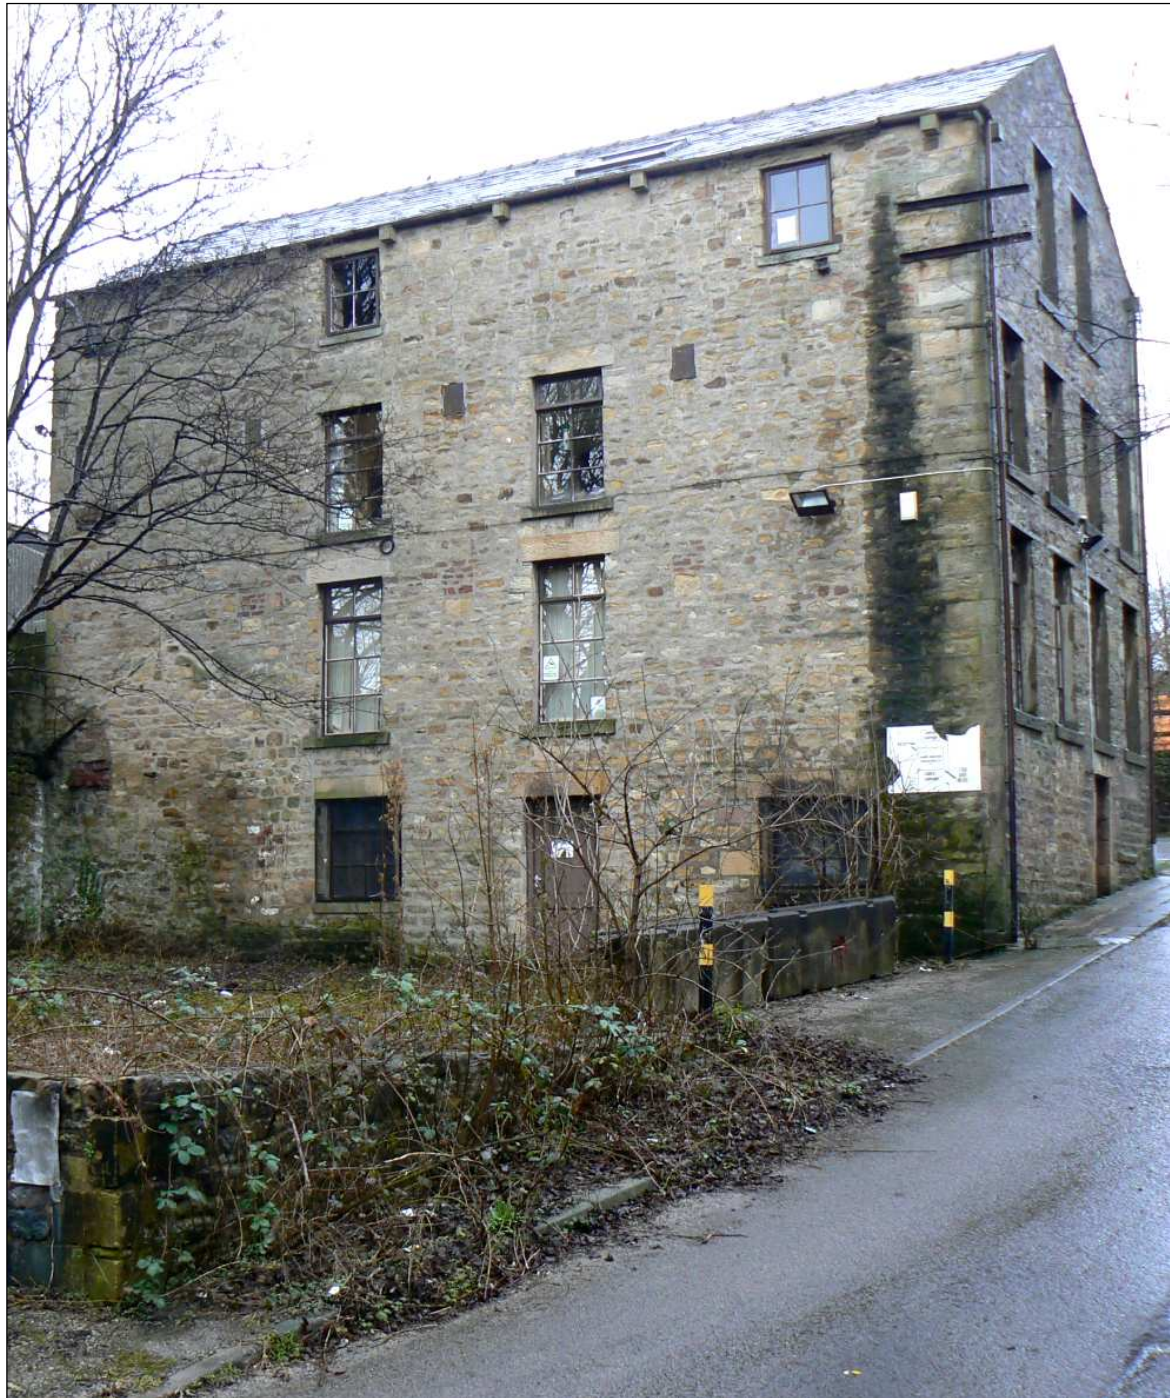
Plate 7: The western façade of the multi-storey block, viewed from Factory Hill

- 3.2.1 The building is of local sandstone construction, faced externally with roughly dressed and coursed blocks, and with irregular quoins to the returns, but of random rubble internally. Windows were only provided originally in the two central bays of the western façade (Plate 7), with dressed stone lintels and projecting stone sills, with those on the second floor being slightly smaller than those below. The two offset windows on the third floor appear to have been late insertions, probably dating to the conversion of the building to offices after the 1960s. At the northern end of the western façade, the wall scar of a perpendicular single-storey shed with pitched roof survived (Plate 8). This appears to have been of a contemporary build to the multi-storey block, and both are depicted on the Ordnance Survey 1:500 map of 1892 (Plate 3). Elements of the north wall of this structure survived *in-situ*, forming a retaining wall against the raised ground level to the north (Plate 9).

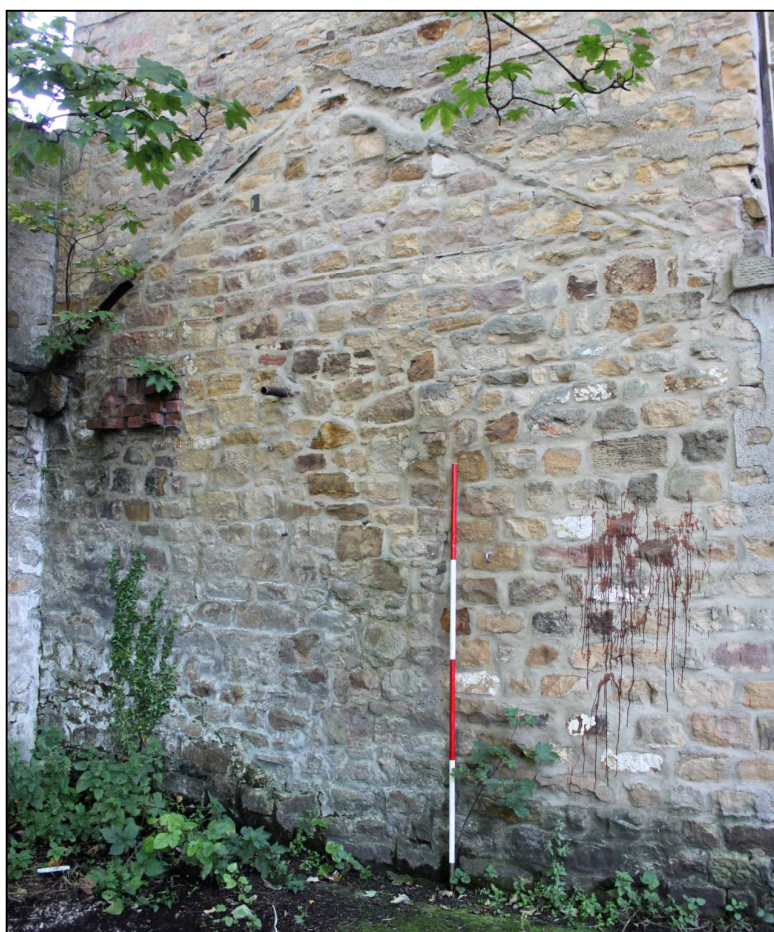
Plate 8: Wall scar at the northern end of the western façade

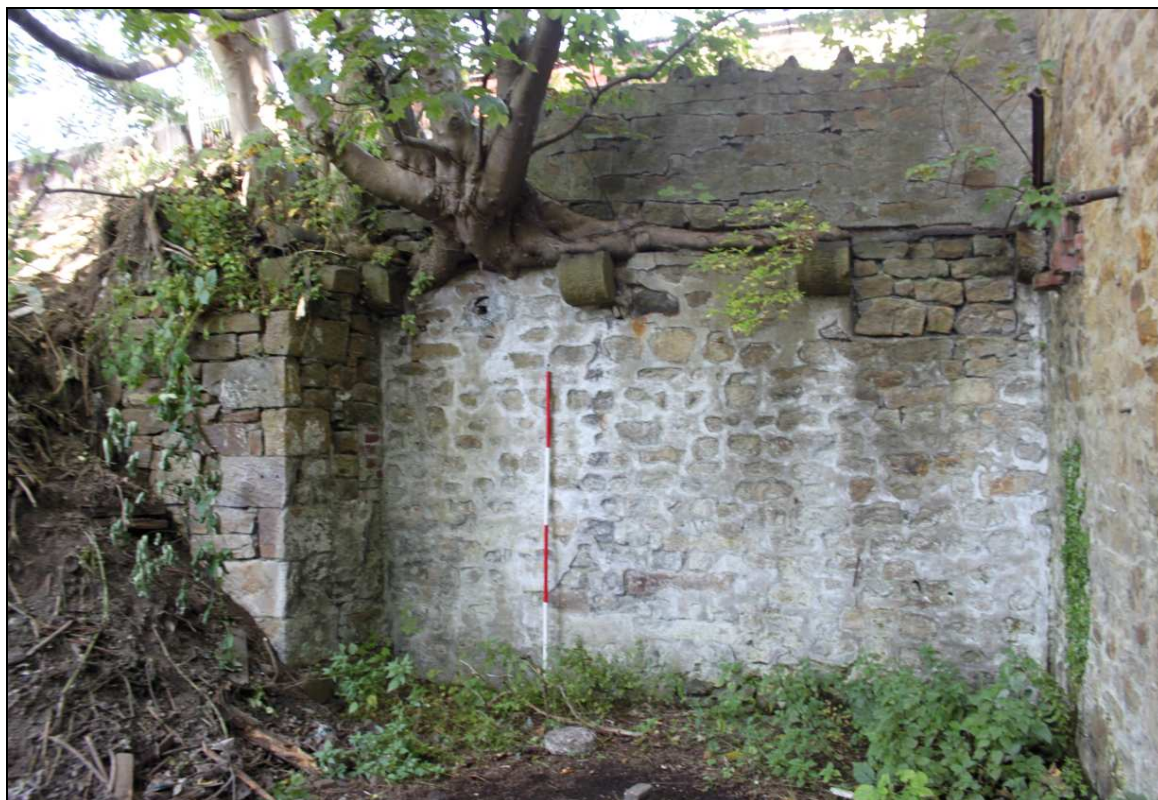
Plate 9: Remains of the north wall of the former single-storey building

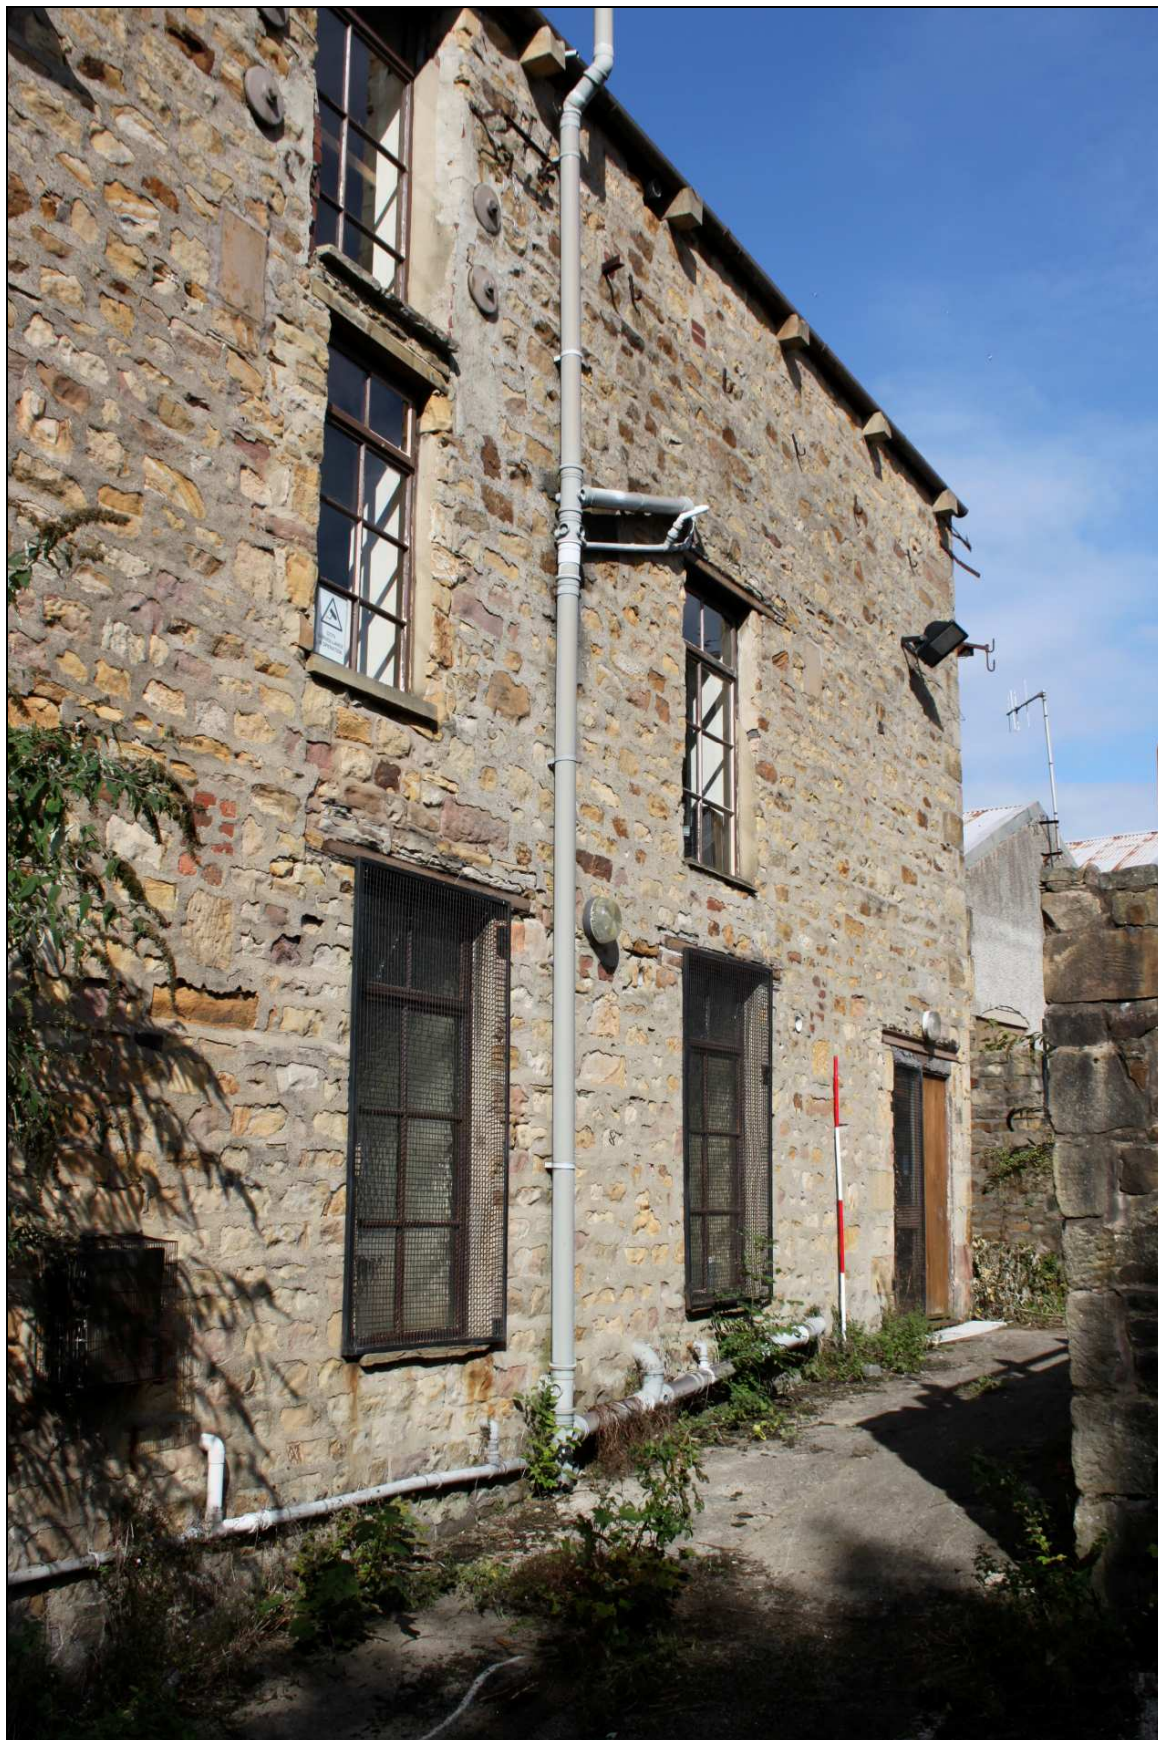
Plate 10: The eastern façade, showing the doorway at the northern end

- 3.2.2 The eastern façade appears to have been devoid of fenestration originally, the only aperture comprising a wide, quoined doorway at the northern end at first-floor level. This afforded access, via a stone stair, to the higher ground to the east. An irregular arrangement of windows was inserted subsequently, with short re-used lengths of railway track utilised as lintels, and a mixture of flagstone and dressed stone sills (Plate 10).

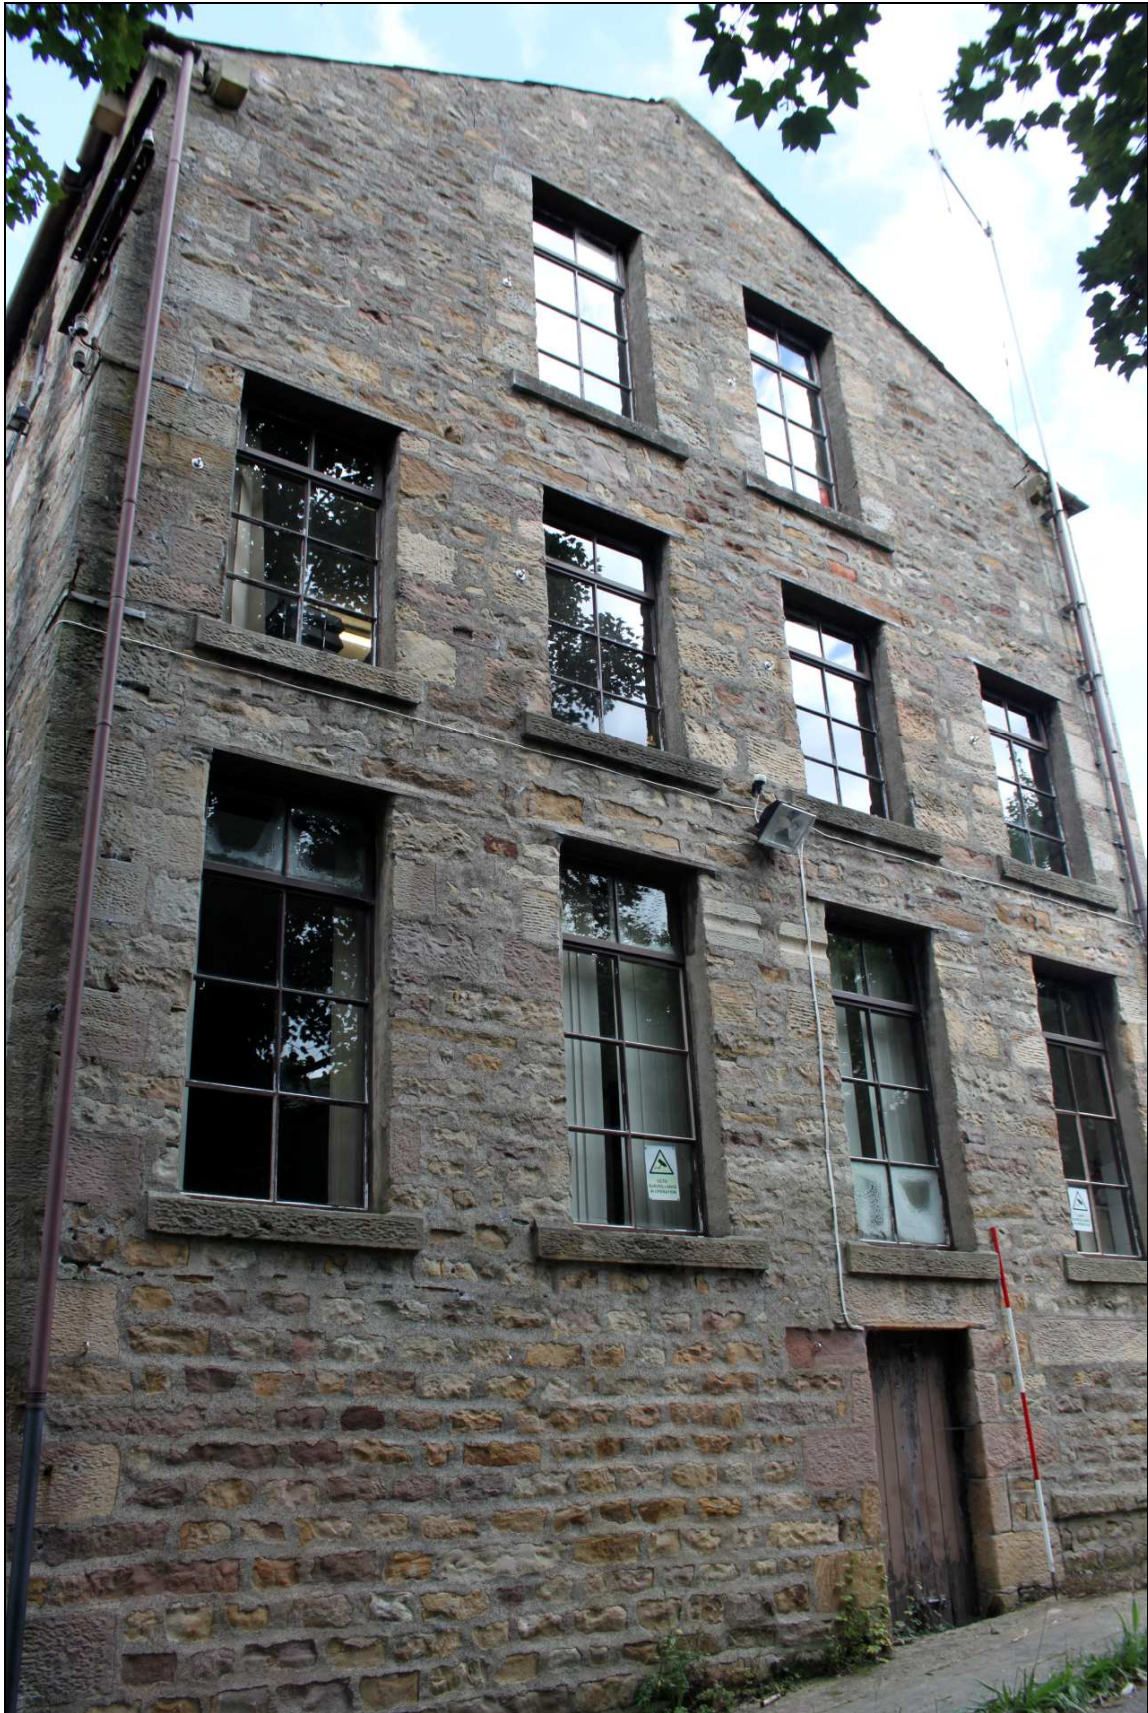
Plate 11: General view of the southern façade

- 3.2.3 The south façade had windows to each bay at first- and second-floor levels, and windows limited to the two central bays on the third floor (Plate 11). The windows differed from those in the west wall by having cast-iron lintels (Plate 12). These comprised a continuous band of cast-iron sheeting through the whole wall thickness. The south wall also incorporated a doorway into the ground floor, flanked on its eastern side by a small horizontal window, which was blocked subsequently (Plate 13).

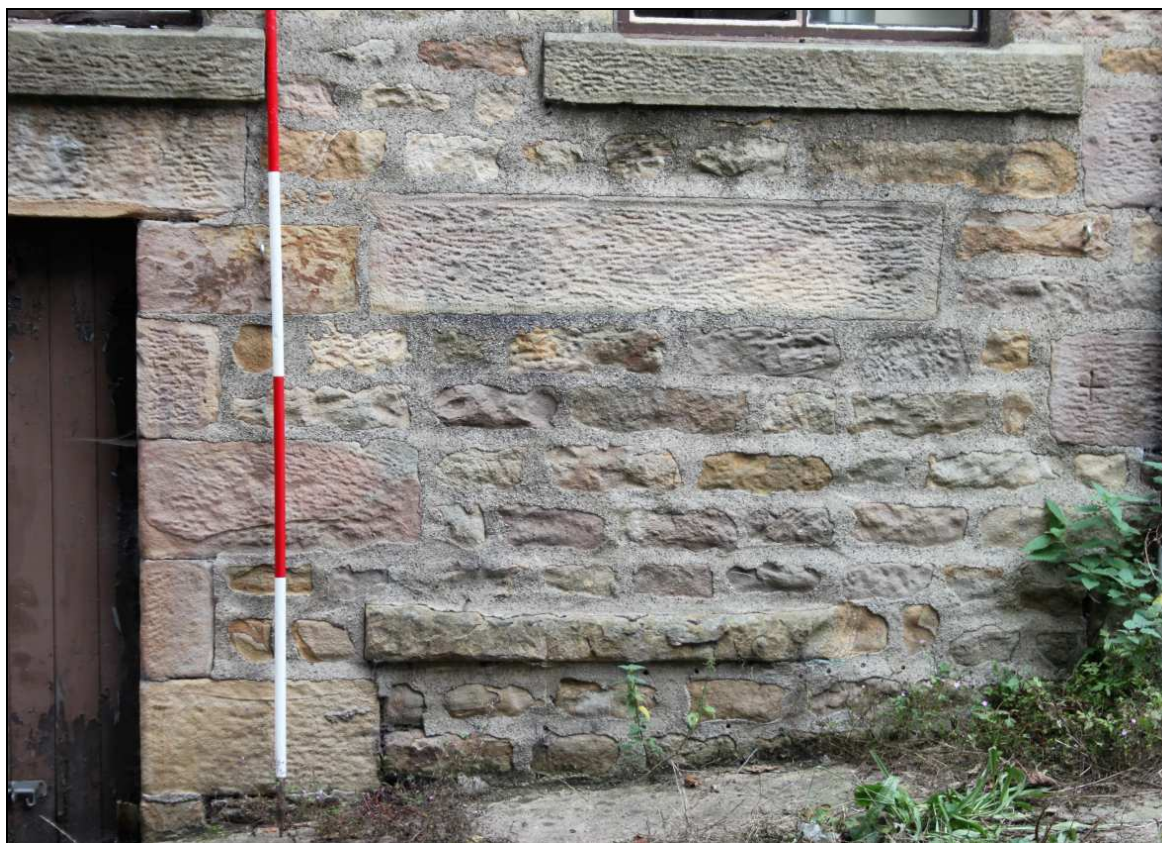
Plate 13: Detail of the blocked window at ground-floor level in the southern façade

- 3.3.1 The ground floor was subdivided by an approximately central spine wall of almost 2' (0.58m) thickness, and of similar stone construction to the exterior walls. The spine wall created two separate rooms, the western room measuring 3.56m wide, and the eastern 3.43m wide. Access to the western part of the ground floor was afforded originally by a doorway with dressed quoins in the south-western corner of the building, with two vertical windows placed to the north (Plate 16). However, this was remodelled subsequently to a window (Plate 17), with the adjacent window remodelled to form a centrally-placed doorway. The eastern part of the ground floor was accessed by a doorway in the southern gable, flanked on its eastern side by a small window, which was blocked subsequently (Plate 12).

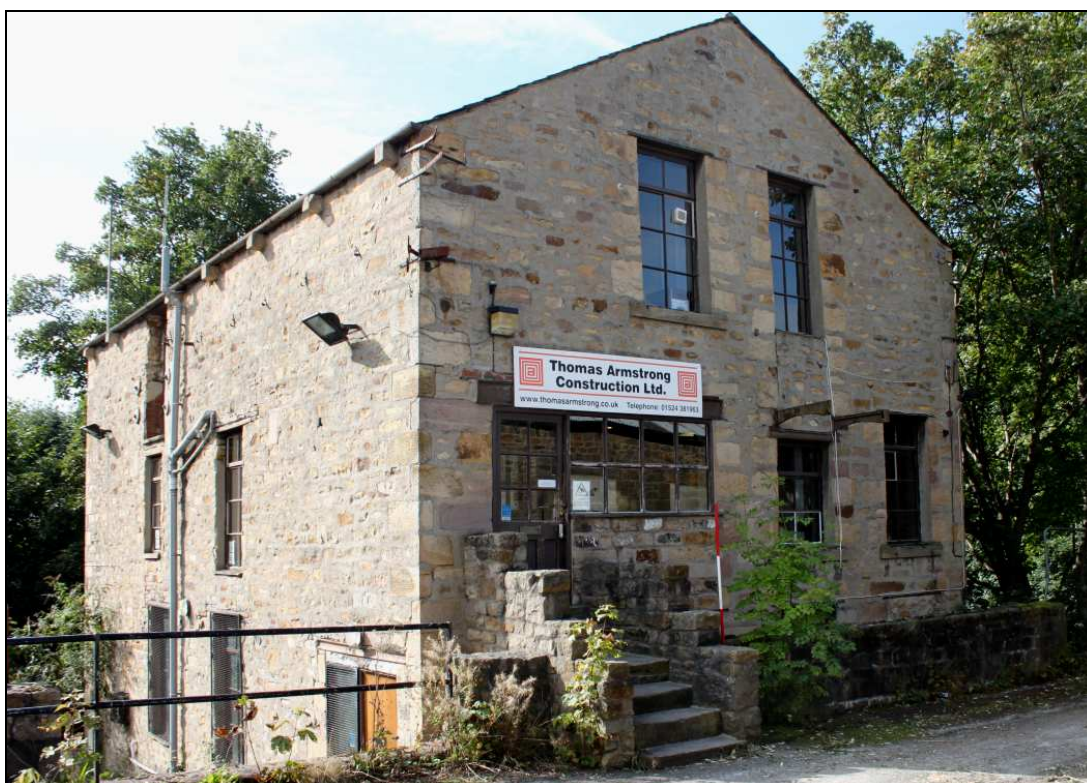
Plate 14: The northern façade

- 3.2.4 Cast-iron lintels were also used in the northern gable (Plate 14). Here, fenestration was punctuated by a central loophole, whilst the windows of the first floor afforded light from a passageway (known as an ‘area’) below the level of yard to the north (Plate 15). A stair down from this yard, placed opposite the eastern window, is depicted on the Ordnance Survey 1:500 edition of 1892, but was blocked subsequently and replaced with a stair and bridge to a doorway inserted into the eastern bay of the north wall at second-floor level (Plate 14).

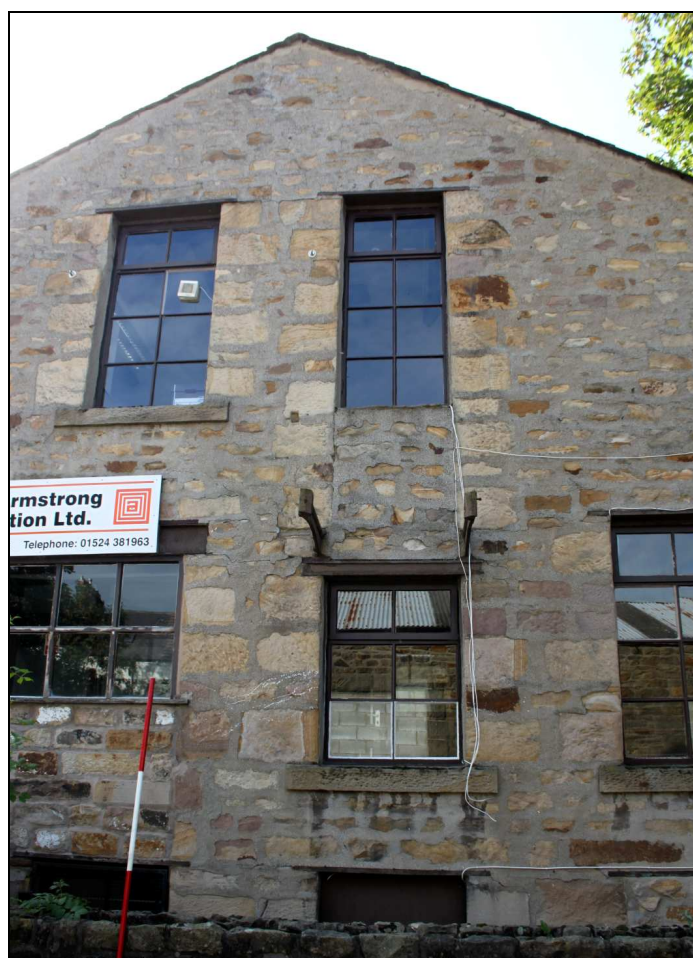
Plate 15: The remodelled loading loop in the northern facade

- 3.2.5 The loading loophole, which retained no evidence for having housed a powered hoist, was also remodelled at first- and second-floor level, with an external platform carried on cast-iron brackets inserted within brick blocking (Plate 15). The window below was reduced in height, with the insertion of an inverted, fish-bellied cast-iron beam as a lintel. The window to the east was remodelled concurrently with the insertion of the doorway to form a continuous horizontal window, sharing an I-section steel lintel with the doorway.

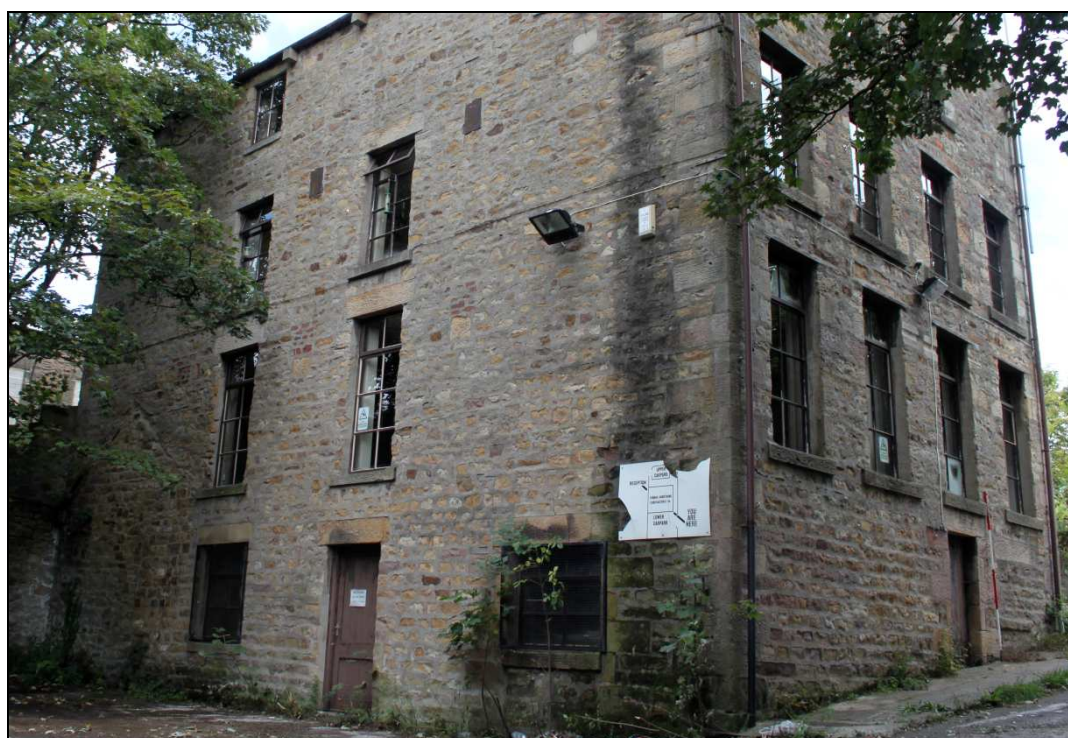
Plate 16: The doorway providing access to the western part of the ground floor

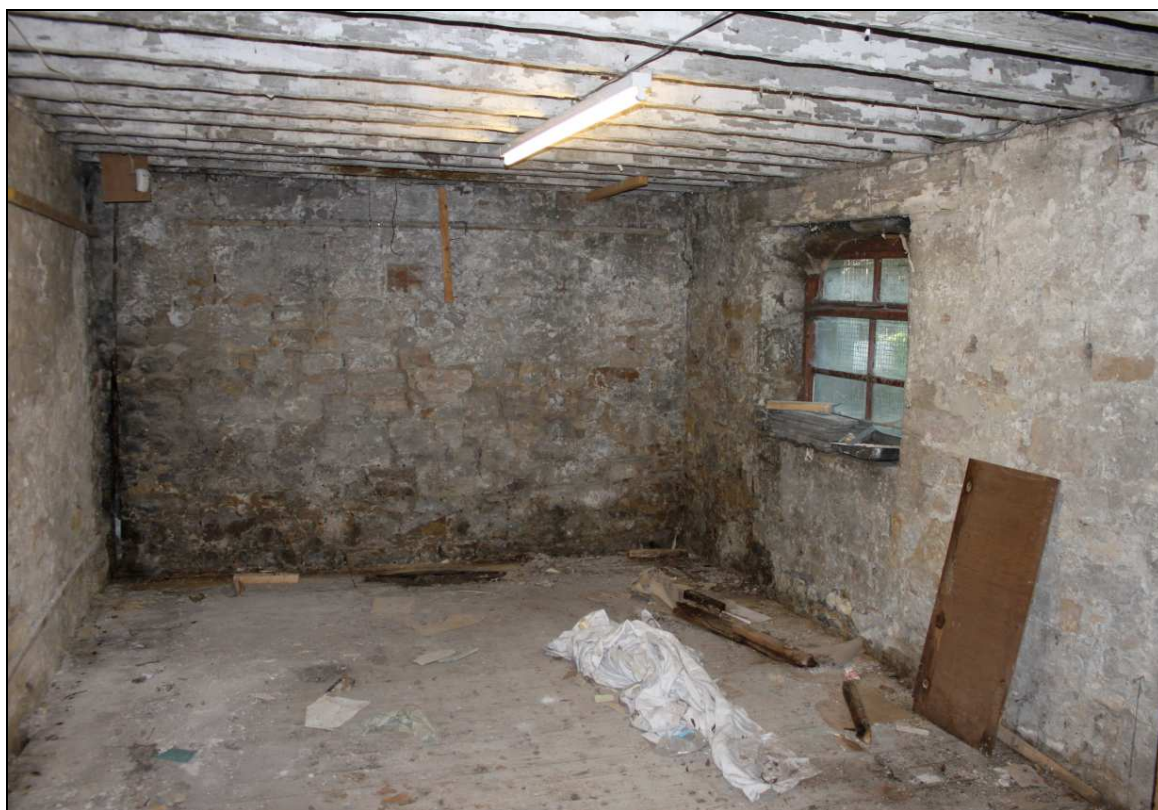
Plate 17: The southern end of the western room on the ground floor, showing window in blocked doorway

- 3.3.2 Whilst there did not appear to have been any direct communication between the western and eastern parts originally, a doorway was inserted through the spine wall in the twentieth century, facilitating access between the two rooms. Access to the first floor from the western part of the ground floor was also afforded via a steep timber stair (Plate 18). This was possibly contemporary with the expansion of the building in the 1870s, but may be slightly later.

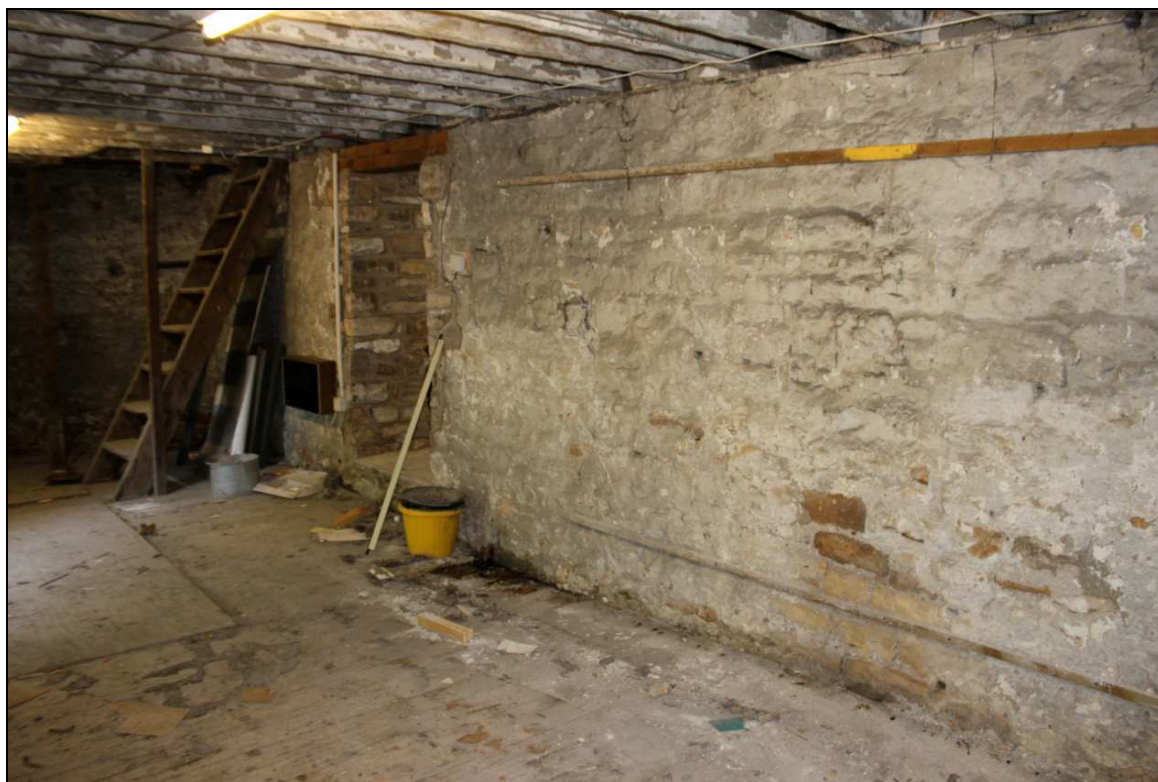
Plate 18: The western room on the ground floor, showing the central spine wall and inserted doorway

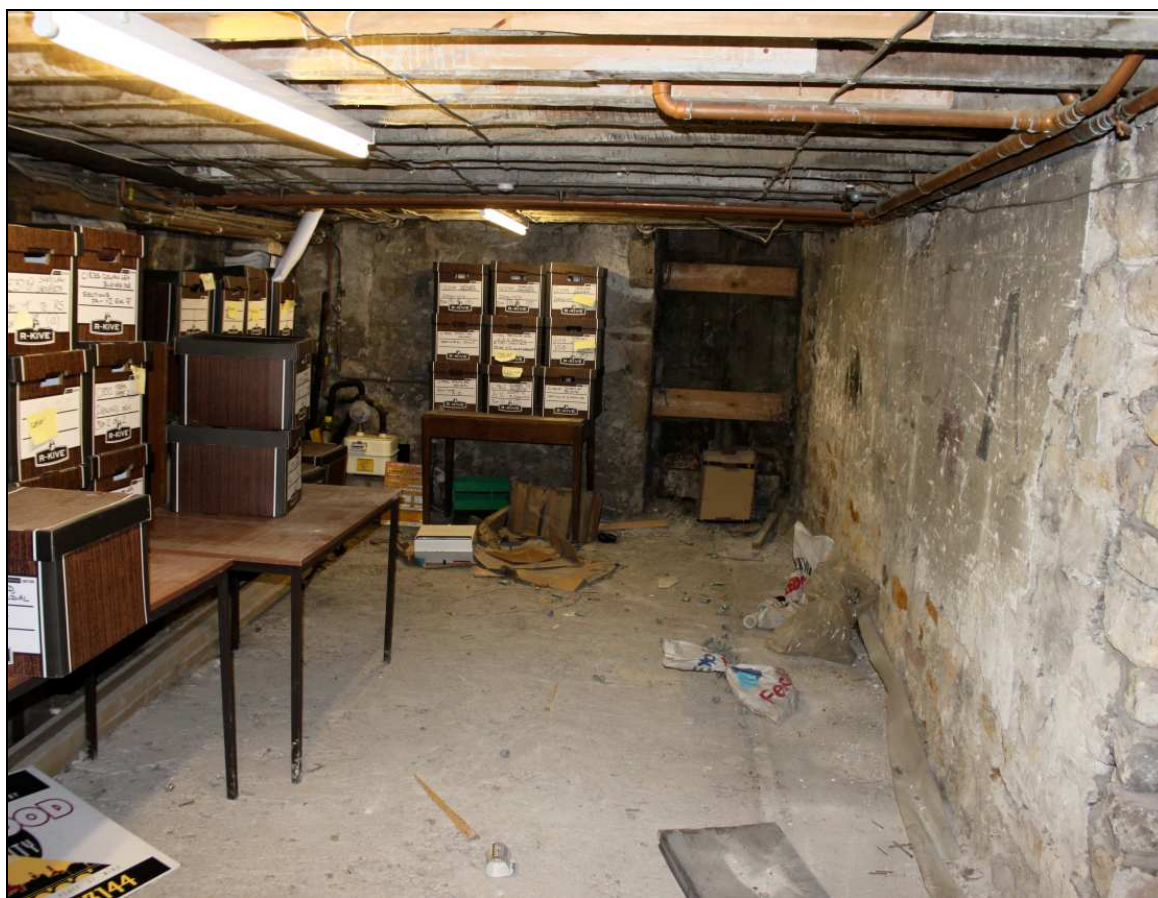
Plate 19: The southern end of the eastern room on the ground floor

- 3.3.3 The original flooring in the western room was stone flags. This was covered subsequently with timber boards, and was probably contemporary with the insertion of the timber stair. It is unclear whether the eastern part of the ground floor, which was at a slightly higher level, had a similar floor inserted, as it was covered latterly with a concrete screed (Plates 19 and 20).

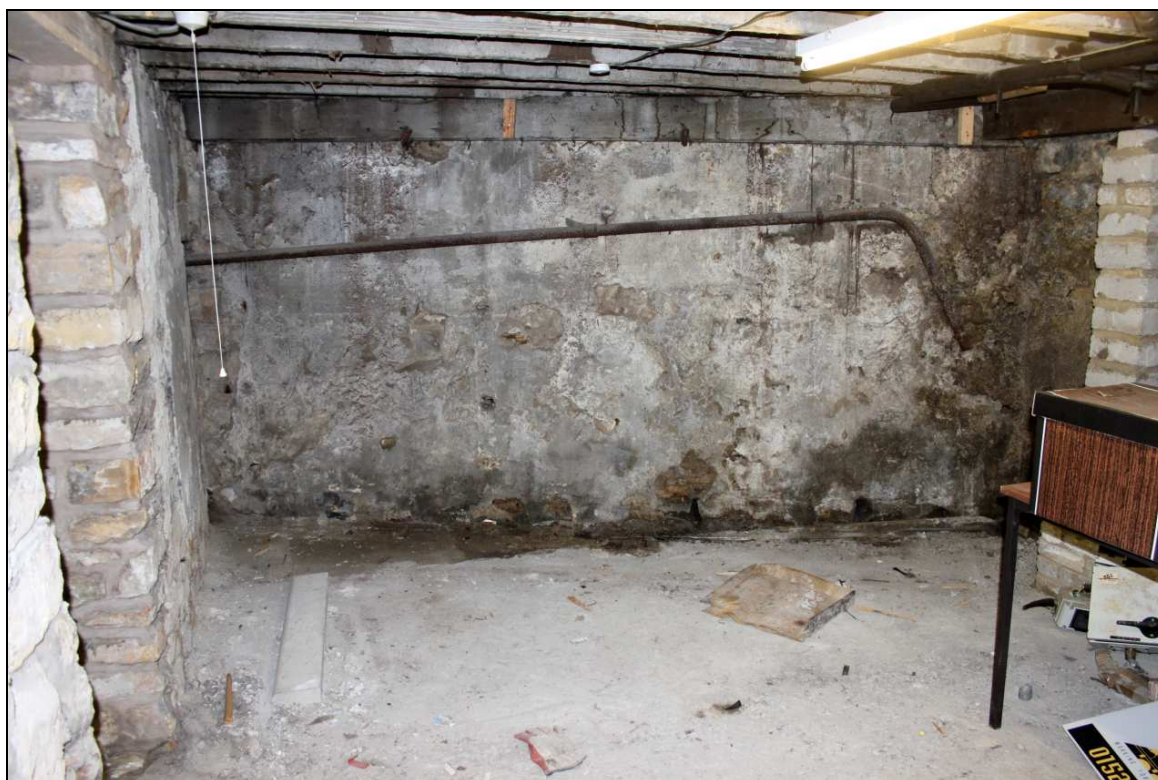
Plate 20: The northern end of the eastern room on the ground floor
