Albion Mill, Factory Hill, Lancaster, Lancashire

Archaeological Building Investigation

Oxford Archaeology North

October 2013

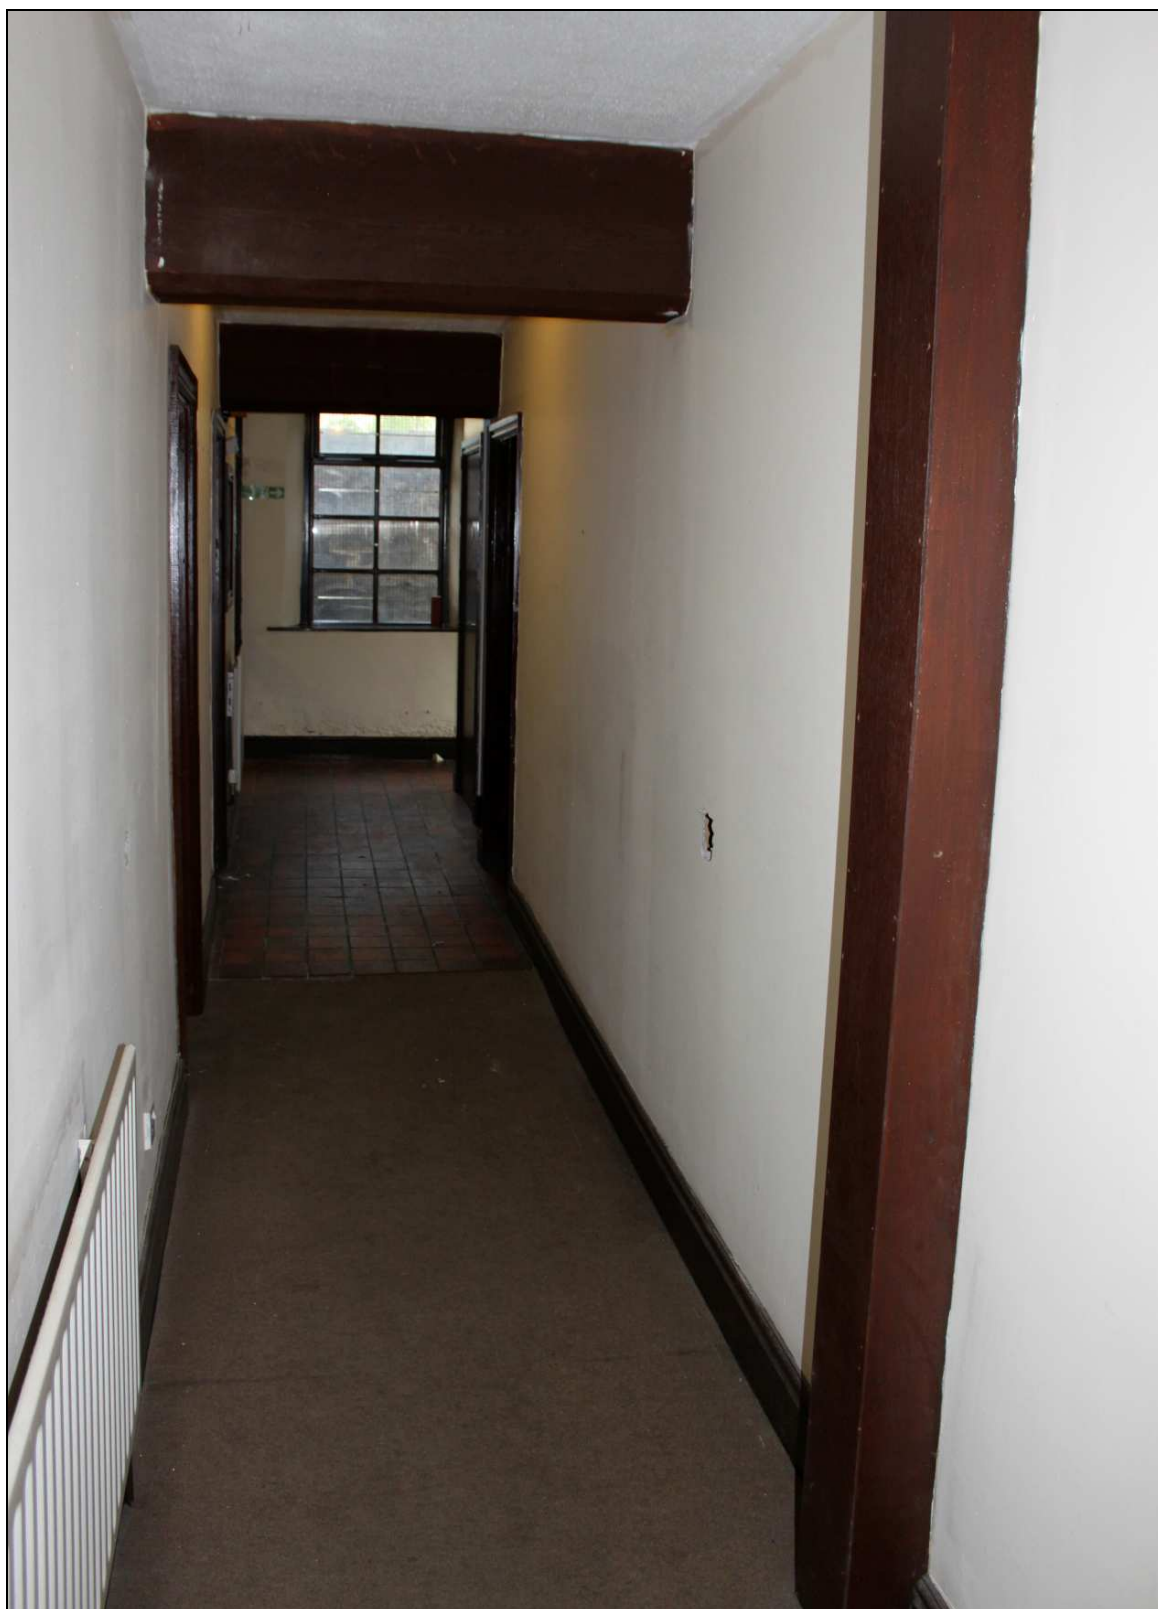
Plate 21: View along the main corridor on the first floor

- 3.4.1 Internally, the floors overlying the ground floor had been heavily remodelled during the second half of the twentieth century, probably during the conversion of the building to offices (Plate 21). This remodelling included the insertion of stud partition walls throughout the building, suspended ceilings and a new staircase. One of the partitions on the ground floor was backed with coconut matting fibres, which may have been produced within the complex, and perhaps indicates that some partitioning of the building had been undertaken whilst it was still in use for textile-manufacturing purposes. A substantial cast-iron safe, manufactured by Thomas Perry & Sons of Bilston, was incorporated into a partition wall on the first floor (Plate 22). This leading firm of iron-founders and manufacturers of armour plate produced safes from the mid-nineteenth century until 1925.

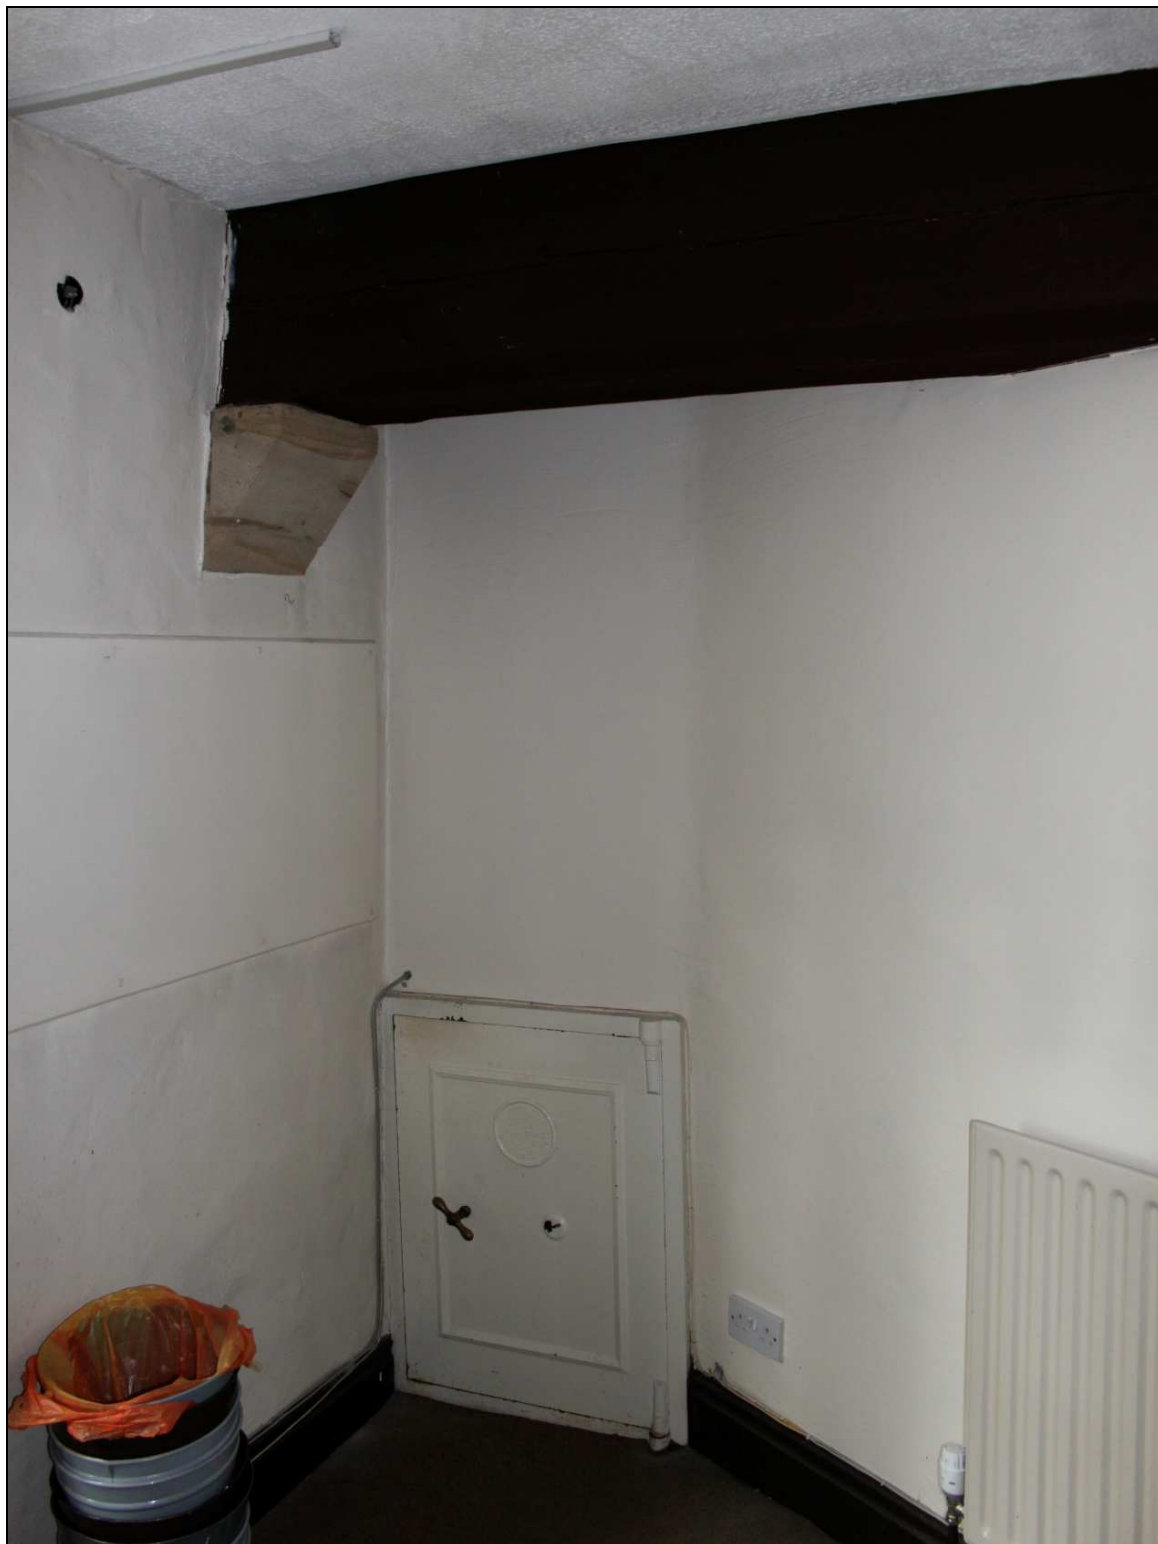
Plate 22: Ceiling beam on first floor supported on dressed, angled sandstone corbel, above cast-iron safe

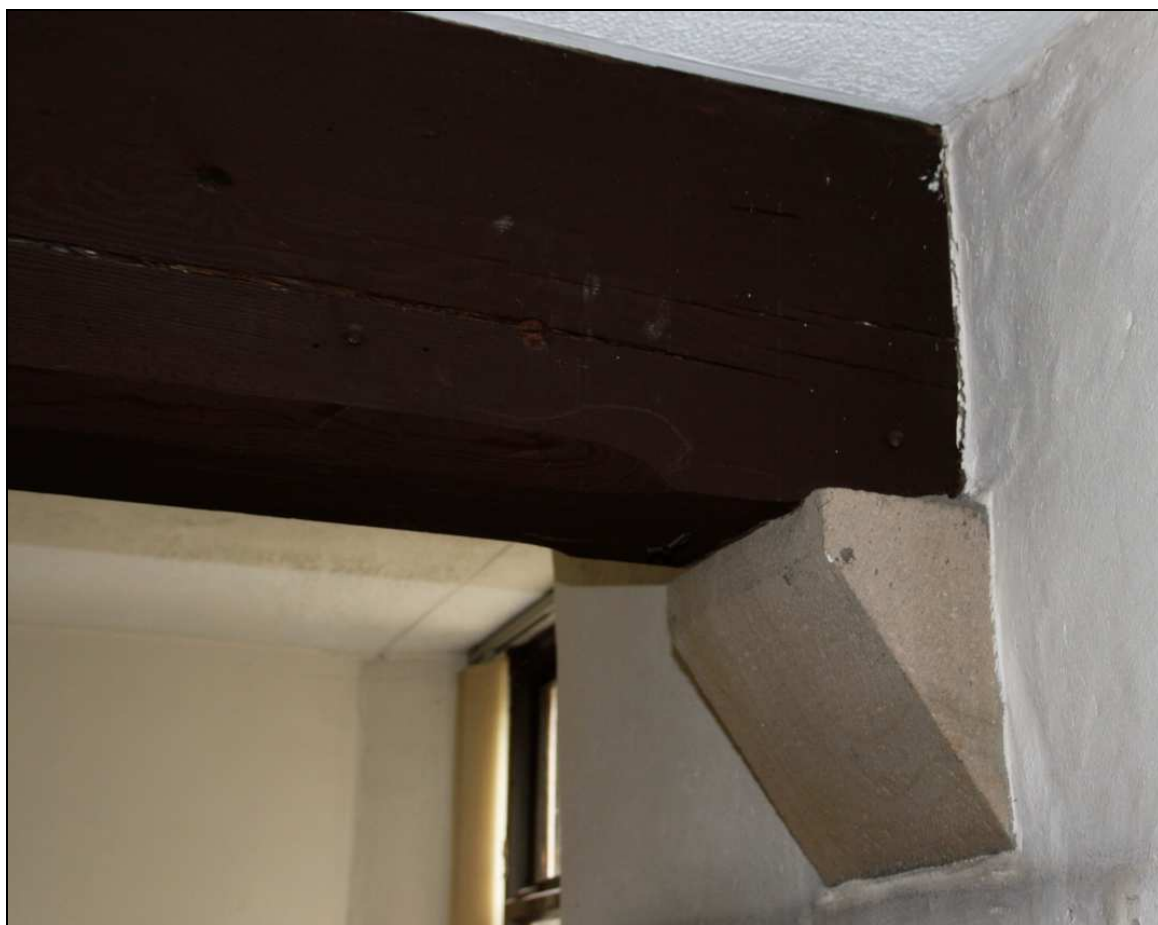
Plate 23: Detail of angled sandstone corbel set into the east wall on the first floor

- 3.4.3 The large-scantling ceiling beams all appear to date from the expansion of the structure in the second half of the nineteenth century, and were circular-sawn with lambs-tongue chamfers. At first-floor level, these were carried on dressed, angled sandstone corbels (Plate 23), whilst at second-floor level the ceiling beams were housed in projecting cast-iron brackets (Plates 24 and 25). At third-floor level, however, the beams were carried on roughly hewn stone corbels, which projected only marginally beyond the wall face (Plates 26 and 27).

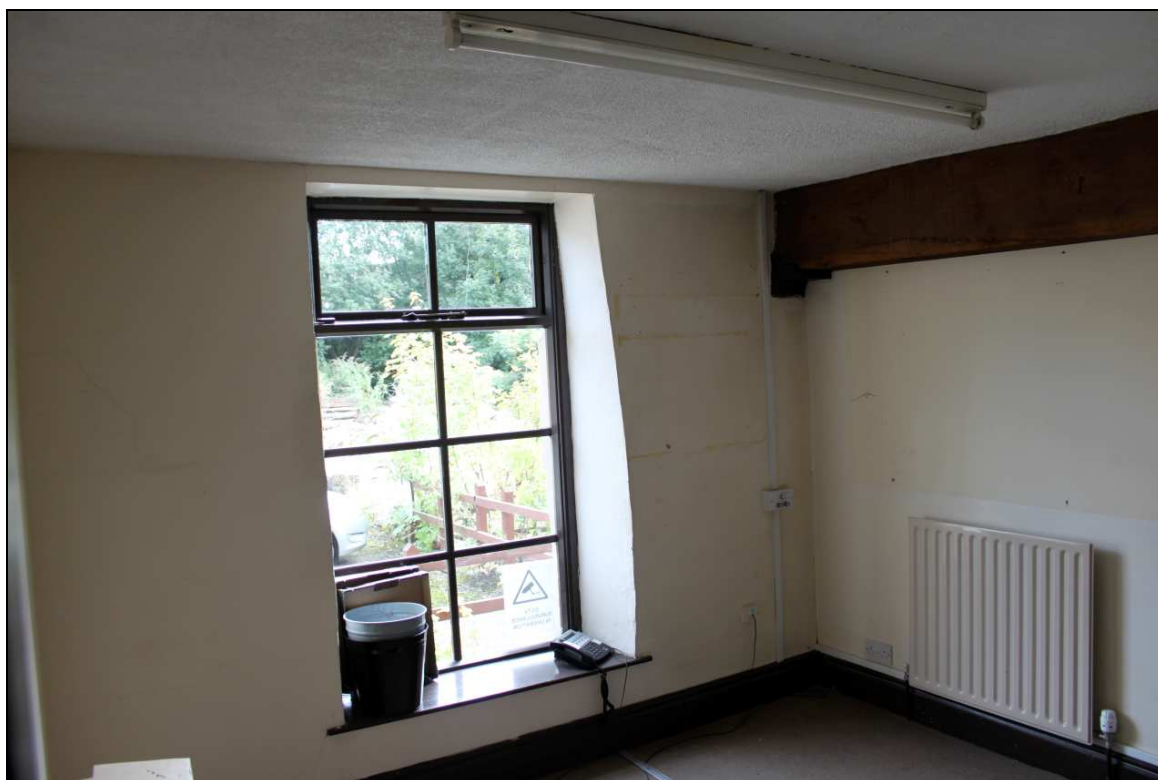
Plate 24: General view of empty office on the second floor

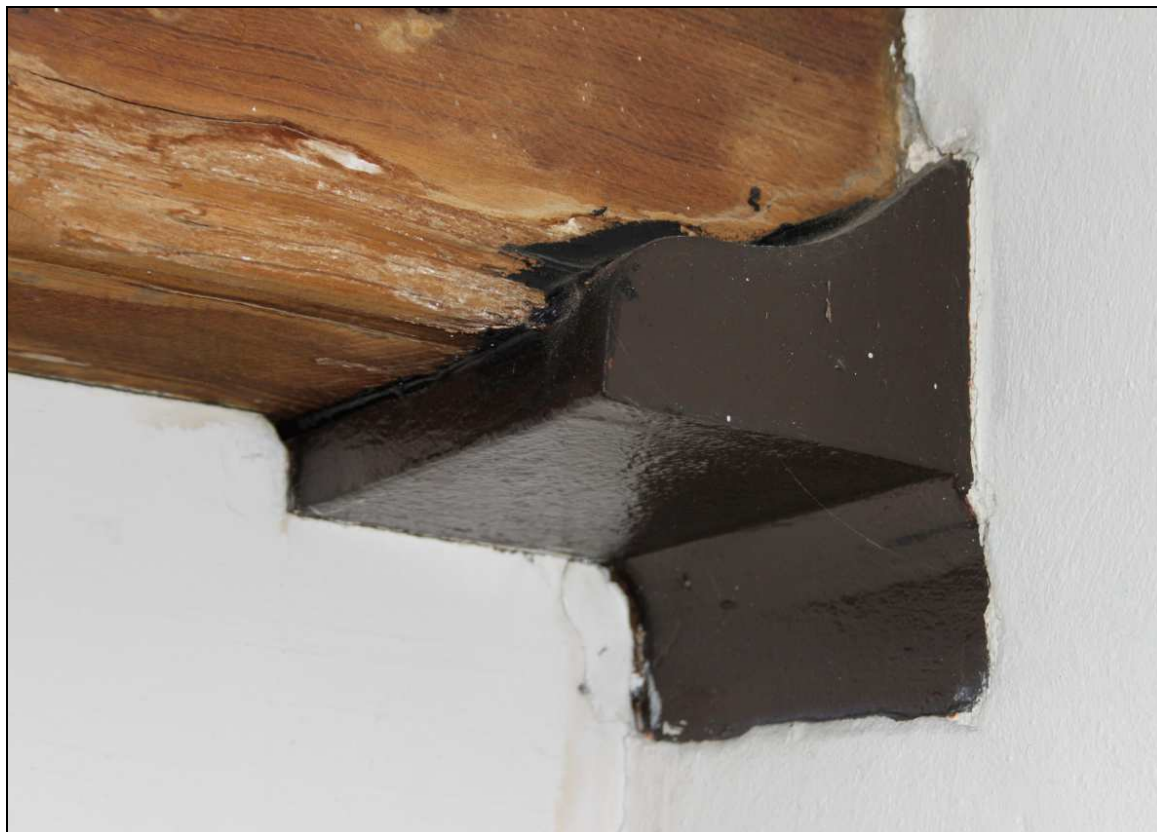
Plate 25: Detail of cast-iron bracket supporting the ceiling beam on the second floor

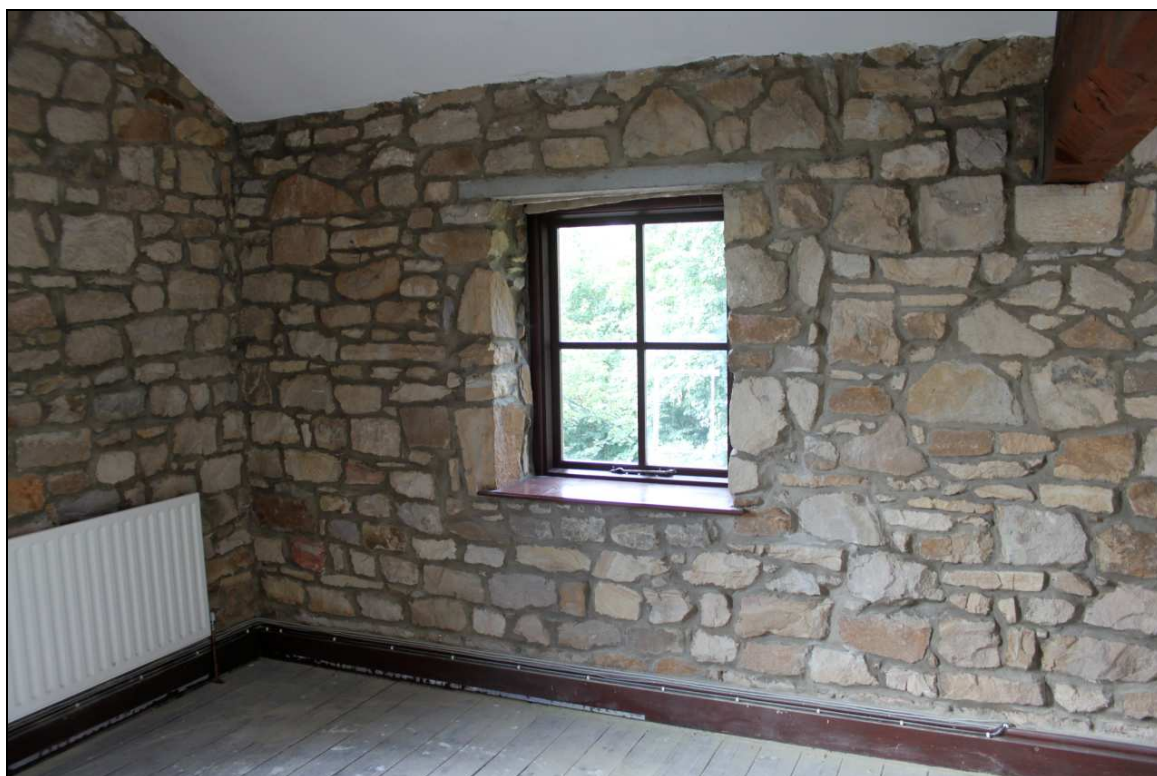
Plate 26: The south-western corner of the third floor, showing large scantling timber beam supported by a stone corbel

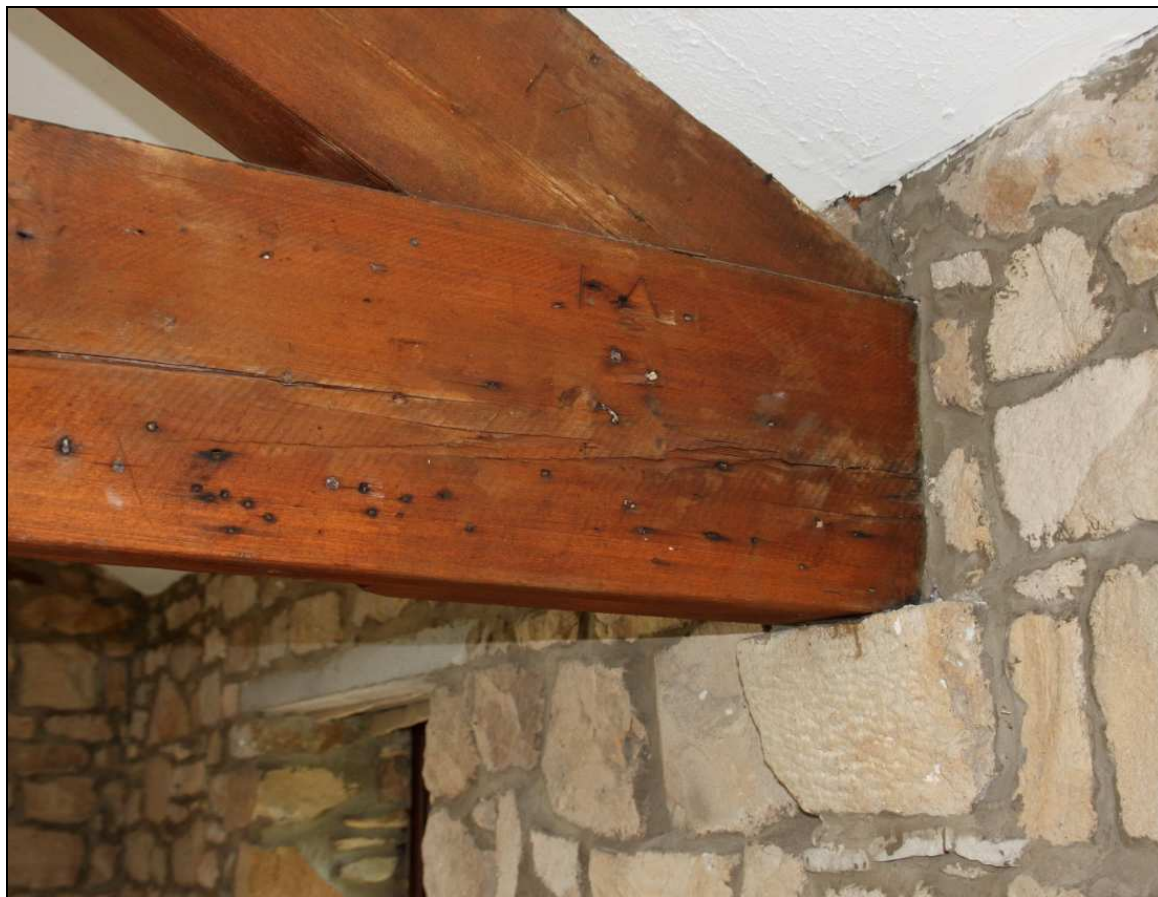
Plate 27: Detail of the timber beam and stone corbel on the third floor

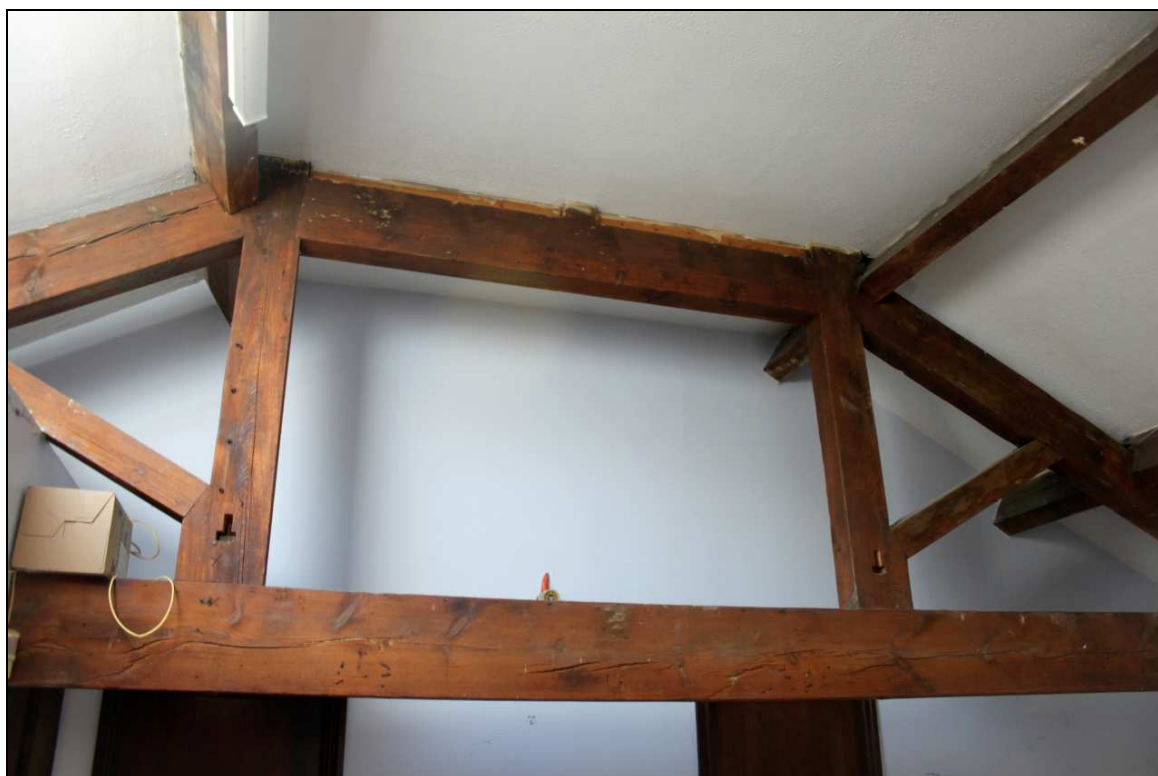
Plate 28: One of the three queen-post trusses supporting the roof

- 3.4.4 The upper beams formed the tie beams of queen post trusses (Plate 28), the straining beams of which carried timber upper king ties. Each queen post was braced on the outer side, above the lower of two trenched and butt-ended purlins. All joints were marked with Roman numeral carpenter's marks on their northern face (Plate 29), with a continuous sequence running from the eastern principal rafter on the southern tie beam throughout this truss, and through those to the north.

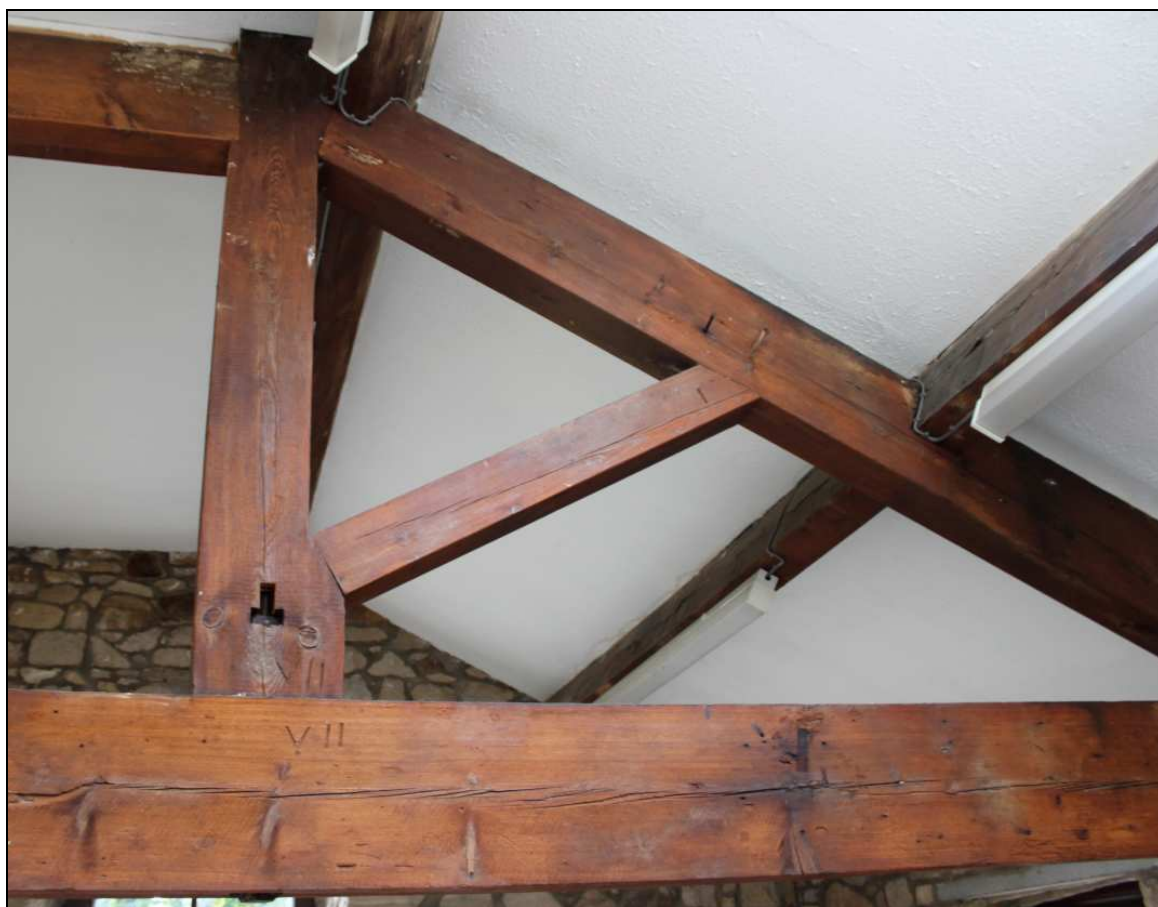
Plate 29: King ties and carpenters' assembly marks on the roof truss

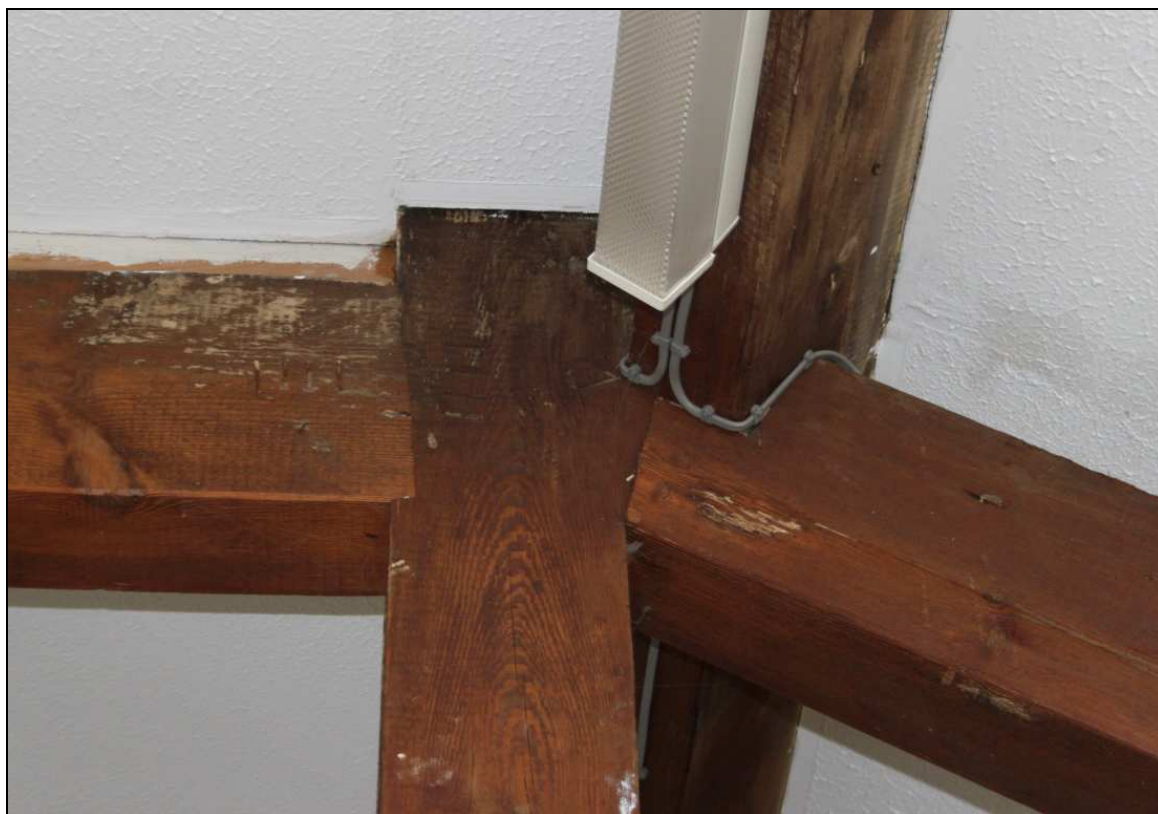
Plate 30: Detail of joint on the roof truss

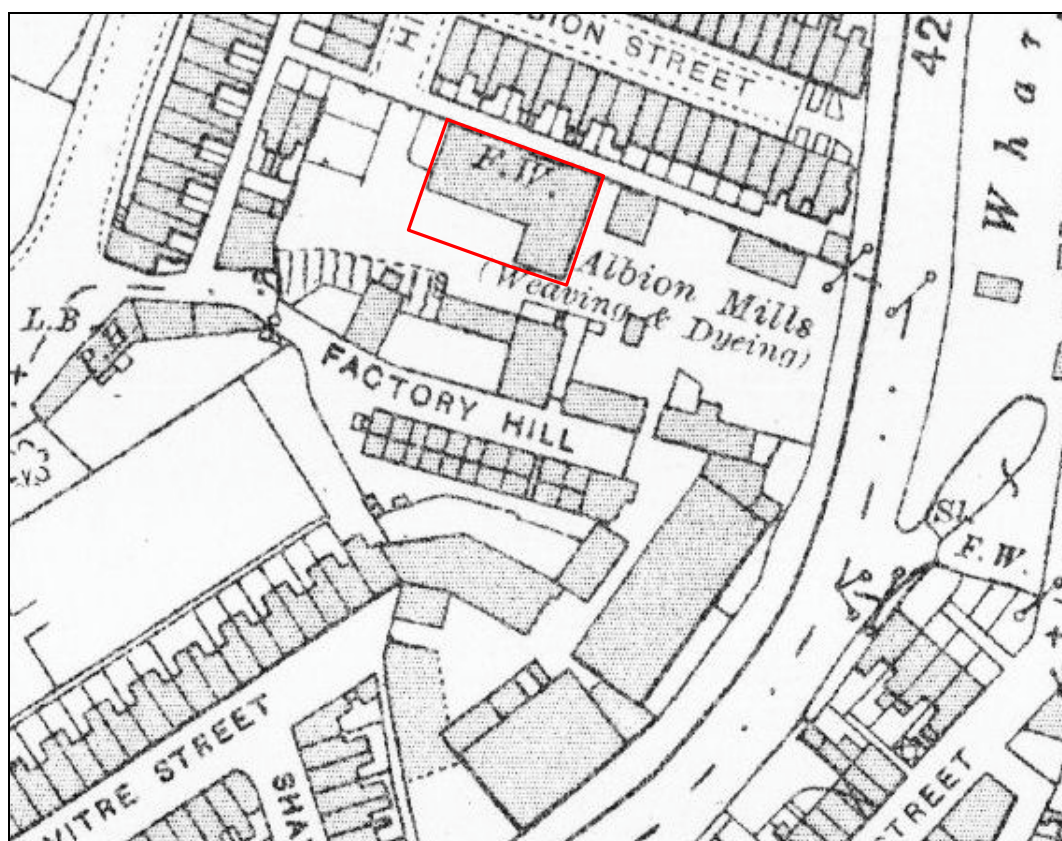
Plate 31: The Ordnance Survey map of 1936, marking the footprint of the single-storey range

- 3.5.2 A small rectangular building is depicted in this area on Ordnance Survey maps published in 1892 (Plate 3) and 1913. However, the next edition of Ordnance Survey mapping, surveyed in 1931 and published in 1936, shows this structure to have been replaced with a larger, L-shaped building (Plate 31); the same layout is depicted on the Ordnance Survey map of 1939. By 1956-7, however, an extension had been added to create the rectangular block that occupies the site currently.

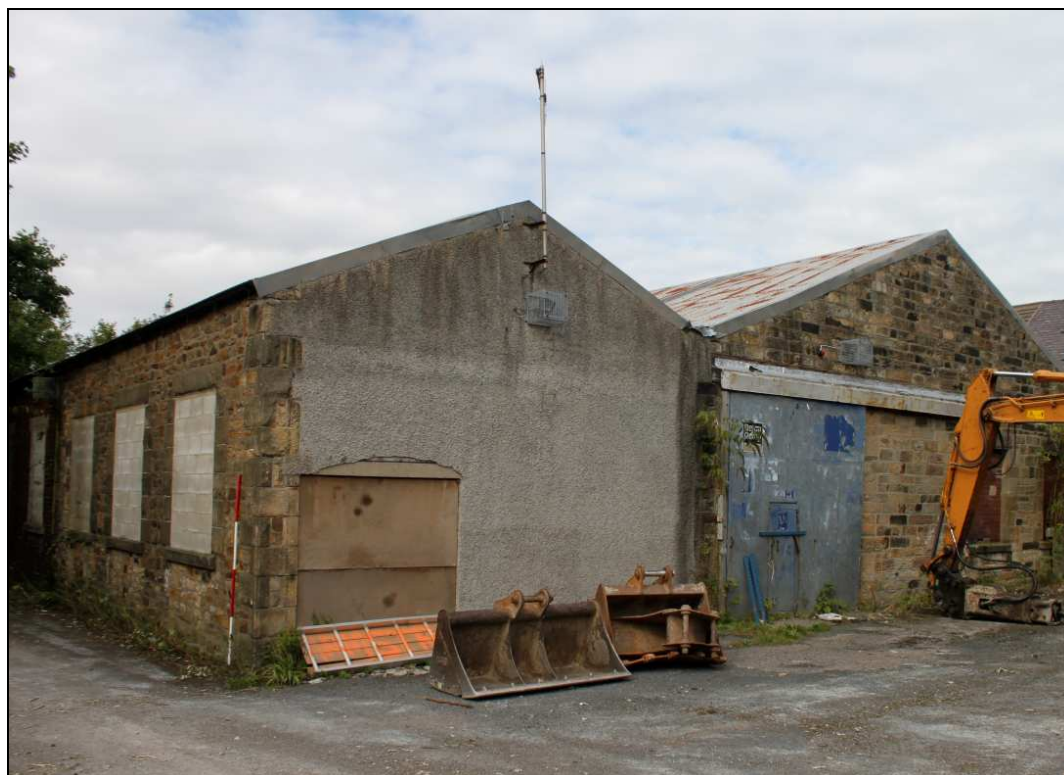
Plate 32: The single-storey buildings to the north of the multi-storey block

- 3.5.3 The original L-shaped block was of coursed rubble construction, with quoins (Plate 32). The short projected wing forming the south-eastern corner of the range contained three large windows with stone surrounds in the south elevation, although these had been infilled with cinder blocks (Plate 33). The east gable had similarly been blocked and finished in render, although it may originally have been open-fronted.

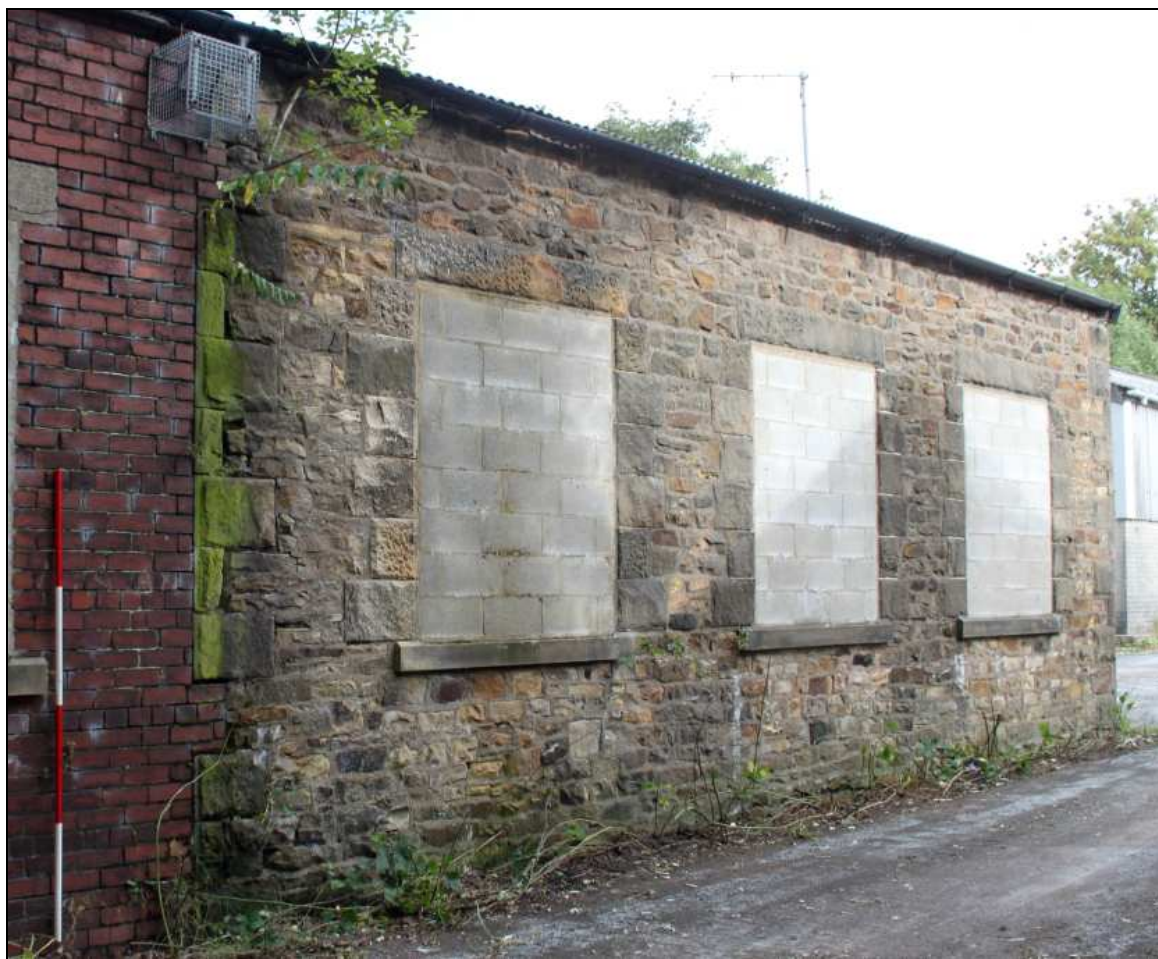
Plate 33: The south elevation of the projecting wing

- 3.5.4 The short wing had its own pitched roof of modern materials, aligned parallel with that fitted to the adjacent long block. This was similarly of coursed rubble construction, with a steel sliding door for vehicular access inserted in the east elevation. Two large windows with stone sills and lintels to the north of the sliding door appeared to be original features (Plate 34).

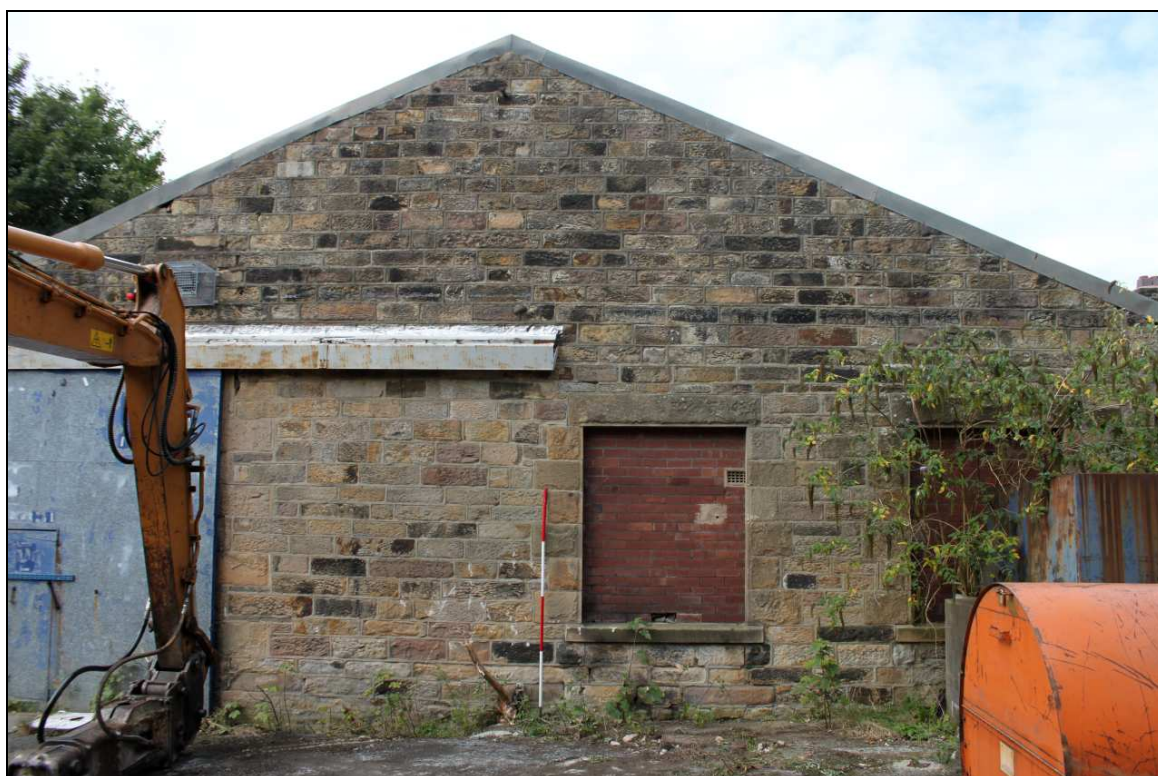
Plate 34: East-facing elevation of the long block

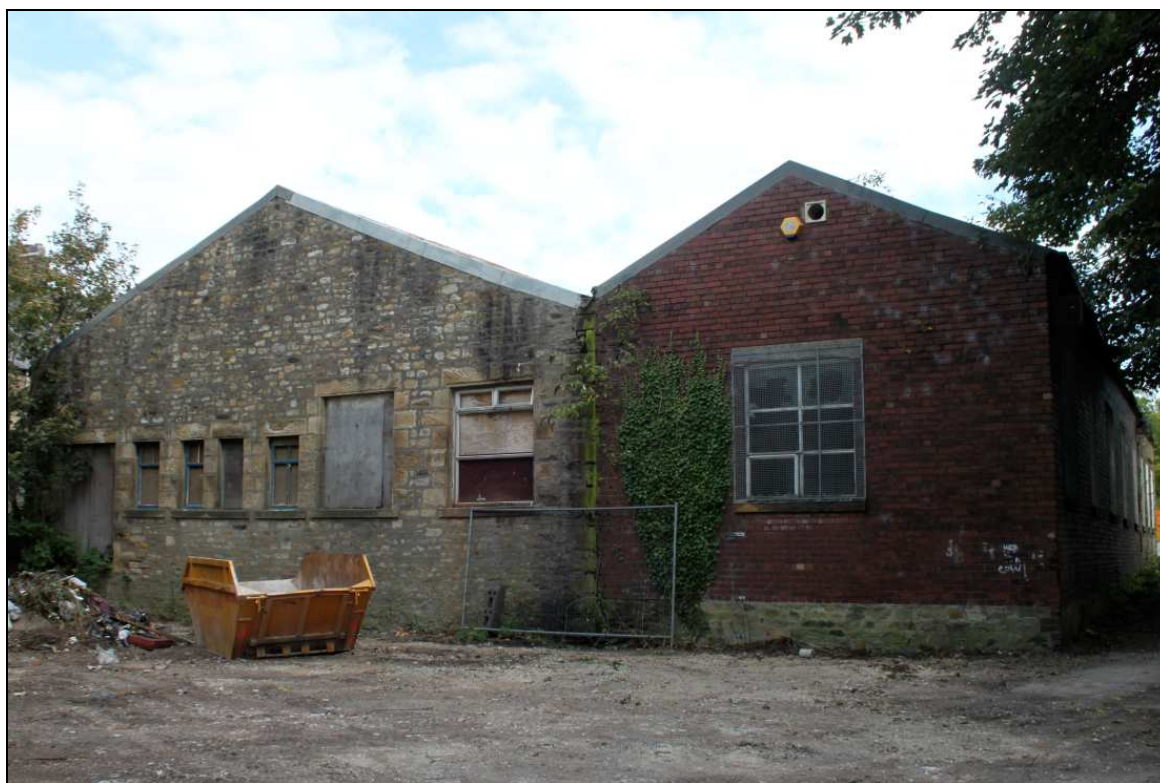
Plate 35: The rear, west-facing elevation of the single-storey buildings

- 3.5.5 The west elevation of the long block contained two windows of a similar size, together with four smaller windows and a raised-level loading door in the north-western corner (Plate 35). This presumably serviced road vehicles accessing the mill complex from the north, via Hinde Street.

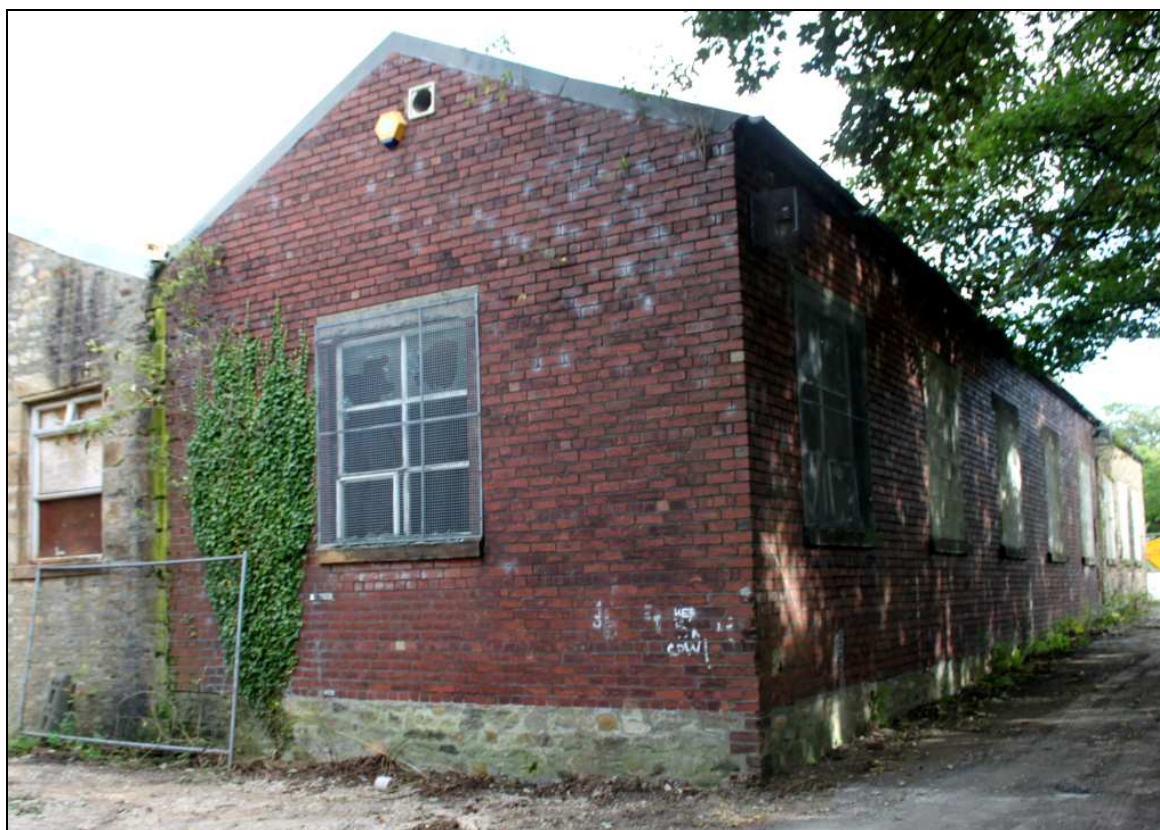
Plate 36: The west-facing elevation of the brick-built extension

- 3.5.6 The fabric of the mid-twentieth-century extension that formed the south-western corner of the building range comprised machine-pressed brick set on a stone foundation (Plate 36). The south elevation contained five large, six-light windows with timber frames, stone cills and concrete lintels. Four of the five windows had been infilled with cinder blocks.
