FRODSHAM CUT AND LOCK, RIVER WEAVER, FRODSHAM, CHESHIRE

Heritage Assessment

Oxford Archaeology North

April 2005

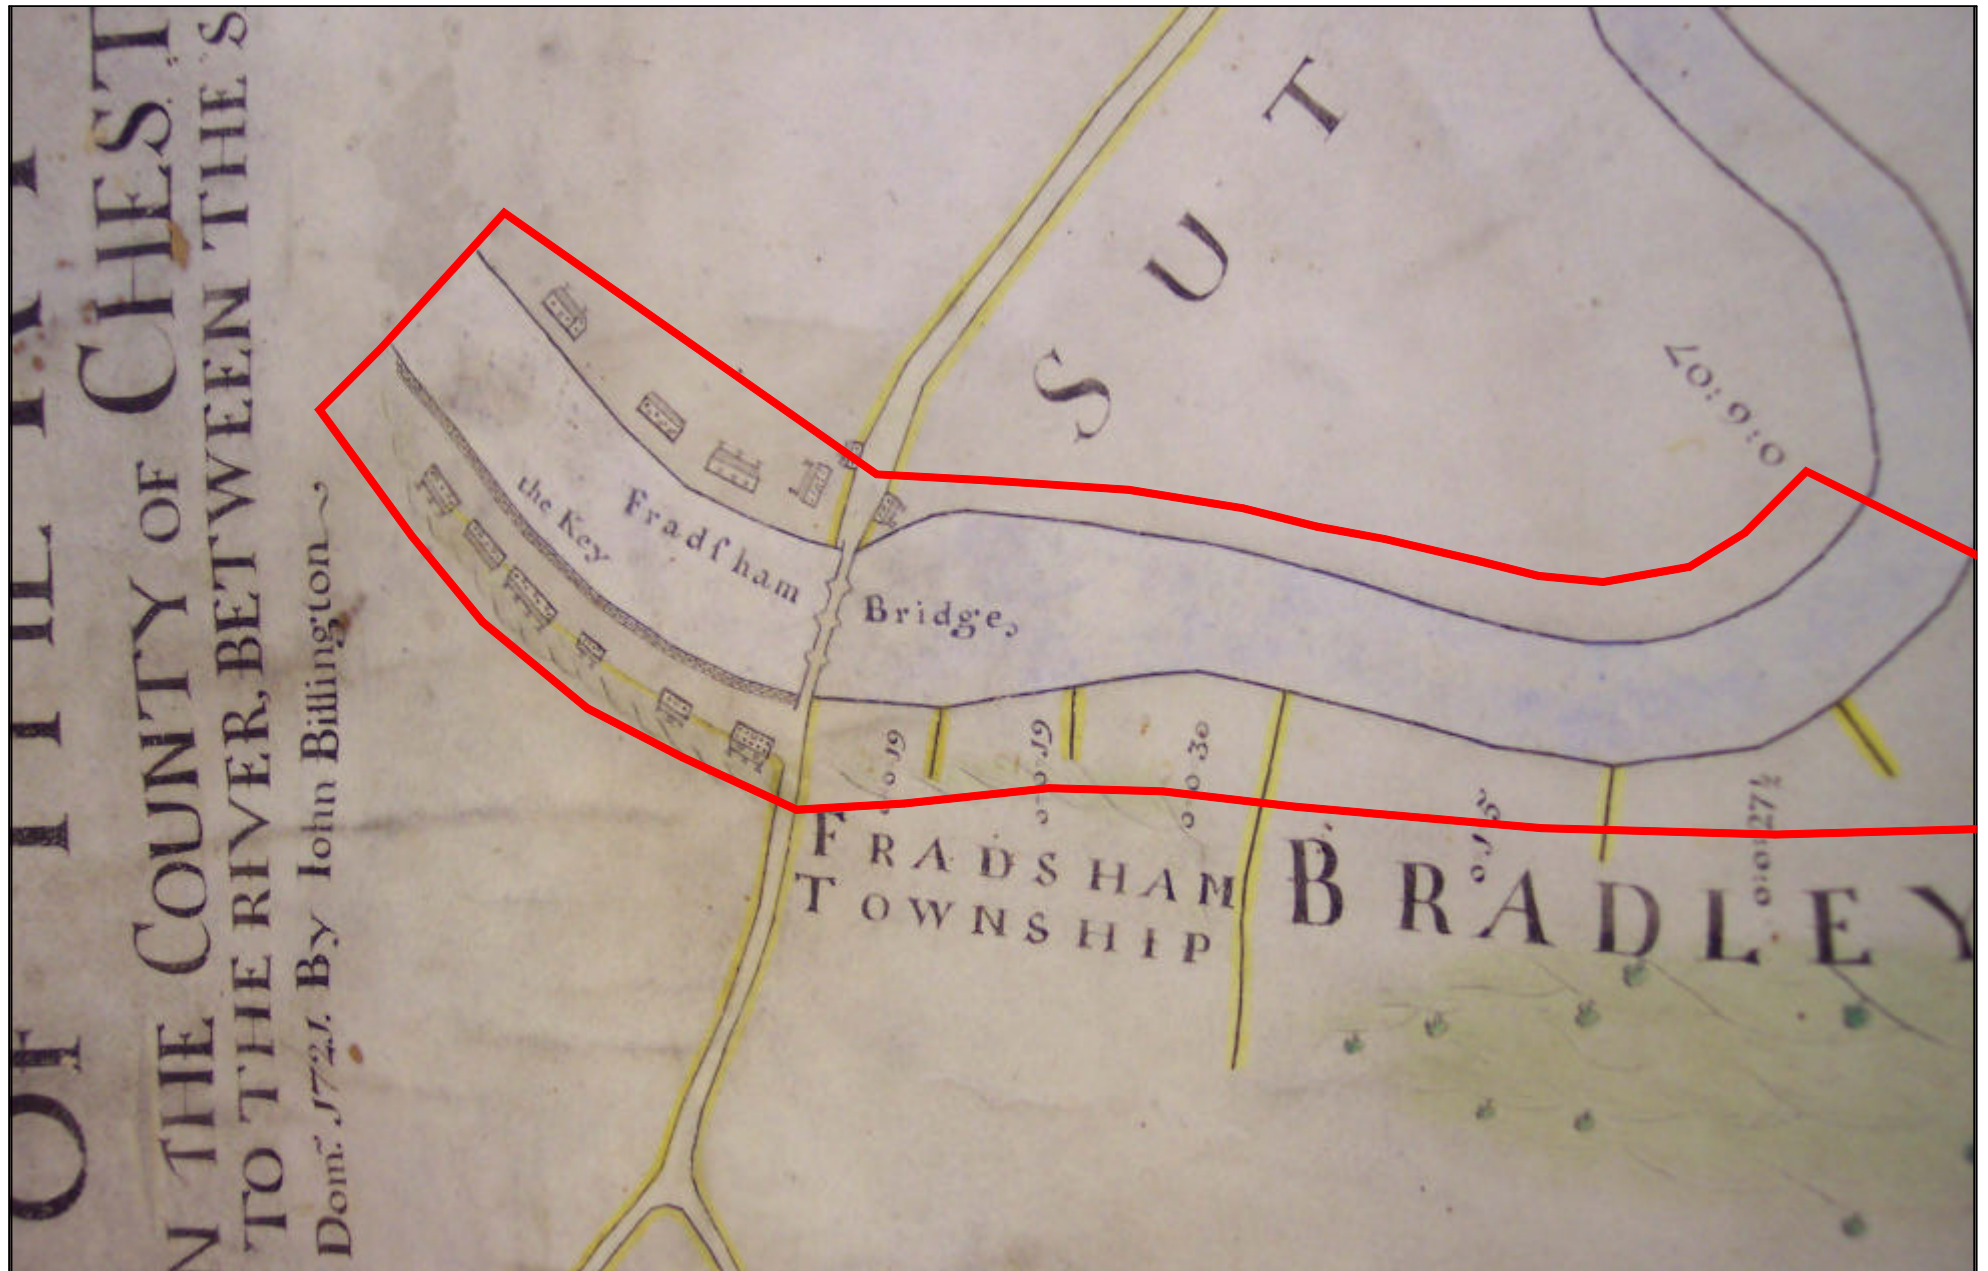
Figure 3 : Extract from River Weaver Map of 1721

the tithe map Frodsham Bridge (Site **14**) can be seen, although less elaborate than that from 1721 (Fig 3). Buildings associated with the quay can also be observed, although the quay is not specifically marked. Almost all of these buildings (307-9, and 313-20, Fig 5) are houses (Site **04**), the only notable exception (323, Fig 5) being the saltworks (Site **01**). The reference to the field-name Maltkiln Croft (Site **06**, 310 on Fig 5) in the tithe apportionment details (CRO EDT 162/1 1846) indicates the possible presence or former presence of a maltkiln in the area. The alignment of the south bank of the River Weaver at Frodsham Bridge seems curious, since it does not match that shown on the other tithe maps of similar date.

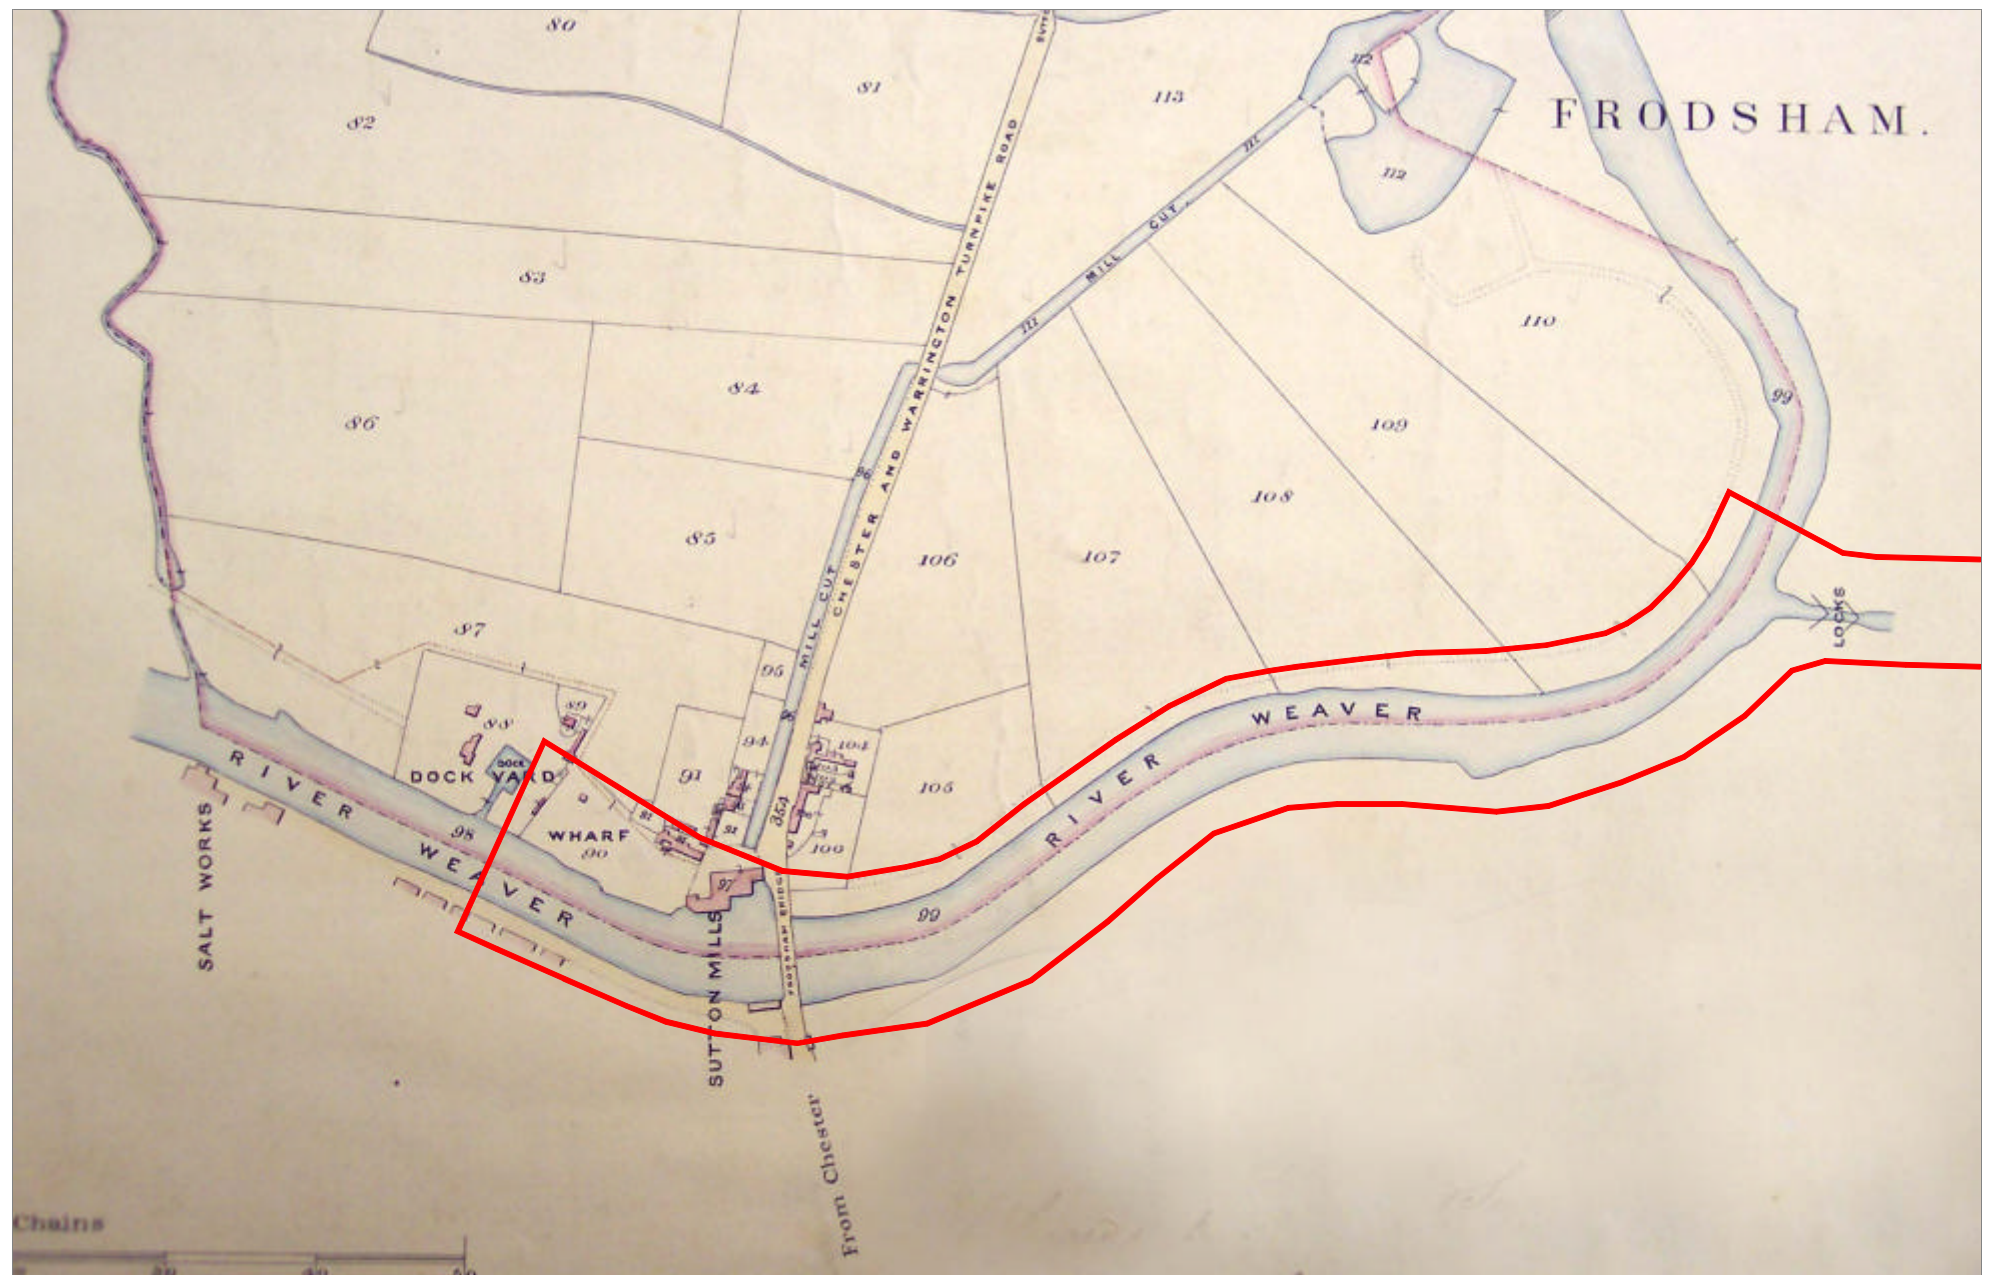
Figure 4 : Extract from Sutton Juxta Frodsham Tithe Map, c1844

- 3.3.3 **Sutton tithe map, 1844 (Fig 4; CRO EDT 380/2 1844):** within the proposed restoration area, the east banks of the River Weaver and Frodsham Cut (Site 28) are still within the township of Sutton, and are therefore included in the tithe map. It shows the Dock Yard (Site 02) comprising the dock and associated buildings (also including a smithy (CRO EDT 380/1 1845)) lying immediately to the north-west of the line of the present viaduct. Such a collection of buildings may have represented a dry dock for boat repairs, potentially representing an important diversification of local economic activity. Only the southern portion of the yard lies within the proposed restoration area. Sutton Mills (Site 11), with the Wharf (Site 10) to the north, lies on the eastern side of Frodsham Bridge (Site 14). A mill cut is clearly shown to divert water as a controllable power source to Sutton Mills. Several buildings can be observed clustered to the north of Sutton Mills, and aligning the Chester and Warrington Turnpike Road, including a butcher's shop and a public house (*ibid*).

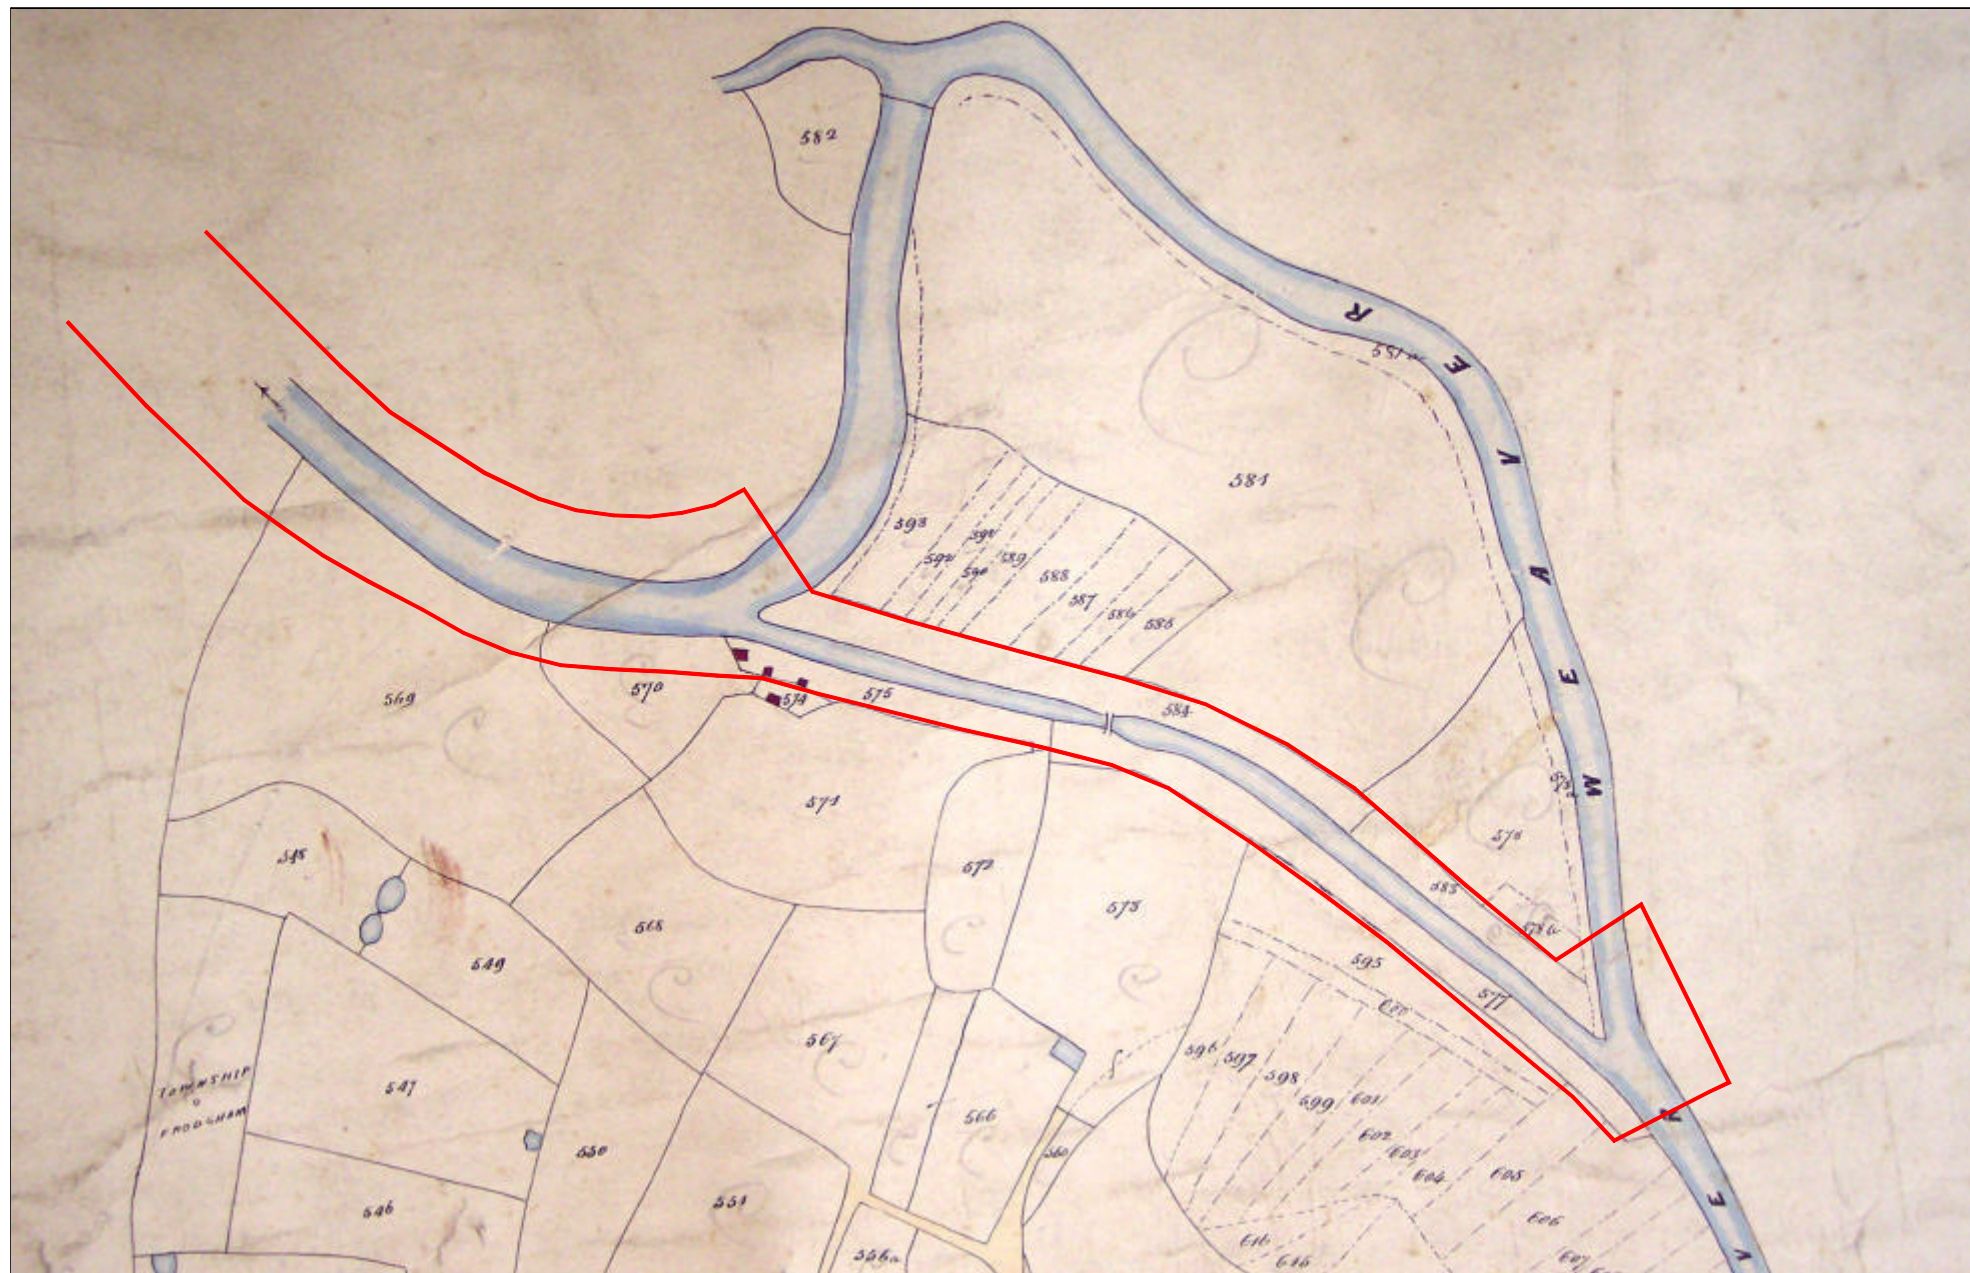
Figure 6 : Extract from Frodsham Lordship Tithe Map, c1846

- 3.3.8 The function of Sutton Mills (Site **11**) is specified as a flour mill, and the large outlet for the mill cut can be seen issuing into the River Weaver. Many of the buildings between the viaduct and Frodsham Bridge remain the same, although a number of others have been added. The unenclosed path along the north side of the River Weaver that was depicted in the Sutton tithe map (Fig 4) can now be seen to be aligned by an embankment (Site **16**), presumably created to minimise or prevent flood damage across the marshes. Each of the fields is depicted as having access through the embankments to the river via a 'ramp'. The enclosed banks along the Frodsham Cut observed in Figure 6

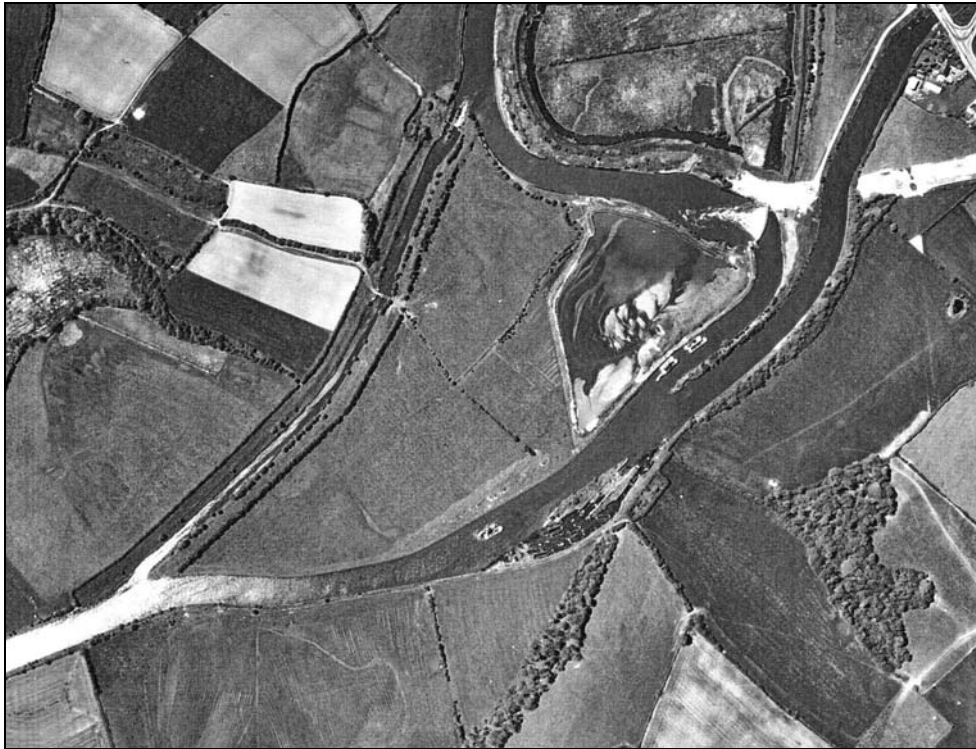
Plate 1: Aerial Photograph of Frodsham Cut, with north on the left of the shot
(HSL UK 1973, shot 1602)

Site number	37
Site name	River Weaver palaeochannel, Frodsham
NGR	SJ 5409 7805
Site type	Palaeochannel
Period	Unknown
HER No	-
Statutory Design.	-
Sources	CCC 1985, shot 180; HSL UK 1973, shot 1602
Description	The path of the River Weaver (Site 17) appears from aerial photographs to have altered considerably over time. Abandoned river meanders can be seen north-east of the east end of Frodsham Cut (Plate 2; CCC 1985, shot 180), and crossing the eastern half of Frodsham Cut (Plate 1; HSL UK 1973, shot 1602).
Assessment	The proposed restoration area covers part of the observed palaeochannels, which will be affected.

Plate 1: Aerial Photograph of Frodsham Cut, with north on the left of the shot (HSL UK 1973, shot 1602)

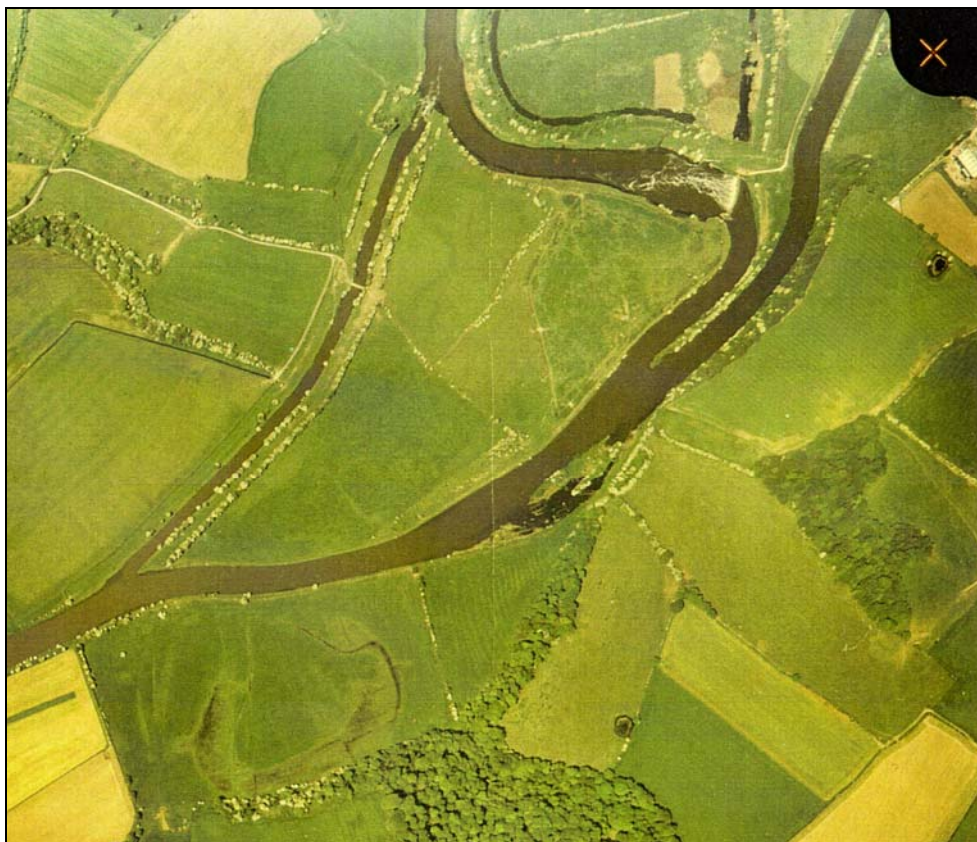
Plate 2: Aerial Photograph of Frodsham Cut, with north on the left of the shot
(CCC 1985, shot 180)

Plate 2: Aerial Photograph of Frodsham Cut, with north on the left of the shot (CCC 1985, shot 180)

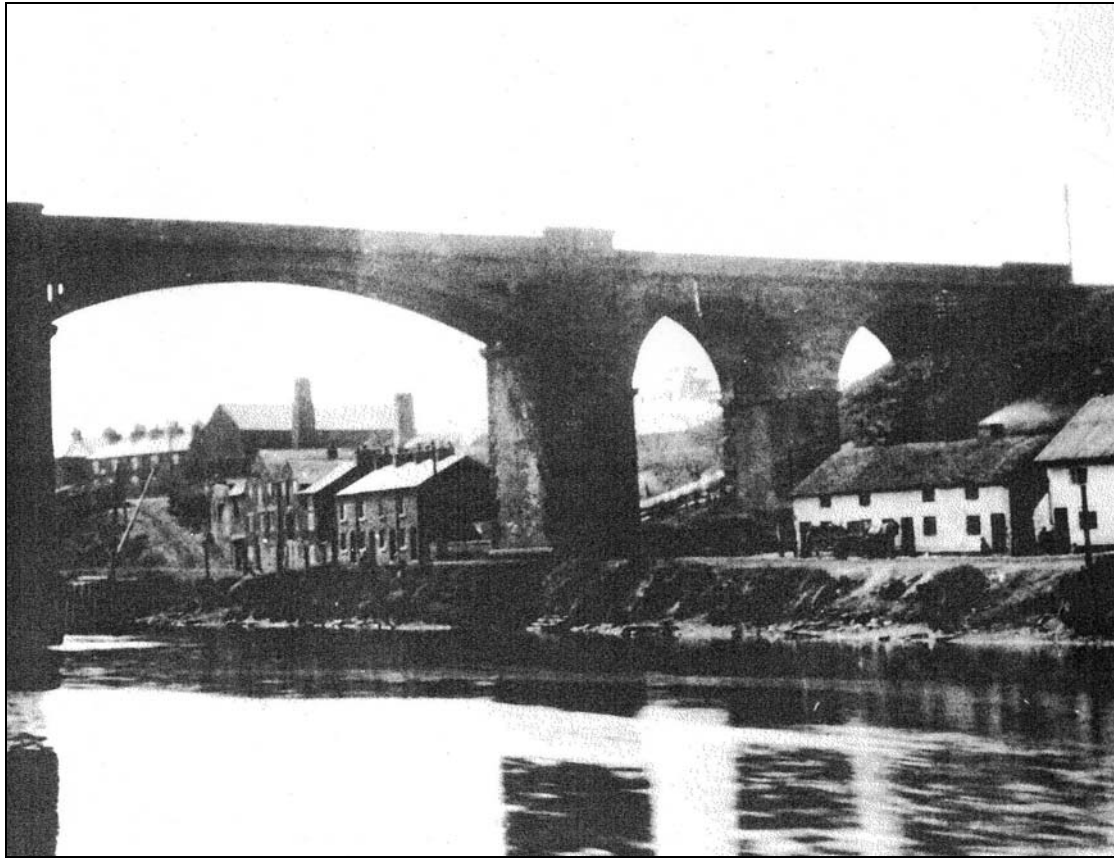
Plate 3: View of the Quay at Frodsham viaduct (Site **03**), c1900, looking south (FDLHG 1995, 39)

Plate 3: View of the quay at Frodsham viaduct (Site **03**), c1900, looking south (FDLHG 1995, 39)

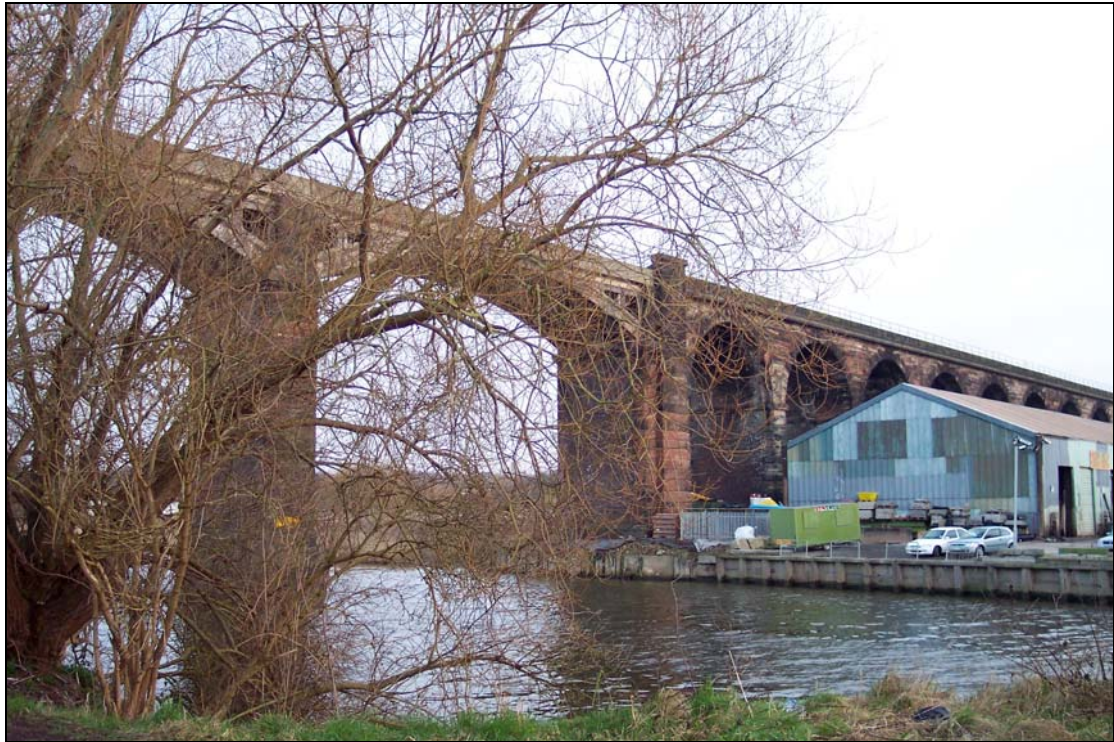
Plate 5: View of Frodsham Viaduct (Site **03**), looking north

- 3.5.2 The viaduct (Site **03**), Frodsham Bridge (Site **14**), and the Wharf (Site **10**) and its associated buildings were all observed as being present, as were the embankments noted during the map regression analysis (Sites **16**, **19**, and **30**). The watercourses of the River Weaver (Site **17**) and Frodsham Cut (Site **28**) were observed, with Frodsham Lock (Site **22**) and the cattle bridge (Site **25**) on the latter stretch of water. The wharf and landing stage on the south bank of the Weaver (Sites **08** and **15**) were also present.

- 5.2.6 **Survival/Condition:** Frodsham Lock and Sluice (Site **22**) is listed and is not in working condition. Due to its importance and statutory designation it would benefit from restoration. Similarly, the swing bridge (Site **25**), which is now a static bridge, would benefit from restoration. Many of the timber posts associated with quayside and canal side fixtures and features are in a decayed state, including those associated with the wharf and landing stage (Sites **08**, **20-1** and **31**). Frodsham viaduct (Site **03**) and Frodsham Bridge (Site **14**) are in good condition.

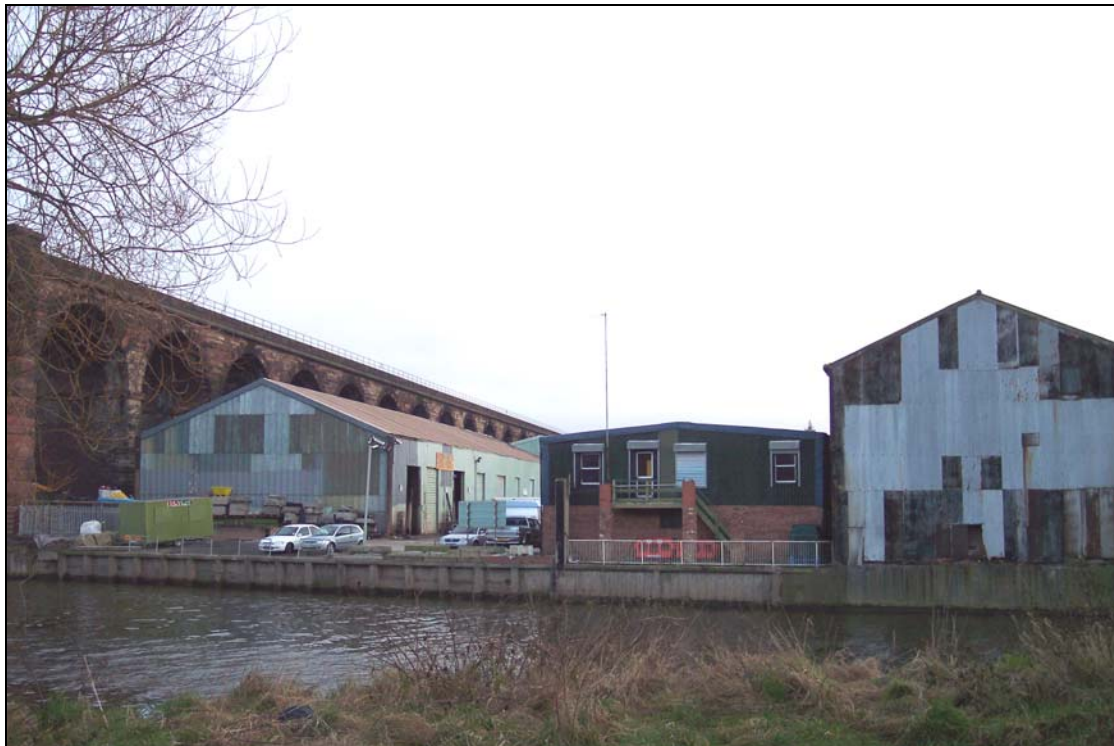
Plate 6: View of current buildings located on the east side of Frodsham Viaduct (Site **03**), looking north

Plate 6: View of current buildings located on east side of Frodsham viaduct (Site **03**), looking north

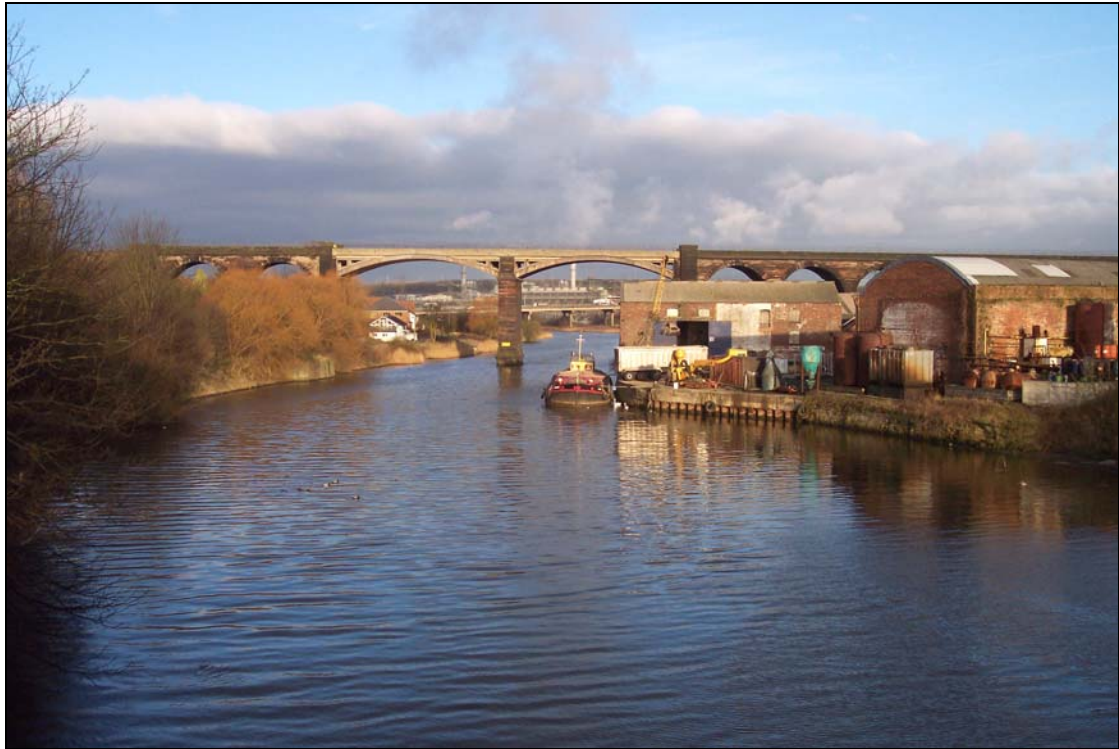
Plate 7: View of Frodsham Viaduct (Site **03**) and the Wharf (Site **10**), looking west

Description	The wharf to the north of Frodsham Bridge on the east bank of the River Weaver is first named on the Sutton tithe map of 1844 (CRO EDT 380/2 1844), and it was observed in use during the walkover survey (Plate 7).
Assessment	The site lies within the proposed restoration area and will be affected.

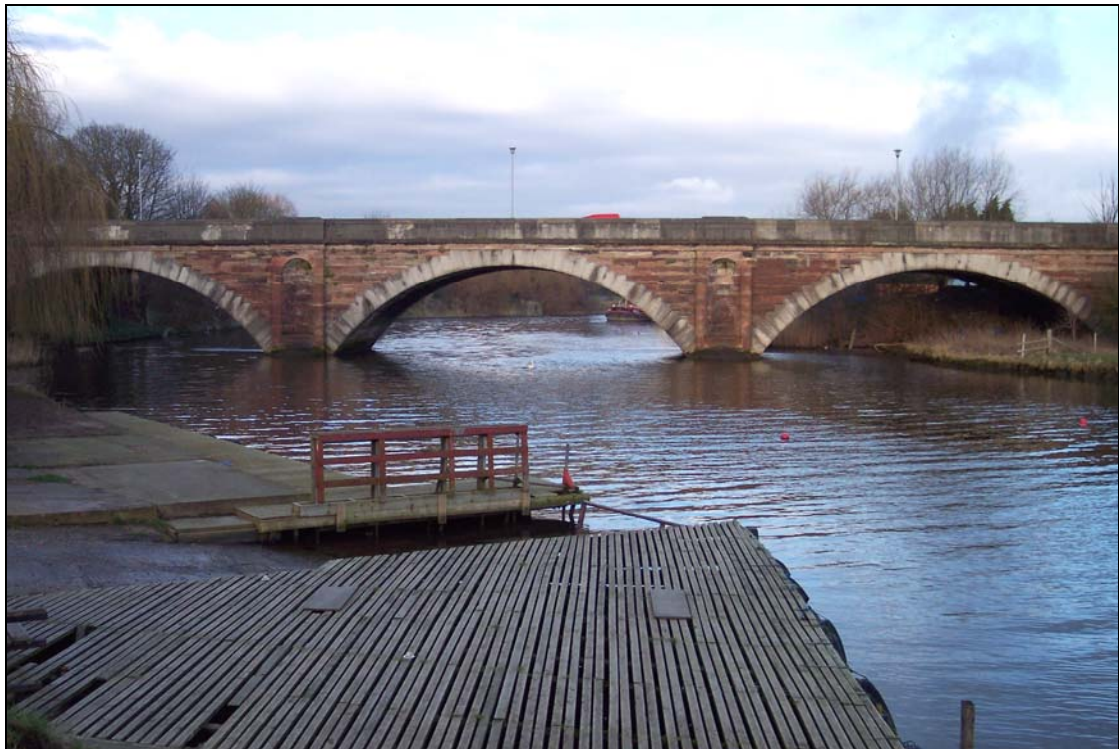
Plate 8: View of Frodsham Bridge (Site **14**), looking west

Site number 14
Site name Frodsham Bridge
NGR SJ 5300 7845
Site type Bridge
Period Medieval - Post-medieval
HER No 987
Statutory Design. Grade II Listed Building
Sources DoE 1986 (Map 2, Item 56); Ormerod 1882
Description Frodsham parish bridge at the east end of the town dates from the reign of Henry III (Ormerod 1882, 53). The original bridge was of wood. In the fourth year of Henry V's reign, John Done, forester of Delamere, was requested to give one oak for the repairs of Frodsham bridge (*ibid*). The bridge was rebuilt in brick in the reign of Elizabeth I (*ibid*). In 1625 it was rebuilt in stone with four arches (*ibid*), and the remains of it could be seen on the Frodsham side of the river approximately 30 yards downstream of the present structure (Hawkin n.d.(b)). This was taken down some time before 1816 to make way for the present structure (*ibid*), which is now a Grade II Listed Building (Plate 8).

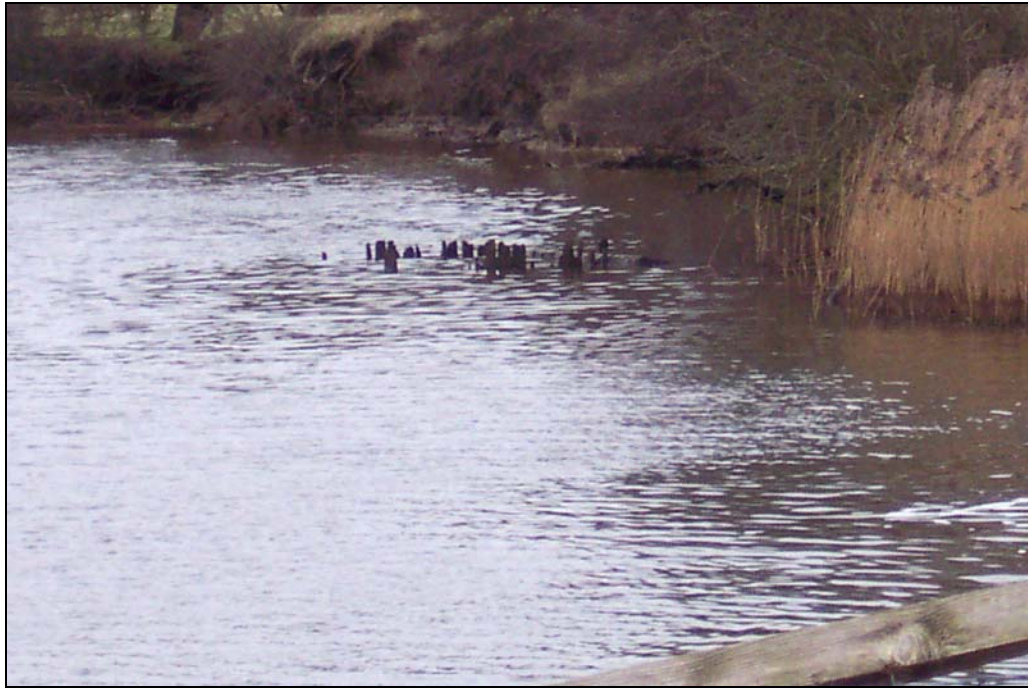
Plate 9: View of extant posts (Site **21**), protruding from the water, looking east

- 5.2.7 **Fragility/Vulnerability:** the timber posts are in a vulnerable state due to their poor condition (Sites **08**, **20-1** and **31**). The projected line of the Roman road (Site **34**) lies within the proposed development area, and any remains that may

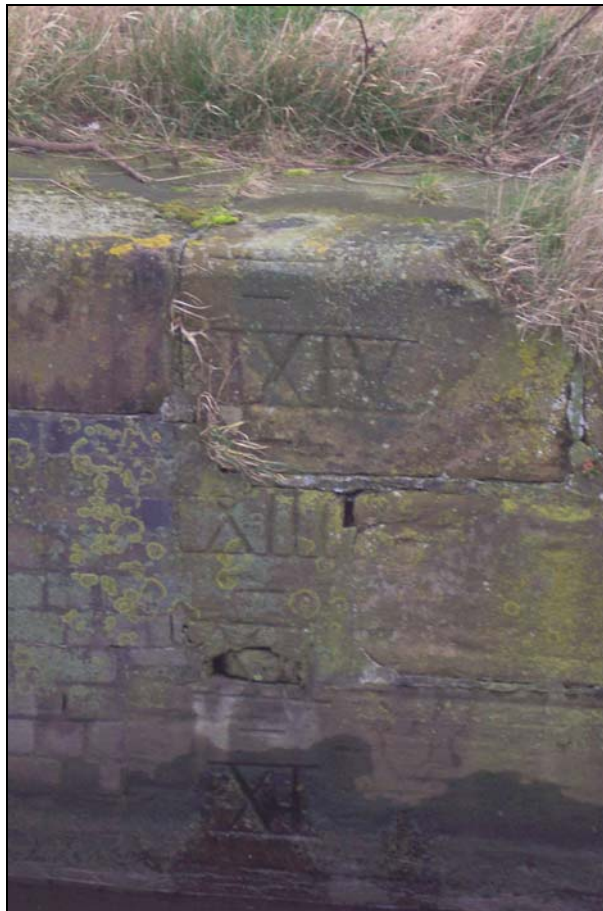
Plate 10: Detailed view of depth markers on the north-western end of Frodsham Lock (Site **22**), looking north

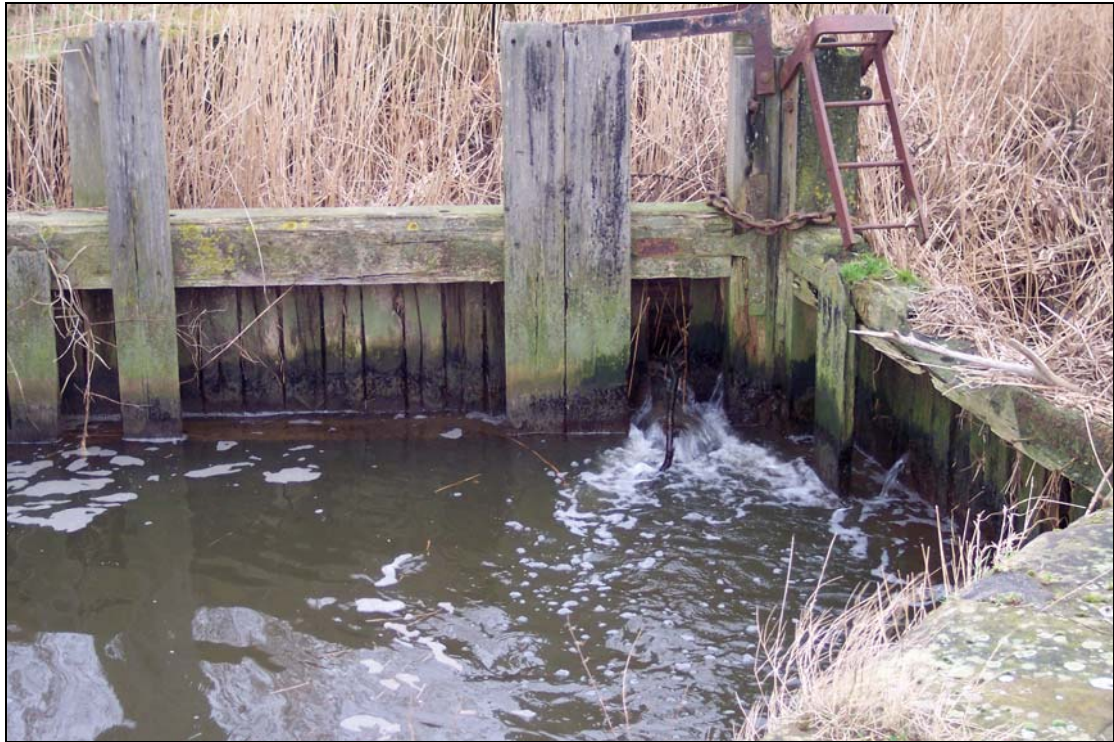
Plate 11: Detailed view of lock gates at Frodsham Lock (Site **22**), looking east

- 6.2.5 **Provision of new lock gates and pivots:** six options for the replacement of the lock gates have been proposed. The first, option (a) (TEP *et al* 2005, 25), of timber balanced beam mitre gates is the most preferable heritage replacement, in terms of matching the original construction on a Grade II listed structure, and would have a beneficial effect.

- 6.2.6 Option (b) proposes the use of mechanically operated timber mitre gates. However, the installation of the control boxes is likely to have a negative impact on the historic setting. This would also require excavation of the chamber walls in preparation for the installation of rams, which would inflict damage to the historic fabric. Similarly, this negative impact also applies to option (d), which also necessitates modification to the chamber walls. Options (e) and (f) require substantial modification and reconstruction of the chamber walls and, due to the statutory protection of the lock, it is advised that these options are disregarded in terms of the adverse negative effect on the historic fabric. The steel mitre gates considered as option (c) would also have a negative effect on the heritage value as they are unsympathetic to the visual impact.

- 6.2.7 Replacement of the lock gates will require Listed Building Consent. Therefore, many of these options are likely to be unavailable due to the restrictions of its statutory status, although consideration will need to be made for any Health and Safety risks. It is recommended that prior to any restoration a detailed photographic survey and record is undertaken.

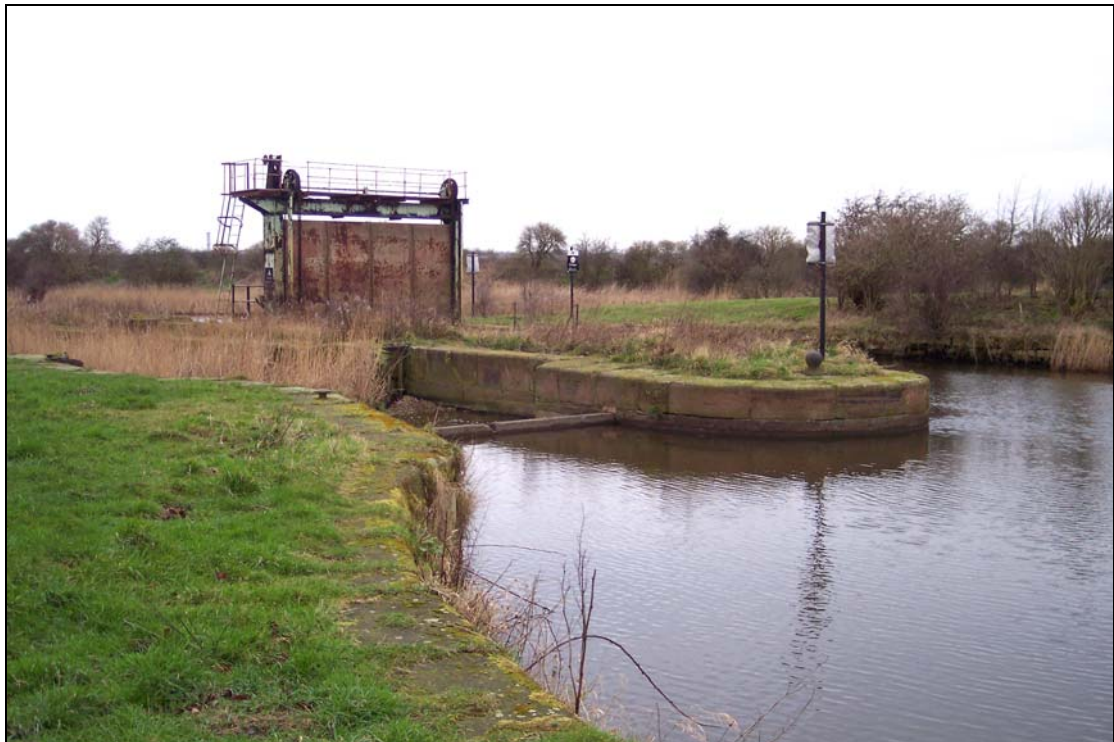
Plate 12: View of Frodsham Lock (Site **22**), looking north-west

- 6.2.4 **Masonry repairs and re-pointing to chamber:** Frodsham Lock (Site 22) has a Grade II listed status. Therefore, it is a requirement to obtain Listed Building

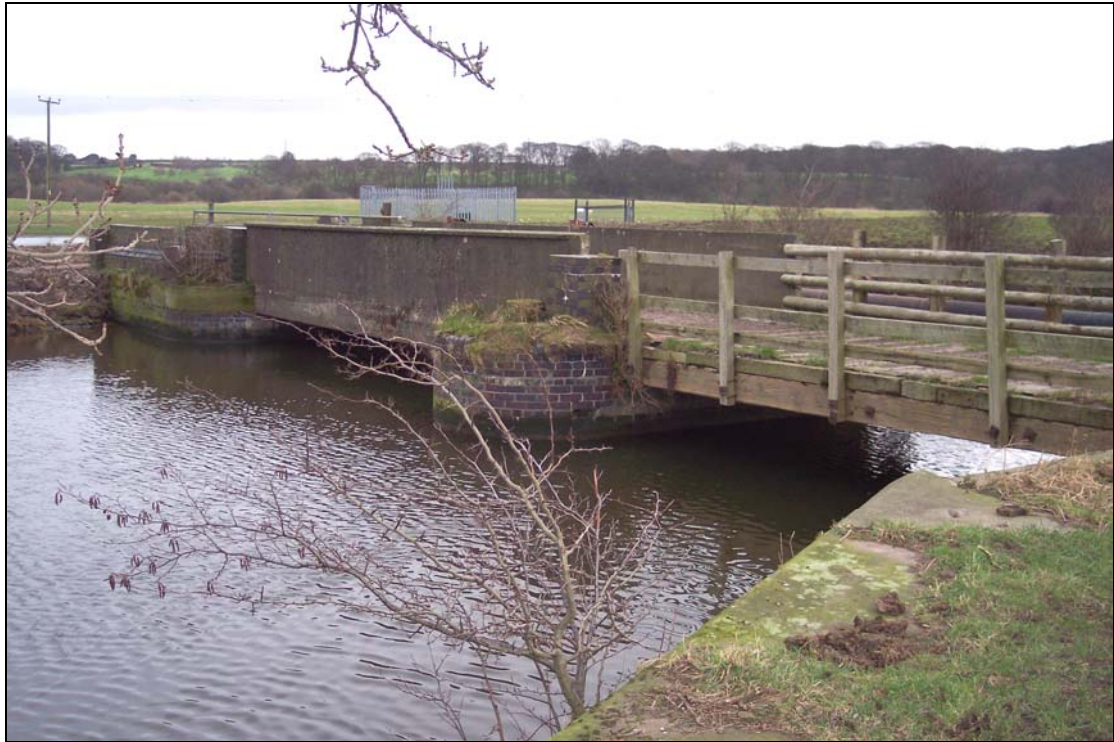
Plate 13: View of Cattle Bridge (Site **25**), looking east

- 6.2.13 **Accommodation Bridge:** the proposals to alter the existing bridge are beneficial to enable the lock and Cut to be navigated. A number of options have been provided (TEP *et al* 2005, 28), and the recommended archaeological mitigation work will need to reflect the chosen option. In any case, a detailed photographic and recording survey will be required prior to the work. However, the proposed lifting type bridge, as one option, requires substantial modification which will have an adverse negative impact on the historic fabric.

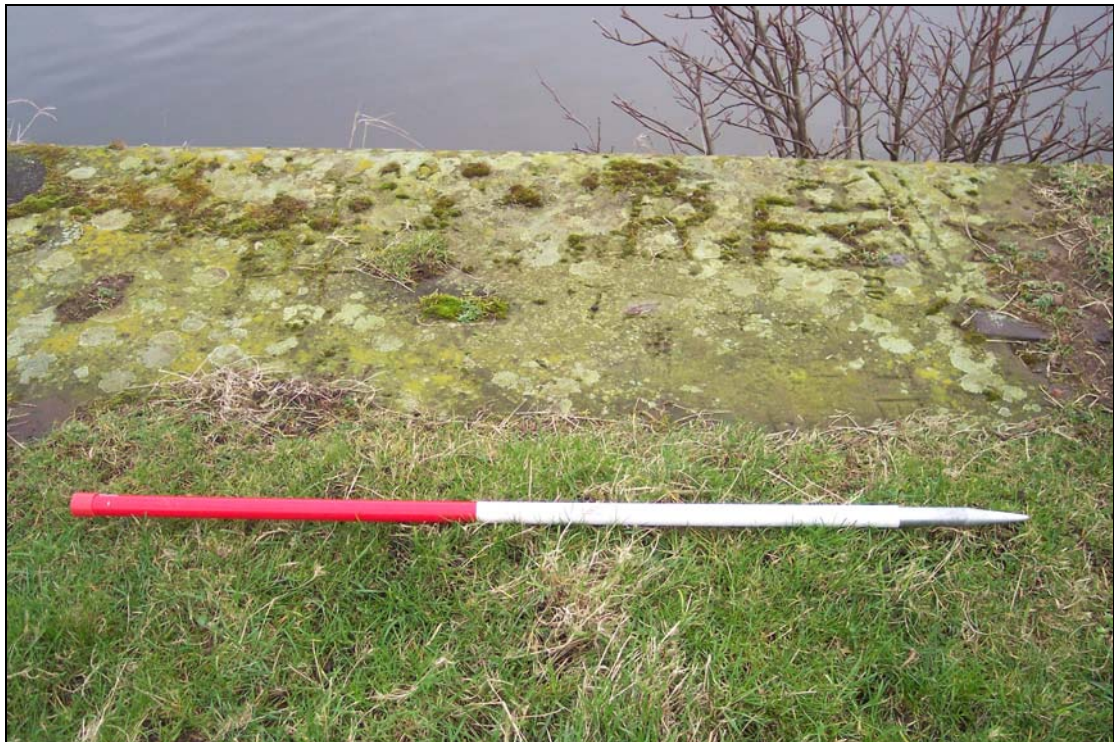
Plate 14: Detailed view of graffiti on canal side (Site **27**) by the Cattle Bridge (Site **25**), looking north-east

Site number	27
Site name	Stone-edged canal side, east of Swing Bridge, Frodsham Cut
NGR	SJ 5394 7812
Site type	Stone area associated with former swing bridge
Period	Post-medieval
HER No	-
Statutory Design.	-
Sources	Observations made during walk-over survey
Description	Stone-edging blocks were observed on the south bank of Frodsham Cut to the east of the former swing bridge. Some of these blocks had been defaced by carvings, within which moss had rooted making it very visible (Plate 14).
Assessment	The site lies within the proposed restoration area, and will be affected.

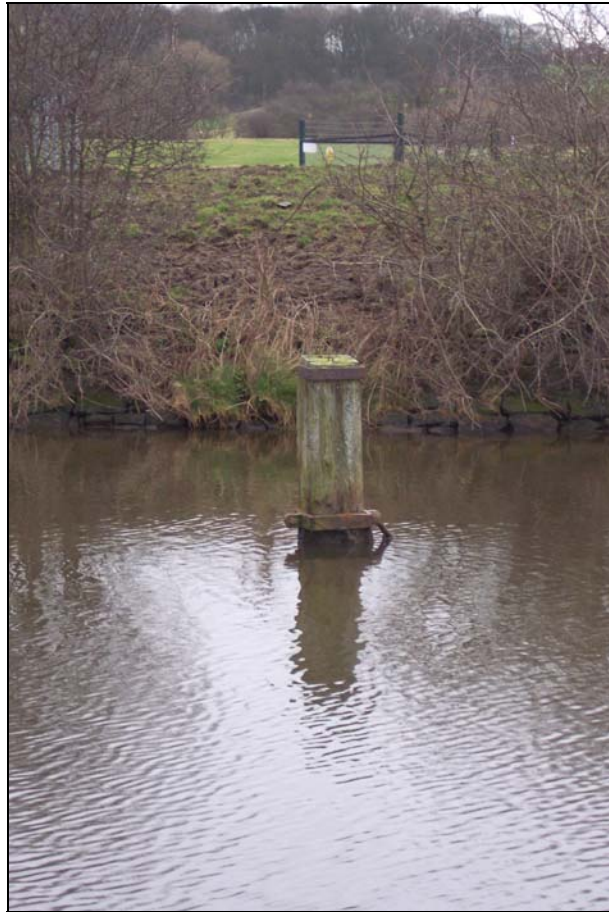
Site number 26
Site name Timber posts, east of Swing Bridge, Frodsham Cut
NGR SJ 5397 7814
Site type Timber posts
Period Post-medieval
HER No -
Statutory Design. -
Sources Walkover survey 2005
Description A line of three square-sectioned timber posts was observed east of the former swing bridge over Frodsham Cut. The western post was close to the southern end of the bridge, and the eastern post was adjacent to the north bank of Frodsham Cut. The posts appeared to be equally spaced, with identical iron fittings including a substantial anchor pin on the east side of each one (Plate 15). The posts are likely to be associated with the former swing bridge, and may have held warning lights aimed at stopping barges attempting to go any further.
Assessment The site lies within the proposed restoration area, and will be affected.

Plate 15: View of one of a line of three timber posts (Site **26**), looking north-east

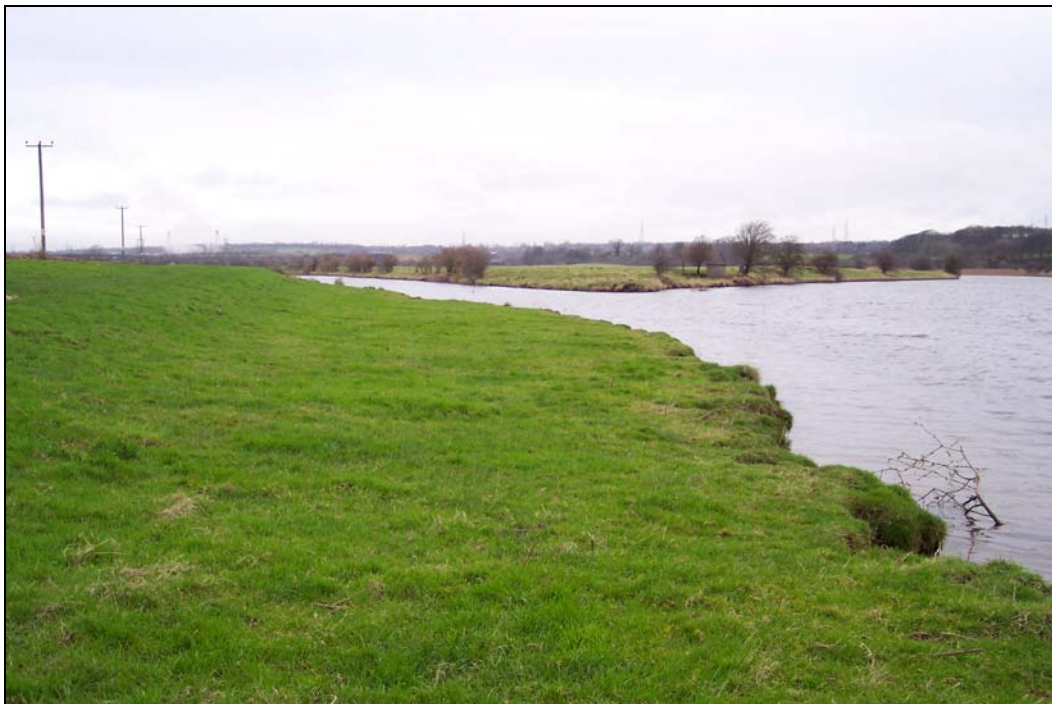
Plate 16: View of the banks on the south-east end of Frodsham Cut,
looking north-west

Nicospan banks along Cut	27, 28, 30		Photographic and earthwork survey before work is carried out, sympathetic materials to be used for banks
Signage (i)	30		Care should be taken not to damage Site 30
Signage (ii)	25, 27		Care should be taken not to damage Sites 25 and 27
Signage (iii)	22	Legal requirement to apply for Listed Building Consent. Inflicting damage on historic fabric	Photographic record should be made of affected areas first, care should be taken not to damage historic fabric
Signage (iv)	16, 20, 21?		Care should be taken not to inflict damage on Sites 16, 20, and 21
Signage (v)	14	Legal requirement to apply for Listed Building Consent. Inflicting damage on historic fabric	Photographic record should be made of affected areas first, care should be taken not to damage historic fabric
