ST CHAD'S CHURCH, POULTON-LE- FYLDE, LANCASHIRE

Archaeological Watching Brief

Oxford Archaeology North

June 2005

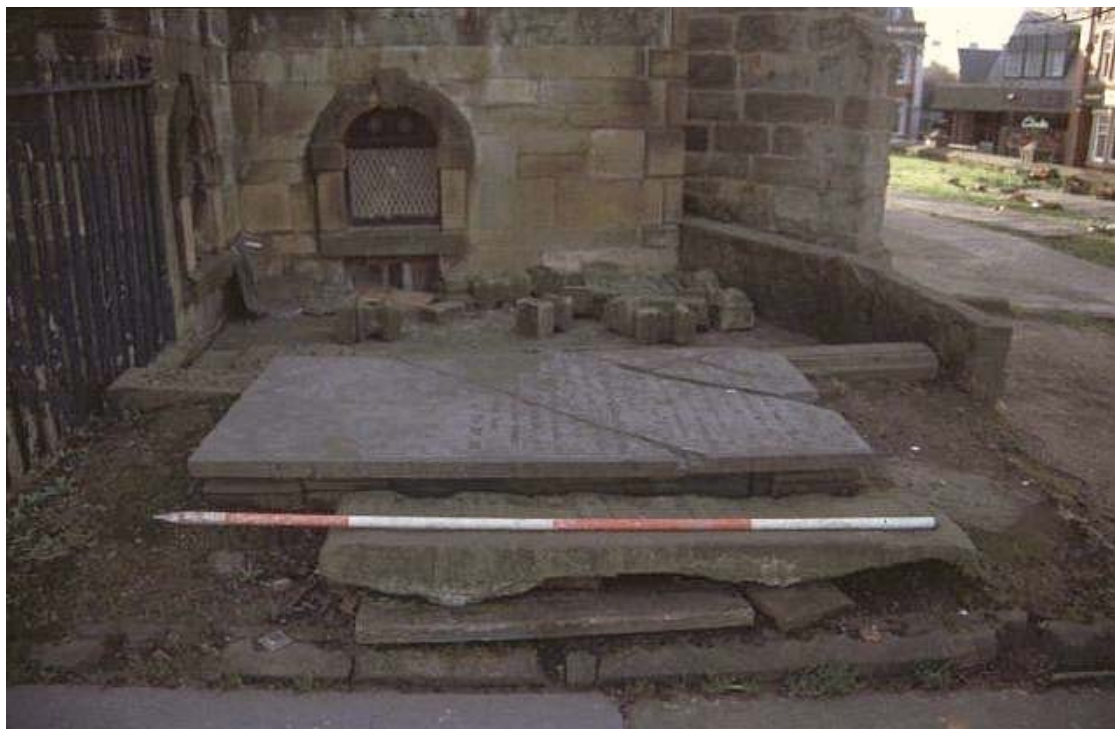
4.2.1 A slate tombstone, **I** (Plates 1 and 2, Figs 2 and 3), was located in the area of the east/west foundation trench. It measured 1.89m in length, 1m in width and was 0.05m thick. The tombstone was aligned east/west, with the inscription at the east end covering approximately two thirds of the stone.

Plate 1: Tombstone, *I*, and surrounding area, looking south

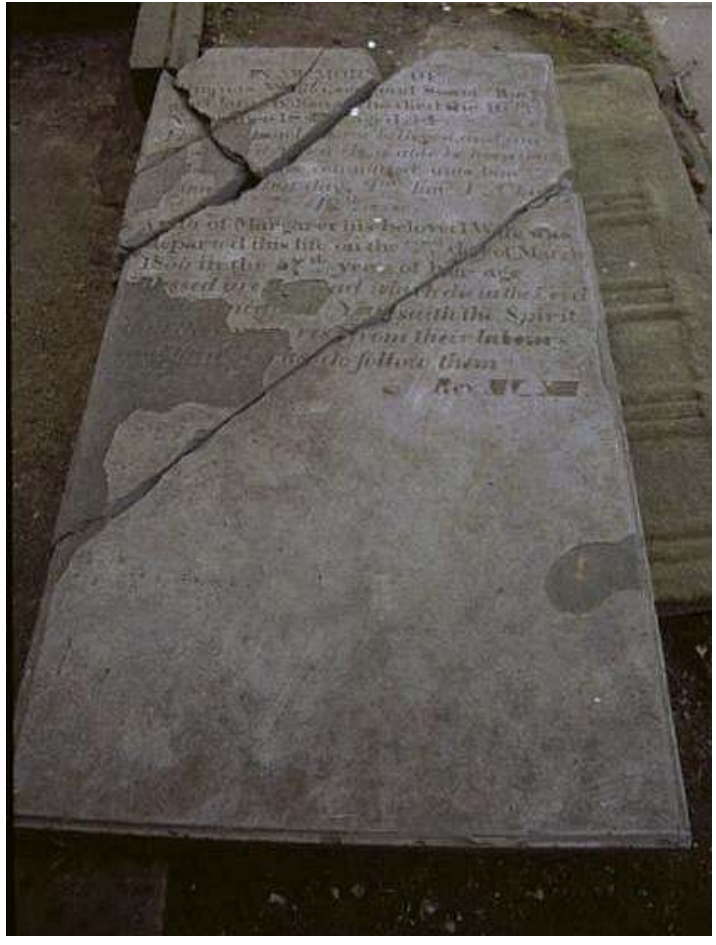
Plate 2: Tombstone I, looking west

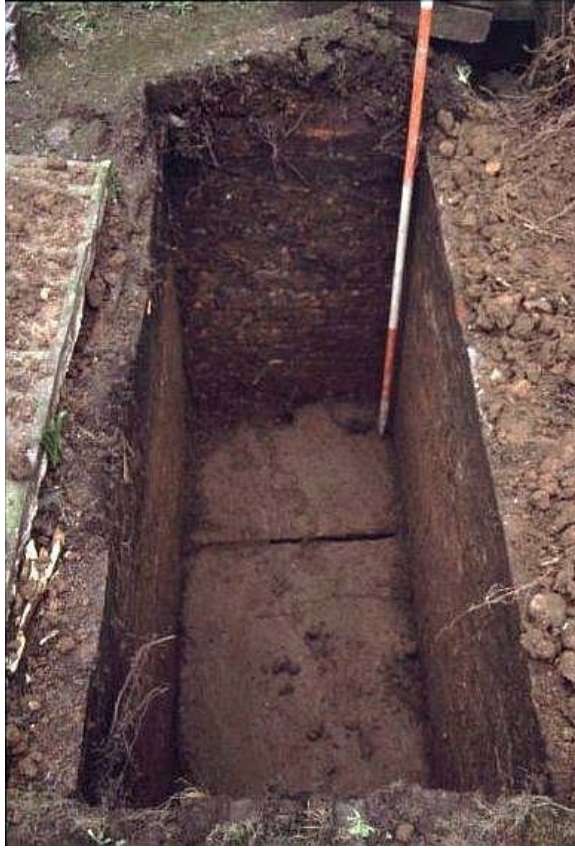
- 4.2.6 Three sandstone flagstones, **4** (Plate 3), of equal size (0.74m north/south, 0.67m east/west and 0.05m in depth) were located 1.16m (15 courses) beneath the top of the brick-lined shaft, **6**. The flagstones were not bonded, and had been placed on a ledge which protruded from the north and south sides of **6**. On the north side the ledge was 0.05m in width, and on the south side it was 0.03m in width.

Plate 3: Sandstone slabs, 4, in brick-lined shaft 6, looking east

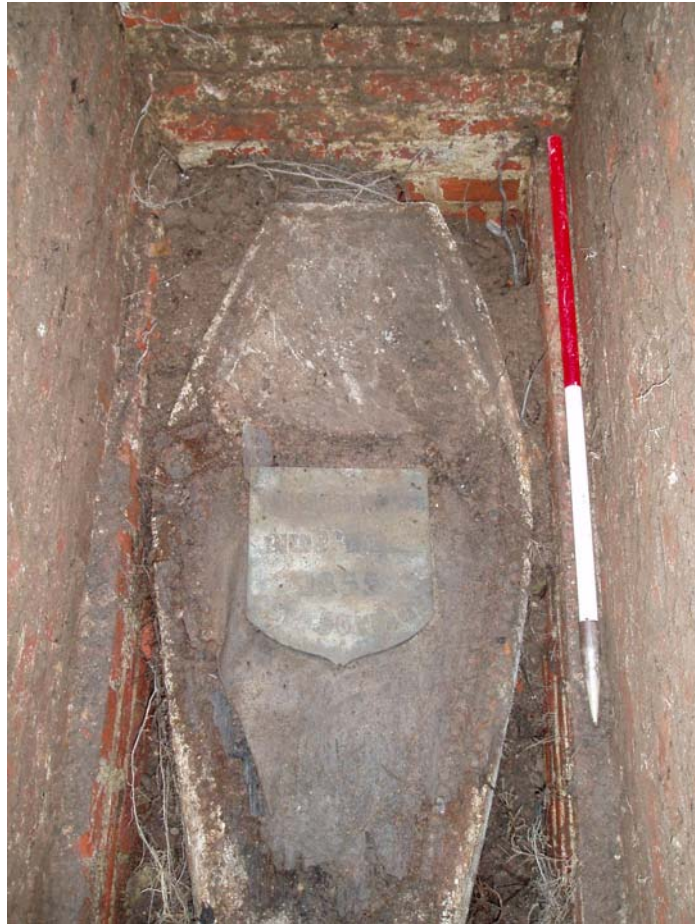
- 4.2.7 Beneath **4** was a chamber containing a lead coffin, **5** (Fig 4, Plates 4 and 5), measuring 1.72m in length and a maximum of 0.57m in width, tapering to a width of 0.26m at each end. The full extent of the coffin to its base was not seen, but it was approximately 0.34m in depth. The coffin had a raised lip 25mm in width around the edge of the lid. The remnants of a timber lid were observed over the central part of the coffin. Two concentric rows of iron studs could be seen preserved within the wood running around the edge of the coffin over the raised lip, 25mm apart. Individually, the studs were 15mm in diameter and spaced 5mm apart. A name plate made of brass (Plate 6) was *in situ* over the timber lid of the coffin. The inscription on the name plate read: 'Margaret Wilson Died 2nd March 1855 Aged 56 Years'. No other coffin fittings were observed and there were no handles, or any indication of where handles might have been.

Plate 5: West end of coffin 5

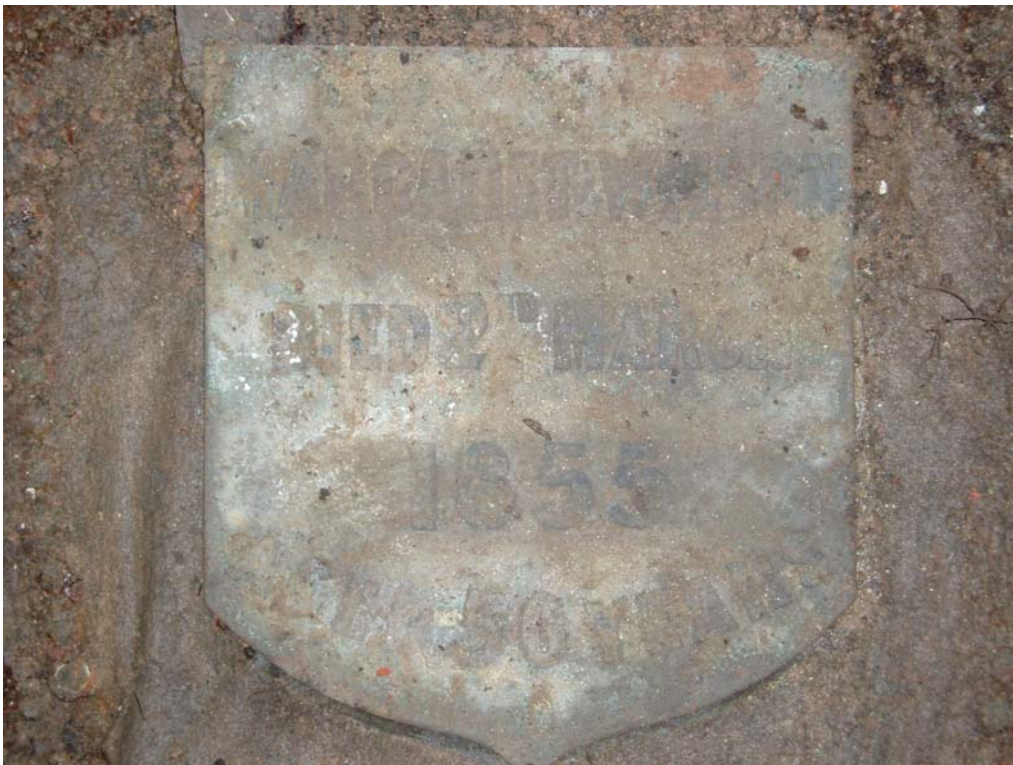
Plate 6: Name plate on coffin 5

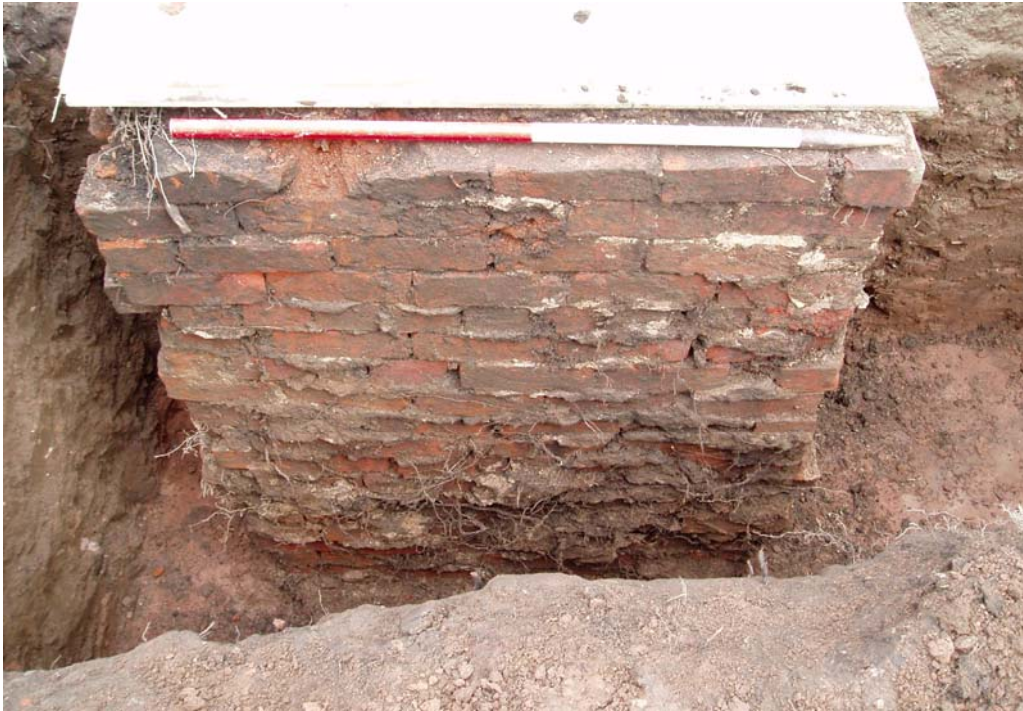
4.2.5 The cut for brick-lined shaft, **6**, (Figs 3 and 4, Plates 7 and 8) and the shaft itself were 2.43m in length (east/west) and 1.18m in width externally and, internally, the shaft measured 2.04m in length and 0.74m in depth. Its full

depth was not seen but it was exposed on the outside to a depth of 1.53m (equalling 18 courses of brick). The walls of the shaft were two courses of brick wide, and were bonded in a stretcher pattern. Individually the bricks measured 0.23m in length, 0.11m in width, and 0.07m thick.

Plate 7: West end of brick-lined shaft 6

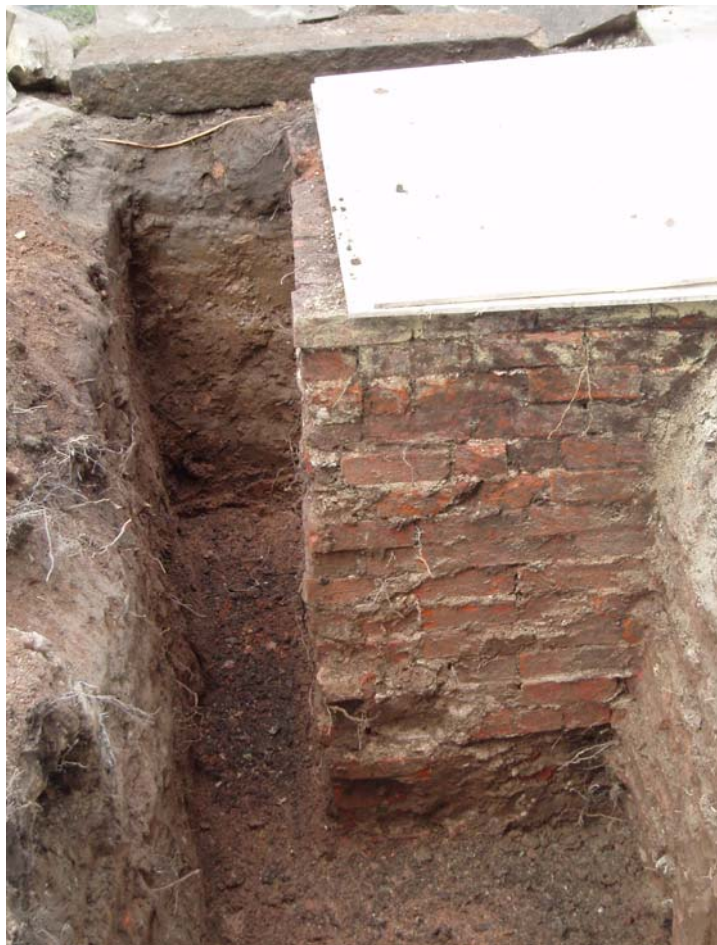
Plate 8: South-facing section showing west end of brick-lined shaft 6

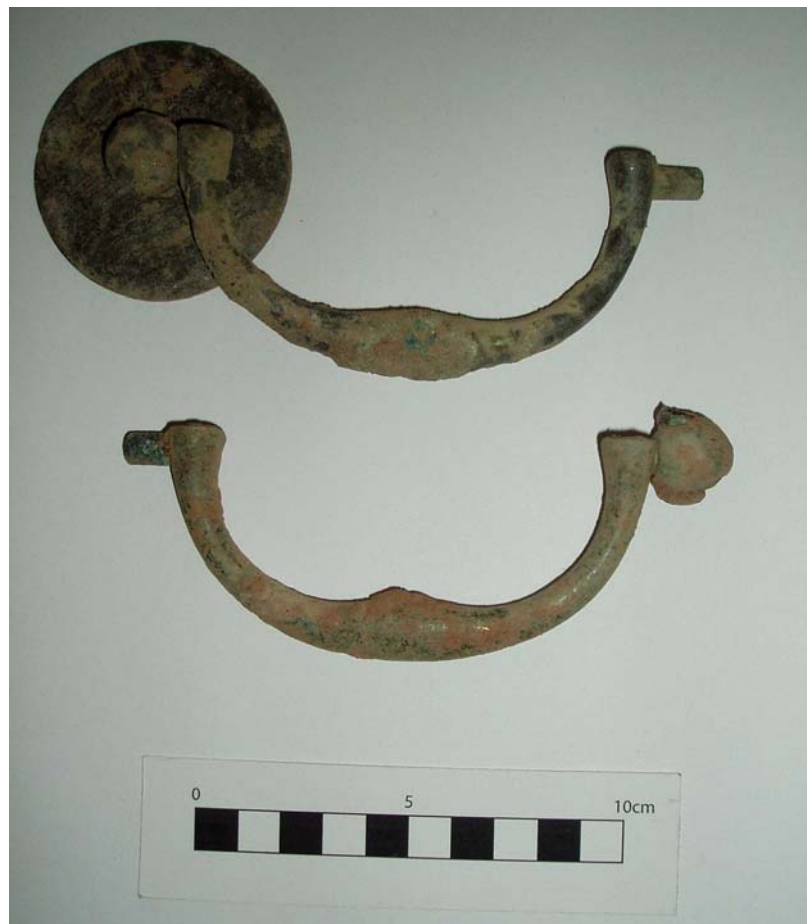
- 5.2.5 **Copper alloy:** two identical coffin handles were recovered from **13** and **18** (Plate 10). They have been provisionally dated to the nineteenth century, on the basis of the dates of the graves uncovered nearby. It is possible, however, that they are somewhat earlier in date, and represent the clearing of early graves to make way for the mid nineteenth century graves identified.

Plate 10: Coffin handles from 13 (above) and 18 (below)

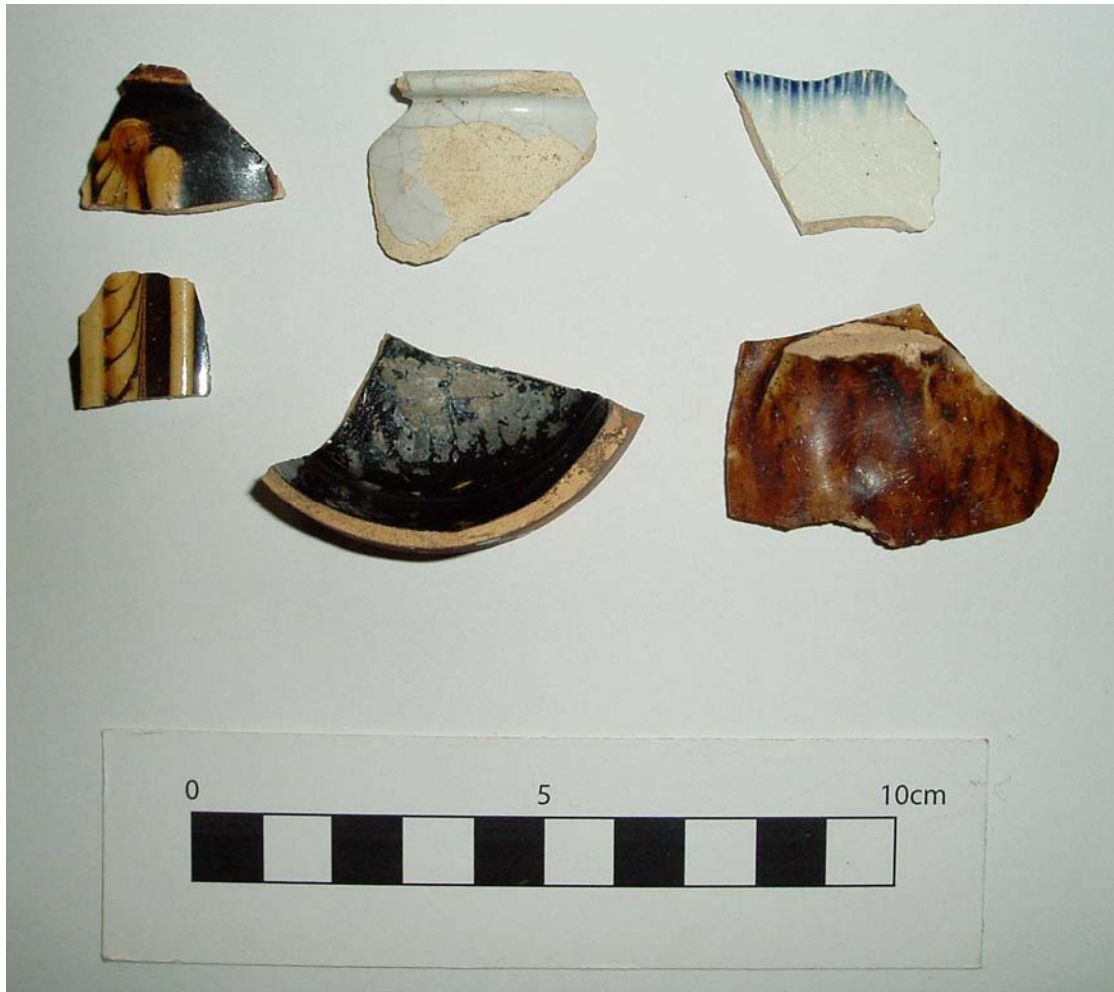
5.2.3 **Pottery:** a small assemblage of pottery was recovered from **2**, **3** and **13/16/18**; the last two were essentially the same deposit. The date of the graves uncovered was of the mid-nineteenth century. Therefore, it seems reasonable

to expect that the pottery from the deposit through which they were cut, and that was subsequently returned as backfill, would contain earlier or at least contemporary pottery. Although many of the pottery fragments cannot be closely dated, none of the fragments recovered were later than the early nineteenth century in date. The earliest pottery recovered from **3**, **16** and **18** was mottled ware dated to the late seventeenth to early eighteenth century (Plate 11). Of a similar date were two fragments of a single fine slip-coated hollowware vessel with trailed slip decoration, recovered from **3** and **16** (Plate 11). A tin-glazed earthenware rim fragment from the same period was also recovered from **16**. A slip-coated cup base dated to the eighteenth century was recovered from **18**, and creamware and pearlware fragments dated to the late eighteenth to early nineteenth century, including a moulded and blue painted shell-edge plate rim, were recovered from **3** and **18** (Plate 11). White earthenware fragments dated to the late eighteenth to twentieth century were recovered from **3** and **16**, including one sponge-printed vessel rim, and one blue 'Willow' transfer-printed vegetable dish or tureen fragment. Many black-, brown-, and self-glazed red earthenware coarseware vessel fragments were also recovered from **2**, **3**, **13**, **16**, and **18**, all of which were broadly dated to the late seventeenth to early twentieth century. The vessel forms identified comprised pancheons and crocks or jars, and a bottle decorated with white slip stripes, and all of these would have been used as kitchen wares.

Plate 11: Clockwise from top left: slipware (3), tin-glazed earthenware vessel rim (16), pearlware blue shell edge plate rim (18), mottledware handle terminal (18), slip-coated cup base (18), slipware (16) probably from same vessel as the fragment above it (3)
