Pecket Well Mill, Pecket Well, Hebden Bridge, West Yorkshire

Archaeological Building Investigation

Revised January 2007

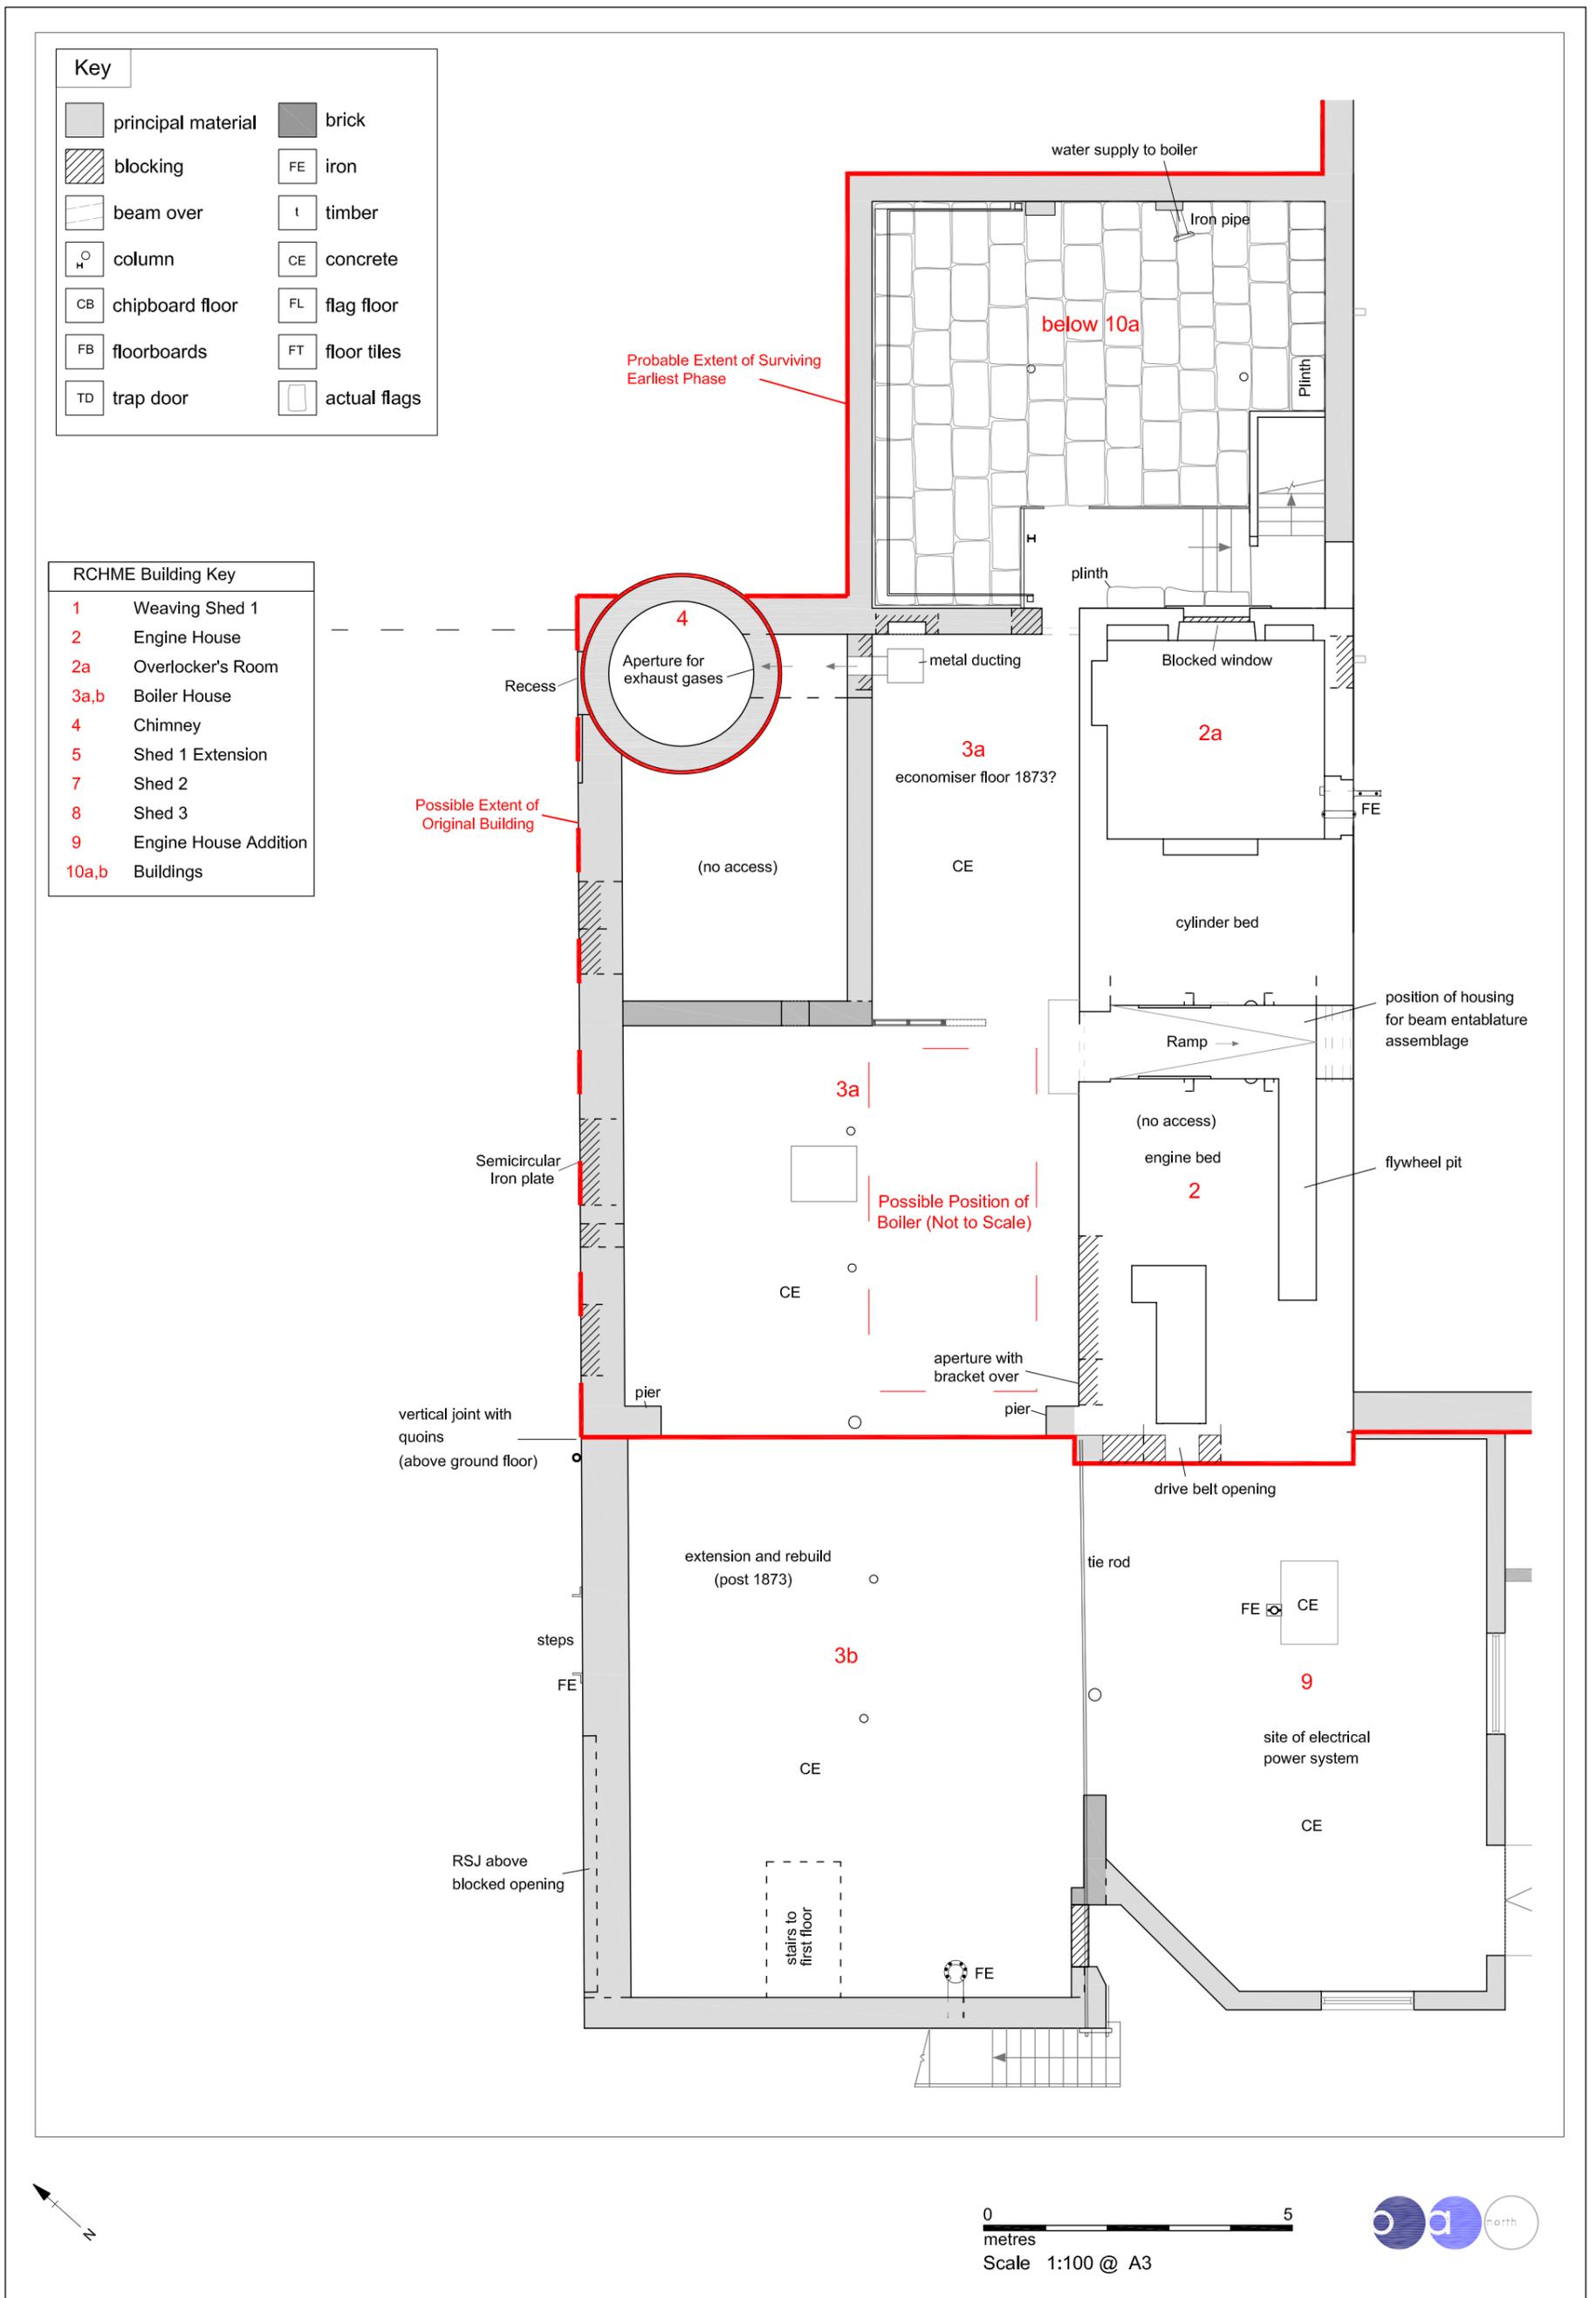
Figure 2: Ground floor plan of Boiler House and Engine House

- 3.2.3 The north, south and east internal ground floor walls of **3a** are mainly constructed from both regular, coursed squared stonework and flat rubblework with some localised areas of brick and cinder block patching, all of which is whitewashed (10:2-5). A partition wall within **3a** (beyond which there was no access) is of regular-coursed rock-faced stone with some areas of brick rebuilding and patching. The chimney base is visible through an aperture with metal ducting at the east end of this wall (Fig 2) (8:17).

- 3.2.4 There is a vertical rectangular aperture visible in the extreme west end of the south wall of **3a** (Fig 2) which is situated next to a 'pier' described below (*Section 3.2.9*) (5:13-14). A cast iron beam (bracket?) surmounts this and it possibly relates to either a revised power transmission system described in *Section 3.3.3* or is associated with the boiler.

- 3.2.13 It is probable that much of the surviving below-ground fabric of **3a** comprises first generation fabric, which makes up the earliest phase of the building (Fig 2). Building **3b** possibly represents extension and rebuilding after the fire of 1873, although parts of this (particularly the ground floor) may contain an amount or earlier fabric incorporated into the rebuilding. The chimney may have been free standing prior to the fire of 1873 and evidence (11:07) shows integration into later fabric on all of the upper floors. Due the limitations of the survey and ongoing demolition works (including the removal of some of the fabric before inspection was possible) detailed analysis of the boiler house was difficult.

- 3.3.3 It is probable that the original boiler room was set in-between the engine house and chimney (Fig 2), and later became incorporated into the sizing place, which was probably constructed during the 1871 expansion. It (the boiler room) may have been incorporated into the original fabric of the 1858 ‘other buildings’. In the original Articles and Memorandum of Association of the Pecket Well Weaving Shed Company Ltd (1858) only a ‘Power Loom or Weaving Shed or Sheds’ is mentioned specifically, although reference is made to ‘steam power’ and ‘machinery and gear’ indicating that a boiler(s) must have been present. Following the fire, probably during construction of the current four-storey warehouse building, the fireproof vaulting and flagged floor above may have been installed to prevent a second fire. It was reported that the policeman who discovered the fire (Document 2 *Appendix II*), stated that he first saw smoke issuing from a room beneath the drying room, (which

- 3.4.1 The engine house (Building **2** Fig 2) is located to the east of the boiler house (**3a**) and is a distinct three-storey, regular-coursed stone building with a hipped roof and rusticated quoins. There are two tall round-headed first floor windows, with rusticated surrounds on each of the west and east elevations (now blocked) (11:02-04). The engine house is attached to the north-west corner of the weaving shed and a single storey addition (Building **9**), probably constructed in the twentieth century when a change in the power transmission system was made (RCHME 1988 4), is attached to the south-west side (of the engine house) (Fig 2). It is of entirely different construction to Buildings **2**, **3a** and **3b**. The engine house and its extension have been briefly described on pages 3 and 4 of the RCHME report (*Appendix II*) respectively.

- 3.4.2 The ground floor of building **2** is largely inaccessible, mostly being made up of the solid ashlar engine and cylinder beds (Fig 2). There is a passageway enabling access from the boiler room (Building **3a**) to the weaving shed (Building **1**) which separates the engine and cylinder beds (8:31-36). This passage would have housed the beam entablature assemblage and four opposing square recesses, which would have carried the entablature, are still present in the walls (8:33). There are also two opposing cast iron flanges bolted to each wall. This passage would probably have been impassable when the engine was *in situ* and the doorways would probably have been there to allow for maintenance of the entablature. The ceiling in this passage is timber and makes up part of the floor of the engine house floor above (8:33). The method of power transmission is described on page 3 of the RCHME report (*Appendix II*). The flywheel pit is visible as a narrow passageway (inaccessible) located at the south-east side of the engine house (Fig 2).

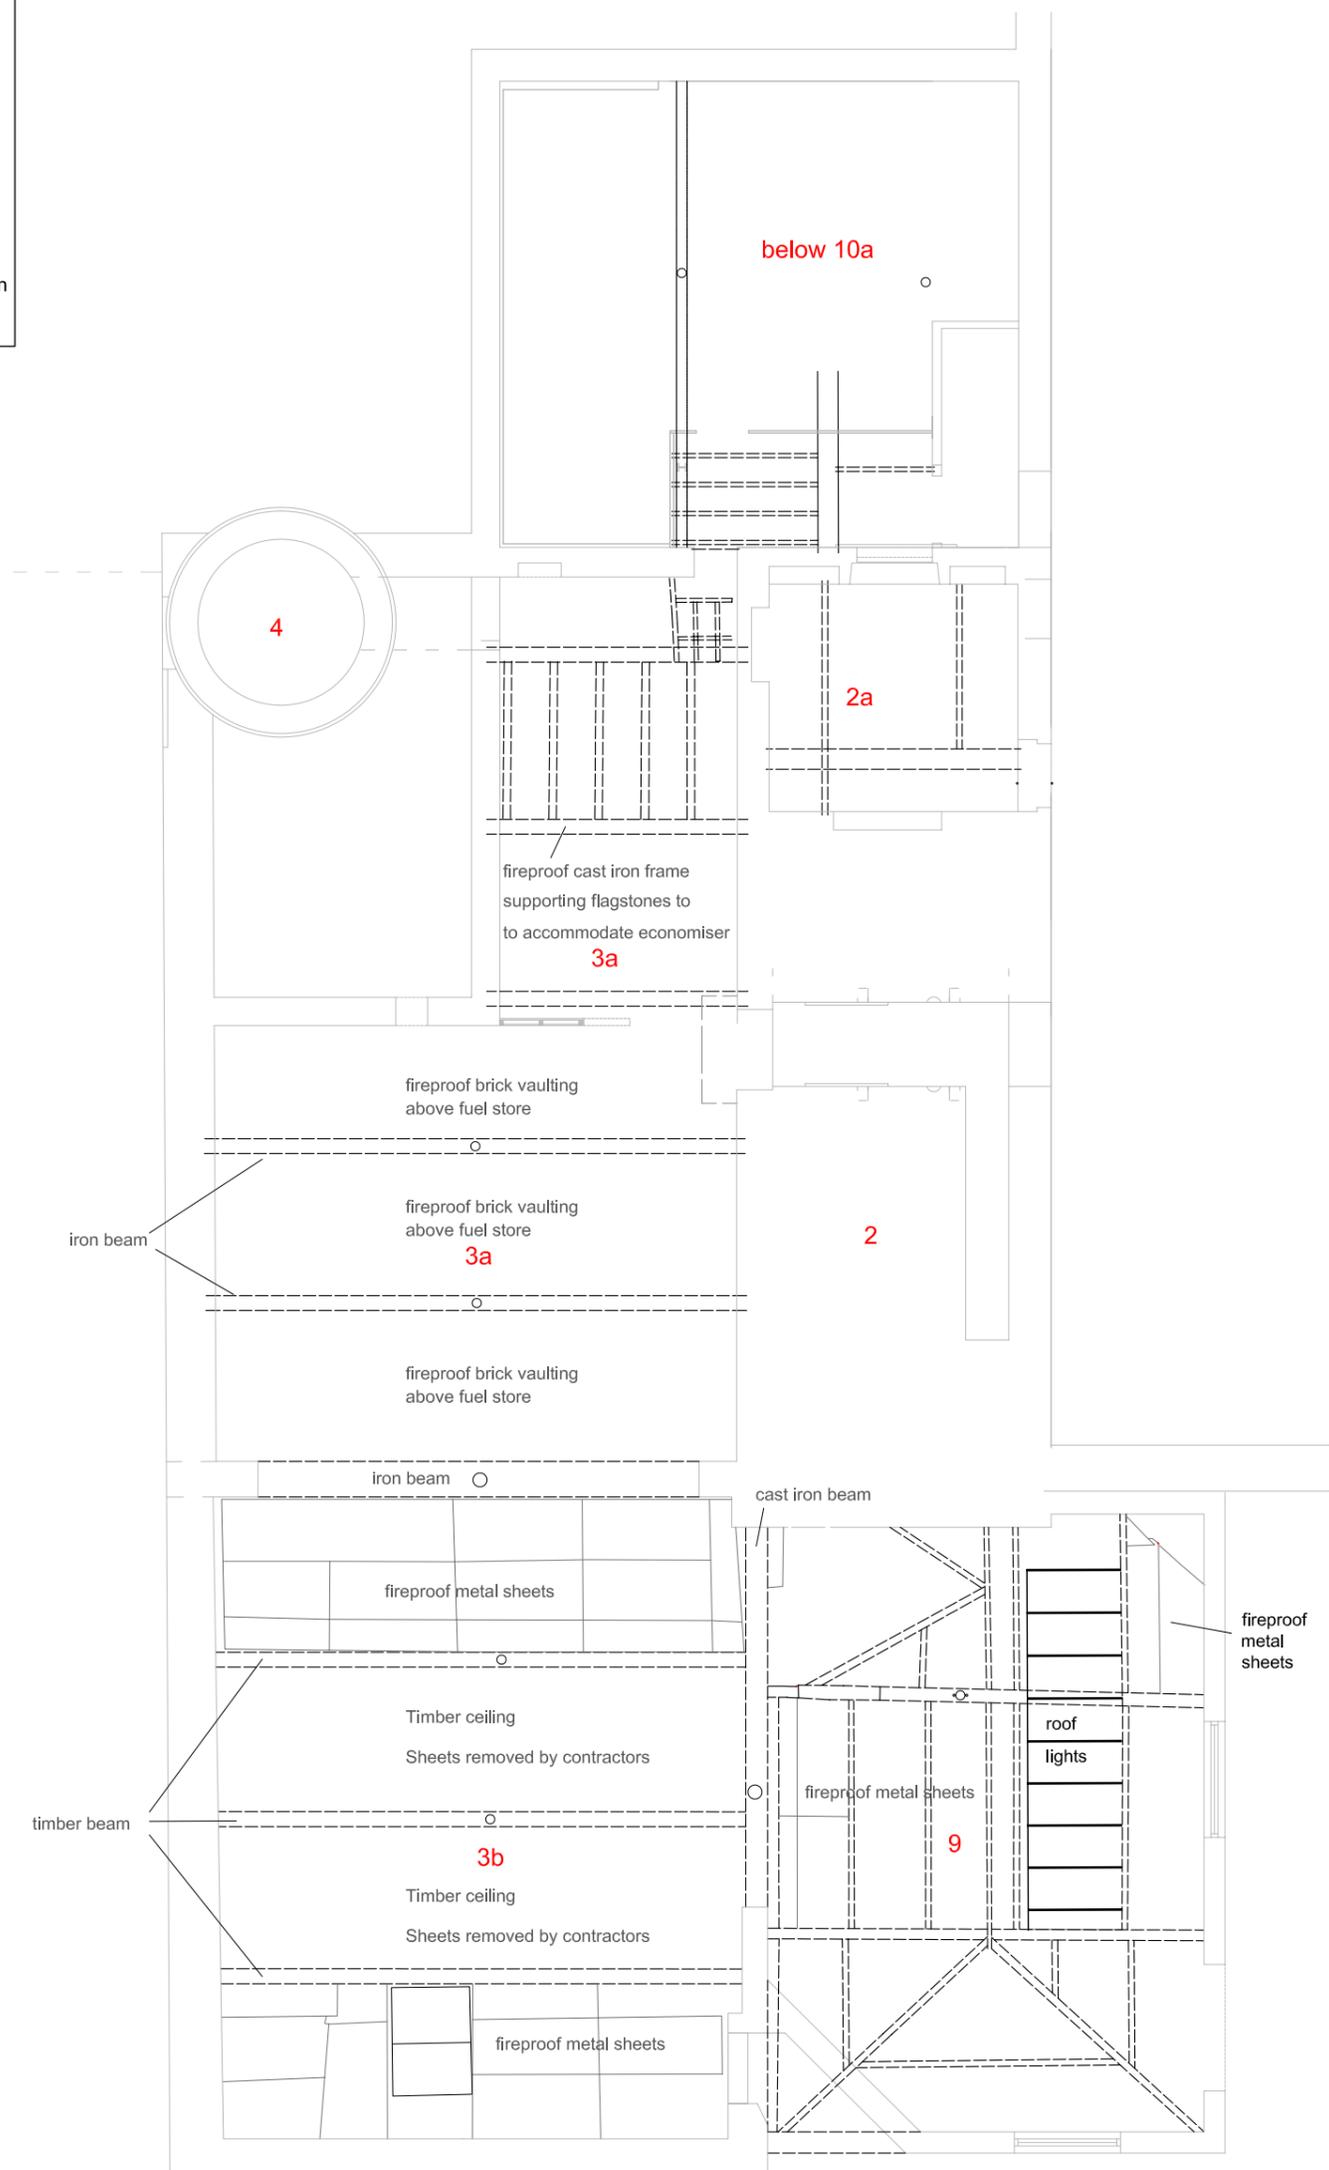
Figure 3: Ground floor Reflected Ceiling Plan of Boiler House and Engine House

- 3.2.8 The ground floor ceiling of **3a** comprises two distinct and separate areas of quite different construction (Fig 3). The eastern part of the room has a part raised ceiling (corresponding to the brick-supported raised area of flags on the first floor), which has a cast iron frame supporting large flagstones (this was probably raised to accommodate an economiser (Fig 9) (5:36-38)). The west side of the ceiling is composed of three north/south aligned brick-vaulted arches (covering the area suggested to be a fuel store (RCHME 1988, 4)), which spring from cast iron beams supported by central round cast iron columns (probably hollow) (10:3-5). Both of these ceilings are obviously of fireproof construction. Above these, on the first floor, the flagged floor continues (Fig 8). A two-part large cast iron beam was revealed during stripping works and is situated within the floor thickness in **3a** (Figs 3 and 5). There are four lugholes visible and it comprises two separate halves, which are bolted together. It supported one side of a brick vault and was itself supported by a cast iron column. This beam separated the two distinct halves of the ceiling. The floor above was of substantial flagstones, which rested directly on the beam.

- 3.2.9 The ceiling of **3b** is of more traditional construction with three timber beams, two of which are supported by cast iron columns (Fig 3). These support a timber floor, the joists of which are covered with metal fireproof sheets (5:16).

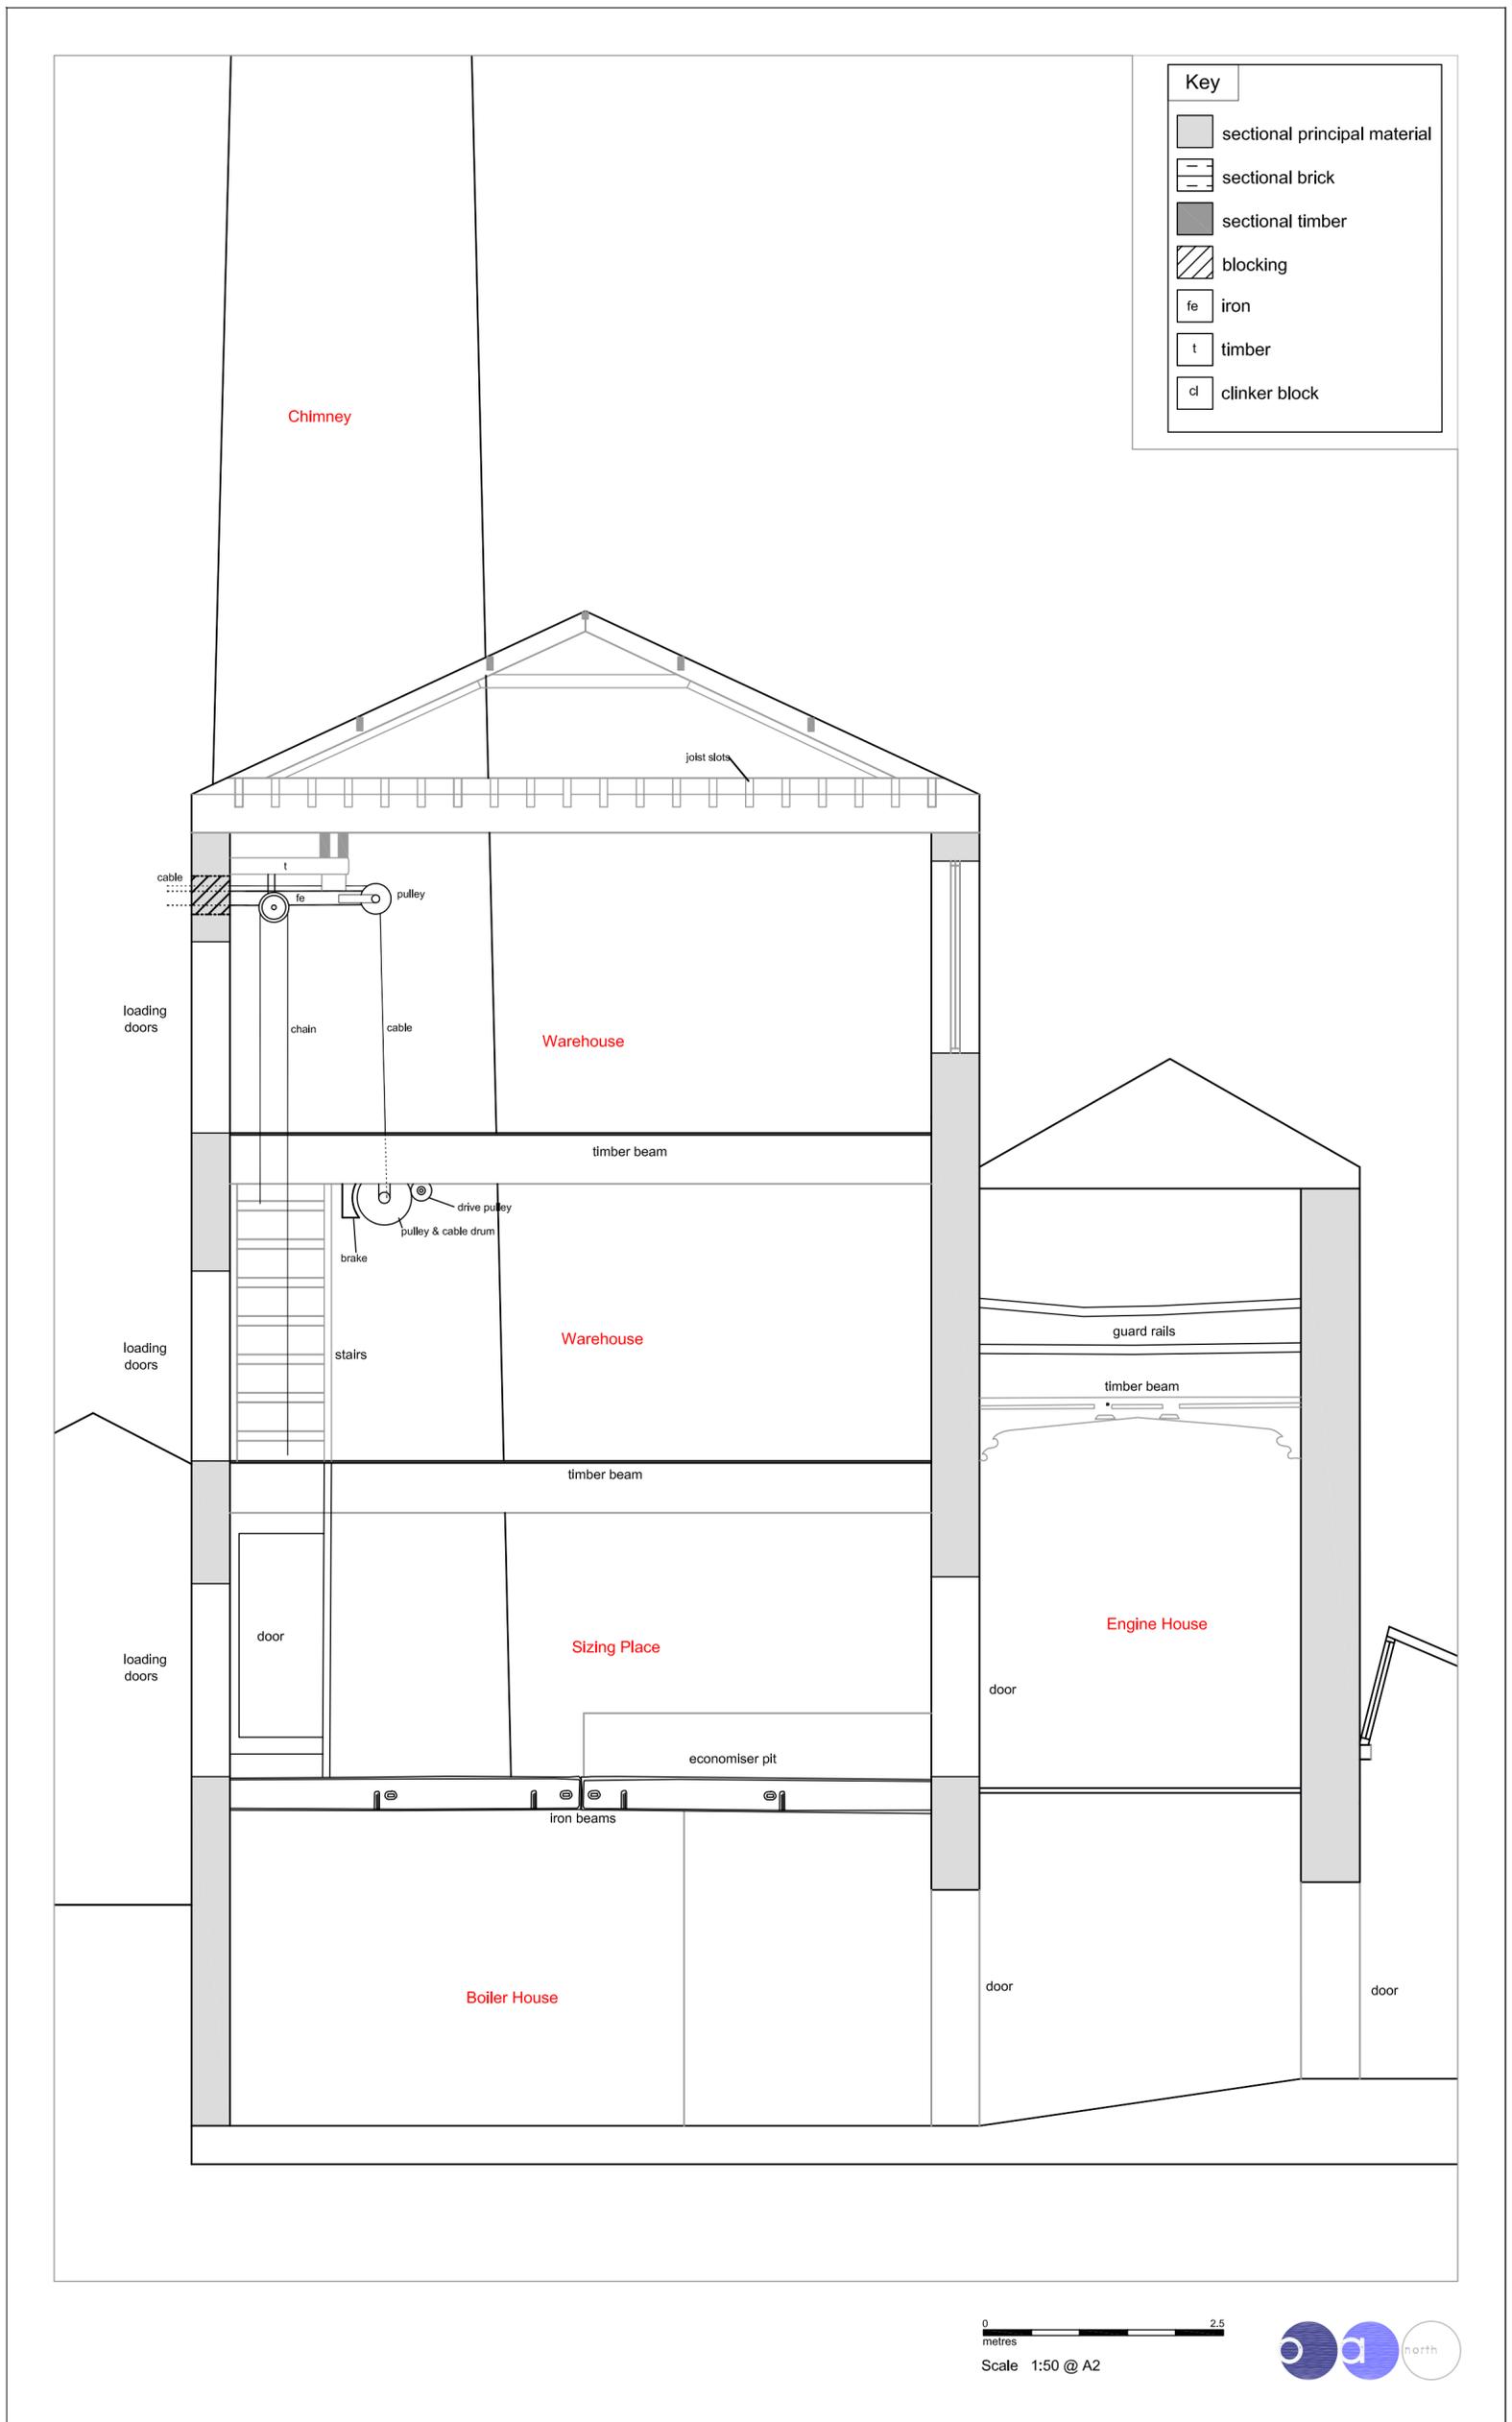
Figure 5a: South-Facing Cross- Section through Mill (west)

- 3.2.10 A large opening between **3a** and **3b** is characterised by two large stone ‘piers’ either side (Fig 2) (5:24) which support a cast iron beam (Fig 5). The RCHME report states that the springing of the boiler house’s front arched opening survives (*Appendix II*, 3), which these piers may represent. The current large opening may have been knocked through when **3b** was added. The solid dividing wall above this may be part of the pre-fire 1873 fabric (*op cit* 4) and probably formed the original west elevation of **3a** (Figs 9 and 10). A cut beam is present high in the south ‘pier’ and the ‘pier’ contains run-out stopped ovolo chamfering on what was probably the external side of the opening (the internal side is worn and damaged) (5:24). The rusticated quoins on the corner of Building **2** appear to butt against the ‘pier’.

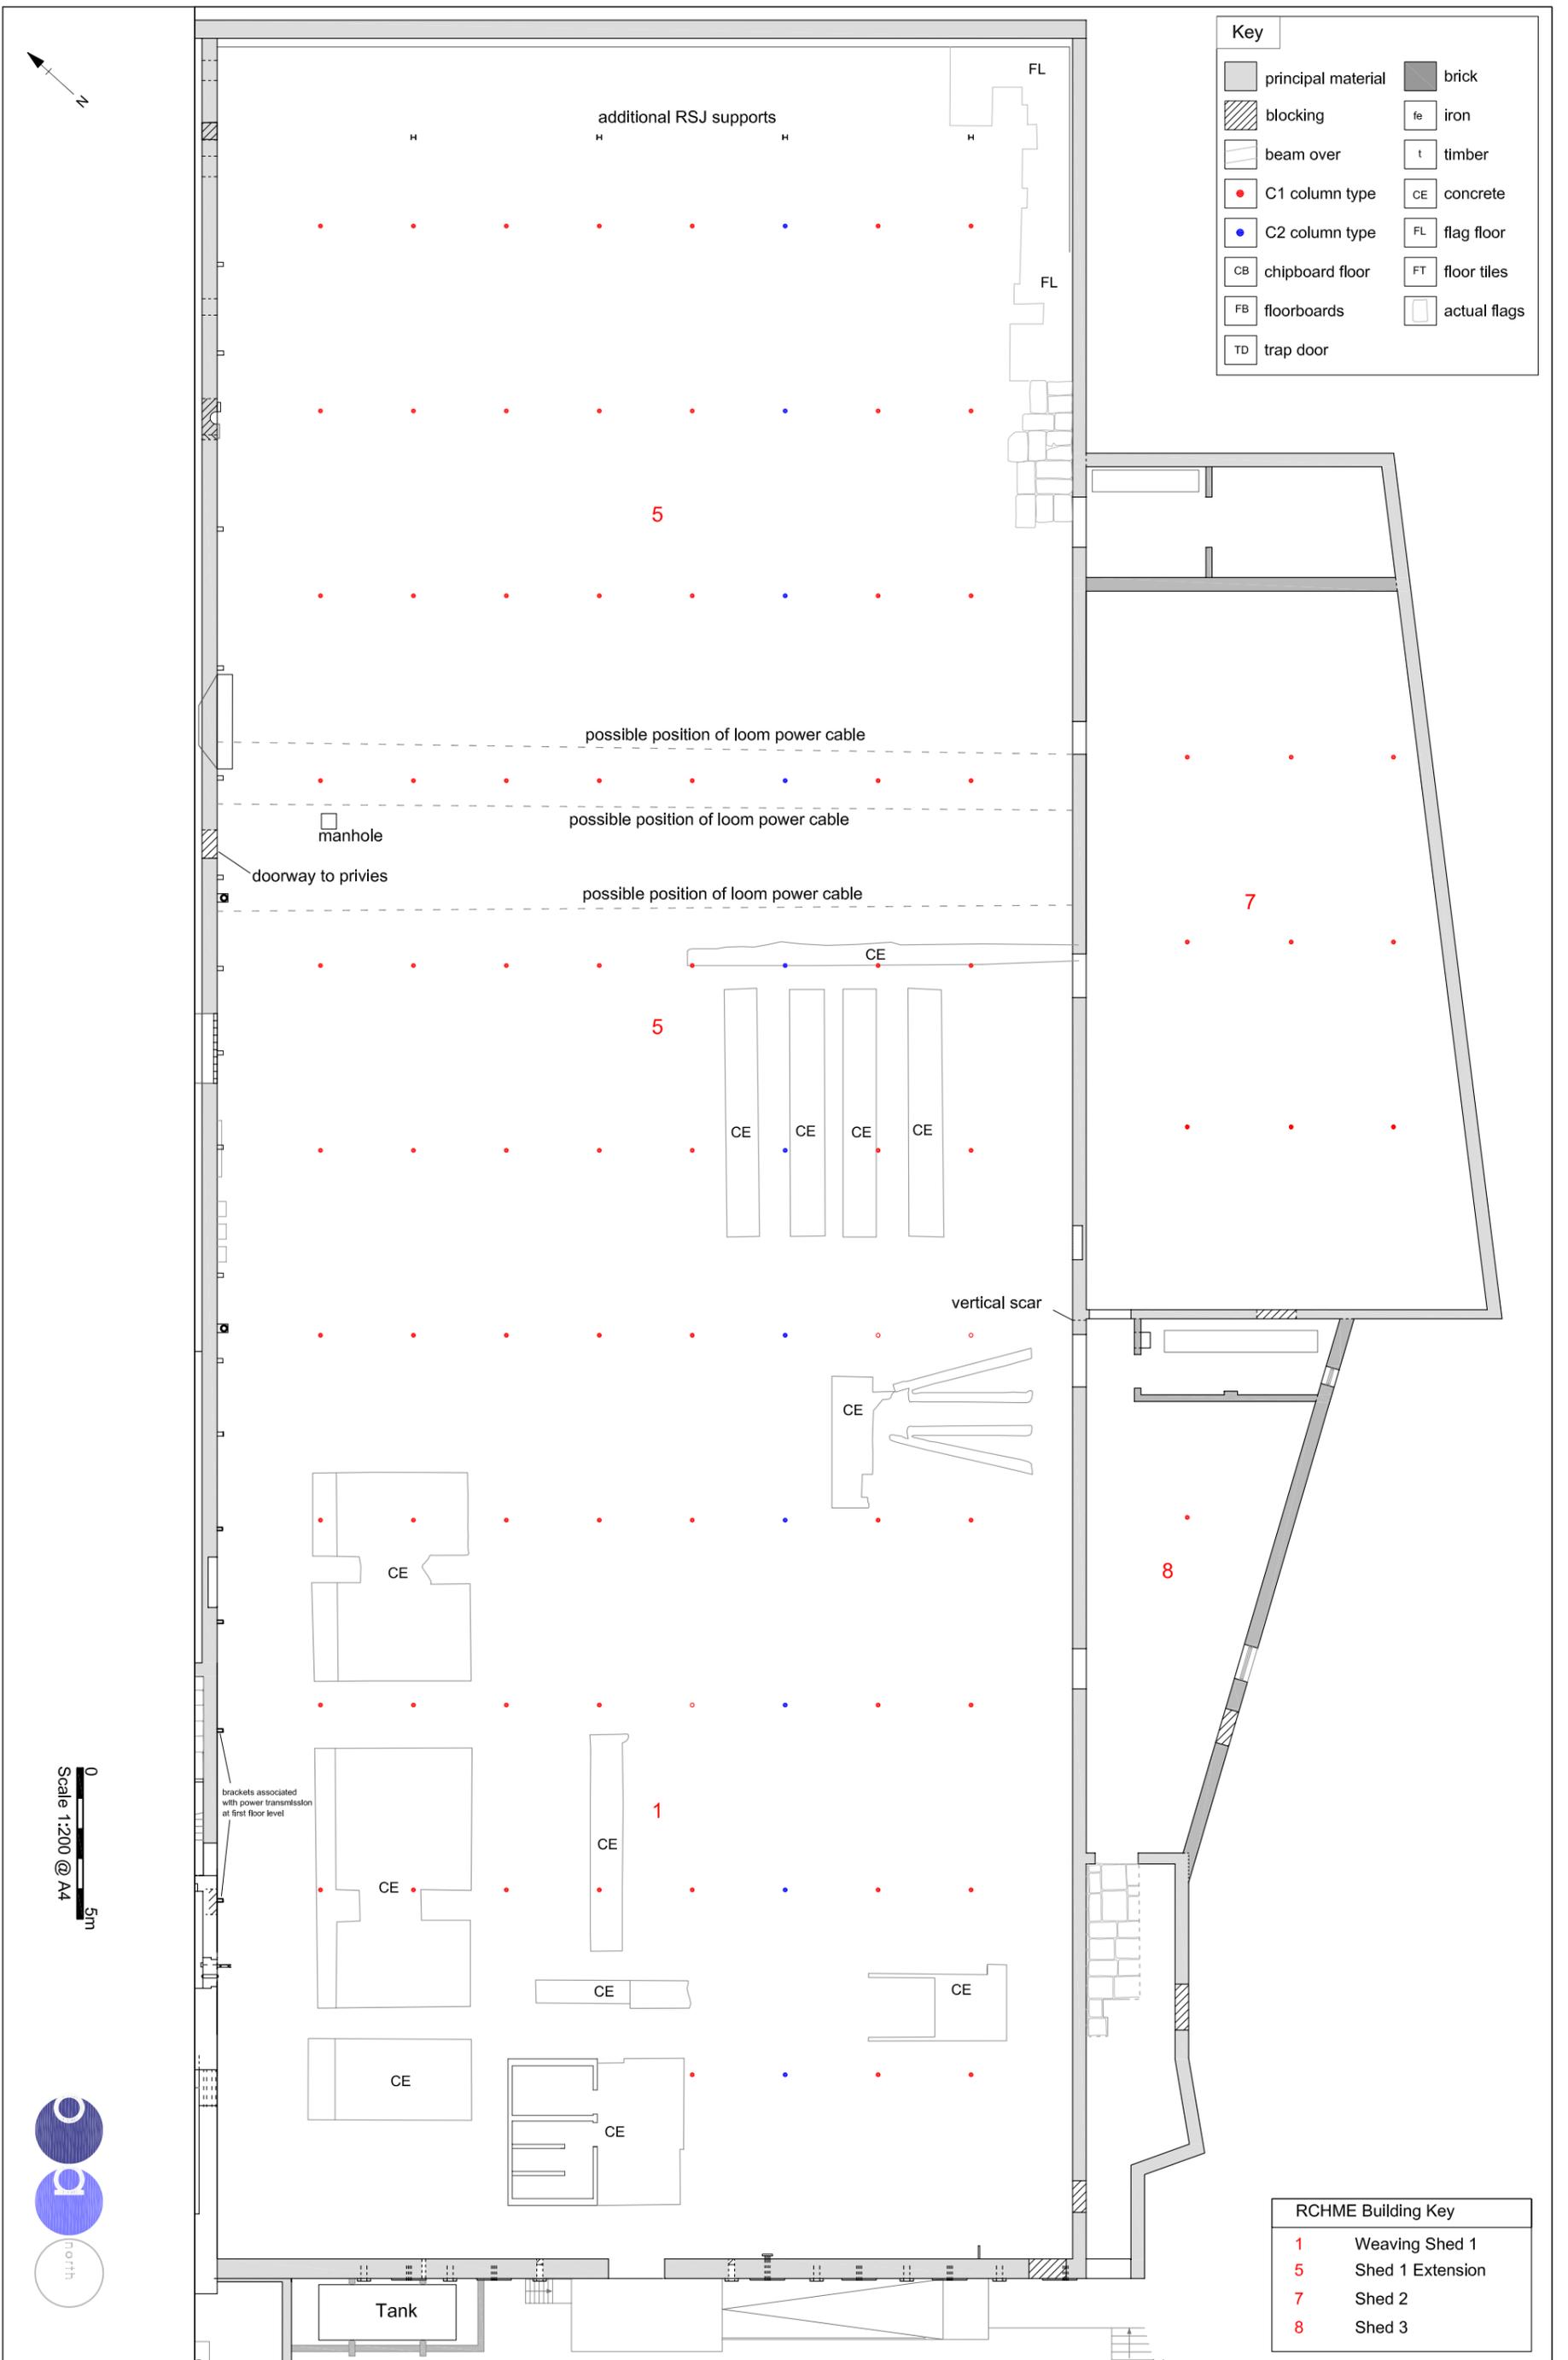
Figure 6: Ground floor plan of the Weaving Shed

3.1.1 Pecket Well Mill consists of a large weaving shed (Building **1** and **5**, Fig 6), warehouse/boiler house (Buildings **3a** and **3b**) and engine room (Building **2**) (Figs 2, 8, 9 and 10), together with other associated structures, which are cut into the hillside in the centre of the hamlet of Pecket Well. The Royal Commission Report (RCHME 1988 *Appendix II*) already describes the complex to a certain degree and the information outlined below is intended to augment or correct this document, as necessary. The aspects of the building that will be discussed are; the detail of the boiler house (Buildings **3a** and **3b**) construction; the detail of the engine house layout (Building **2**); and the phasing of the single storey sheds (Buildings **1** and **5**). The extent of the survival of the first generation fabric (pre-1873 fire) will also be discussed. Numbers in brackets (for example 10:2-5) refer to the relevant photographs (film and frame number(s)).
