CARLISLE CITY CENTRE CUMBRIA

Archaeological Watching Brief

Oxford Archaeology North

January 2006

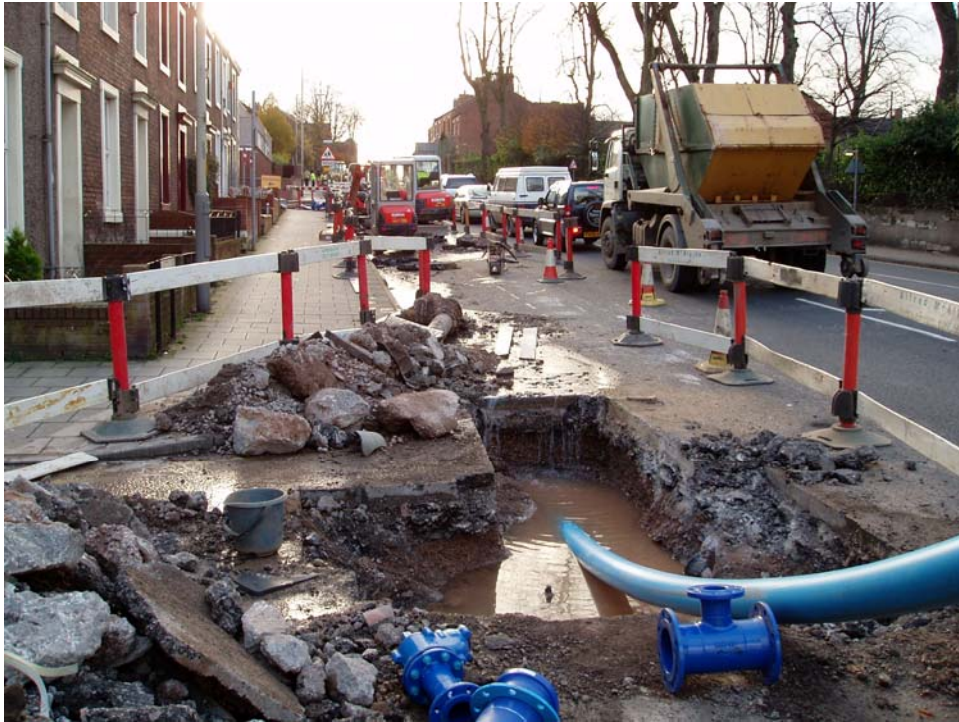
Plate 1: View along Church Street from Trench CS3

- 4.2.1 Generally, all of the trenches displayed an upper surface layer of road or pavement (tarmac, setts, brick, paving slabs or concrete), overlying concrete, sand or hardcore. This would in turn overlay the backfill of previous service trenches, with natural deposits at the base. Plate 1 shows a view along Church Street from CS3, a typical scene of the nature of the works.

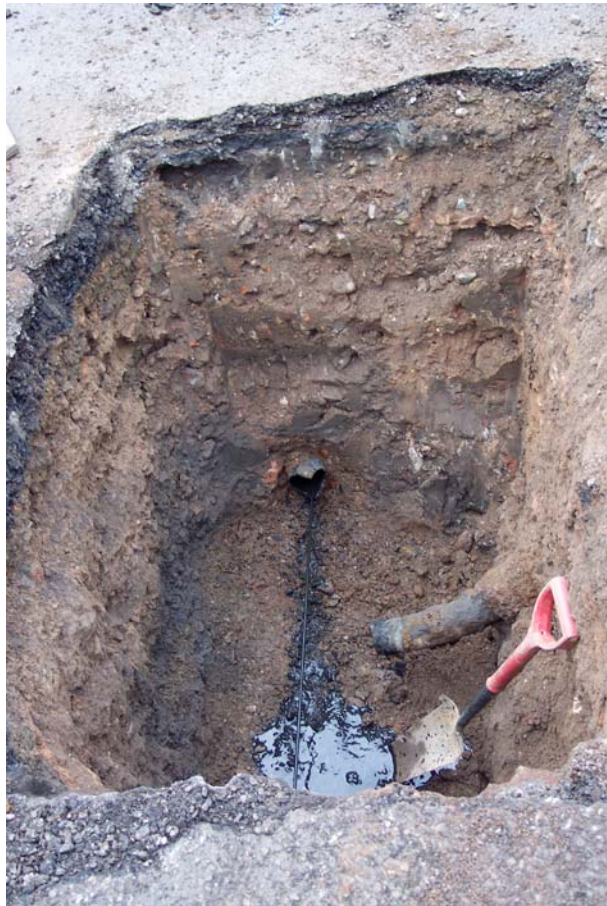
Plate 2: West-facing section of Trench CR14

- 4.2.3 Twenty-two trenches displayed stratigraphy derived from levelling layers, make-up layers and dumped deposits from demolition, domestic and industrial activity. This was evident in Trenches RG4, CR7, CR14, SS5-SS8, MS1, MS5, MS6, FS2-FS4, FS6-FS13 and ES6. The layers observed contained building rubble and gravels, with the trenches in Fisher Street (FS) containing a mixed dark to mid-brown sandy-clay, probably derieved from construction activity. Plates 2 (CR14), 3 (SS8) and 4 (MS6) illustrate typical backfill deposits found throughout the trenches.

CR 14	2	1.5	1.2	Excavated within the existing pipe trench of grey crushed hardcore. Original ground observed in the west section made up of black sandy-gravel with building rubble, sealed by road surface
CR 15	4	2	1.2	Excavated within the mid-brown sandy-gravel backfill of previous service trenches, sealed by road surface
CR 16	1	1	1.2	Excavated within the grey crushed hardcore backfill of previous service trenches, sealed by road surface

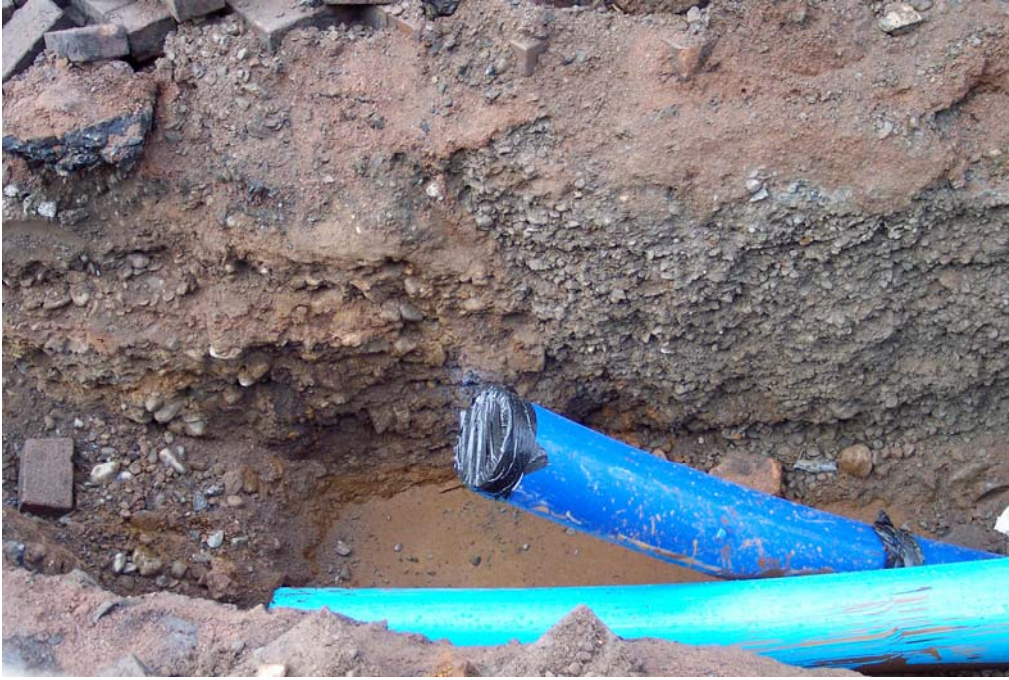
Plate 3: East-facing section of Trench SS8

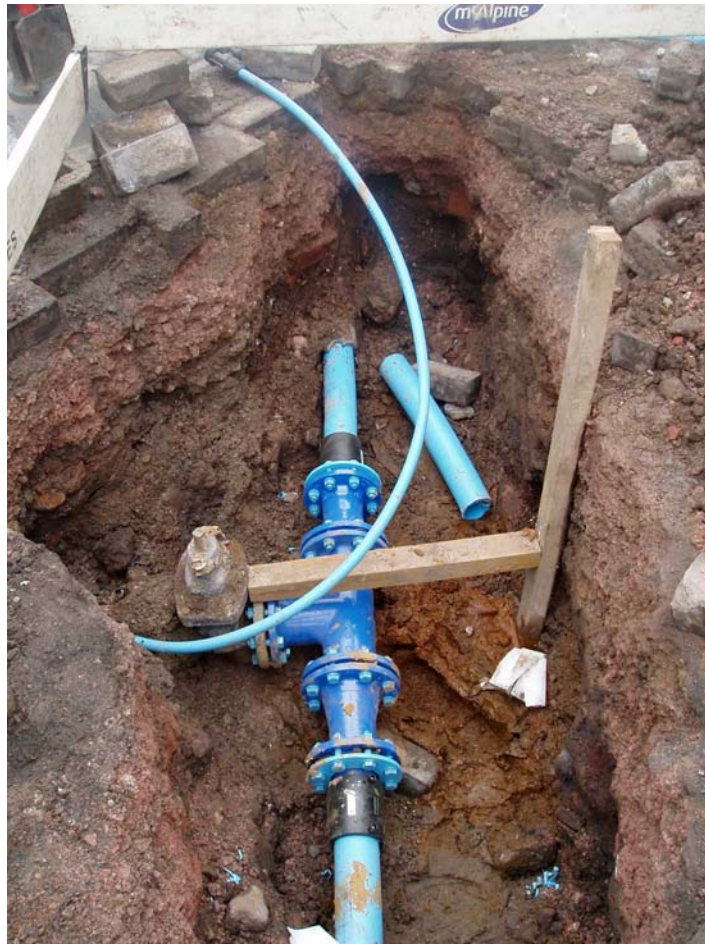
Plate 4: Plan view of Trench MS6

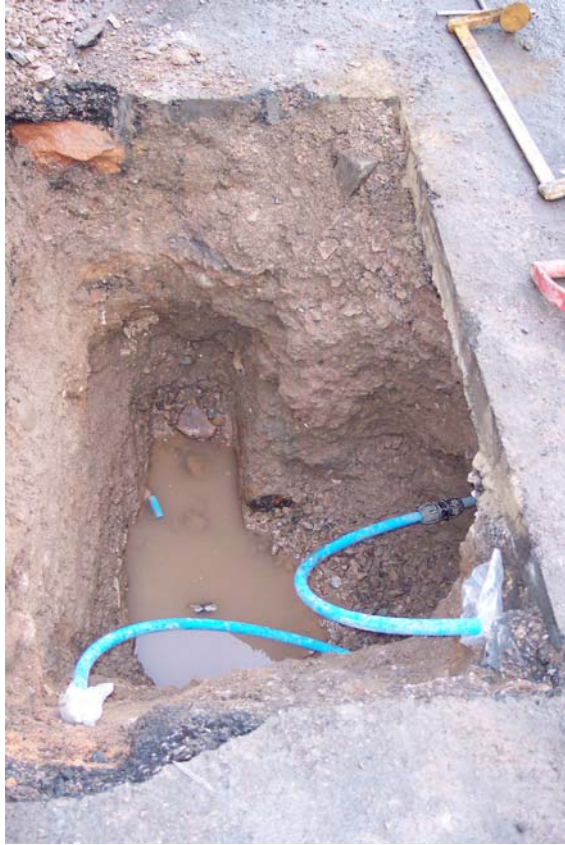
Plate 5: Plan view of Trench CR11

- 4.2.5 Ninety-four of the trenches were excavated entirely within previous service trenches, with some of the services still being live. The backfill of these trenches was mostly made up of aggregates and gravels, whilst some revealed the disturbed make-up, levelling layers and dumped deposits, which have accumulated over the continuing development of the city centre. Plates 5, 6 and 7, from Trenches CR11, PS8 and CLS1 respectively, illustrate the typical backfill from previous service trenches. Trenches FS5, RL3 and ES14 were backfilled before any archaeological observations could be implemented, with FS7 mostly backfilled before investigations were undertaken.

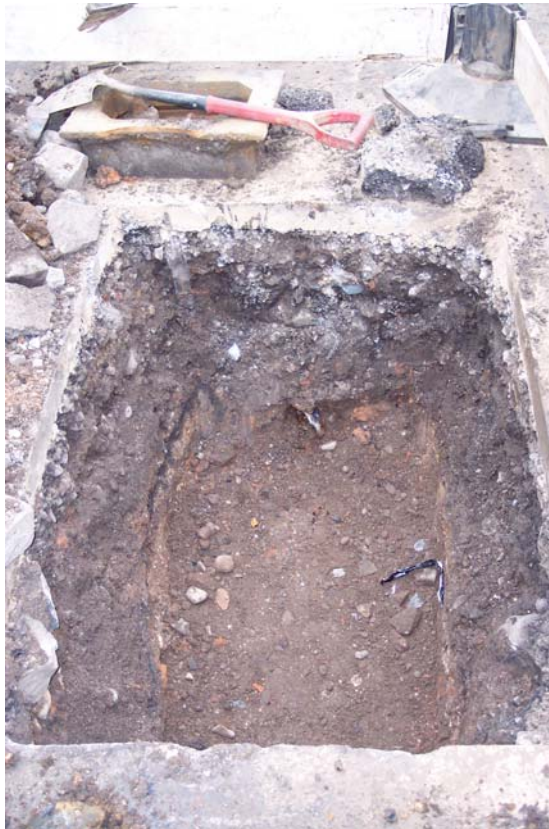
Plate 6: Plan view of Trench PS8

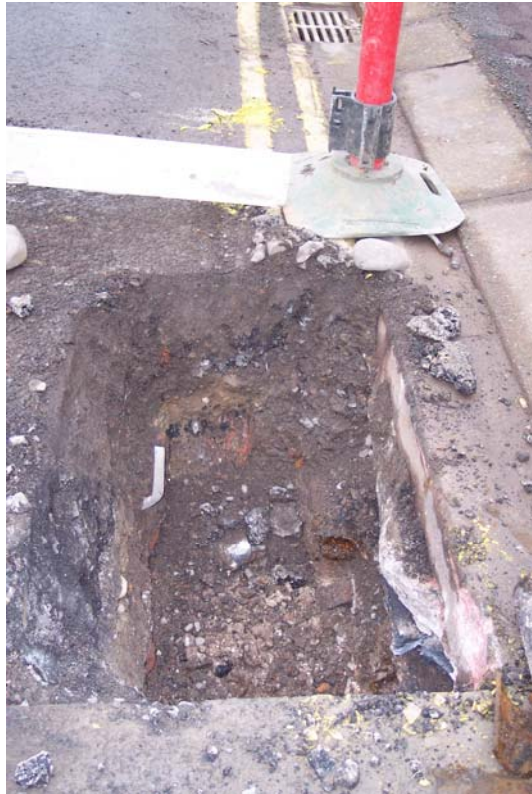
Plate 7: Plan view of Trench CLS1
