130-130a STANDISHGATE, WIGAN

Archaeological Evaluation

Oxford Archaeology North

May 2005

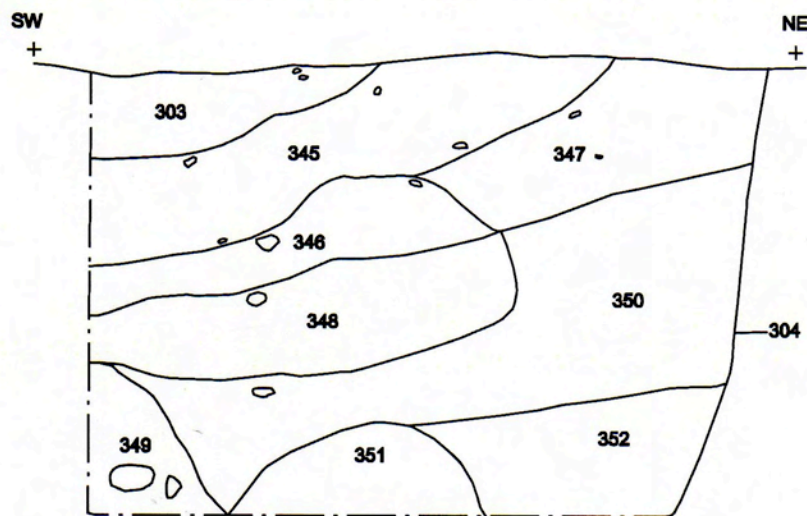
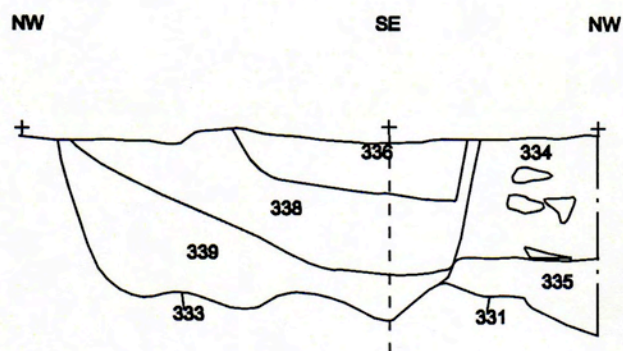
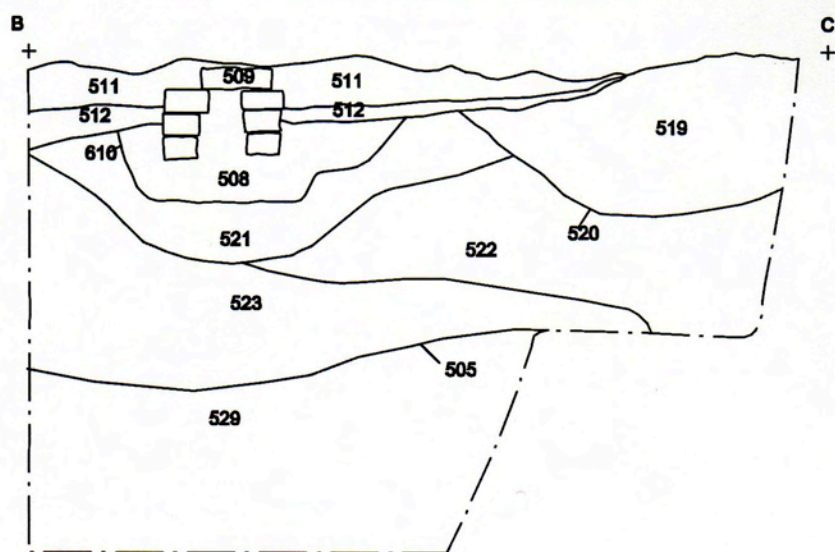
Figure 10 : Sections across pit 304, pit 333, feature 331 (Trench 3), and pits 505 and 520 (Trench 5)

Section across pit 304

Section across pit 333 and feature 331

Section across pits 505 and 520

- 4.2.51 A large sub-circular feature, **505**, was exposed in the centre of the trench. This feature measured at least 2m by 1.2m, with a depth of 2.2m, and appeared to represent a large pit (Fig 10). The lower three deposits (**523**, **522** and **521**) in the pit were all of a clayey-silt composition. As the intervention progressed deeper, these layers of clayey-silt were found to graduate from light grey (**521**), through mid-grey (**522**), to dark grey at the base (**523**). While these three deposits were all relatively free of stony inclusions (less than 5% small stones in each case), an unusually high level of animal waste and other organic matter was present in each of the fills. In addition, fill **522** yielded a single sherd of medieval pottery, which has been ascribed a twelfth or thirteenth century date (4.3 below).

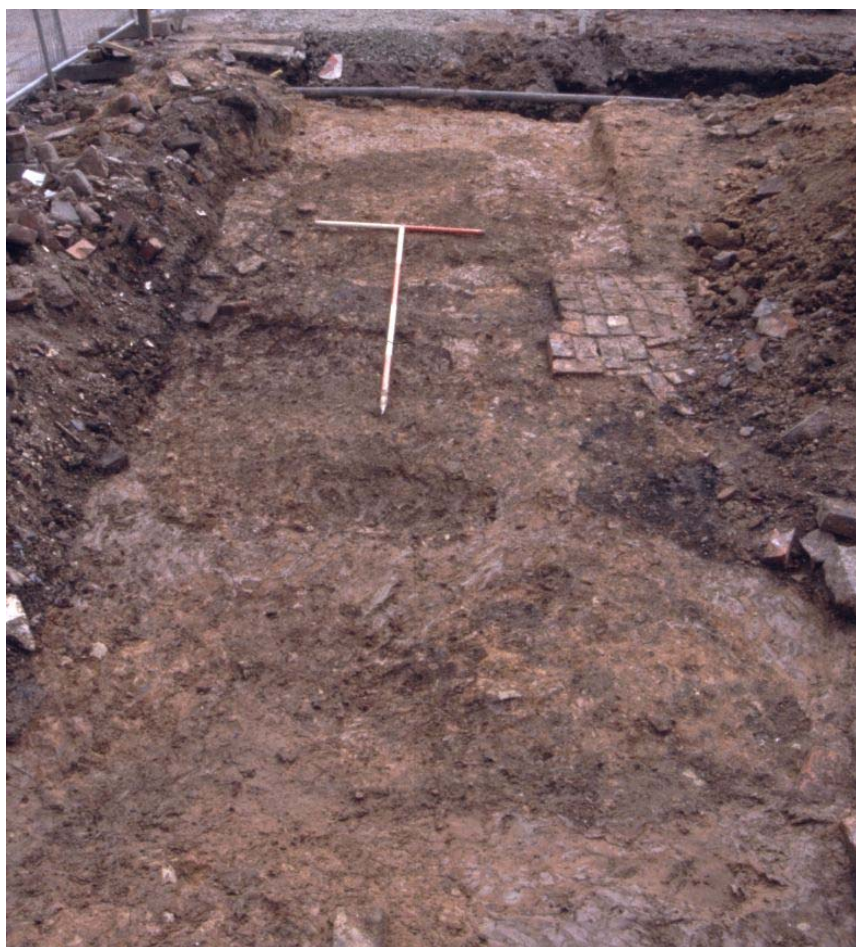
Plate 1: General view of the north-eastern end of Trench 1, showing shallow pit features *124*, *125*, *126*, and *127*, and clay subsoil *133*

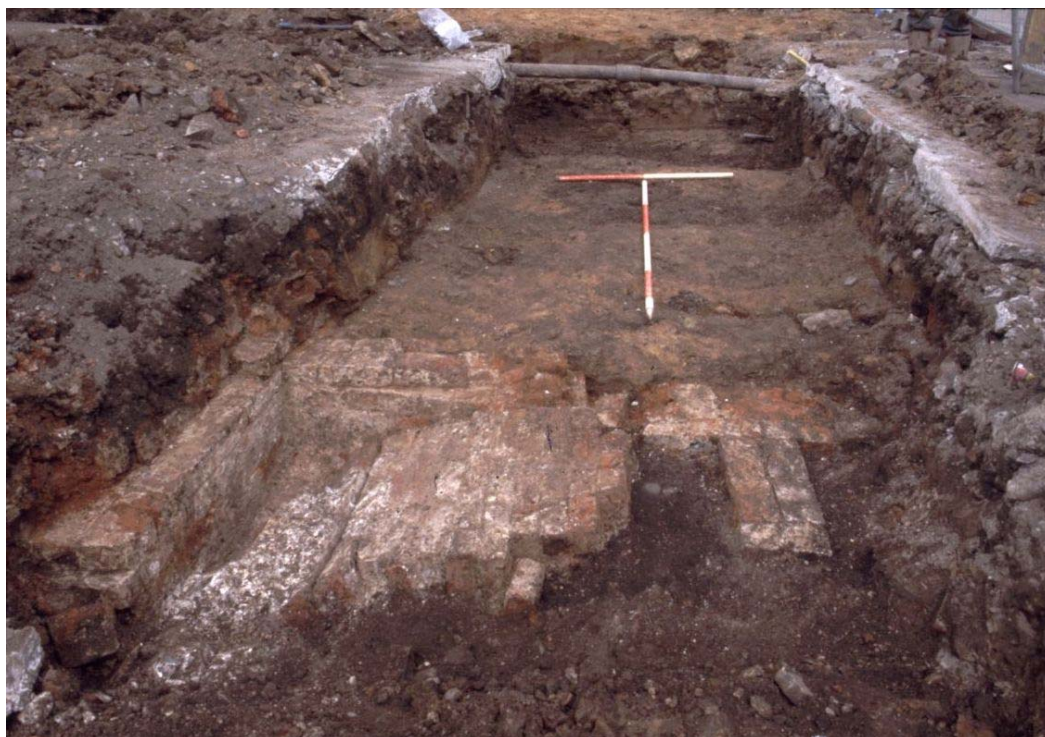
Plate 2: General view across central part of Trench 1, showing structure *109* and vaulted cellar *112*

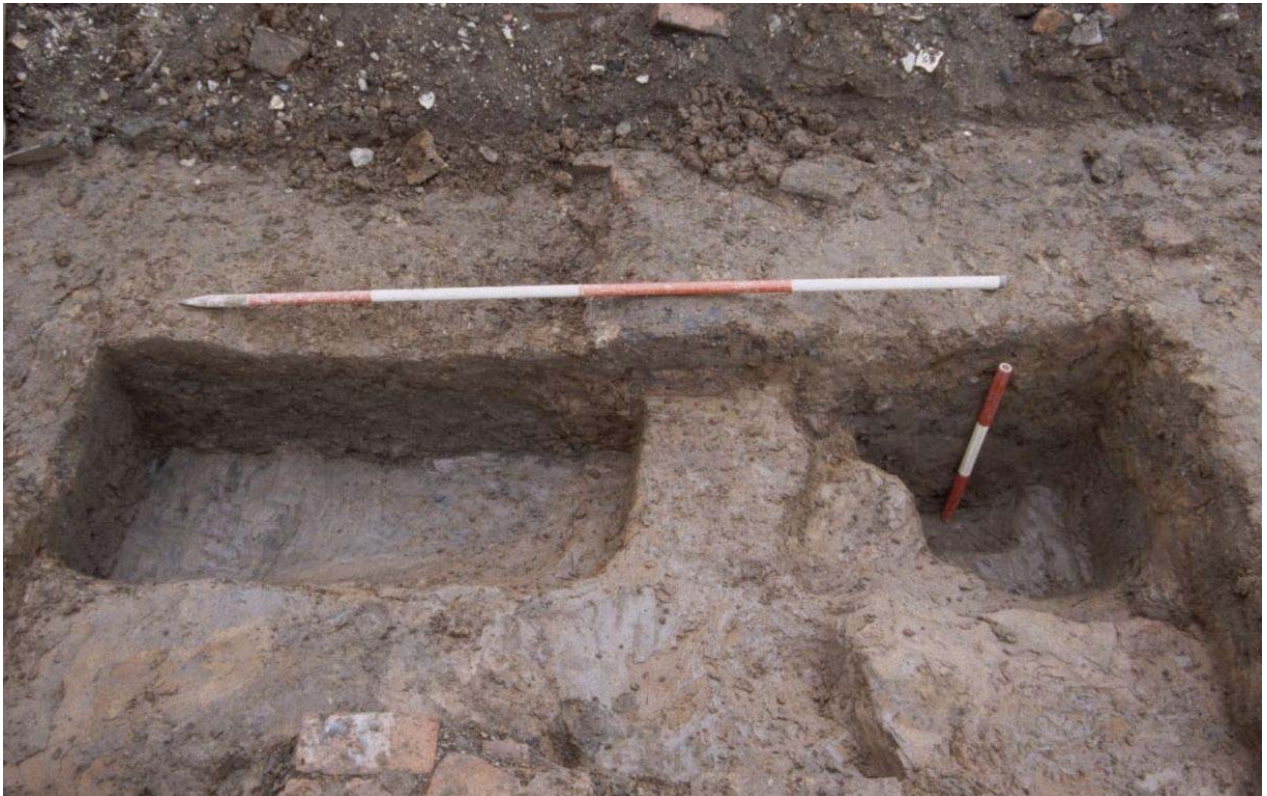
Plate 3: West-facing sections of pit features *124* and *125*, Trench 1

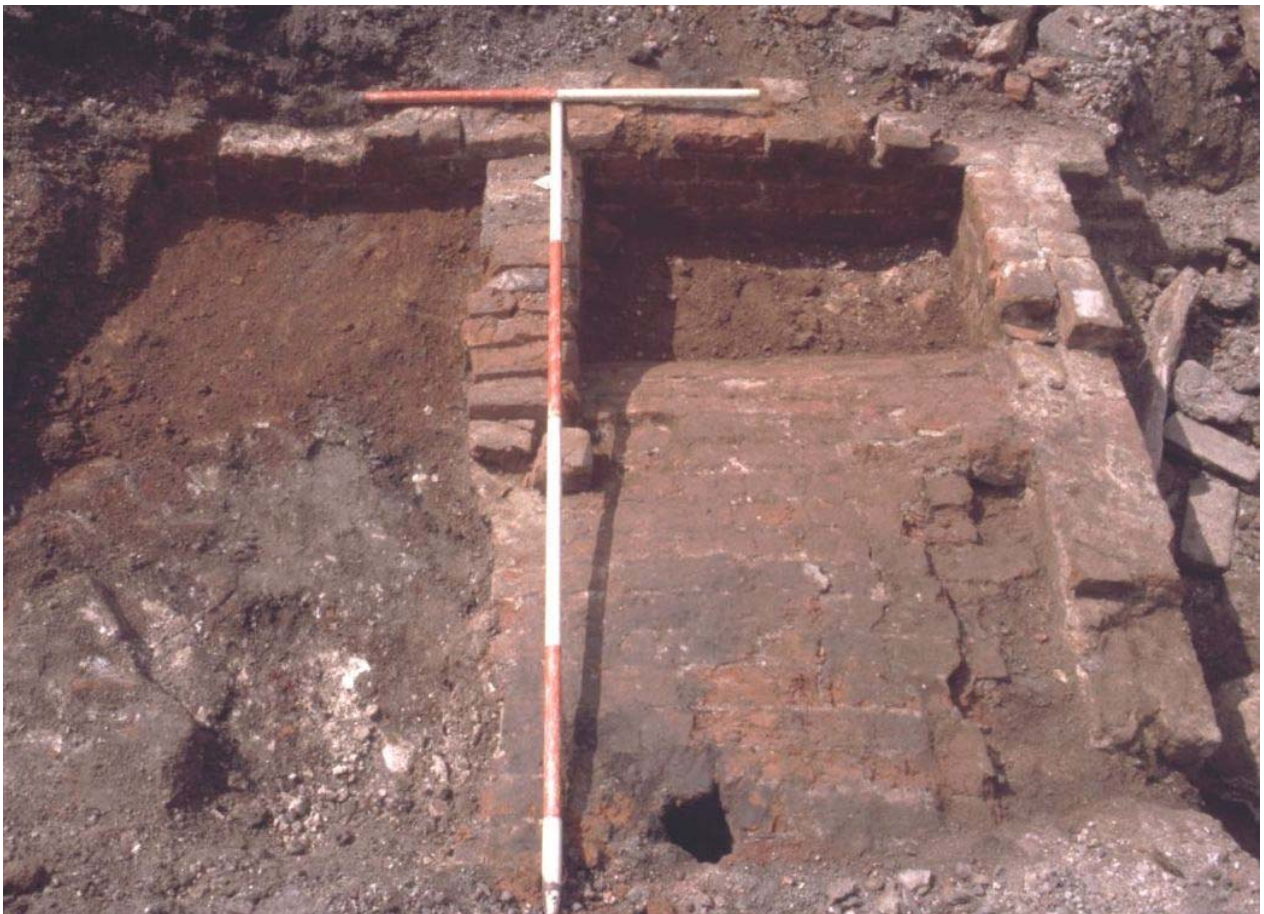
Plate 4: Roof of vaulted cellar *115*, bounded to the north-east by wall *113*, Trench 1

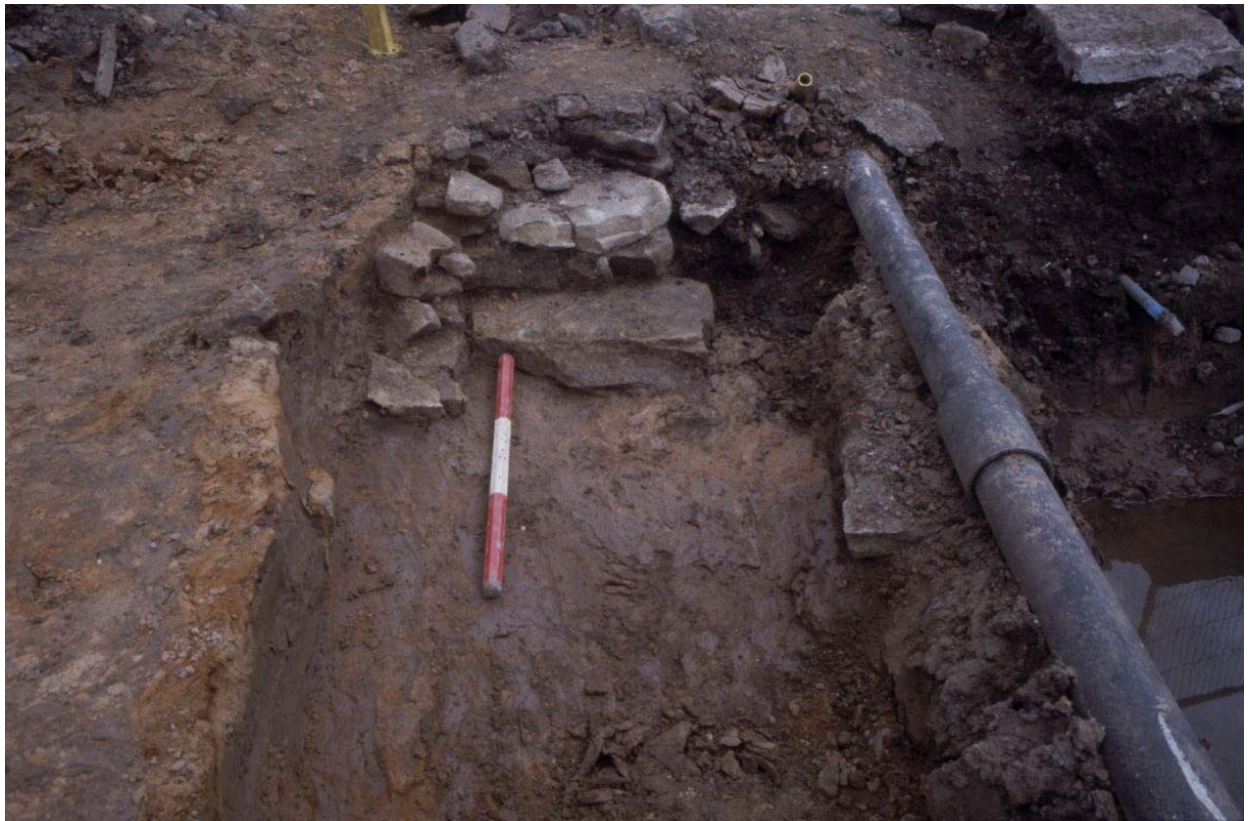
Plate 6: Wall **203** in section at south-eastern end of Trench 2

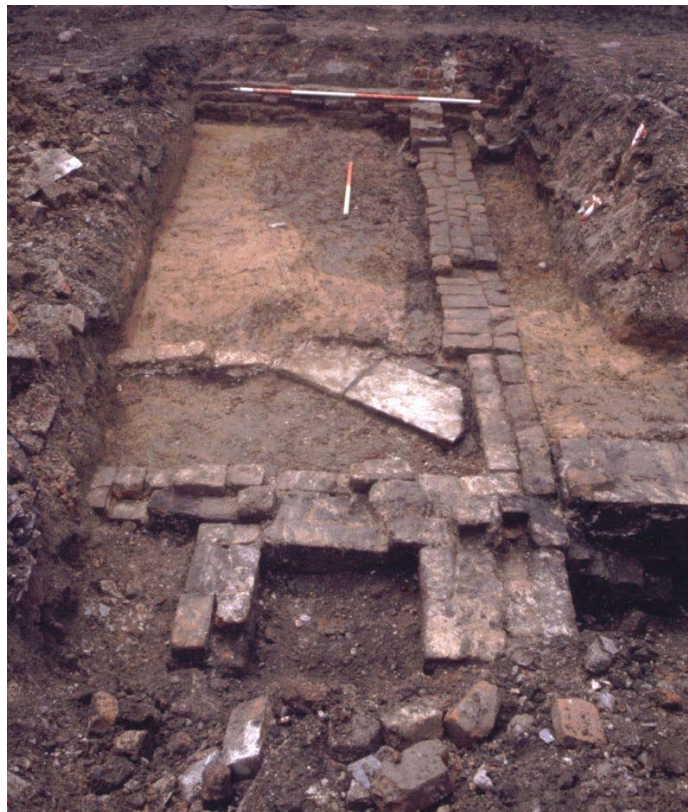
Plate 8: General view of Trench 3, looking south-west, showing pit 304 to the rear

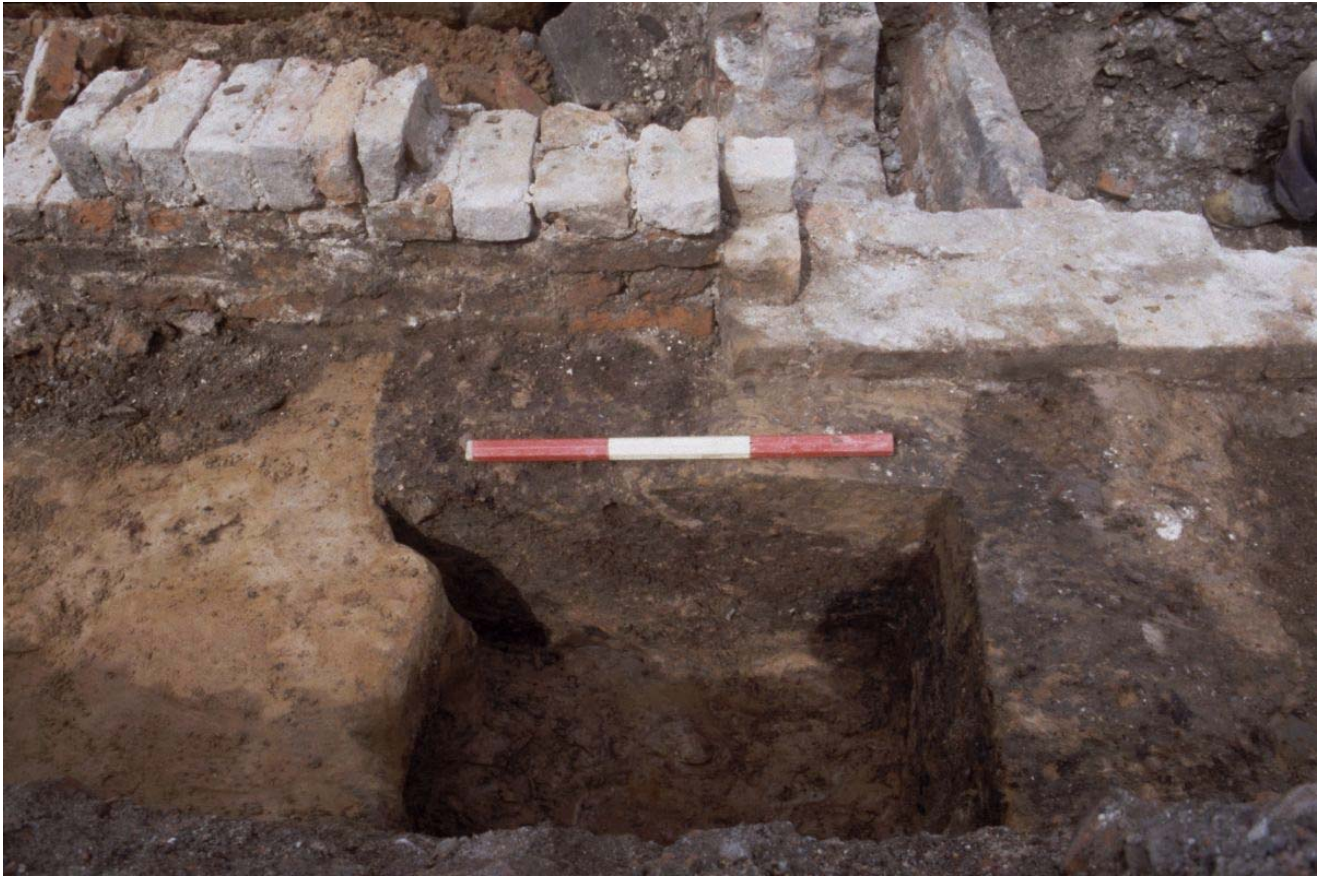
Plate 9: Pits 332 and 333, Trench 3

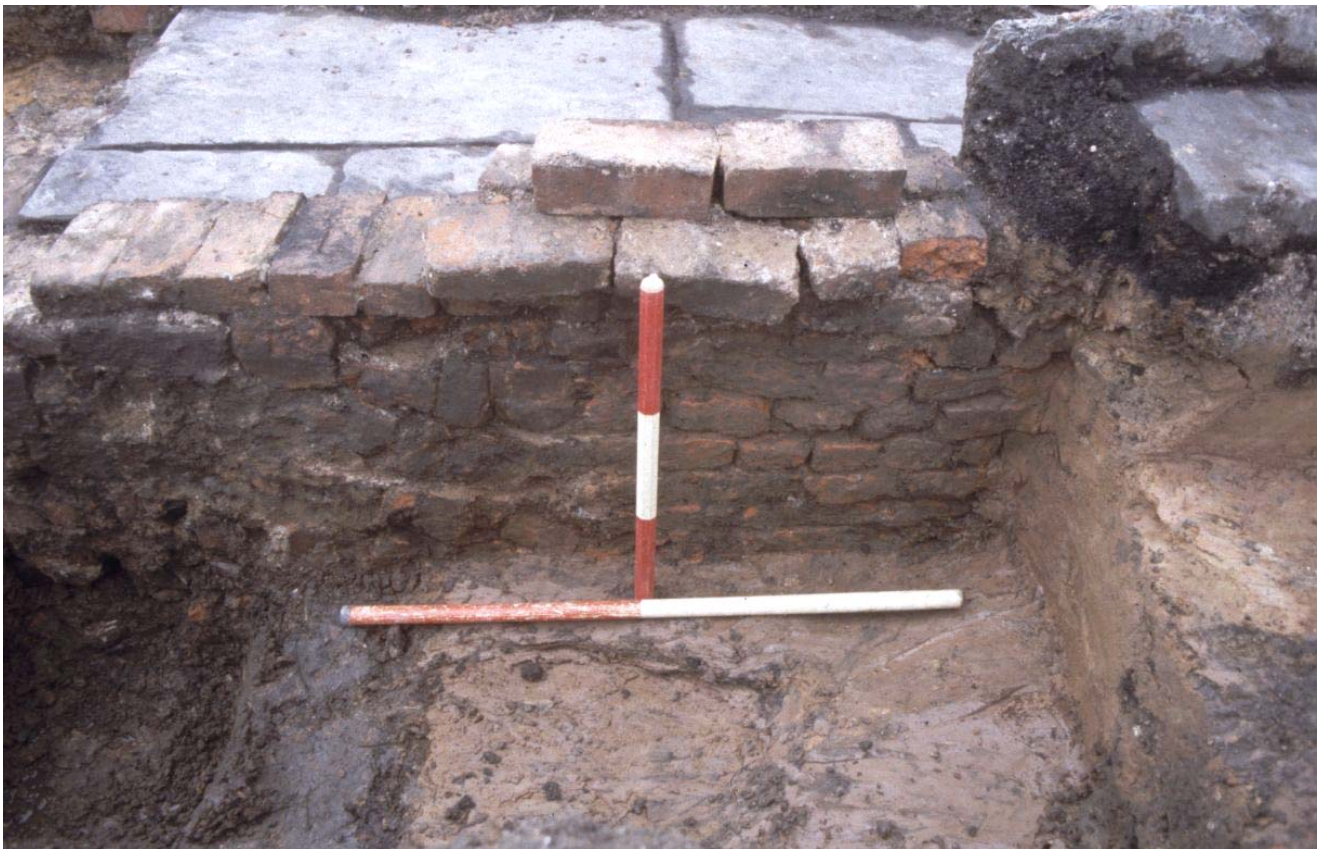
Plate 10: North-east-facing elevation of wall 355, Trench 3

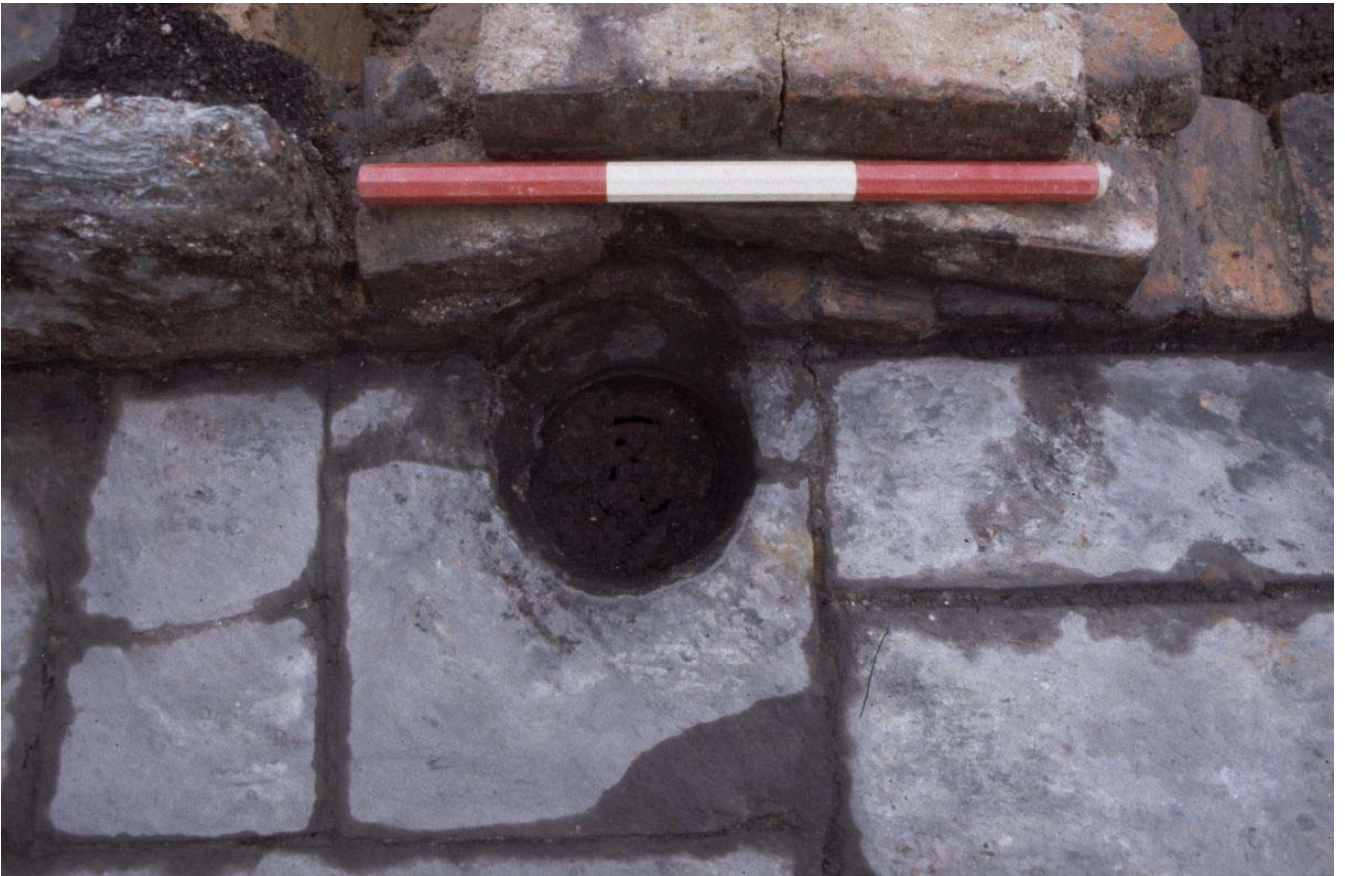
Plate 11: Drain **328** within surface **302**, Trench 3

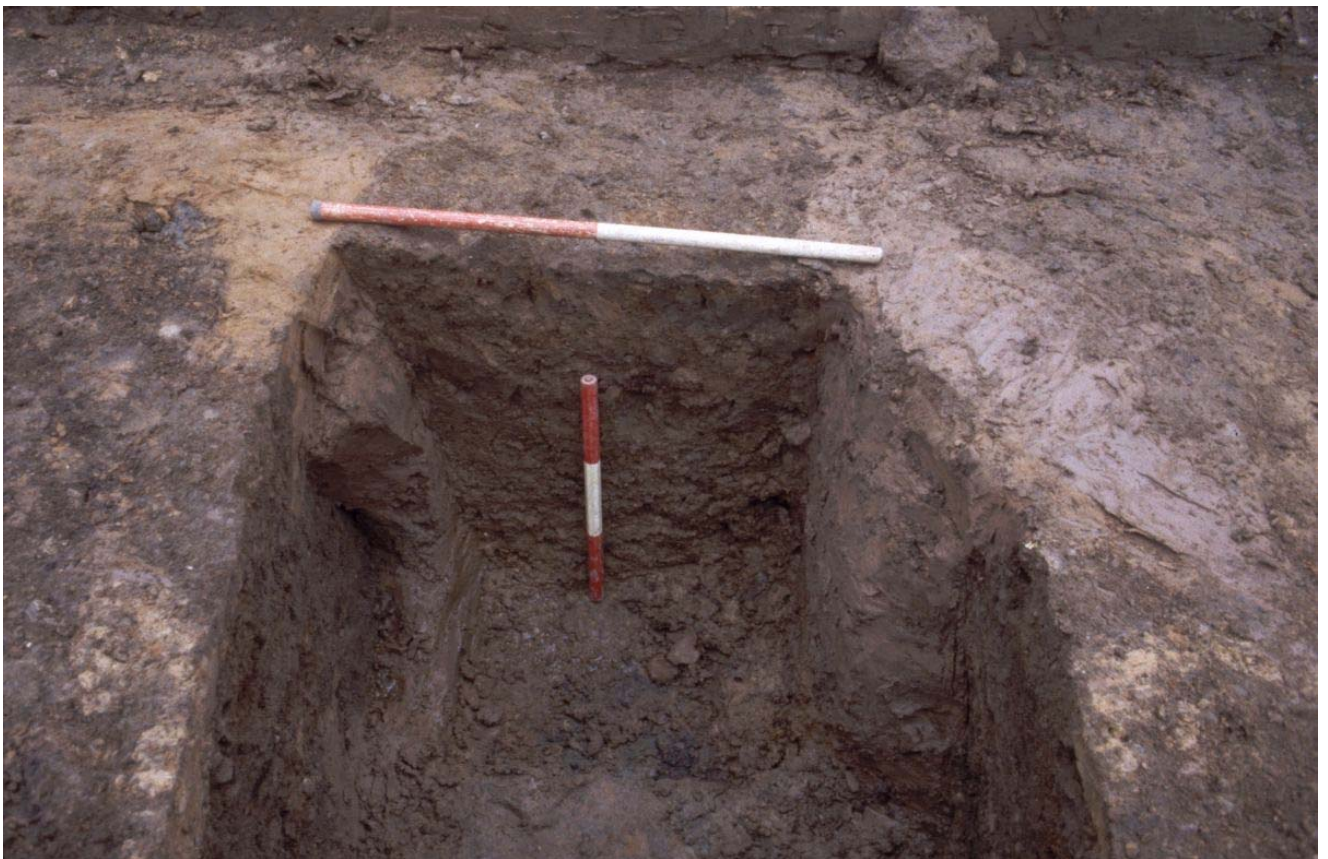
Plate 12: Linear feature **407**, Trench 4

- 4.2.39 Linear feature **407** was observed crossing the trench on a roughly north-east/south-west alignment. This feature was 0.80m wide and at least 1.20m deep, with vertical sides. It seemed to have been filled rapidly in a single backfilling episode (Plate 12). The fill, **408**, comprised a mixed orangey-red clay/sand deposit characteristic of re-deposited natural subsoil, and yielded no finds. The south-western part of the feature was truncated by pit **409**.

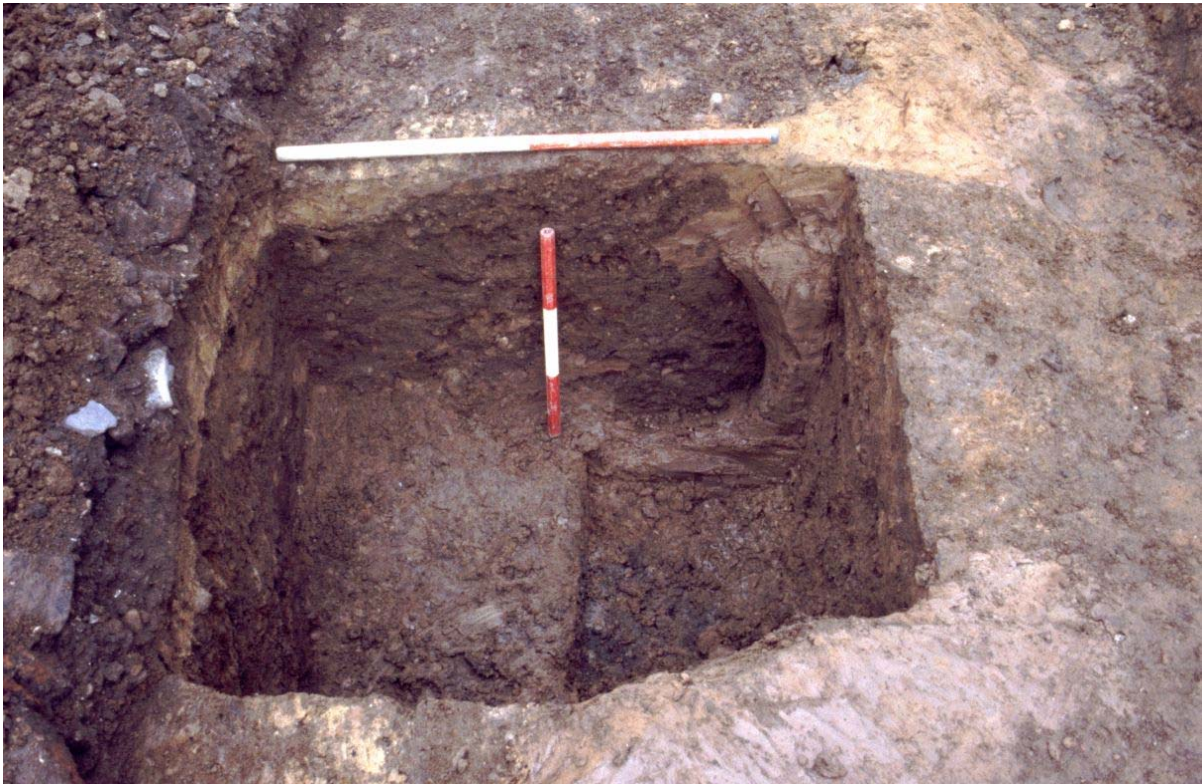
Plate 13: Pit **409**, Trench 4

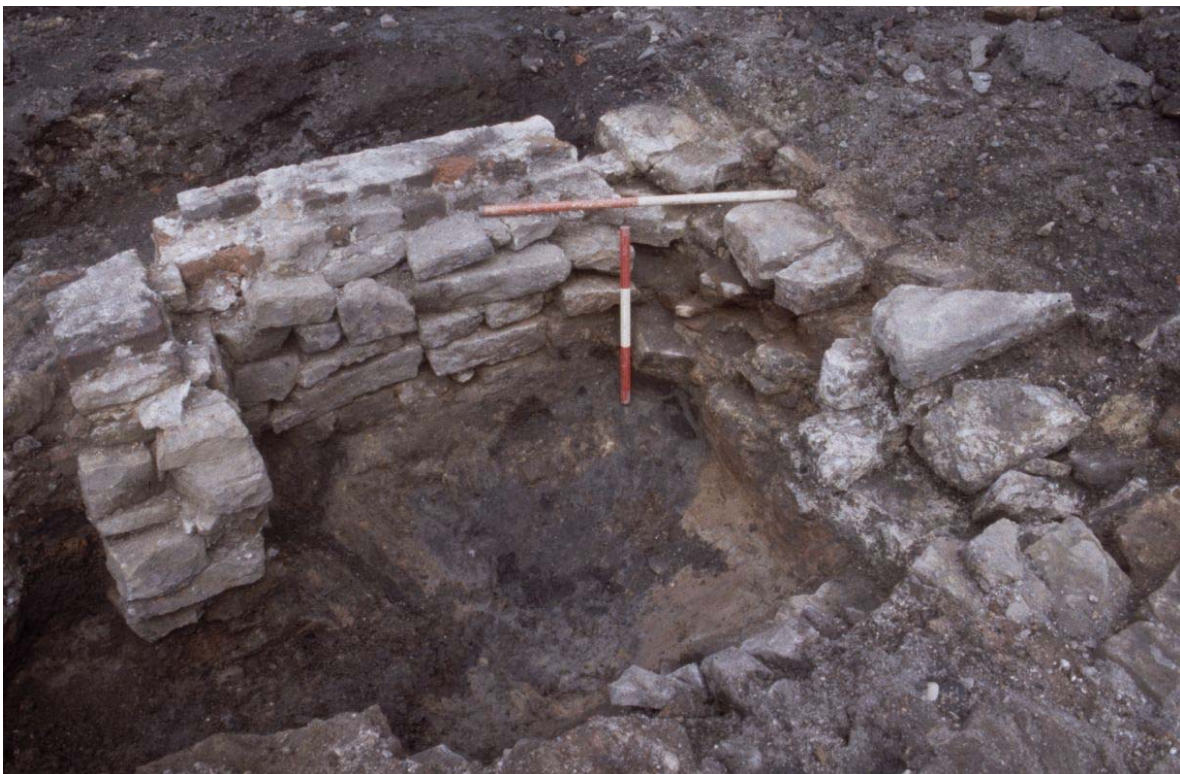
Plate 16: Walls *514* and *515*, and pit fill *518*

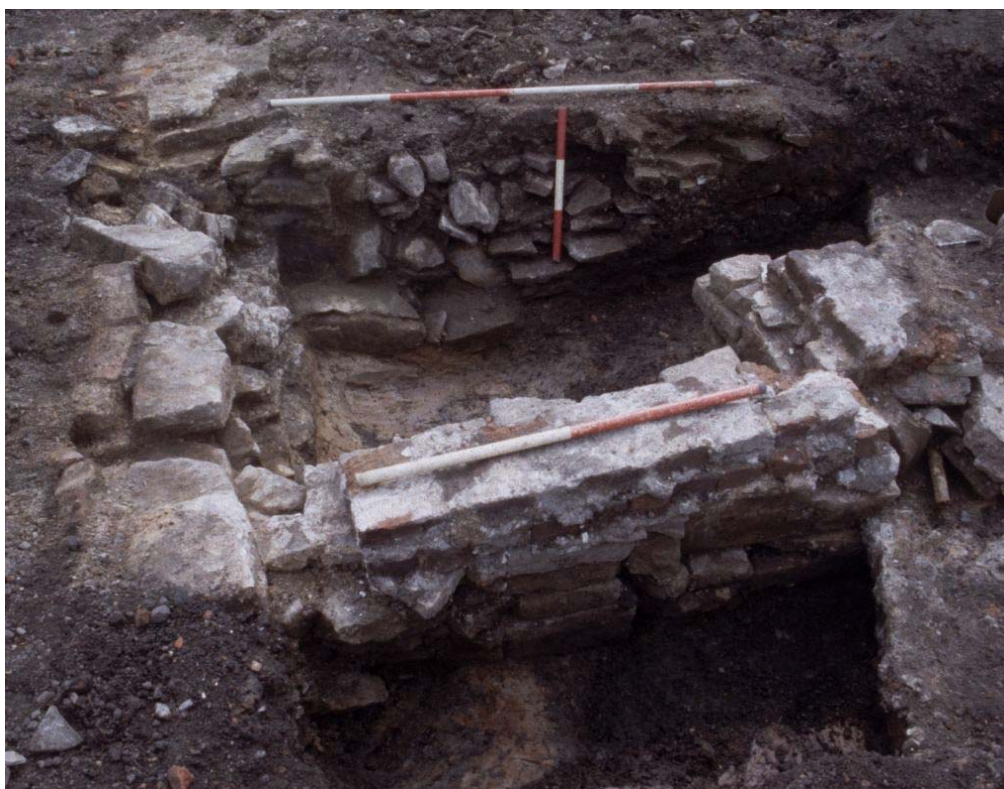
Plate 17: Walls *514*, *515*, *516*
