# **ST OSWALD'S CE PARISH CHURCH, RAVENSTONEDALE**

## **Archaeological Desk- Based Assessment, Visual Inspection and Watching Brief**

June 2005

**IWA Architects/ St  
Oswald's Parochial Church  
Council**

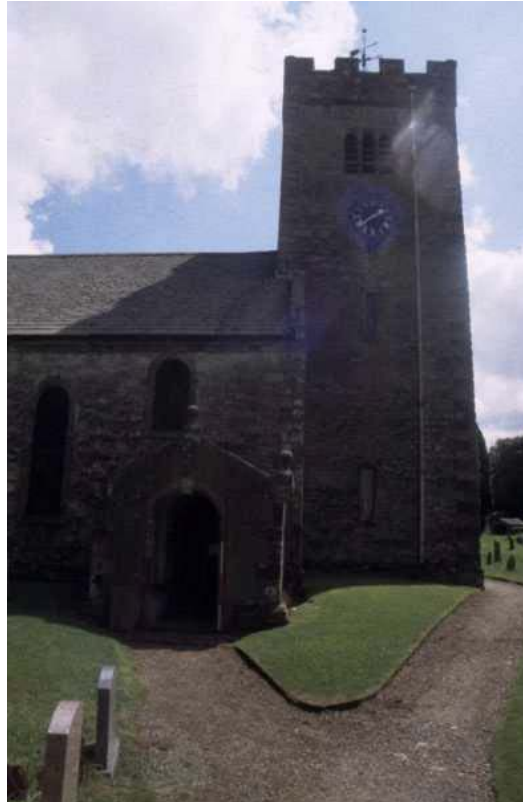
Plate 5: The tower and north porch, looking south

- 4.1.2 **External details:** the north elevation has a porch on the west end with an outer doorway in the same style as the round headed windows (Plate 5). The porch forms a gable, has a rendered plinth and is decorated with ball finials. Internally the porch has a similar doorway and stone benches along the east and west walls. At the east end of the elevation the wall returns towards the vestry and incorporates a small outshut (Plate 6). The tower is situated at the west end and its north elevation has two small, square lancet windows on the first and second floor and a three panel window above. The west elevation is dominated by the tower, which is battlemented and has a string course (Plate 4). It has a large doorway with a broken pediment and fluted keystone decoration. The remainder of the west elevation is made up by the west face of the porch and the south aisle.

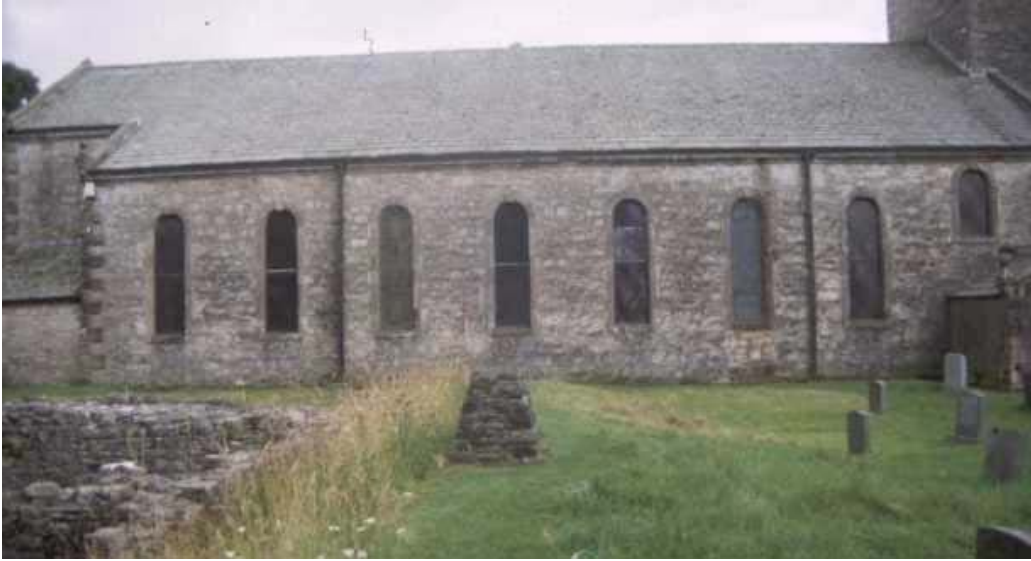
Plate 6: Rectified photograph of the north elevation

2.3.2 Rectified photographs were also taken of the north and south external elevations (Plate 6 for example), parts of which may have to be rebuilt or repaired so that a more accurate record was made prior to the renovation works. It was not possible due to the topography and space to take rectified photographs of other external elevations or the interior walls, although general photographs were taken.

6.2.3 The masonry repairs will have a major impact on the church, as some walls will be taken down. However, it is again assumed that the walls will be rebuilt using similar materials, and that this and other repairs to the masonry will be carried out in a sympathetic manner to minimise the impact.

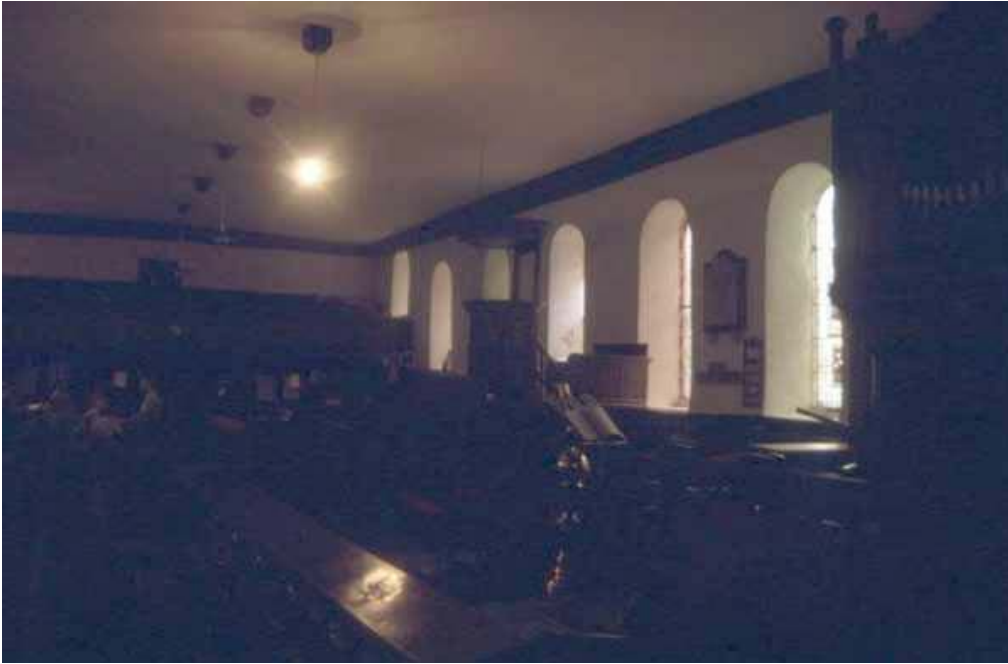
Plate 7: Interior of the nave

- 4.1.6 The nave has whitewashed walls and a denticulate cornice. The pews are arranged college style and there is a triple pulpit with a sounding board in the center of the north side (Plate 7). There is an organ situated in the north-east corner and a gallery at the west end over the entry corridor. There is a large arch with engaged columns at the east end allowing access to the chancel. The chancel is very small and plain with the plaster scored to imitate ashlar blocks. There is a doorway on the north side allowing access to the small outshut.

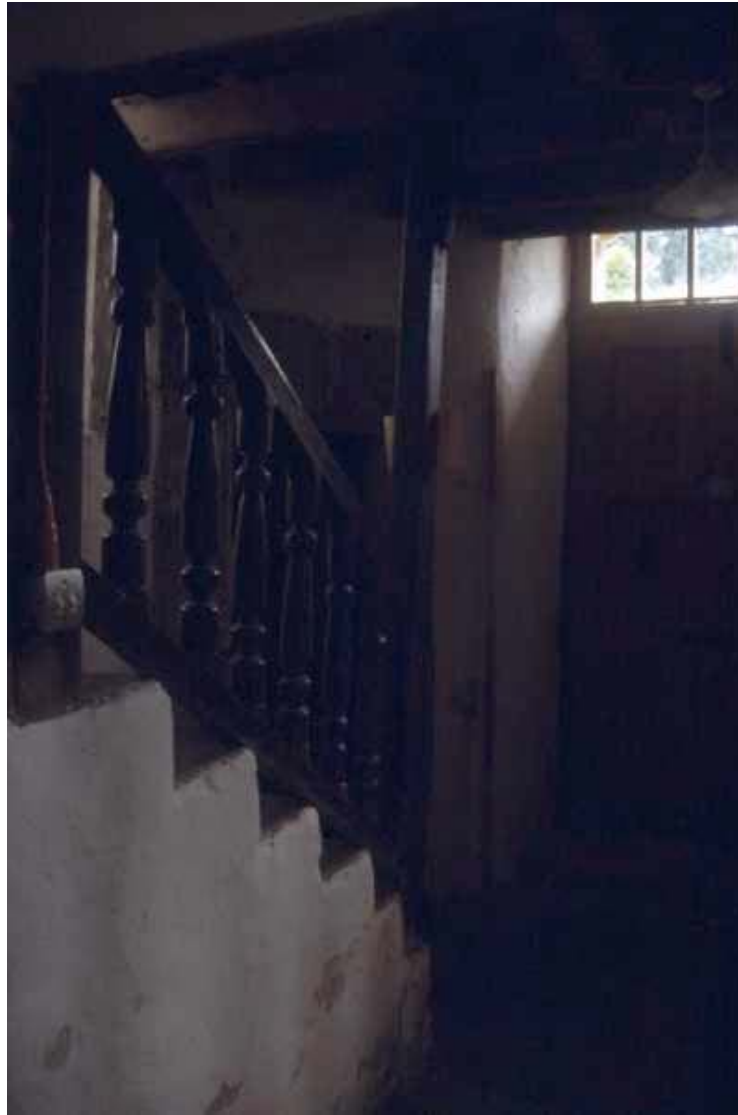
Plate 8: The south side of the stairs in the tower

- 4.1.5 The entry corridor is formed by a timber panelled wall along the east side and has a low roof below the gallery. A clock face is attached to the wall in the corridor connecting the entry corridor to the stairs and is inscribed '*This clock was given to this church by John Fothergill of Brownber in the year 1719*'. There are ogee moulded corbels on the south-west side and two loose corbels or arch springers carved with a wolf's head motif lying on the floor, which is flagged. The gallery is accessed via a double flight of dog-leg stone stairs with

baluster turned timber hand rails and beaded posts (Plate 8) supporting a more recent floor within the tower, although elements of this seem original. A small doorway in the south-west corner allows access to the stair tower. The ceiling is more original, although there are many modern repairs, and comprises a flat floor supported by beams sat on stone corbels. A similar ceiling remains in the upper floor of the tower, which houses the bell ropes.
