Archaeological Monitoring South of Cheddington Road, Pitstone, Buckinghamshire

Archaeological Monitoring Report

November 2018

Client: Anglian Water Services

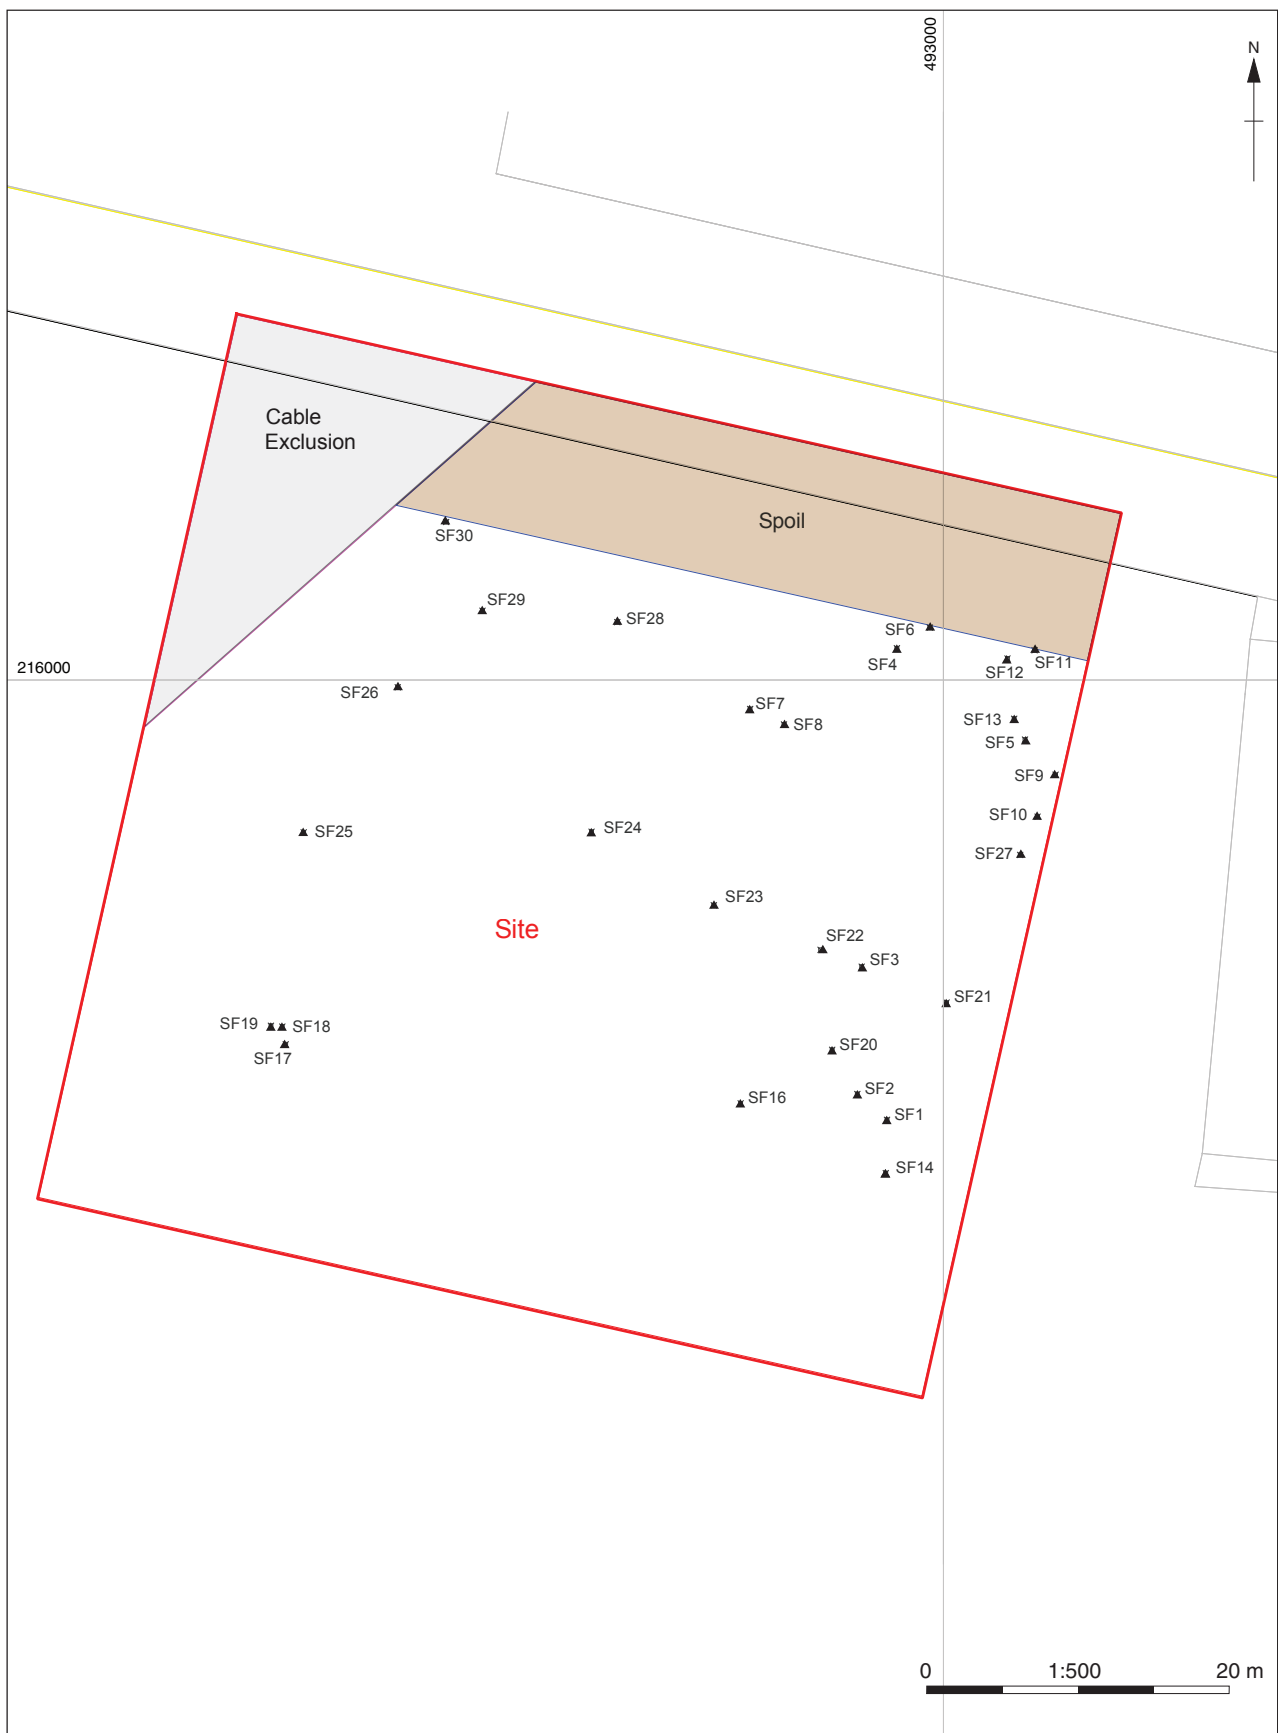
Figure 2: Site plan showing distribution of small finds. Scale 1:500

- 3.1.5 Most of the finds on site were located in the northeast quadrant, with a distinct cluster of CBM (SFs 5, 9, 10, 11, 12, 132) located in the very northeast corner of the site.
- 3.1.6 Nine of the fifteen pieces of CBM recovered were found in the topsoil layer (60%), whereas only 4 of the fourteen pieces of metal work (29%) were found in the topsoil layer.
- 3.1.7 The majority of the metalwork recovered from site was found on the eastern side of site, approximately half way between the north and south boundaries of the site (SFs 3, 14, 16, 20, 21, 22).

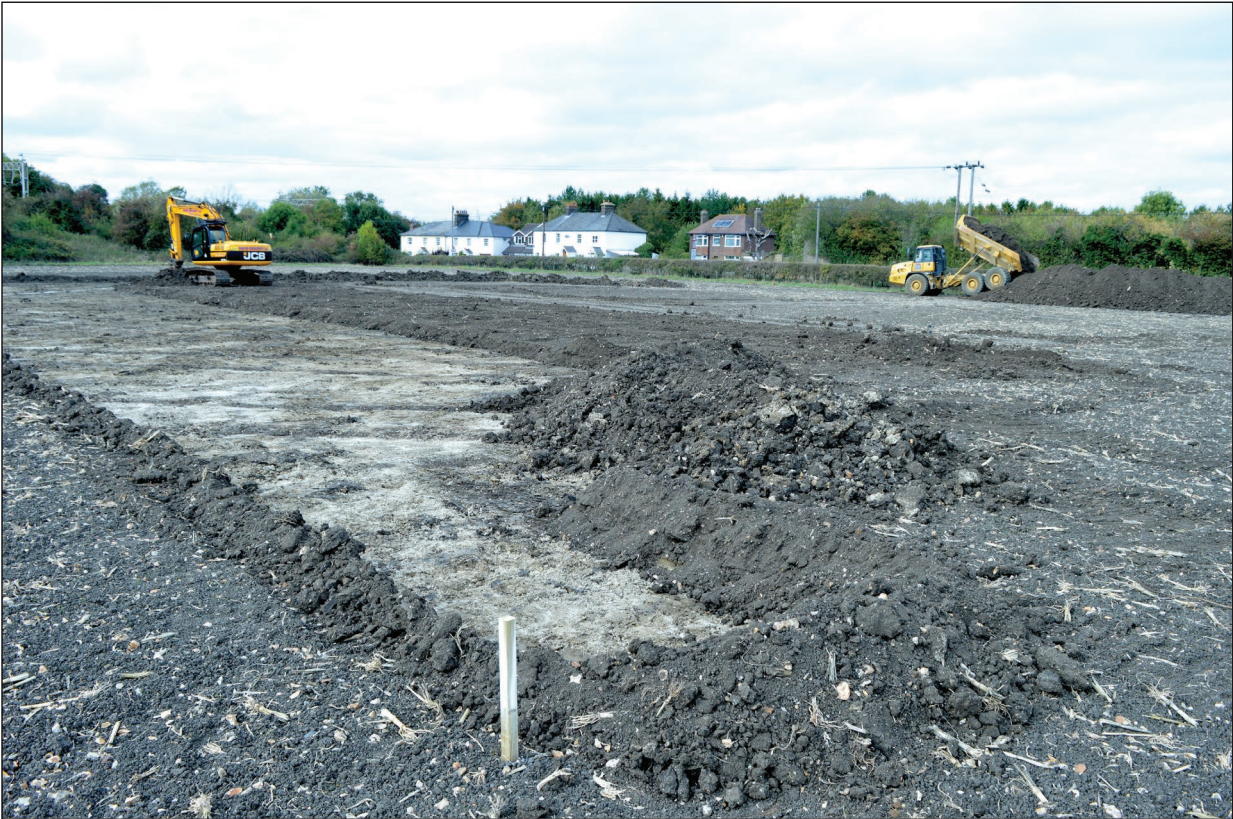
Plate 1: Machine stripping being undertaken on site, looking northwest

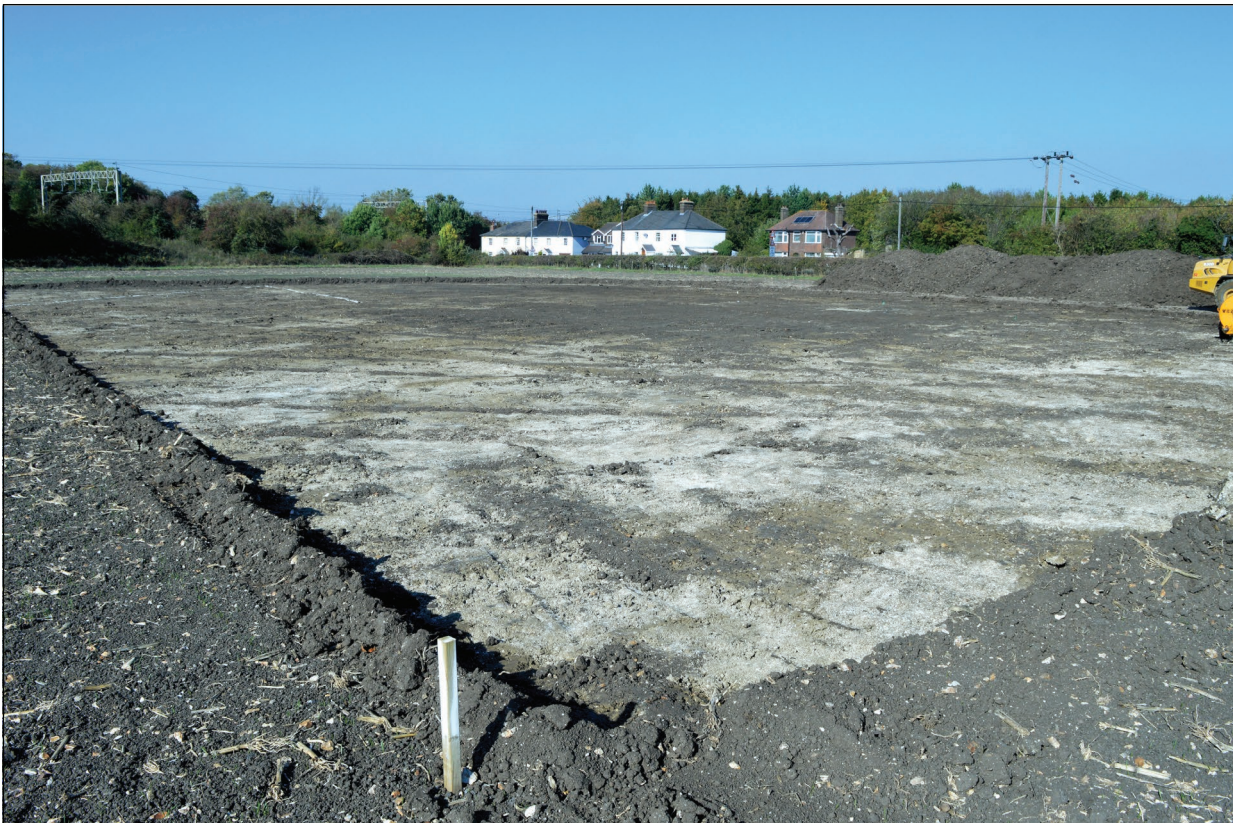
Plate 2: The site fully stripped, looking northwest

- 3.1.1 The archaeological remains encountered during the fieldwork were restricted to finds recovered from topsoil and subsoil deposits. Across the site the mechanical stripping exposed a subsoil of pale brown grey silt (Plate 2) and in no areas was the natural geology encountered.
- 3.1.2 The results of the monitoring are shown in Table 1 below, which gives details of the finds recovered from the site. Attached to this report is also a plan of the site with the locations of all the finds plotted on to it (Fig. 2).
- 3.1.3 A total of two contexts were identified on site, context (1) being the topsoil and context (2) being the subsoil.
