141 Ditton Walk, Cambridge

Archaeological Evaluation Report

May 2019

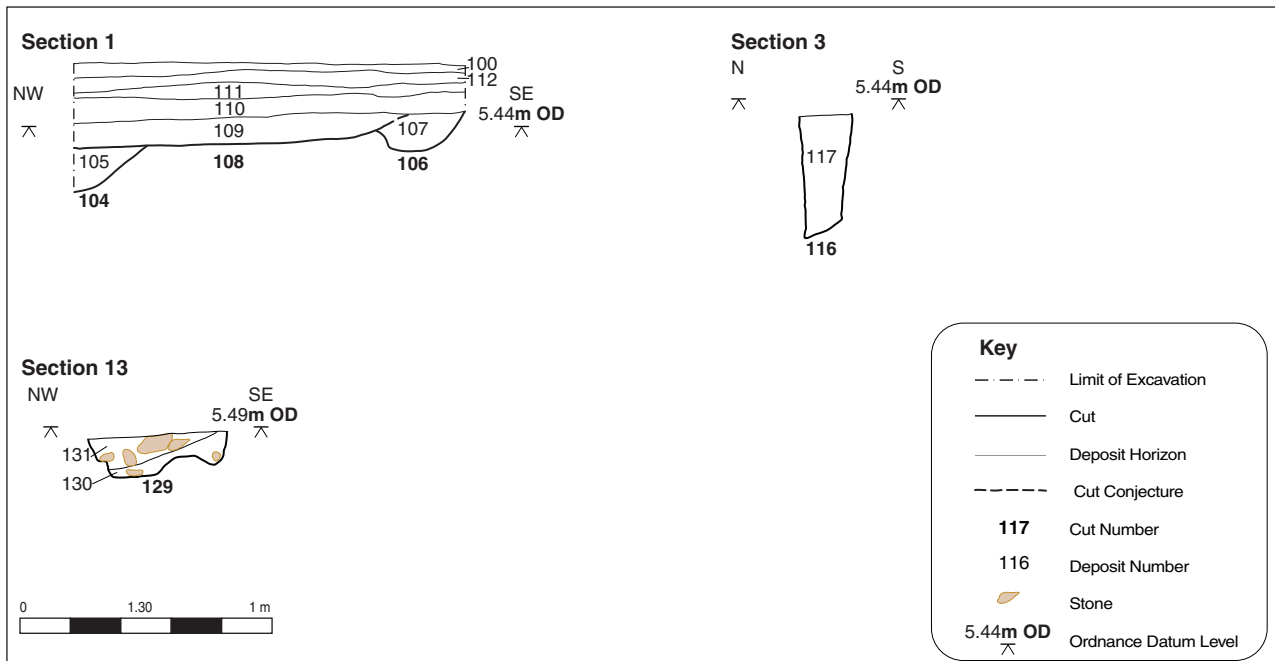
Figure 3: Selected Sections

- 3.4.4 At the northern end of the trench was the edge of a probable paleochannel **104** (Fig. 3, Section 1). This was found to be 0.56m wide and 0.34m deep with a series of mid to pale green blue deposits (105). It was overlain by a 0.24m deep layer (109), possibly an older topsoil layer that had been compressed and overlain in turn by a series of modern hardcore levelling layers as described above.

- 3.4.5 Gully **106** (Fig. 3, Section 1) was found to be aligned north-east to south-west and measured 0.54m wide and 0.3m deep. A single mid brownish grey deposit (107) of silty clay was excavated, from which one small fragment of post-medieval ceramic building material (CBM) was recovered but not retained. This feature was truncated to the south-west by small pit **127**.

- 3.4.7 A series of postholes was identified to the south of gully **106**. These included **116**, **125**, **121** and **123** (Fig 3, Section 3, Plate 2). Also forming a north-west to south-east alignment, these postholes were found to be between 0.14m and 0.48m deep with widths between 0.2m and 0.15m. Fills 122, 124 and 126 from **121**, **123** and **125** respectively were of mid to dark greyish brown silty clays with **125** and **121** containing remnants of wooden posts.

- 3.4.10 Pit **129** located at the south-east end of the trench was found to be 1.98m wide with a total depth of 0.32m (Fig 3, Section 13). Two distinct deposits were excavated; basal fill 130, a mid greyish brown sandy silt and fill 131, a mid brownish grey sandy silt. Both deposits were found to contain modern CBM, asbestos tile (which in the upper fills was not disturbed and left in situ with the lower fills), and degraded iron fragments of likely modern origin.

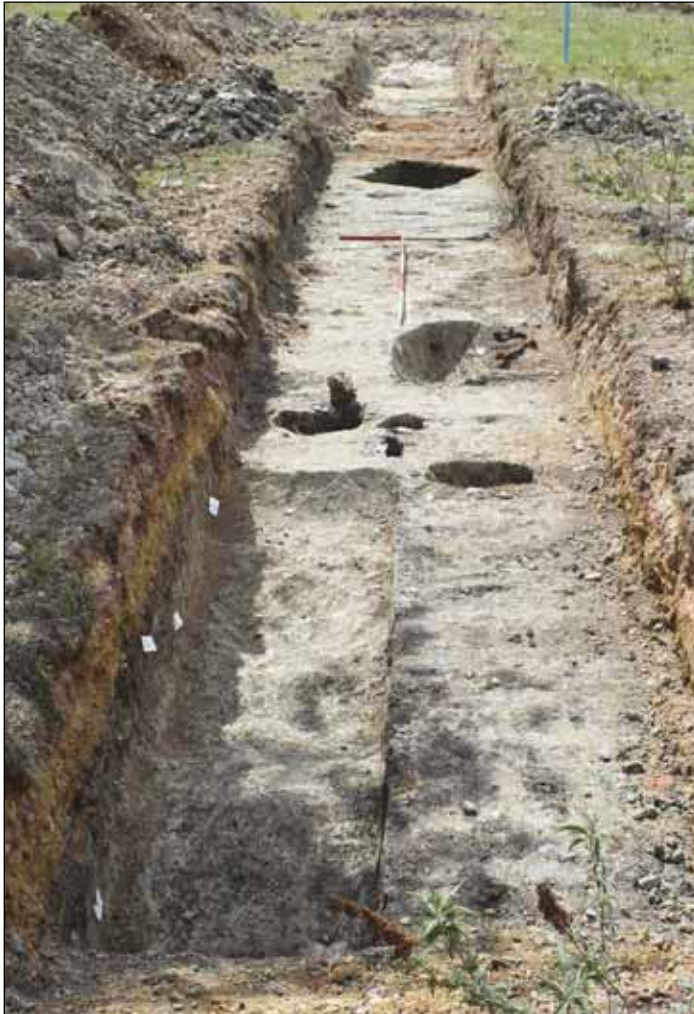
Plate 1: Trench 1 viewed from the north-west

- 3.4.2 Trench 1 (Fig. 2, Plate 1) was located at the northern limit of the development area and positioned so as not to remove the monitoring pipe to the north-west. Aligned north-west to south-east, Trench 1 measured 20m long and 2m wide. A series of postholes, pits, gullies and modern service trenches were revealed.

- 3.4.3 The north-west and south-east ends of the trench showed slightly different sequences within the removed overburden. The northern end had a series of four levelling layers to a total depth of 0.68m, consisting of layer (109) a possible topsoil which was sealed by various types of hardcore (112, 111 and 110); that were all overlain by a 0.15m organic layer (100) resulting from colonisation by new plant life in more recent years (Fig. 3, Section 1). At the south-east end this series had been replaced by 0.54m of a single whitish grey hardcore rubble layer (132) likely relating to the demolition of the industrial building(s) previously occupying the location with 0.08m of organic layer (100) over the top.

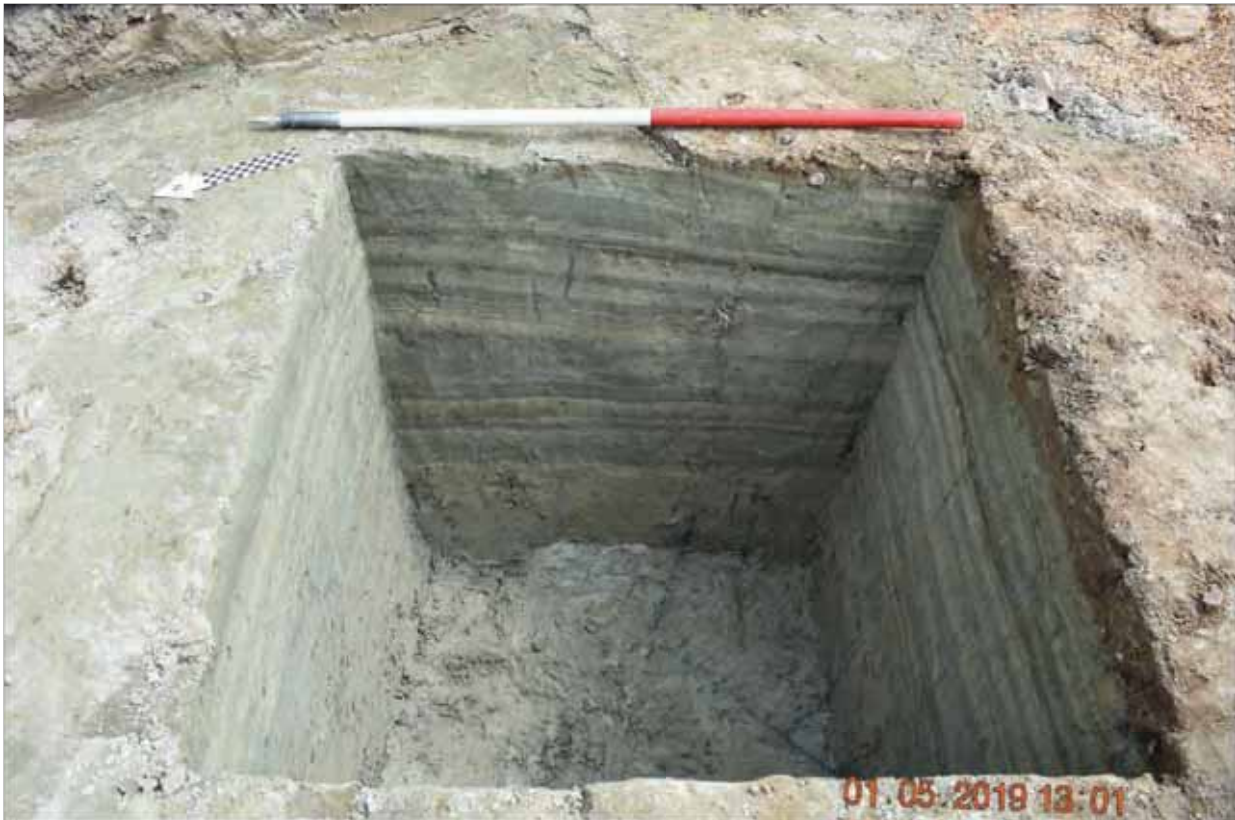
Plate 3: Paleochannel test-pit, viewed from the north-west

- 3.4.9 A test pit (Plate 3) was dug in the centre of the trench due to the presence of a greenish blue deposit (118), which was found to be identical to deposits seen in Trenches 2 and 3. Measuring 1m deep, the test pit comprised a sequence of thin laminar layers. Clearly alluvial in nature, the layers were formed of blueish grey or whitish grey clayey silts. The alluvium was overlain by a thin layer of modern backfill from nearby service trenches that were located to the south (Fig. 2).

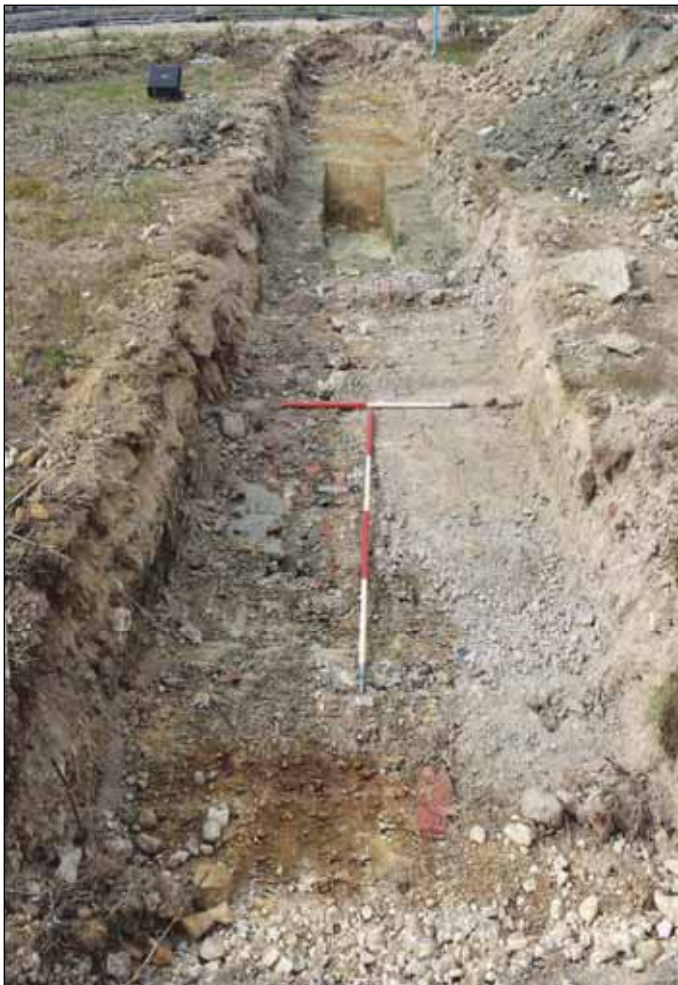
Plate 4: Trench 2 viewed from the north-east

- 3.5.1 Trench 2 (Fig. 2, Plate 4) was aligned north-east to south-west and measured 15m in length, due to the presence of Heras fencing in the west limiting plant movements around the site. Within this trench was identified an area of modern disturbance and a paleochannel **201** (Plate 5).
- 3.5.2 At the eastern end of the trench there was a slight variation in the levelling and build up layers. A series of four hardcore levelling layers (207, 208, 209 and 210) were identified to a depth of 0.69m. These are likely to be contemporary with the original construction of the industrial buildings that once stood on the site as well as those seen at the northern end of Trench 1.

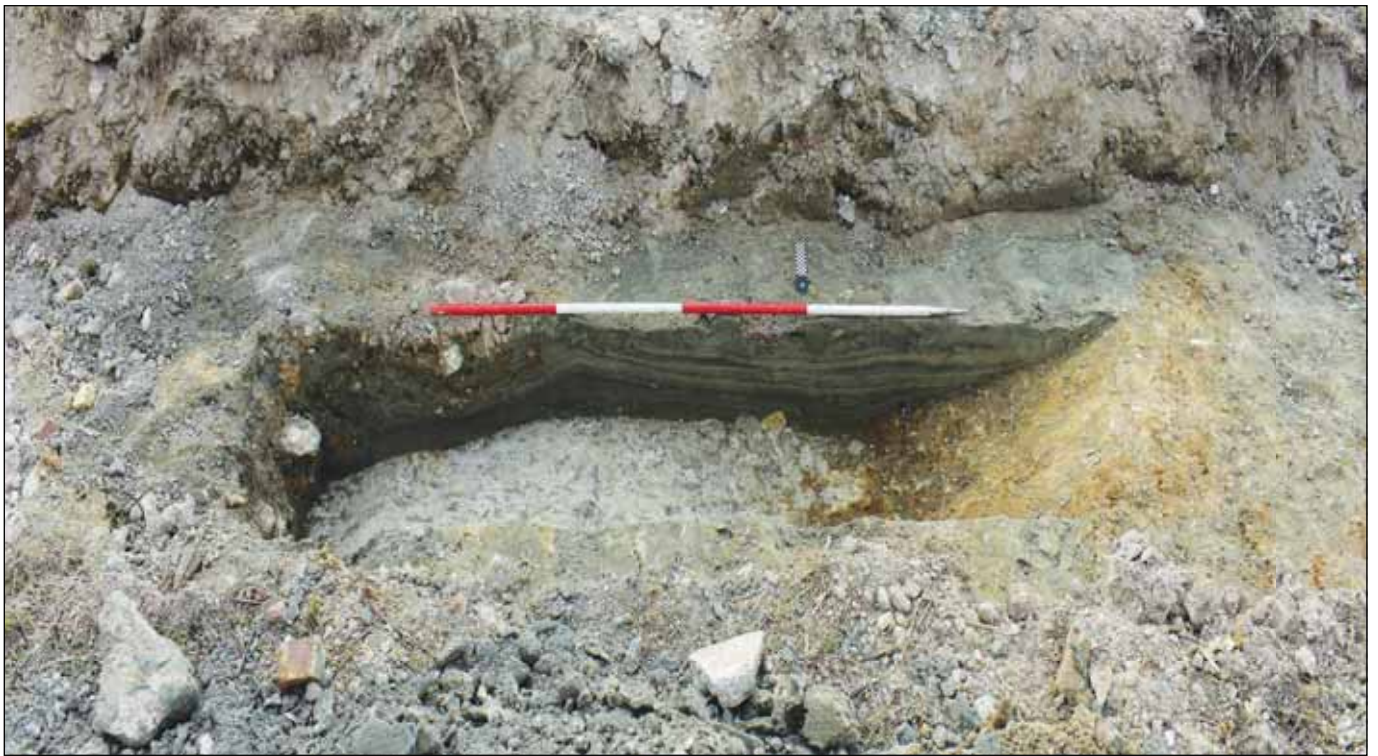
- 3.5.3 The alluvial deposits within paleochannel **201** were truncated by modern disturbance **203**, comprising mid whitish grey rubble with concrete fragments, reinforcing rods, brick and tile fragments throughout. This in turn was overlain by 0.05m of a slightly organic layer (210) over the top, likely a result of recent colonisation by new plant life. The modern disturbance may relate to the construction of the industrial buildings previously occupying the site.

Plate 5: Paleochannel **201** and modern disturbance **203**, viewed from the north-west

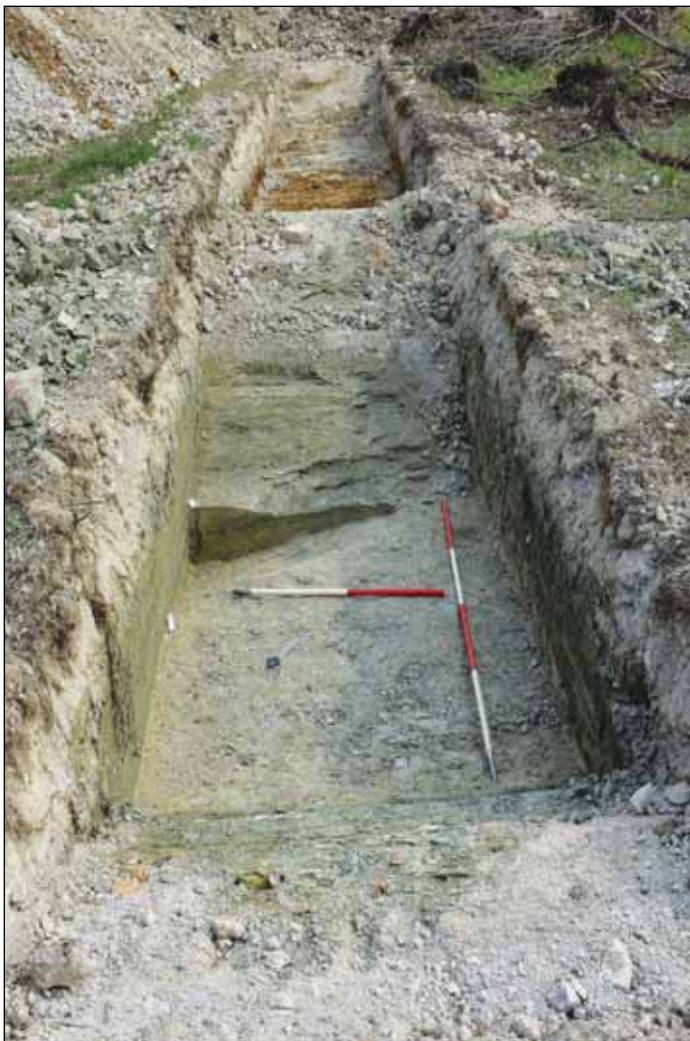
Plate 6: Trench 3 viewed from the north-west

- 3.6.1 Trench 3 (Fig. 2, Plate 6) was aligned north-west to south-east and measured 14.5m in length. It was shortened to allow for Trench 4 to be moved northwards due to services. The only feature present within the trench was part of a likely paleochannel **304** (Plate 7) that was found to be 0.83m deep. A series of laminar deposits were seen within the fill (302), typical of alluvial deposition.

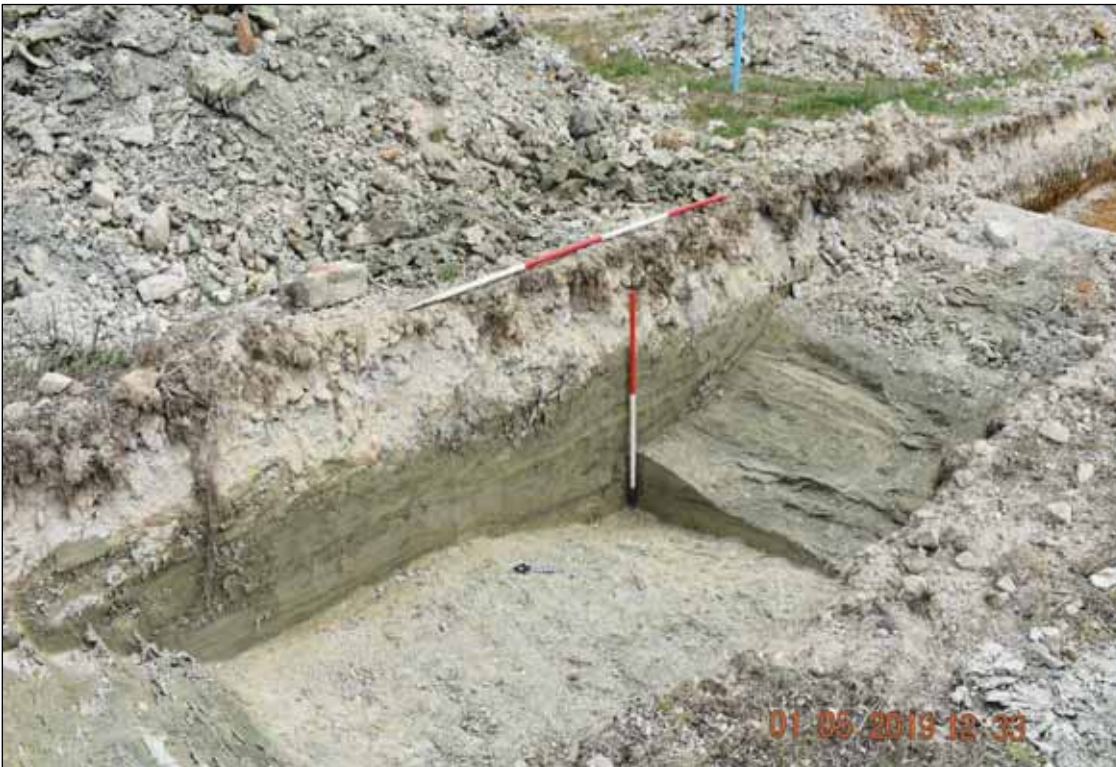
- 3.6.2 This was overlain by layer 301 to a depth of 0.34m, which contained a large quantity of modern building materials including reinforcing rods, concrete and CBM fragments. It is likely to be the equivalent of layer 200 and related to the demolition of the industrial building(s) previously occupying the site. This in turn was overlain by 0.05m of an organic brown silty clay layer (210), likely a result of colonisation by plant life over the intervening period between demolition and this evaluation.

Plate 7: Paleochannel **304** and demolition layer **301**, viewed from the north-west

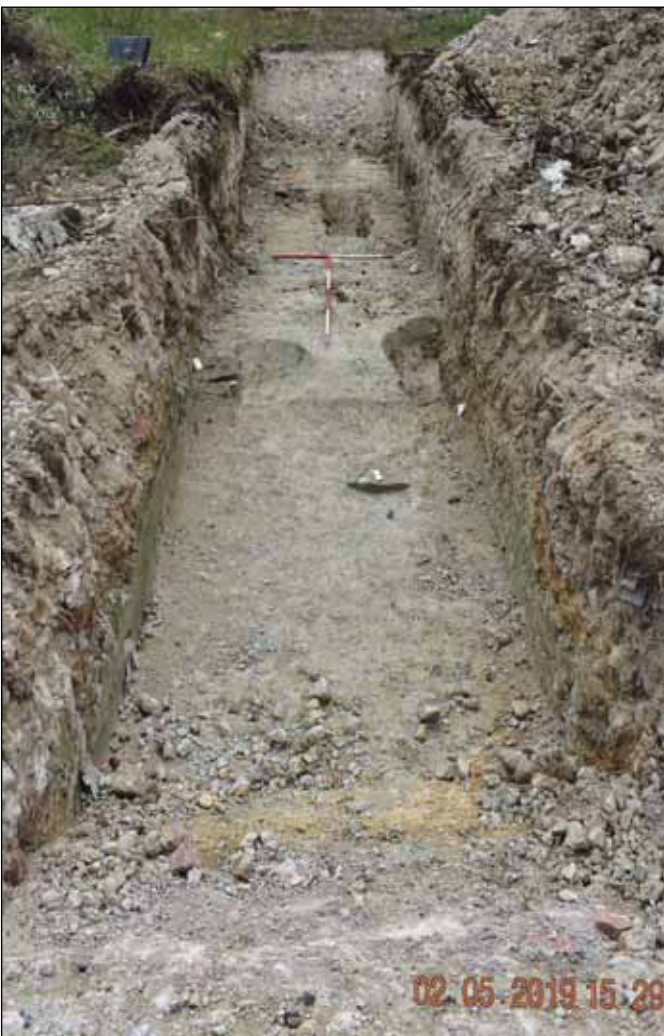
Plate 8: Trench 4 viewed from north-east

- 3.7.1 Trench 4 (Fig. 2, Plate 8) was located at the southern end of the development site and was aligned north-east to south-west. It measured a total of 6.5m in length due to a live service being identified to the east.

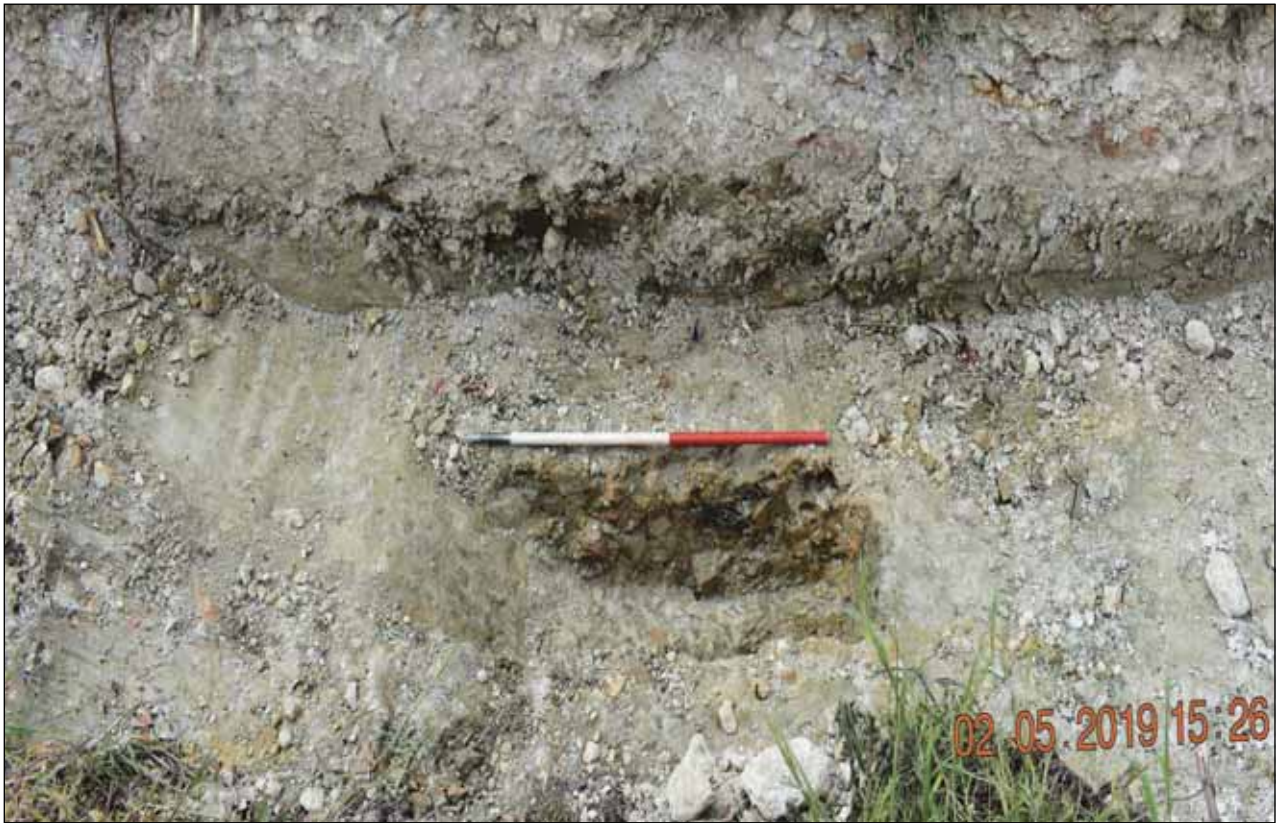
- 3.7.2 At the south-west end of the trench was an area of modern disturbance (Plate 9), into which a 1m long slot was excavated. This revealed the presence of a possible foundation trench (409), characterised as having a moderately steep side and a flat base. Measuring 0.36m deep, it had subsequently been backfilled and levelled with modern rubble (402) including CBM, concrete, plastic bags, cable ties and plastic signs. Sealing this was layer 401, a 0.7m thick whitish grey demolition layer with frequent concrete, reinforcing rods, metal drainage grates and other modern CBM. In turn this was overlain by layer 400, an organic mid grey brown silty clay, 0.12m deep, likely resulting from the recolonisation of plant life into the area.

Plate 9: Backfilled possible Foundation Trench **409** and Leveling Layer **402**, viewed from south east.
