Castle Quay, Banbury, Oxfordshire

Archaeological Excavation Report

June 2019

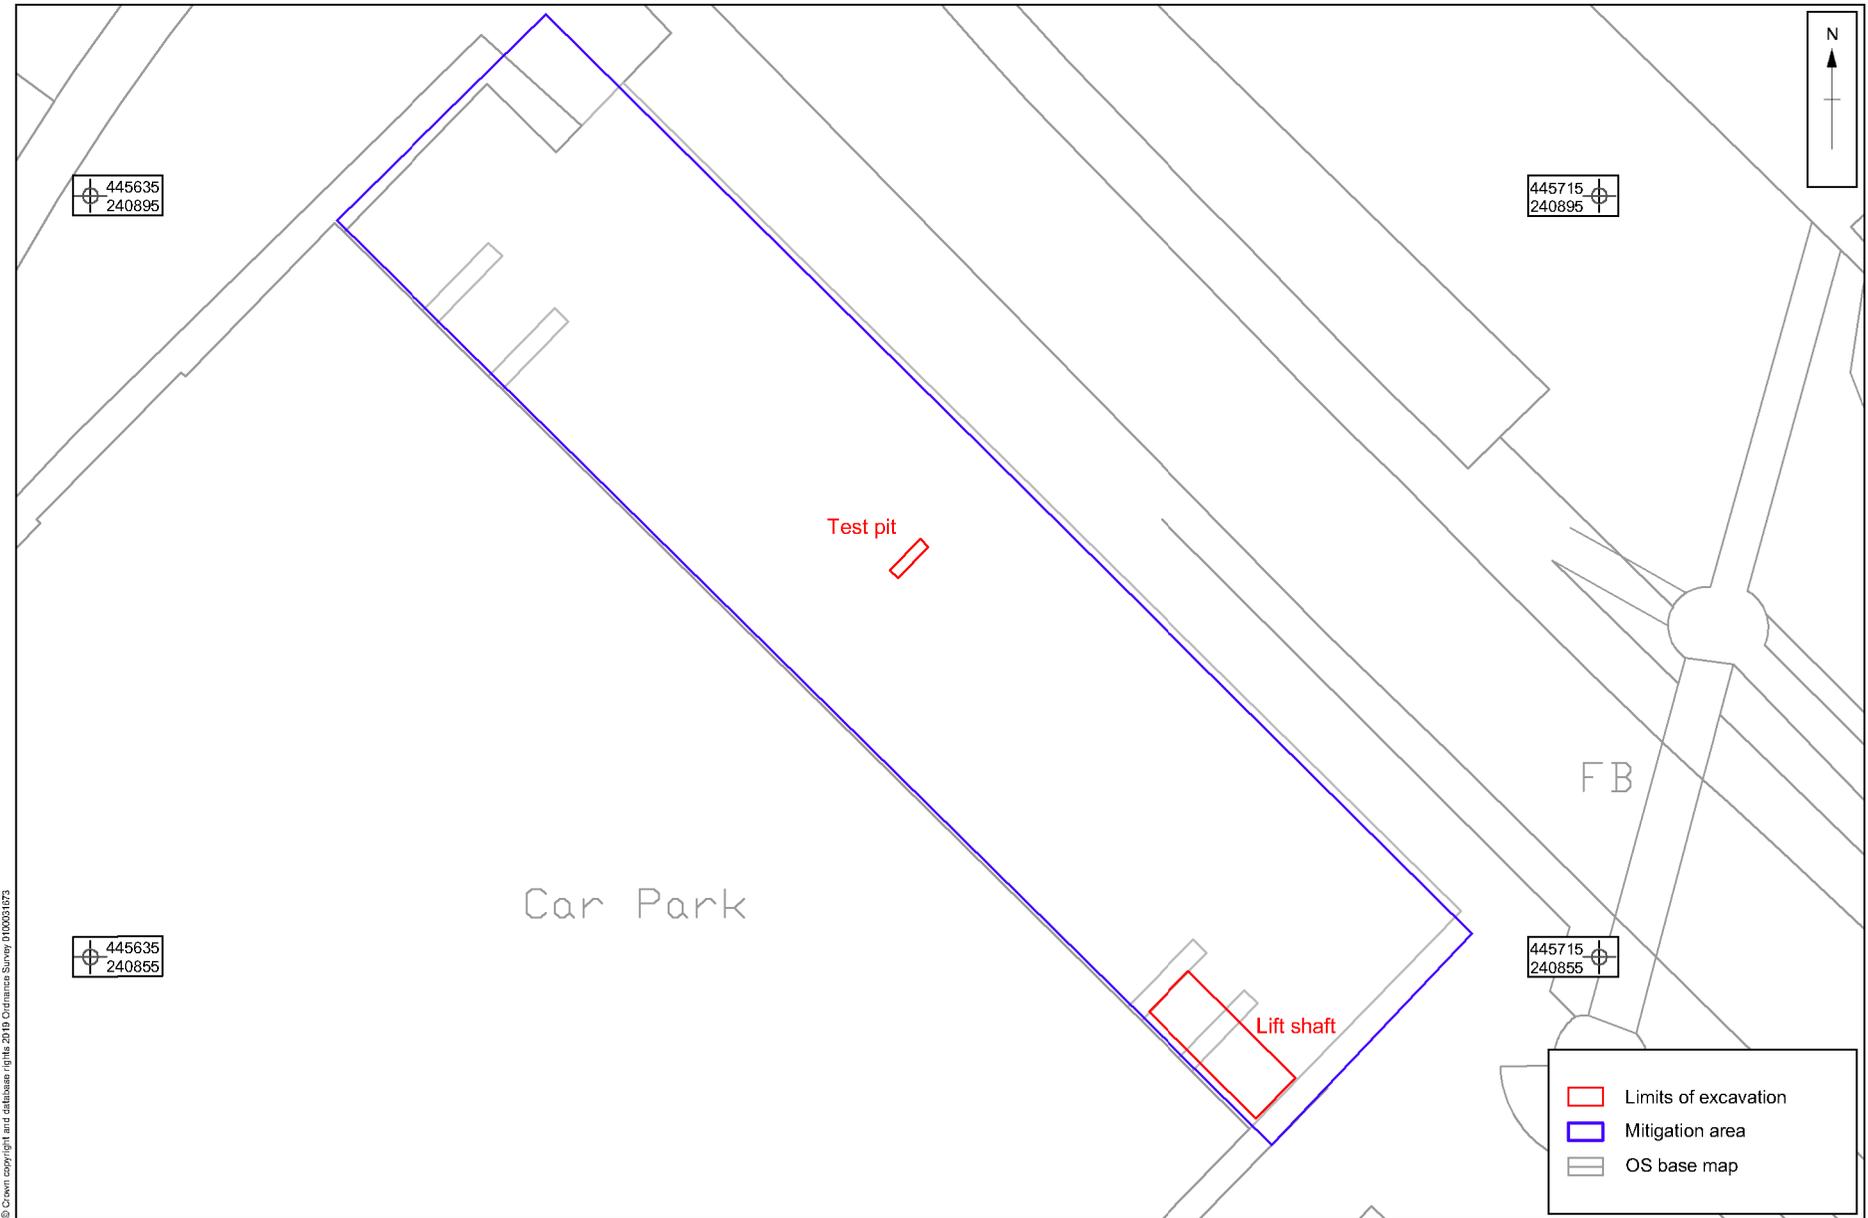
Figure 2: Location of lift shaft pit and service trench test pit

2.3.2 In the first instance the lift shaft pit (see Fig. 2) was excavated in spits using a mechanical excavator using a toothless bucket and operating under archaeological supervision. No archaeological deposits were encountered so the pit was excavated to the full impact depth of the lift shaft. A test pit was also excavated to establish the presence of the existing drainage and the truncation of deposits caused by this. The lift pit provided a section through the deposits that would be impacted by the development.

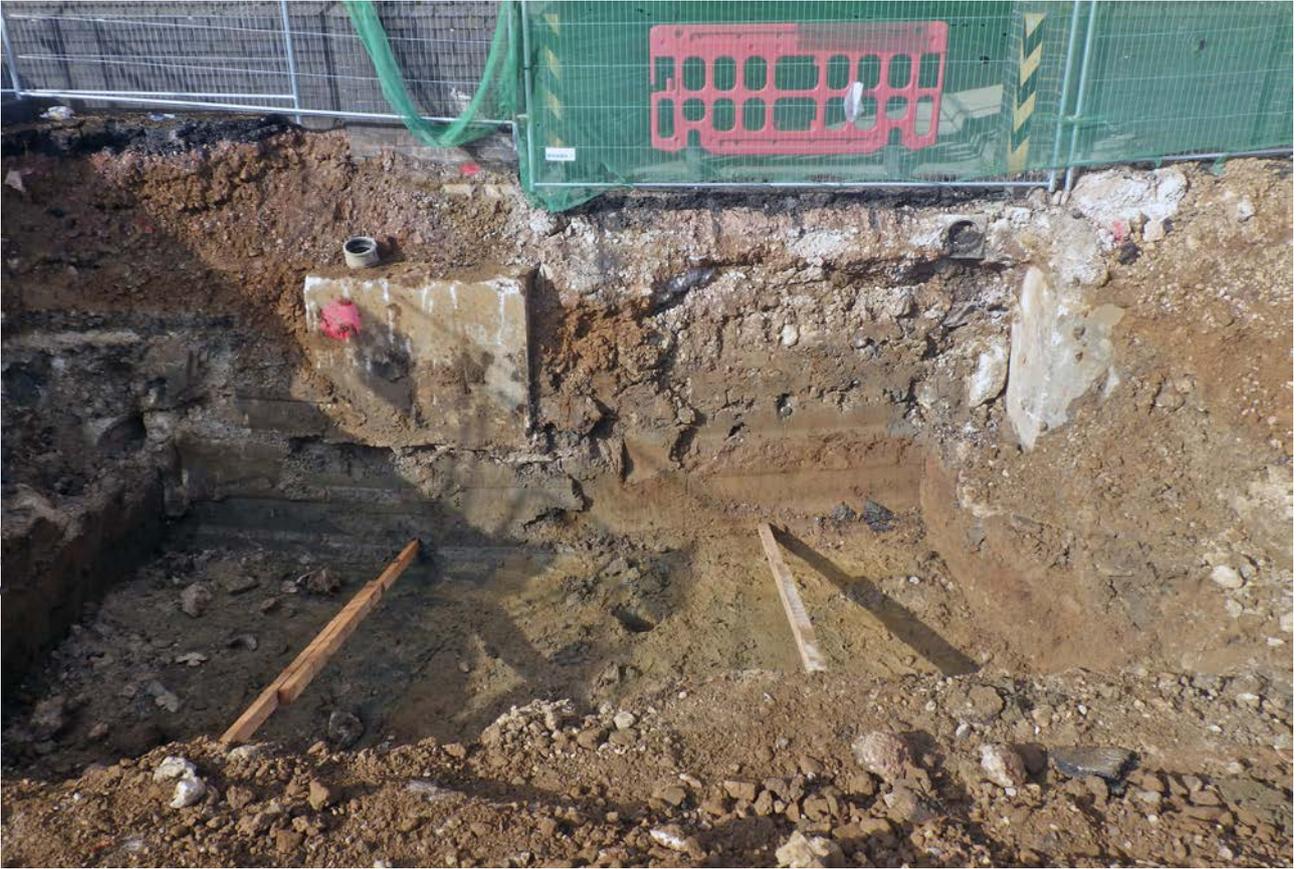
3.2.1 The natural geology of silty clay was revealed at the base of the lift pit shaft. This was overlain by a sequence of modern made ground deposits relating to the existing development. The existing car park hardstanding overlay the uppermost layer of made ground.

Plate 1: Lift shaft pit excavation, looking south-west

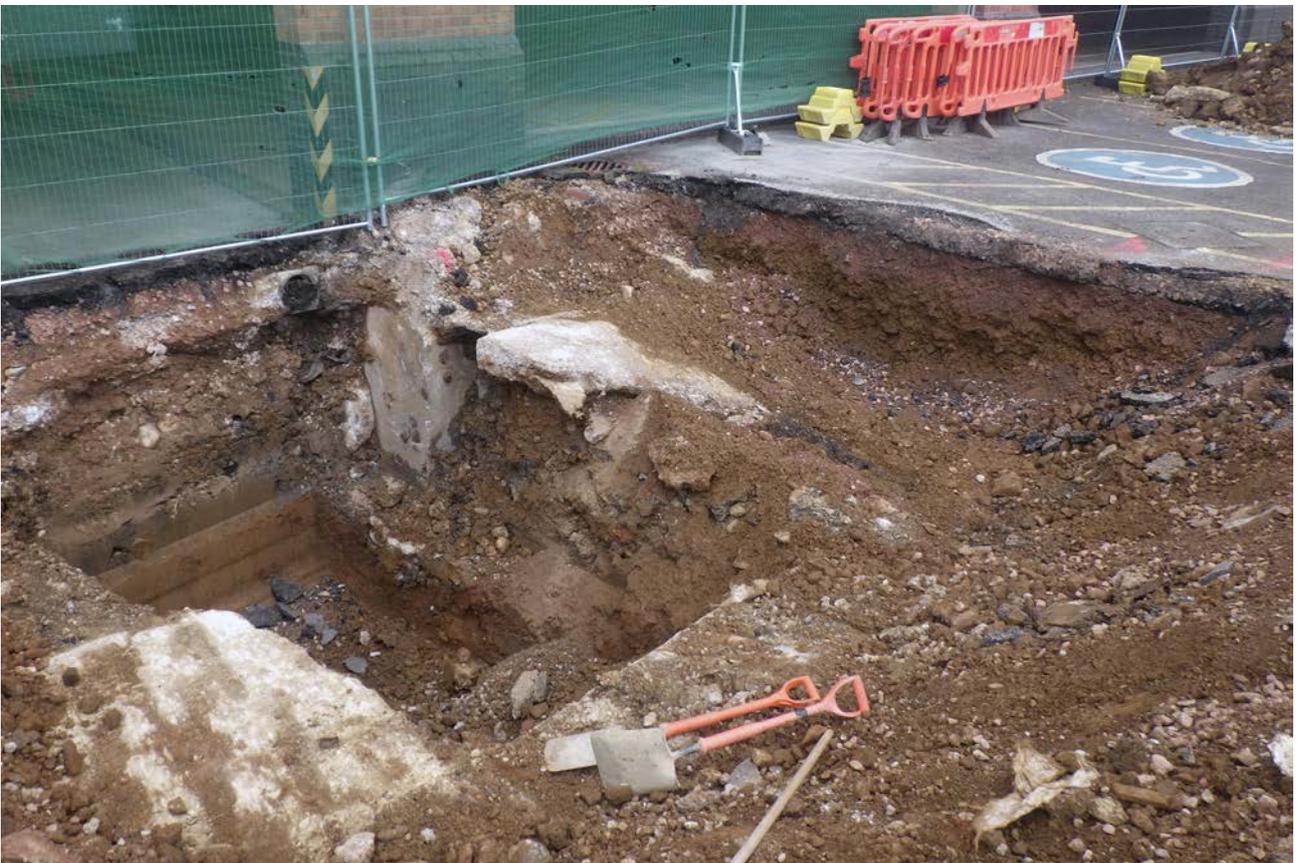
Plate 2: Lift shaft pit excavation, looking west

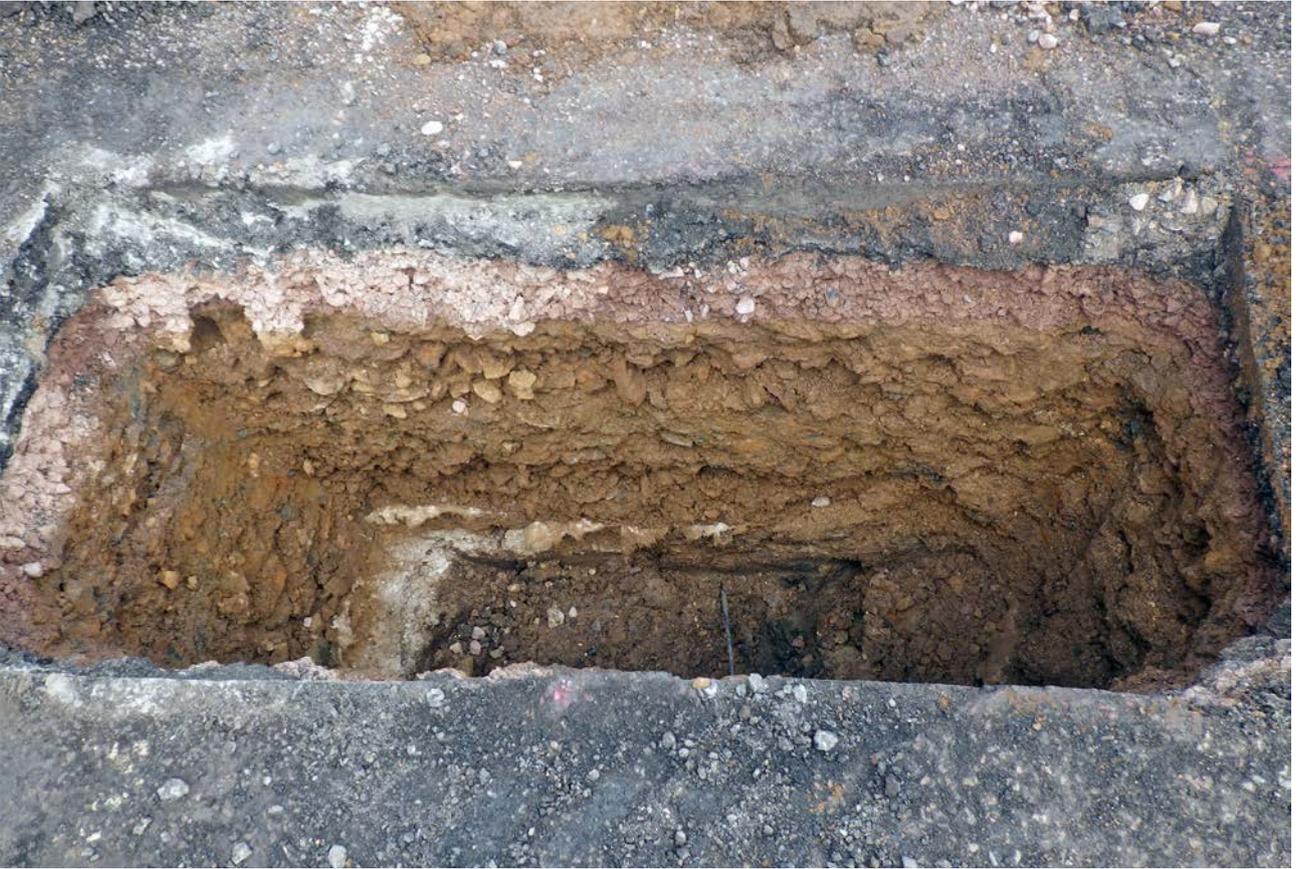
3.2.2 A large concrete drainage pipe was revealed at the base of the test pit trench excavated to locate this service. This confirmed extensive truncation to depths of approximately 4m below the current ground level with the service trench infilled with aggregate and capped by the existing car park surface. Undisturbed or natural deposits were not encountered within this trench.

Plate 3: Test pit, looking north-west
