THE SWAN PUBLIC HOUSE, ASTLEY GATE, BLACKBURN LANCASHIRE

**Rapid Desk-Based
Assessment,
Archaeological
Building Investigation
and watching Brief**

Oxford Archaeology North

September 2007

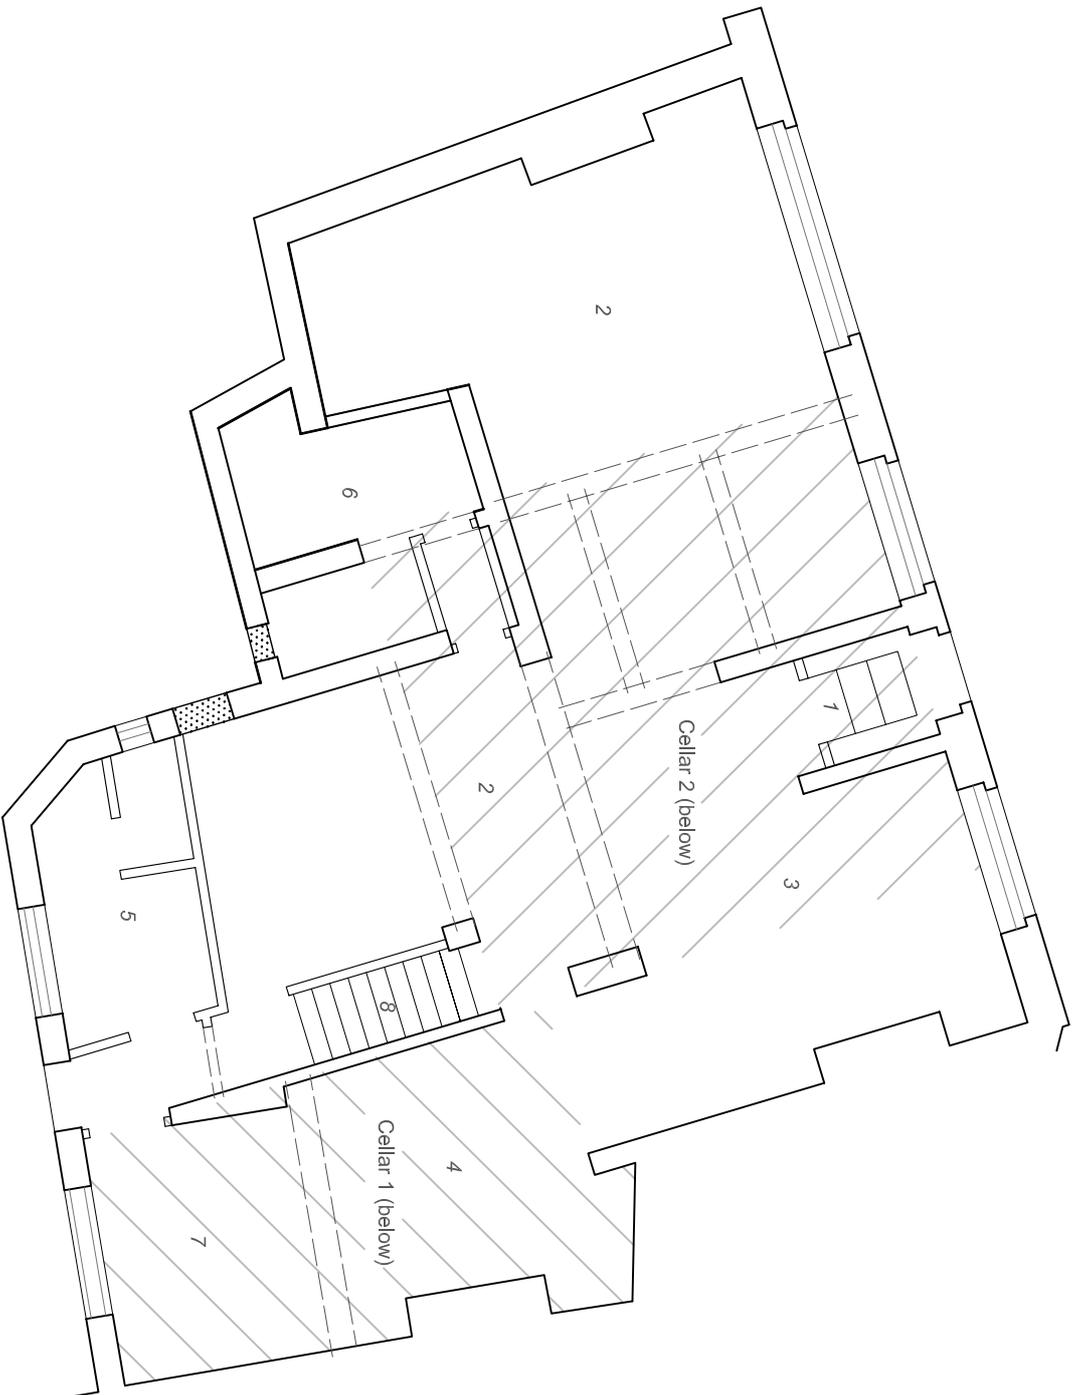
Figure 2: Ground floor plan

- 4.2.2 The main structure of the building is three rooms wide and two rooms deep (Figs 2 and 3) and has a central staircase, which allows access to and from the first floor. The basement has a separate flight of steps. The only access to the building was via a small door within an extension at the rear of the property.

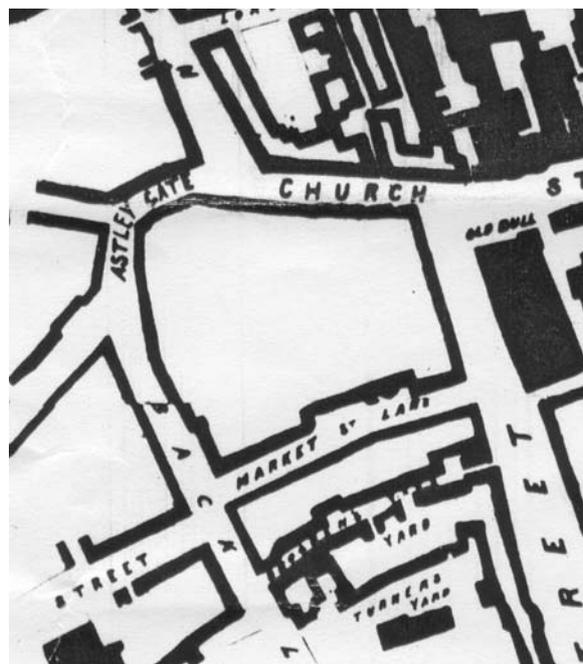
Plate 2: Part of a plan of Blackburn from c1795 showing the study area (BCL MM076)

- 6.2.1 Based on the results from the building investigation it appears that the building has undergone three main phases of building and/or alteration. The first phase of construction probably took place some time around 1795 when the area was apparently built upon (Plate 2) and was almost certainly carried out by 1822 (Plate 3). Certainly, the nature of some of the beams and the reed plaster on the third floor would seem to support a late eighteenth date for the original phase of construction. The 1822 map shows that the building more or less had its current shape. This may have always been the case but earlier mapping is less detailed.

Eighteenth Century: the earliest map Astley Gate in any detail dates to 1739 (Plate 1), and shows Darwen Street, Church Street and Back Lane, with buildings fronting onto the two former streets (OA North 2005; LUAU 1995; 2000; Lancashire County Council and Egerton Lea Consultancy 2005, 24). Astley Gate is evident at the end of Church Street and there are some structures shown on its south side (Plate 1). The junction of Darwen Street and Church Street probably formed the focus of the medieval town (OA North 2005, 8; Lancashire County Council and Egerton Lea Consultancy 2005, 18), and so these plots are undoubtedly medieval in origin. Subsequent maps by Yates (1786, in Timmins 1993, pl 2) and a map of c1795 show that Blackburn had continued to expand (BCL MM076), and by this date the area in and around Astley Gate was apparently built on (Plate 2).

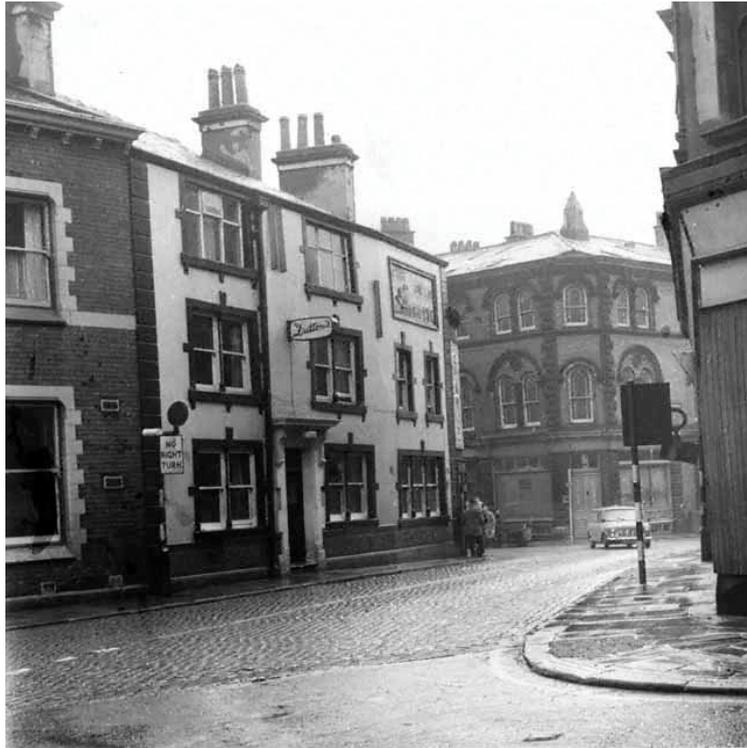
Plate 8: The Swan public house post-1959

- 6.2.3 Phase three dates to the late twentieth century when many of the windows were replaced, the chimney-stacks removed (carried out after 1959, see Plate 8) and some of the internal walls on the ground floor were removed. The adjacent buildings to the west were also demolished after this date.

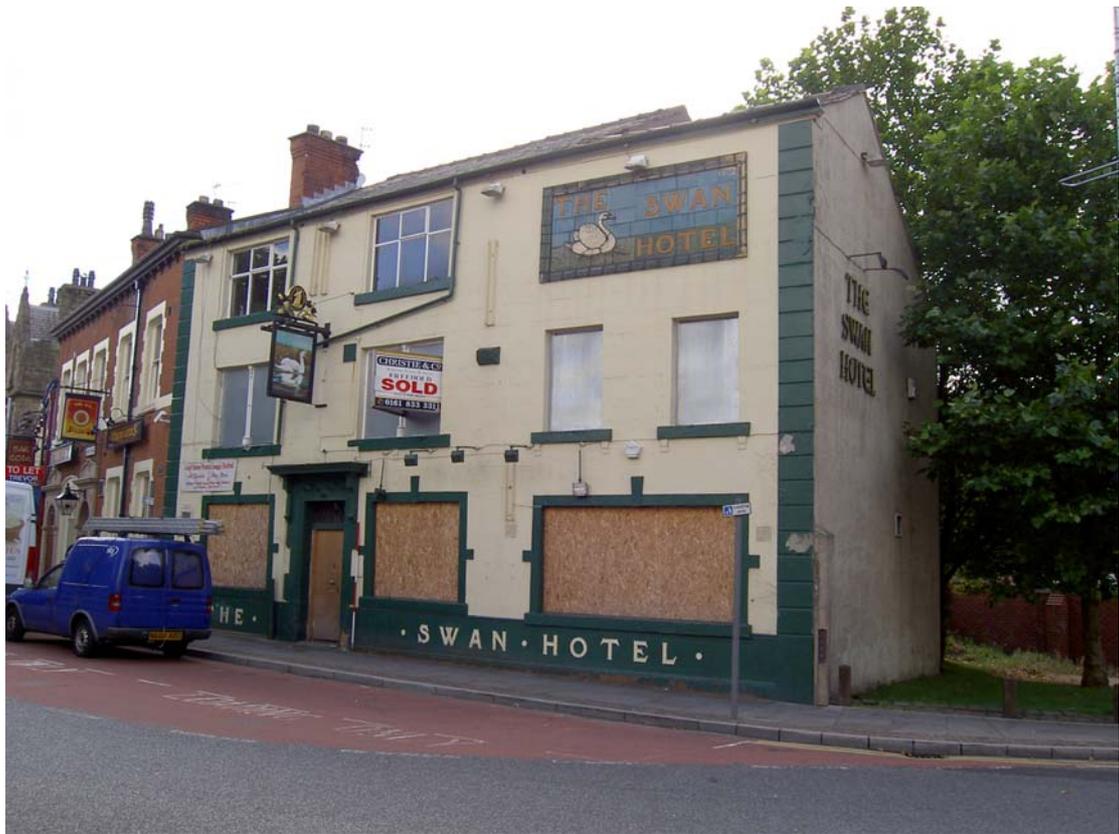
Plate 10: North elevation of the Swan public house, looking south-east

- 4.4.3 The main part of the elevation is three storeys high and has varying fenestration (Plate 10). The west side of the elevation is two storeys high. The ground floor windows are wide and have painted sandstone surrounds and slightly projecting sills. The wide windows on the ground and first floors have decorative mullions (not inspected in detail). All the upper windows are similar, with plain surrounds and slightly projecting sandstone sills (Plates 8 and 9 illustrate the upper windows as having similar surrounds to those on the ground floor). The windows on the first floor of the west side of the elevation are narrower than the others. Most of the windows are boarded but they appear to be of late twentieth century timber construction.

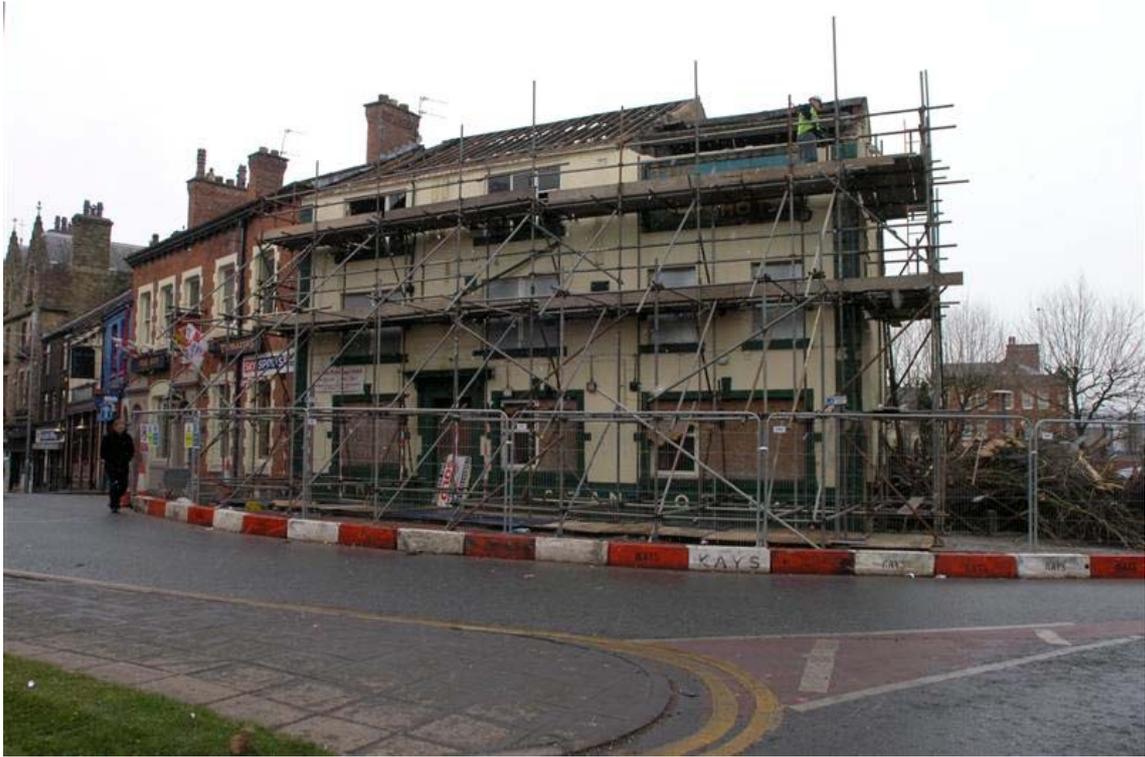
Plate 11: North Elevation of The Swan Hotel

- 4.4.2 ***The Main (Front) Elevation:*** as already mentioned (*Section 4.1.1*) the front elevation was obscured by scaffolding at the time of survey (Plate 11). It does appear, however, that the elevation was not much altered since the photograph (Plate 10) was taken, and is of painted stucco with painted rusticated quoins at the extremities.

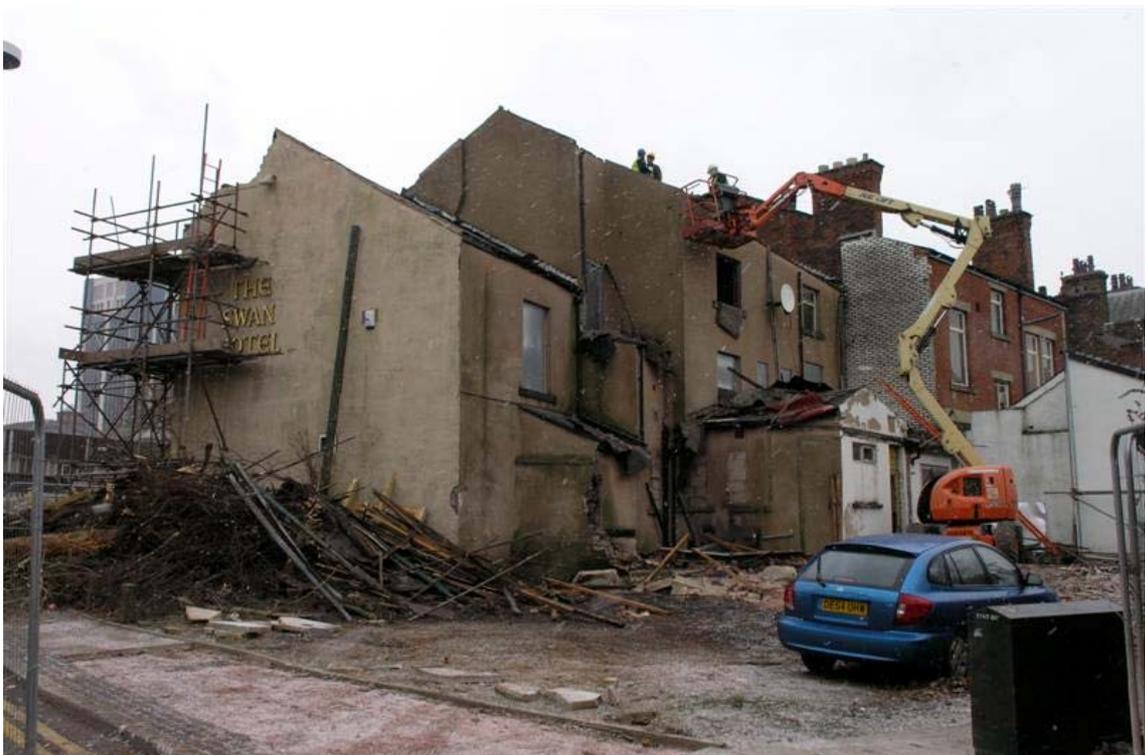
Plate 12: Rear of The Swan Hotel

- 4.2.1 The Swan Hotel comprises two main parts as illustrated on Plate 12. The main, eastern part of the building is 'L-shaped' and is laid out over three floors together with a basement. The layout of each floor is not identical, the ground floor containing three rooms, the first floor (Fig 3) has six rooms (the top floor was briefly inspected but not planned). The west side of the building is of two storeys each floor having two rooms. There are two single storey extensions attached to the rear of the property. The building lies on a north-east/south-west axis and the front elevation of the building faces Astley Gate. The site slopes gently to the south.

- 4.3.1 The whole of the building is cement rendered, the application of which has obscured the main fabric of the building (Plate 12). Hand-made brick with lime mortar bonding was revealed during the limited internal inspection, and it is reasonable to assume that the building is quite probably entirely of brick construction (although the bonding and type is impossible to deduce). A number of windows at the rear of the building have been blocked with cinder block. All the windows are of timber construction. The front elevation is painted and has painted sandstone window surrounds and sills. There is a large tiled 'The Swan Hotel' frieze on the upper part of the front elevation and there is tiled plinth at the base of the elevation also with the 'The Swan Hotel' lettering.

- 4.4.6 ***The Rear of the Building:*** there are several single storey extensions attached to the rear of the public house (Plate 12). Plate 12 clearly illustrates the two

main parts of the building, with the western part being lower and not as deep as the main (east) part. The whole is rendered and all of the windows (except one) are blocked or boarded. Interestingly, the eaves of the main roof slopes down to the east (Plate 13). It is apparent that the join between the Swan Hotel and the adjacent Sun Inn is not clearly defined (Plate 13 and Figs 2 and 3)

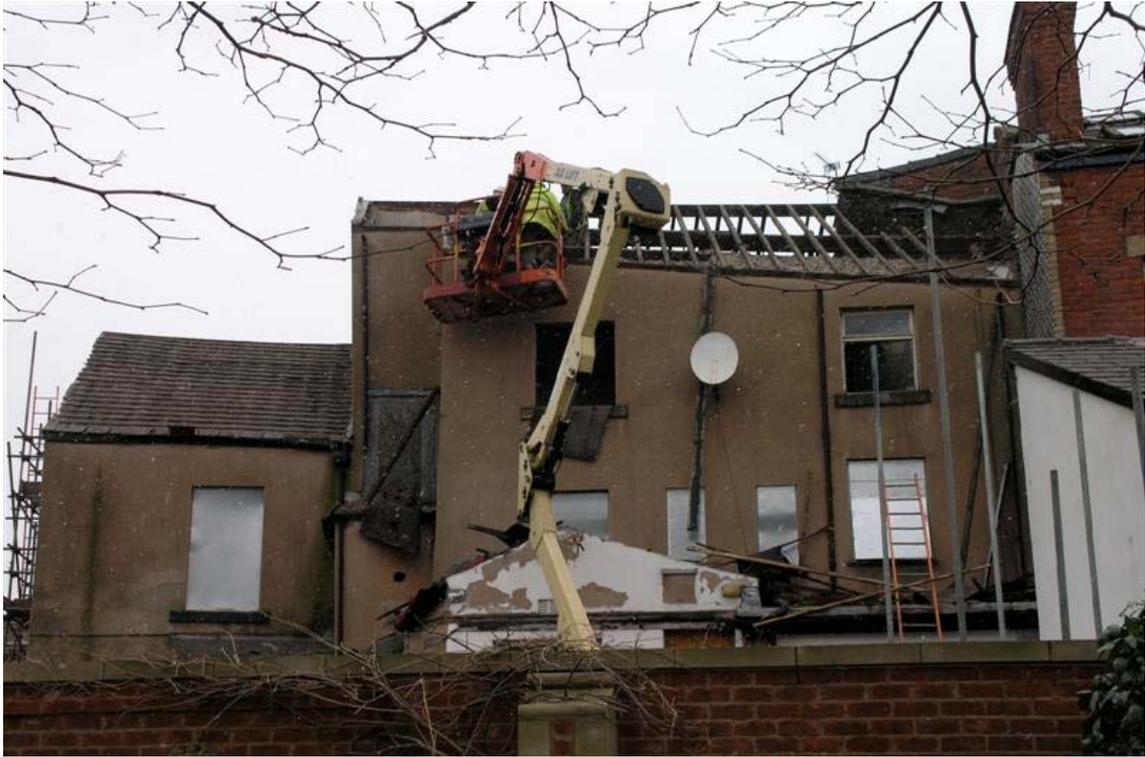
Plate 13: The rear elevation illustrating the sloping eaves line

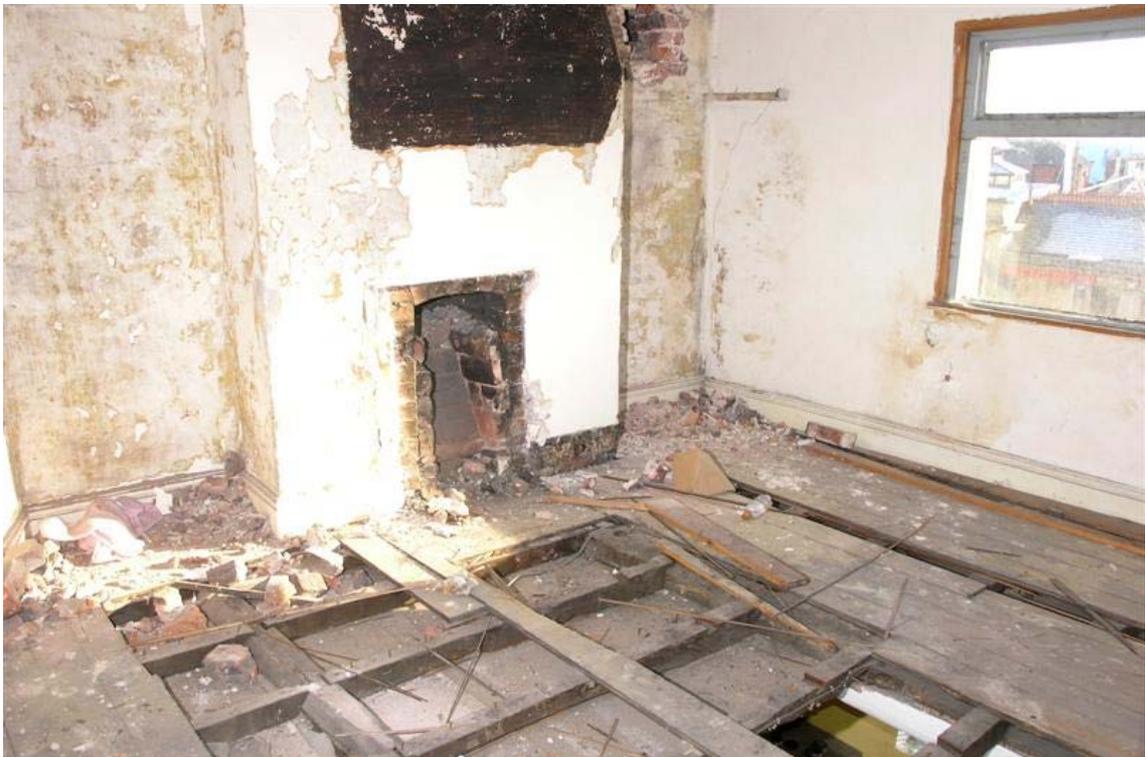
Plate 14: Room 19

- 4.5.3 **Room 19:** this room is located at the south-east corner of the second floor and functioned as a bedroom (Plate 14). It is an odd shaped room, the east wall (forming the west wall of the adjacent Sun Hotel) lies at an oblique angle. All the walls are of solid construction and there is a 2.62m high picture rail on the north, east and west walls. A small section of brickwork is visible, which appears to be hand-made and bonded with lime mortar (Plate 17).

- 4.5.5 There is a single fireplace set within a chimney-breast at the east side of the room (Plate 14). The surround and grate have been removed but the slate hearth remains *in situ*. The doorway into Room **18** contains a four panelled door of Victorian appearance (Plate 18) with a simply-moulded architrave. There is a single window located within the south wall.

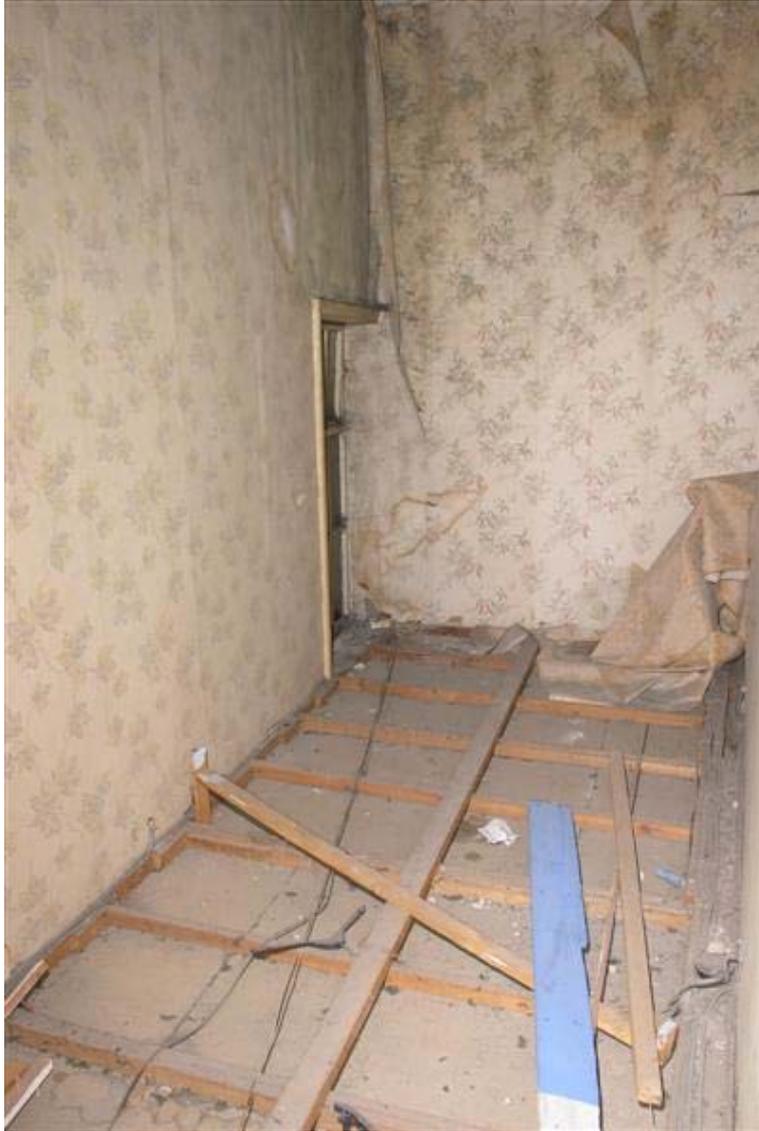
- 4.5.2 **Room 18:** this forms the landing on the second floor, from which access to all the other rooms is available. It is rectangular in plan and has a high ceiling and there is evidence that a roof light once existed. All the walls are solid except the south wall, which is constructed from lath and plaster. There are two windows within this room. The window in the south wall may have been a stair window. The other is at high level and has sash ovolo glazing bars. The architrave to this window is similar to the door architraves. For the most part this room is inaccessible, the floor has been removed to expose the ceiling below (Plate 15). The room is wallpapered and of plain appearance. It is likely that this room has been created from the stairwell and landing as the exposed ceiling appears to be a later insert.

Plate 15: Room **18** illustrating the inserted ceiling

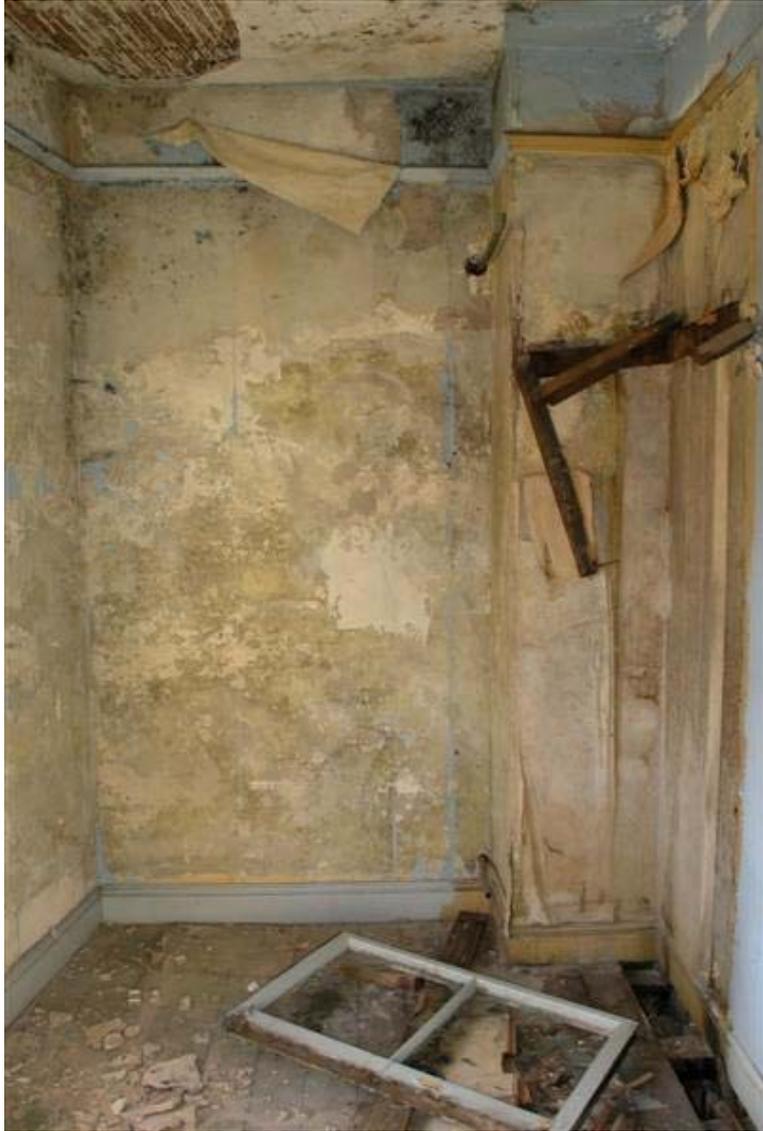
Plate 16: Room 20

- 4.5.6 **Room 20:** this rectangular room is of similar appearance to Room **19** and appears to have functioned as a bedroom (Plate 16.). It lies in the south-west corner of the building and access is from Room **18**. All the walls are solid except for the north wall, which is of lath and plaster construction. There is a picture rail at 2.58m and the ceiling is the same height as that in Room **19** and it slopes to respect the roofline. The floor is laid down to 5 ½ inch wide tongue and groove boards and there is a two-over-two sliding sash window (with horns) located in the south wall. The door and doorway onto Room **18** are identical to those in Room **19**. Evidence is present to suggest that a water tank or cistern was once fixed to the wall in the north-west corner of the room (Plate 16).

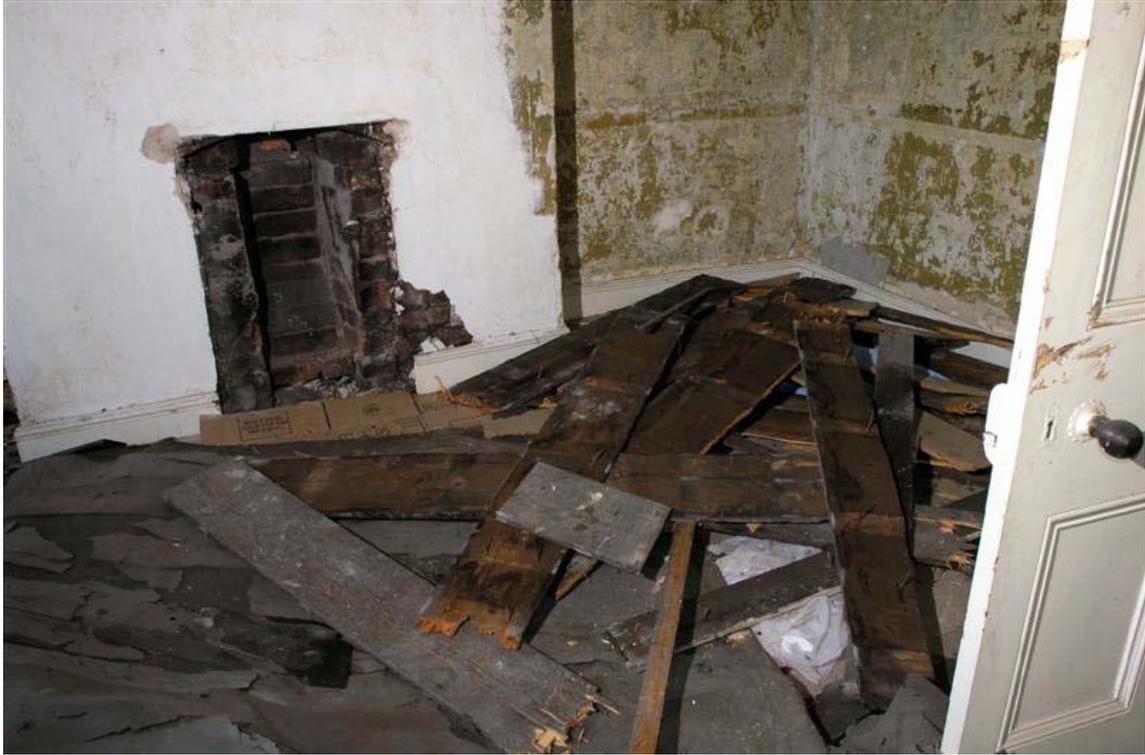
Plate 17: Room 22

- 4.5.8 **Room 22:** this is a large square room that appears to be one of the main bedrooms (Plate 17). At the time of the survey, and in common with the other examined rooms, access was limited due to missing floorboards. The room shares identical features to the other rooms already discussed. the removal of the floorboards allowed a view of the ceiling below (Room **15**, Fig 3), which is of be of reed and plaster construction (Plates 18 and 19). Most of this had been damaged during removal of the floorboards. There is a wide window located on the north wall, which contains a late twentieth century casement (damaged).

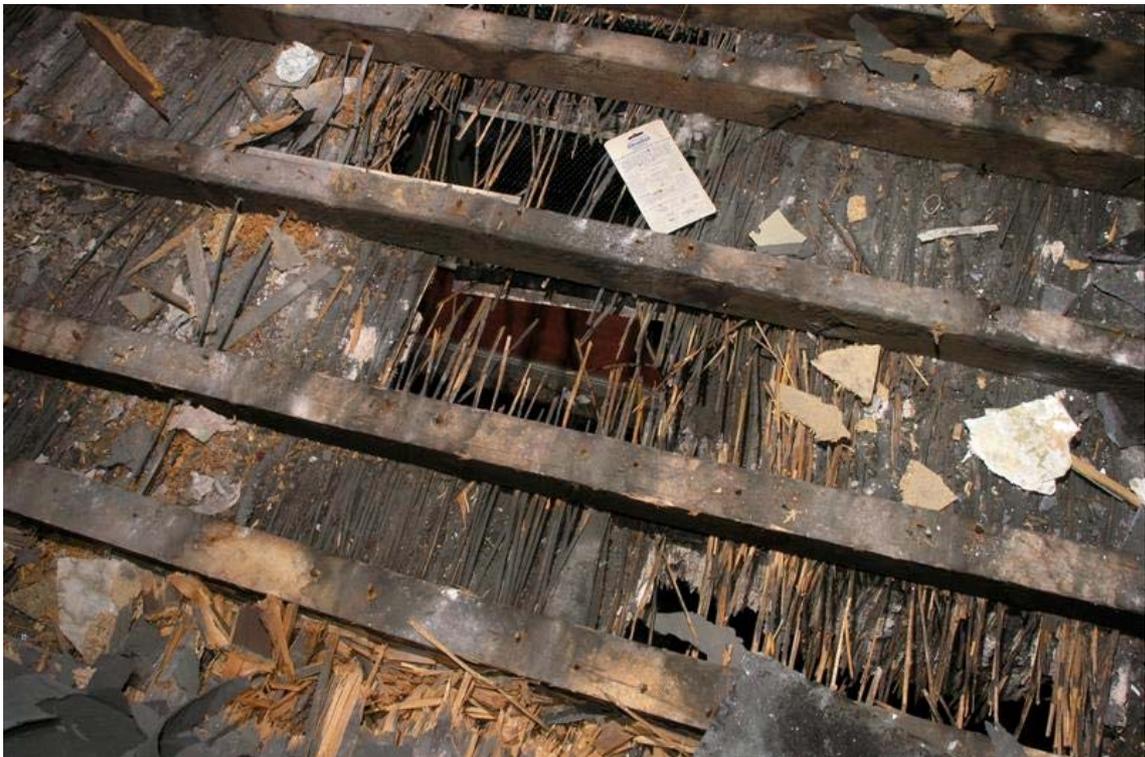
Plate 18: Reed plaster in Room 22

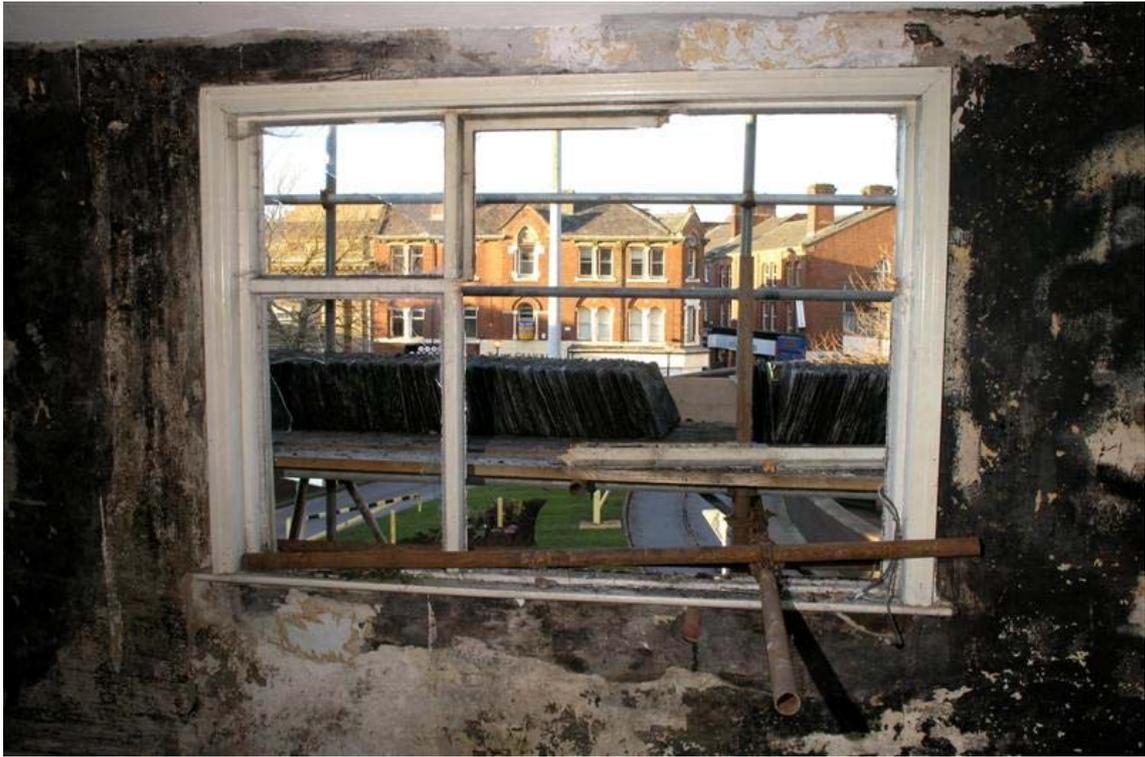
Plate 19: The window in Room 22

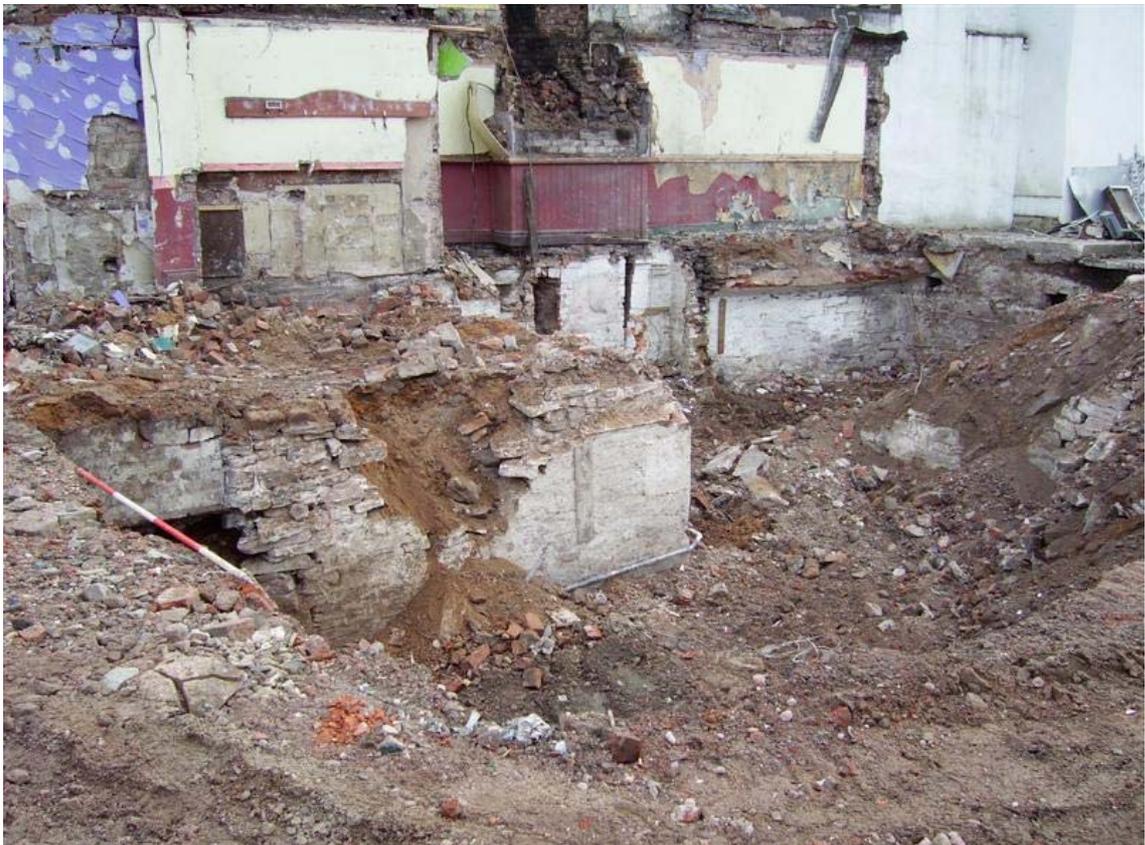
5.2.1 During the first phase of the watching brief (Plate 20), carried out on 22nd February 2007, a north/south aligned cellar-like structure was discovered, which was approximately 5m in length. This was located beneath the south-east corner of the building (Fig 2). The width of the feature was unable to be ascertained due to demolition debris. Unfortunately, plans of the basement of the Swan Hotel were not supplied by the client, and the basement was not surveyed or inspected due to the early curtailment of the building survey.

5.2.2 The cellar was excavated to a depth of approximately 2m where a concrete floor surface was discovered. It appears that the cellar room had a barrel vaulted ceiling and the spring point is visible in the east wall. All the walls are of hand-made brick construction and appear to have been whitewashed. A line of modern brick is visible which projects from the east wall.

Plate 20: General view of watching brief excavated area

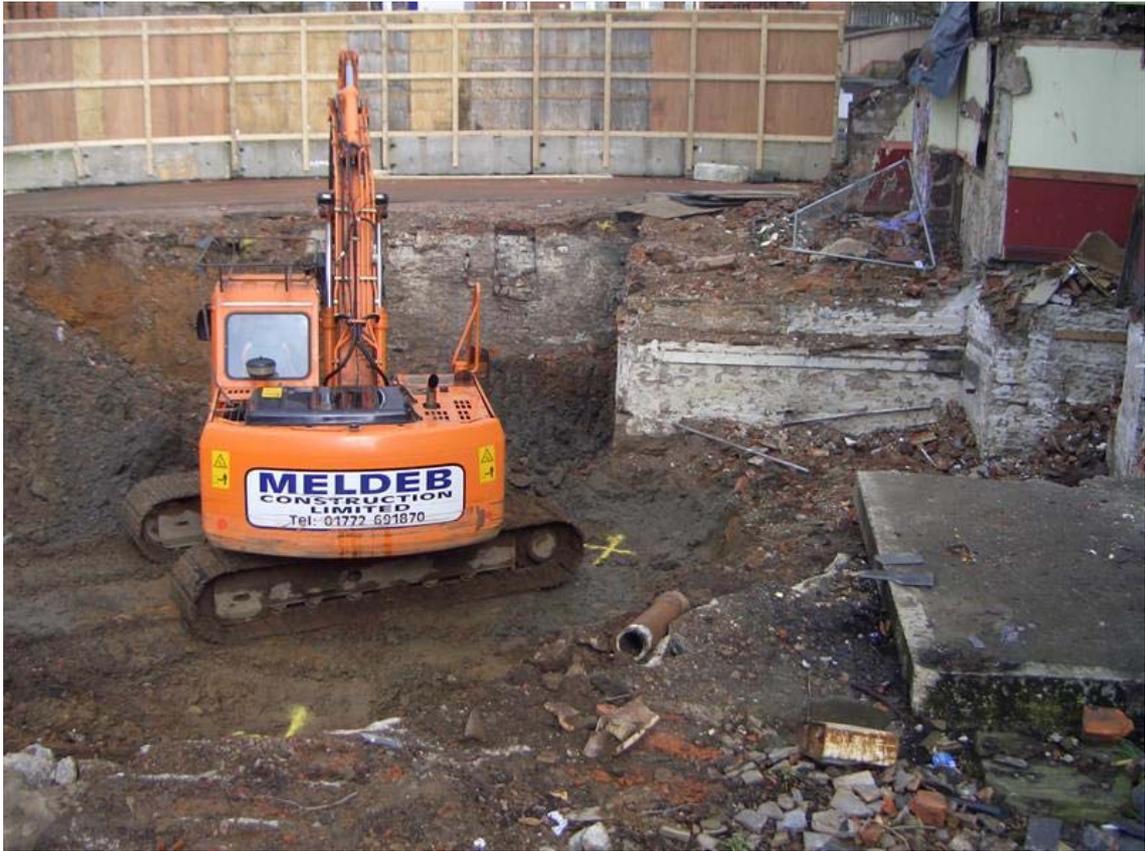
5.2.5 The final visit to the site was made on 7th March and the extent of the excavated area remained unaltered (Plate 21). The level of the excavated area was being reduced, however, and a further 0.5m of demolition rubble together with underlying orange-brown, friable, silty-sand and dark grey firm silty-clay had been removed from the western half of the excavated area.

Plate 21: View of northern part of watching brief area
