# **BURTON ENGINEERING WORKS, BRIDLINGTON, EAST YORKSHIRE**

## **Archaeological Evaluation and Watching Brief**

Issue No: 2006-07/476  
OA North Job Nos: L9558; L9595  
NGR: TA 1729 6780  
Planning Ref: DC/04/08194/ STPLF/STRAT

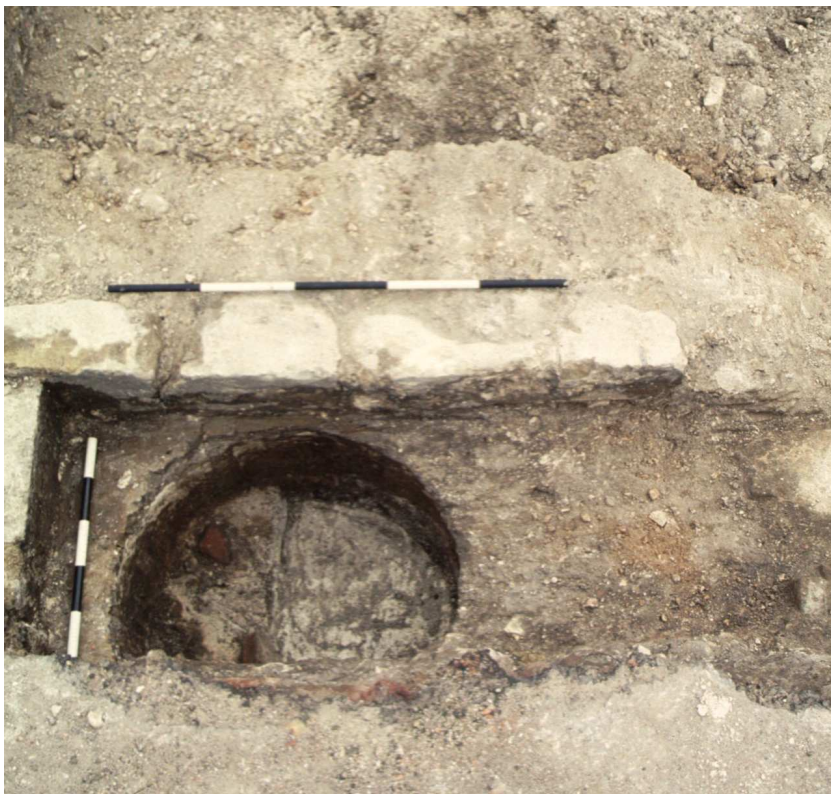
Plate 1: The barrel pit, *1028* and surrounding stone structure, *1012*, in Trench 1 viewed toward the east (1m and 0.5m scales)

beneath the base. This barrel pit resembled the example found within Trench 1, both in its contents - mortar, **2002** - and diameter of the barrel, which was 0.70m.

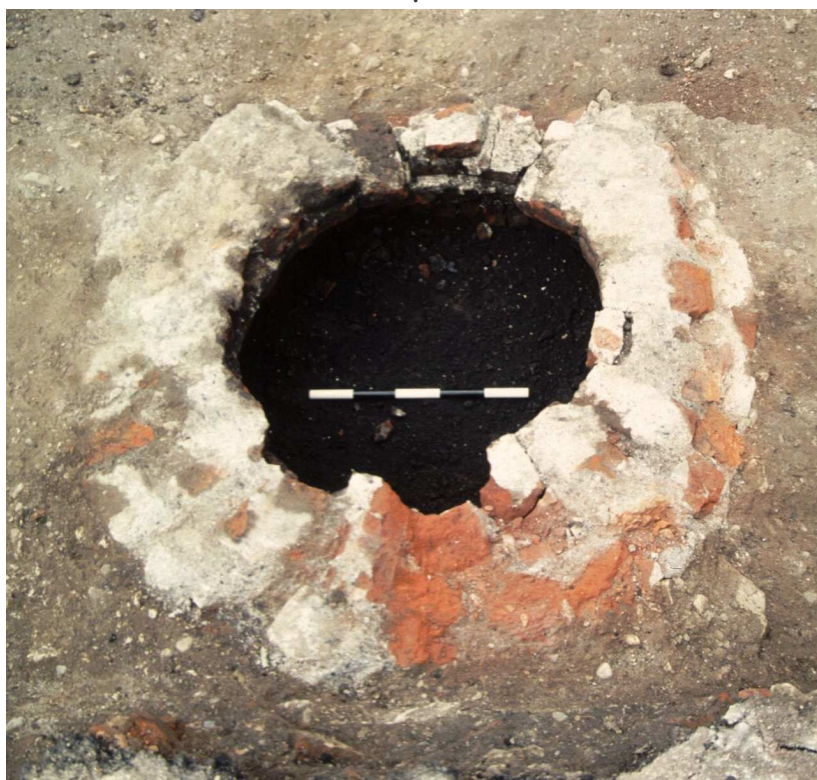
Plate 2: The brick-built well, *1018*, at the southern end of Trench 2, facing east (0.5m scale)

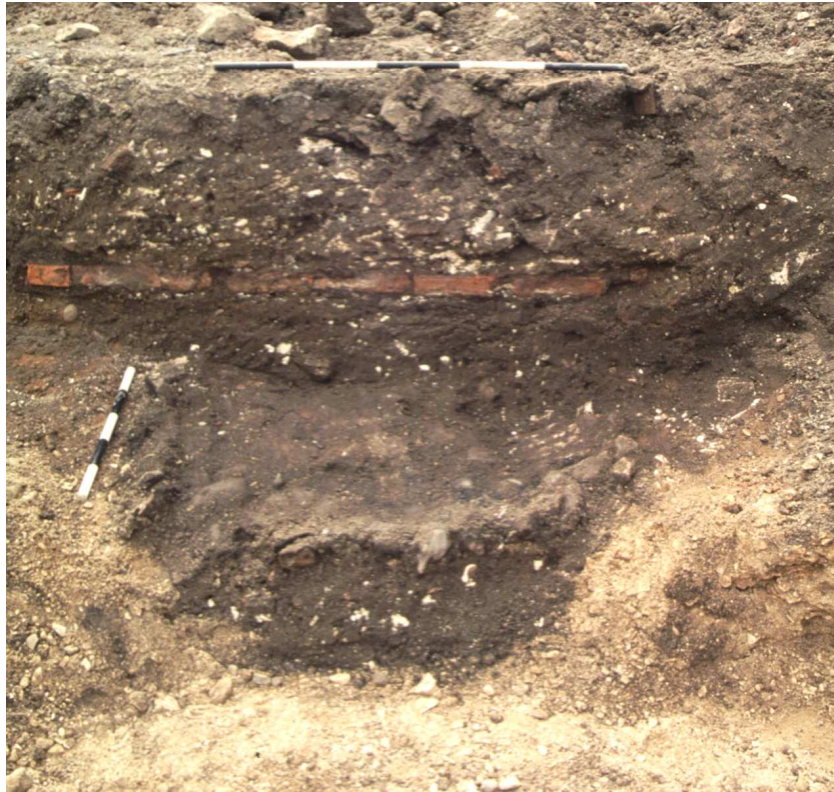
Plate 3: The medieval hearth, **2047**, in Trench 2, with later post-medieval floor, **2045** and deposit above, viewed from the north (1m and 0.5m scale)

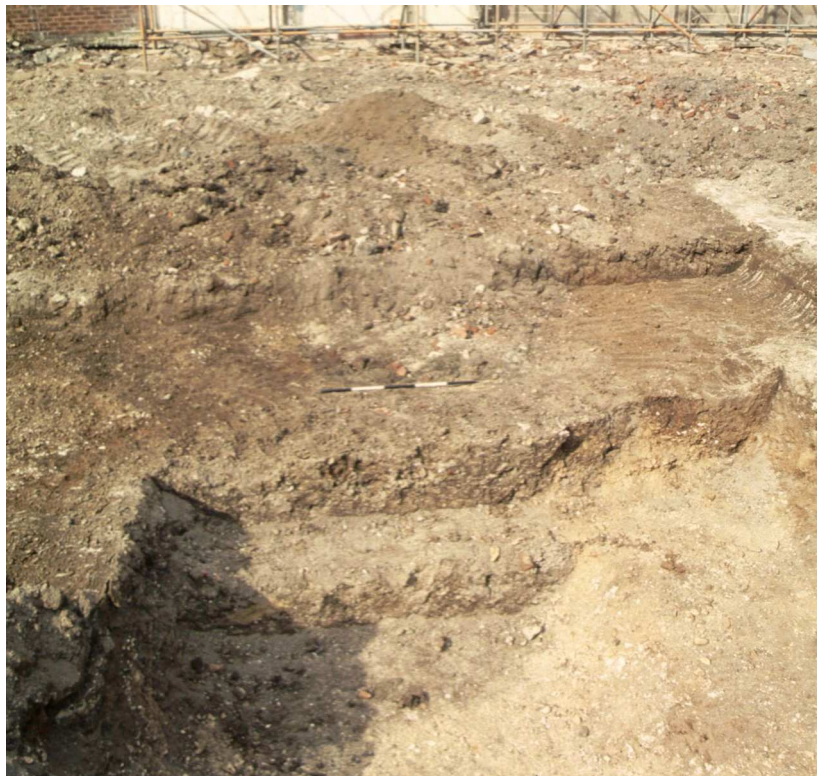
Plate 4: Pits **2039** and **2038** in their largely unexcavated state, viewed from the south (0.5m scale)

- 4.3.5 Cutting into deposit **2019** at the west end of the trench were two pits (Plate 4); the earliest, **2039**, was oval, measured 3.50m long by approximately 2m wide and was 1.45m deep (16.06m OD). The fill, **2038**, was composed of dark brown silt, with occasional inclusions of building rubble: notably mortar, chalk fragments, brick and tile. In the latter assemblage were several distinct small (160mm x 80mm x 35mm) bricks, exhibiting a worn surface (Section 7.3). A sherd of Humberware and another of Staxton/Potter Brompton ware were also recovered from context **2038**. The building rubble within the fills might suggest that a building had been demolished nearby. The bricks from this fill, despite the presence of medieval pottery, were likely to be later seventeenth century in date (J Tibbles *pers comm*). This date would be supported by the absence of clay tobacco pipe and pan tile within the fill.

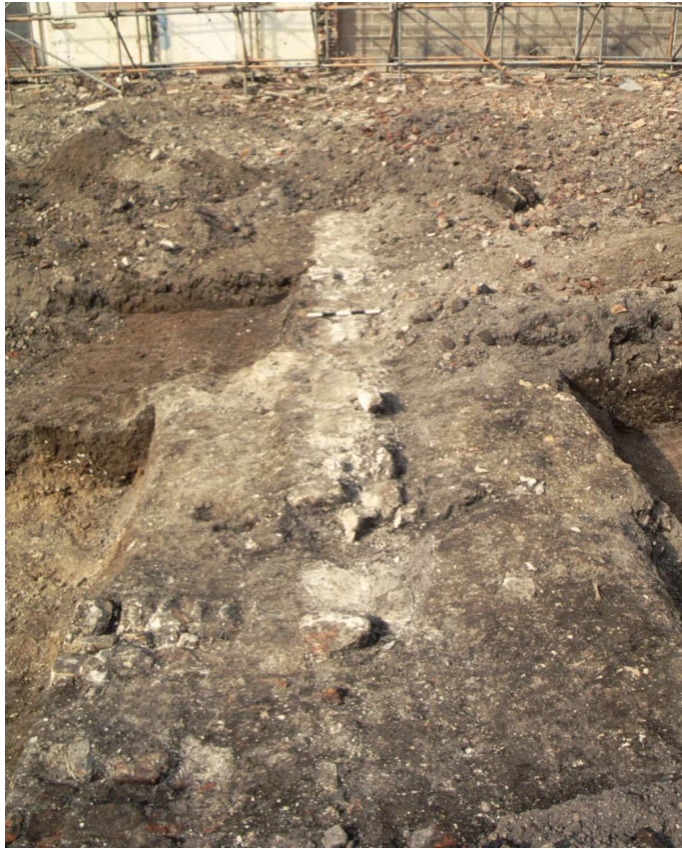
Plate 5: North/south aligned wall, **2006**, in Trench 2 (0.5m scale)

- 4.3.10 A north/south aligned wall, **2006**, and its east/west return (Plate 5), lying level at 17.73m OD, was seen in the middle of the trench and defined a building. Wall **2006** had been placed within a shallow foundation trench, **2007**, which had been cut into deposit **2019**. The wall was composed of roughly-hewn chalk blocks and measured 4.5m long north/south, 5.5m long east/west and up to 0.6m wide. Bonded half-way along the north/south aligned section of wall **2006** was the remains of an east/west aligned wall, **2051**, which would have divided the structure in half. Wall **2051**, of which only a small section remained, could however be traced for some distance across the trench as a linear strip of whitish mortar, **2020**, seen above levelling layer **2037**.

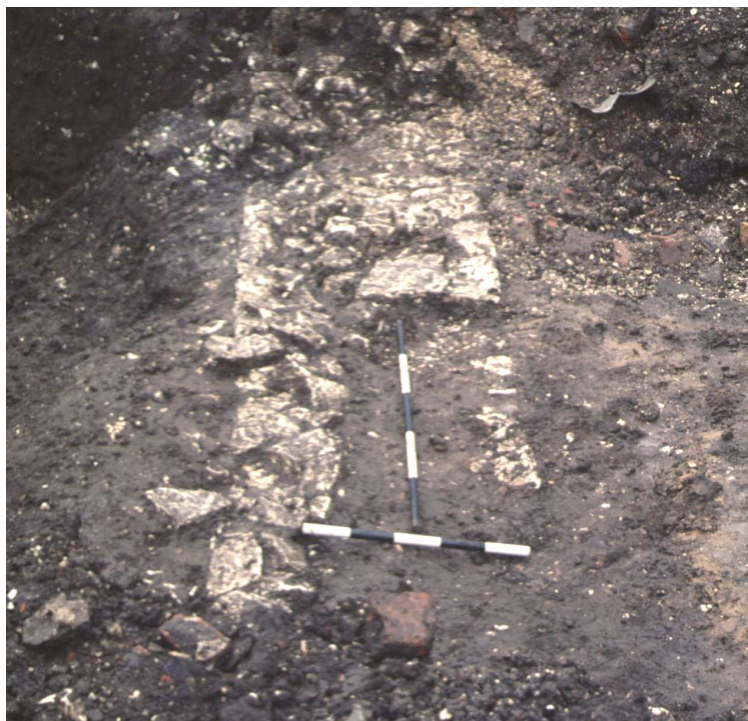
Plate 6: The thirteenth or fourteenth century walls, **3005/3028**, revealed in Trench 3, viewed from the south (1m and 0.5m scales)

- 4.4.7 On closer inspection, north/south aligned wall **3005/3028** appeared to be two walls placed side by side; both walls were constructed from roughly-hewn chalk blocks measuring between 200mm x 80mm and 250mm x 70mm. No bonding material could be discerned. The south-eastern wall, **3005**, was approximately 0.35m wide and survived to a height of 0.55m (16.46m OD), whilst its neighbour, **3028**, only survived to a height of 0.20m and was of a similar width. It should be noted that at the southern end, the two walls could not be distinguished from each other, which suggests that they had later been bonded together to form a single structure.

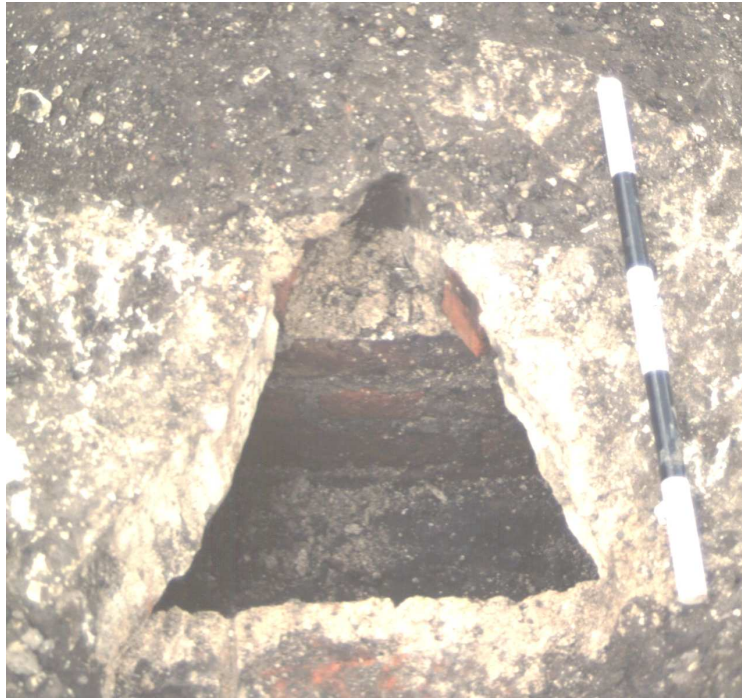
Plate 7: The north/south aligned chalk-capped and brick-constructed drain, **3003**, found in Trench 3, which could be traced for a considerable distance southwards (0.5m scale)

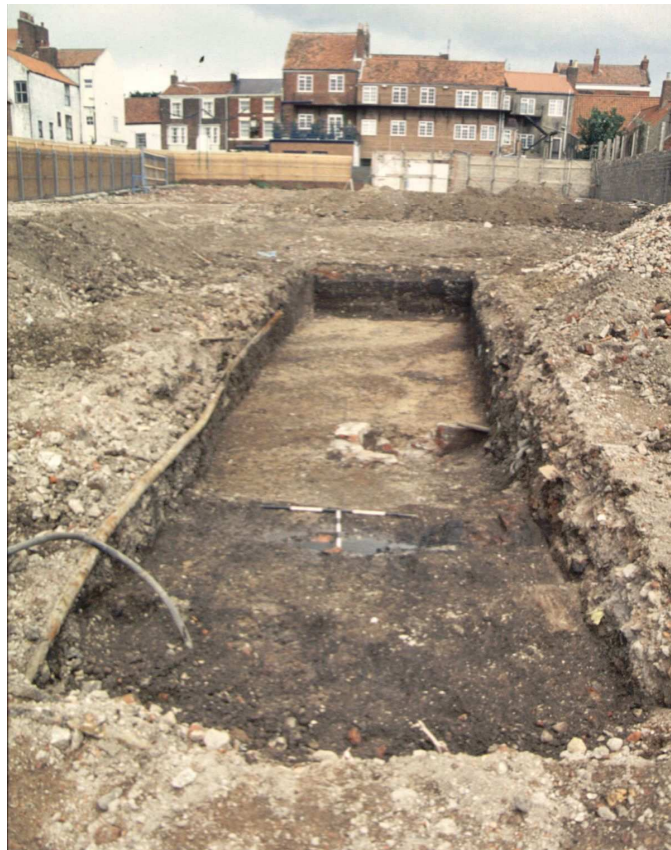
Plate 8: Trench 4 viewed from the south. Structure **4007** can be seen in the middle of the trench, while the buildings in the background mark the course of High Street

- 5.2.5 The machine excavation of Area A also revealed the eastern extents of apsidal feature **4007** located during the evaluation of Trench 4 (Plate 8). This structure, identified as feature **8** during the watching brief, was found below 1.6m of made-ground and was constructed of a double thickness of bricks surviving to a height of five courses. The extant remains survived to a length of 4.5m east/west, but had clearly been truncated to the east.

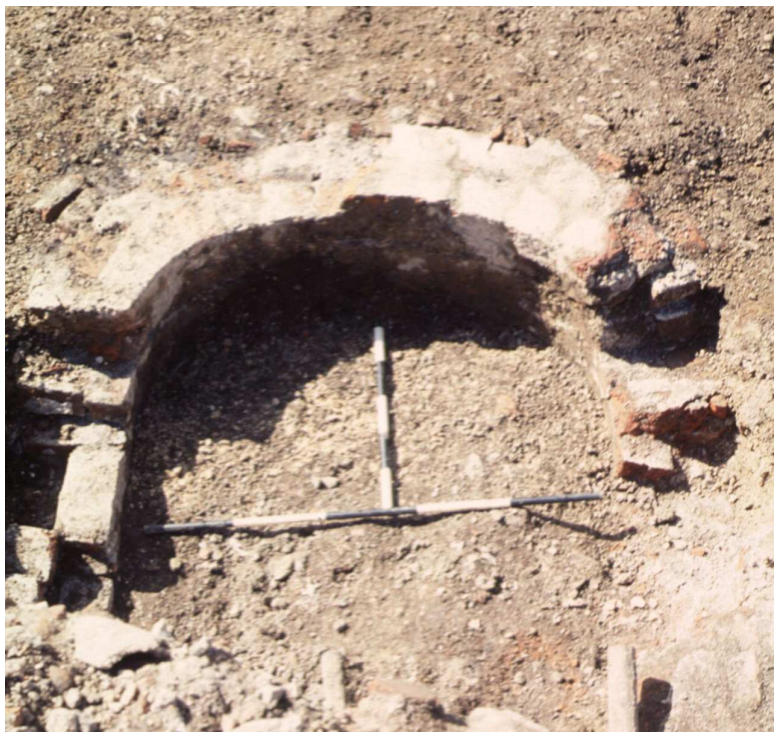
Plate 9: The apse-ended brick structure, **4007**, of unknown use, but related to the nineteenth century Victoria Brass and Iron Foundry that was located at the south end of the site (Viewed from the east; 1m and 0.5m scales)

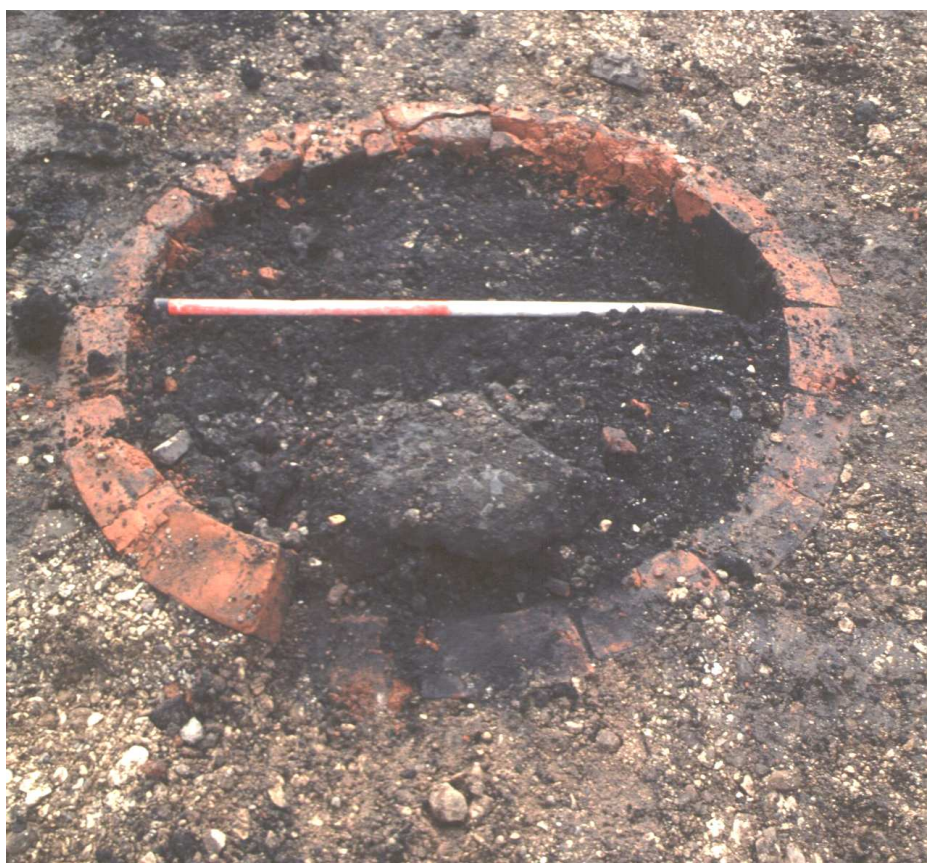
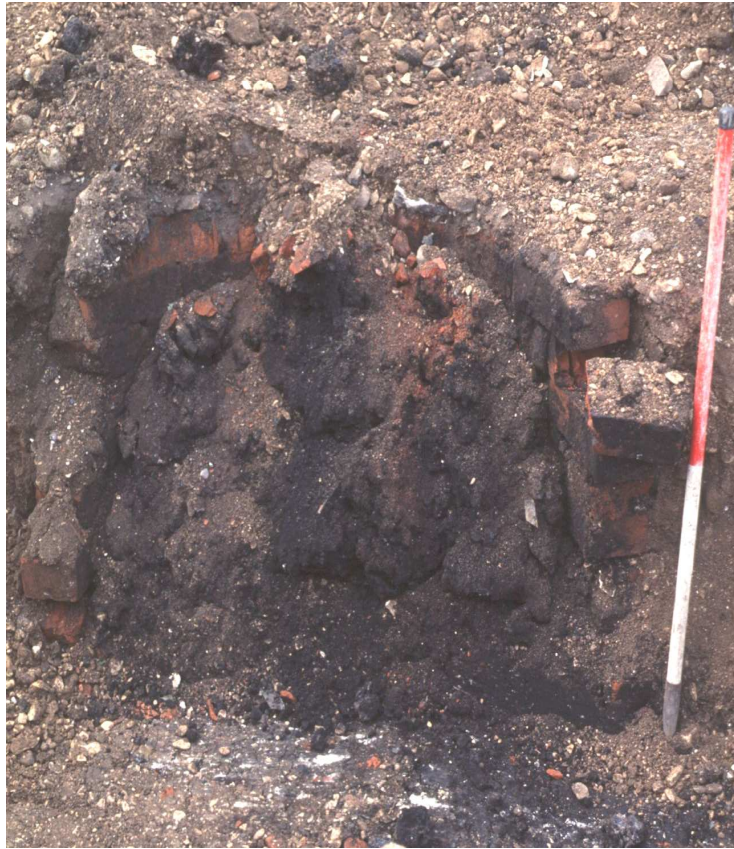
Plate 10: Possible well, **7**, filled with slag, ash and clinker

Plate 11: Possible well, 7, half-sectioned by footing trench

- 5.2.4 About 1m to the north-west of walls **5** and **6**, was a circular feature, **7**, measuring 1m in diameter and constructed from slightly curved bricks (Plates 10 and 11). The feature was filled with slag, ash and clinker, although there was no sign of fire damage or differential burning to the bricks of the structure itself. This feature was revealed to be at least 0.8m deep, with at least seven courses of bricks surviving *in situ*. Unlike several other brick-built features encountered during the evaluation, probable well **1018**, for instance, feature **7** appeared to have been constructed by placing bricks around the margins of a carefully excavated shaft into the natural, rather than built free-standing within a larger pit before being packed with secondary material. It has been suggested that feature **7** formed part of chimney base, but, since it was constructed of only a single thickness of bricks, and there was no associate flue, a more plausible interpretation is of a brick-lined pit or a well. The curvature of the bricks and the depth of this feature may lend weight to the latter interpretation.

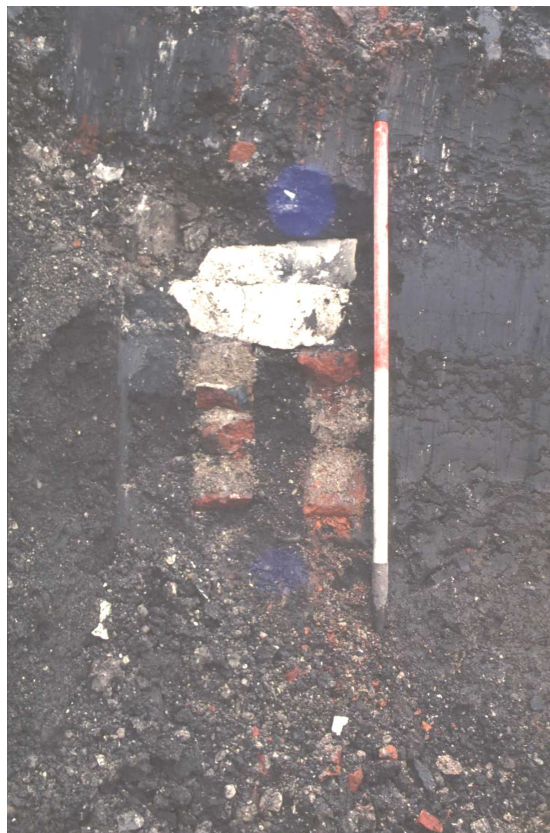
Plate 12: Brick-lined chalk-capped drain, 9

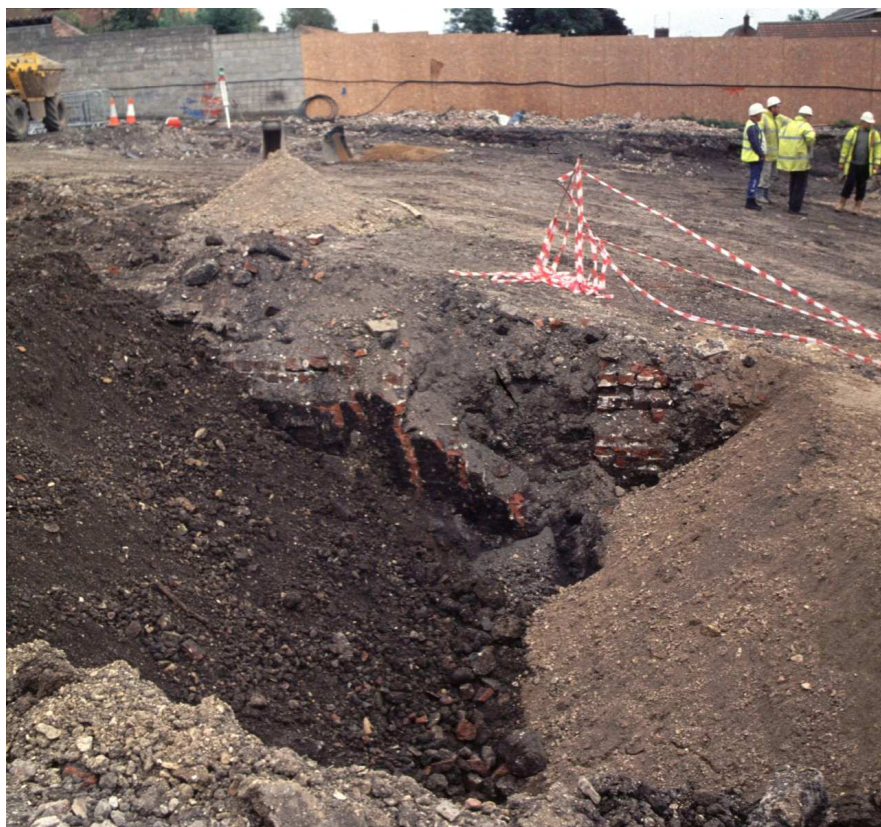
Plate 13: Brick walls, *15*, seen in contamination trench

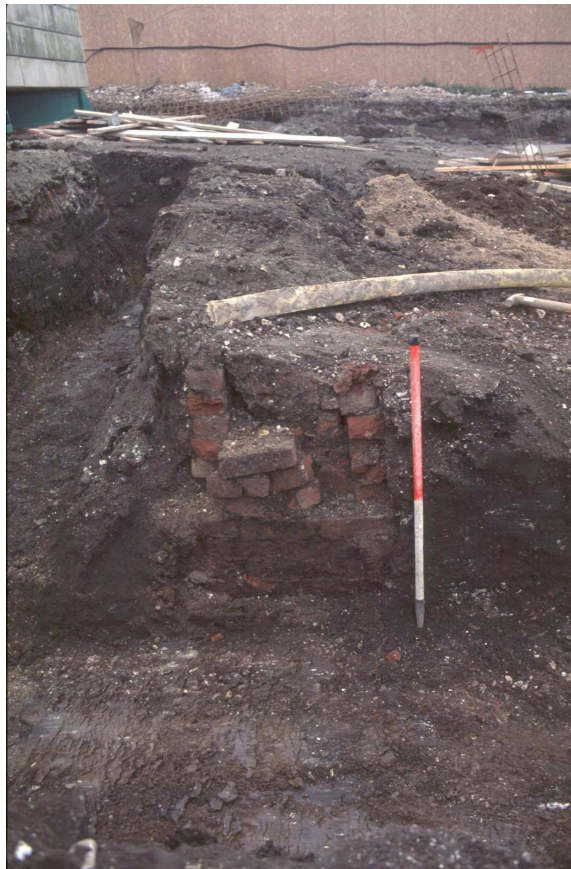
Plate 15: Brick wall, *12*, seen within footing trench

- 5.3.1 Within the southern part of Area B, immediately north of the stripping for Area A, a small brick pillar or base, **12**, was recorded (Plate 15). The feature was constructed from factory-made bricks, English Garden-bonded with lime mortar and was cut into a deposit of natural gravel, **11**. It measured 1m high by 0.5m square. Although its function was unknown, it was thought to be associated with the foundry.
- 5.3.2 A short stretch of chalk wall, **13**, was noted within the central eastern part of Area B. The wall was north/south aligned and was constructed in a similar manner to walls **3005/3028** in Trench 3. However, the orientation of wall **13**, more closely matches that of Phase 2 wall **2006** found in Trench 2 and was located very close to a wall depicted on the 1858 OS map.

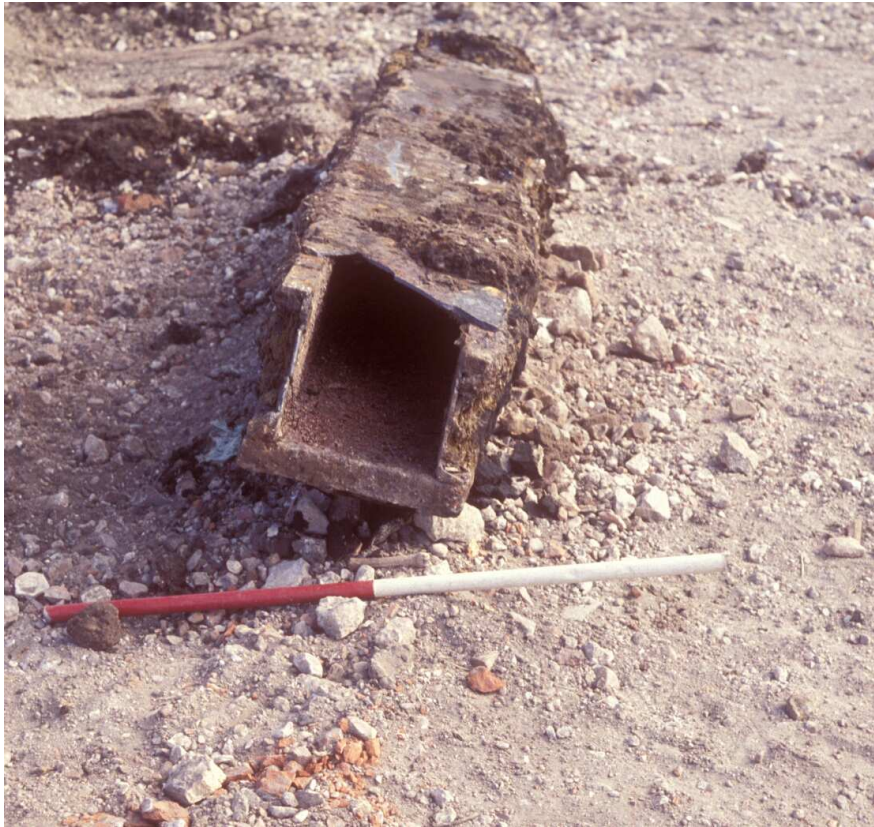
Plate 17: Rectangular iron object removed from Area A (1m scale)

- 5.2.2 Two rectangular iron objects measuring 2.60m by 0.27m by 0.23m were removed by the machine during the area reduction (Plate 17). Their function was unknown; they may have formed part of the machinery within the foundry or possibly represent an unfinished casting.
