Hemingford Abbots Village Hall: An Archaeological Evaluation

Report No. A250

Commissioned by David Pitts Chartered Architects

The Cambridgeshire County Council Archaeological Field Unit conducted an archaeological evaluation by trial trenching in June 2003 at the village hall, Hemingford Abbots (TL28287130). The work was carried out in advance of the total rebuilding of the village hall.

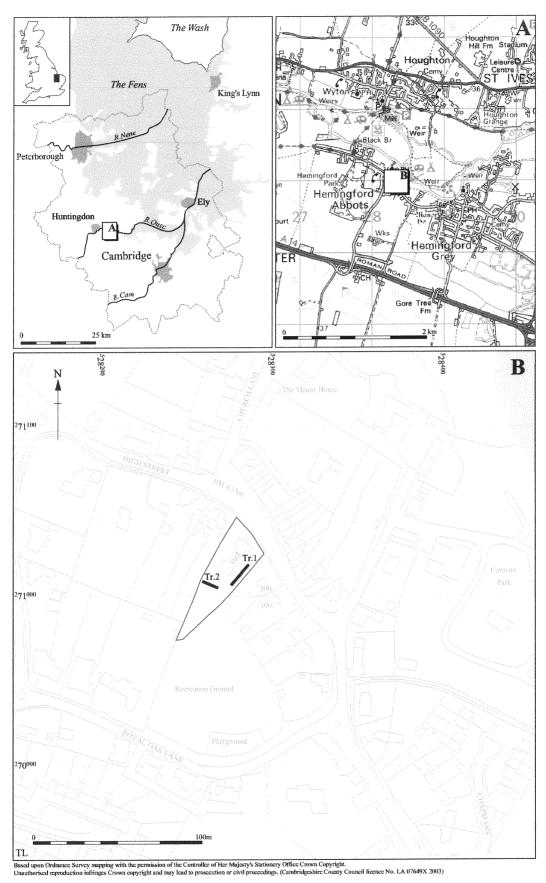
Figure 1 Location of Trenches with Development Area outlined.
