# **FORMER STABLES AT NATLAND HALL FARM, NATLAND, CUMBRIA**

## **Archaeological Building Investigation**

**Oxford Archaeology North**

November 2005

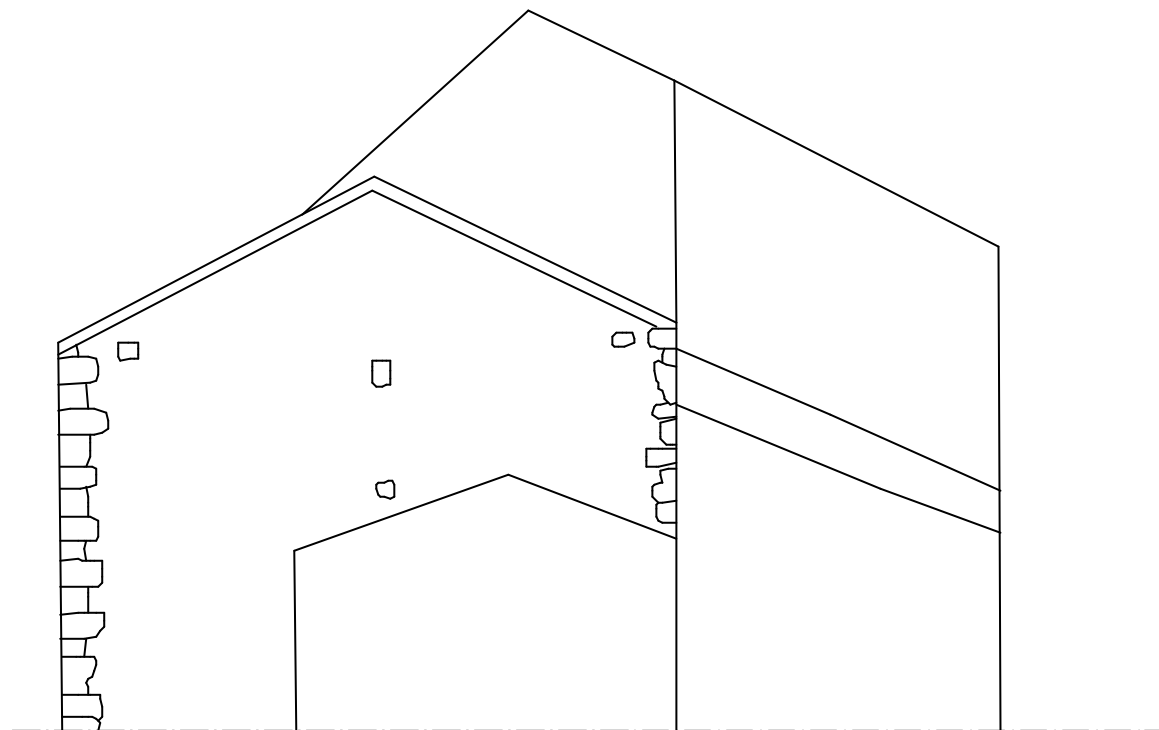
Figure 6c: North-facing elevation

- 4.2.2 **North elevation** (Plate 4; Fig 6c): this is the gable of the stables, the lower part of which is obscured by the attached outshut. There are three square ventilation holes arranged up the centre of the stable gable, and two either side on the first floor. The north, gable, elevation of the outshut follows the angle of the road. It is essentially the same build as the stables, but with much rougher courses and smaller, less finely-dressed quoins.

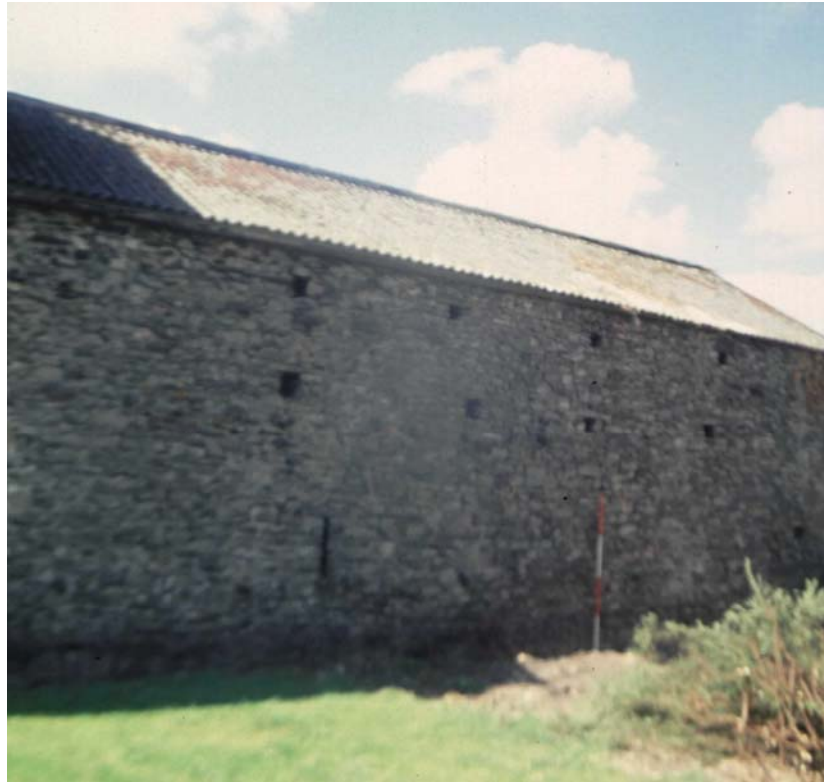
- 4.2.1 **East Elevation** (Plate 3; Fig 6a): there are three intermittent courses of throughstones within the fabric of the wall. On the ground floor, at the southern end of the elevation, there is an inserted pedestrian doorway with a dressed sandstone lintel and plank door. There is a single narrow winnowing slot to the north of this. On the first floor there are two rows of square ventilation holes.

Plate 3: The east external elevation, looking north-west

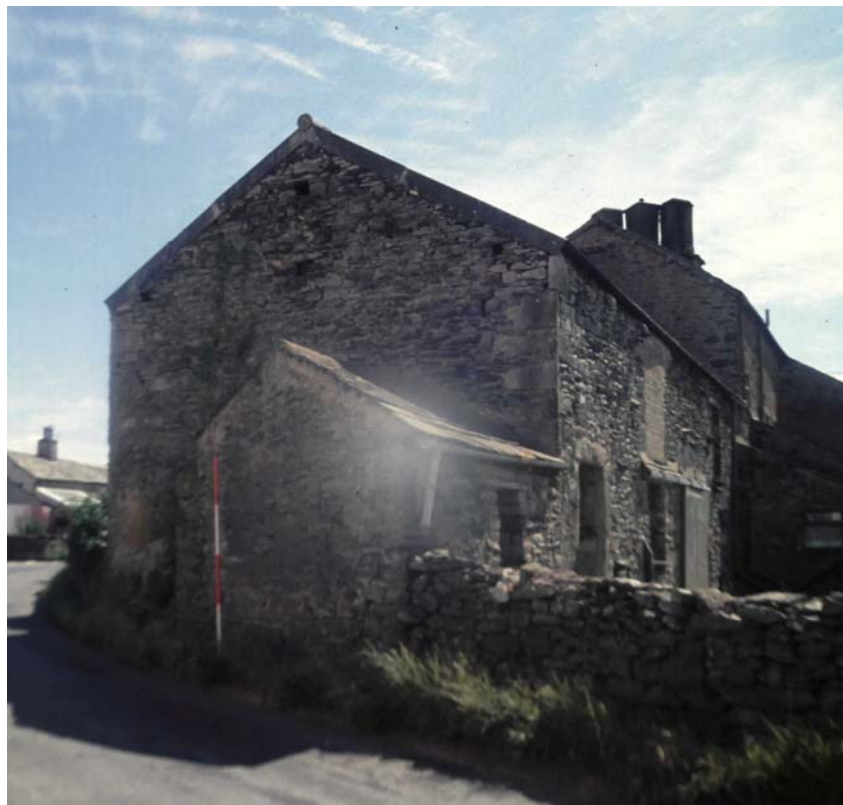
Plate 4: The north external elevation, looking south-east

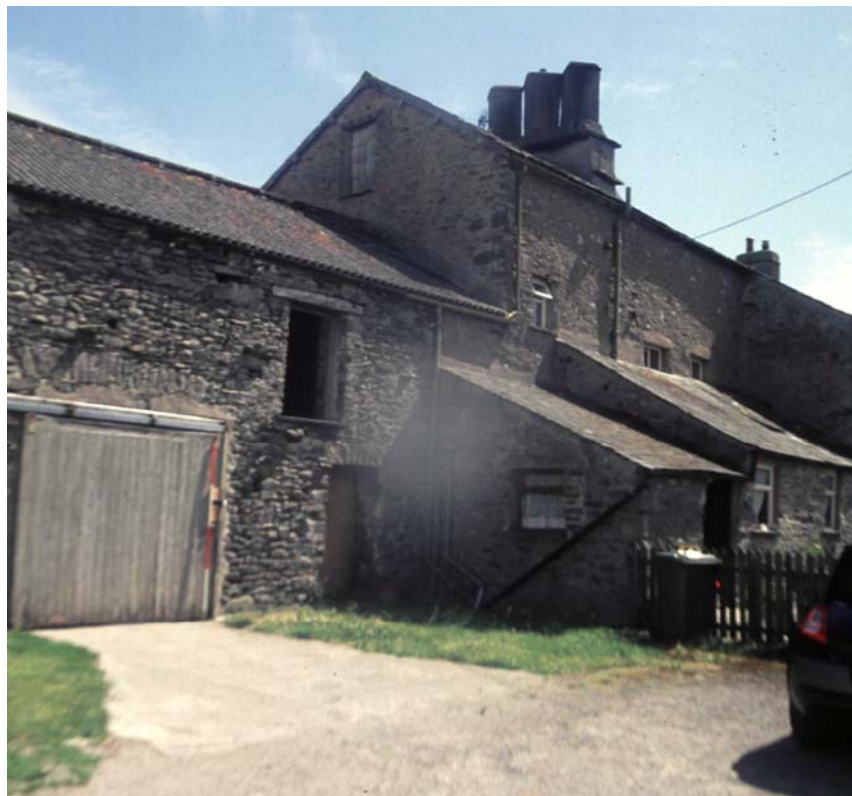
- 4.3.1 **Room 1:** this comprises the small porch attached between the hall and stables. It has a concrete floor and flat, plaster ceiling, and there are taps and other fittings attached to the north elevation. There are pedestrian doorways into the north end of the hall, up a single step, and to the east into Room 2.

Plate 6: The south end of the west external elevation showing the porch, looking south-east

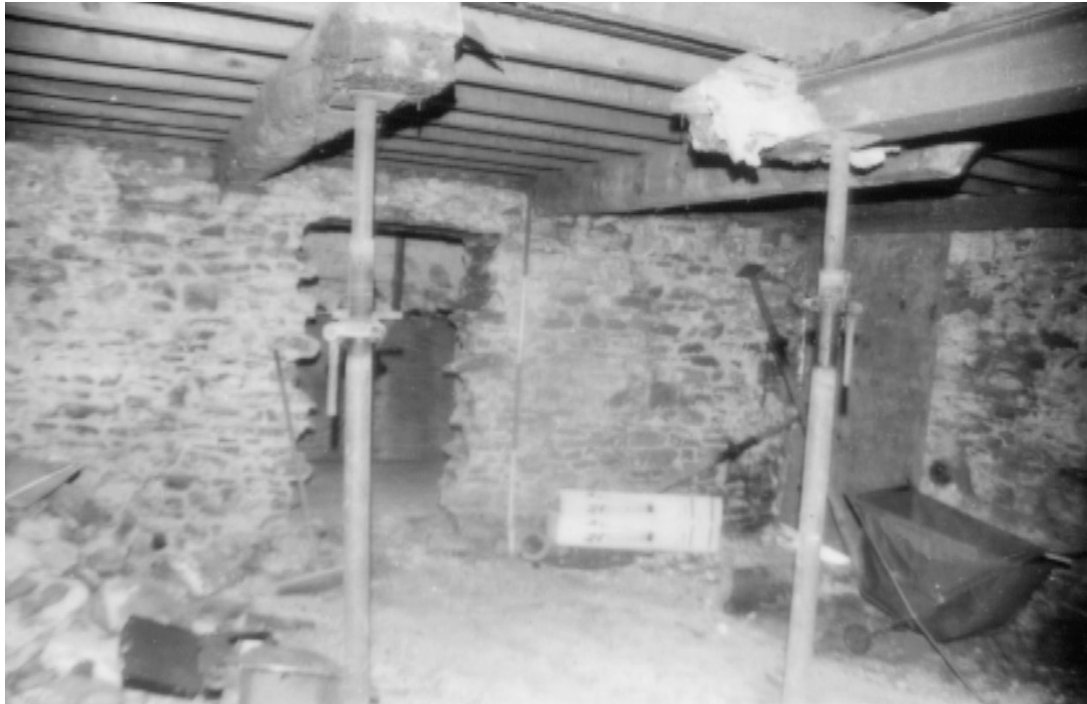
- 4.3.3 **Room 3:** this originally formed a small room between Rooms 4 and 2, but the recent removal of the north wall (visible as a scar) has effectively made it part of Room 4 (Plate 7). It has a rough cobble floor, and in the south-west corner a short section of low concrete block wall has been added, forming a passage or lobby. The ceiling is the same as in Room 2, with the same machine-cut beams and large, chamfered, hand-finished beams continuing through the south wall (Plates 7 and 9; Fig 5). These evidently respected the position of the former north wall, and the stop of the chamfer also clearly ends with respect to this wall. The winnowing slot in the east wall is splayed internally.

Plate 7: General view of Room 3, looking south-west

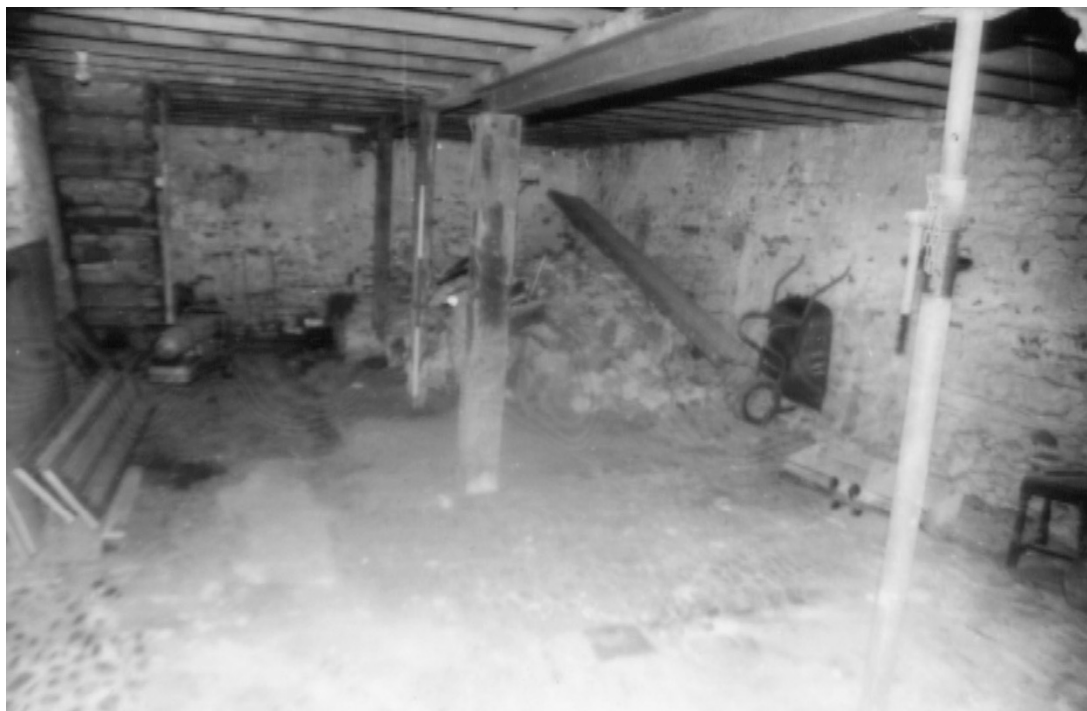
- 4.3.4 **Room 4:** this is the main part of the stables on the ground floor. It has good cobble floor with a stone drainage channel along the west side. The scars for four stalls that were originally attached to the east wall are evident on the ground and two original stall posts survive. These comprise finely dressed pieces of timber with a simple chamfer decoration to each corner, and they sit on square stone pads (0.21m<sup>2</sup>), which are trapezoidal in section, with a central hole 0.09m<sup>2</sup> (Plate 8). A later, inserted post, at the south end with a much rougher finish (Plate 8) supplements these posts. The posts support a north/south orientated beam, which is machine-cut. The south end of this has been burnt and replaced by an iron I-beam. Some of the joists orientated east/west are also charred and it is evident that the floorboards forming the ceiling are different between Rooms 3 and 4.

Plate 8: General view of Room 4, looking north-east

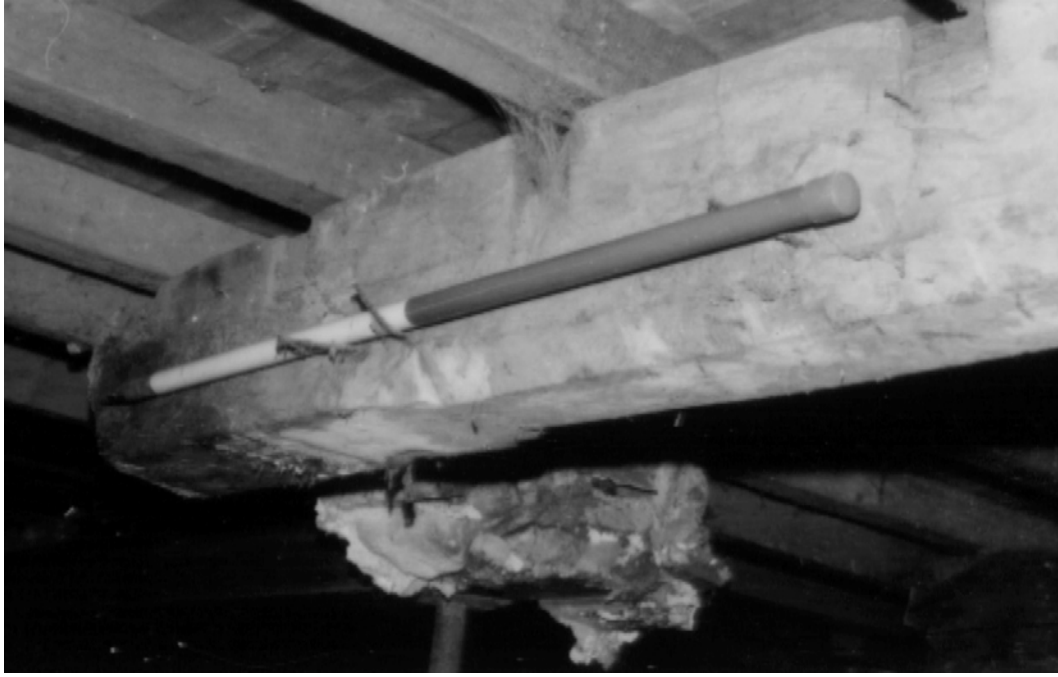
- **Phase I** – early fabric in the form of the two chamfered beams extending north/south through Rooms 2 and 3 suggests that an earlier building stood in this location, probably contemporary with or slightly later in date than the hall itself. The style of chamfer evident in the beams would suggest a late seventeenth century date (Alcock and Hall 2002, 36; Brunskill 2000, 147). It is not certain whether these remains and the re-used timbers evident throughout the building belong to a building on the exact same spot or have been brought from elsewhere, as often occurred (Tyson 2000b). These two beams do, however, appear to have been deliberately positioned to leave the chamfer visible and were associated with the wall dividing Rooms 3 and 4 (since demolished). This would suggest that the beams and this wall formed part of a smaller structure attached to the north end of the hall, which was encased by the subsequent rebuilding. The attention to detail in the finish of the beams suggests that this was a domestic building, rather than an agricultural one. It is conceivable that these remains are all that is left of the chapel described by Machell as having been rebuilt in c1687 (see *Section 3.2.6*), possibly on the site of a chapel established some time after 1246. Clearly, this phase has to be contemporary with or slightly later than the hall itself, but as this is not accurately dated (see *Section 3.2.3* and *Appendix 3*) this provides only a broad relative date of the seventeenth century.

Plate 9: Detail of the beam chamfer in Room 3

- 6.1.2 The remains of the chapel and of Natland Hall are of great historical and archaeological importance to Natland and the surrounding area. Despite the extensive documentary evidence, however, it is still difficult to prove that the beams with the barn formed part of the chapel. It is therefore recommended that they be subject to dendrochronological dating in order to establish whether they fit within the phasing outlined above, especially if they are to be removed during the development. If they did form part of the chapel, and were included in its rebuilding in *c*1687 then they should date from this period, or earlier, if they were re-used.
