BARN CONVERSION AT SALTER HALL FARM, KIRKLAND CUMBRIA

Archaeological Building Investigation

Oxford Archaeology North

October 2005

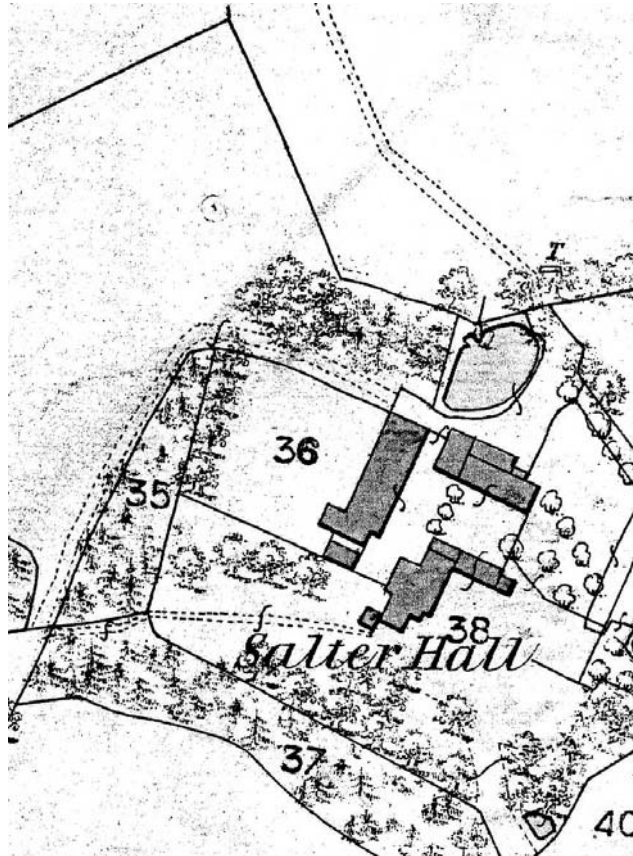
Plate 1: Part of the undated Ordnance Survey map 25": 1 Mile showing Salter Hall

- 3.4.4 **Ordnance Survey 1867 and n.d.:** by this date the hall and barn have reached their full extent. The undated 25": 1 Mile map (Plate 1) is probably of a similar date to the 6": 1 Mile, and clearly shows the hall, barn, and attached outshuts. The hall extends some distance to the south where it meets a small outbuilding, probably the one still standing in the adjacent field, and it also clearly extends to the west. To the north of the building on the north side of the courtyard a pond is clearly visible.

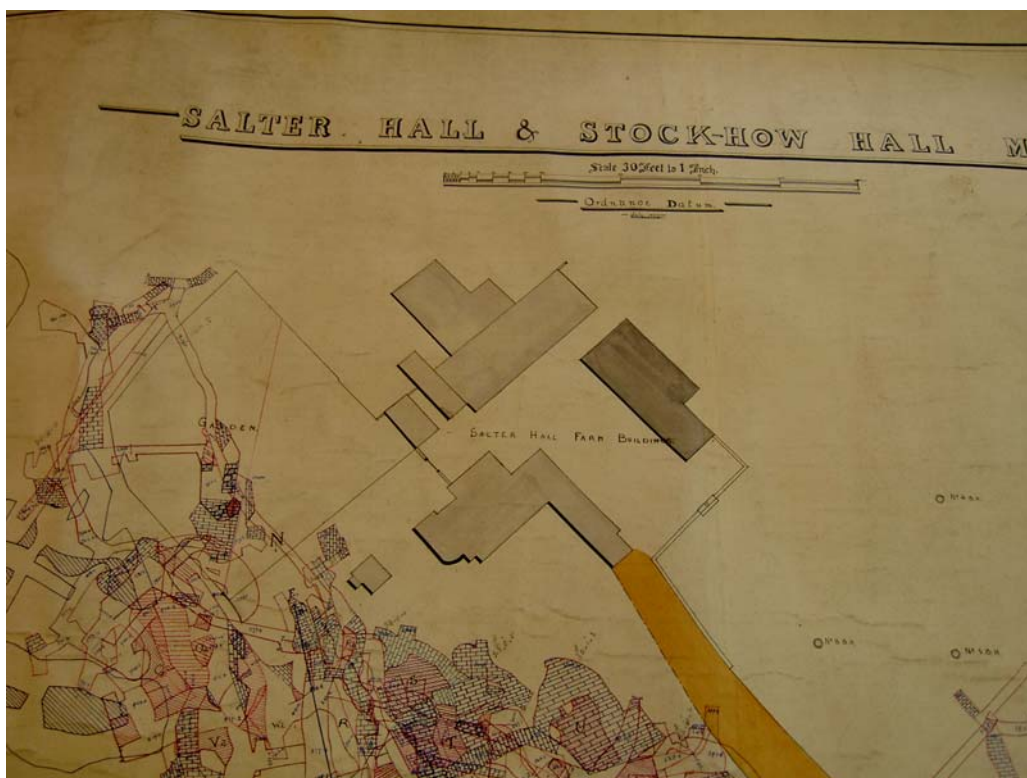
Plate 2: Part of a mining plan of 1907 (DBH/16/26) showing Salter Hall

- 3.4.6 **DBH 16/26 1907; DBH 16/27 1907:** this arrangement is also clearly shown on mining plans of the early twentieth century (Plate 2), although this give limited detail regarding the surrounding area.

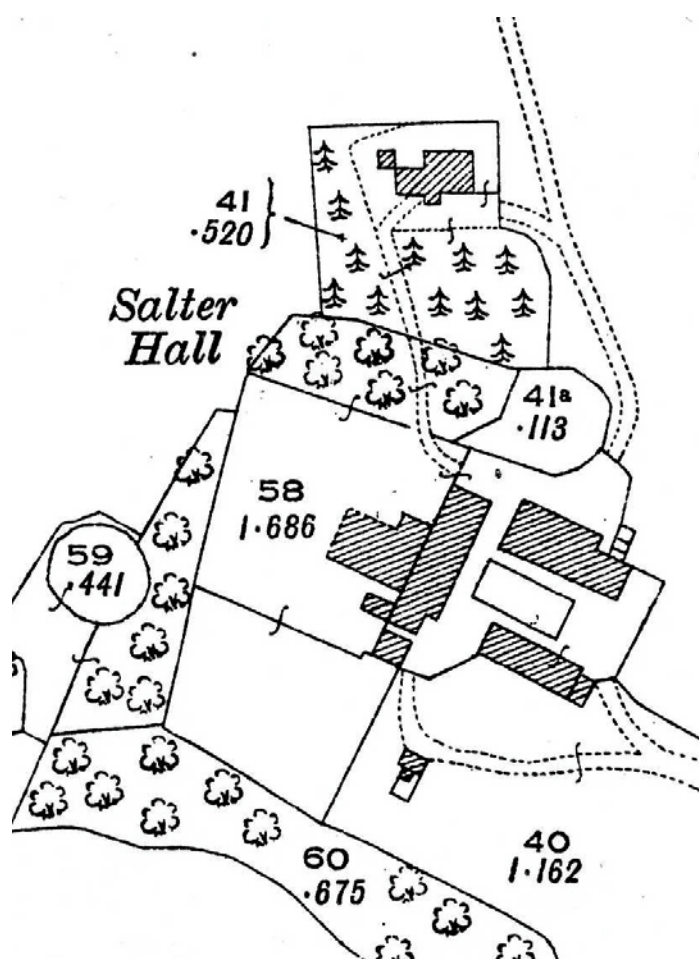
Plate 4: Part of the Ordnance Survey map of 1925 showing Salter Hall farm, following the demolition of the hall

- 3.4.7 **Ordnance Survey 1925:** the site has been extensively altered by this date (Plate 4). The entire hall has been removed leaving only the adjoining barn to the north-east and outbuilding to the south. A rectangular enclosure has been constructed in the courtyard, and a new farmhouse has been built some distance to the north-west.

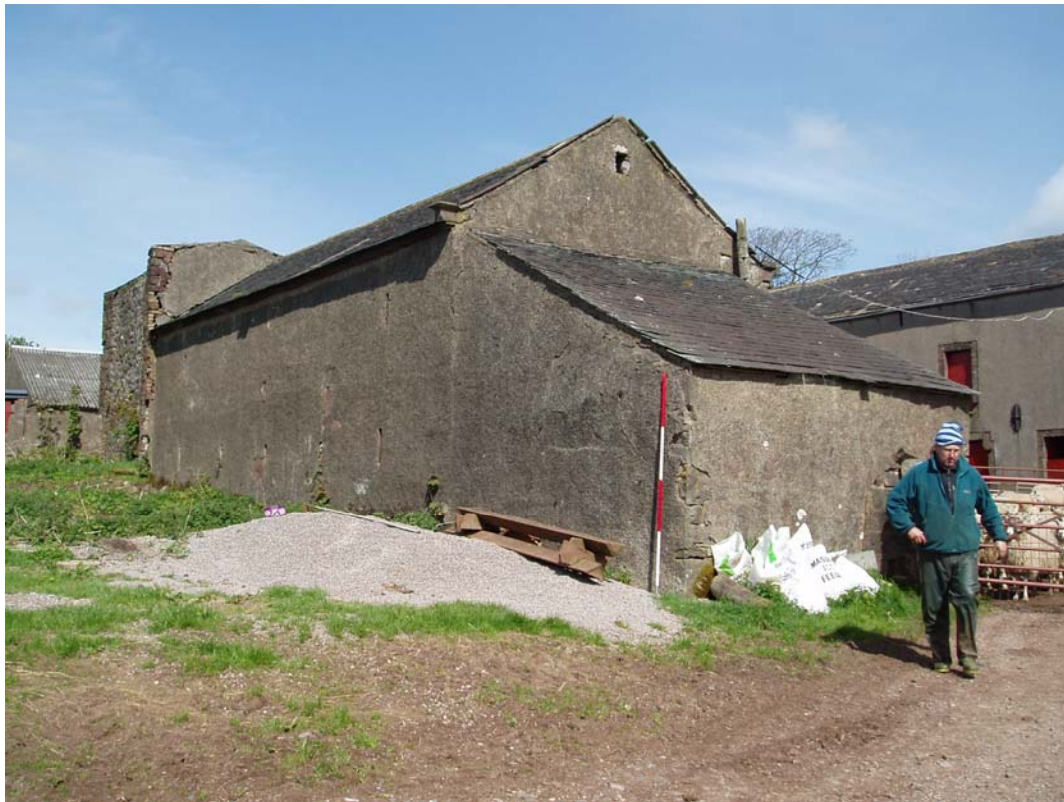
Plate 5: The south and east elevations of the barn

- 4.4.5 **East elevation:** the lower part of this is formed by the east outshut, which is finished with render (Plate 5). Attached to this is a short length of concrete block wall forming one side of a gate to the yard to the north. Where the

stonework of the outshut is exposed it can be seen to comprise roughly dressed limestone blocks, with a large boulder situated beneath the north-east corner. Above the outshut is the east gable of the barn, which has moulded sandstone coping and moulded kneelers. In the centre of the apex is a square owl hole.

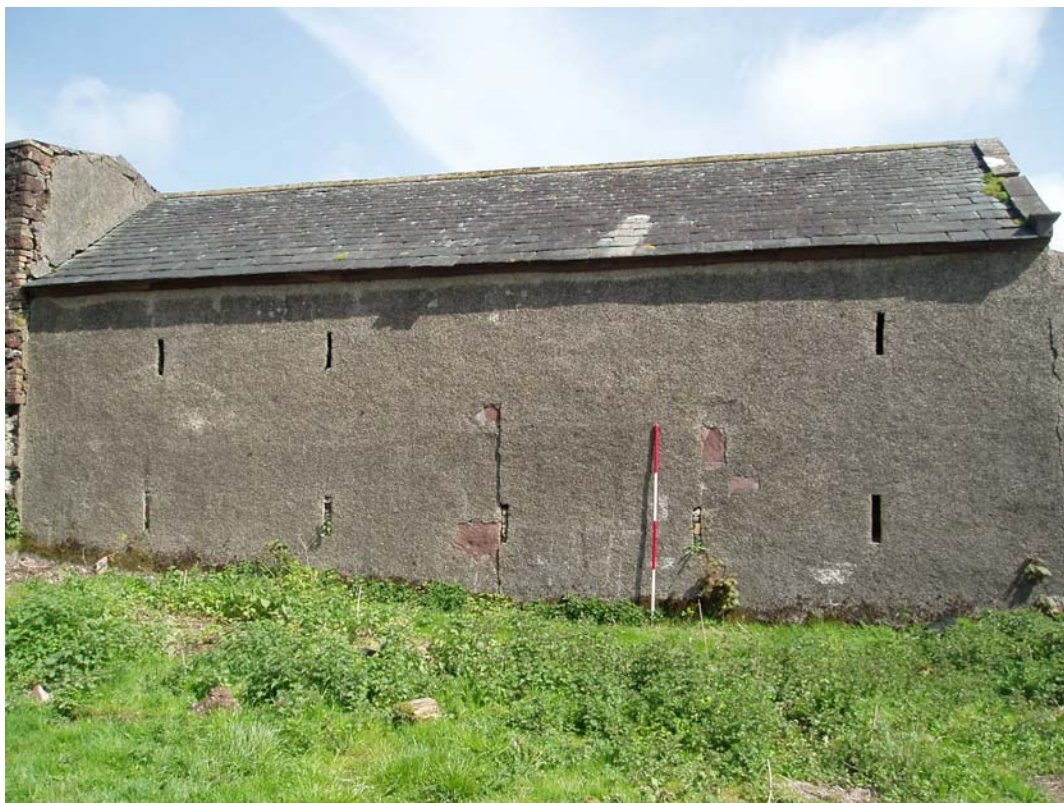
Plate 6: The south elevation of the barn

- 4.4.4 The main barn is finished with a rough render, but has three winnowing slots filled with bricks on two levels visible across it. Immediately east of centre a blocked wagon doorway is visible as a pair of cracks in the render, and sandstone quoins are also visible. Curiously, two further ventilation slots have been created within the blocking of the wagon doorway, which have been subsequently filled with brick. The eaves of the roof are finished with dressed sandstone and there are scrolled sandstone kneelers with a square moulding at the corners of the east gable. The gable is also finished with dressed stone coping and the roof has sandstone V-shaped ridge tiles. The east end of the south elevation is made up by the mono-pitch outshut, which is also rendered although cracks in the render make it evident that this butts the barn. It has roughly dressed limestone quoins.

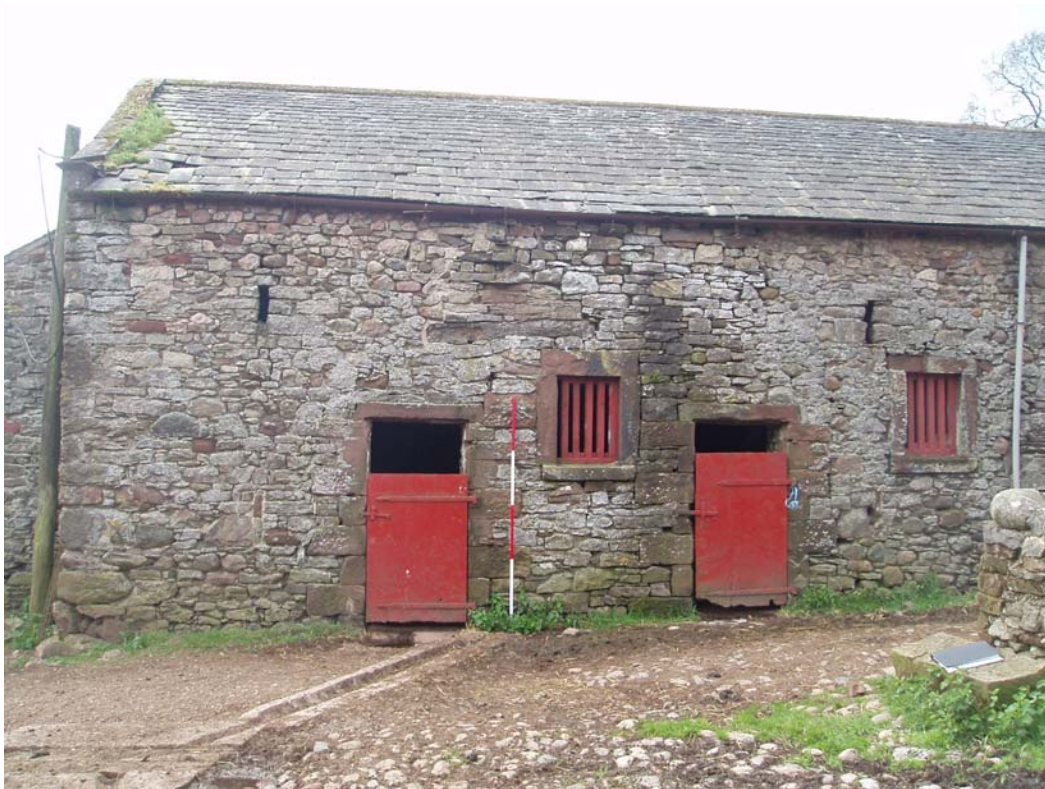
Plate 9: Inserted doorways and windows in the north elevation of the barn

- 4.4.1 **North (front) elevation:** this includes the front of the main barn and the two outshuts (Plate 9). The east end is made up of the east monopitch outshut (Plate 5), which has a central wagon doorway that has evidently been rebuilt or possibly enlarged as the jambs and area above the lintel are built of brick. There are also some bricks amongst the stonework, and three ceramic pipes forming ventilation slots. To the west of this is the barn. This has been extensively altered, with three pedestrian doorways and two windows, all with dressed sandstone surrounds having been inserted. A number of original winnowing slots are visible, on two levels, across the elevation of the barn. All of the low-level slots have been blocked with stone. Immediately east of centre

the remains of a large, hand-finished timber lintel are present. This evidently marks the position of a blocked wagon doorway, and part of the east jamb is visible. At the west end the barn is butted by the western outshut. There are two or three additional winnowing or ventilation slots within this and a central doorway with a window or pitching-hole above and a rough limestone lintel.

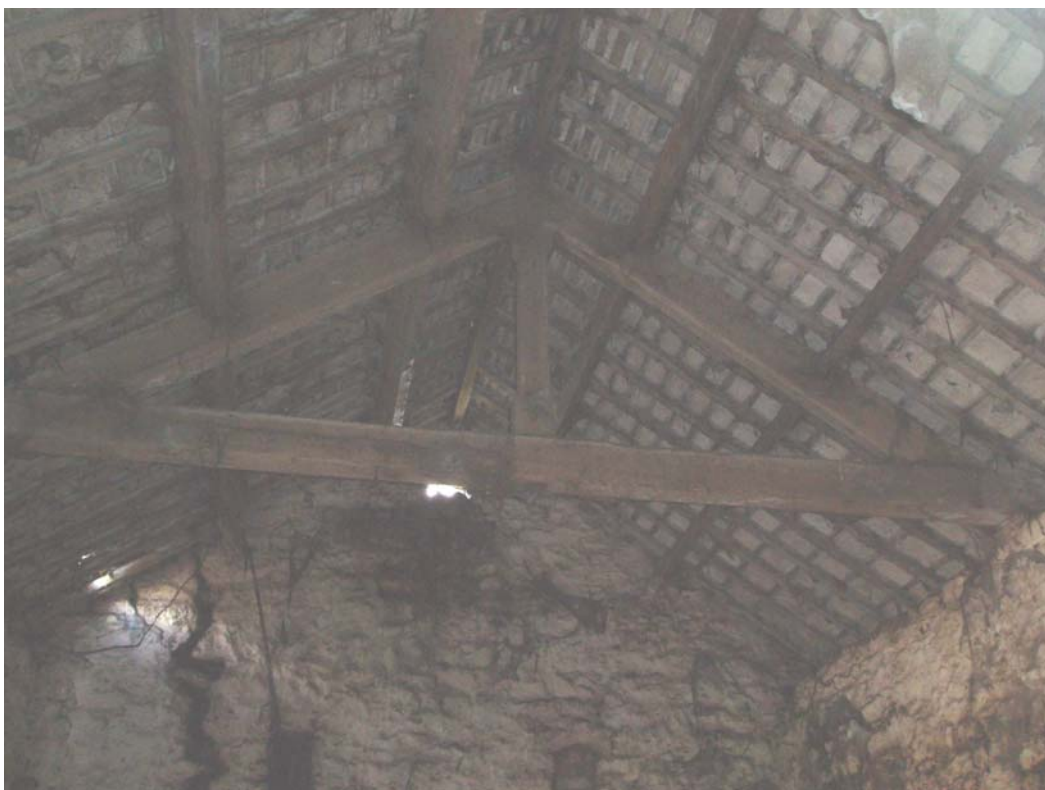
Plate 10: A truss within the barn, looking east

- 4.5.1 **Barn:** the barn is of four-bay construction, divided internally by low walls effectively making three pens. The walls are typically whitewashed and the floors are concrete and slope slightly to the north. There are brick-built troughs along the south wall with timber feeders above. In each pen there is a smaller iron trough for water in the north-west corner, two of which are sat on small brick plinths. There are water pipes supplying these troughs throughout. The roof is supported by three simple king post trusses (Fig 4; Plate 10). In each case the king post has a splayed head and joggled base (although there is no evidence for struts) and is screw-thread bolted to the tie beam (Campbell 2000). There are two purlins per pitch, which overlap at the trusses, and a ridge purlin supported by the king post. The dividing walls are later insertions they are typically around 1m tall, but very irregular, and incorporate a variety of re-used pieces of dressed stone, timber and so forth.

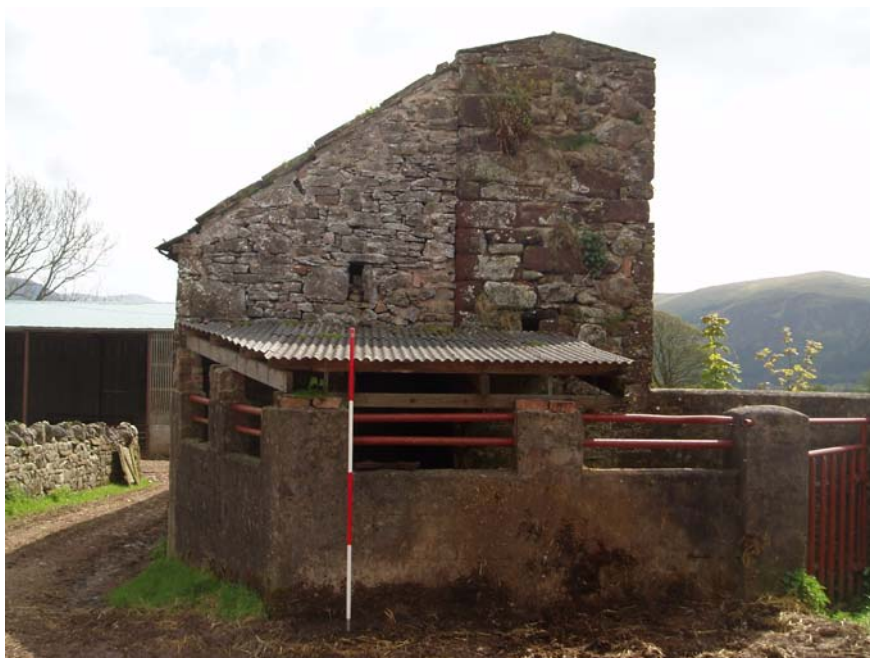
Plate 11: The modern bullpen attached to the west end of the of the original hall, looking east

- 4.4.2 **West elevation:** the west end of the building is largely obscured by a modern bullpen, which butts both the western outshut and the remains of the old hall (Plate 11). The bullpen is built of concrete blocks topped by brick pillars, which support a mono-pitch roof of corrugated concrete sheets supported by timber joists. Behind this the elevation consists of two parts: the north part is the mono-pitch gable of the west outshut, which has a single ventilation slot and an inserted pedestrian door beneath an iron-girder lintel, which is rebuilt on the north side. The south half comprises the remains of the old hall, which is built of large stone blocks, with particularly large sandstone quoins, and has a single putlog hole on the north side. The south side has been largely rebuilt in brick, presumably following the removal of the rest of the hall.

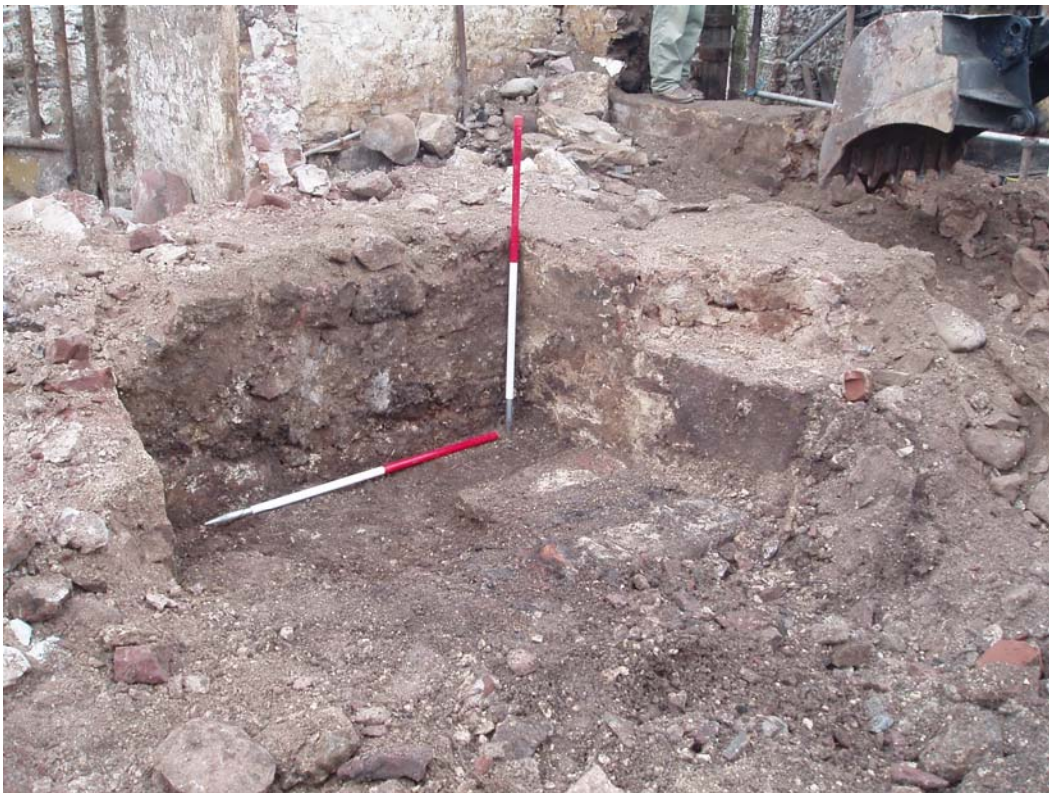
Plate 19: The base of the large ground floor fireplace exposed during the watching brief

- 4.7.4 Within **201** the large ground floor fireplace was filled with rubble, probably from the earlier period of demolition. At its base was a cobble surface (**204**) made up of small water-worn stones in a dark to mid-brown sandy-clay matrix. This appears to have been cut through on the east side to allow three sandstone slabs (**205**) to be laid. These were mortared into place and sat on the soot-covered surface of a larger, finely-dressed slab beneath, forming a surface up to 0.1m thick. This slab was bedded into a layer of loose dark red sand (**206**) little more than 0.05m thick, which was in turn sat on a mid-orange sandy-clay (**207**) with occasional flecks of mortar, which was not excavated but may have been the top of the natural drift geology.

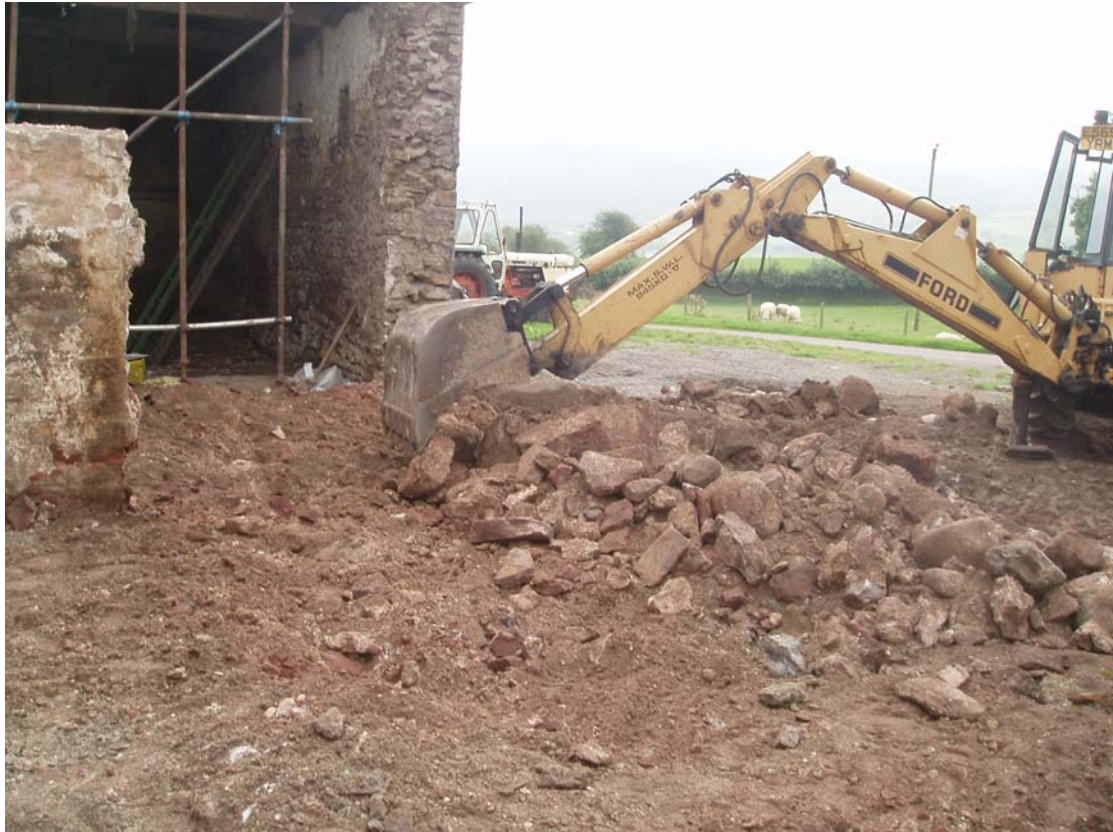
Plate 20: The removal of the remaining courses of the hall wall (**201**)

- 4.7.3 **Trench 2:** following the demolition of the upper section of the remaining wall of the hall two courses were left standing (**201**). These were removed with a mechanical excavator using a toothed bucket approximately 1.2m wide to the approximate ground level, except where large foundation stones required deeper excavation. The two courses were between 0.5m and 0.6m in height, 2m deep, 7.5m long, and made up of a mix of rough limestone blocks and large rounded stones (used in the foundations), smaller pieces of limestone (used throughout), and large dressed sandstone blocks (used for the quoins). These were held in a loose sandy mid-orange-yellow to red mortar. To the north of the remains of the hall the concrete floor (**202**) of the western outshut was still present. This was approximately 0.1m thick, and overlay a dark brown sandy-clay (**203**) deposit up to 0.4m thick, which was more fully exposed during the excavation of Trench 3 (see Section 4.7.5).

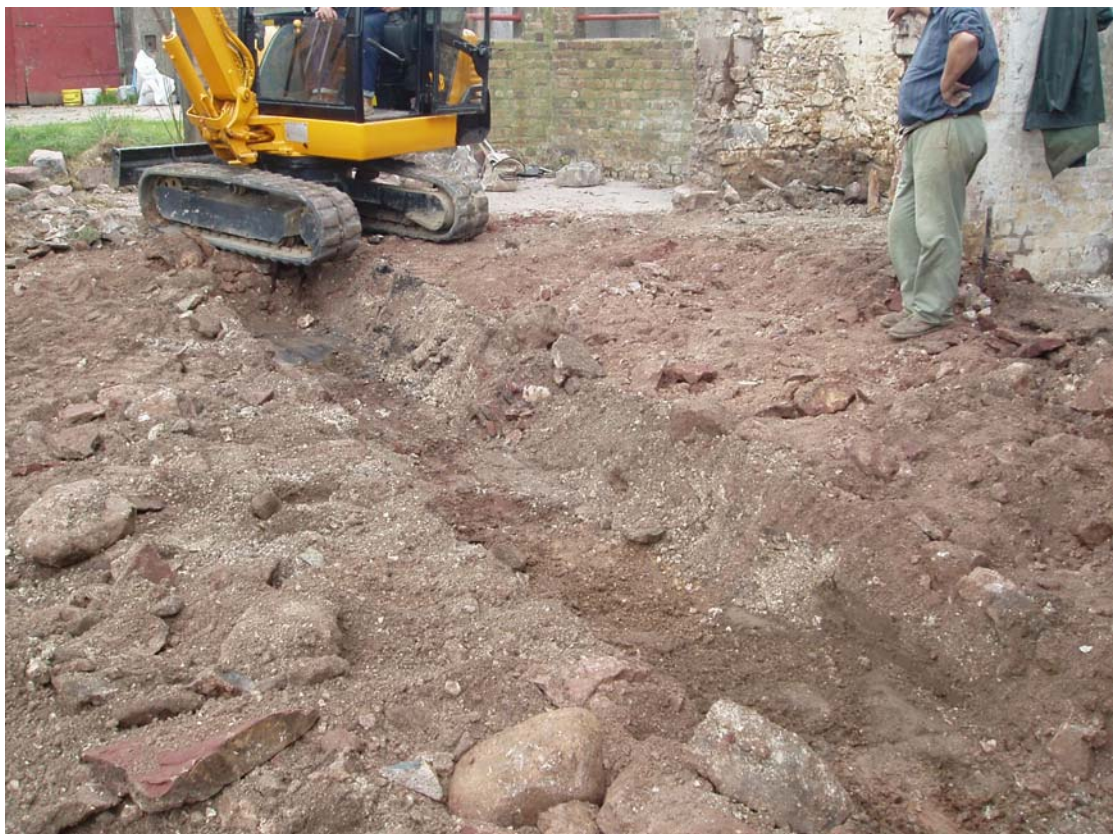
Plate 21: The excavation of Trench 3

the western wall of the western outshut (Fig 10). Beneath a 0.2m thick deposit of overburden generated during the demolition was a loose mid-brown loamy soil (**301**) with occasional fragments of waterlogged wood approximately 0.03m thick. Below this was an equally thin layer of very sandy-clay (**302**) with large amounts of mortar and occasional fragments of slate and sandstone. This in turn overlay a firm but mixed mid-brown, orange and red gravelly-clay (**303**) to the base of the trench (0.3m below the surface). This appeared to be the natural boulder clay, although there were flecks of charcoal, which would suggest some disturbance. Trench 3 was also excavated through the north end of wall **201**, which revealed some very large boulders making up the foundations, at a depth of approximately 0.6m. These were sat on a very wet mid brown and orange clay (**304**), presumably the boulder clay. The far north end of Trench 3 also cut through **202** and **203**. Within **203** there was a ceramic field drain-type pipe orientated east/west, above which was a plastic water pipe.
