Pembroke College Oxford Old Quad and Porter's Lodge

Historic Building Recording and Archaeological Watching brief

Old Quad and Porter's Lodge, Pembroke College, Oxford

Archaeological Watching Brief and Building Recording

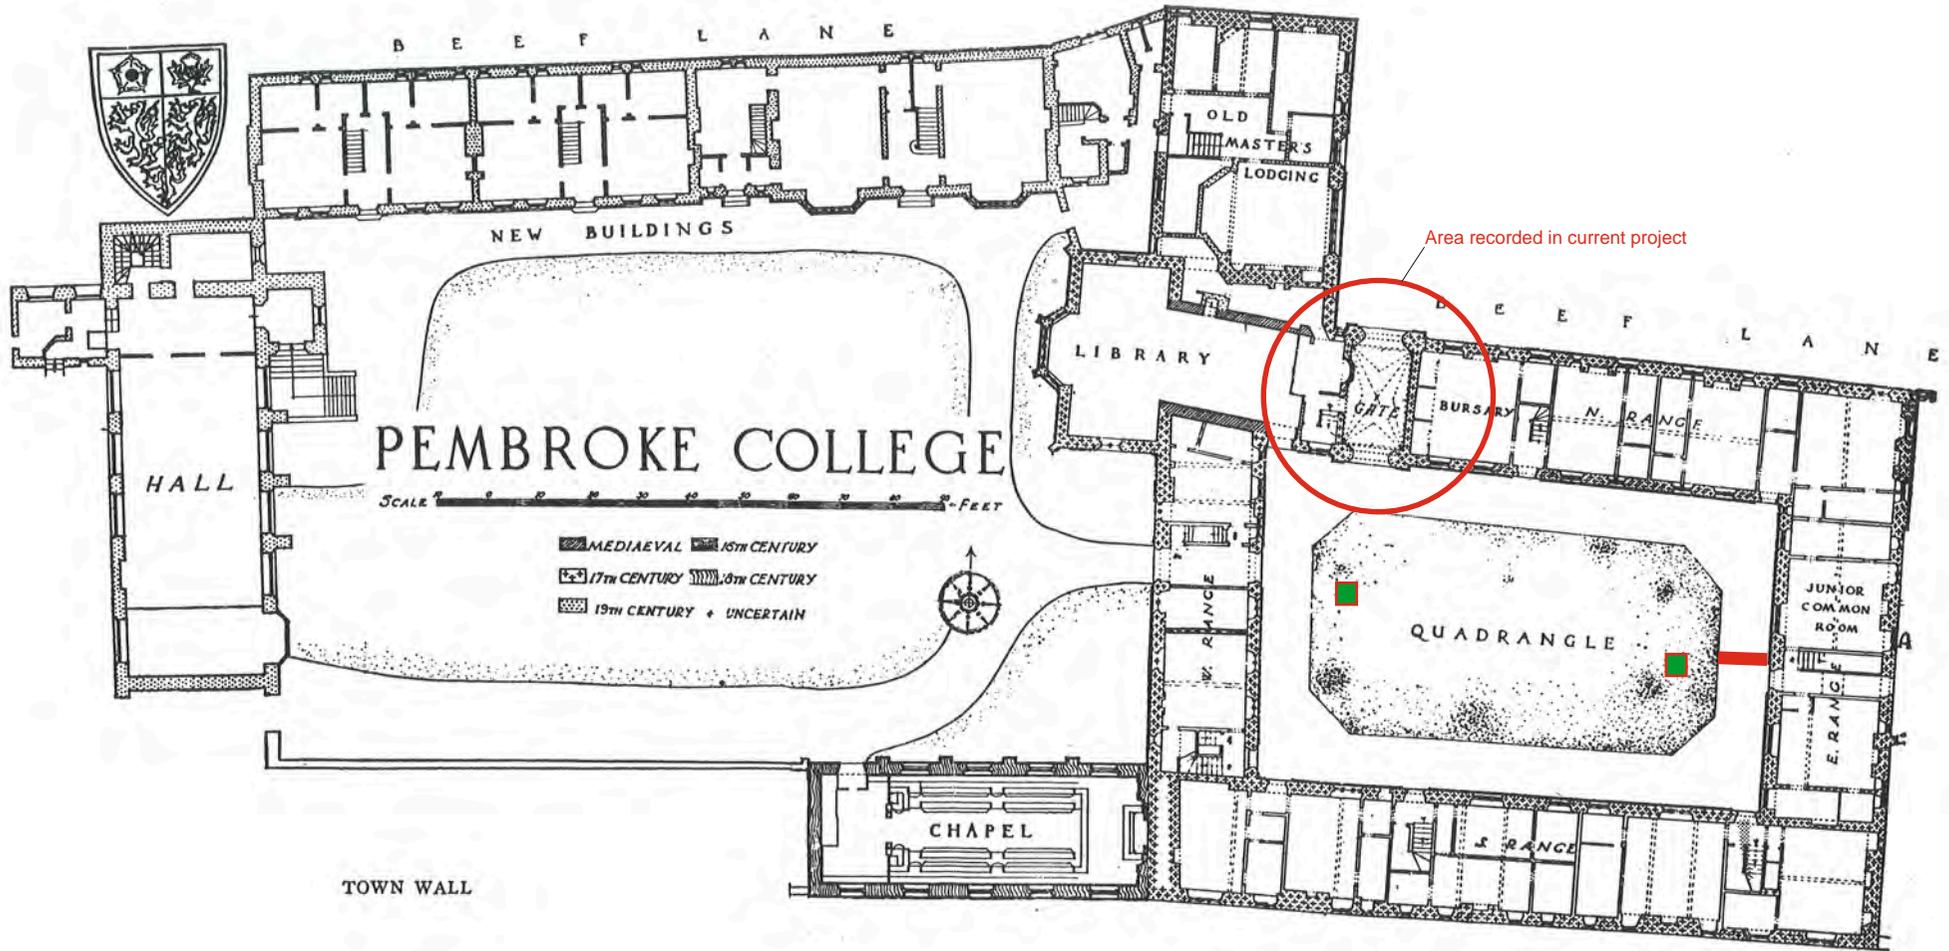
Figure 2: Plan of Pembroke College, from VCH

■ Test pit locations
— Watching Brief area

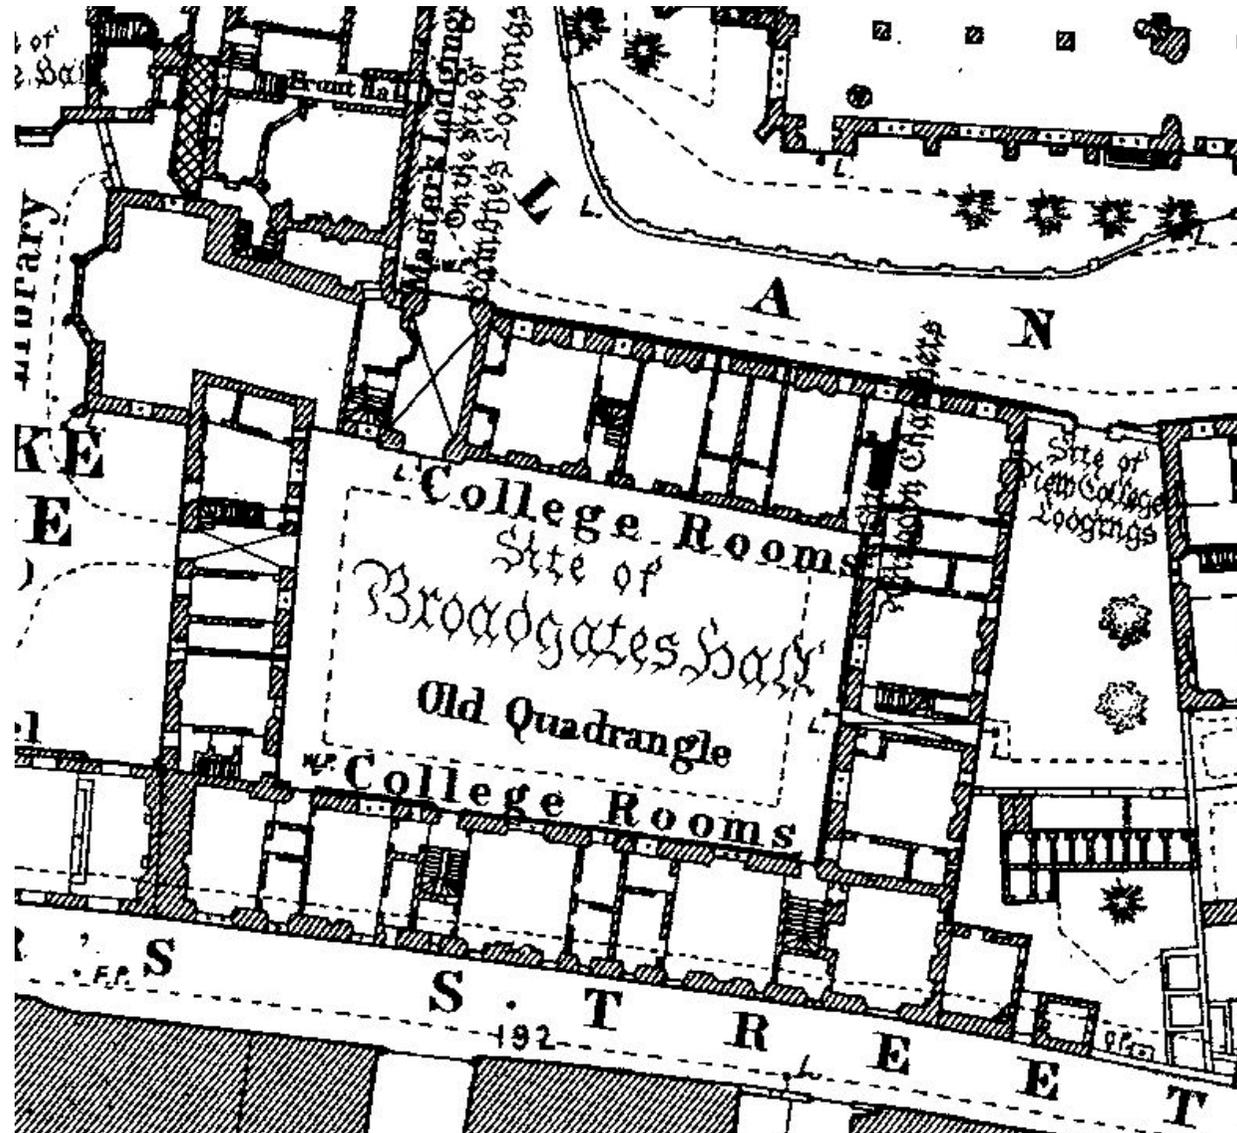
Figure 5: First edition 1:500 Ordnance Survey Town Plan (1875)

- 1.3.9 The Ordnance Survey's 1:500 town plan was published in 1875 and this provides some indication of the internal layout of the western part of the north range which has been investigated in the current project. The plan shows the vaulted passage from Beef Lane to the quadrangle, together with what appears to have been a small lodge on the west side with bay window and larger room on the east side. The plan shows what appears to have been a pair of partitioned off areas or cupboards within this room immediately to the east of the vaulted passageway.

- 4.2.5 This layout closely matches the arrangement shown on the Ordnance Survey plan of 1875 as well as the plan shown in the RCHM Inventory on the Monuments in the city of Oxford (dated 1939) although the area has been altered in the 20th century.

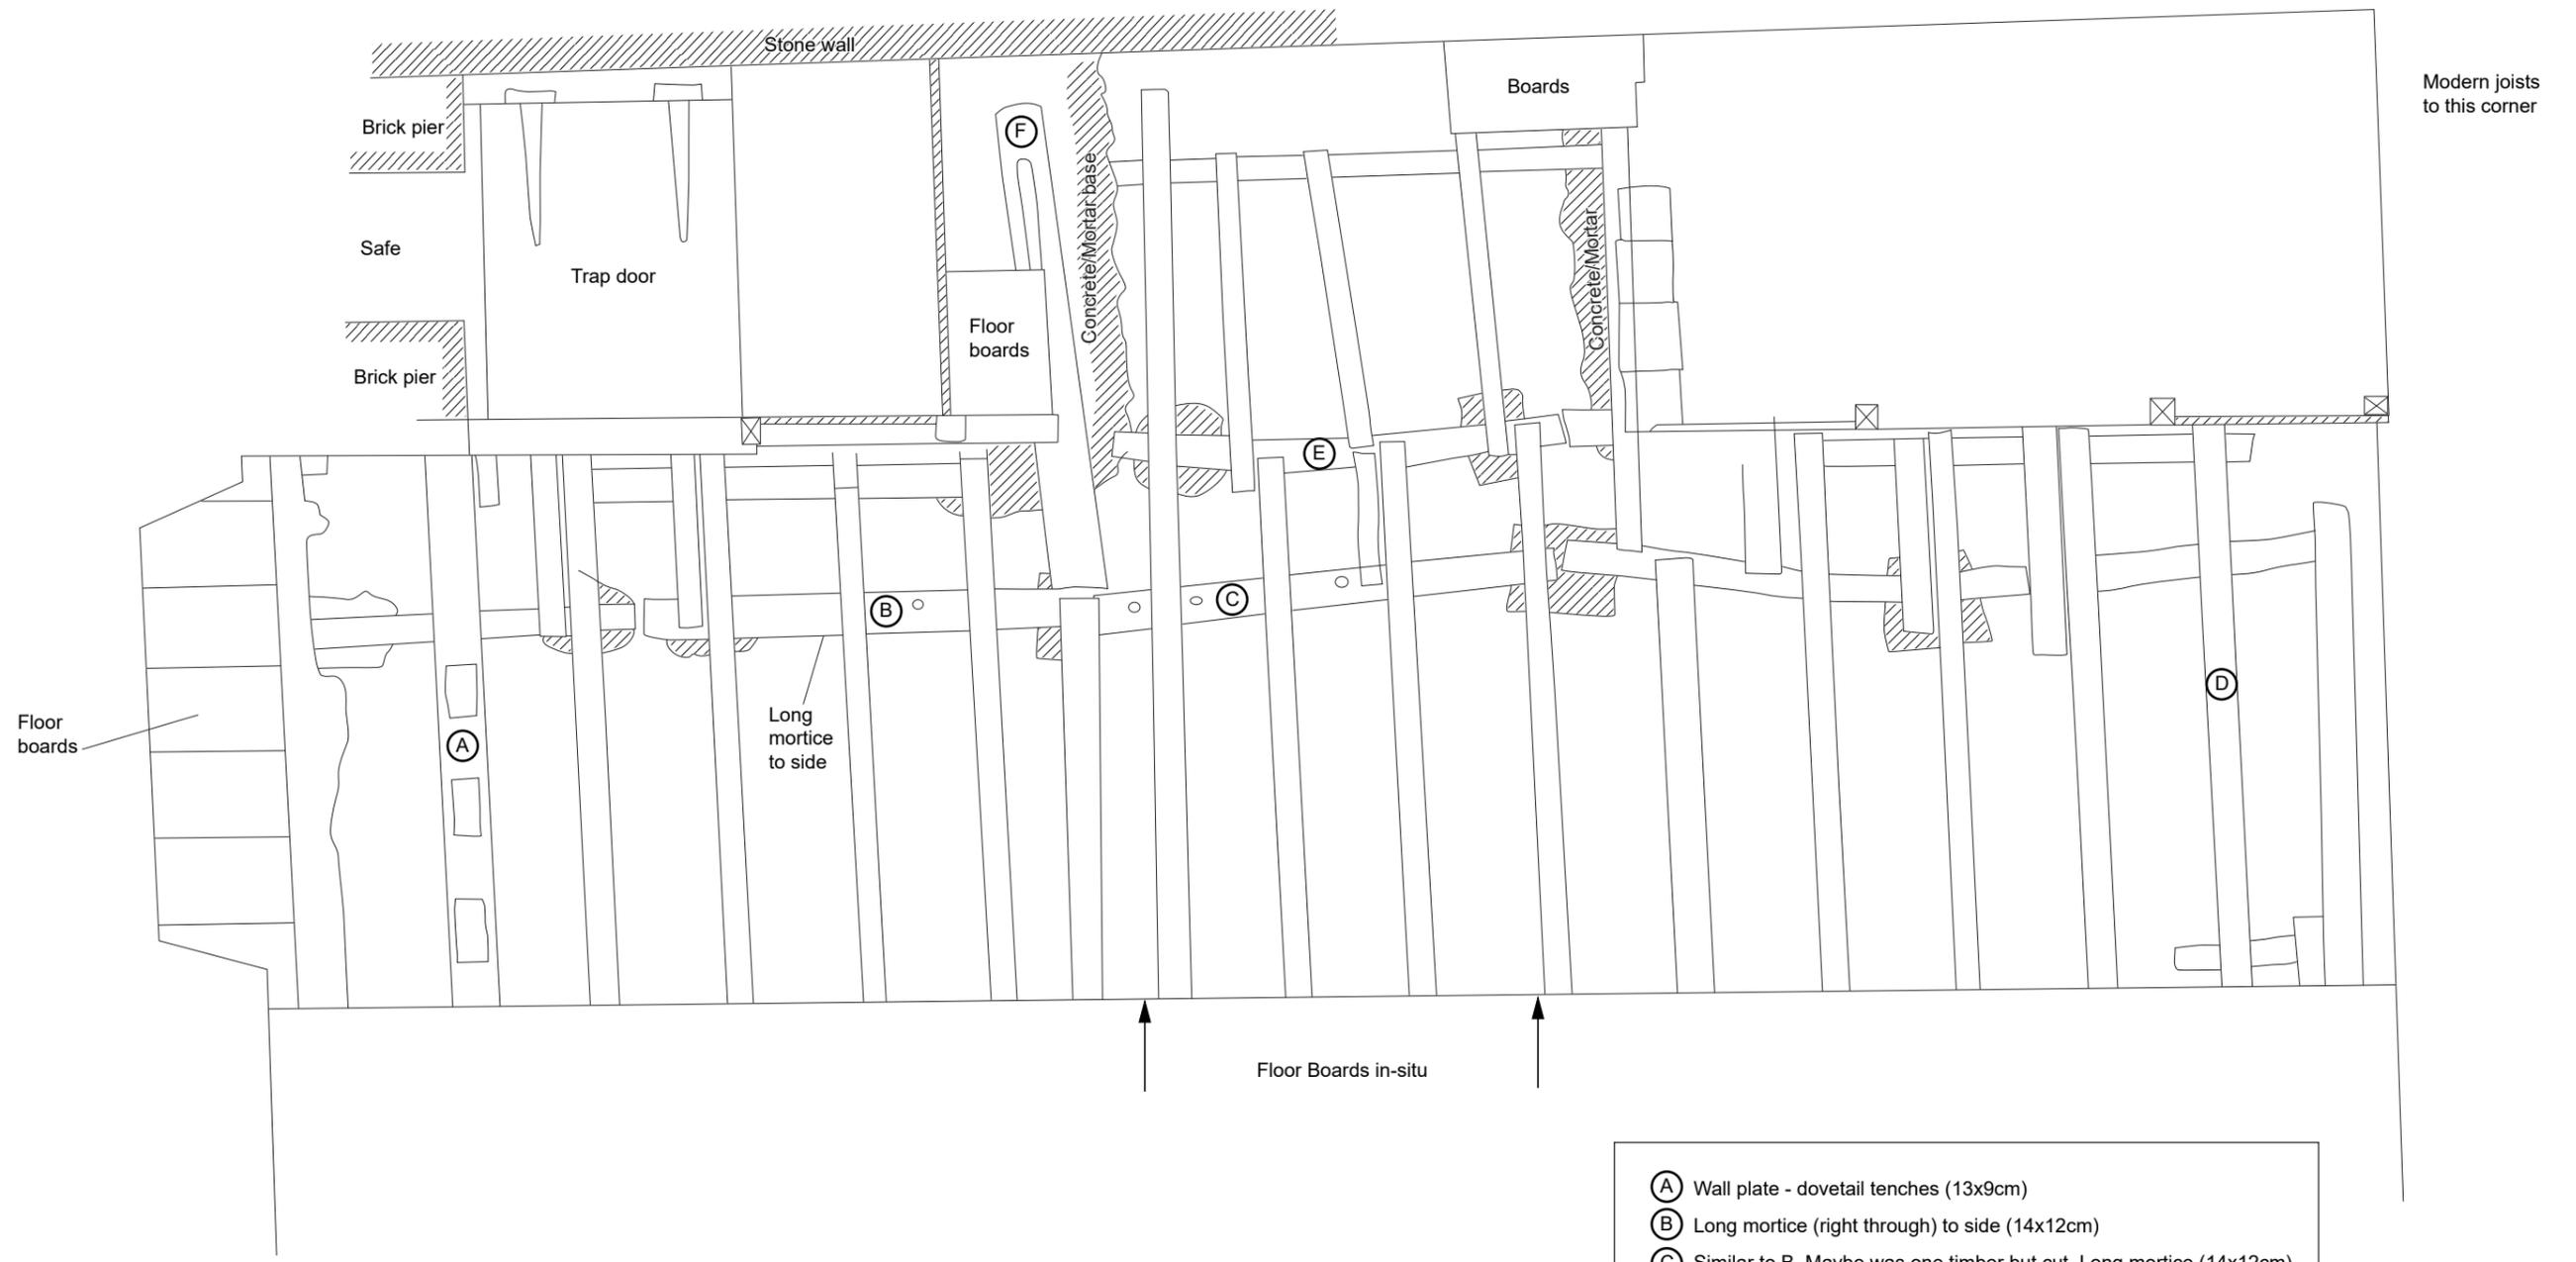
Figure 7: Plan of floor exposed in Events Office

- (A) Wall plate - dovetail tenches (13x9cm)
- (B) Long mortice (right through) to side (14x12cm)
- (C) Similar to B. Maybe was one timber but cut, Long mortice (14x12cm)
- (D) Partition rail - lots of stud mortice inside (11x8cm)
- (E) Trench/Groove right along side. Arched (12x12cm)
- (F) Long trench in top with tenon (?) in-situ (16x10cm)

- An east-to-west timber (F on Fig 7) long trench in the upper faced with what appears to be a tenon in-situ (Pl. 17).
- 4.2.16 The north-to-south sleeper joists were set on a number of crudely formed pads which appeared to be formed of rubble stone with mortar to the top. These pads were set on a layer, c.35 cm below the floorboards formed from a loose, stoney, hard-core fill. This fill incorporated a small number of larger stones, roof stone slates, mortar, building debris, animal bones, oyster shells and a number of clay pipes (see section 5 below). The surface of this layer (c.20 cm max) was removed to allow for the new insulated floor.

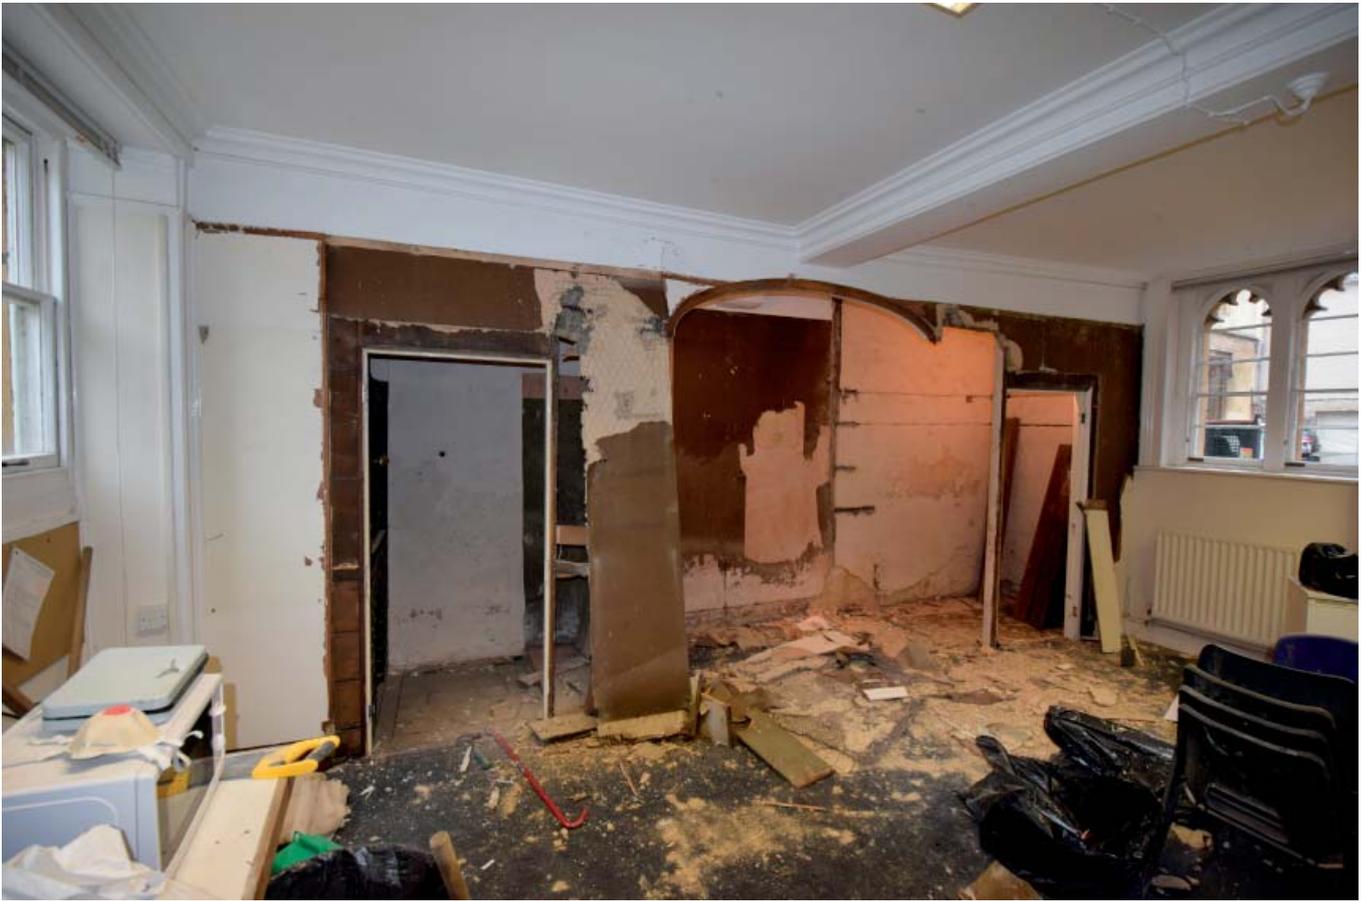
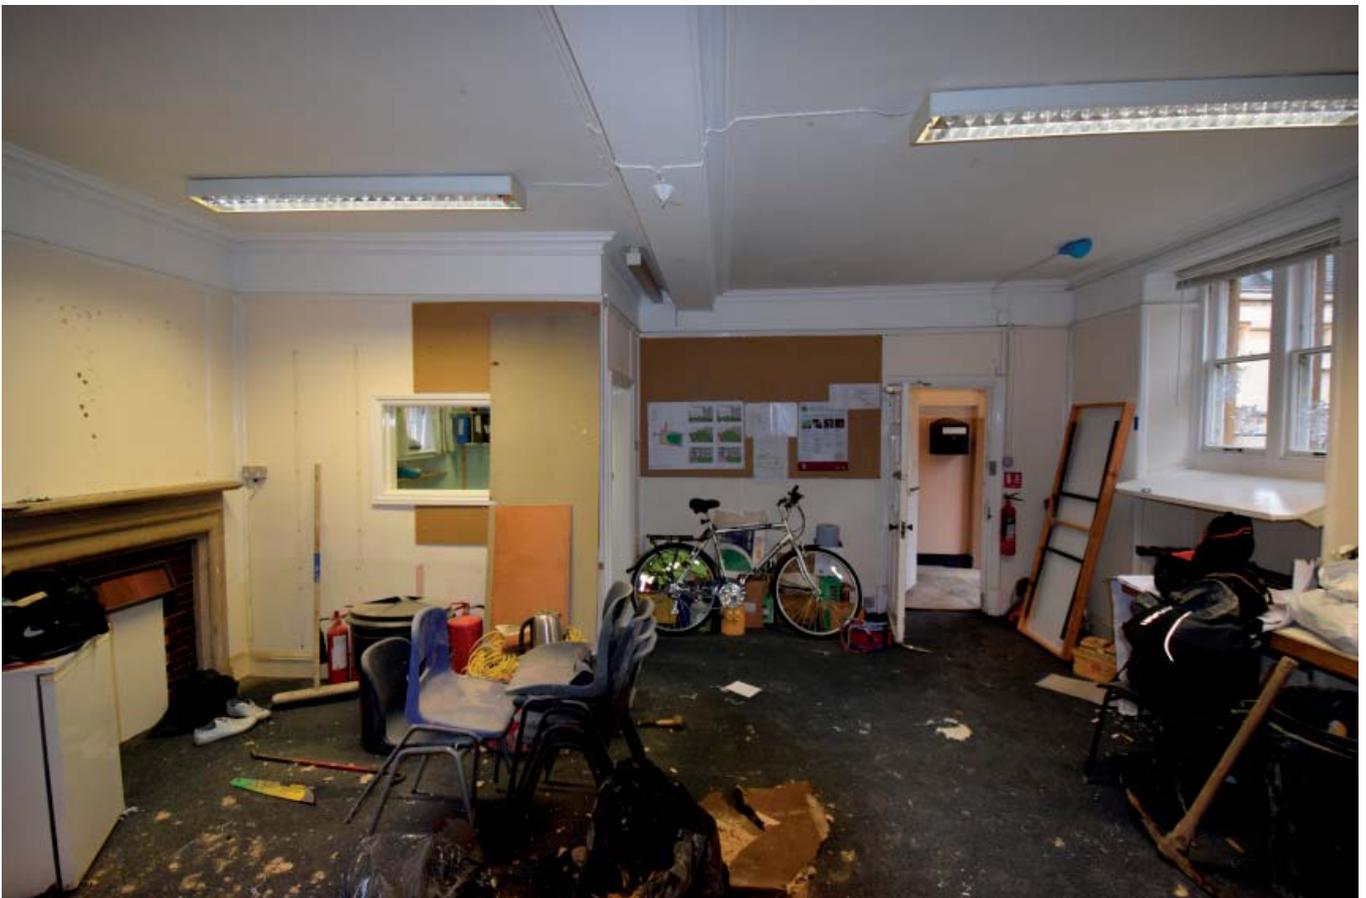
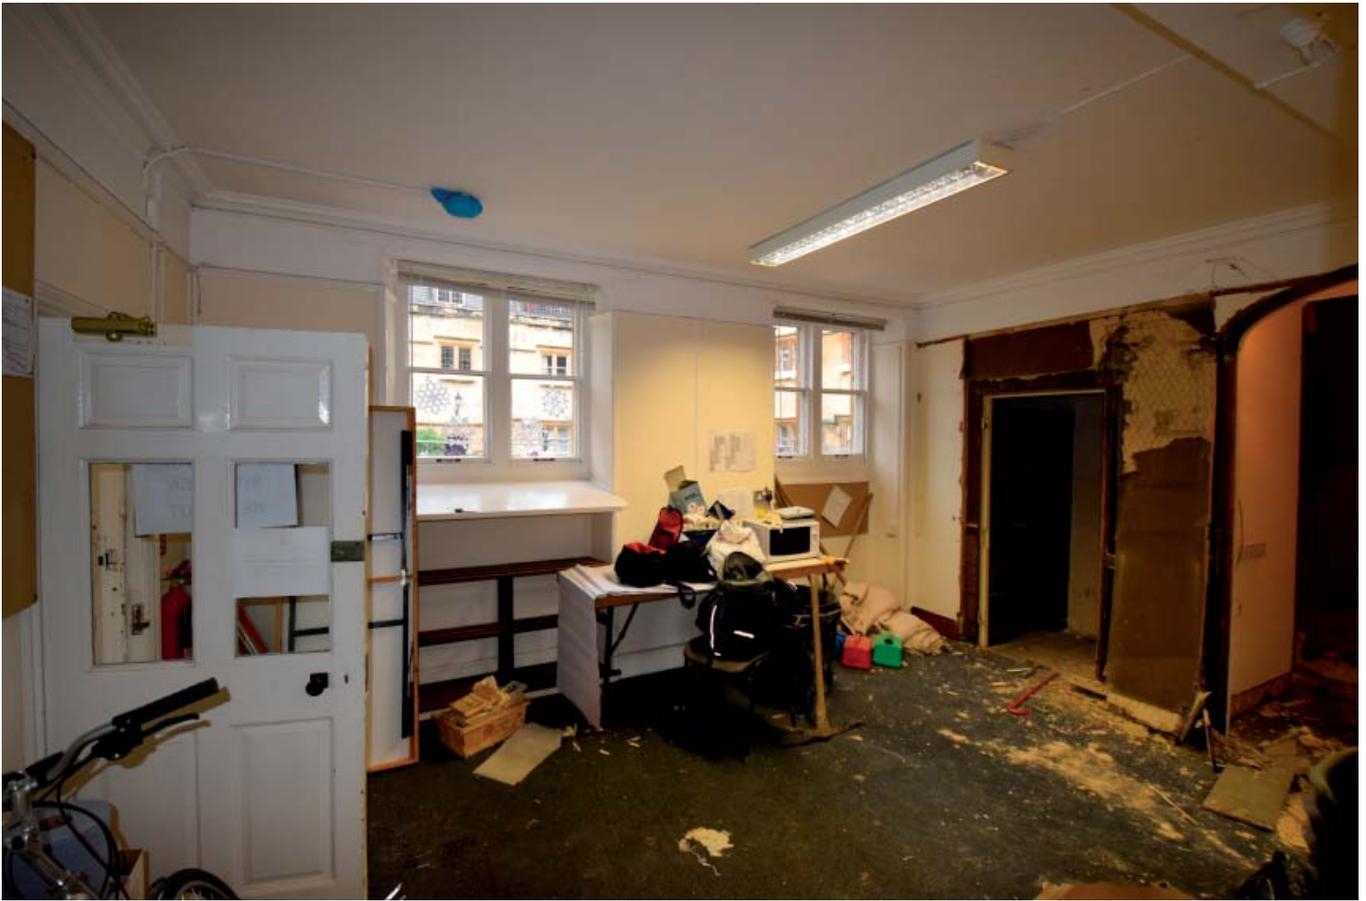
- 4.2.1 The Events Room was a plain room with plastered walls and ceiling and a boarded floor covered with a modern carpet (Pl. 1-3). The room was entered via a door at the south-east corner at the foot of the stairs and at the north-east corner of the room there was a small separate office formed by modern stud partitions (removed in current work. Pl. 2). The western side of the room incorporated a set of three alcoves or walk-in cupboards which have also been removed in the current development to allow for the new openings to connect the Events Office with the passage (Pl. 4).

Plate 1: General view in Events Office looking north-west

Plate 2: General view in Events Office looking east

Plate 3: General view of Events Office looking south-west

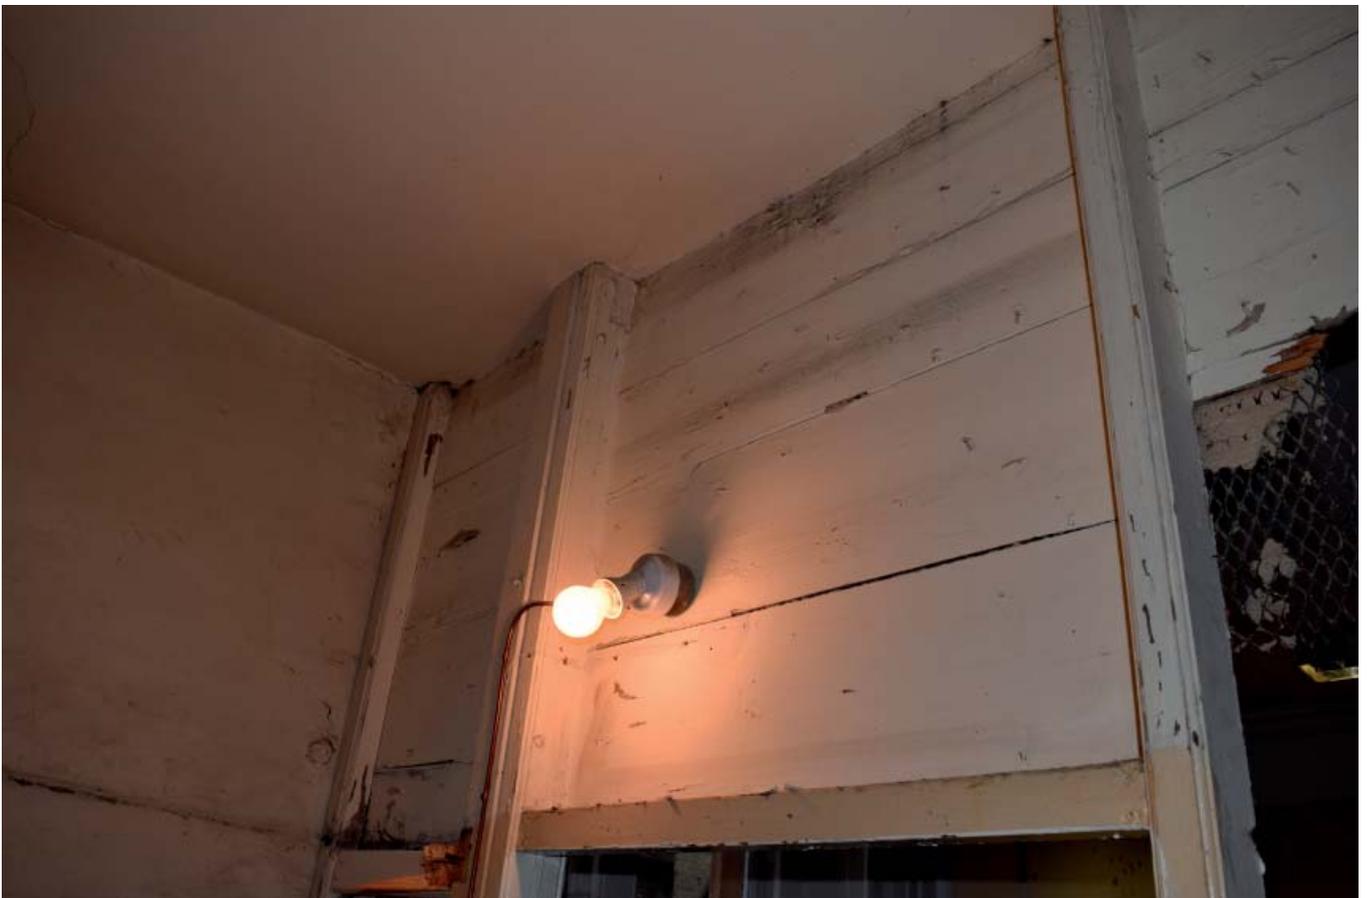
Plate 6: West side of partitions forming alcoves in Events Office

- 4.2.6 The partitions which formed the alcoves were constructed from nailed softwood and the internal faces had lath and plaster which probably survived from the 1875 plan but the eastern side of the main partition, facing into the room, was clad in modern plaster held on chicken wire. This is likely to have been added as part of a mid 20th-century redecoration of the room and the earlier face seemed to have been formed of horizontal boards (Pl. 6).

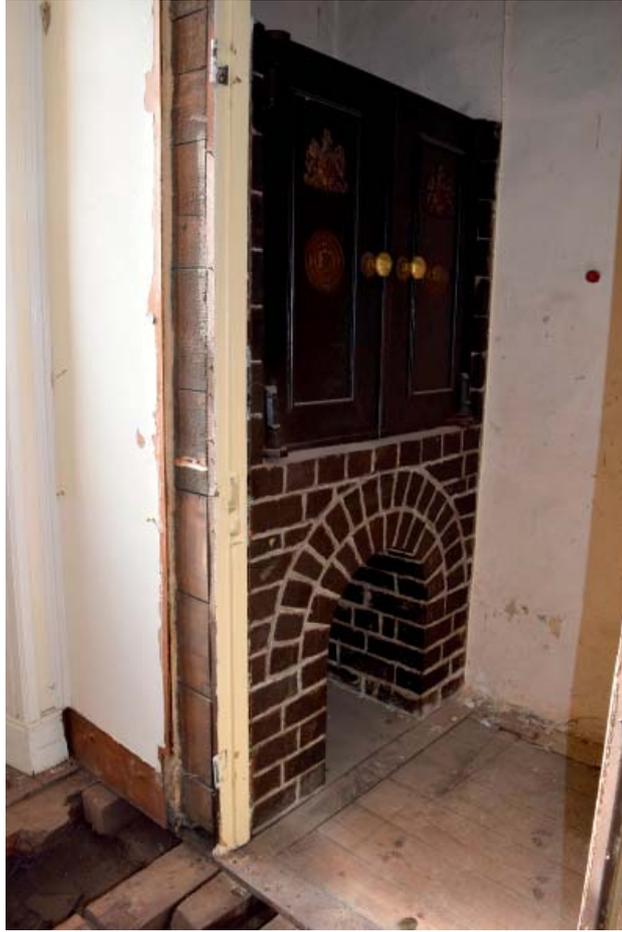
Plate 19: Safe at south-west corner of Events Office

- 4.2.7 At the southern end of the alcoves there was a safe (Pl. 19), probably of 20th-century date, against the external wall and immediately adjacent to this was a lockable hatch in the floor which filled much of the southernmost alcove (Pl. 20).

- 4.2.8 The steel safe was supported on a vaulted, black brick arch with two brick piers and it had clearly been inserted into an existing opening. The piers supporting the safe and the void beneath this area are discussed below in the section on the reduction of the floor in this area.

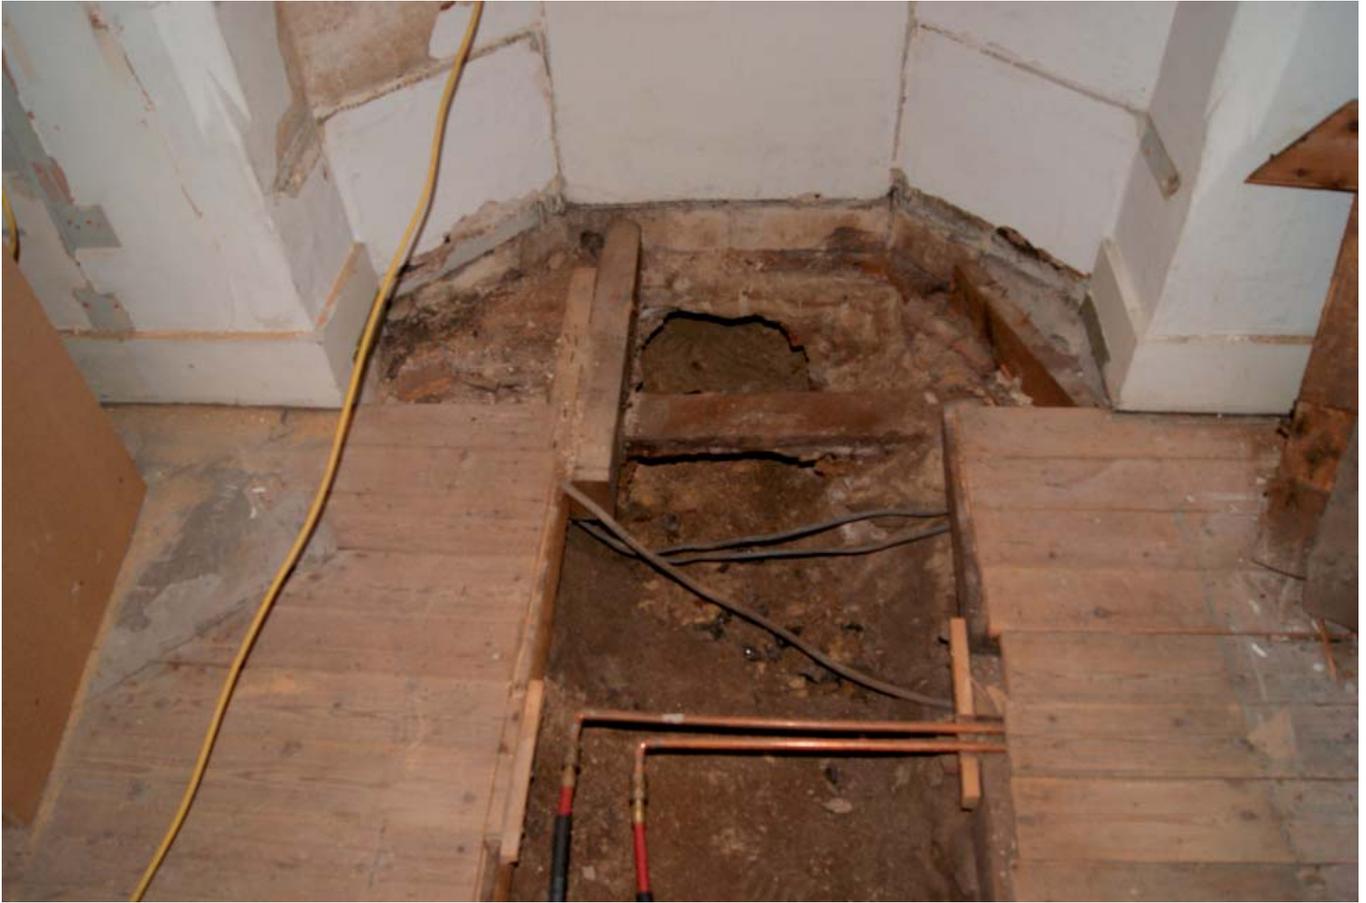
Plate 29: section of floor boards lifted in Porter's Lodge

- 4.4.4 In the lodge the floor is formed from joists and 20th-century boards but a small east-to-west section of these were lifted to allow the insertion of some cabling. The cables were largely set in an existing void beneath the boards but at the east end of this area two courses of a small section of a modern brick wall below the floorboards were removed. This wall was orientated north to south. Towards the east end of this void, close to the porters bay window various animal bones (possibly a workman's lunch) were found. These are discussed further below in Section 5. The exposed section beneath the floorboards adjacent to the bay window was scraped slightly (c.10 cm) to allow for the cabling and this was a chalky rubble base.

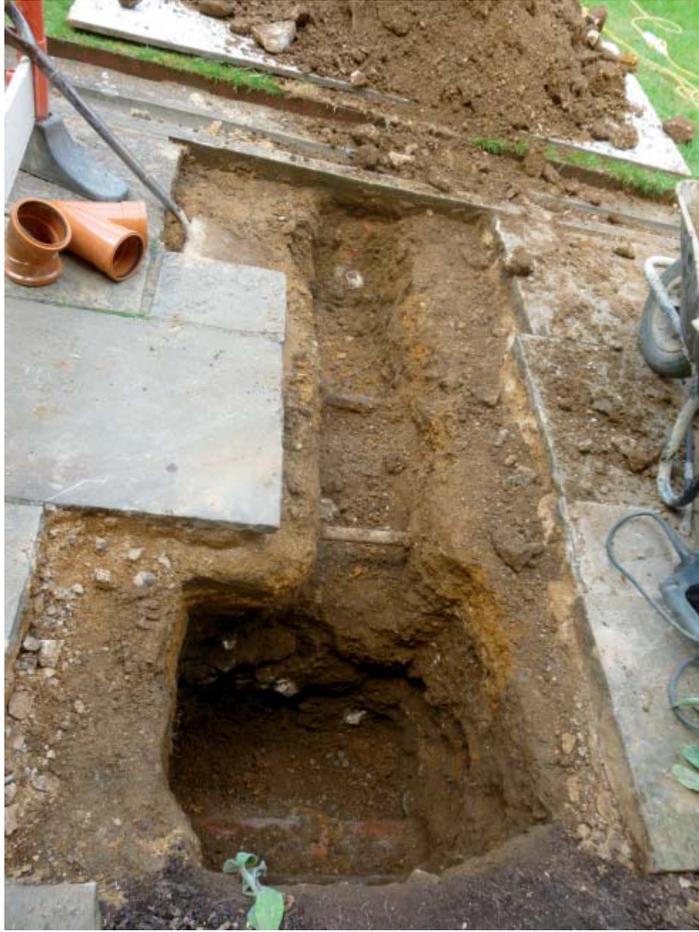
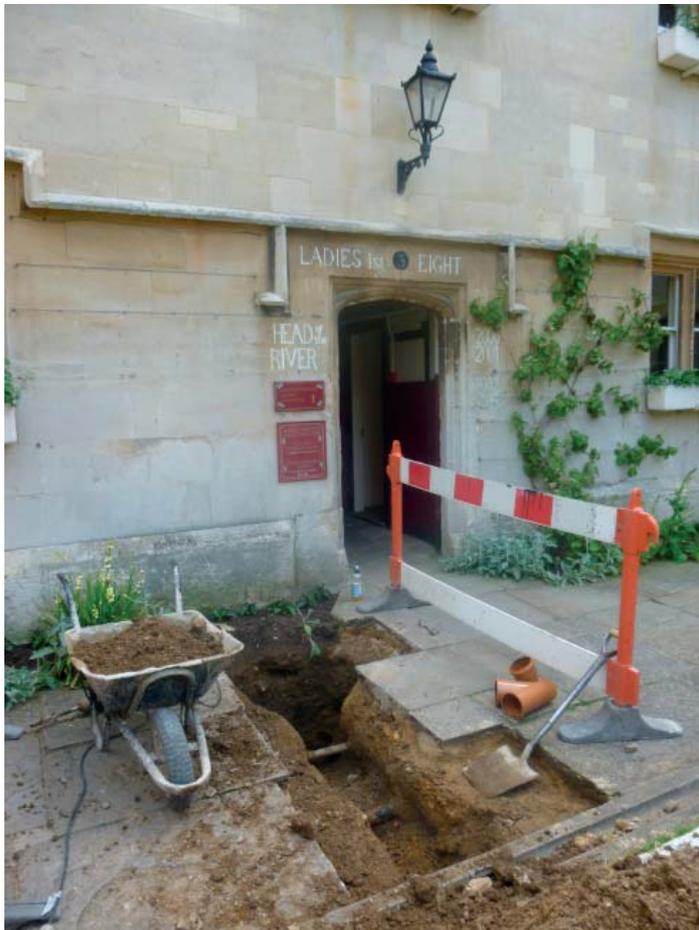
- 3.2.1 An excavation area, measuring 2.10m by 0.35m by 0.9m deep was excavated to locate a drainage pipe to be replaced on the east side of the Old Quad (PI. 53-54).
- 3.2.2 A 45 degree angled sloped trench was excavated from the drain by the quad lawn back towards the college building, to locate the length of the drain and any other drains feeding into it.
- 3.2.3 Below the stone slabs of the path, a mixed gravel and garden soil and rubble deposit (01) backfilled the drainage trench. Undisturbed garden soils (02) could be seen in the

Plate 53: Drainage outlet watching brief at east side of quad

Plate 54: Drainage outlet watching brief at east side of quad
