GARDEN COTTAGE, CASTERTON, KIRKBY LONSDALE, CUMBRIA

Archaeological Measured Building Survey Report

Oxford Archaeology North

January 2009

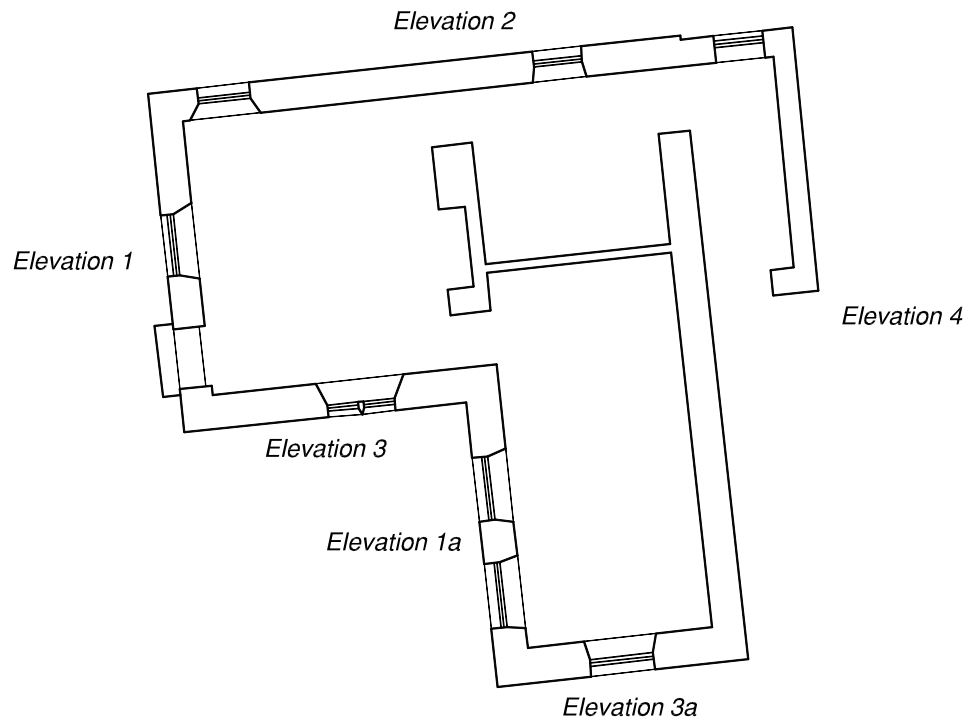
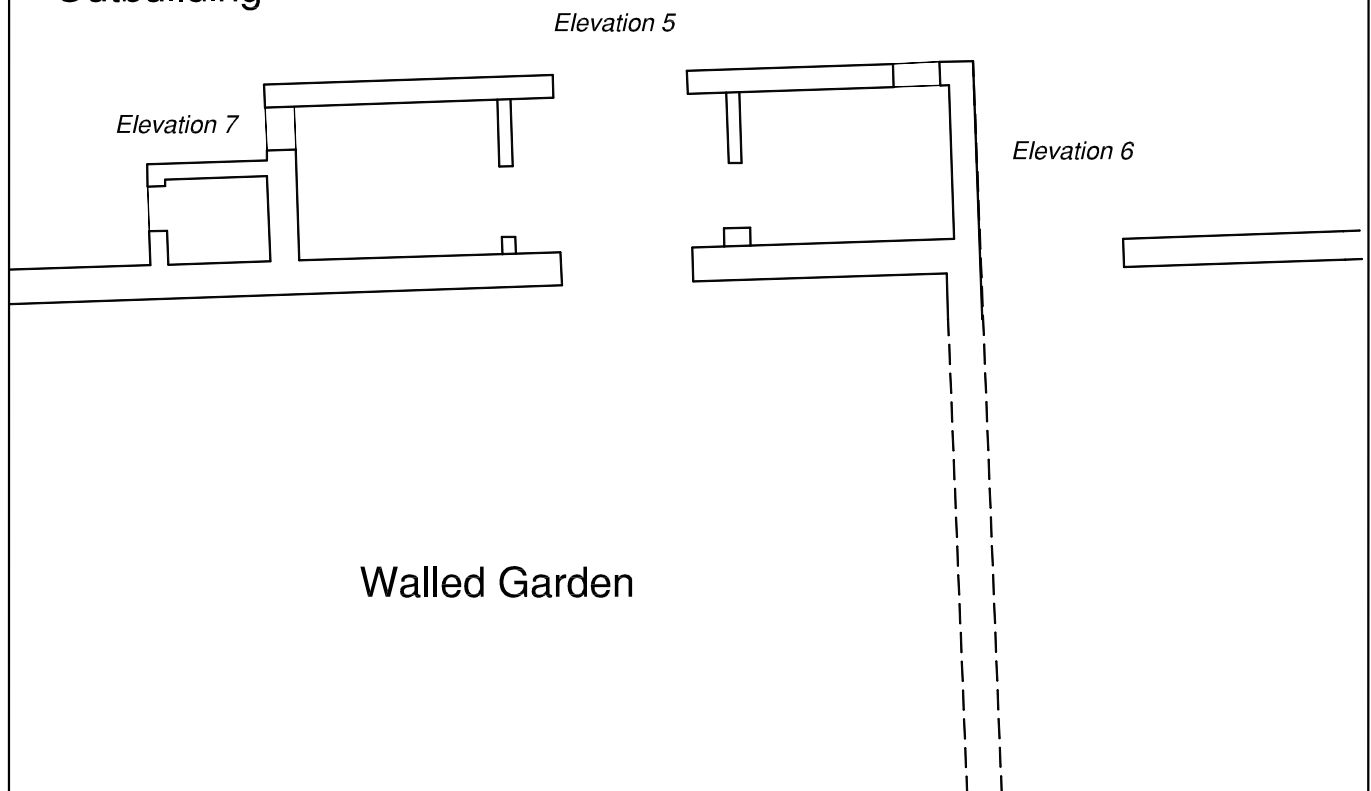
Figure 2: General Layout of Garden Cottage and Outbuilding

- 4.1.2 Garden Cottage and the adjacent outbuilding are located at the north-east corner of the large rectangular walled garden (Plate 1, Figs 1 and 2). The outbuilding is attached to the corner of the walled garden, whilst the cottage is detached. Access to the site is via either a track through the orchard to the south or track leading to Casterton village to the north. Access to the interior of the walled garden is through the outbuilding.

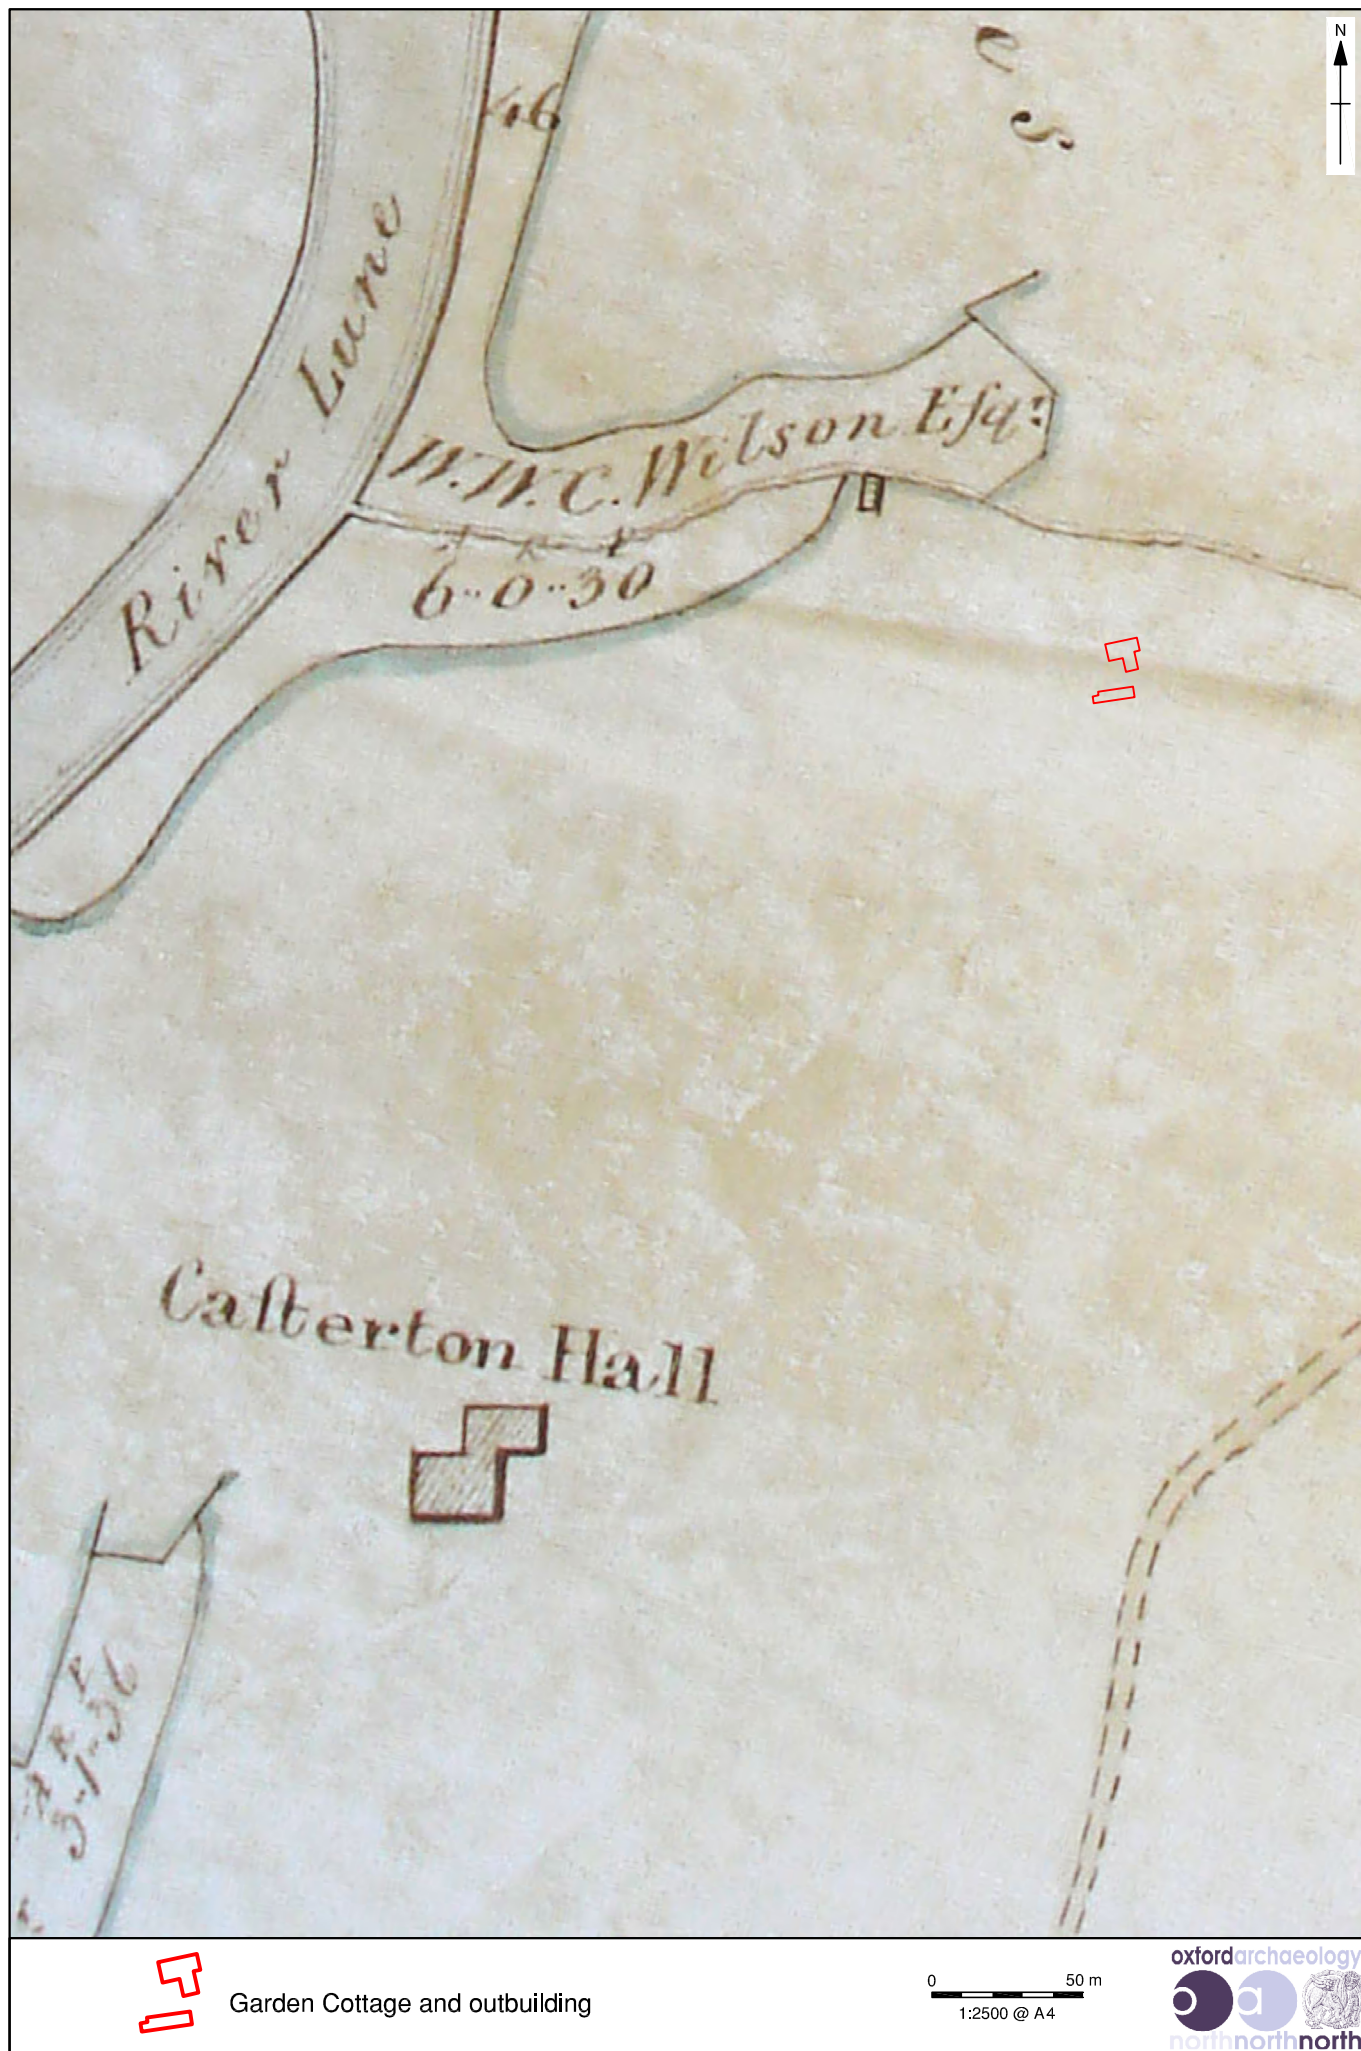
Figure 5: Casterton Inclosure Map, 1816 (CRO WQR/114)

- 3.3.5 ***Casterton Inclosure Map, 1816 (CRO WQR/114) (Fig 5):*** Casterton Hall is clearly illustrated on this simplified map, mainly intended to show the enclosure of Casteron Fell to the east. The Hall is listed (No 47) in the associated schedule as being owned by William Wilson Carus-Wilson. The footprint of the house is clearly outlined and is similar to Figure 3, which differs slightly from later maps. There are few other buildings illustrated within the immediate area. However, this may be due to scale and the intended representation of specific detail.

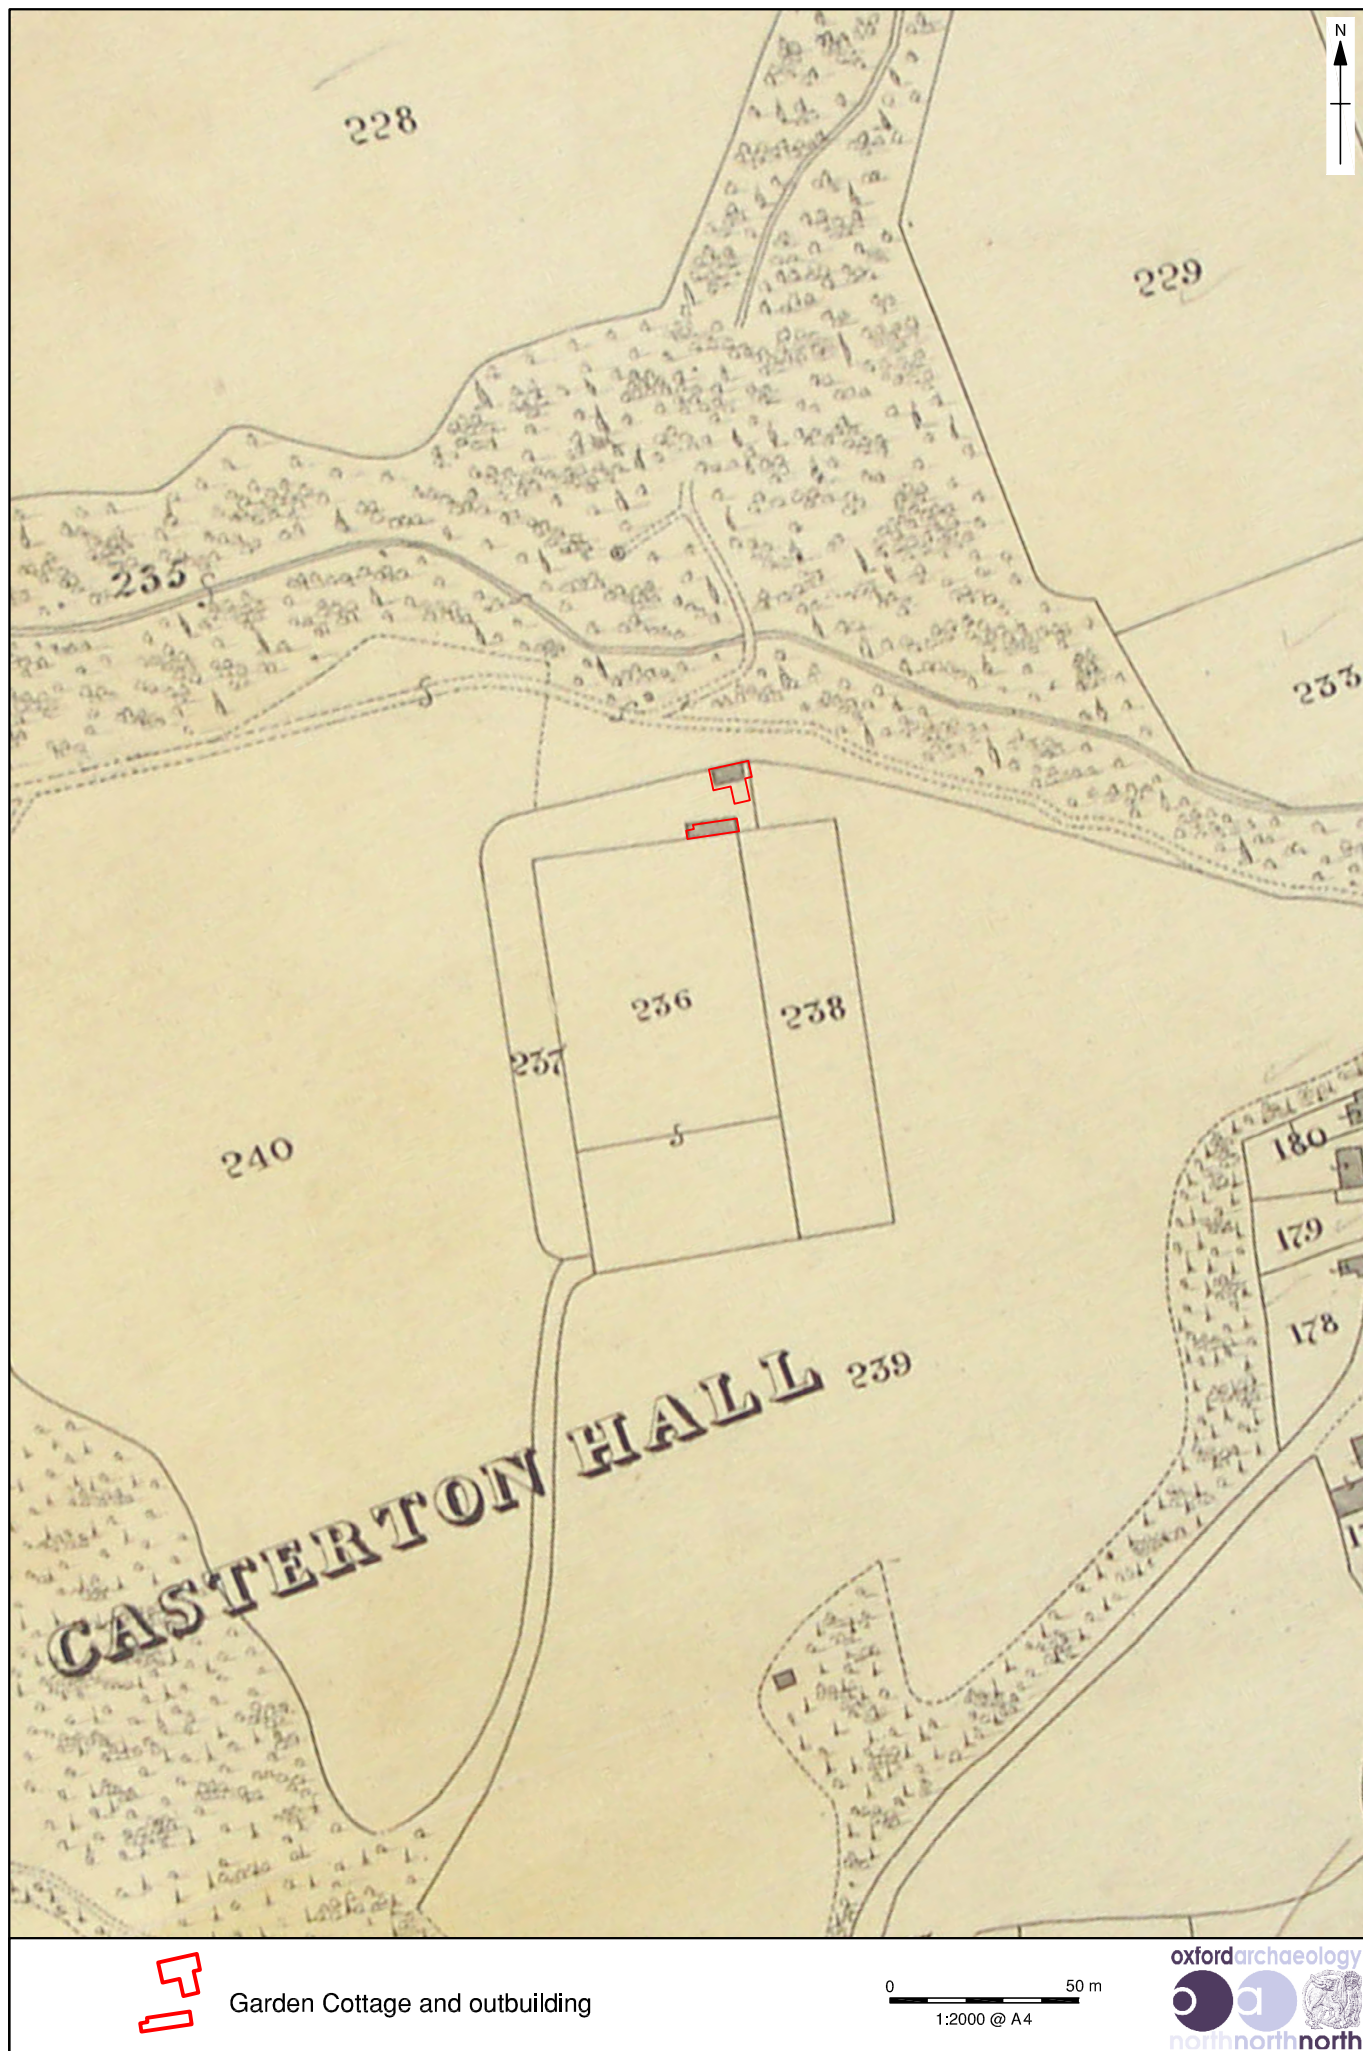
Figure 6: Tithe Map, 13 May 1843 **CRO WDRC/8/250**

- 3.3.6 ***Tithe Map, 13 May 1843 (CRO WDRC/8/250) (Fig 6):*** this map shows the detailed layout of Casterton and Kirfitt Halls. To the north-east of Casterton Hall, the large rectangular outline of the walled garden can be clearly seen. Two rectangular structures are visible at the north-east corner of the garden. In addition to the outbuilding previously seen (Fig 4), Garden Cottage has now been added to the north, although somewhat smaller than its present size. This comprises plot nos 236, 237 and 238 in the accompanying schedule, which are all listed as being owned and occupied by William Wilson Wilson-Carus Esq. They are described as being Garden (236), Out Garden House (237) and the recently added Orchard (238). The access track from the woodland in the south is clearly visible.

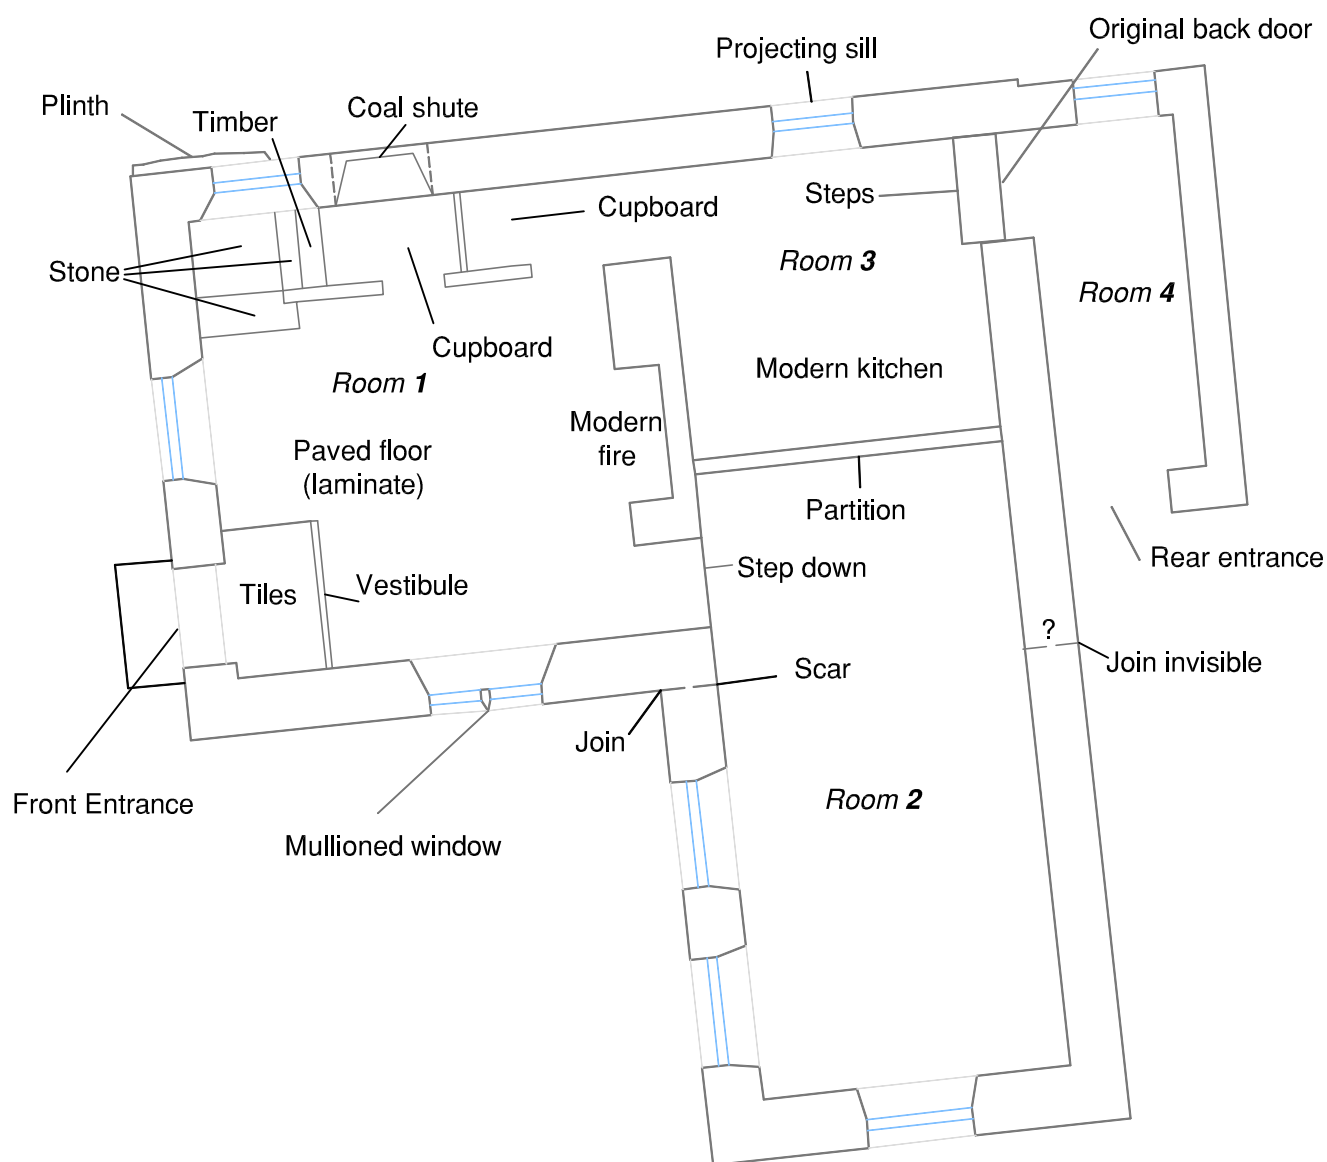
Figure 9: Ground Floor Plan of Garden Cottage

- 4.2.1 Garden Cottage is 'L-shaped', the main part of which lies on an east/west axis, and is of two-storey construction with pitched roofs. There are two entrances, the main front door being situated on the west-facing gable elevation (Plates 1-3). The back door is situated in a small extension at the rear of the property (Plate 9). There are four rooms on the ground floor (Rooms **1-4**) and four main rooms on the upper floor (Rooms **7-10**). There is a single staircase (Room **5**) and a corridor allowing access to the rooms on the upper floor (Room **6**) (Figs 9 and 10). There is a below-stairs cupboard on the ground floor (Plate 13), and two small cupboards on the upper floor, one of which houses the modern boiler.

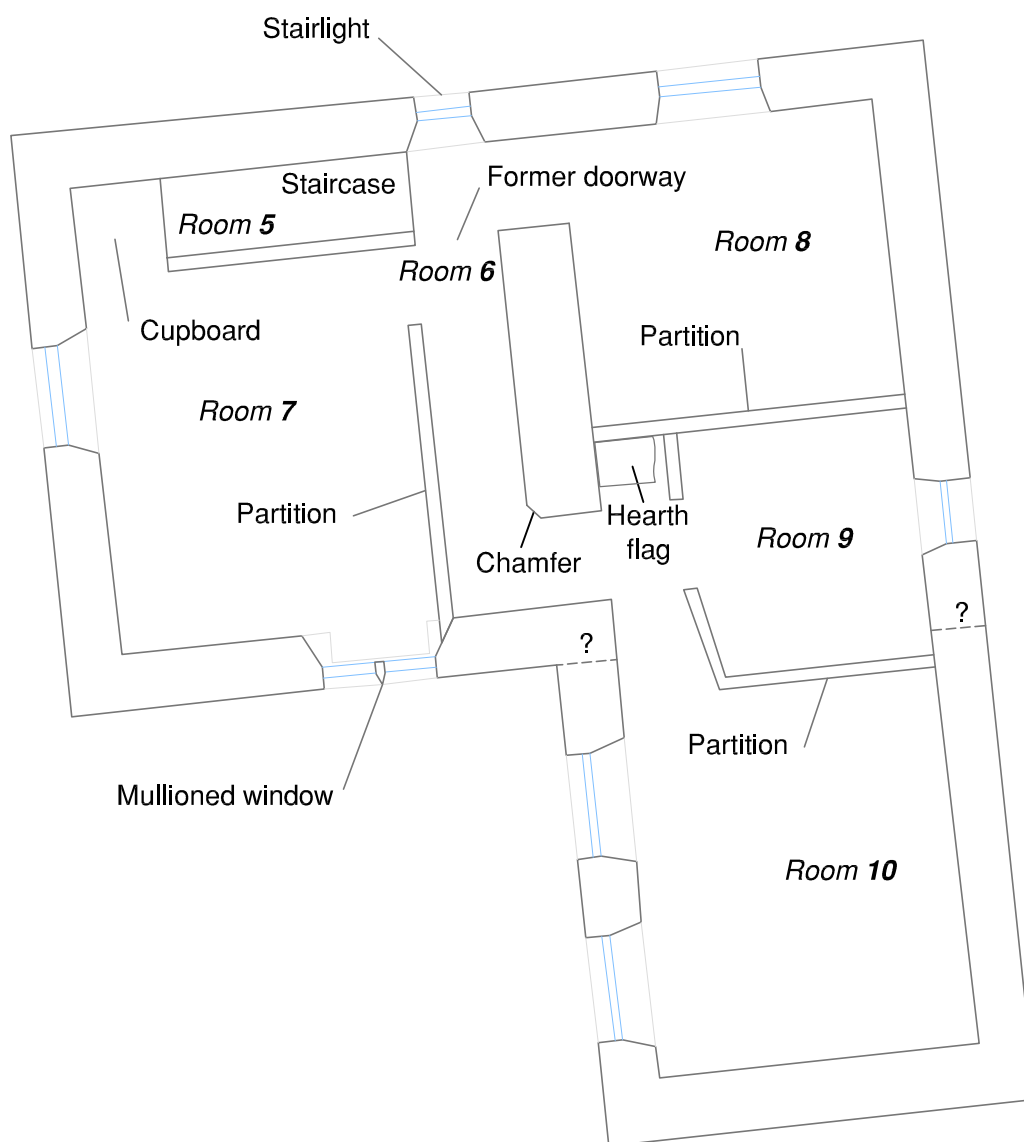
Figure 10: Upper Floor Plan of Garden Cottage

4.4.17 **Room 7:** this room is a bedroom and is situated above Room **1** (Fig 10) and is for the most part, plain in appearance. The door is six-panelled and has a rim lock. In common with all the internal doors in the building it has been stripped. The ceiling is 2.5m high, the south side sloping to respect the base of the south slope of the roof (Fig 11). The end of a rafter is visible which has been stripped and stained, the position of which corresponds to that observed in Room **5**. The floor is laid down to carpet over a quite uneven, probably board, floor. There are two windows present, one of which is a sash window of similar appearance to those described on the ground floor, and the other is identical to the mullioned window in Room **1** (Plate 17).

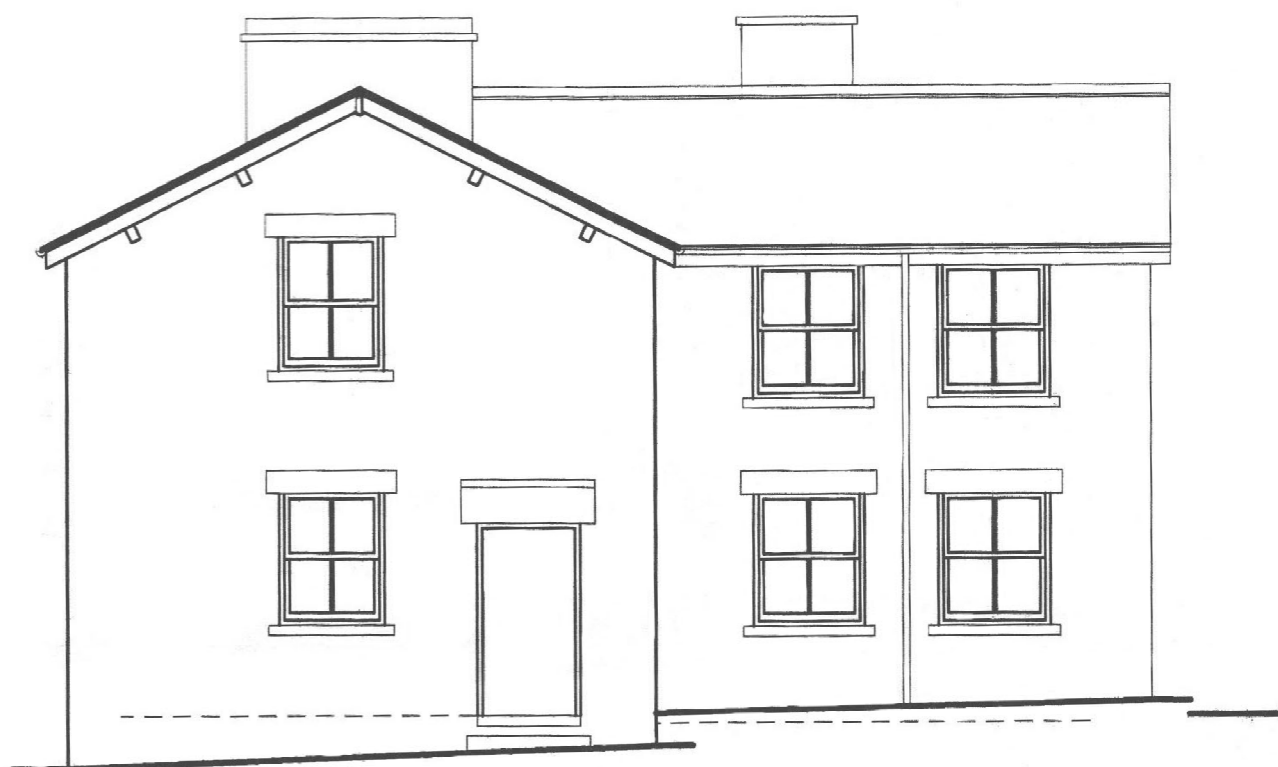
Figure 12: West elevation of Garden Cottage, Elevation 1

- 4.3.2 **Main (West) Elevation (Elevation 1):** this houses the main door to the house and forms the west-facing gable of the east/west part of the house (Plate 3). The west-facing elevation of the north/south part of the house will be discussed separately (see *Section 4.3.5*). It comprises two windows, one on each floor, together with the main entrance. These are laid out asymmetrically and the windows differ slightly in size (Fig 12). The lintel of the upper window is sandstone and appears to have been replaced whilst the lower is limestone.

- 4.3.3 The main door is reached via a large well-worn step and threshold, and the substantial lintel is chamfered. The soffit of the hood exhibits an incised drip mould. The jambs are crudely chamfered. It is apparent that each of the jambs has either been rebuilt or repointed, and a slightly different mortar has been used.

- 4.3.4 The projecting verge is visible and there are two projecting outriggers on each roof slope, together with a ridge plank at the apex. Sometimes the purlins project through the gable wall (as in Elevation **3a**, Plate 9), but these outriggers have been added to support the verge rafters. The purlins are of much more crude appearance (see *Section 4.4.24*) and probably did not project originally. The verge is boxed in and is not decorative. The ground slopes from south to north, and there are a few larger stones almost forming a plinth at the base of the elevation (see *Section 4.3.8* also).

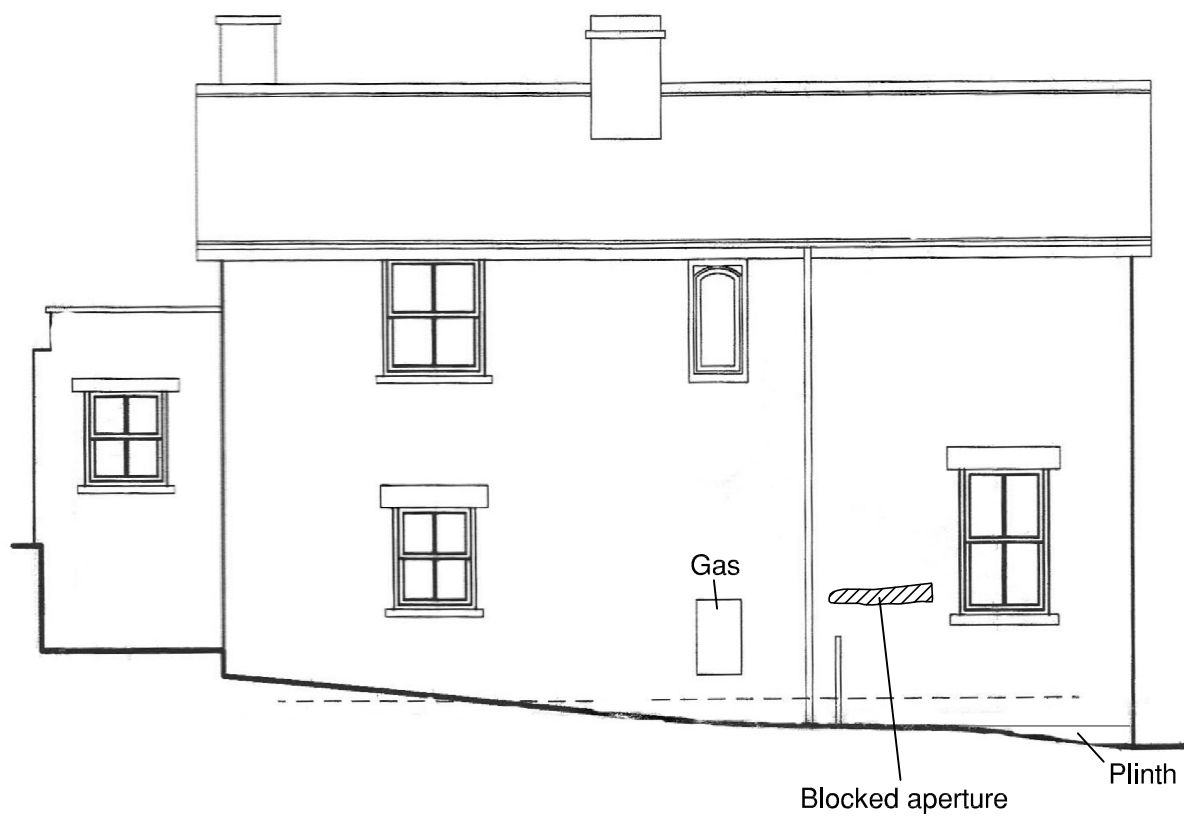
Figure 13: North elevation of Garden Cottage, Elevation 2

- 4.3.6 **North Elevation (Elevation 2):** this is the longest of the elevations and comprises the whole of the north side of the house, together with part of the rear extension (Fig 13, Plate 4). The elevation is asymmetrical and has four windows of varying sizes, three of which are of modern timber double-glazed sashes of identical appearance to those already described. The ground floor windows have limestone lintels of similar appearance to that of the ground floor on the west elevation. The upper window has no lintel. The western window jambs are crudely chamfered. The jambs of the eastern window appear to have been rebuilt and the sill is concrete. There is a casement window on the upper floor which allows light to the stairs. This has a tooled projecting sandstone surround that is similar in appearance to the mullioned windows on the south elevation and is probably contemporary (see *Section 4.3.10*). The frame has a three-centred arched head.

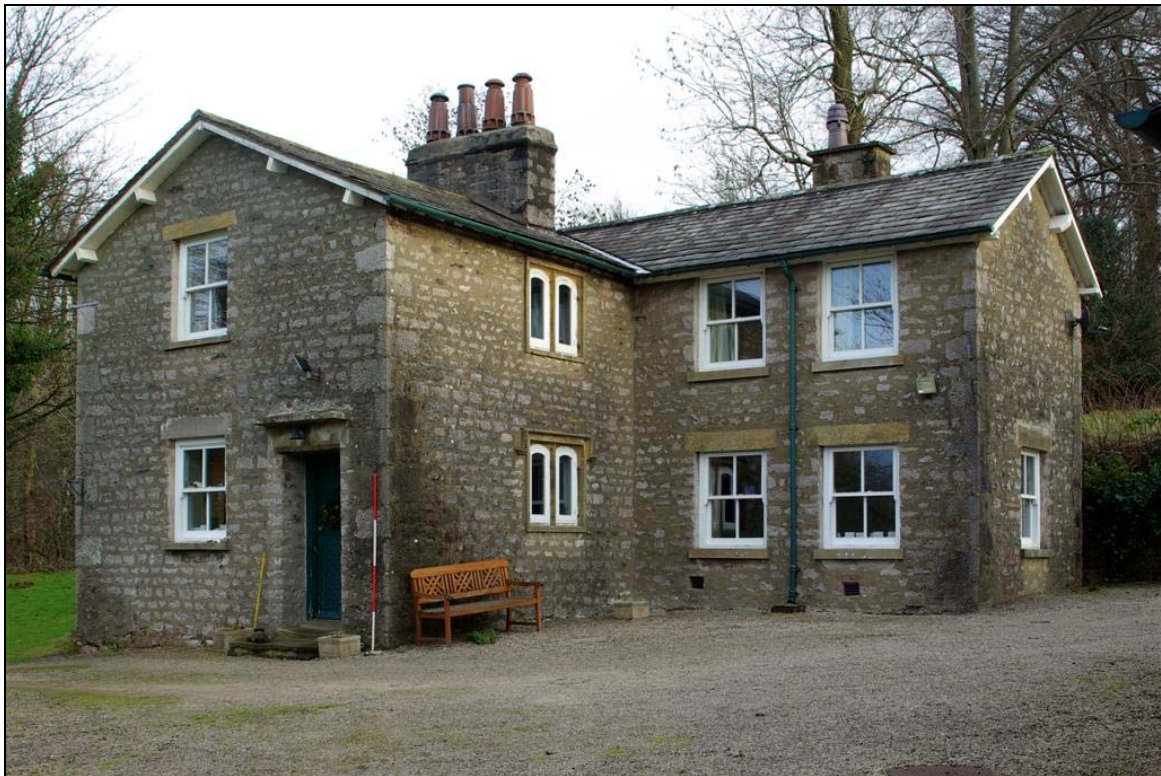
Plate 2: Three quarter view of Garden Cottage

- 4.2.2 **Fabric:** the cottage is constructed from coursed limestone rubble-stone (Plate 2). All the elevations have been re-pointed using cement mortar that has been smeared and obscures the joints. This may also obscure evidence for rebuilding and/or blocking. There is, however, evidence of previous pointing on the east elevation, which is lime based. There is also evidence to suggest that the exterior of the cottage was limewashed/lime-rendered at some point, as fragments of lime still cling to some of the surfaces. Each corner consists of substantial quoins, most of which exhibit tool marks.

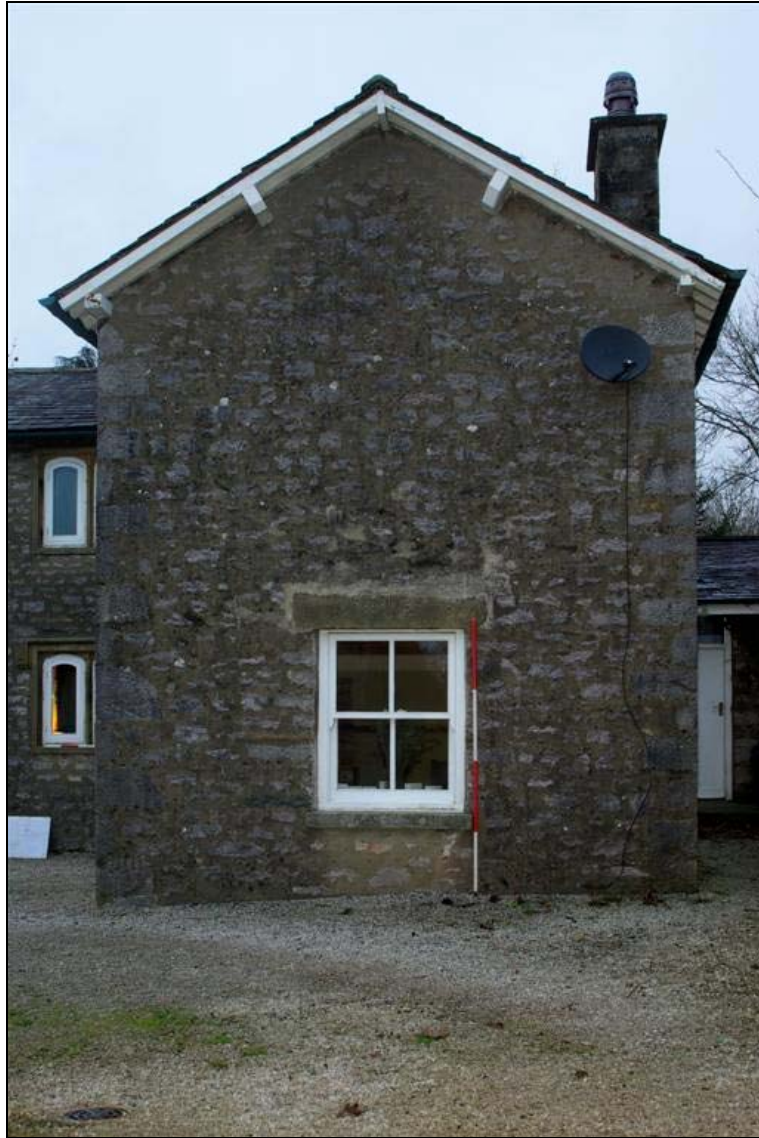
Plate 9: South gable elevation of Garden Cottage, Elevation 3a

- 4.3.11 **South Gable Elevation (Elevation 3a):** this forms the south gable of the north/south part of the cottage (Plate 9). There is a single ground floor sash window that is symmetrically placed and is similar to those already described. For the most part, the elevation is plain and the most interesting feature being the projecting members which, unlike the others on Elevation 1, are in fact projecting purlins. They have been given a simple decorative end treatment. The pitch of the roof is somewhat steeper than that observed on Elevation 1.

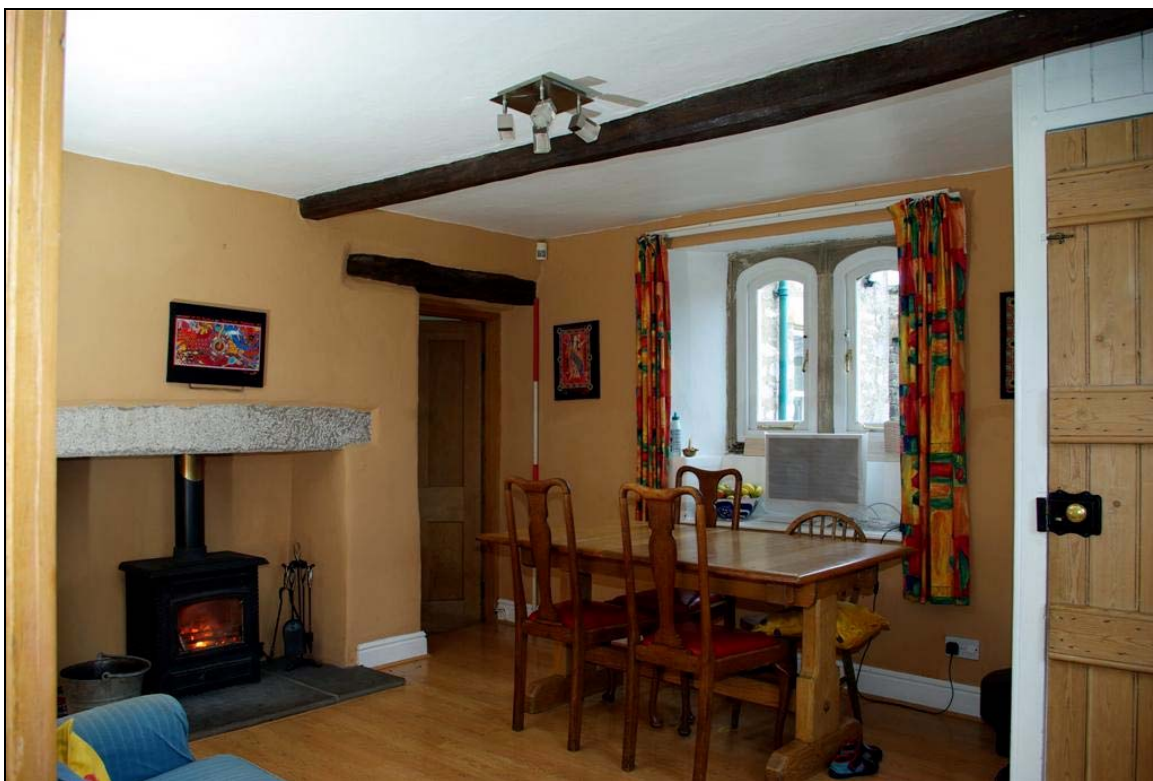
Plate 11: General view of Room 1

- 4.4.3 The main part of the room is plain and all the walls, except the north wall, are solid and plain plastered (Plate 11). As with the other rooms in the house, it has been comprehensively modernised, and the lintels above the doors into Rooms 2 and 3 have been revealed. There is a single large fireplace set within a wide chimneybreast on the east wall, which is of late twentieth century appearance, and it is likely to have once housed a range. The large lintel has been inserted recently (G Mawdesley pers comm), and a wood burning stove provides heating.

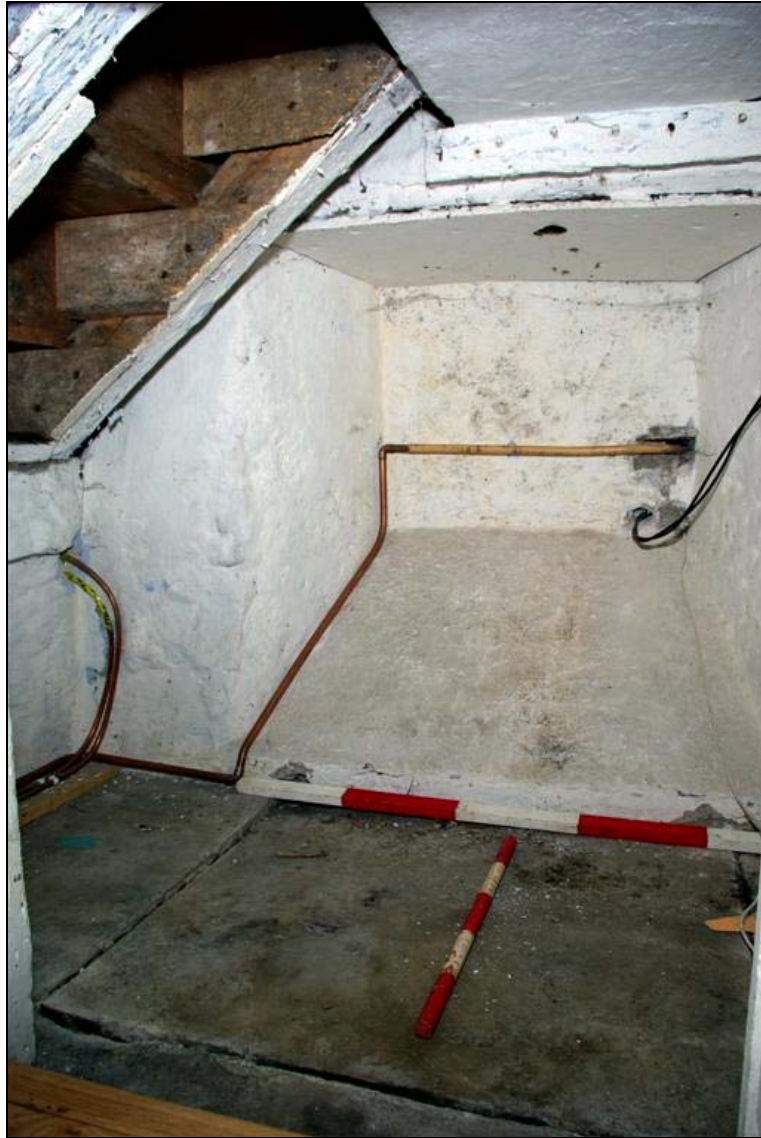
Plate 13: Small cupboard below the stairs in Room 1

- 4.4.6 Access to a small space below the stairs is available via a small matchboard door. Upon inspection, this was revealed to be a small cupboard, with a flagged floor (Plate 13). The floor apparently continues into the main part of Room 1 (G Mawdesley pers comm) that is now overlain by a timber laminate floor of recent origin. The north wall has a splayed reveal, with a sloping sill and timber lintel that corresponds to the large sill observed on the north elevation (see *Section 4.3.10*). This appears to have once been an opening, possibly a coal/fuel chute. The east side of the cupboard has a flag orthostat, above which is a stone shelf. There was no evidence of a basement/cellar. A second cupboard is located opposite the entrance to Room 2, detailed inspection of which was impossible.

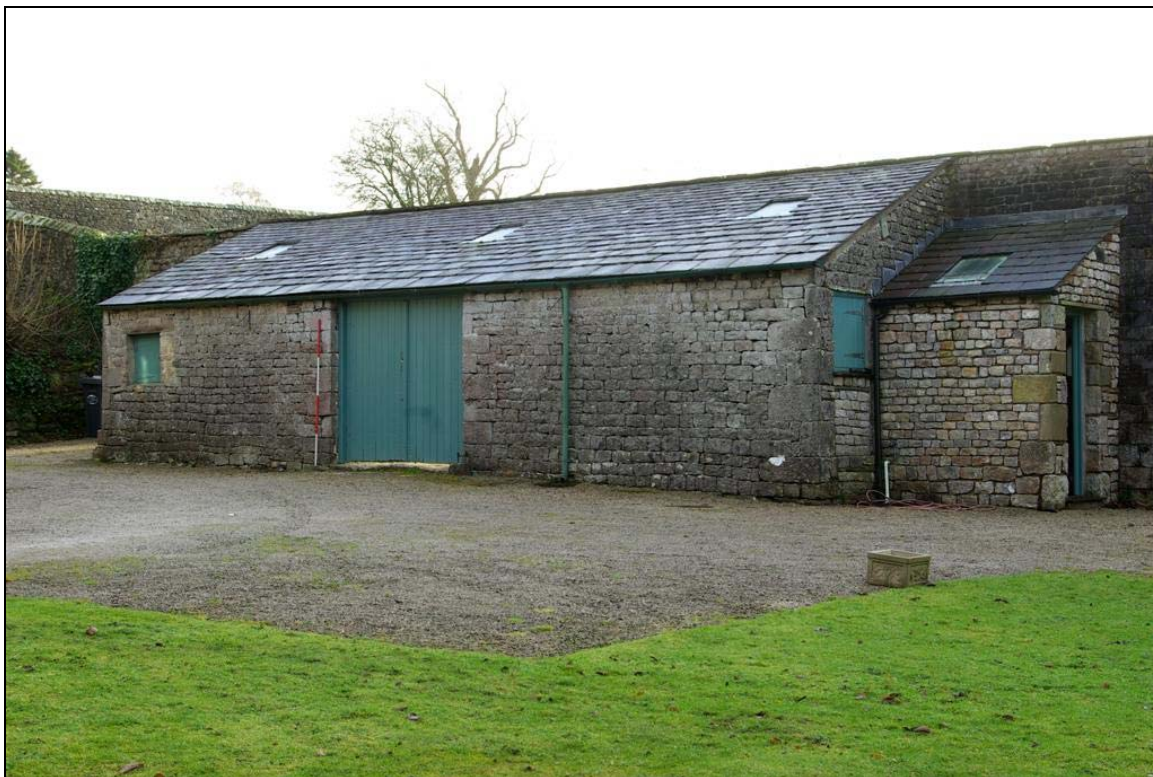
Plate 21: South-east-facing view of the outbuilding

- 4.5.2 **Fabric:** the building is constructed from coursed, squared limestone rubble, which is laid in slightly diminishing courses (Plate 21). There are substantial roughly-squared quoins at the corners and door jambs that exhibit picked tool marks. Most of the mortar (where present) is lime, that is weathered in places, with some localised repointing and repair. The roof is of slate, and three reinforced glass roof lights are present. The window openings have either timber or stone sills and lintels, and the main double doors are timber. The rain water goods are iron and PVCu, the guttering being supported on wrought iron brackets. There is a small toilet attached to the west elevation that is of modern construction (G Mawdesley pers comm).

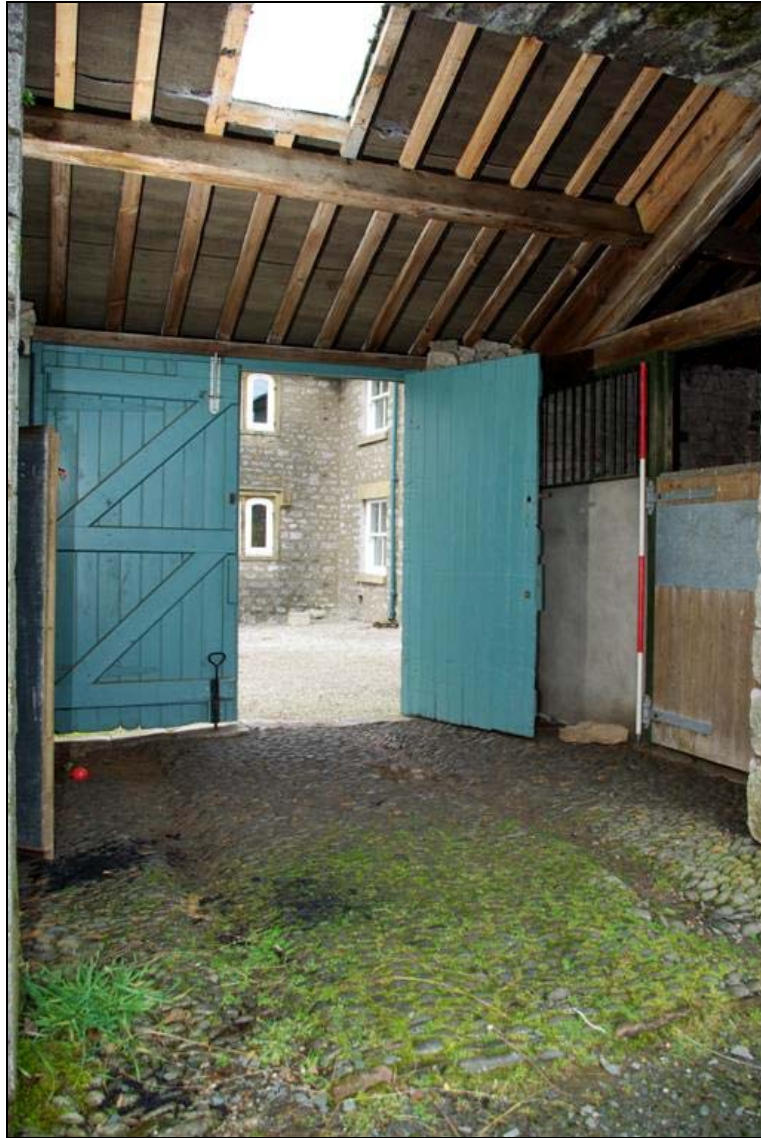
Plate 25: The passage through the outbuilding (Room 11)

- 4.7.2 **Room 11:** this room forms a passage that allows access and egress to and from the walled garden. The most obvious feature is the cobbled floor, which is deeply rutted due to vehicular traffic. There is some damage but most of the floor is in relatively good condition.
