St Mary's Church, Lyford, Oxfordshire

Archaeological Watching Brief

July 2017

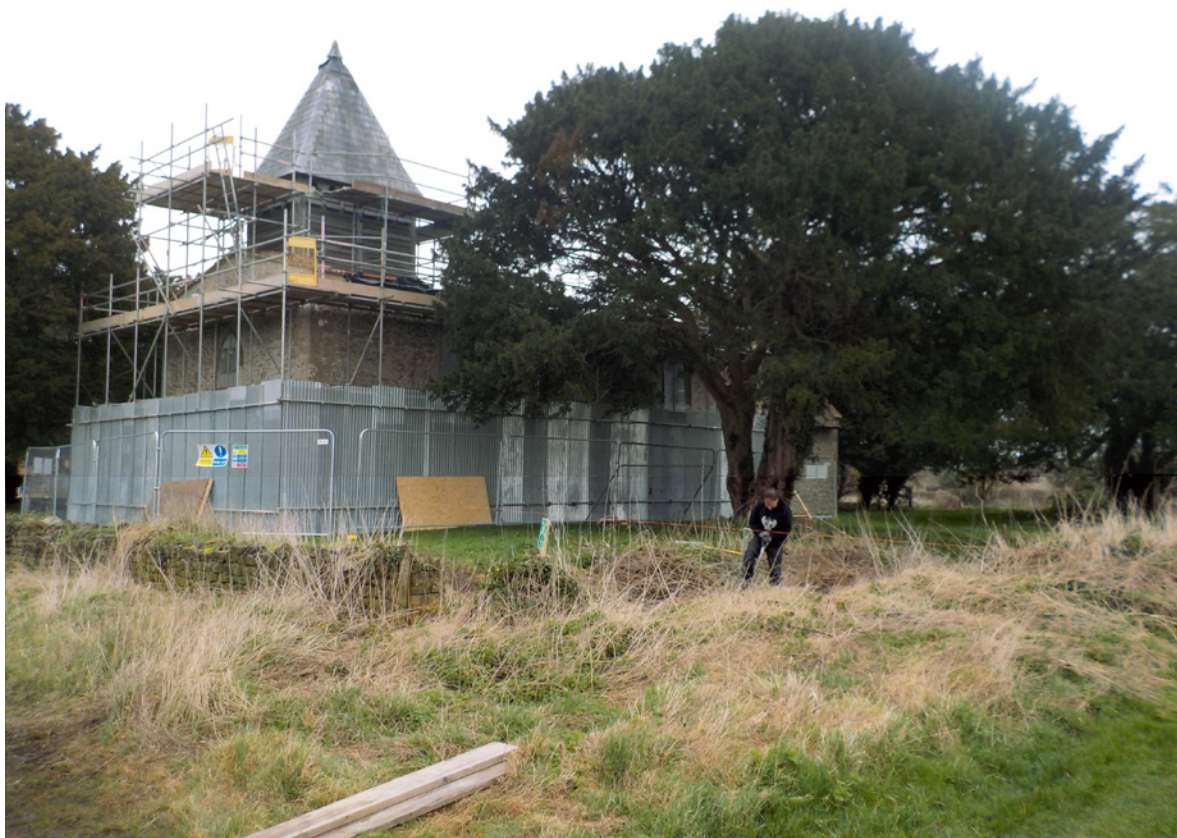
Plate 1: St Marys Church - looking NE

1.2.2 The area of work comprised the churchyard and the edge of an adjacent field just beyond the churchyard's southern boundary. The churchyard is elevated above the level of the surrounding ground due to repeated burials (Plate 1).

1.3.1 St Mary's church comprises a nave with clerestory, chancel and north porch. A timber-framed bellcote rises from within the line of the west end of the nave (Plate 1). The building dates from the early 13th century and much of the original church remains today, although the bell tower and clerestory were added in the 15th or possibly the early 16th century. Extensive renovation was carried out in 19th century, when the north porch was added, incorporating a 15th century oak arch-headed doorway.
