**Christchurch Park, Ipswich**  
**An Archaeological Evaluation of a Former Pond F11**

Rob Atkins and Dennis Payne

January 2005

Report No. 787

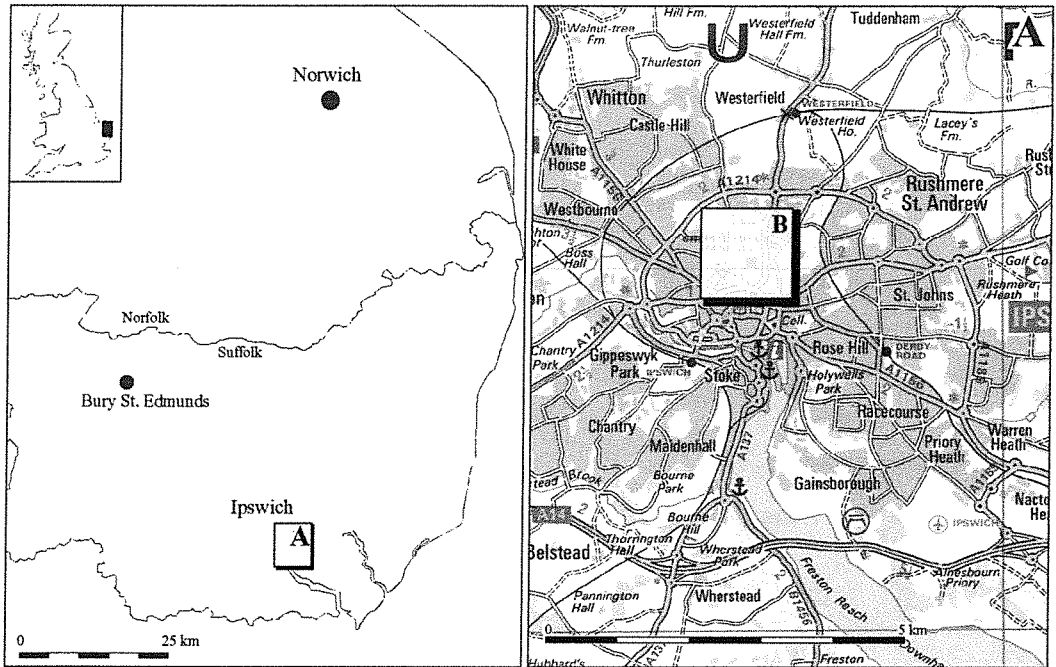
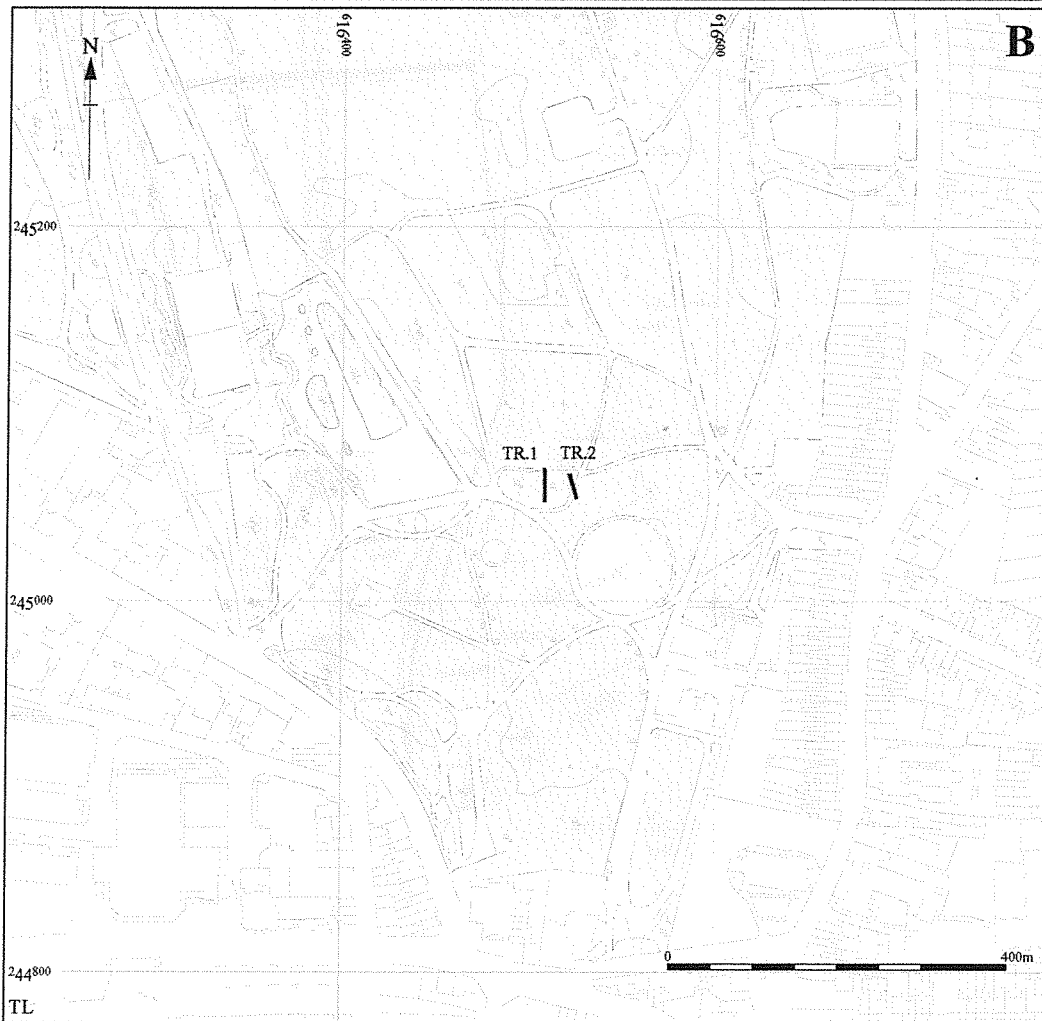
**Figure 1** Location of Trenches

A mechanical excavator with a 1.6m wide ditching bucket was used to excavate two trenches under archaeological supervision (Figs. 1 and 7). The trenches were located away from mature trees and were excavated down to the natural sand silt geology. Due to the depth of deposits both trenches had to be widened and stepped down. Heavy waterlogging on the site impeded the excavation works and a pump had to be used to remove water flowing into the trenches from the springs. Parts of the trench sides collapsed from the pressure of the water of the springs flooding into the trench. The evaluation shows that the natural water table is less than 1m below the present ground level.

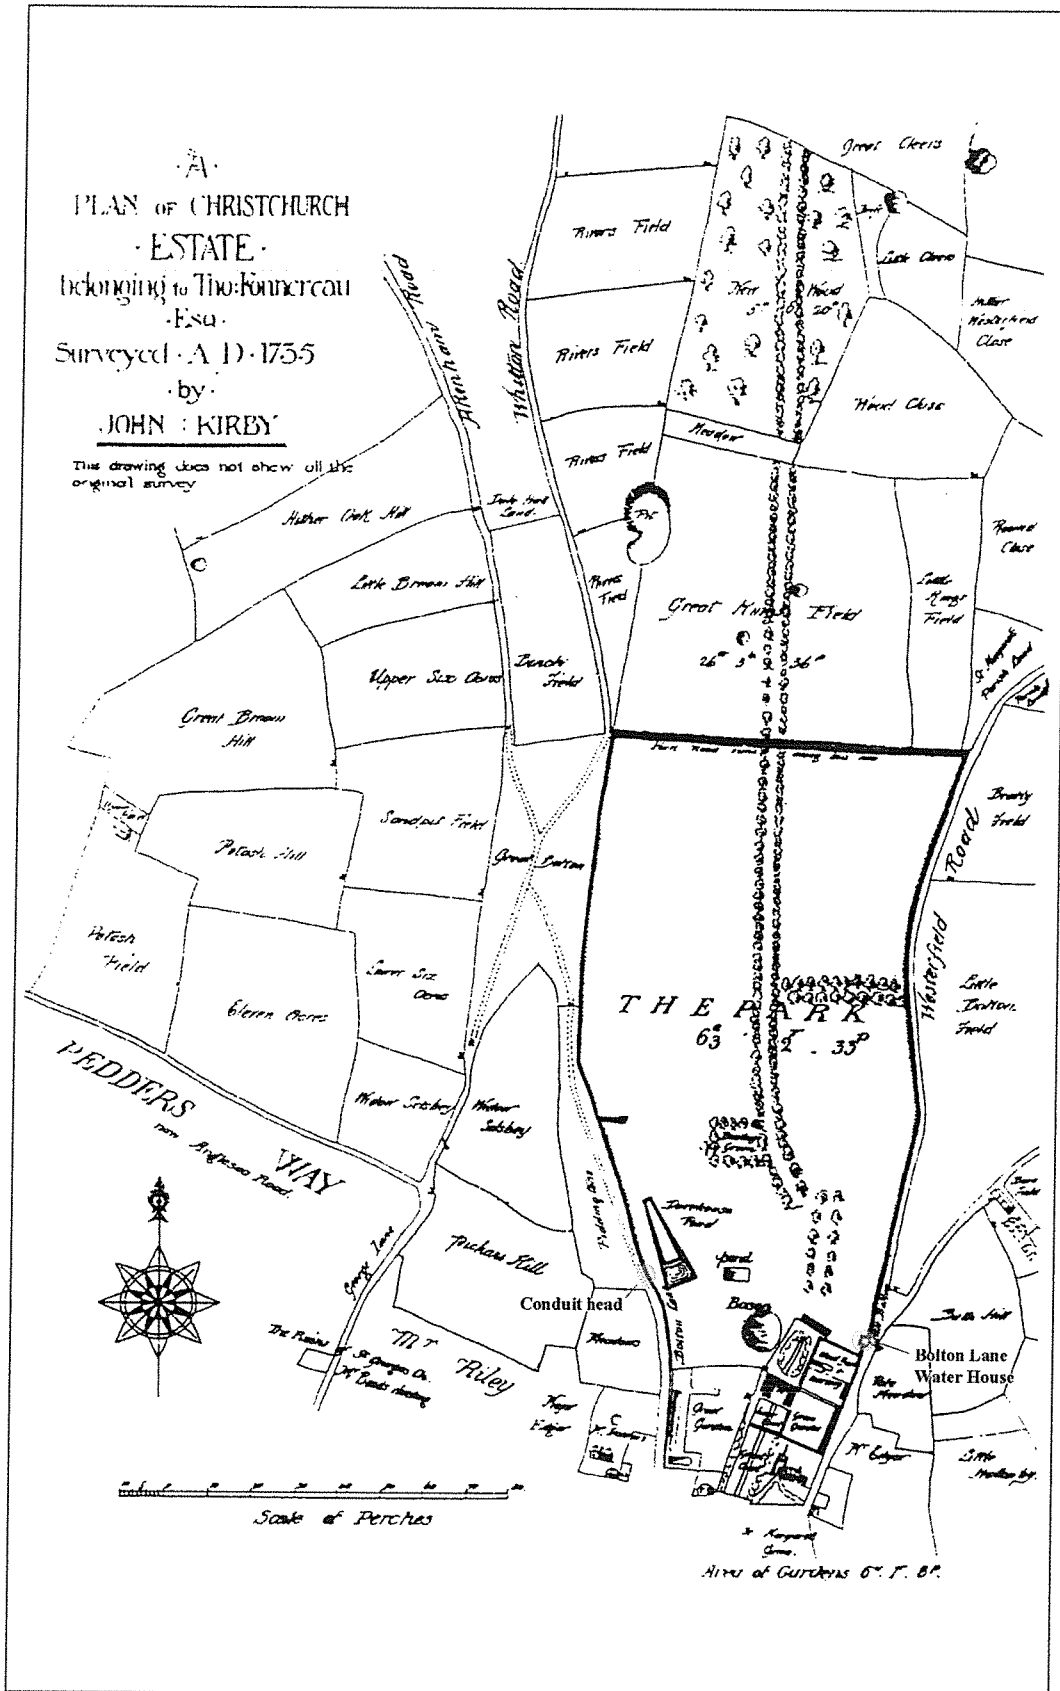
Figure 2 1735 Kirby map with position of water supply for the town and former Priory (after Allen 2001, pag. 8)

The present park is within the grounds of the former Augustinian Priory of the Holy Trinity, with its foundation in the twelfth century. Included in the park is a significant portion of the precinct of the post-Conquest religious house. Breen (2003, 13) has raised the possibility that a building from the former Priory survives in the foundations of the present Mansion house (brick work surviving in the cellars). Some of the present parkland lakes and terraces probably originated in this medieval period. Documents indicate that former medieval ponds supplied the monks with carp, trench, roach and gudgeon (Breen 2003). Among the details at the dissolution there was a reference to "*several fishings iij ponds and stewes within the scite of the late house very comodius and well replenysed with fisshe*" (quoted in Breene 2003, 6). These ponds seem to relate to fish ponds shown along Dairy Lane in the Speed map as well as the later Kirby map of 1735 (Fig. 2).

There is no documentary evidence for the source of water which supplied Holy Trinity Priory itself but it was very probably taken from very nearby (Allen 2001, 33). Allen suggests that the supply could have been from the former Bolton Lane water house which had stood in the 19th century behind the Mansion, abutting on the boundary wall adjoining the present-day Bolton Lane (Fig. 2).

Allen suggests that the water supply for this part of the town was probably from a conduit head just to the west of the Wilderness pond (Allen 2001; Fig. 2). The park itself was opened to the public in 1724 by the then owners. The 1735 Kirby map shows the landscape design of the park in this period (Fig 2). In 1894 it was given to the council and became a public park.

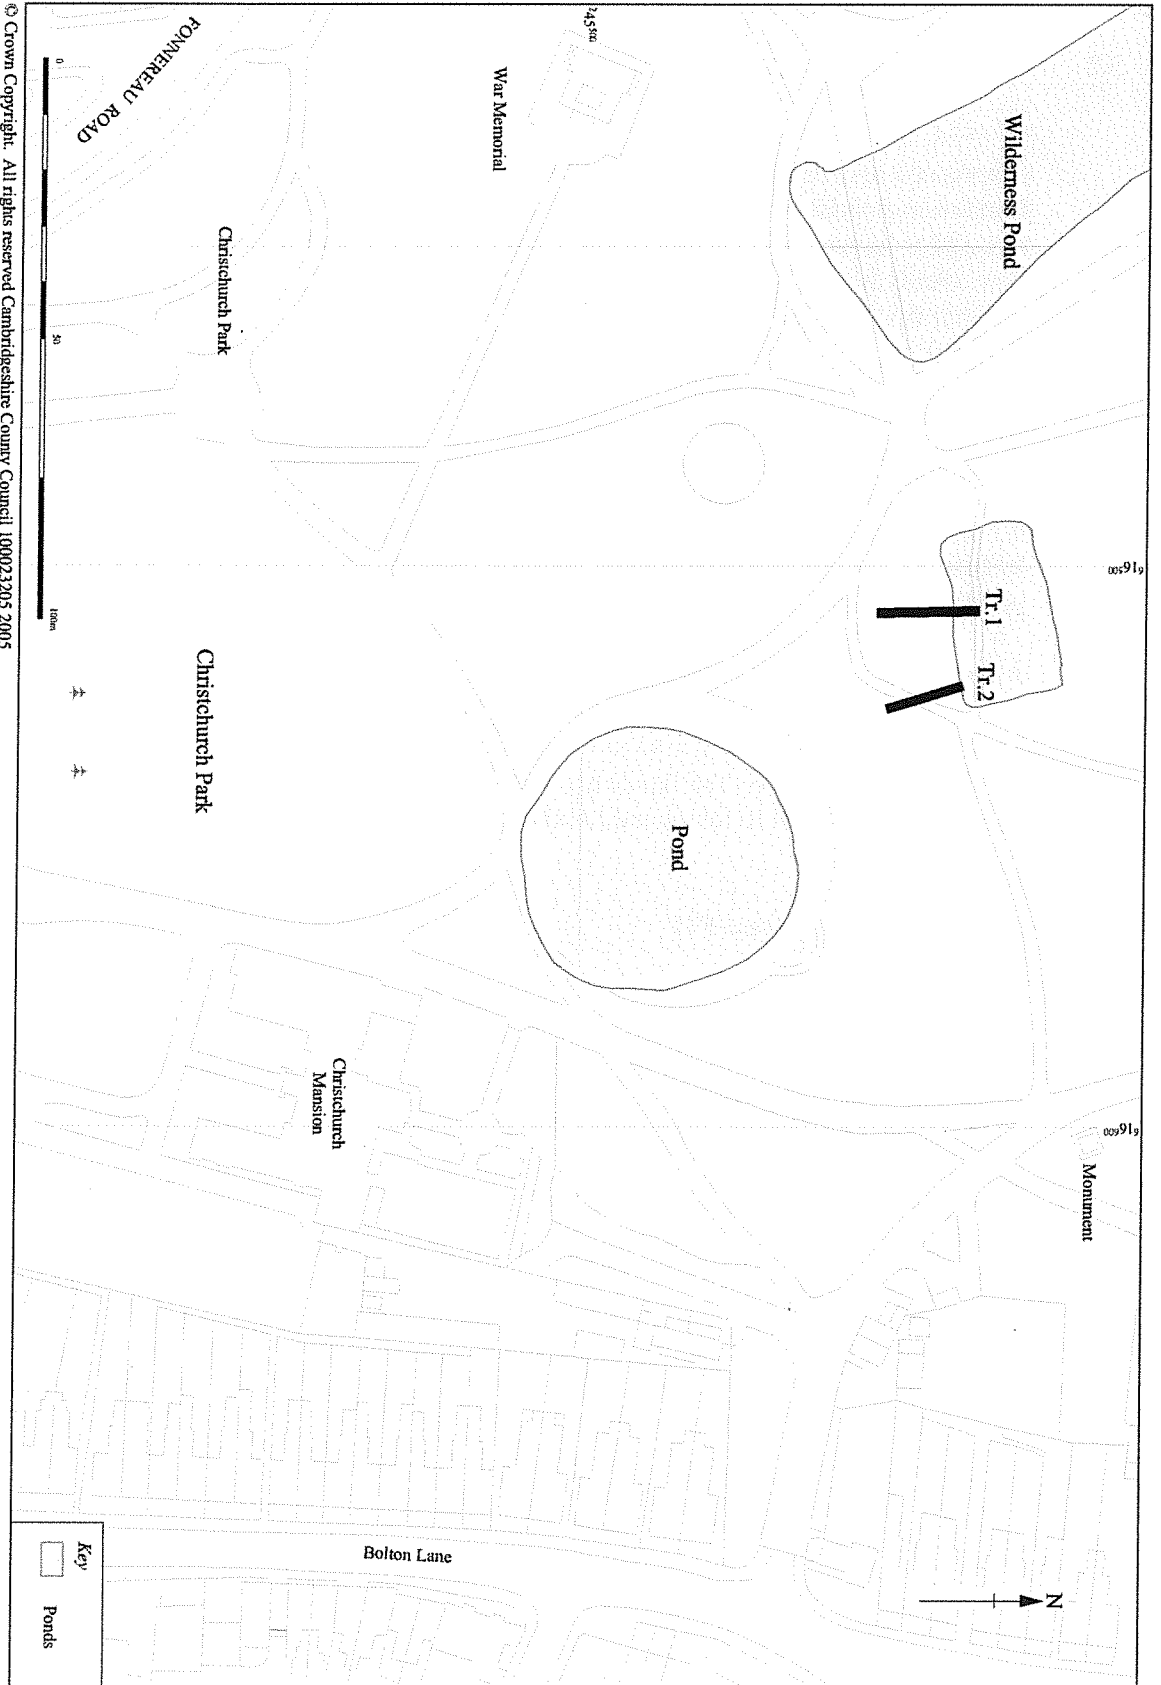
© Crown Copyright. All rights reserved Cambridgeshire County Council 100023305 2005  
*Figure 3 John Kirby Estate Map (1735) overlaying modern OS map*

### John Kirby Estate Map, 1735 (Figs. 2 and 3)

The earliest map that shows the pond under investigation is John Kirby's Estate Map of 1735. The 1735 map seems fairly accurate with the round pond and the south eastern corner of the wilderness pond located well (although the orientation of the latter is slightly out). Former pond F11 is on the northern periphery of the site. The two archaeological trenches would have just entered the southern edge of the pond.

The pond is sub-rectangular in shape approximately 30m x 18m. Comparing this map with the later maps of 1848 (Fig.3) and 1867 shows the pond to be orientated slightly differently – more to an east-west alignment rather than a slightly more northwest-southeast alignment. The probable reason for this is that the 1735 map was less accurate.

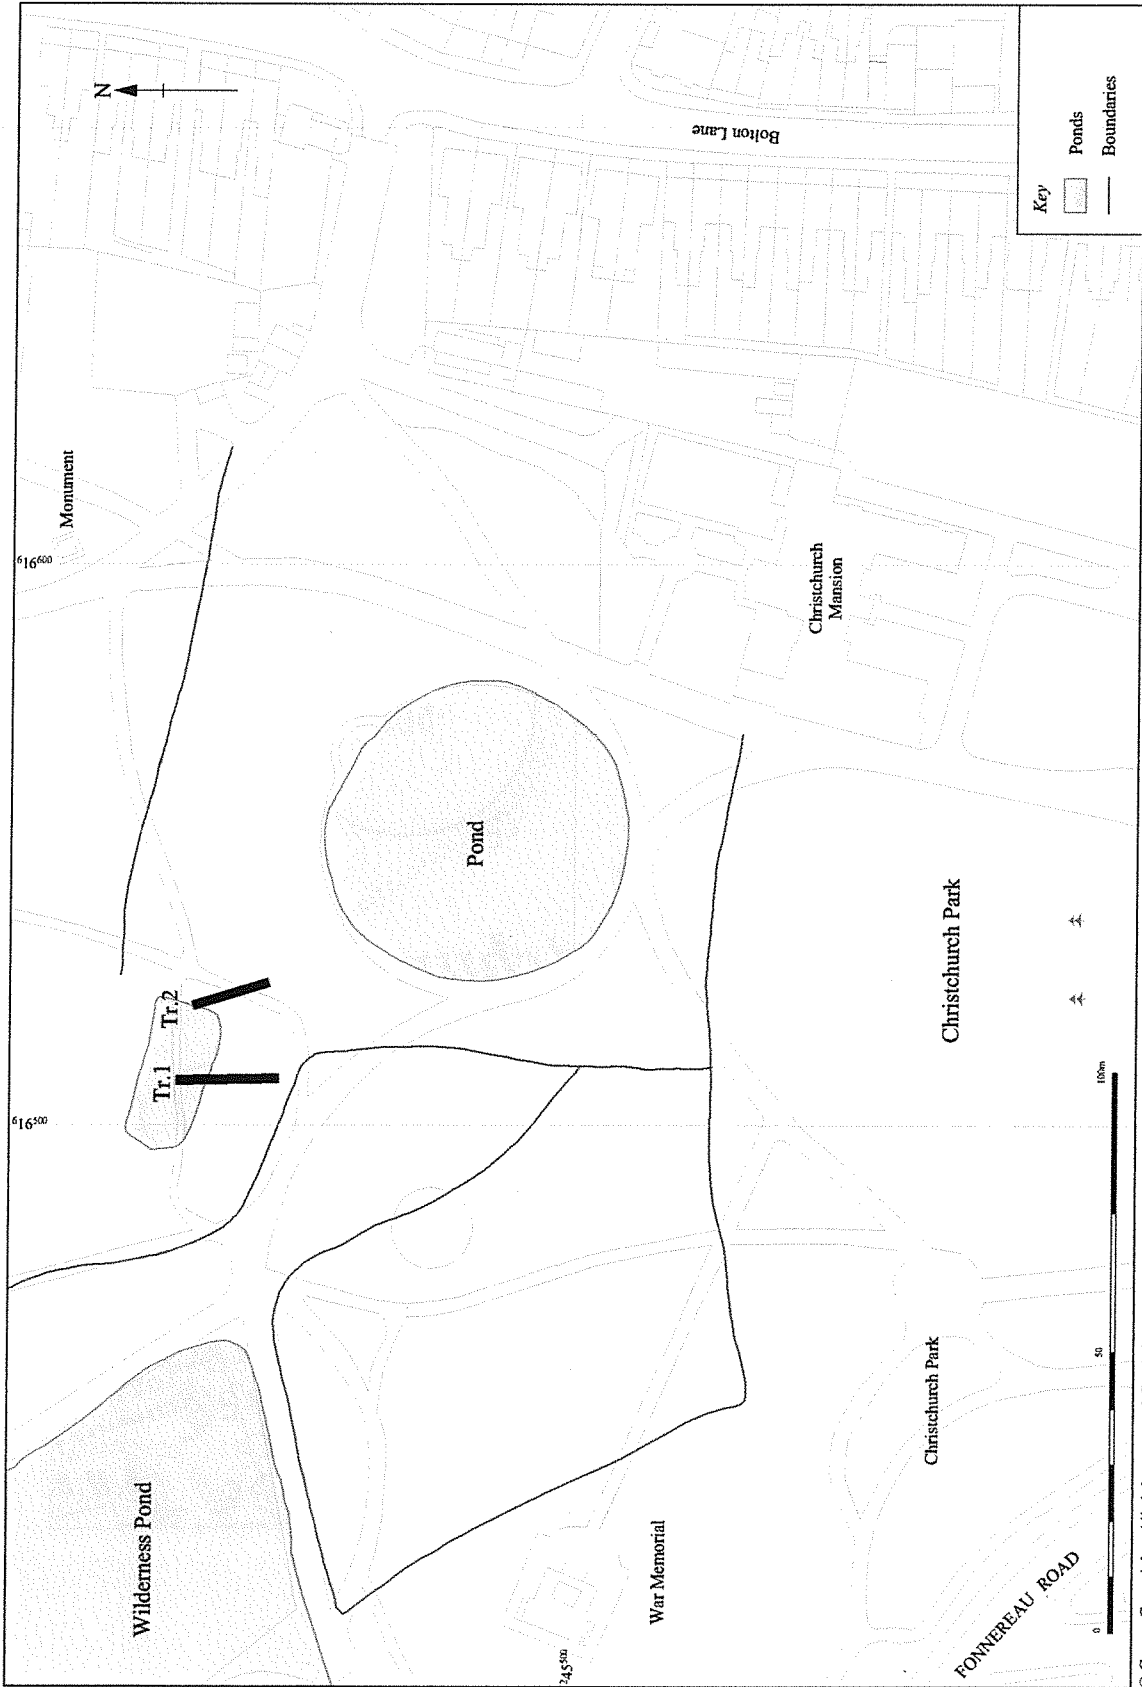
**Figure 4 Edwin White Survey (1848) overlaying modern OS map**

### Edwin White Survey map, 1848 (Fig. 4)

The 1848 map seems to be very accurate with the round pond and the wilderness pond accurately located. This would give a lot of credence to the 1735 map which also places pond F11 on the northern periphery of the site. The pond (F11) is clearly shown as sub-rectangular c.25m by 13m. An east to west fence (shown in plate 1) stops near the north-east corner of the pond. There are no trees recorded in the proximity to the pond.

The photo must have been taken between *c.* 1848 and *c.* 1867 as the fence in the foreground has extended from its 1848 position (Fig. 4) to run across the northern boundary of the pond shown on the 1867 map. The lack of trees in the foreground may imply a date nearer 1848. The pond edge is vertical and this may imply the pond was lined. This lining would seem to be several courses in depth as the water level looks to be about a metre below the top of the pond.

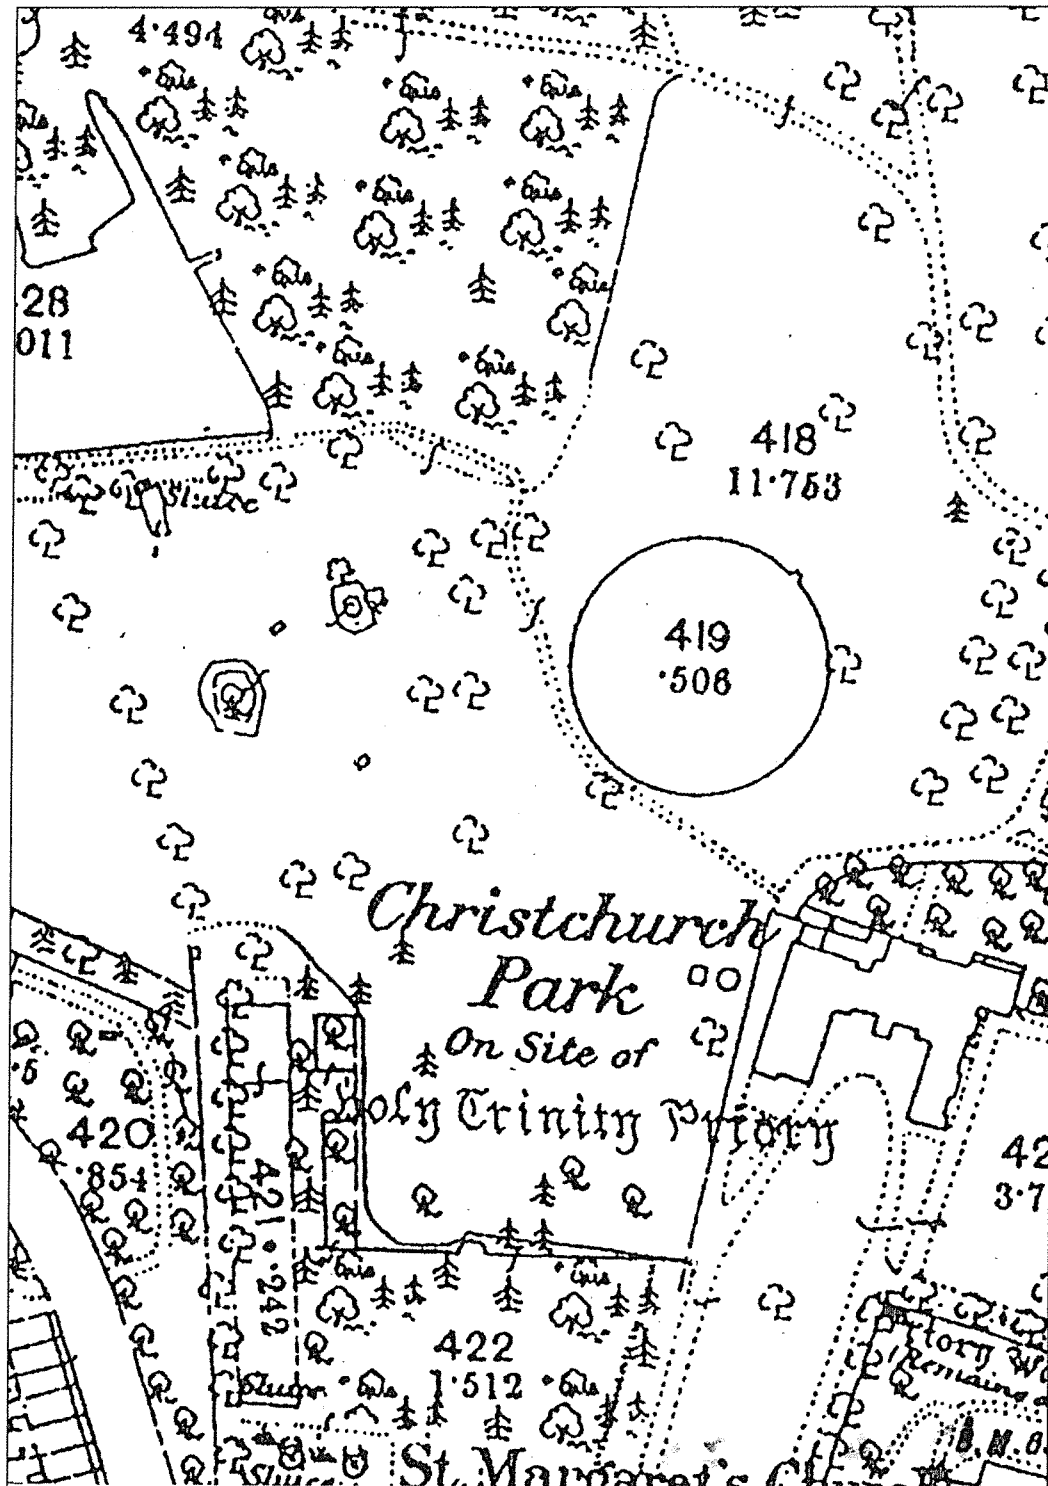
Figure 5 1884 1st Edition 25" Ordnance Survey map

#### 1st Edition 25" Ordnance Survey Map 1884 (Fig. 5)

The 1884 Ordnance Survey Map clearly shows that the pond had gone. What is shown in its place is an area of trees (which has been expanded) with a footpath just to the south and east of the former pond.

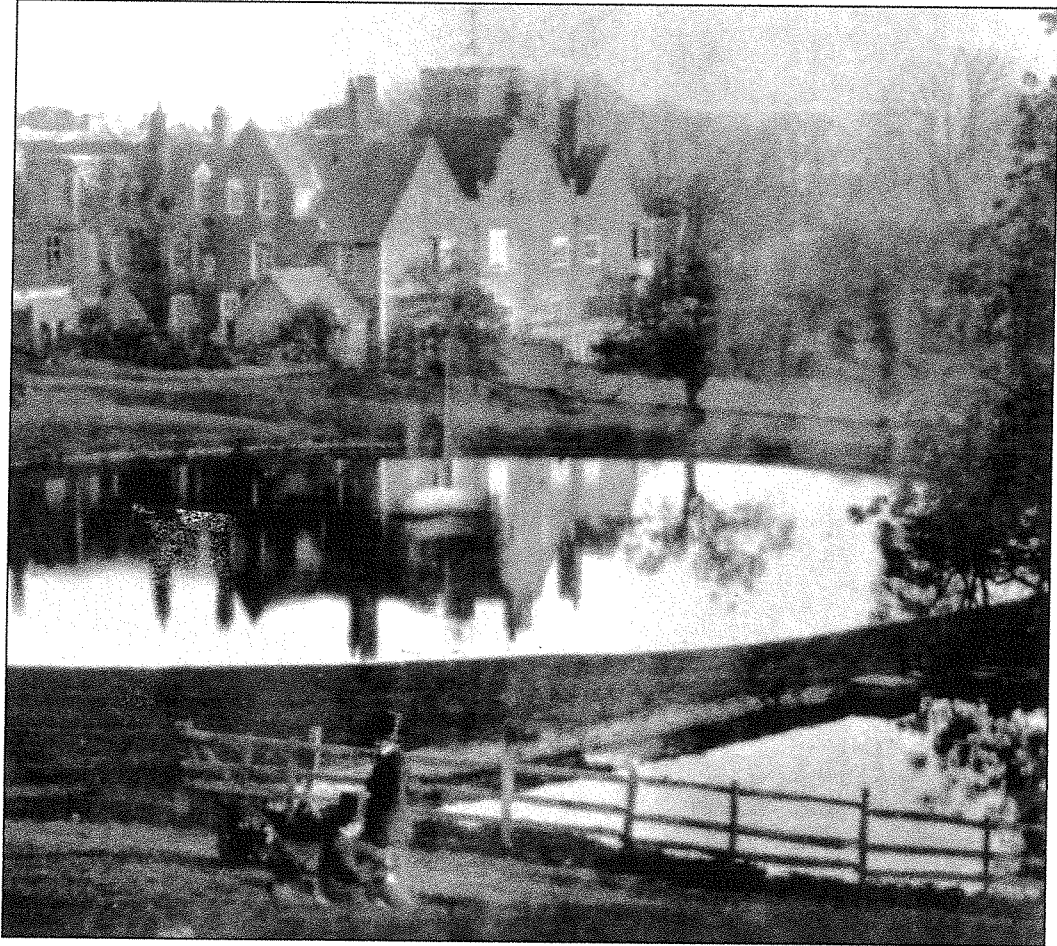
### **3.4 Circa 1850 photograph (Plate 1)**

*Plate 1 Circa 1850 photograph showing F11 on the foreground and mansion in the background*

The Edwin White Survey 1867 map locates the pond in the same position as his 1848 map although the pond is less rectangular in shape with the eastern side being more rounded. The east to west fence has been extended across north boundary of the pond (see Plate 1) and trees planted to the north of the pond and fence.

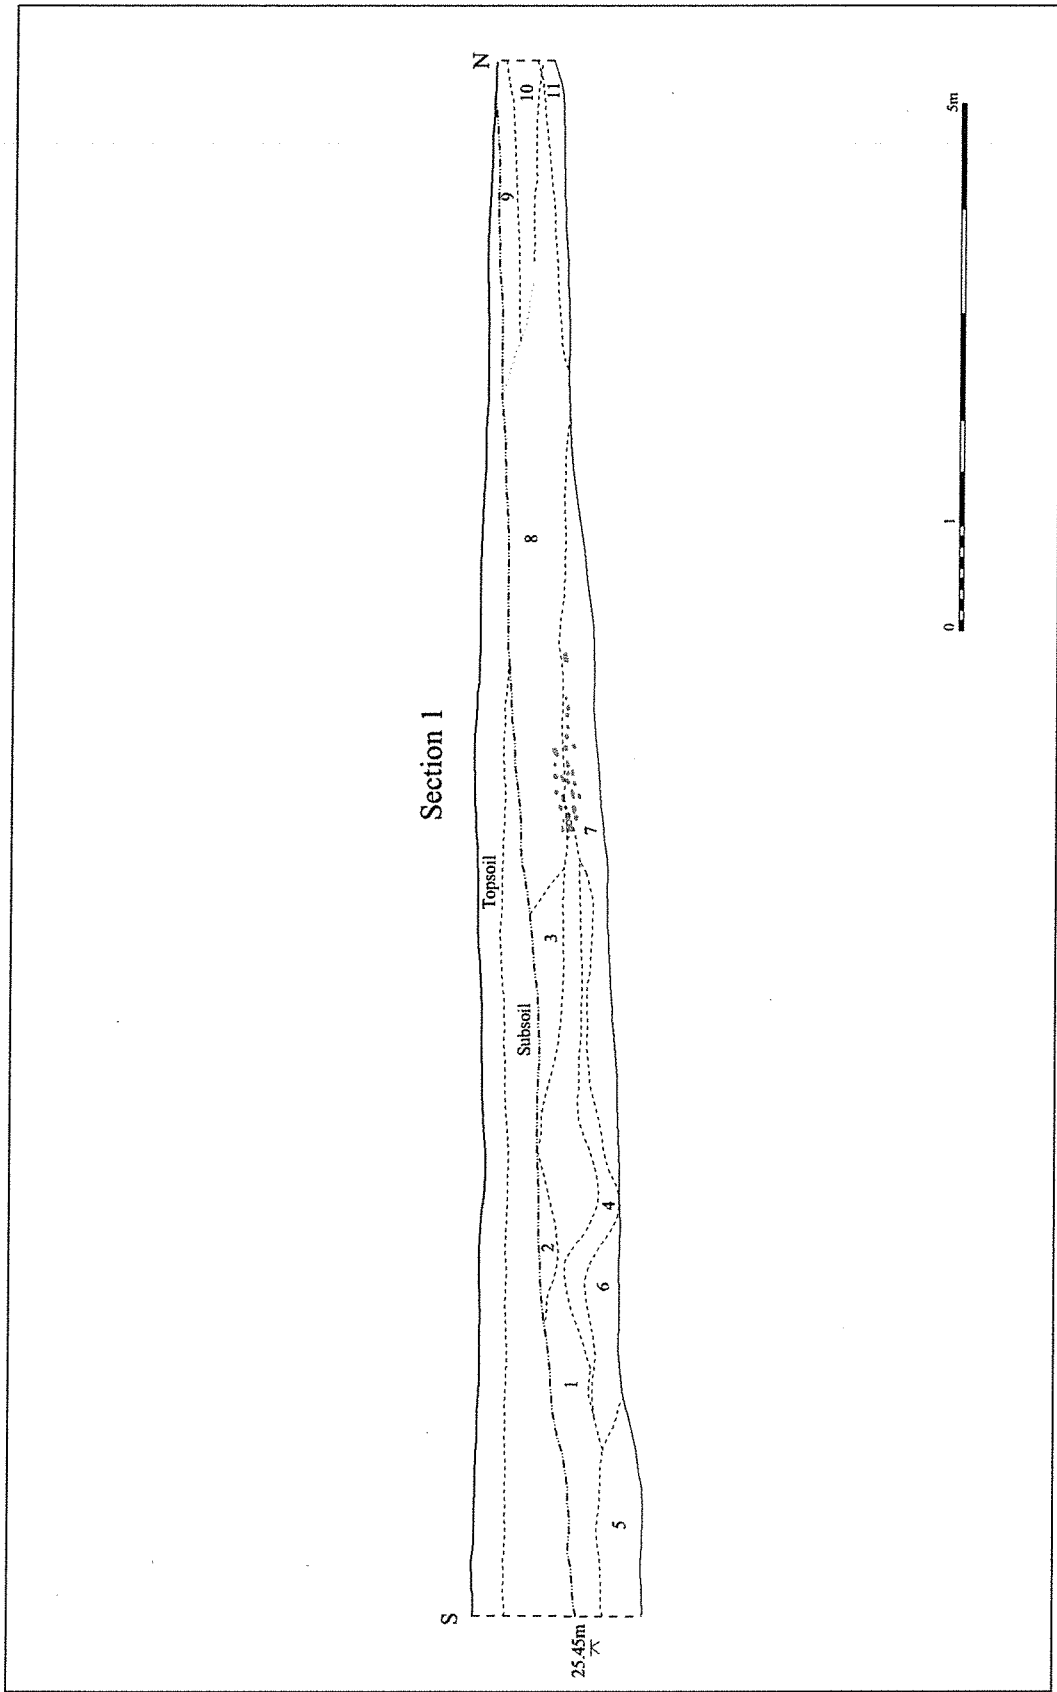
Figure 7 Trench 1 section

### 5.1 Trench 1 (Fig. 7)

Trench 1 was 18m long and ran north to south through the middle of the terrace. Natural silty sand was exposed below 0.6m of deposits on the northern side of the trench to 1.6m of deposits at the southern part. The deposits consisted of eleven layers of silt deposits (Table 1). These layers were very different deposits in both colour (from yellow to black as well as from very organic to clean redeposited natural). It seems that the deposits were largely dumping layers coming from several different locations as well as some possible fluvial material consistent with run-off from the springs.

The layers were clean of material except a large amount of 17th century or 18th century bricks dumped within part of layers 7 and 8 in a 1.2m wide area and 0.22m deep (Fig. 6). The bricks originally had been part of a structure as lime mortar was still adhering to them. A couple of modern glass fragments were found in the topsoil and subsoil.
