# **Clayton Brook Pipeline Walton Summit Lancashire**

## **Archaeological Watching Brief**

**Document Title:** CLAYTON BROOK PIPELINE, WALTON SUMMIT,  
LANCASHIRE

**Document Type:** Archaeological Watching Brief

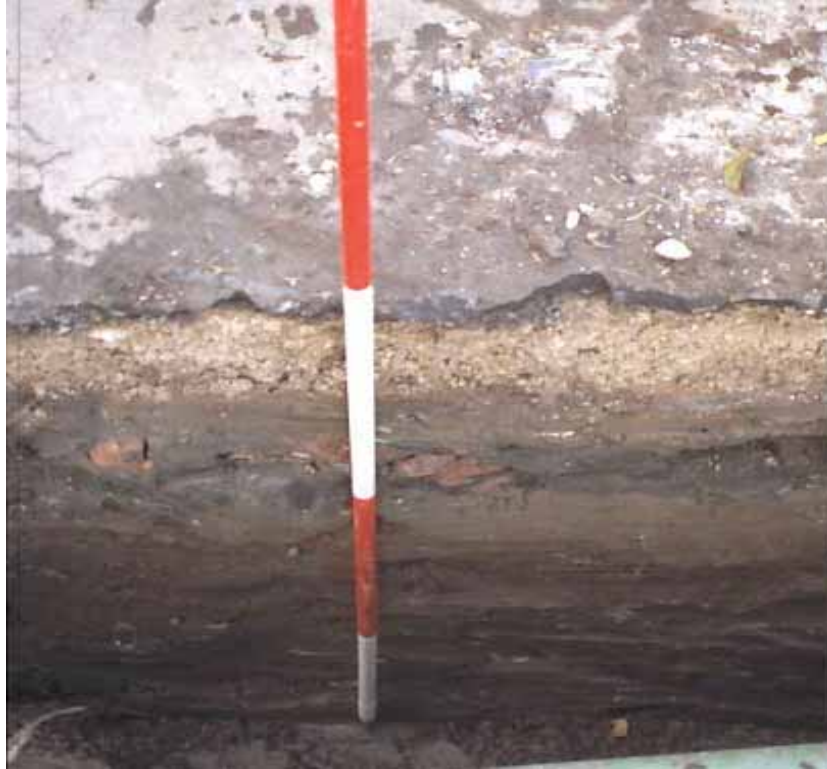
Plate 1 : North-east-Facing Section, Trench 1

- 3.1.3 **Trench 1:** being approximately 30m in length, Trench 1 was 0.6m wide, 1.35m deep and situated northeast of the location of the canal warehouse. The stratigraphy varied, but largely comprised 0.5m to 0.6m imported mid-brown sandy clay directly above a layer of 0.25m to 0.3m of rubble consisting of brick fragments with modern plastic inclusions within a matrix of sandy clay (Plate 1). This layer lay directly above very firm, mid-brown grey homogenous clay with the occasional rounded boulder not more than 0.4m in diameter. The layer comprised entirely redeposited clay from the construction of the M61. There were no finds and no horizons of archaeological significance present.

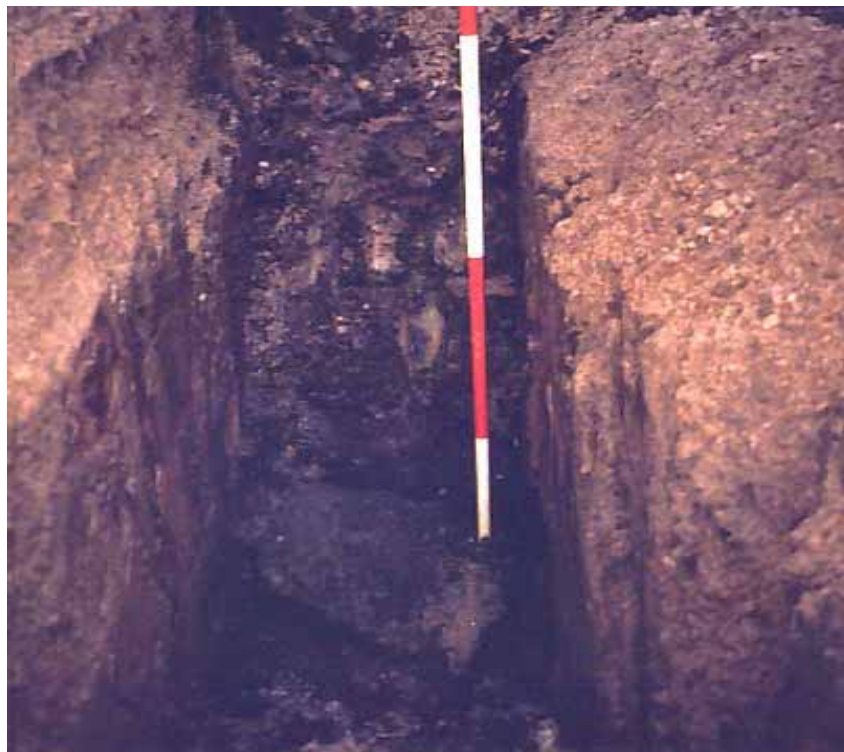
Plate 2: Sandstone Blocks as First Encountered

- 3.1.6 At a point level with number 44 Woodfield and c 25m south-east of Manhole 6, two sandstone blocks were encountered at 1.35m below ground surface, seemingly placed one on top of the other and lying transversely across the trench (Plate 2). They were beneath the redeposited clay layer and embedded in a very dark grey to black organic-rich sand silt matrix with lenses of sandy clay. Further excavations to this depth revealed a surface comprising one course of sandstone blocks laid transversely across the trench (Plate 3). The sandstones were not present in the north-eastern quartile of the trench and appeared to taper off towards the south-west. Several of the sandstones were necessarily removed and were seen to be only roughly hewn. They were not of any uniform size as one measured c 0.4m x 0.3m x 0.15m whilst another measured 0.65m x 0.3m x 0.15m.

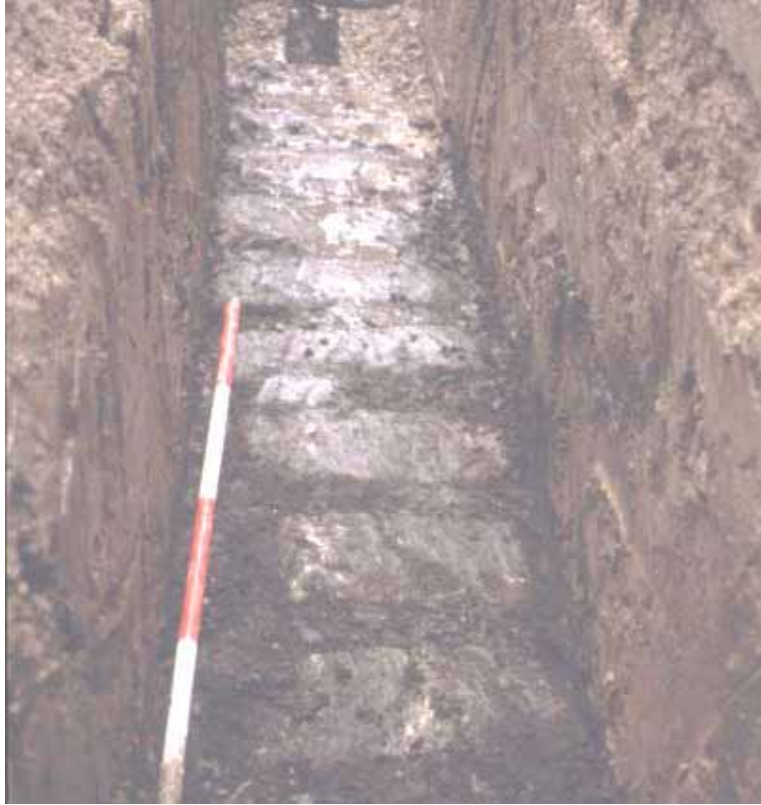
Plate 3: Sandstone Sleepers *in situ*

- 3.1.7 **Manhole 6:** measuring 1.9m x 1.9m x 1.3m, several sandstone blocks were removed from its base. The sandstones now occurred only 0.90m from ground surface, an apparent 'rise' of 0.45m since they were first encountered. Most of these blocks had been worked and were roughly of the same dimensions, being around 0.60m x 0.32m x 0.20m. Each was indented on one side and had two or three pin-holes within the central indentation (Plate 4), some with the pins still *in situ*.

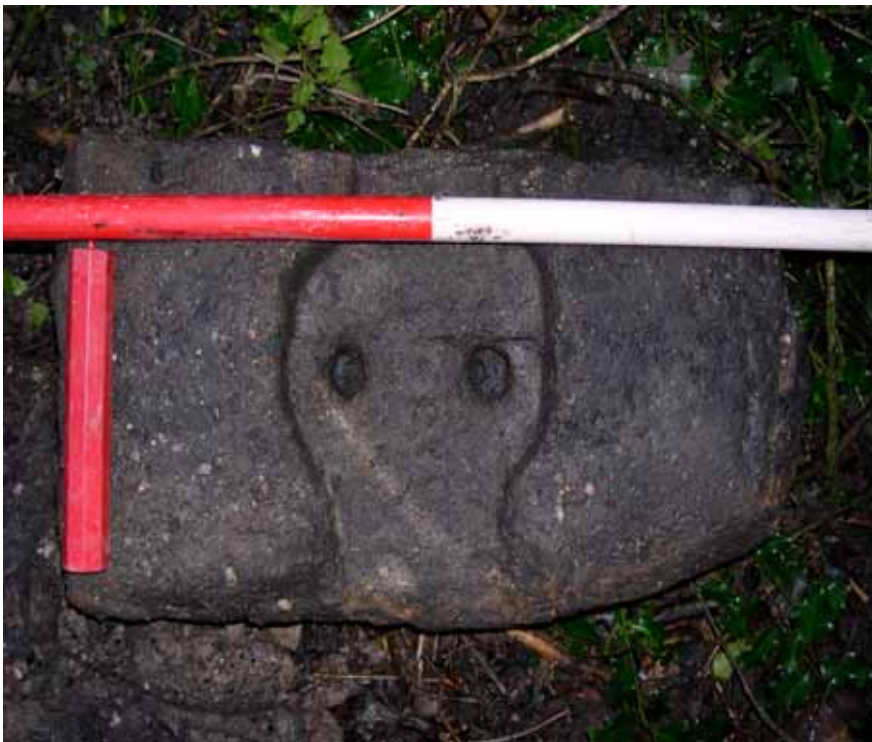
Plate 4: Sandstone Sleeper

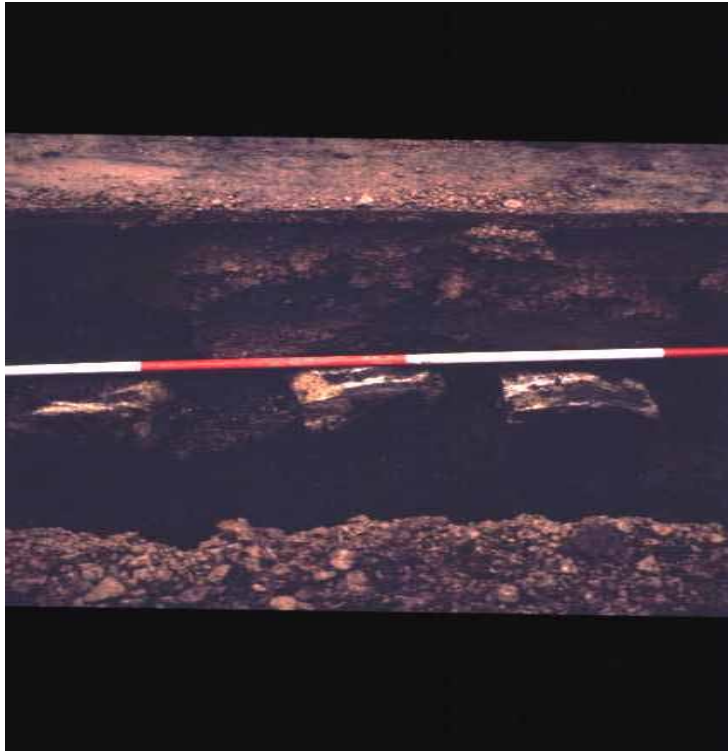
Plate 5: Sandstone Sleepers in North-east-Facing Section, Trench 4

- 3.1.9 **Trench 4:** the stratigraphy within Trench 4 to the north-west remained the same, but with a diminishing layer of the redeposited clay, which disappeared entirely at a point around 20m north-west of and downhill from Manhole 6. At this juncture, few sandstone blocks were actually within the trench but could be seen in section at around 0.40m below ground surface (Plate 5). They were sealed only by the tarmac and hardcore of the modern public footpath.

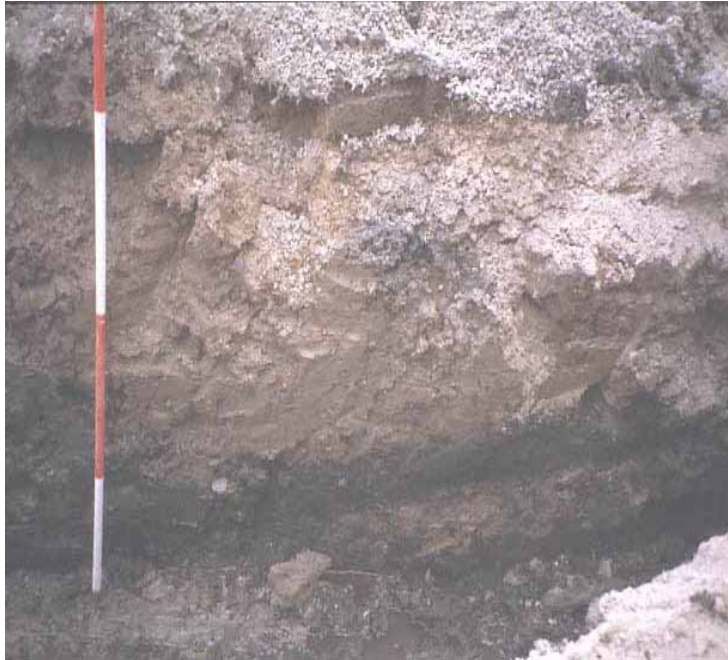
Plate 6: South-west-Facing Section, Trench 5

- 4.1.5 The persistent absence of sleepers and blocks in the north-eastern side of the trench, and their presence only within the south-western section implies that the excavations just skirted the north-eastern edge of the inclined plane. When Trench 5 was opened, it was observed in the north-eastern section that the black layer dropped away rapidly (Plate 6), further supporting this inference

and demonstrating that only the very north-easternmost part of the inclined plane was disturbed by the works.

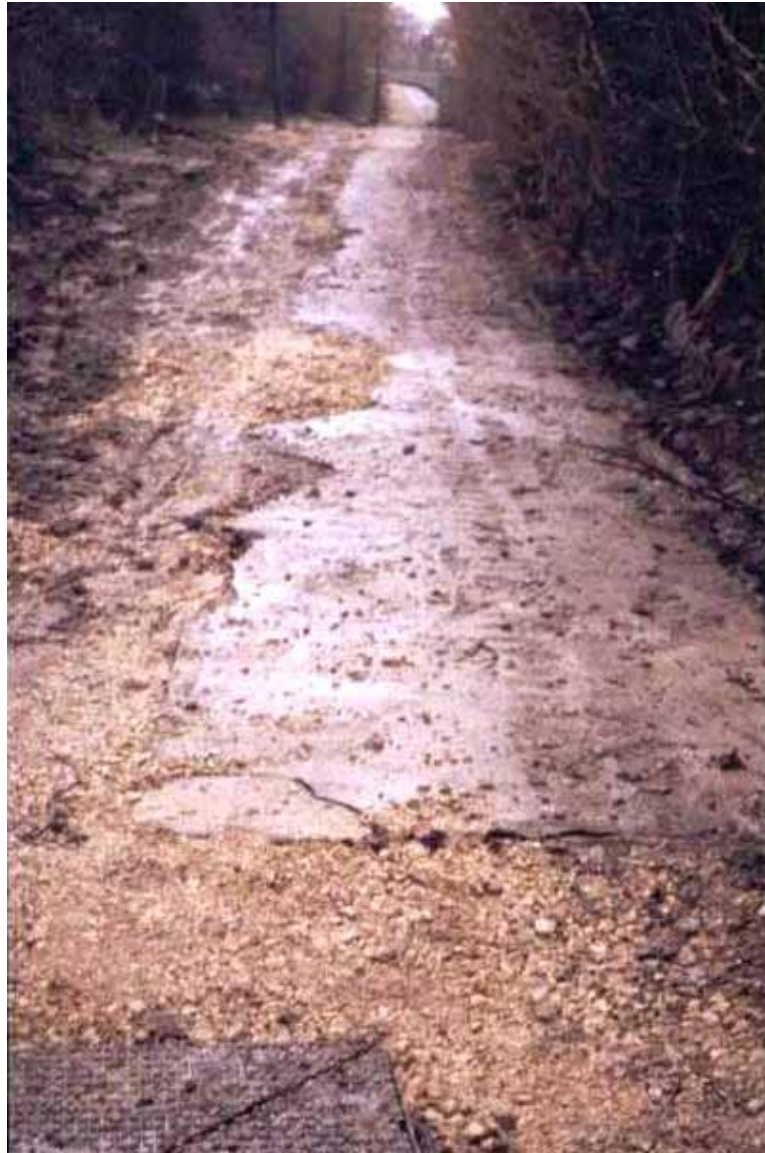
Plate 7: Gradient of Current Ground Surface, Trenches 3-5 Facing South-east

- 3.1.1 Two phases of works were observed during which nine manholes and five trenches were opened. The opening of Trenches 1 and 2 was observed between November and December 2003. They were located between Manholes 1 and 2 and 2 and 3 respectively (Fig 2). The opening of Trenches 3, 4 and 5 was observed between 8th and 23rd January 2004. They were located between Manholes 5 and 8 (Fig 2). The whole pipe-trench was excavated from south-east to north-west, and is described as such in this section. Trenches 3, 4 and 5 lay along a moderately steep slope inclined downwards from south-east to north-west (Plate 7) along the line of the inclined plane and tram plateway.
