High Dovecote Farm Cumbria

Archaeological Evaluation

Oxford Archaeology North

February 2004

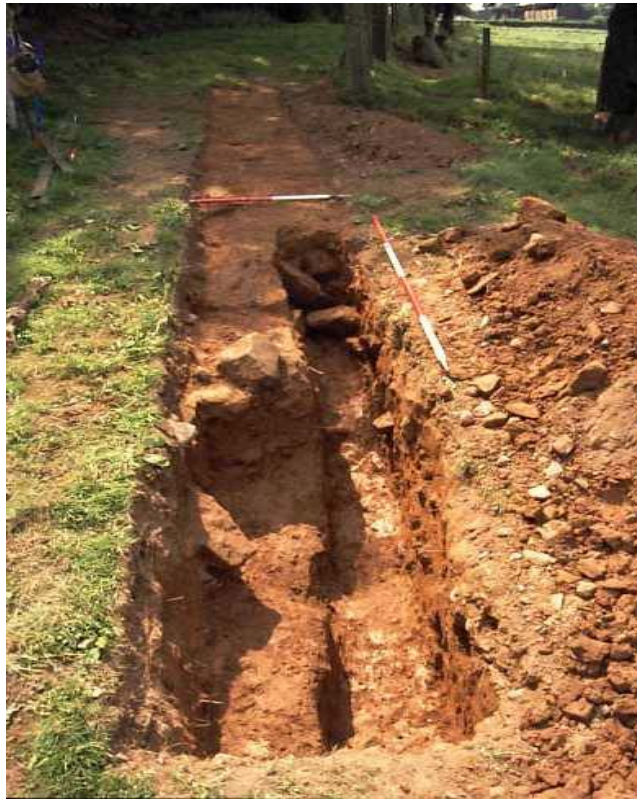
Plate 1: Evaluation trench, looking south

3.1.1 Only a single phase of activity was recorded at the site, of which a summary account is given below. The trench was excavated, by hand, on a north/south orientation and measured 11m in length and 1m wide. Detailed descriptions of all contexts may be found in *Appendix 2*.

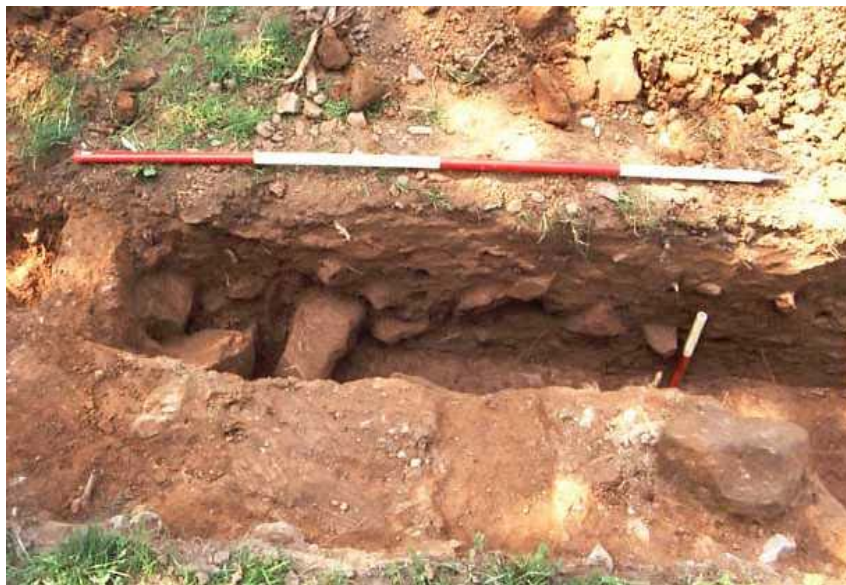
Plate 2: Section through deposit 2, looking west

- 4.1.2 It is, however, surprising that the Wall ditch was not located in the trench. In its estimated position, a thick layer of colluvial material was found, presumably deriving from the erosion of unstable topsoil further up the slope to the south; included within this colluvium was a single fragment of Roman pottery. It is suggested that, rather than digging a ditch at this location, a defence was created by casting up a bank to the north of the Wall, thereby forming the semblance of a ditch. When the section immediately to the east is examined, it certainly seems as though the Wall was placed on the lip of a natural slope, and the northern side was created by a large counterscarp bank, although without excavation the presence or absence of a cut feature between the two cannot be established; whilst some of the structure may have been created by a natural land formation, it certainly has the appearance of being largely artificial. This is reminiscent of the situation to the west of Blackcarts, in Wall mile 29, where a very shallow ditch was revealed, its defensive qualities being considerably enhanced by the counterscarp to the north (Wilmott and Bennett forthcoming). It is thus possible that the colluvial layer, 2, was the result of hillwash from the side of the natural slope directly below the Wall washing down this slope, hence the presence of a sherd of Roman pottery.

A mid-grey orange fine sandy clay. Included within the layer was less than 1% charcoal flecks and 1-5% sub-angular unworked sandstone of a maximum size of 0.22m by 0.20m by 0.18m. It was stratigraphically above the natural till, 3, and below topsoil, 1, and was 0.72m thick.

A colluvial deposit formed from the deposition of material eroded from unstable soils further upslope.
