# **Durham Street, Rochdale**

## **Archaeological Evaluation and Excavation**

### **Report**

**August 2019**

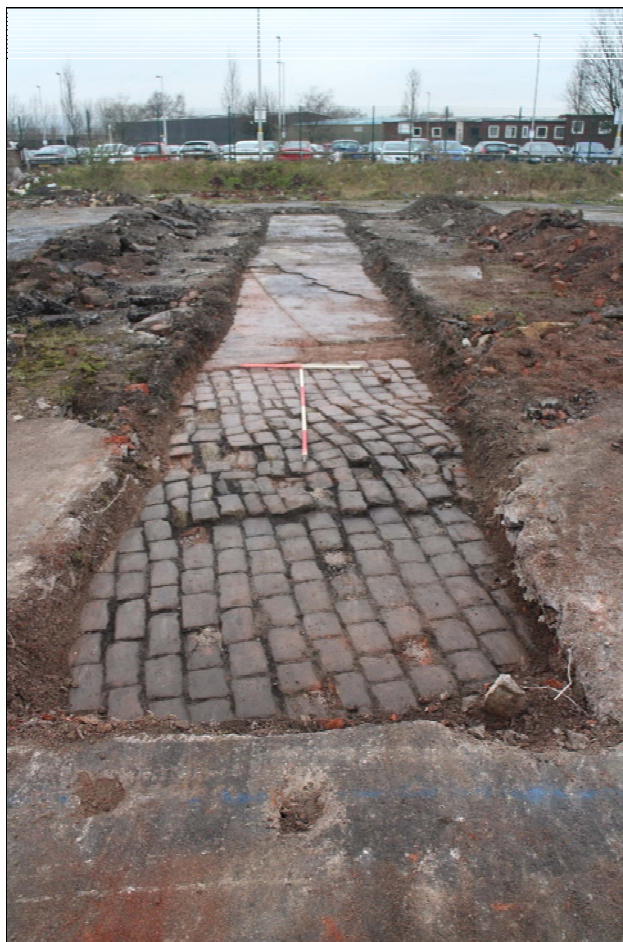
*Plate 1: Trench 1, viewed facing north-east*

- 3.4.1 **Trench 1:** (see Plate 1 and Fig 3) measured 20m x 2m, aligned north/south, and was located to the north-west of the study area. It was located in order to investigate the remains of buildings within the western extent of the Larkfield Mills complex. Unfortunately, the original location lay outside the current site boundary and Trench 1 was subsequently moved to the east by approximately 10m (see Fig 2). Archaeological remains were observed at shallow depths below a tarmac surface

extending across the entire trench. These included a sequence of overlying concrete surfaces **103**, **106**, **107** and **108**. These were located within the northern and central areas of Trench 1 and each no more than 0.10m in depth. Surface **106** was noted to seal surfaces **103** and **107** which were probably the same surface. Surface **108** was distinguished from other surfaces by colour and fabric and probably represents a different phase of construction, or an amendment to **106**.

- 3.4.2 Two pillar bases (**104** and **105**) were also recorded within the trench. Both bases were similar in construction and located in close proximity on opposite sides of the trench within the northern half of Trench 1; they were bounded by concrete surfaces **103** and **107**. Further excavations within the vicinity of **104** observed a substantial sandstone foundation below the base. This extended to approximately 3m bgl, where excavations were halted. A possible construction cut for this foundation was observed at a depth of approximately 1.50m.

- 3.4.3 Structures **109** and **110** formed the southern wall of the northern mill building with **110** forming a potential threshold or entrance extending into the western baulk. These features were bounded to the north by surfaces **107/108**, and to the south by road surface **111**. Structure **109** was constructed using large sandstone blocks and a light grey mortar. Only the upper surface of this wall was visible. Structure **110** represented a concrete addition to the line of wall **109**, representing either a repair or modification to the original structure.

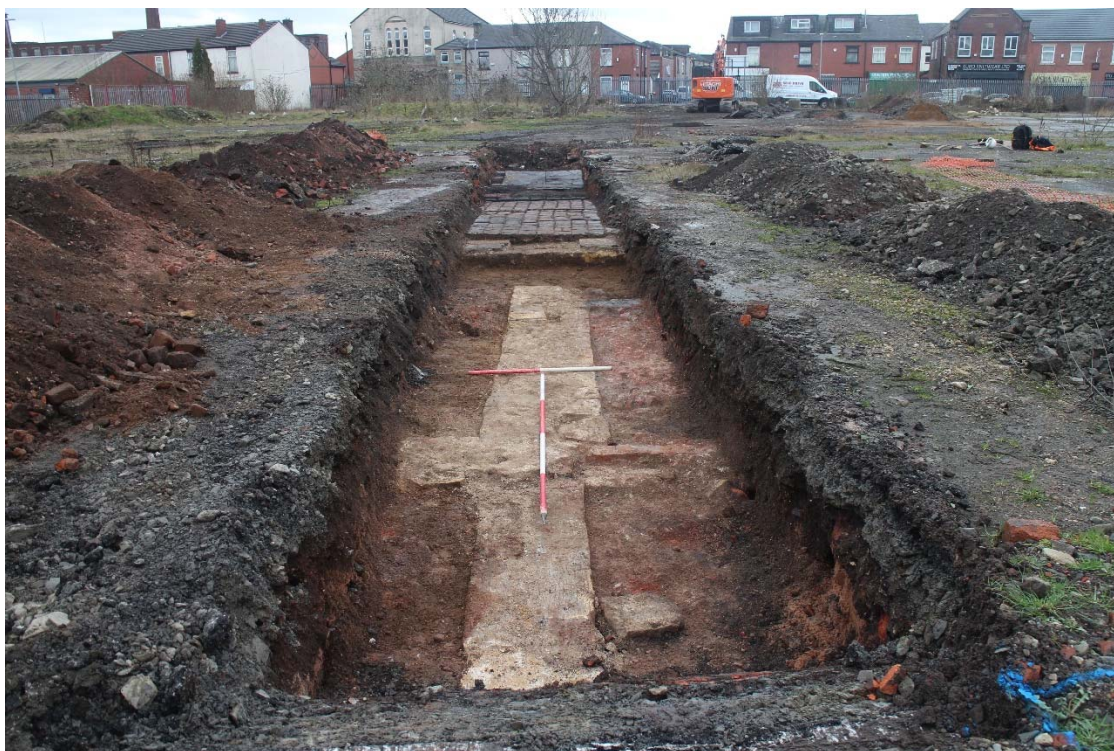
*Plate 2: Trench 2, viewed facing south*

- 3.4.5 **Trench 2:** (see Plate 2 and Fig 2) measured 20m x 2m, was aligned north/south and centrally located, within the northern half of the study area. The trench was located to investigate further aspects of both the north and south building range of the Larkfield Mills complex. Archaeological features were observed at varying depths, up to 0.70m below the modern tarmac surface and hardcore.

- 3.4.9 The southern extent of this footpath was defined in Trench 2 by wall **208**, which extended across the trench on an east/west axis. Wall **208** was constructed using hand-made bricks bonded with a dark grey cement-like mortar. The bricks were 'soldiered' suggesting a foundation or load bearing coarse, but is set back from the northern extremity of the building when overlain on historic mapping, and therefore probably relates to an internal dividing wall. Potential partially preserved aspects of the same wall were observed as a single course of red brick, overlying elements of structure **1013** in Area 1 (see *Section 3.5.23*) and probably represents an internal dividing wall within a building of the southern mill range.

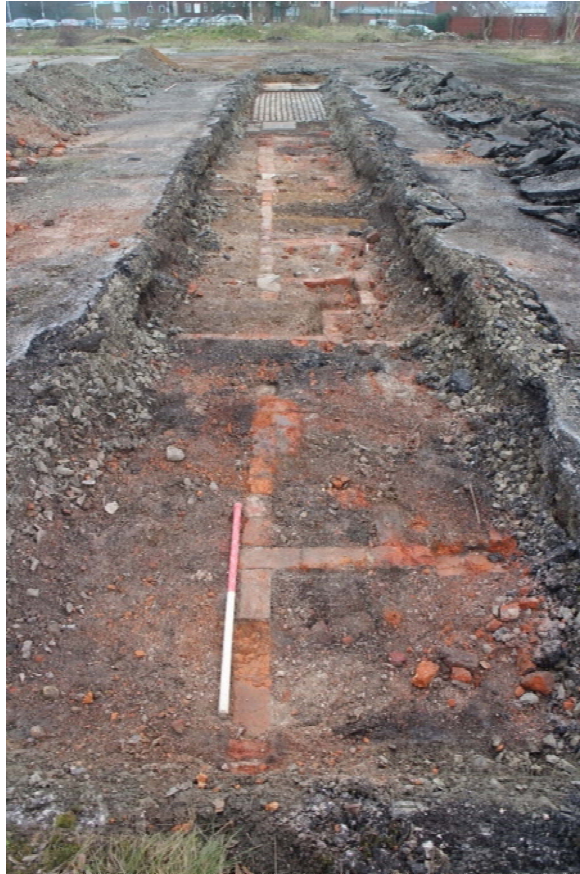
*Plate 4: Trench 4, viewed facing north*

3.4.12 **Trenches 4 and 5:** (see Plates 4 and 5 and Fig 4) these trenches were located within the south-western quadrant of the development area and measured 30m x 2m and 20m x 2m respectively. Trench 4 was aligned north-east/south-west and Trench 5 approximately east/west. Both trenches were primarily intended to target a portion of the housing observed on the 1893 OS map, between Haigh Street and Durham Street (Fig 5).

3.4.13 Excavations within both trenches confirmed the presence of below ground remains in the form of walls and floor surfaces (Plates 4 and 5). Additionally, both trenches identified the use of cellared space within the footprint of several structures. Based upon the good level of preservation and the cartographic evidence highlighting differences in form between individual houses, Area 2 was targeted for further excavation, in order to fully realise the footprint of those structures observed. It was also agreed that a sample of one example of each different cellar type would be subject to excavation. *Section 3.5.32* describes the findings within Area 2.

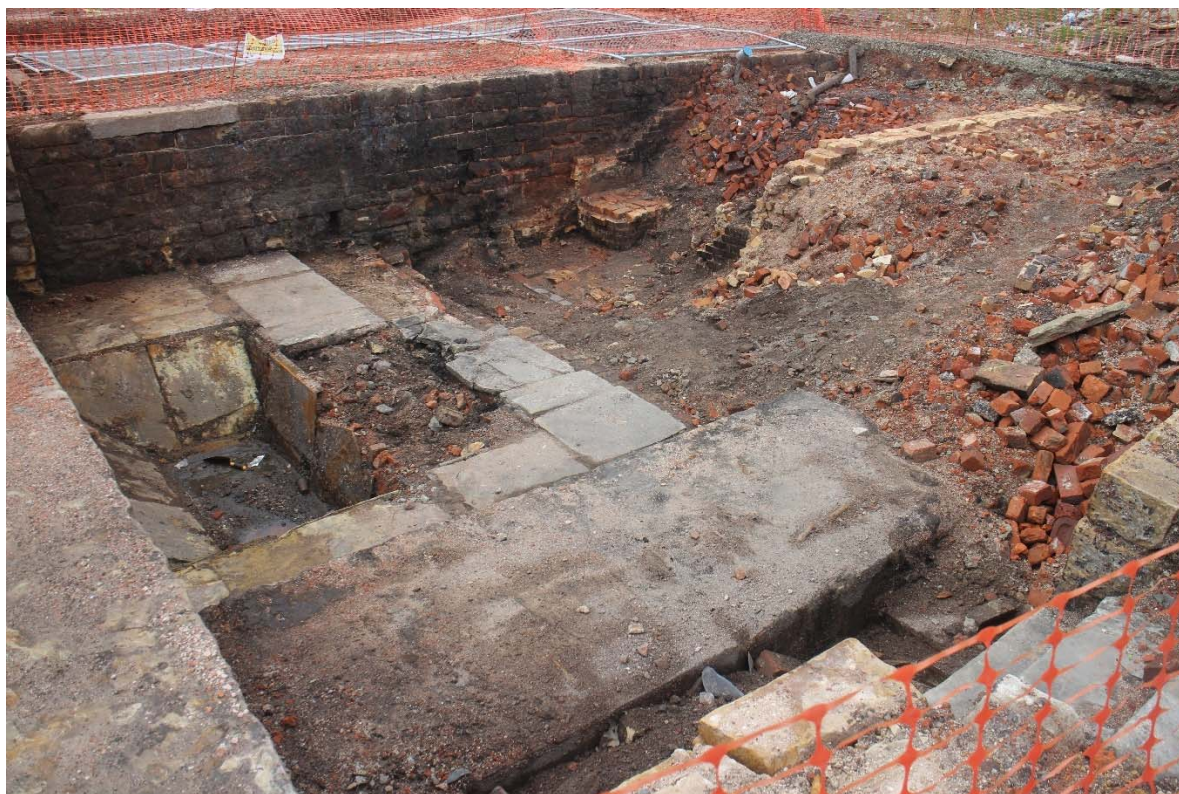
Plate 6: Room **1004**, viewed facing north-west, with main mill wall (bottom left), the eastern boundary wall and stepped access (bottom right), flagstone floor and boiler bays (centre), and dividing wall and room **1005** (background)

- 3.5.3 Room **1004** lay within the footprint of evaluation Trench 3 (see Section 3.4.12 above) and formed what would have been the Larkfield Mills boiler room. The room measured 9m x 7m and was largely characterised by two rectangular, brick-built ‘bays’, which would have housed a pair of boilers. These were bordered to the south by a flagstone floor surface, which incorporated a sub-surface, stone-lined coal hopper (Plate 6).

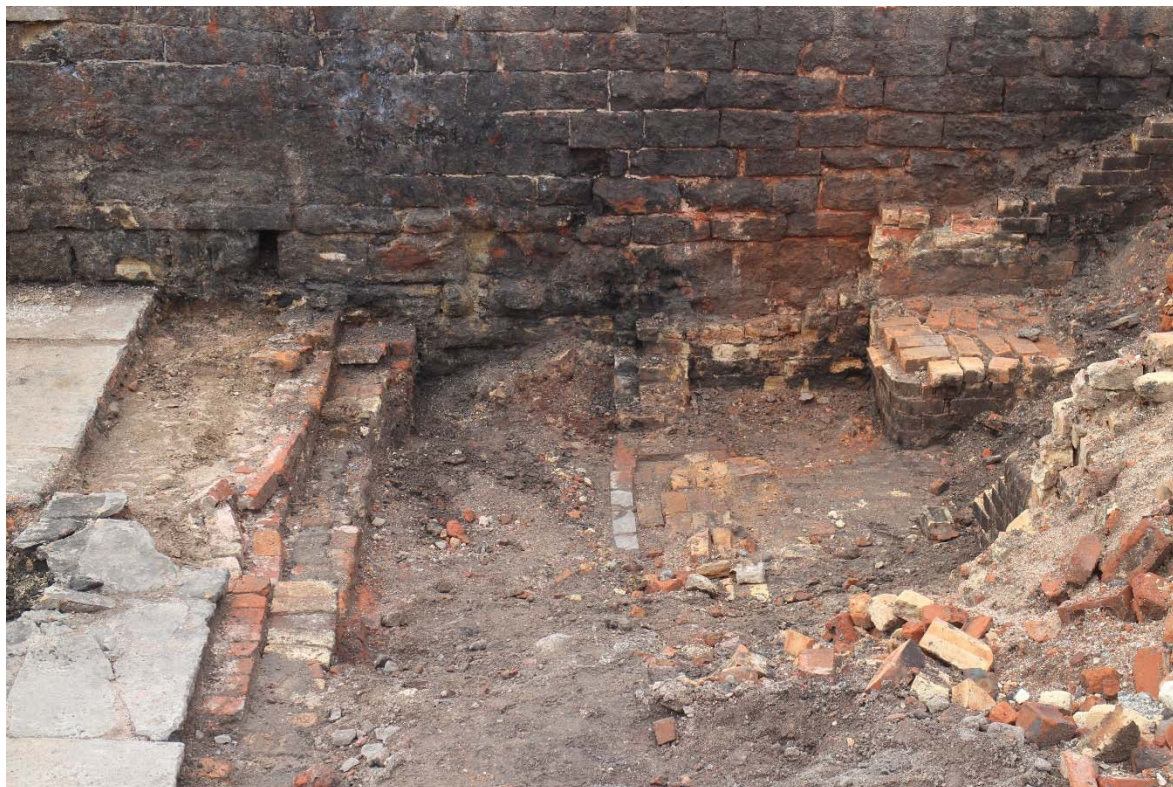
- 3.5.5 Expansion of the Area 1 excavations, revealed the western extent of room **1004** and confirmed the presence of a second boiler housing bay to the west of that originally identified in Trench 3. Excavations therein exposed a right-angled, return of wall **308**, which formed the southern limit of the western bay. An additional, single course of refractory brick, returned northwards at the western extent of this wall and was bonded to the fabric of the stone-built western elevation of the boiler room, with a highly degraded grey mortar (Plate 7).

*Plate 7: The western return of wall **308** forming the southern extent of the western boiler bay, with the supporting boiler plinth (centre right), western boundary wall to room **1004** (background)*

- 3.5.6 A second set of refractory brick plinths and a refractory brick floor surface were also observed within the western boiler chamber (Plate 7). The plinths were 0.84m in width and spaced 1.10m apart. The southern extent of the plinths incorporated bull-nosed bricks to form a rounded corner. The eastern plinth also incorporated a row of refractory brick 'mountings' within the western edge of the upper surface (Plate 8). It is therefore evident that both boiler chambers were of identical construction.

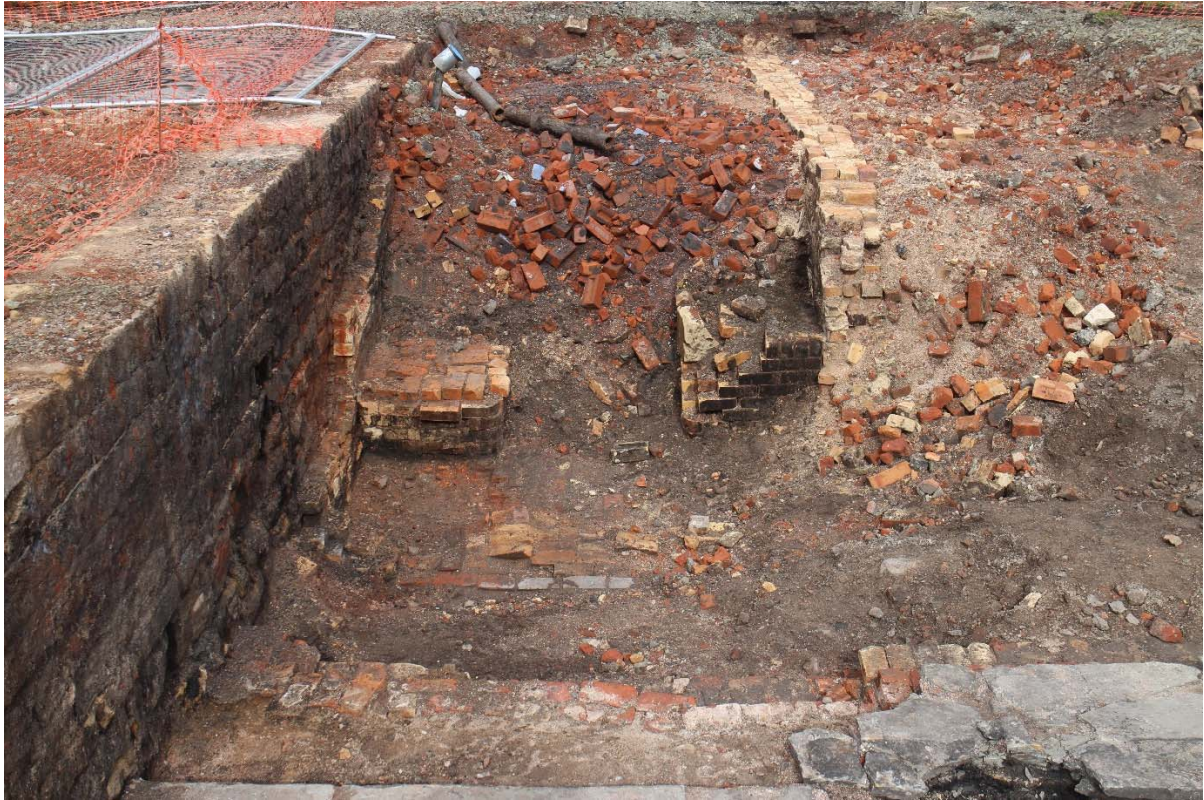
*Plate 8: The supporting boiler plinths in the western boiler house bay.*

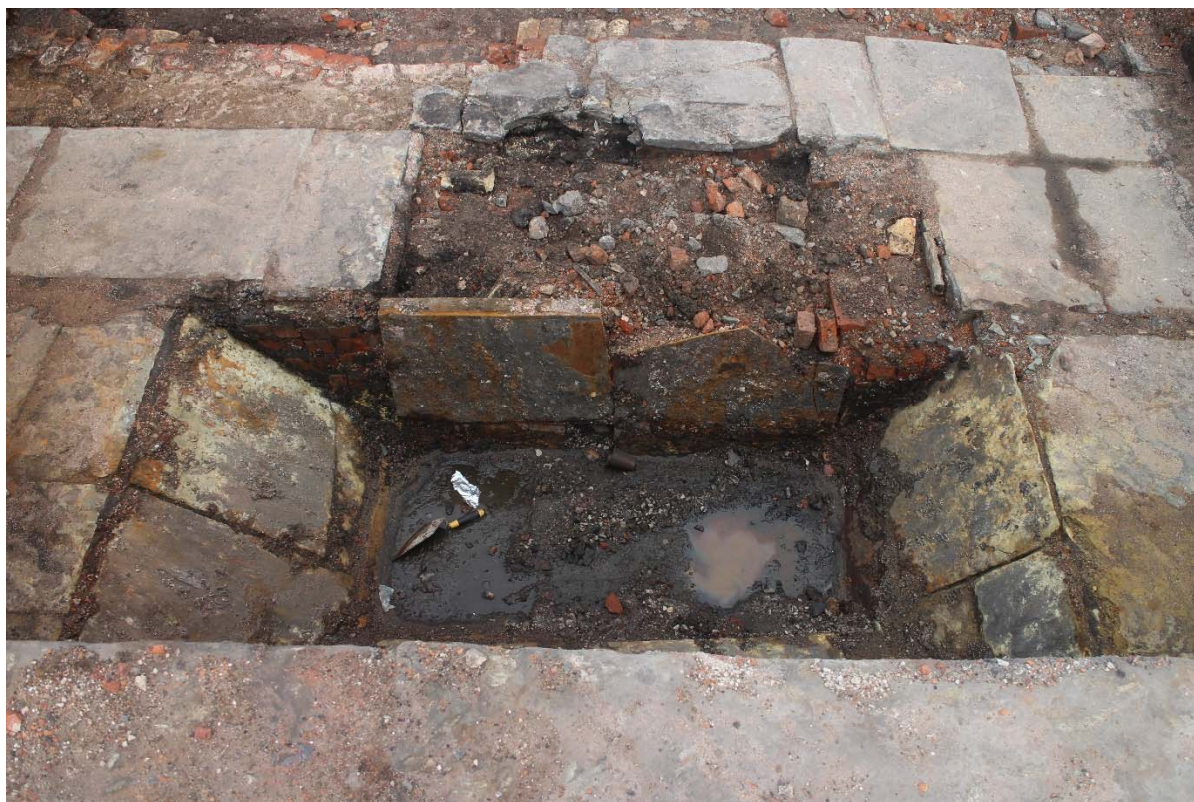
- 3.5.7 As noted above (*Section 3.5.3*), the southern half of room **1004** contained a flagstone floor surface that bordered the southern extent of the boiler housing bays, extending up to the west, south and east boundary walls. Set within this floor, at a roughly central location, and bordering the southern elevation, was a large stone-lined sunken hopper. The structure was approximately 3.10m x 1.80m and 0.50m in depth. A set of vertical iron plates with flanged brackets were set between brick supports along the northern extent and the remaining three sides were angled to create a 1.90m x 1.20m stone lined base. A smaller recess was also observed to the northern extent and additional vertical plating was observed within the backfill between the boiler housing and the floor surface (Plate 9).

- 3.5.8 This evidence suggests the location of the charging or stoking platform from which the two boilers would have been fuelled. The sunken hopper within the floor was heavily saturated with hydrocarbon residues and coal staining was noted along the northern face of the southern elevation, inferring that coal was delivered via the road (**1008**) and stored within this area. The iron plates and sequential recesses to the north may have been used as sluice gates with smaller holding areas used to channel coal towards the boilers under gravity.

*Plate 9. Detail of the sunken coal hopper within room 1004 of the boiler house. Viewed facing north*

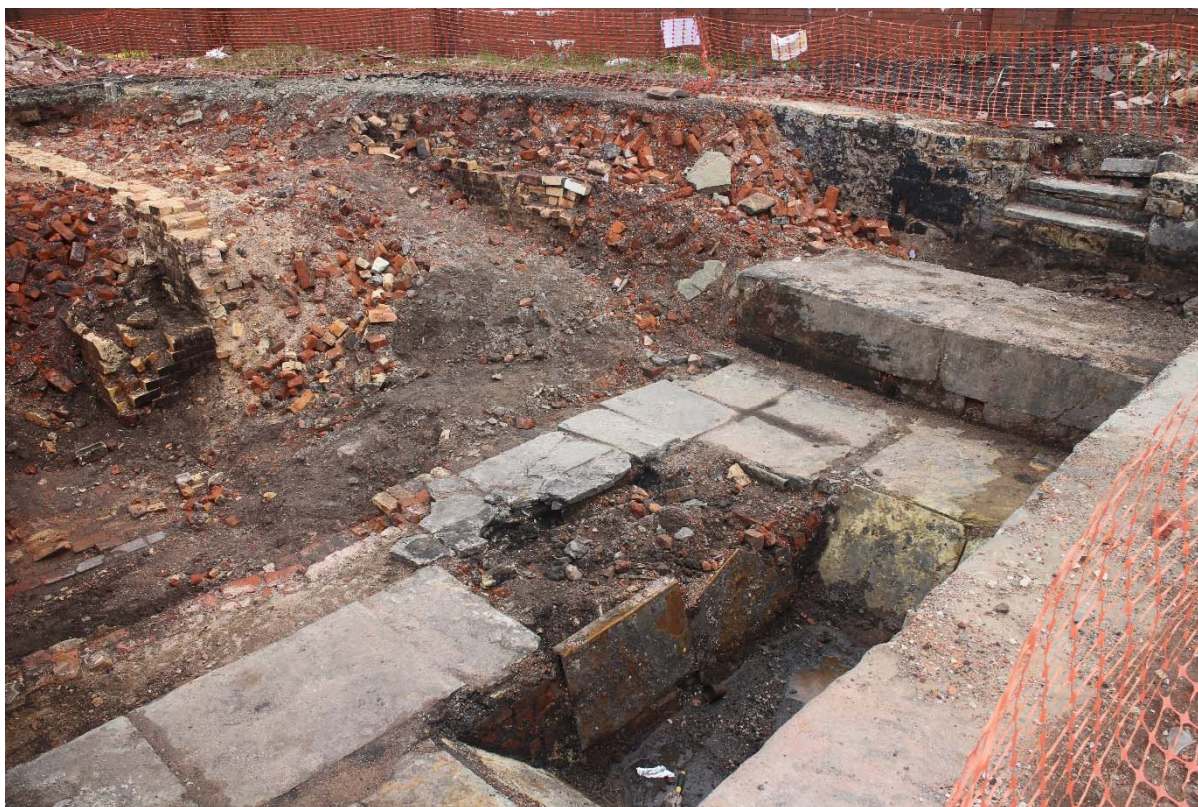
- 3.5.9 A further feature observed within room **1004** was a large stone machine base identified within Trench 3 as structure **306**. The machine base was located within the south-east corner of the room and constructed using two large cut stone blocks, approximately 1.85m x 1.40m. The base stood at 0.50m above the charging platform and was noted to have several holding pins along the upper surface, alongside socketed recesses within the western face at roughly floor level. The base was bordered to the east by a brick and stone-capped culvert or flue which extended up to the face of the southern elevation and then west along the northern internal face of the southern wall of the boiler room. A high-pressure cast-iron pipe was also observed within the south-eastern corner extending south through the wall and beneath road **1008**.

Plate 10. The machine base identified in room **1004**, with the stepped access to the room beyond, within the eastern boundary wall

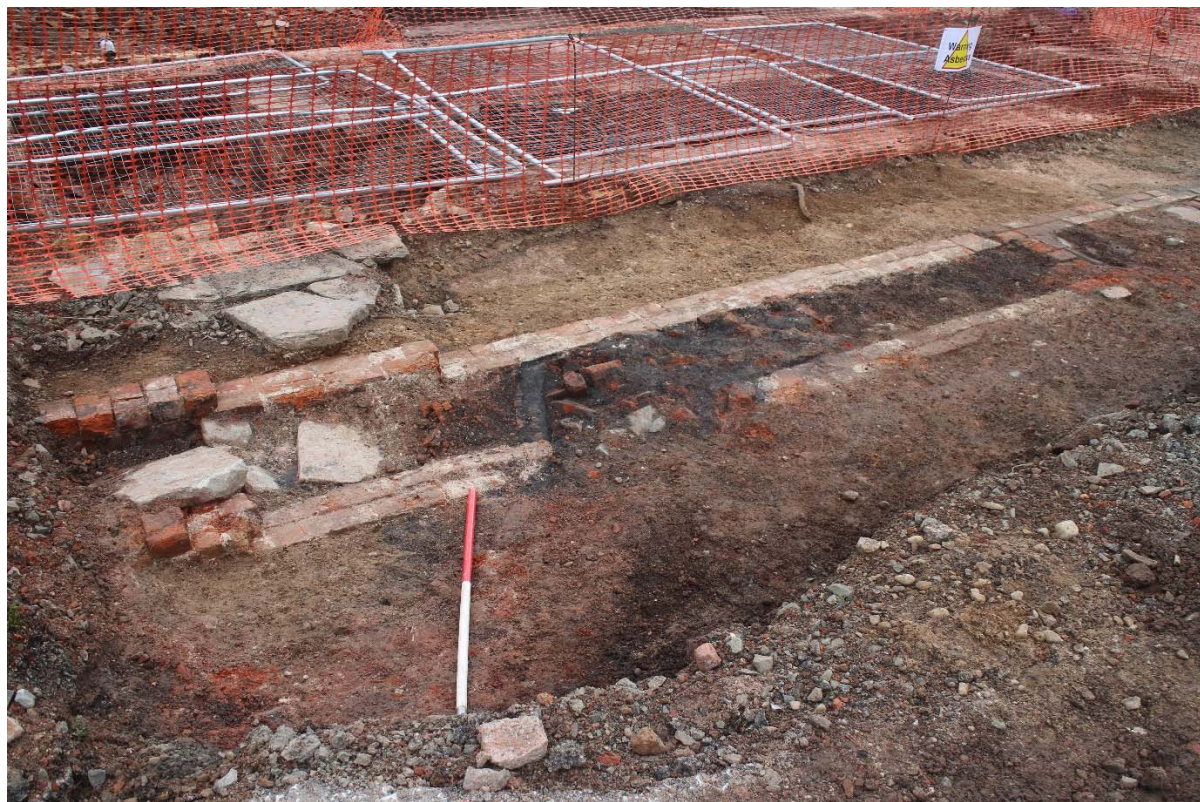
*Plate 13. Detail of structure **1006**, with room **1005** beyond. Viewed facing south east.*

- 3.5.16 The differing elements of feature **1006** suggest a prolonged use and maintenance of structural elements or a deliberate construction comprising re-used materials. Both inferences are common within industrial flue systems where exposure to excessive temperatures would quickly degrade their fabric. The potential surfaces at the southern extent of **1006** may be indicative of machinery being present. These surfaces comprised stone flags and soldiered machine-made bricks, which are generally associated with foundations or other structural supports. The partitioning and truncation at the northern extent, aligns with mortar scarring observed within the surface deposits to the immediate west and highlight the potential for further structural remains at additional depth.

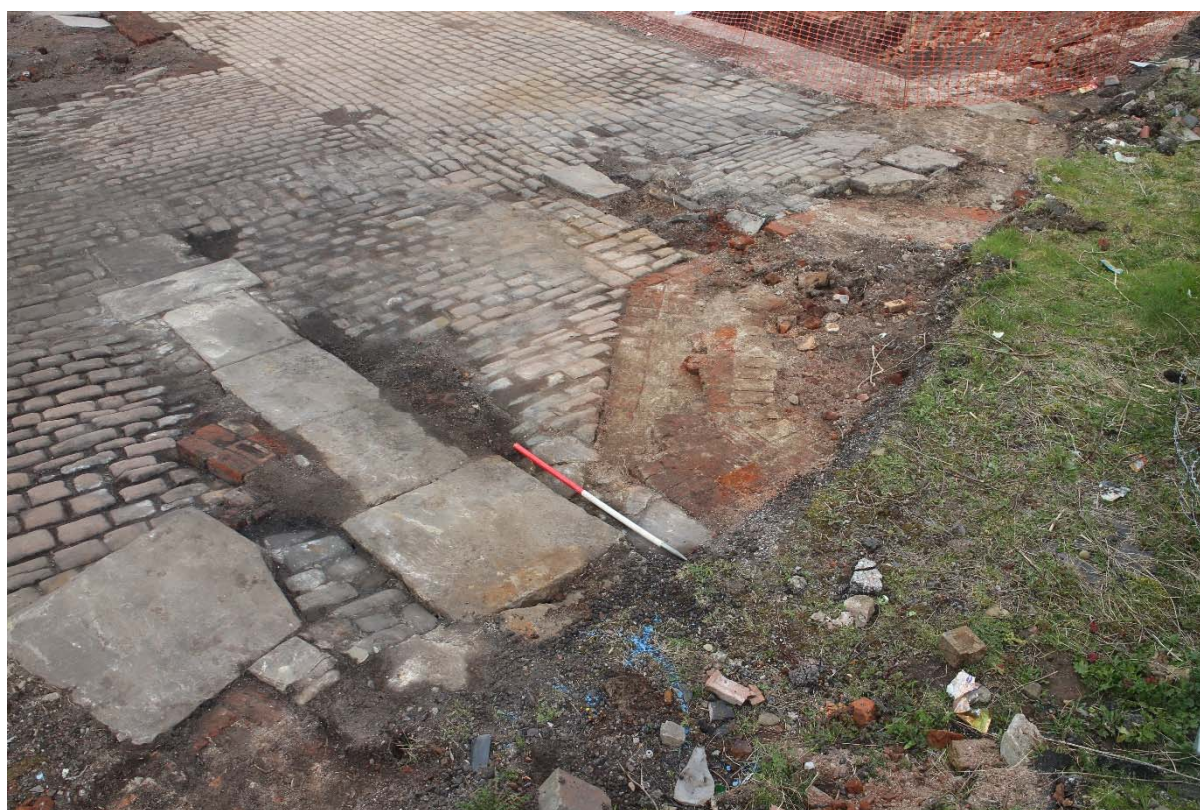
- 3.5.18 Partially revealed against the eastern limit of excavation, a series of up to five skins of hand-made red brick, 0.90m wide, with an internal lining of refractory brick and bonded with a white lime mortar. This formed half of a octagonal structure with a diameter of approximately 4.60m (2.80m internally: Plate 14 Fig 3). The form and position of the structure can be readily related to position of a chimney, which presumably served boiler room **1004**, as identified on historic mapping (Fig 5). A potential flue was observed to extend west from the western elevation of the chimney base. This sub surface structure was bordered by machine-made brick and capped with stone flags, but could only be partially excavated due to the presence of contaminants.

*Plate 14. The partially exposed base of chimney **1007**, with the flagstone capped flue extending west from its centre, and a further flagstone capped flue or culvert to the south.*

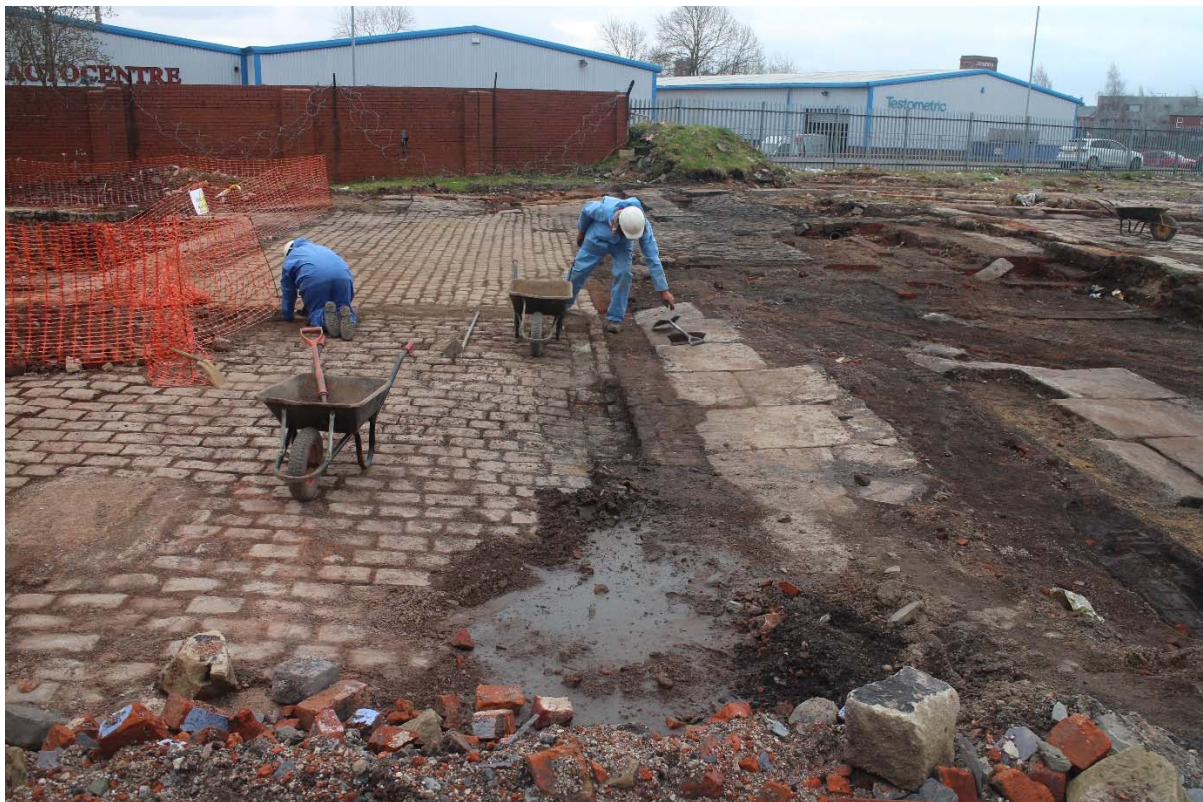
3.5.20 A second, more substantial area of cobbled surface **1008**, 9m wide and between 15m and 20m long, extended directly west of chimney **1007**, and separated the northern and southern range of mill buildings. This area was divided almost equally, with the eastern half defined by cobbled sets extending on an east/west axis, and the western half defined by cobbles set on a north/south axis, the dividing line corresponding with the boundary wall extending between room **1004** and **1005** of the northern mill range. The western half had been disturbed in the area of room **1005**, although it was unclear if this simply related to damage during demolition or else defined a further structural element extending south of the room. This was not investigated due to the presence of asbestos contamination. The western half also contained a manhole cover clearly indicating the presence of drainage systems beneath the surface, possibly joining one or other of the culverts noted further west and abutting the chimney. The surface can clearly be related to similar surfaces further to the west, identified as **207** in Trench 2 (see Section 3.4.8), and **111** in Trench 1 (see Section 3.4.4), and clearly formed a service road between the two former mill ranges, with OS mapping suggesting an entrance at the western extent of the complex (Plate 15 Fig 5). This service road would have been crucial for the movement of materials within the Larkfield Mills complex (see 3.5.8 above).

Plate 15. Cobbled road surface **1008** (left foreground), yard area **1018** (centre background), and elements of the southern mill buildings (right foreground and centre), under excavation. Viewed facing east.

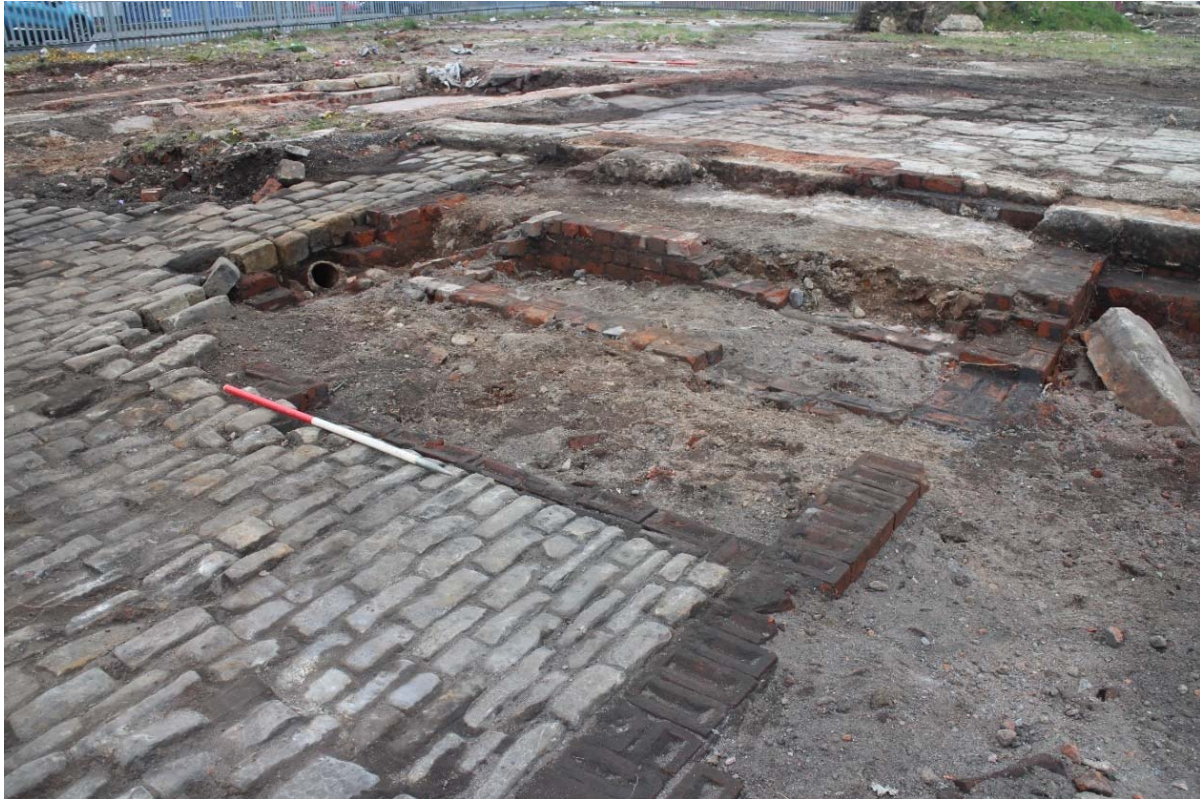
frogged brick, bonded with a dark cement mortar. The north-eastern corner of the structure was truncated by a ceramic drain. The materials used in the construction of room **1010**, are the same as those used within the eastern length of wall **1011**, suggesting they are contemporary, possibly representing a phase of modification to the original layout, although the form of this small annexe is evident on the earliest mapping of the southern mill building (Fig 5).

Plate 16. Detail of Room **1010**. Viewed facing south-east.

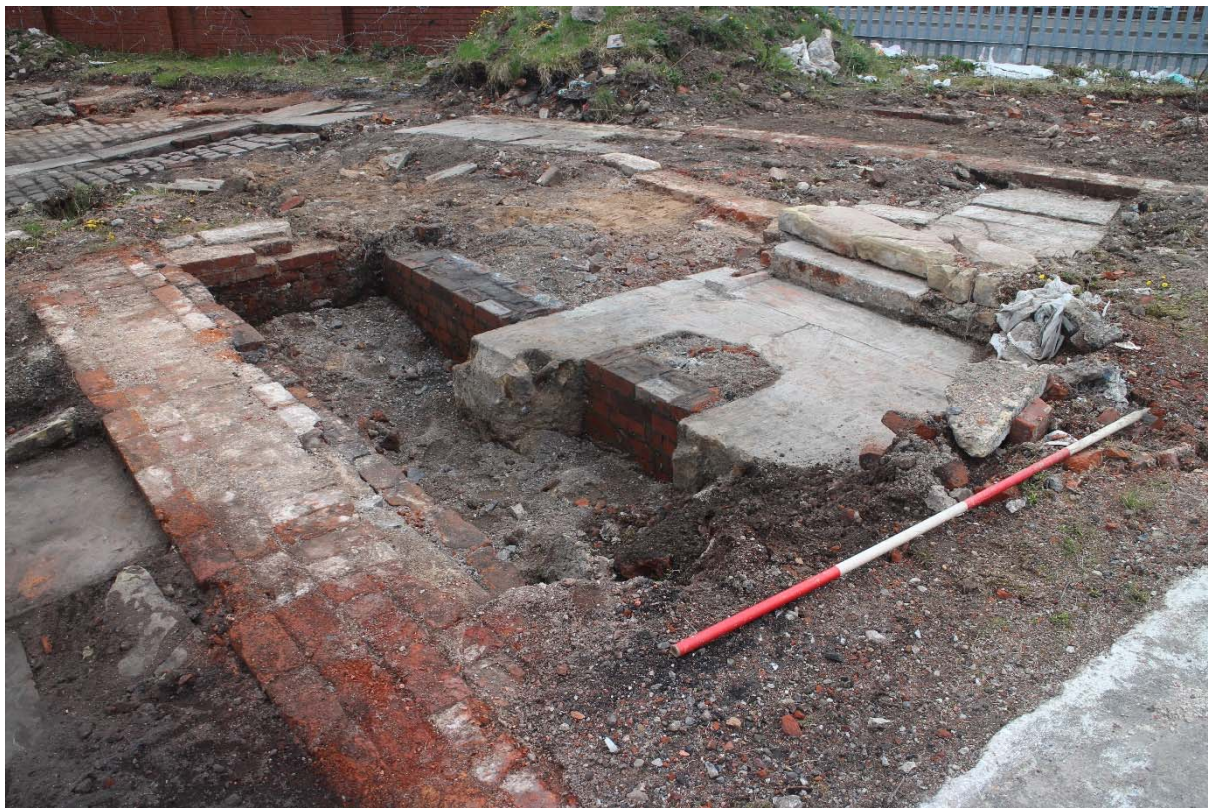
3.5.28 Immediately east of and abutting the external eastern elevation of wall **1014**, a further room was identified (**1015**: Plate 17 Fig 4). This room measured approximately 3.70m x 2.75m with the external defining wall comprising three skins of hand-made red brick set with a light grey lime mortar. The room contained a large stone base measuring 2.10m x 1.90m, with two threaded bolts, fitted around a large recessed slot, which had been cut into the western side. A set of stone steps formed an entrance within the eastern elevation leading on to the surface of the stone base from the external flagstone surface **1018**. A 1m gap filled with demolition debris occupied the space between the stone base and the western elevation. (Plate 17). The room can be clearly related to a small structure appended to the eastern elevation of the main mill building on historic mapping, with several more smaller structures extending east beyond that (Fig 5)

Plate 17. Detail of Room **1015**. Viewed facing north-east.

3.5.29 Whilst room **1015** obviously housed some sort of machinery, as evidenced by the large machine base and fixtures, it is difficult to ascertain what that machinery may have been. The location and character may suggest that the area housed a rope race (Plate 18). Used in mills from the late nineteenth-century onwards, a rope race was used to distribute power through a vertical shaft, to the upper floors of a mill. In this instance, the wheel holding the rope may have slotted into the space between the machine base and the western elevation. However, it should be noted that these structures are generally found within close proximity of the engine room and the only power source observed during excavations was located within room **1005** within the northern range of mill buildings (see Section 3.5.11). This may suggest a further power source may have been housed within the building at the eastern limit of the site, potentially relating to wall **1017** along the eastern limit of the Area 1 excavations.

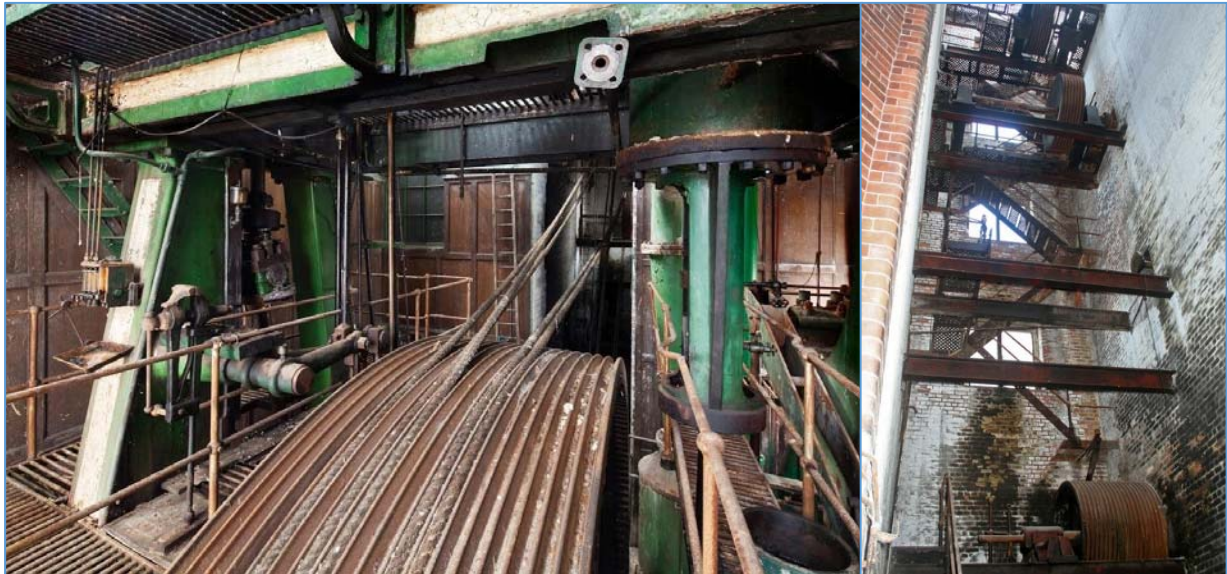
Plate 18: The fly wheel from a steam engine distributing power via a rope race (left) and an example of a rope race (right)

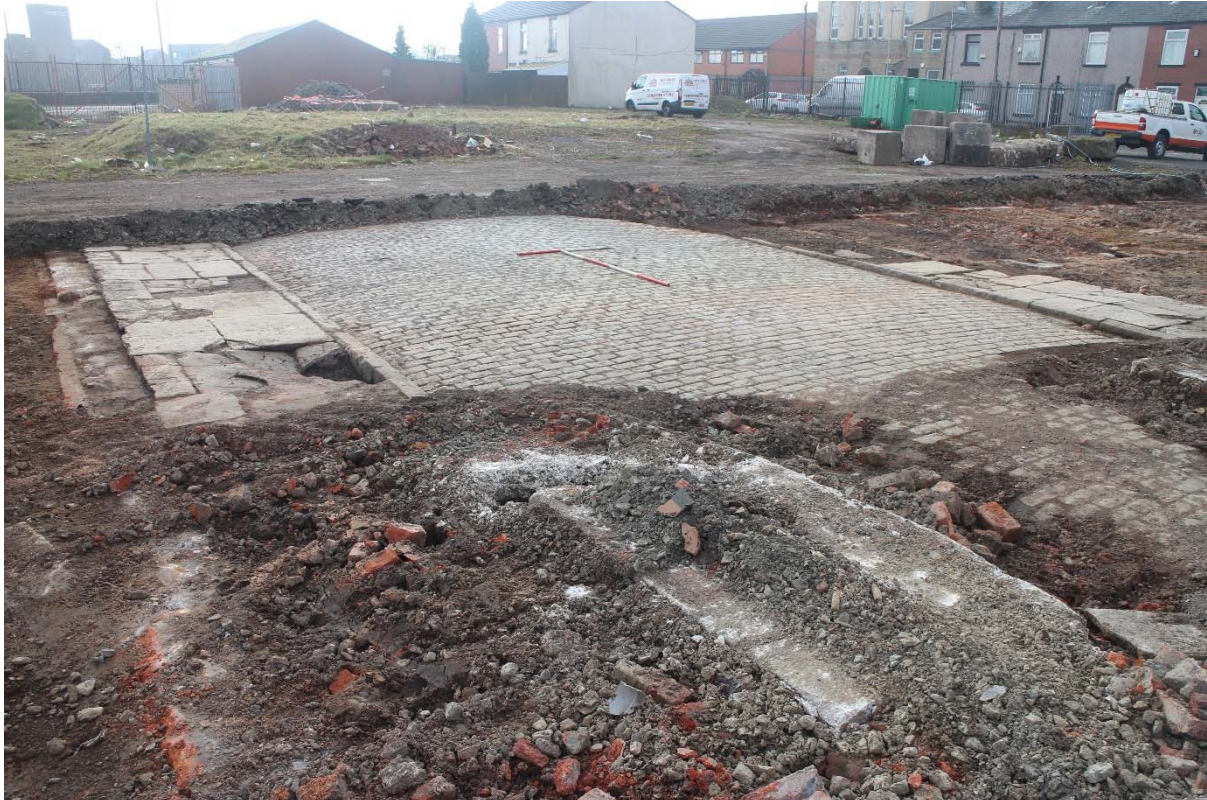
3.5.32 Immediately south of wall **2027**, a series of surfaces defined a road surface (Structure **2005**), comprising central sets of well-dressed sandstone blocks, laid running north/south (Fig 4: Plate 19). This was bracketed to the north and south by a series of well-dressed sandstone blocks, laid running east/west and forming a curb line either side of the road, with the remains of a flagstone footpath also on either side. To the north, the footpath butted against the southern mill wall (**2027**). These remains can clearly be related to the former line of Haigh Street, which previously ran through the PDA on an east/west alignment and divided the buildings of Larkfield Mill from the rows of terraced workers housing to the south (Fig 5).

Plate 19. The remains of Haigh Street (Structure **2005**). Viewed facing south-east.

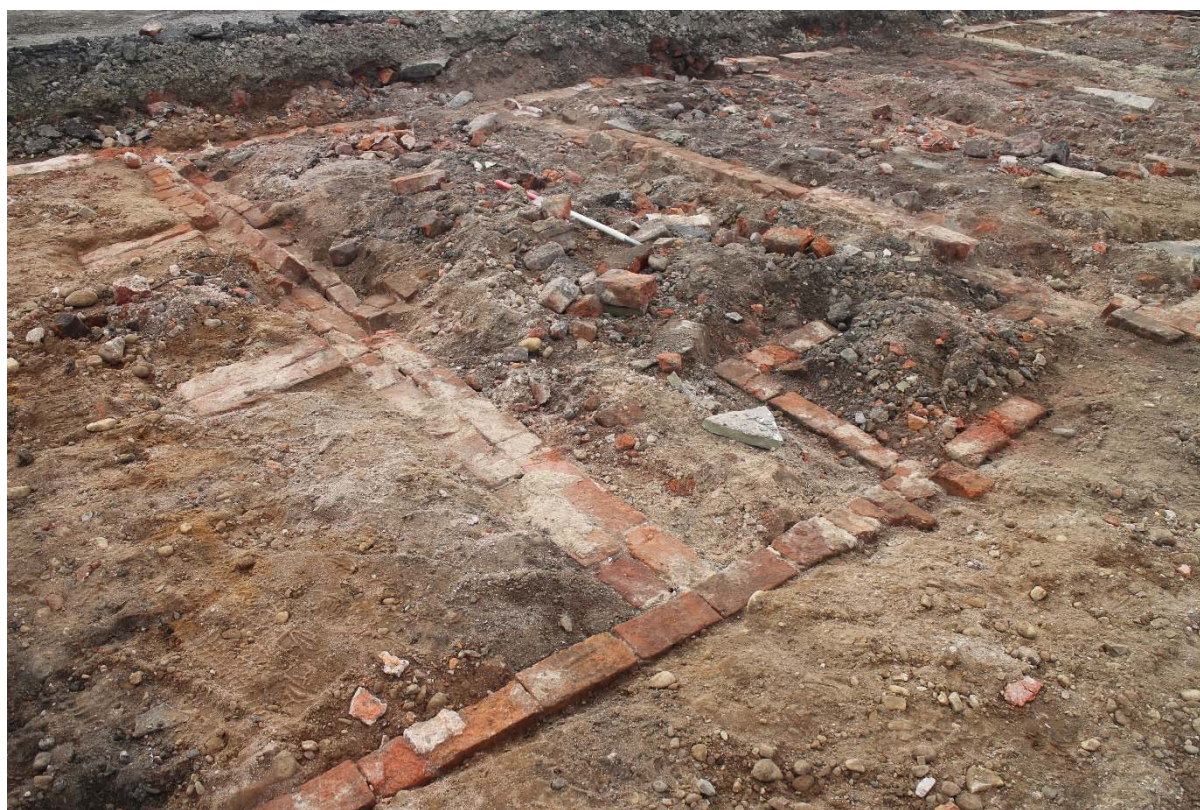
- 3.5.35 The general form of each structure comprised a 10m x 5m rectangle, divided into two roughly equal halves, by a single north/south aligned central wall. In addition, the eastern half of each block was further subdivided into two equal sections by a central east/west aligned dividing wall, absent within the area of structure **2010** (Fig 4), although this may simply be a result of preservation rather than structural difference. All walls were constructed from hand-made red brick bonded with a light grey lime mortar, with each separate block seemingly tied into adjoining blocks, suggesting all four were constructed at the same time. Within the eastern half of each block, as well as the external walls at either end of the entire range, the walls were predominantly two skins wide, while the majority of internal dividing walls were generally only one skin wide (see Plate 20). This difference supports the notion of cellared space, with a probable vaulted roof, exclusively within the the eastern footprint of each building.

*Plate 20. The eastern half of structure **2007** and **2008**. Viewed facing south-east.*

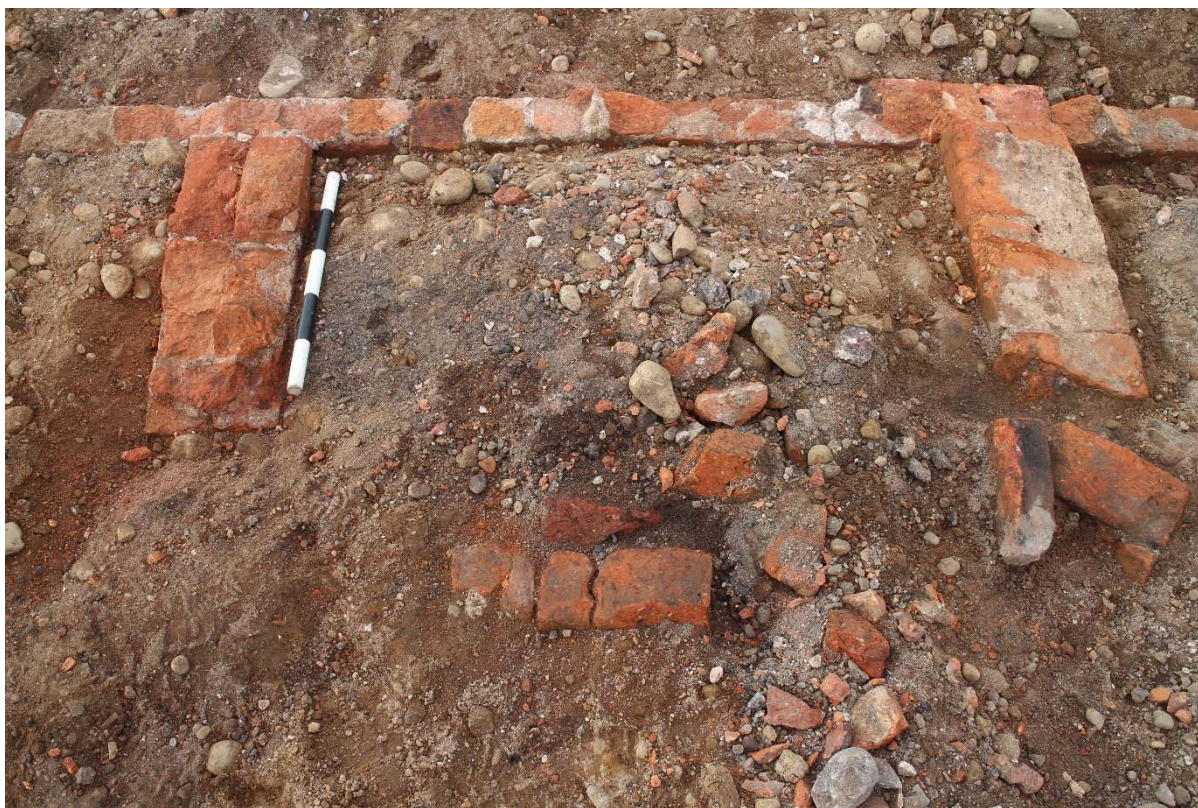
presumably at ground floor level, although very limited evidence for any wider floor surfaces at this level was preserved. This would suggest the western undivided rooms within each building served as the living room for each.

*Plate 21. An example of a fireplace recorded in the western half of structure **2006**. Viewed facing south.*

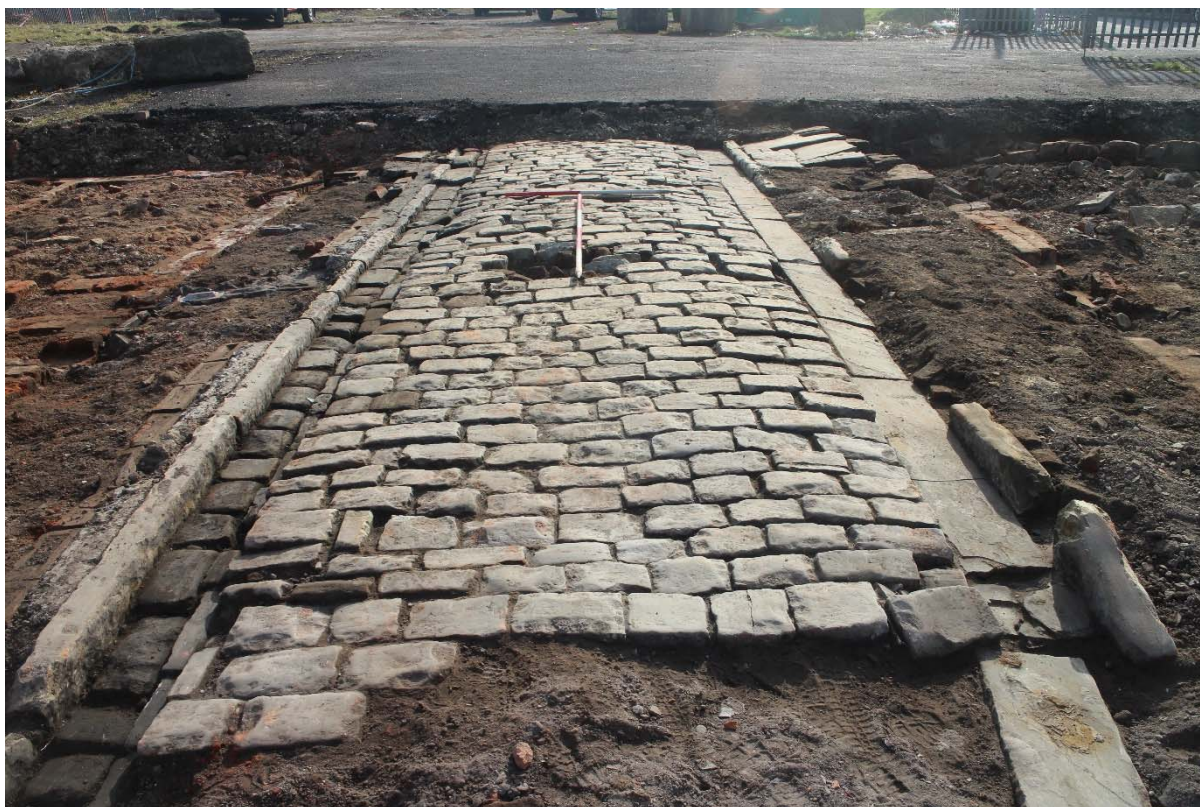
- 3.5.40 Extending east/west across the excavation area, and marking the southern extent of the range of structures defining the row of terraced housing detailed in *Sections 3.5.34-3.5.39* above, was structure **2017**. This comprised a series of well-dressed sandstone blocks, laid running north/south (Plate 22), to form a road surface approximately 7.50m x 1.86m in size. A section of constructed subterranean gutters flanked either side of the surface, with the remains of a covering flagstone surface only partially preserved towards the eastern limit of excavation, but obviously had extended the entire length of the former structure. These structures had been truncated towards their western limit by the construction cut for the modern building, noted to have removed elements of the structures to the north and south-west (see *Sections 3.5.34* and *3.5.41*). The cobbled surface obviously correlates with the position of Back Durham Street identified on historic mapping (Fig 4 and 5) and, consequently, previously divided the two rows of terraced housing targeted by the excavation.

Plate 22. Structure **2017**, the remains of Back Durham Street. Viewed facing east.

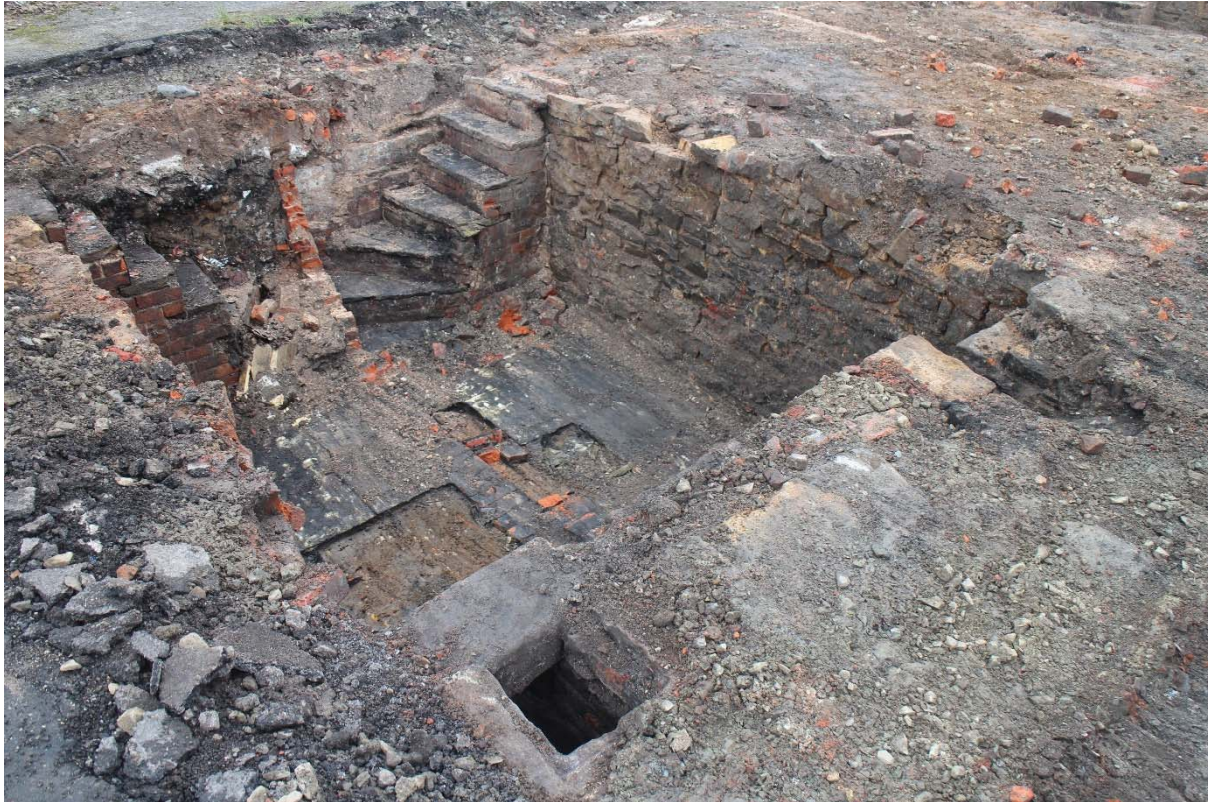
**3.5.44** Located at the eastern limit of the southern range, the footprint of structure **2018** represented one of the best-preserved and most accessible examples (Fig 4). The structure was therefore targeted for further mechanical excavation and its description below will serve as a guide to the layout of rooms in this range (Plate 23). The structure was excavated to a depth of approximately 1.5m below the general level of excavation in Area 2, at which point a flagstone floor surface was exposed and formed the base of the cellar structure. The basic floorplan of this structure measured approximately 3.40m x 4.30m and was bisected by a central brick partition along the north/south axis. The room was bounded by 0.40m wide stone walls comprising rough cut, squared, and partially coursed sandstone blocks, bonded with a lime-based mortar. The northern elevation was found to incorporate two, small 'coal chutes' roughly 0.60m wide and extending into the footpath of Back Durham Street to the north (**2017**: Plate 23). The southern extent incorporated a set of cellar stairs descending into the partitioned cellar, presumably providing access from the southern room. These were constructed using hand-made brick with stone steps and bonded with a lime-based mortar. The layout of Cellar **2018** was identical in form to the second structure also subject to mechanical excavation (cellar **2021**) further to the west.

Plate 23. Structure **2018**, featuring the steps set in the southern elevation (background), and coal chute (foreground). Viewed facing south-west.
