# **Durham Street, Rochdale**

## **Archaeological Evaluation and Excavation**

### **Report**

**August 2019**

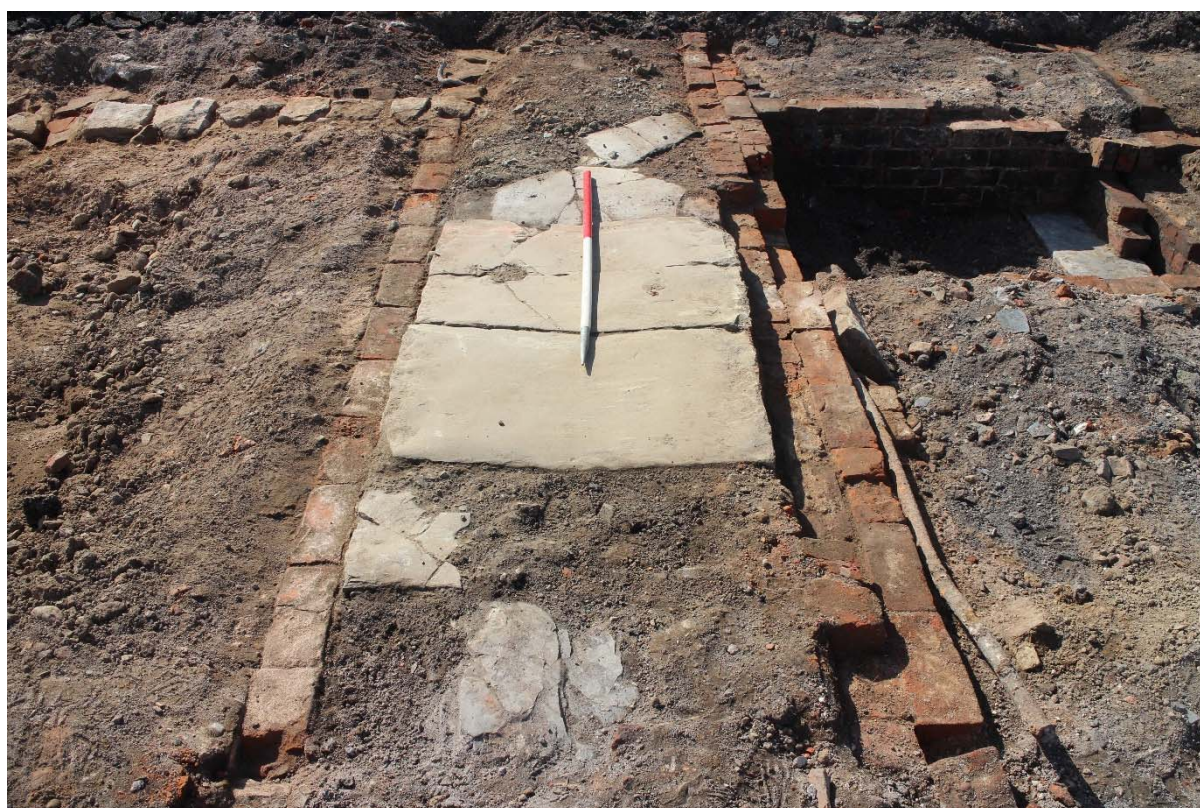
- 3.5.46 The western limit of this range of buildings was defined by the presence of structure **2023** (Plate 25): This structure formed a covered ginnel observed on historic mapping (Fig 4 and 5) and probably incorporated into the first-floor footprint of structure **2022** to the east. The structure was bounded to the east by a single skin partition wall and to the west by a two-skin brick wall, originally observed within evaluation Trench 5 as **506**. Both were constructed using hand-made bricks and bonded with a lime-based mortar. The internal floor surface (**503**) comprised flagstones with an average size of 1.60m x 0.88.

Plate 25. Flagstone surface **2023** representing a probable ginnel dividing the row of terraced housing along Durham Street. Viewed facing south.

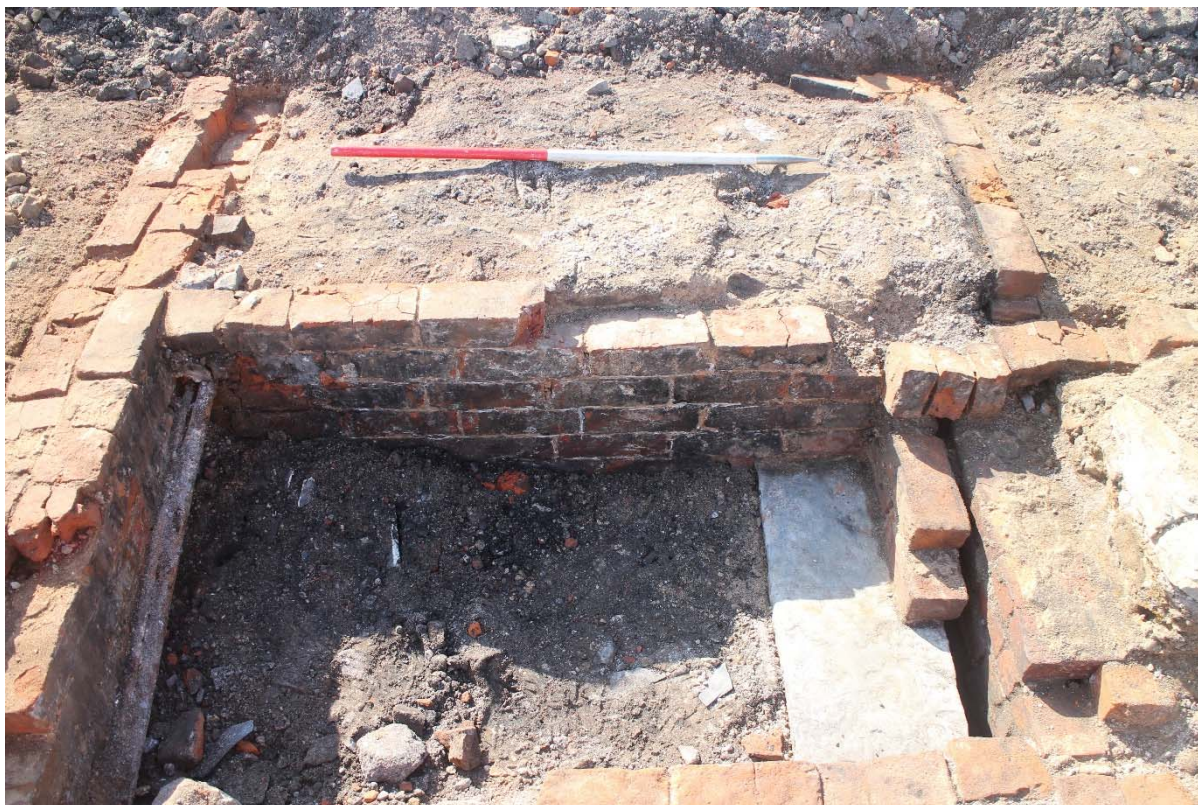
- 3.5.48 Structure **2024** measured approximately 1.62m x 3.36m and was bounded to the east and west by two-skin brick walls (Fig 4 Plate 26). A single skin partition bordered to the south with a 0.75m wide stairwell (descending west/east) observed along the northern face. The presence of the stairwell indicates cellar structures continued to feature among the buildings in this area.

Plate 26. Detail of the east/west aligned stairwell within Cellar **2024**. Viewed facing south.

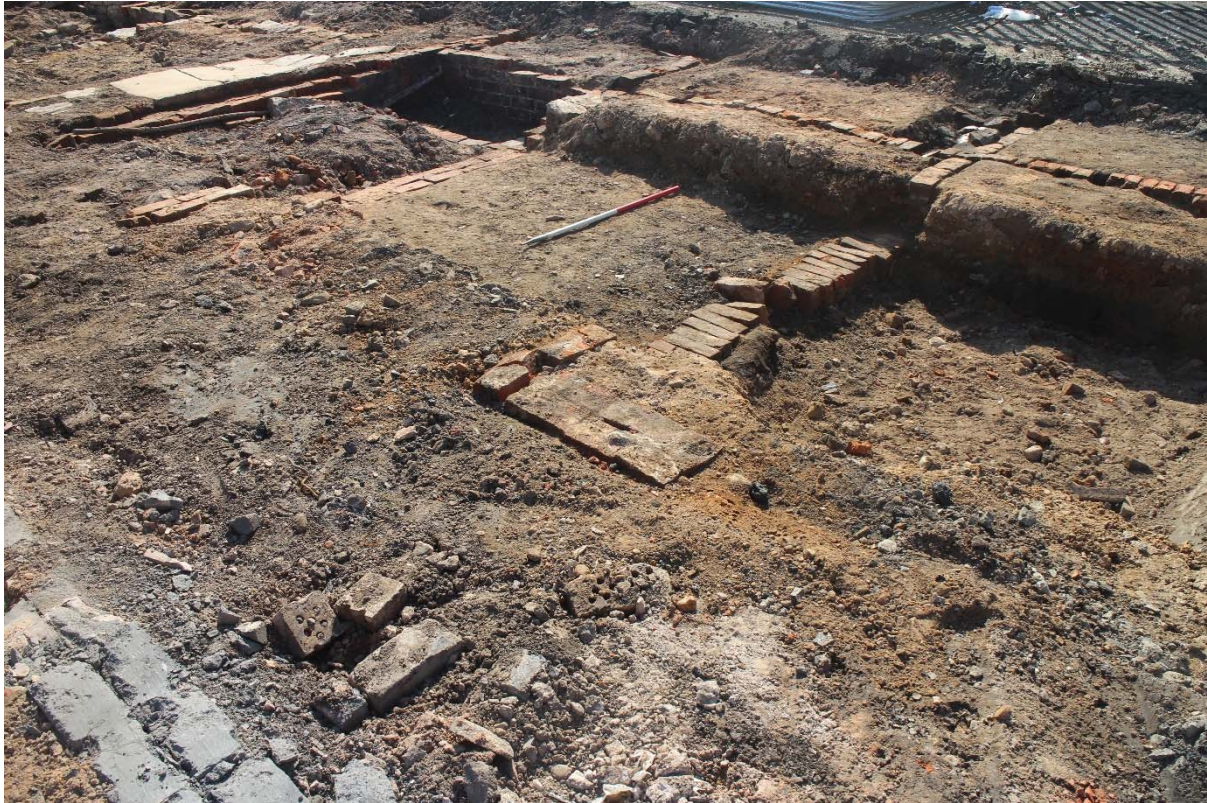
analogous with the northern range, appearing to have a rectangular footprint, further subdivided into roughly equal halves, with cellar space to the rear, further partitioned along the central axis of the building. They did differ from the northern row of terraced houses in some elements, with certain buildings within the eastern half having been constructed with sandstone foundations, and generally being slightly larger in proportions. In addition, the majority of these houses do not appear to have the L-shaped configuration identified on historic mapping relating to the northern terrace. This may indicate a different phase of construction to the northern range, or else perhaps denote slight differentiation in the status of intended occupants.

Plate 27. Cellar **2025** (centre), with cellar **2024** (centre left), ginnel 2023 beyond, and cellar **2026** (center right). Viewed facing south-east.
