# **CORNING'S GLASSWORKS, LISBURN TERRACE, SUNDERLAND TYNE AND WEAR**

## **Final Excavation Report**

**Oxford Archaeology North**

October 2015

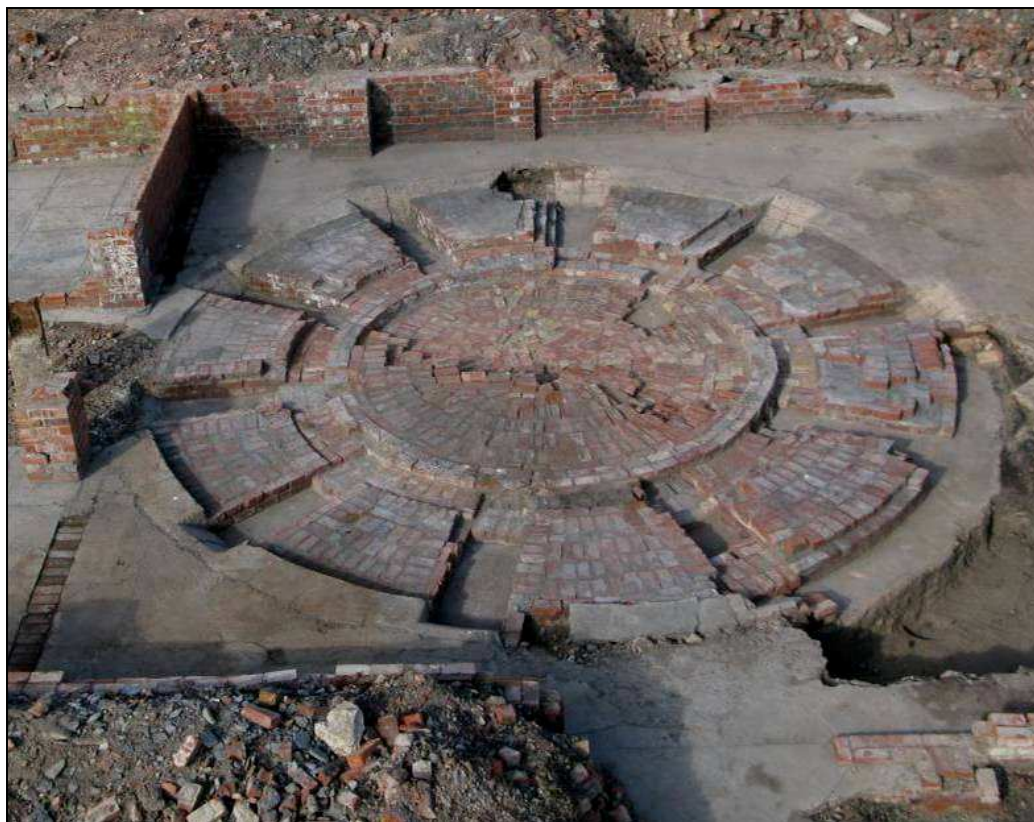
- 3.3.6 Kiln base **105** (Plate 19) survived only at floor level, and measured 25½ft (7.77m) externally, with the kiln floor itself measuring 13ft (3.96m). Ten tapering channels, each a maximum of 19in (0.49m) wide, led from floor level within Room **104** below the kiln floor, representing ash pits placed below the waist-height stoking holes. The layout of the base was consistent with a coal-fired bottle kiln, which had probably been surrounded by a tall brick hovel or cone, of typical bottle shape.

*Plate 19: General view across kiln base 105, looking west*

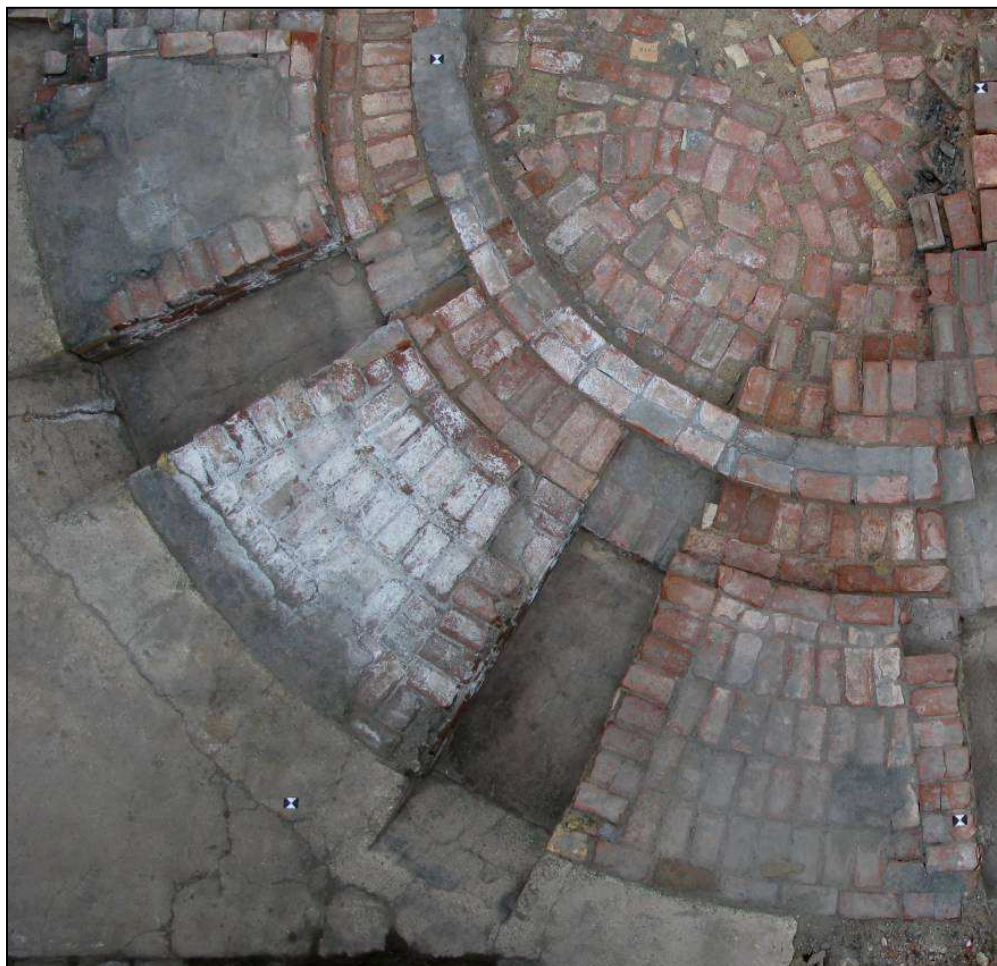
- 3.3.7 The surviving floor at the base of kiln **105** was of three courses, the lower being randomly laid, reused and broken bricks, comprising both regular and refractory bricks (Plate 20). The two upper courses comprised similar material, but laid in a more regular radial pattern. All courses were set in compacted sand, and placed on a concrete base, providing the foundation onto which the kiln was constructed (Fig 6).

*Plate 20: Detailed view of a quadrant of kiln base 105*

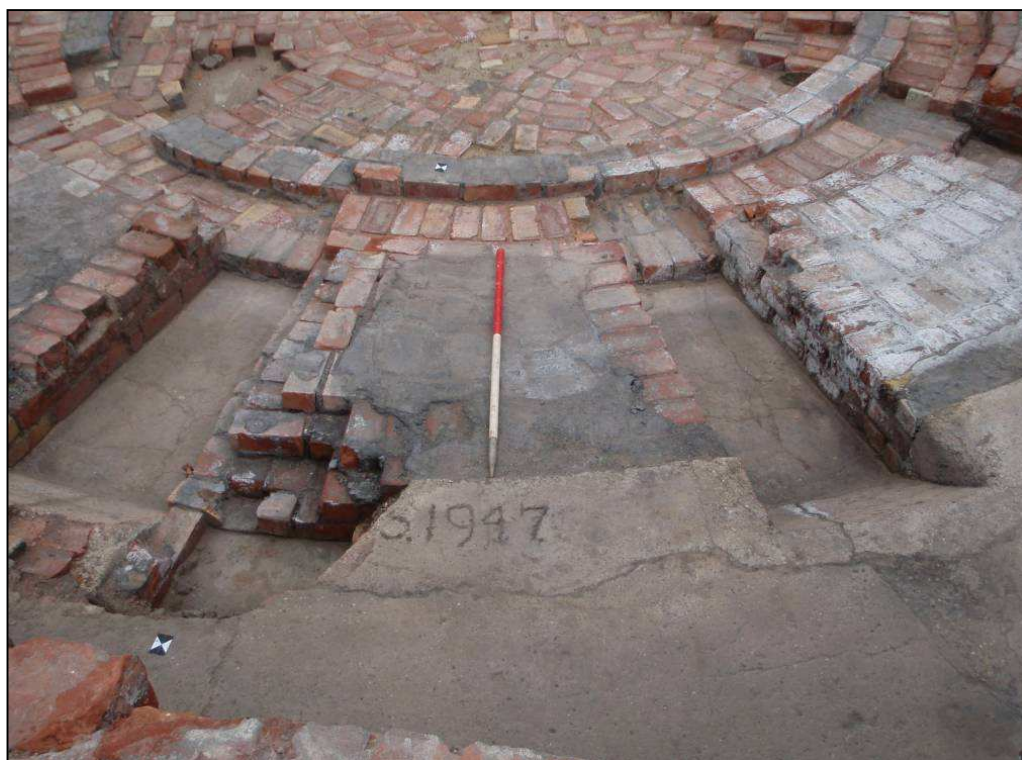
- 3.3.8 The concrete base for the kiln had a maximum thickness of 1m, and comprised three distinct layers (Fig 6). The lower layer contained several large brick fragments, whilst the upper layers contained smaller fragments of crushed brick, and steel reinforcement bars. A date of 1947 inscribed into the floor adjacent to the kiln (Plate 21) provided a construction date for the upper level of concrete and the surviving kiln base, although those below may date from an earlier build. Access to the interior of the kiln was afforded via the 'wicket', which was presumably located on the eastern side, adjacent to the entrance from the main structure. Interestingly, although the remains survived below the level of the wicket from the latest kiln, the ash pit nearest the position of the doorway into Room **109** was infilled with brick, which possibly indicating the position of the wicket.

Plate 21: Date cast into concrete foundation for kiln base **105**

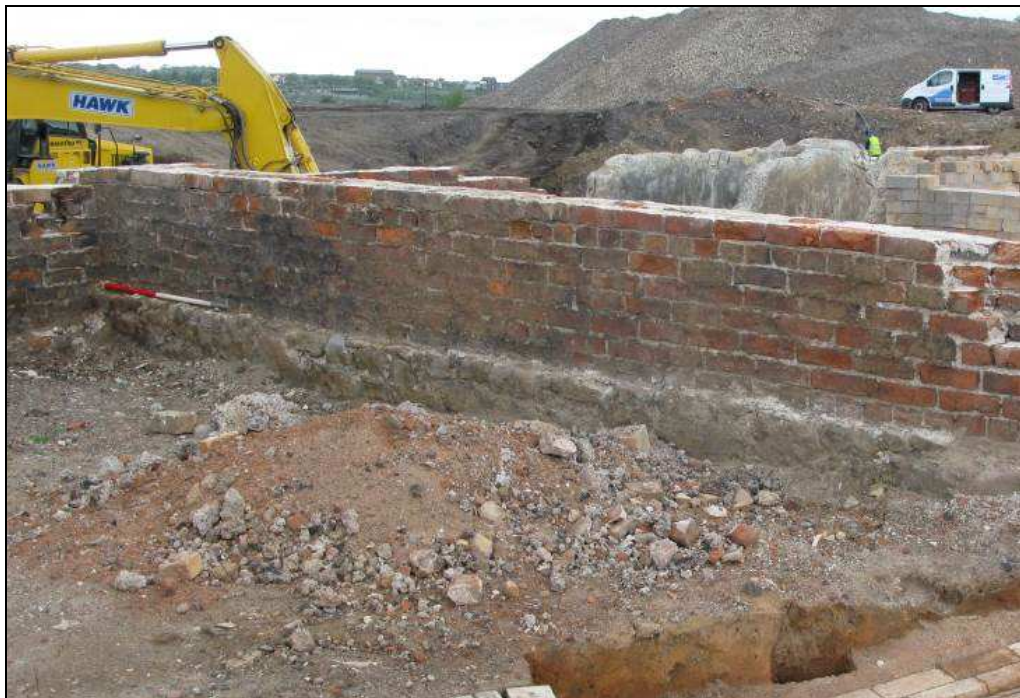
- 3.4.2 **Phase 1 – The Flint Glass Works:** several features that have been interpreted as belonging to the primary phase of the glassworks have been identified. Those that can be ascribed with most confidence to this phase comprised a series of brick- and stone-built walls, several of which correspond to those shown on the Ordnance Survey map of 1897 (Fig 2). Many of the areas adjacent to these walls had been machined down to the level of natural clay, suggesting that no floor surfaces had survived, with the stone portions of the walls probably representing foundational levels. Whilst the thickness of these walls varied between one and one-and-a-half-brick thickness, the construction style comprised three-stretcher English Garden Wall bond, with a pale lime-based mortar, above a wider foundation plinth, comprising typically two courses of irregular sandstone blocks, also bonded with a lime mortar (Plate 26).

Plate 26: Typical section of Phase 1 wall (246), comprising bricks laid on a stone plinth

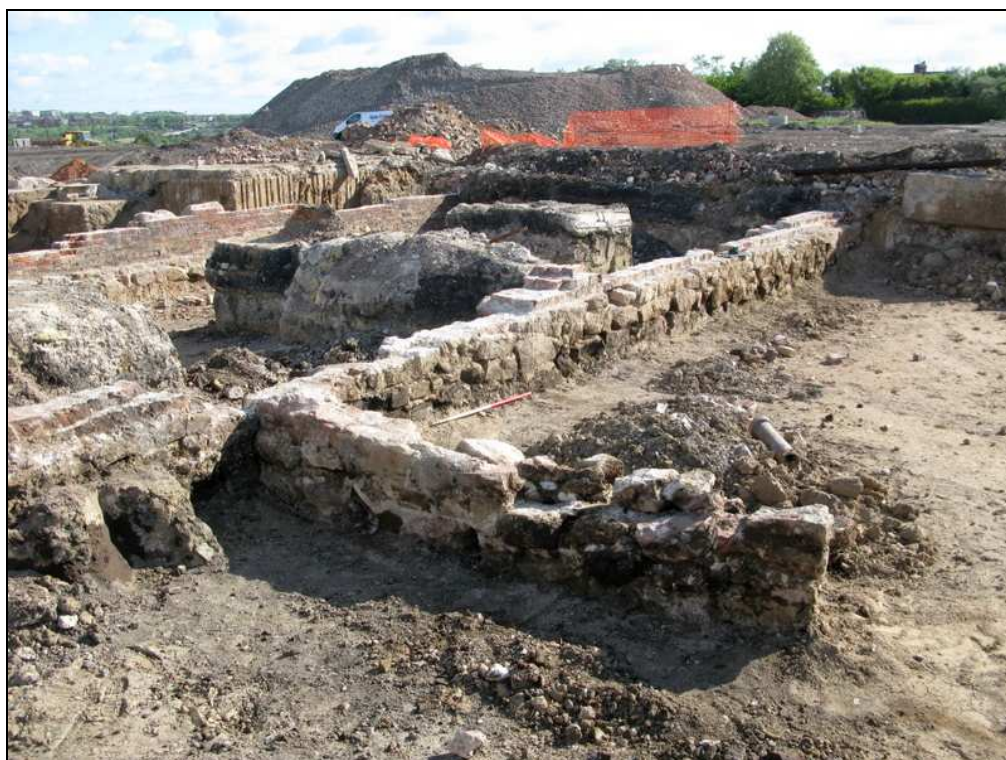
Plate 27: Stone foundations of walls **247** and **248**

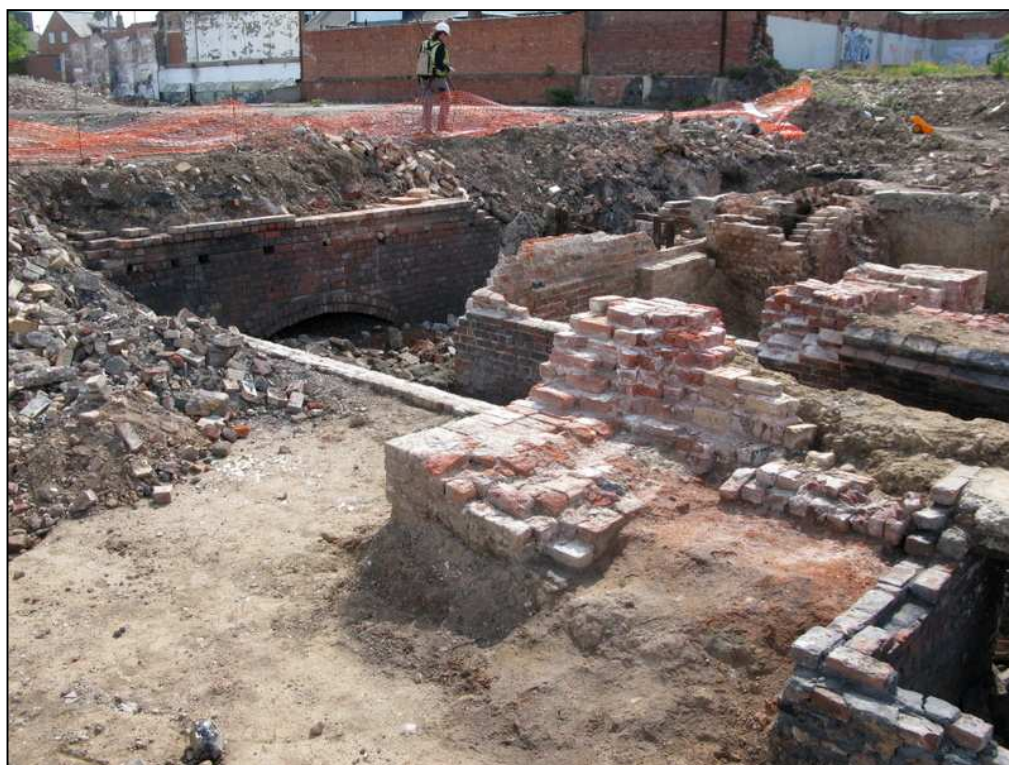
*Plate 28: Northern element of the east wall (229) of the original pot furnace*

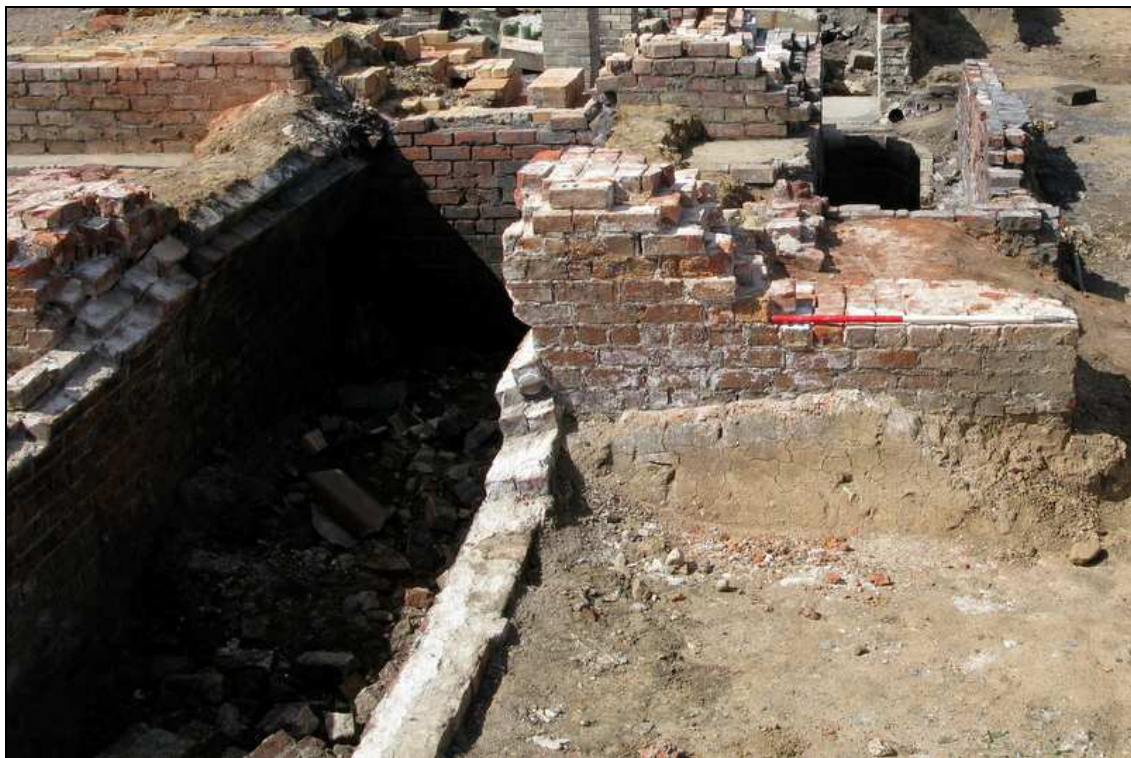
- 3.4.8 The central passage (**226**) identified between walls **222** and **229** (Fig 8) almost certainly represented the sub-surface flue that would have been placed centrally beneath the furnace, providing sufficient room for the workmen, known as teasers, who cleared out ash and clinker from beneath the grate. The flue would also have incorporated a door, or shutter, placed within the passage to the east of the furnace, which had been intended to regulate the flow of air into the furnace. Closure of this shutter will have reduced combustion in the furnace to a minimum, allowing the melting pots to be filled with a fresh batch of raw materials. Fragments of a crucible recovered from Area 3 suggest that all the original furnace heated crucible pots from which the metal was drawn.

*Plate 30: Contemporary central flue (226) between walls 222 and 229*

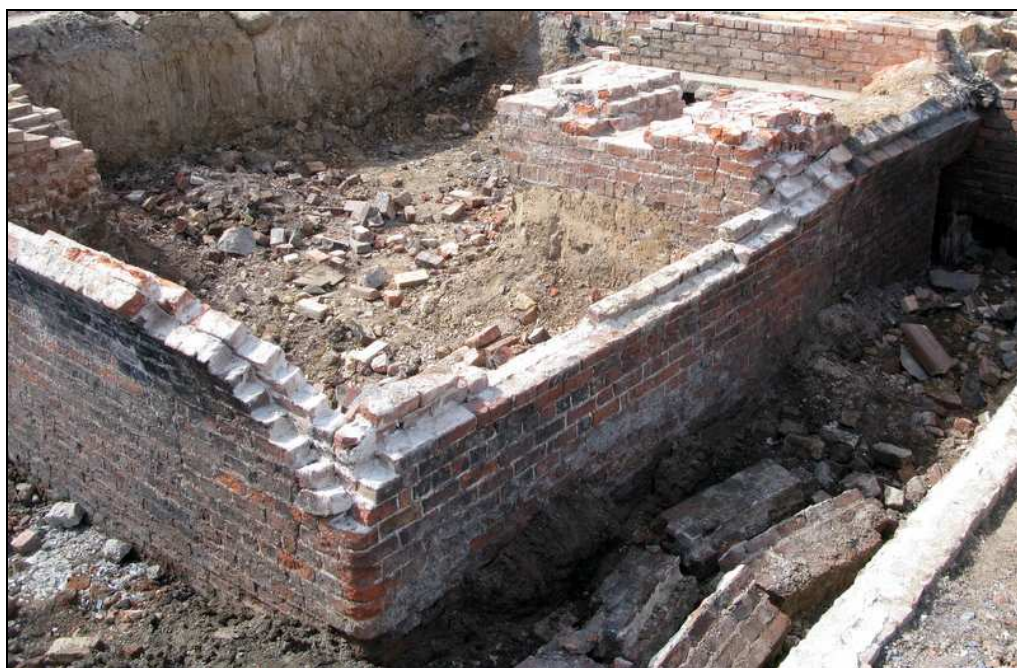
- 3.4.9 The extant remains of flue **226** were 5'6" (1.68m) wide, and comprised a full-brick thickness of hand-made red brick, laid in four-stretcher English Garden Wall bond, using a pale lime mortar, similar to that observed in the earliest fabric elsewhere. To the west of walls **222** and **229**, the flue was rebuilt, using machine-made bricks, bonded in a sooty greyish-black mortar, and associated with a later furnace placed to the west. At its eastern end, the flue returned southward to the external elevation of the building (Fig 8). The bull-nosed inner return of the wall survived extant (Plate 31), and had a constructional break in the upper courses almost immediately to the south of the return, but the outer return had been removed for almost its entire length, for the insertion of a later furnace, visible in the eastern section of the trench. At its southern end, further late remodelling of the flue had preserved its eastern wall, and part of the crown (Plate 32). At this southern end, a similar contemporary tunnel (**228**) was placed on a parallel alignment (Fig 8), sharing the western wall of flue **226**, which was thickened to two bricks at this point (Plate 32). Both were of 5' (1.52m) width on this axis, with a full-brick thickness, arched crown, that of the western tunnel, **228**, surviving at its southern end (Plate 32). This southern end appears to have formed part of the external south wall of the glass house, with a flush pier between the two tunnels, and a westward return of the west wall of **228**. The east wall of **226**, however, continued further to the south (Fig 8), presumably forming part of an external stair down, clearly shown on the Ordnance Survey edition of 1897 (Fig 2). Tunnel **228** appears to have had a westward return inside the building, with a possible stub of its return visible beyond a rectangular chamber inserted into the northern part of the extant tunnel and associated with the later remodelling of both tunnels (Plate 33). This suggests that the tunnel formed access to the main floor level within the glass works, either via stairs, or more likely a ramp, in order for coal from the yard to be delivered to the furnace, as well as the raw materials for the production of glass.

Plate 31: Return of flue **226**, with furnace wall **229** behind

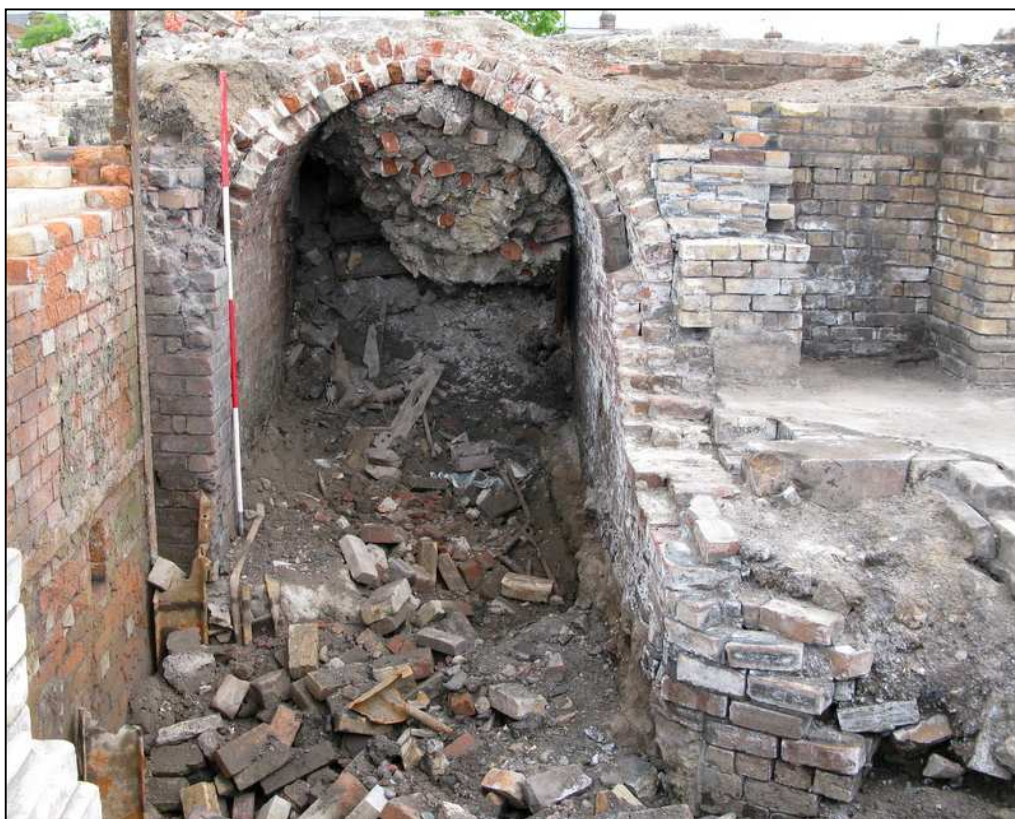
- 3.4.10 At the western end of the building, placed against the original external wall of the glassworks (251) was a further vaulted passage, 252 (Fig 8; Plate 34). This was of similar size and construction to flue 226, but retained its full-brick thickness crown at its western end (Plate 34), and almost certainly forming part of the same flue as 226, giving a through draught from the exterior, and providing additional access. The flue appears to have been remodelled subsequently, solely into an access passage, with a curving wall at the eastern end of its northern side, and a straight return on the southern side, apparently affording access to the switch room of the secondary regenerative furnace (Section 3.4.13, below).

Plate 34: Flue / access passage 252

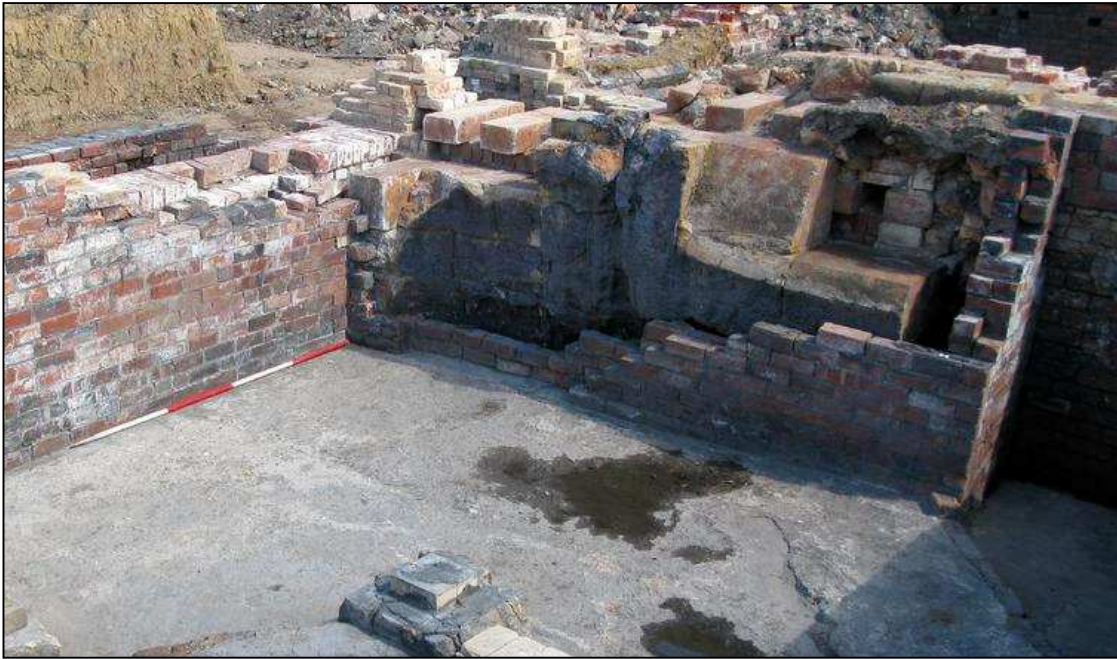
*Plate 35: Remains of the Siemens-type furnace*

- 3.4.16 The blocks beneath the slab floor butted the rear of a wall formed of large refractory blocks, typically 2'2" (0.61m), and 18" (0.46m) high (Plate 36), bonded with a narrow bead of unfired clay. This formed the end of a tank furnace, with chamfered blocks in the upper course representing 'tuckstones' (Plate 36), which formed the interface between the tank, containing the glass metal, and the crown above. In the centre of this tank wall, a 3' (0.91m) wide column rose above the wall either side (Plate 36). The inner face was heavily corroded and glazed by the glass metal (Plate 36), and its exact purpose remains unclear, although it was possibly related to the framing of a gathering port, several of which would have been placed around the working end of the tank. The surface of the pier was also coated with pools of vitreous waste, possibly as a result of spillage during gathering, which would have taken place from the adjacent floor.

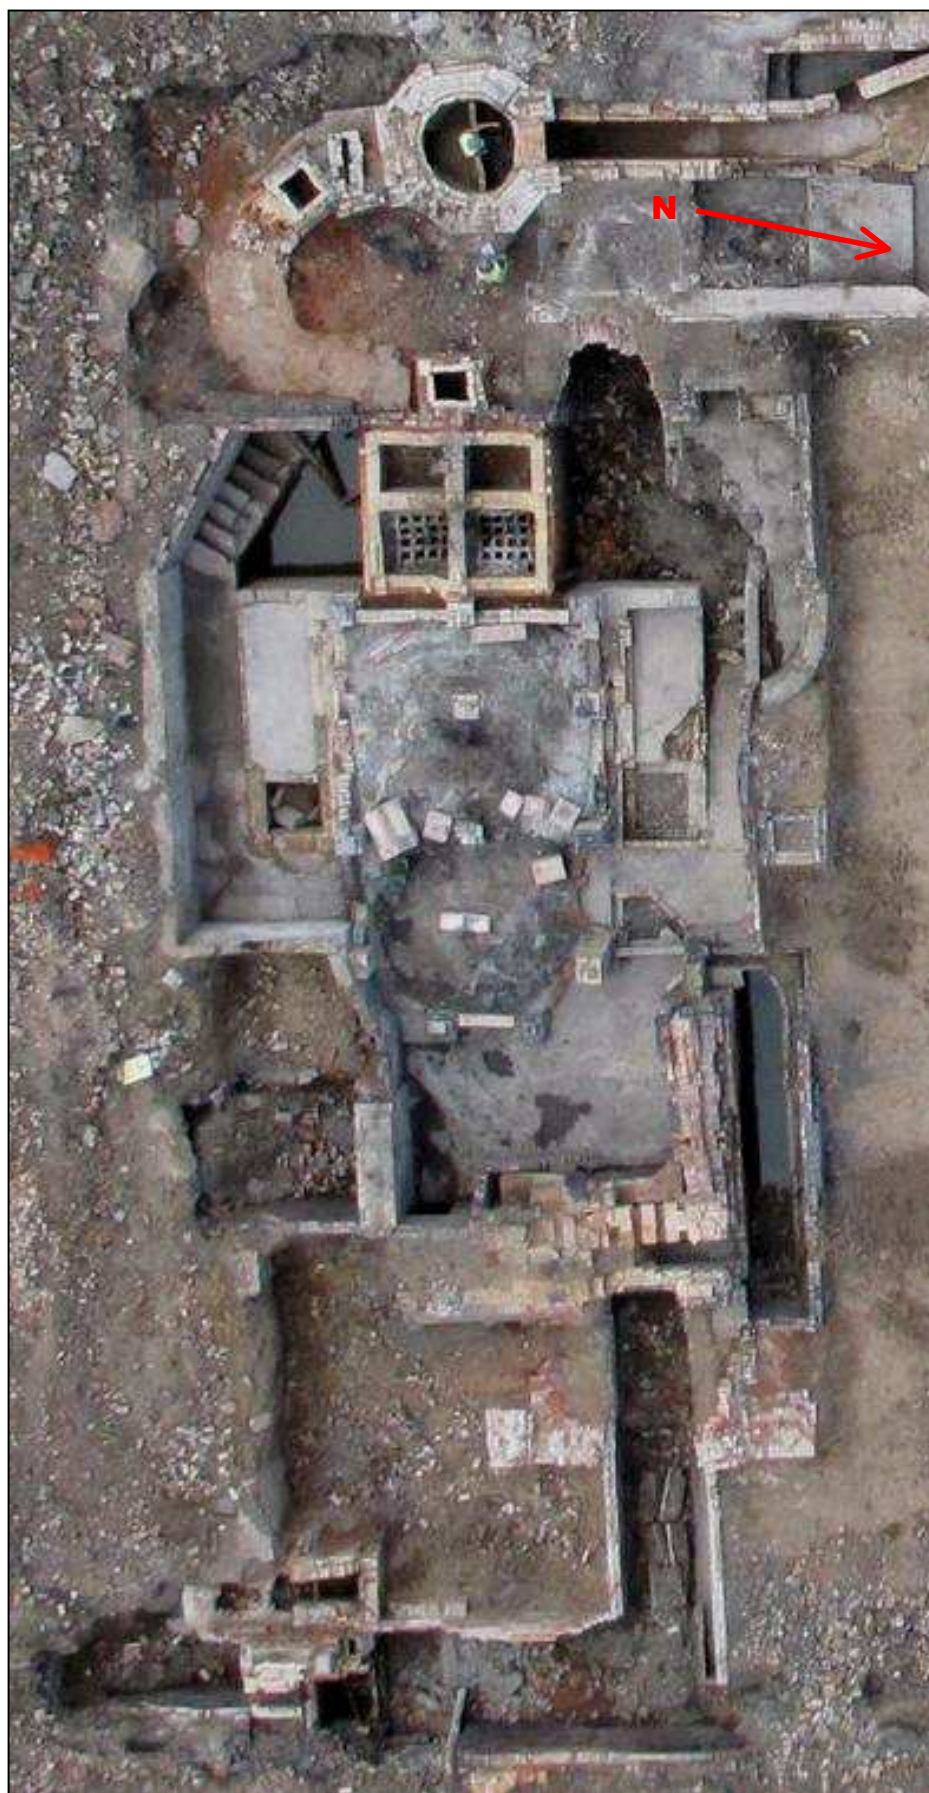
Plate 38: Aerial view of the south-western part of Area 2 showing the Siemens and Pyrex furnaces

- 3.4.18 The arrangement of flues in a horizontal regenerative furnace, for either pots or a tank followed a very similar arrangement, with a pair of central gas flues placed beneath the furnace, flanked by a pair of slightly wider air flues. An access passage, or 'cave', was often incorporated between the gas flues, not only to allow access below the 'switch room' floor, but also to prevent the furnace from overheating, providing a buffer of cooler air between the two pairs of chambers. Other furnaces, however, such as that excavated at the Powell & Rickets Glass Works in Bristol (OA North 2009), had the 'cave' placed along the rear edge of the furnace. The 'switch room' was placed at one end of the furnace, and comprised several valves and dampers, and the control mechanism to allow the flow of air and gas to be reversed with the exhaust approximately every 30 minutes.

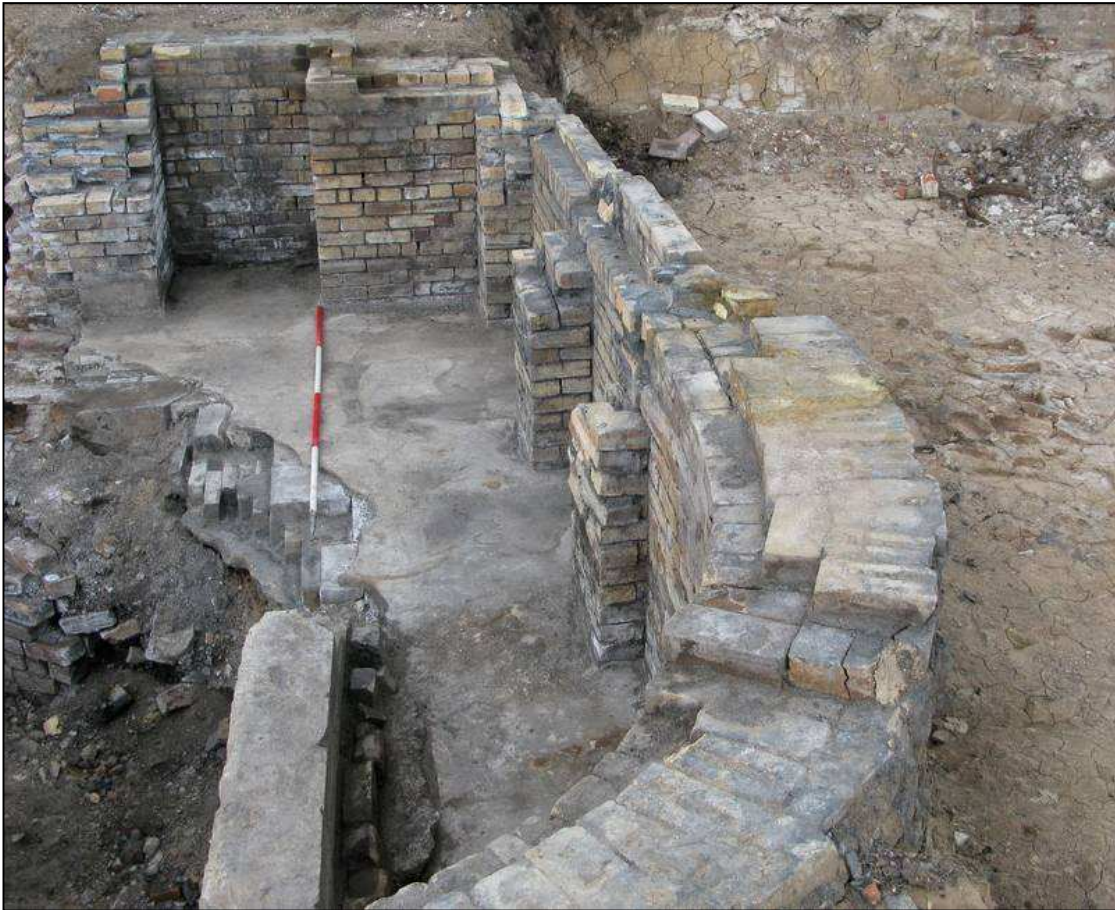
*Plate 39: Curving possible chimney flue 231, north-west of the Siemens furnace*

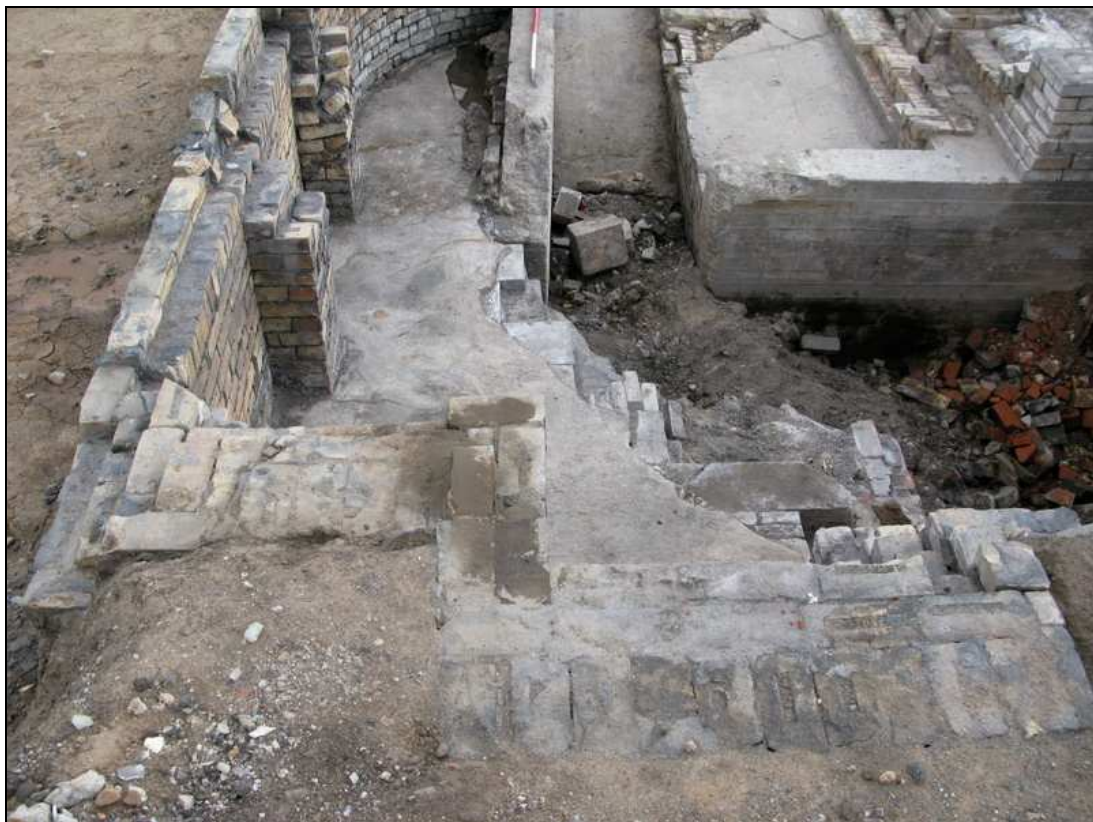
- 3.4.22 A dog-legged, refractory brick wall, **256** (Fig 8), placed at the western end of wall **231** appeared to form the foundation of a 4' (1.21m) wide, square-section chimney, similar to that shown in the nineteenth-century engraving (Plate 6), and placed immediately inside the external wall **251** (Fig 8; Plates 39 and 40). It is also likely that, as in the extant example at Pilkington's No 9 Tank House in St Helens, (Krupa and Heawood 2002), the flue from the switch gear was placed well above floor level, suggesting that the remains of both the chimney flue (**231**) and chimney (**256**) represented only the foundational levels of each.

*Plate 40: Possible chimney foundation, 256*

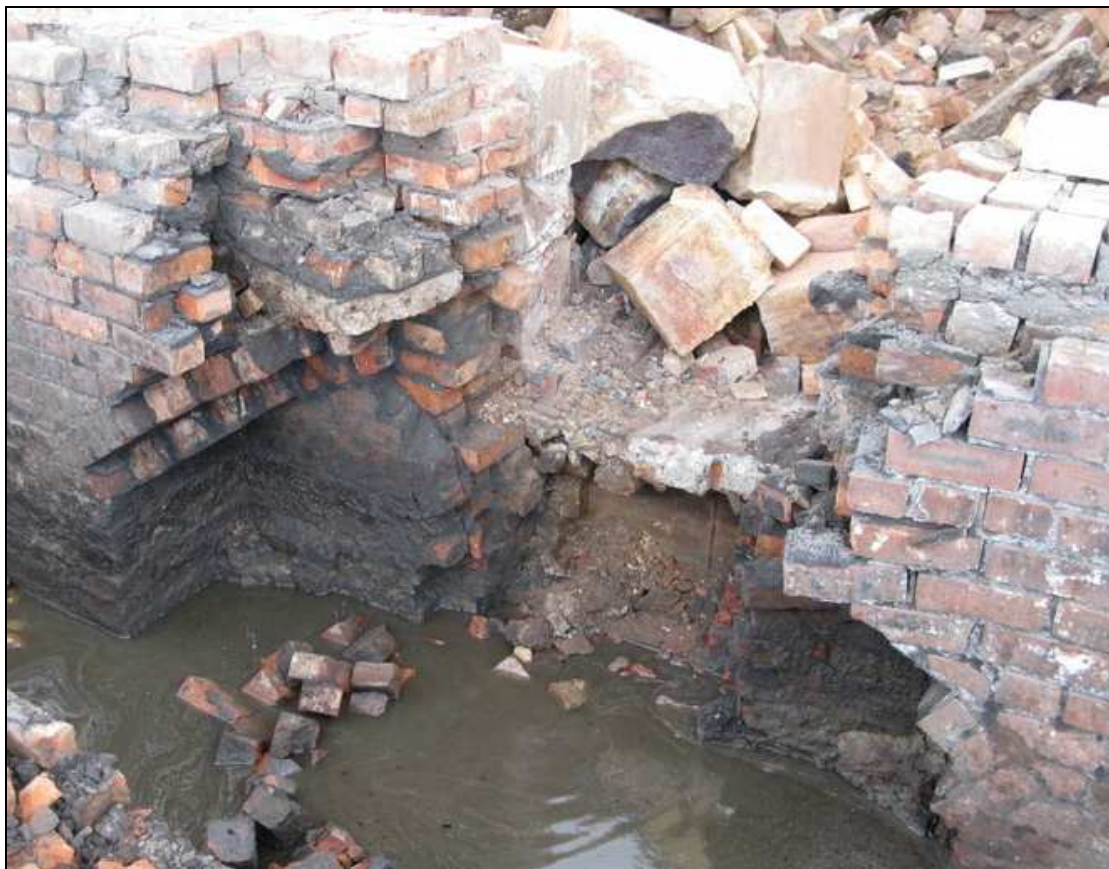
*Plate 43: Bottom block of tank furnace behind relieving arch in north wall of 257*

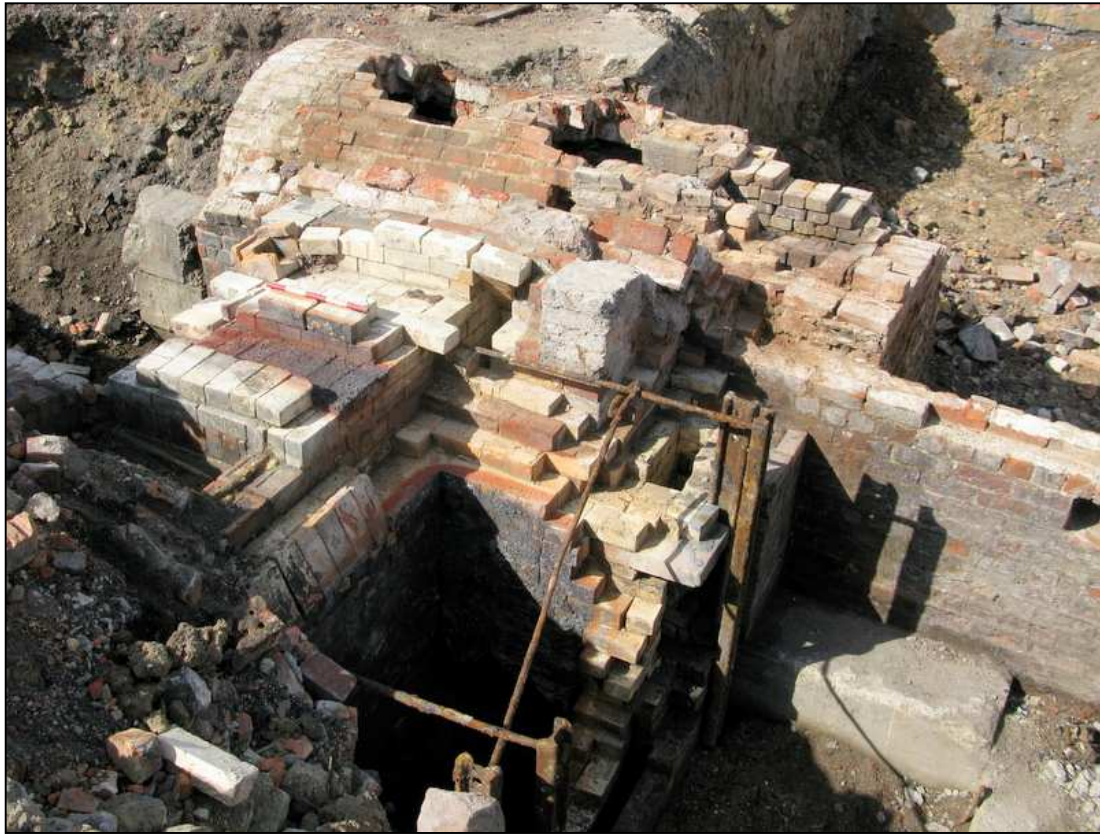
*Plate 46: Gas producer 227, in south-eastern section of Area 2*

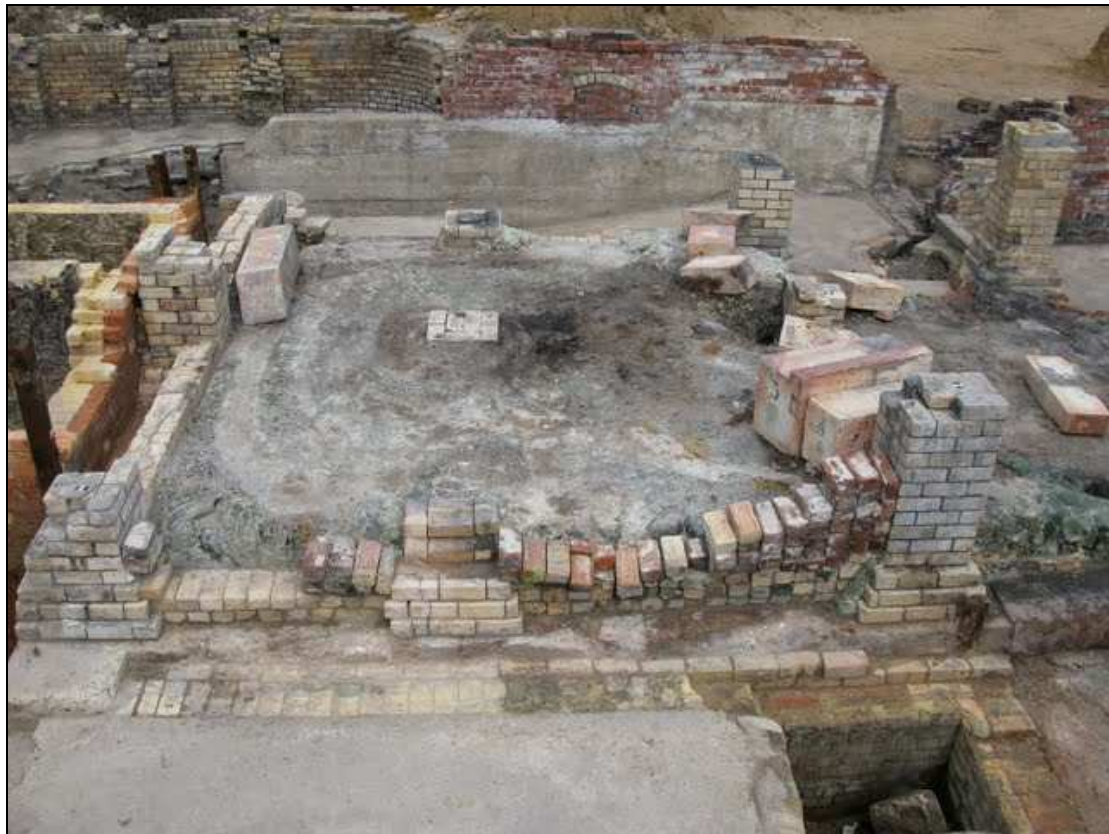
Plate 50: Glass metal 217, above refractory tile floor 216

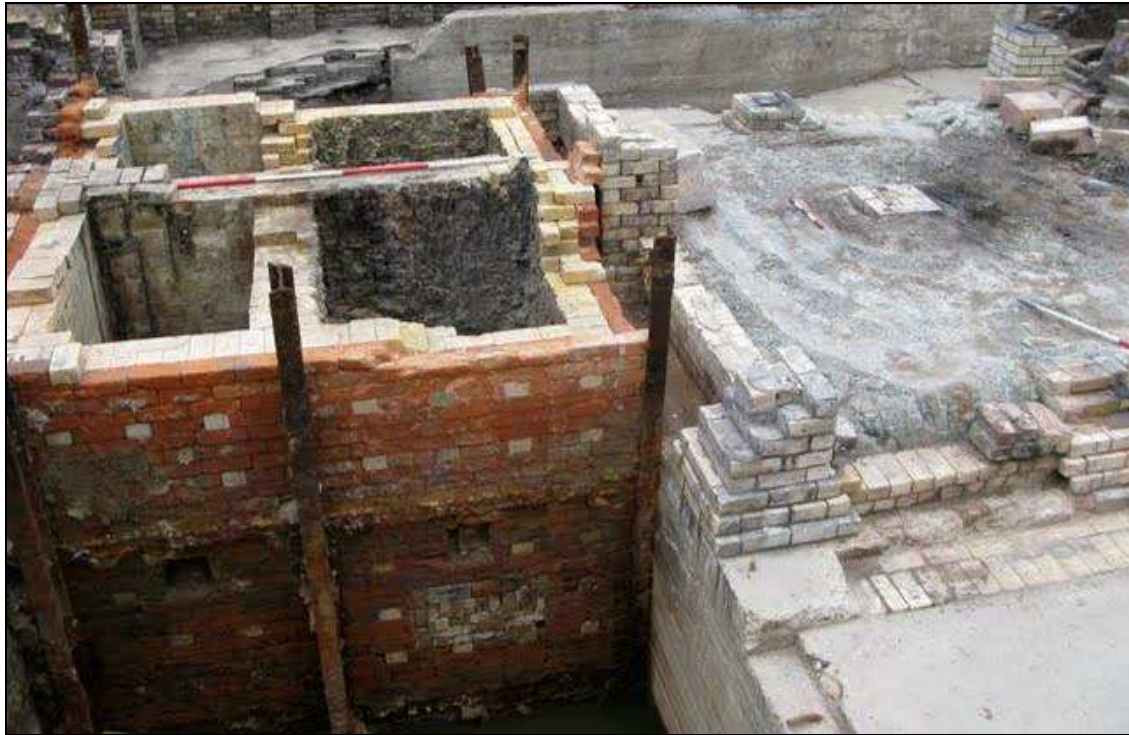
*Plate 51: Recuperative stack, 232, on west side of Pyrex furnace*

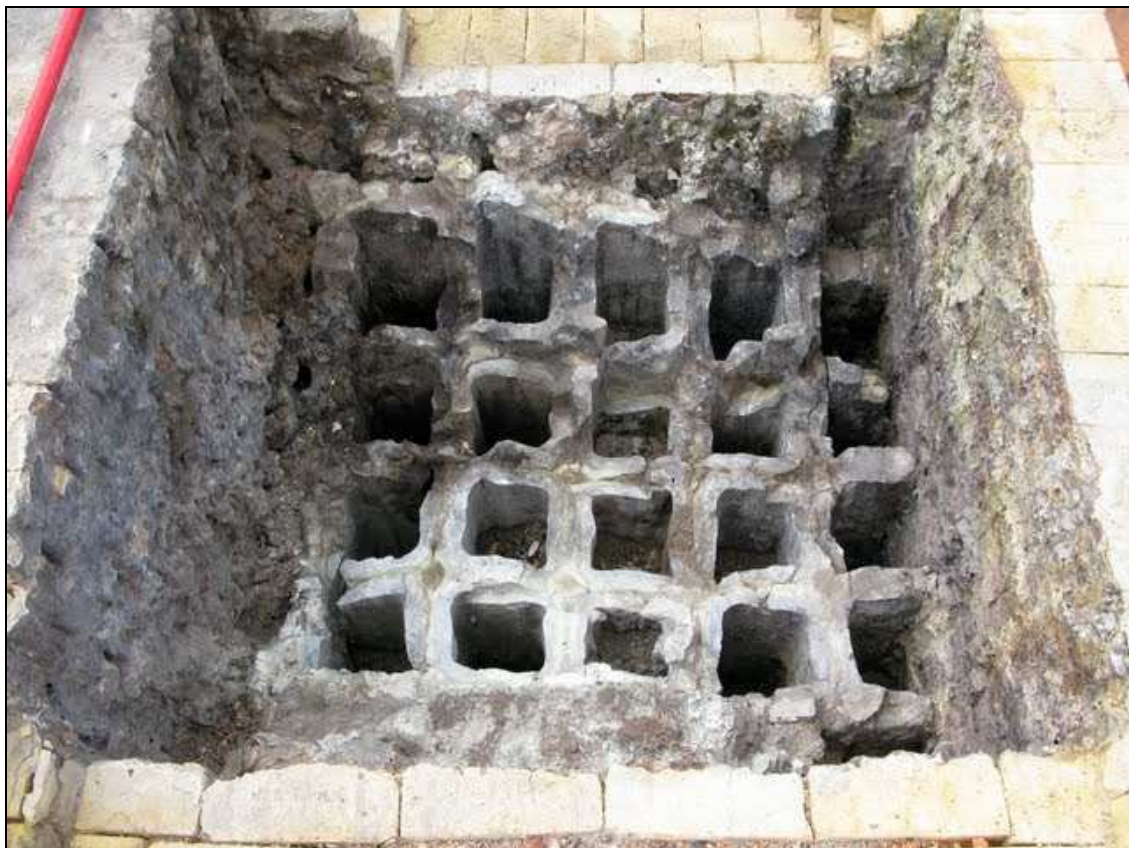
*Plate 52: Detail of recuperator tubes*

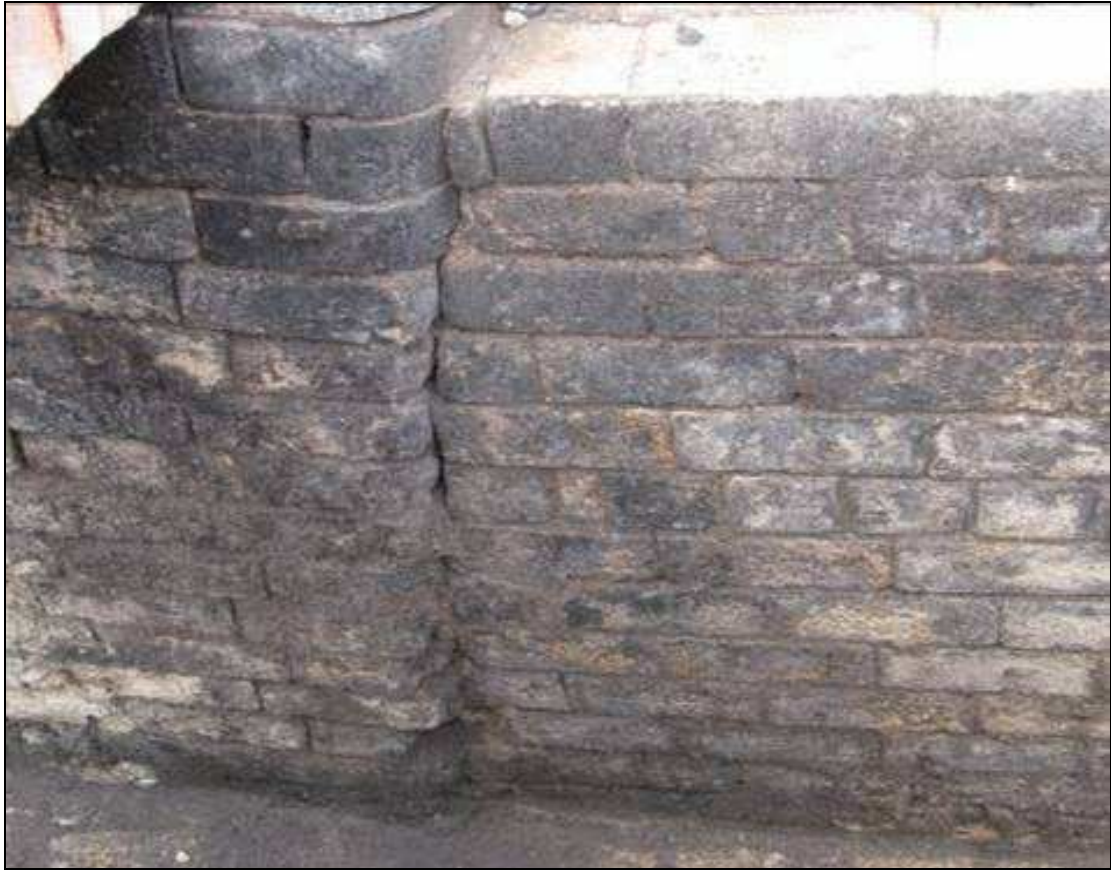
*Plate 55: Butt joint between flue 214 and chimney 213*

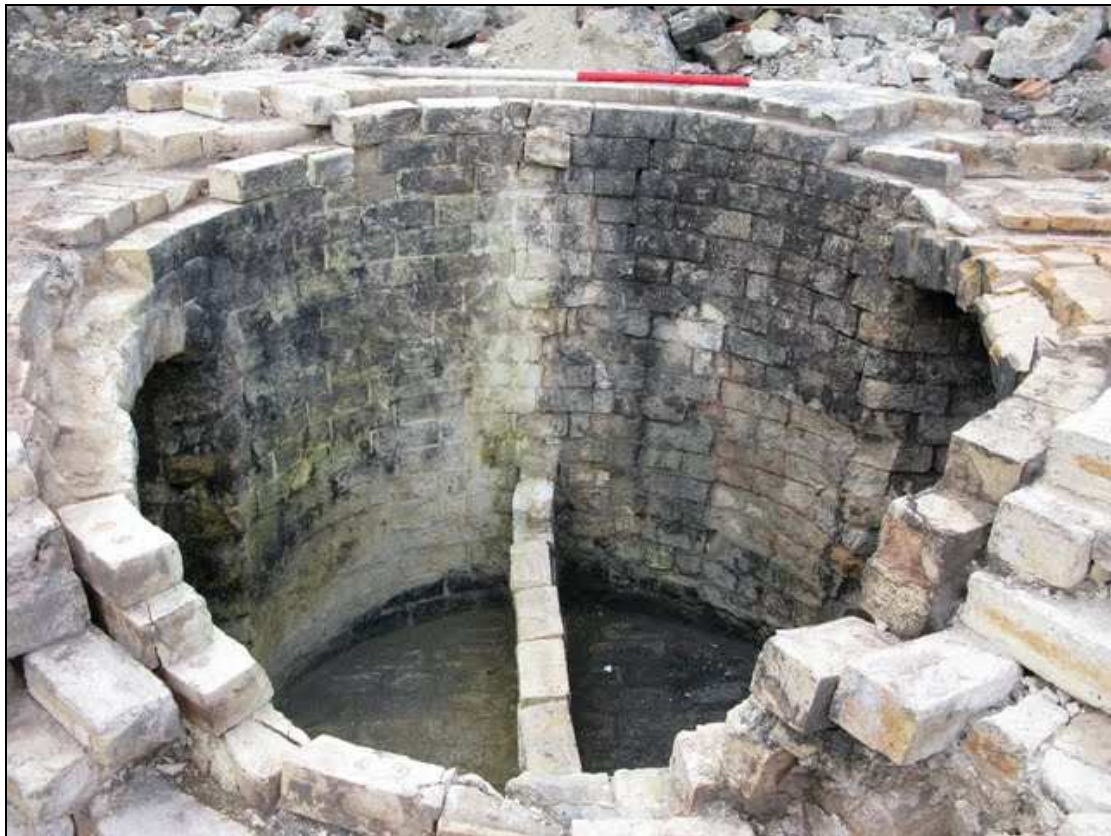
*Plate 56: Dividing wall within base of chimney 213*

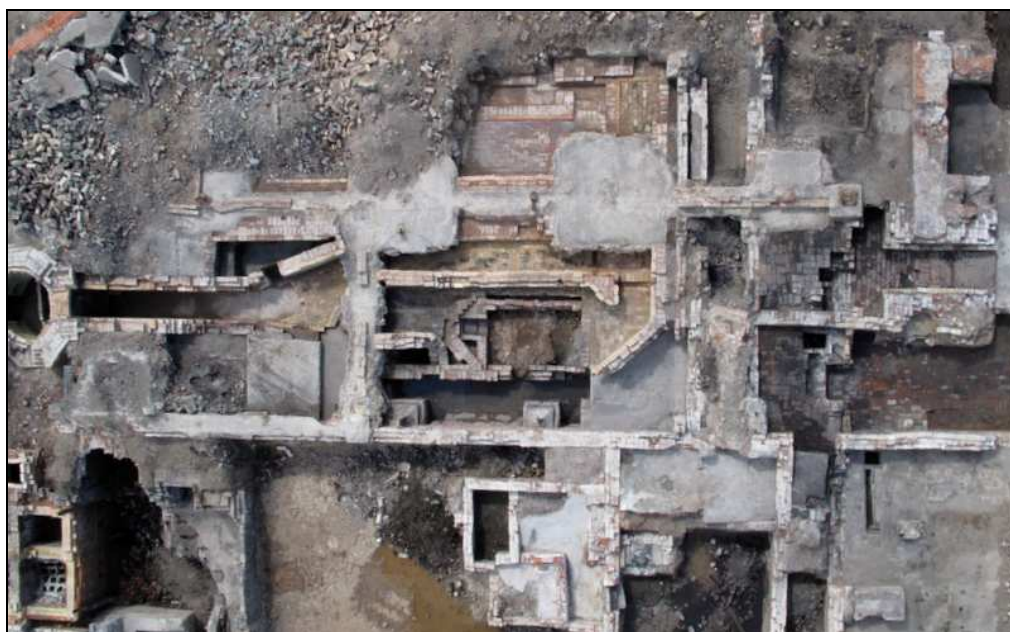
*Plate 57: View of western part of Area 2: flue **214** enters from the left, serving an area with refractory brick floors that probably represented the housing for a Lancashire-type boiler*

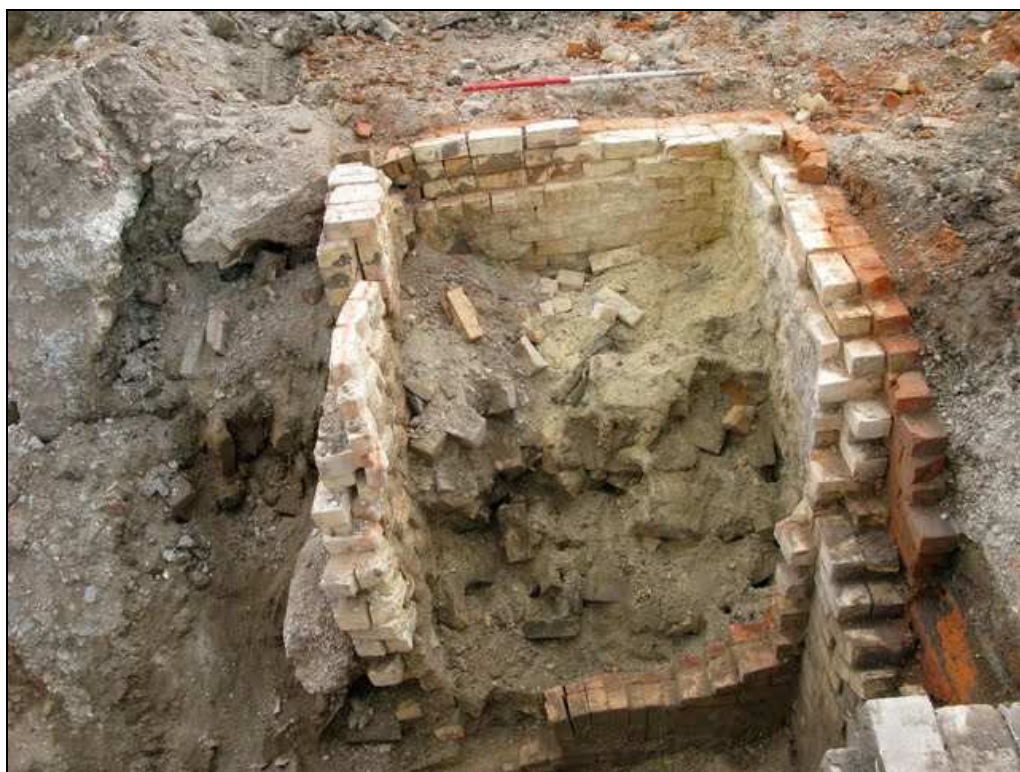
Plate 62: Regenerator 225 during demolition

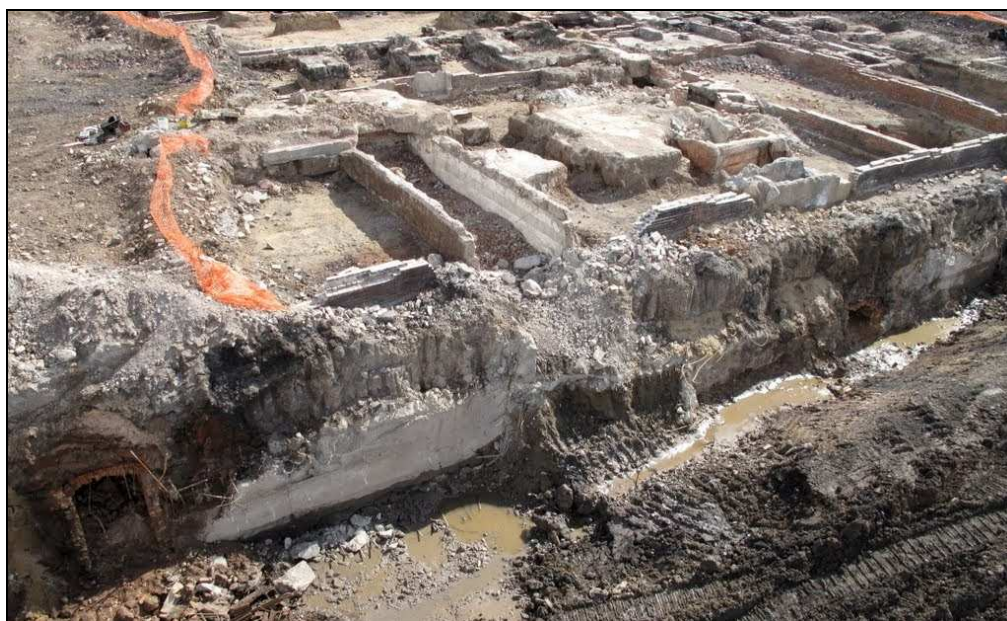
*Plate 63: Flues 262 (left) and 263 (right) in section to north of Area 2*
