# **CORNING'S GLASSWORKS, LISBURN TERRACE, SUNDERLAND TYNE AND WEAR**

## **Final Excavation Report**

**Oxford Archaeology North**

October 2015

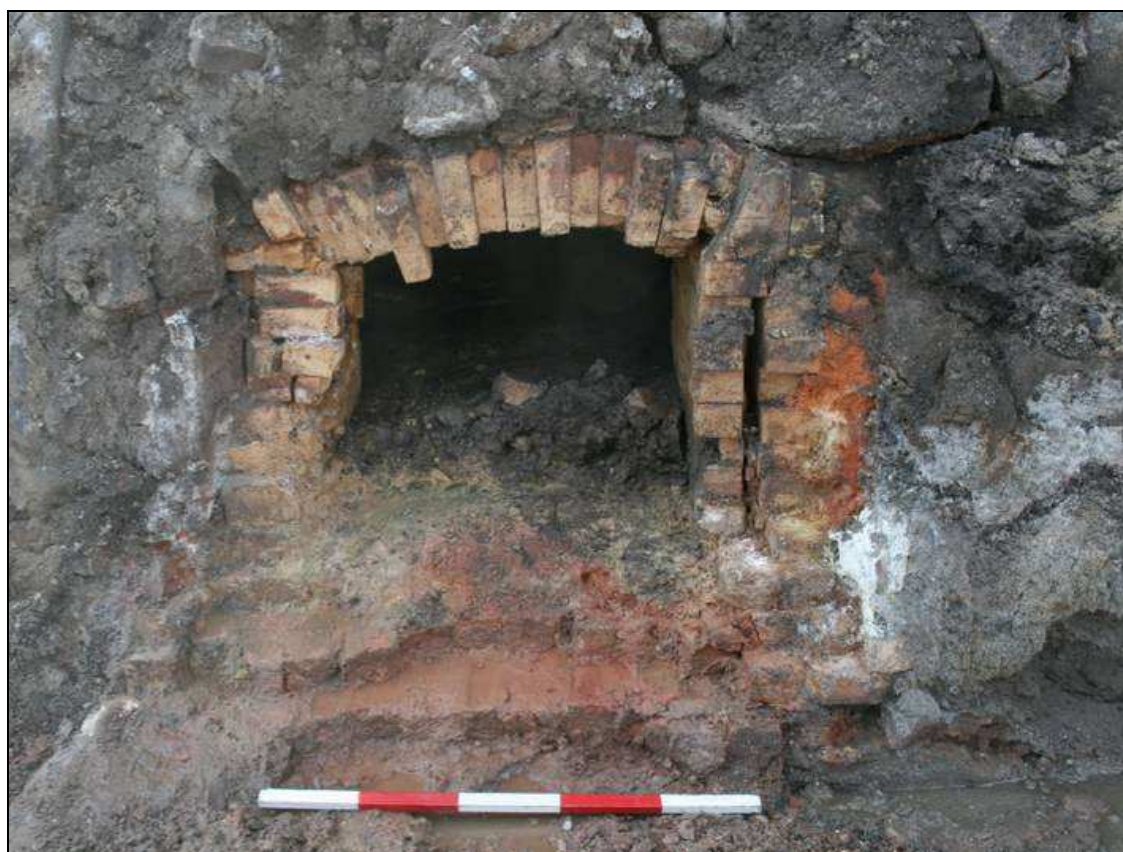
*Plate 65: Detail of flue 263*

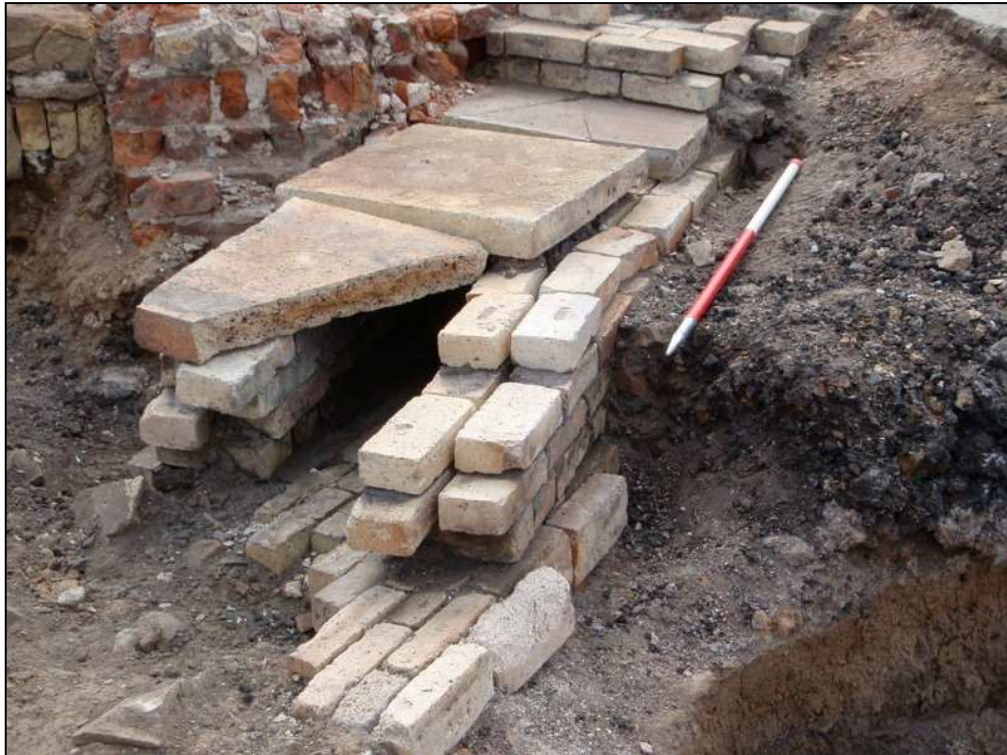
*Plate 67: Detail of Flue 302*

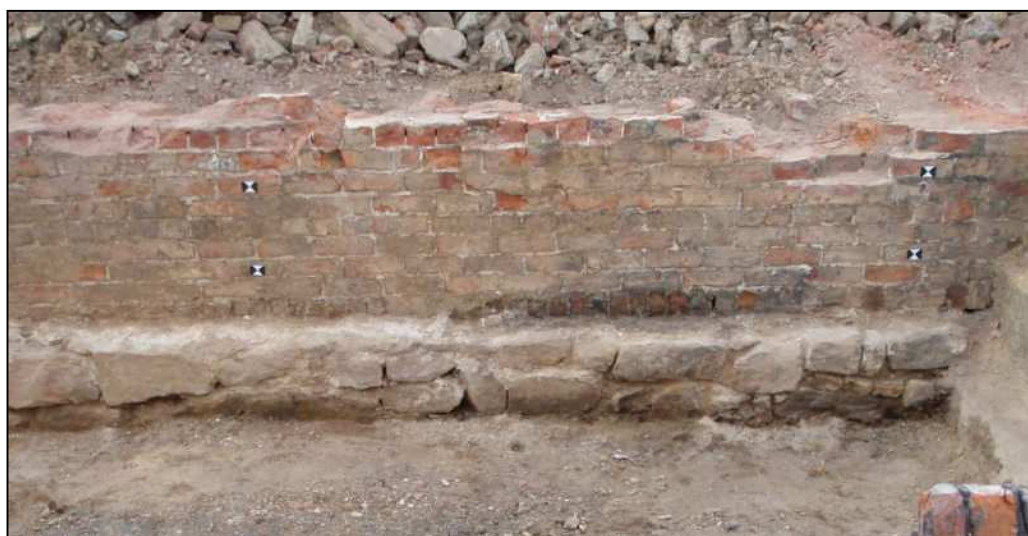
*Plate 68: The fabric of wall 303, showing the sandstone plinth*

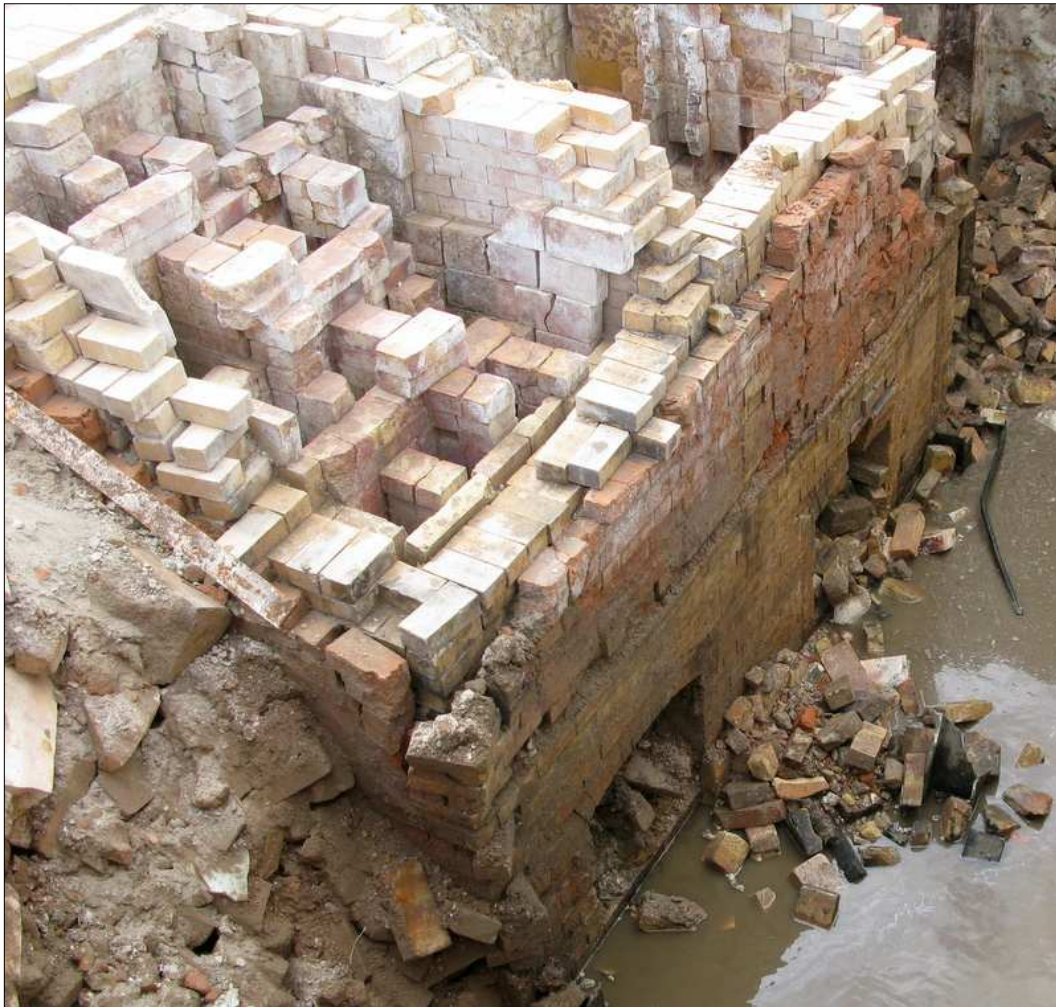
Plate 71: Regenerative furnace 305 within a concrete chamber

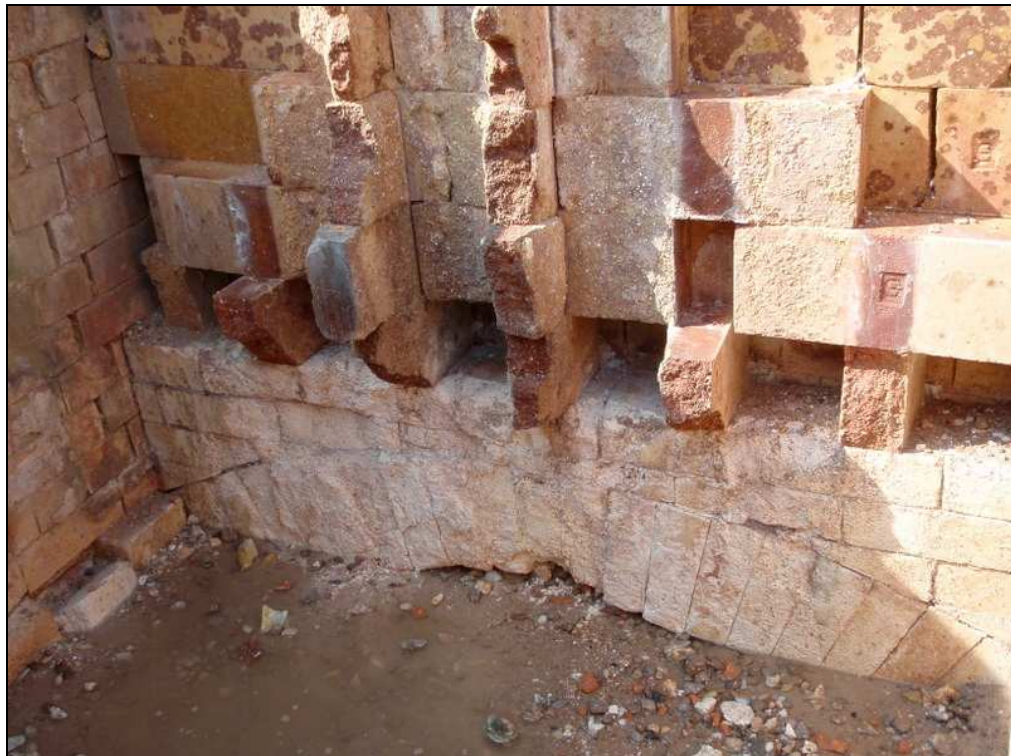
*Plate 73: Regenerative blocks within furnace 305, some bearing an inverted '5' stamp (right)*

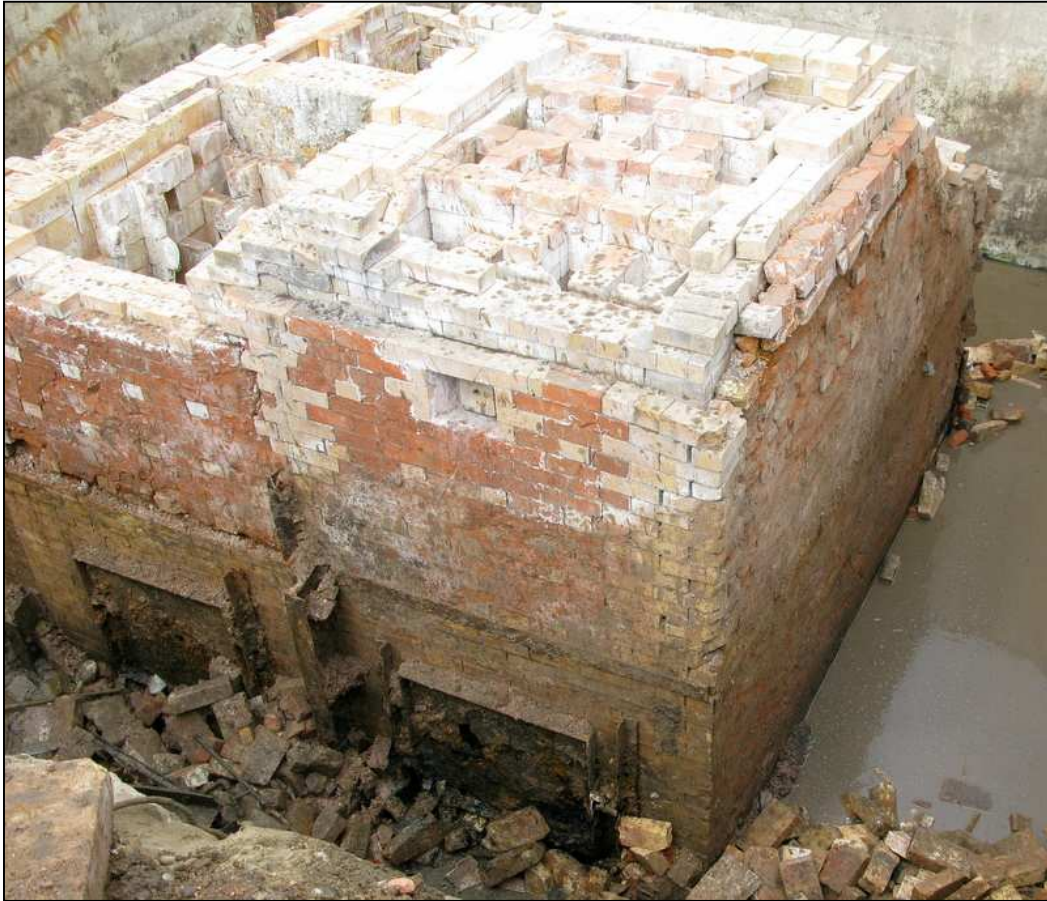
*Plate 74: Sliding steel doors on the north face of furnace 305*
