SIZERGH ESTATE LANDS CUMBRIA

Historic Landscape Survey

Oxford Archaeology North

January 2011

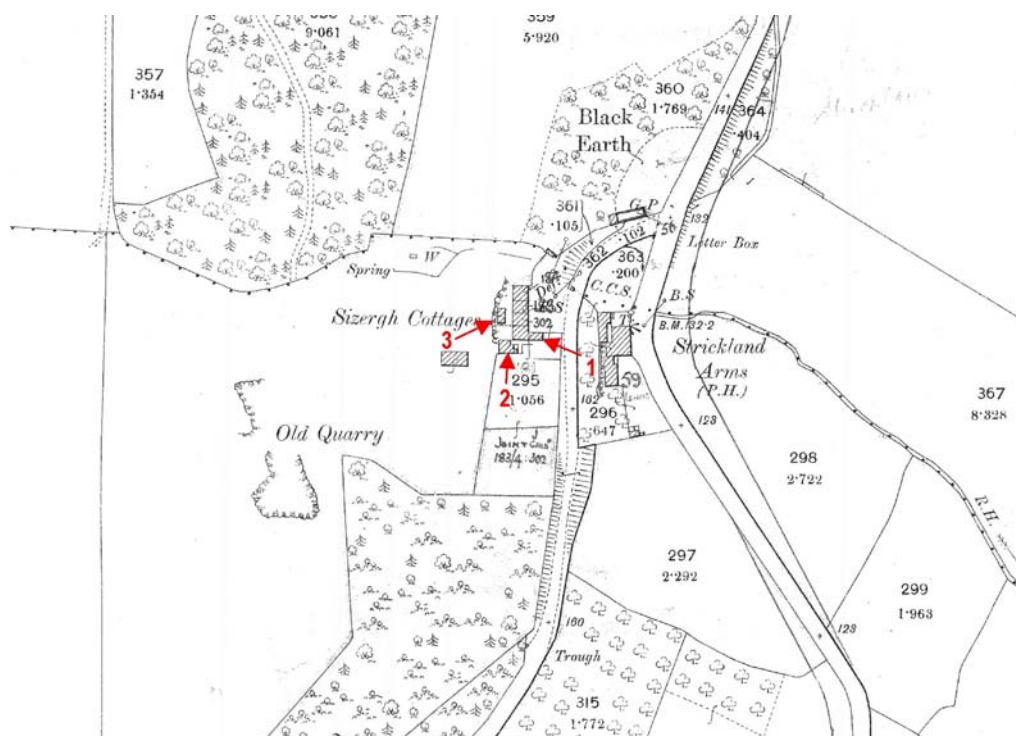
Plate 39: Sizergh Cottage

- 3.6.23 **Sizergh Cottage:** Sizergh Cottage (NTSMR 20568; Building 1) forms the south end of Fellside Cottages and is located to the west of the Strickland Arms, to the south of Sizergh Castle. It originally consisted of a small eighteenth century two-up two-down cottage similar to, but slightly higher than, the other Fellside Cottages (Green 1987c). During the late-eighteenth century/early-nineteenth century a large drawing room with bedroom above and cellar below was added to the east and the kitchen and scullery were added to the rear (east). It is a genteel cottage and during the early twentieth century it was lived in by the Hornyold-Strickland family who also used the adjoining cottage (1 Fellside Cottages). 1 Fellside Cottages is a small building attached to the north end of Sizergh Cottage, comprising a living room and kitchen downstairs and three bedrooms and a bathroom upstairs.

- 3.6.24 A partially demolished nineteenth century coach house was later used as a garage and store (NTSMR 26420; Building 2). It is situated to the south-west of Building 1 and there is also evidence of a lean-to building to the west and possibly a bee hole in an adjacent wall. A large greenhouse was originally situated on the south wall, later replaced by a freestanding one (National Trust 1987). Building 3 (NTSMR 26421) comprises a small, nineteenth century, stone-built coal shed at the southern end of a low range of outbuildings (*ibid*).

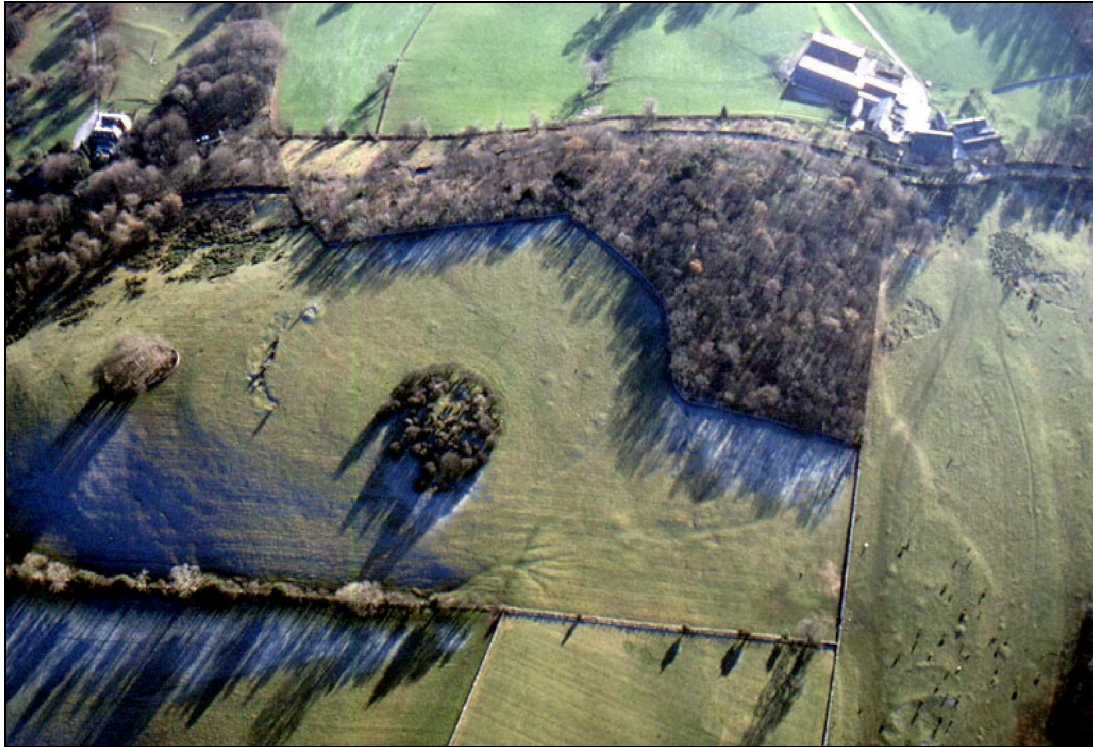
Plate 2: Aerial view of Sizergh Fell (Evans and Edmonds 2003)

- 3.3.6 In the first years of the twentieth century, T McKenny Hughes excavated two mounds (1904a; 1904b) on Sizergh Fell (Plates 2 and 3). The first, Tumulus 1 (NTSMR 20052), was composed of a number of erratic stones arranged around the top of a small mound. Beneath this arrangement, placed in a limestone crevice or gryke and topped by a large boulder, were a number of Beaker sherds accompanied by a small amount of charcoal and burnt stones (McKenny Hughes 1904a). This site was given further context in 2002 as a result of work undertaken by the University of Sheffield and the National Trust which involved further investigation of the wider fellside (Plate 5). A trench located to the south-west of the tumuli revealed a small reworked and broken polished axe of Group VI type tuff which had been wedged into the limestone pavement of a natural mound. In addition, a polissoir (portable axe polishing stone) was found inverted and sealing a gryke in the limestone pavement, which contained a single group VI flake (NTSMR 27783; Plate 6; Evans and Edmonds 2003, 2). Although polished stone axes can be difficult to date, the small reworked examples are relatively common in contexts such as henge ditches during this broad period, and suggests that Sizergh Fell was a focus for activity during the Neolithic/Bronze Age transition (Evans and Edmonds 2003).

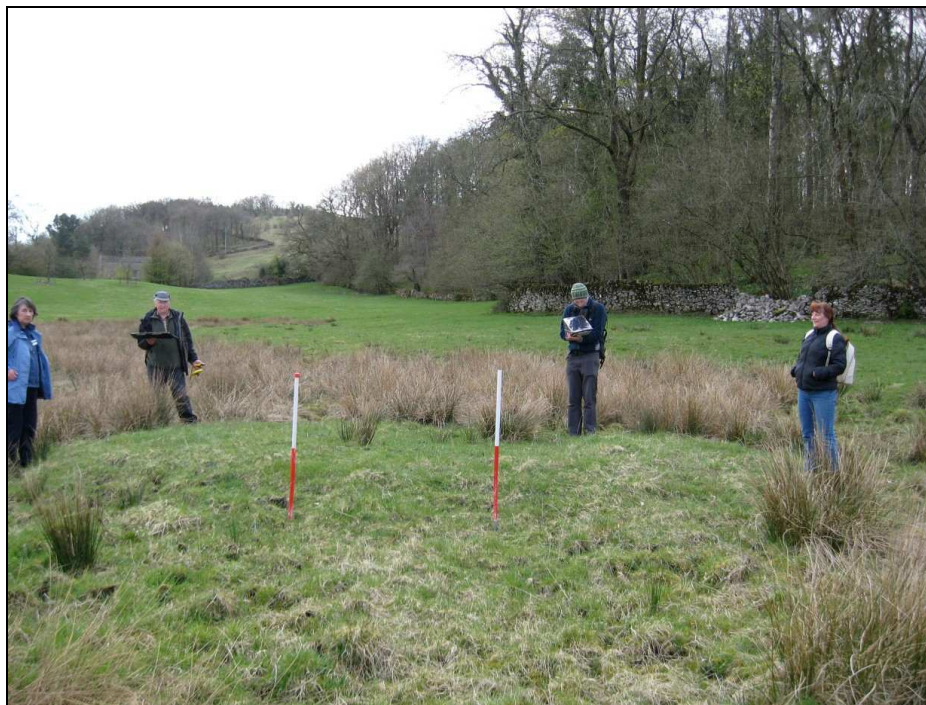
Plate 56: Burnt mound adjacent to haka in Sizergh Park (NTSMR 181419)

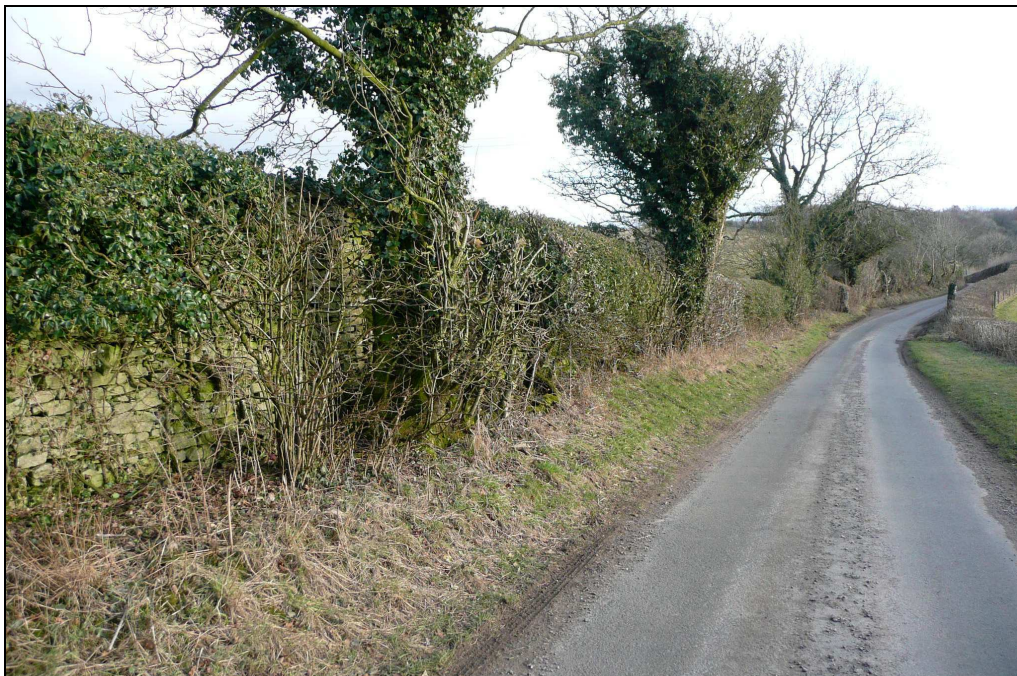
Plate 62: c1713 park wall and gateway at south end of Brigsteer Park (NTSMR 181491)

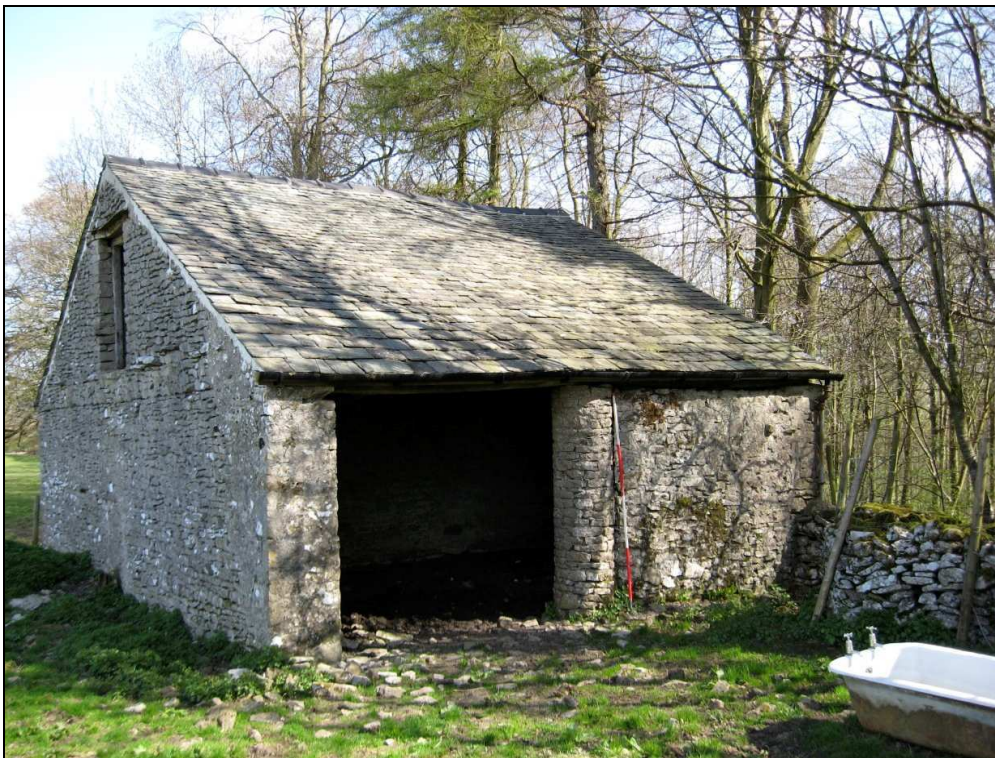
Plate 64: Field barn and/or deer shelter shed Sizergh Park (NTSMR 21278)

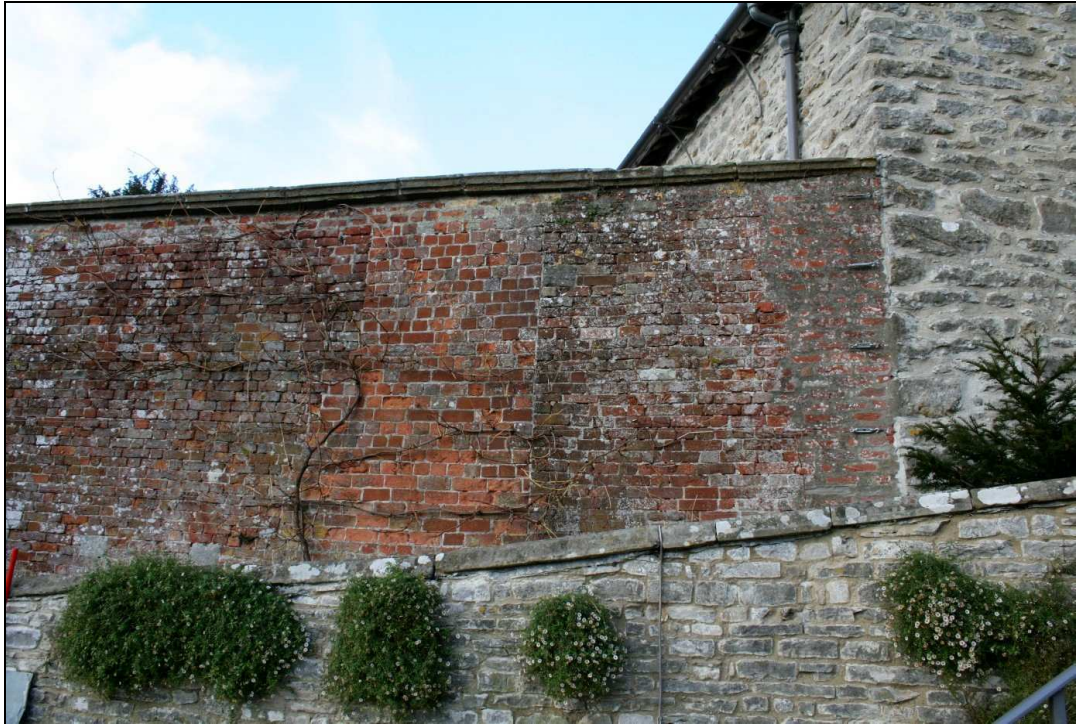
Plate 97: Blocked window within the fruit growing wall (NTSMR 181640)

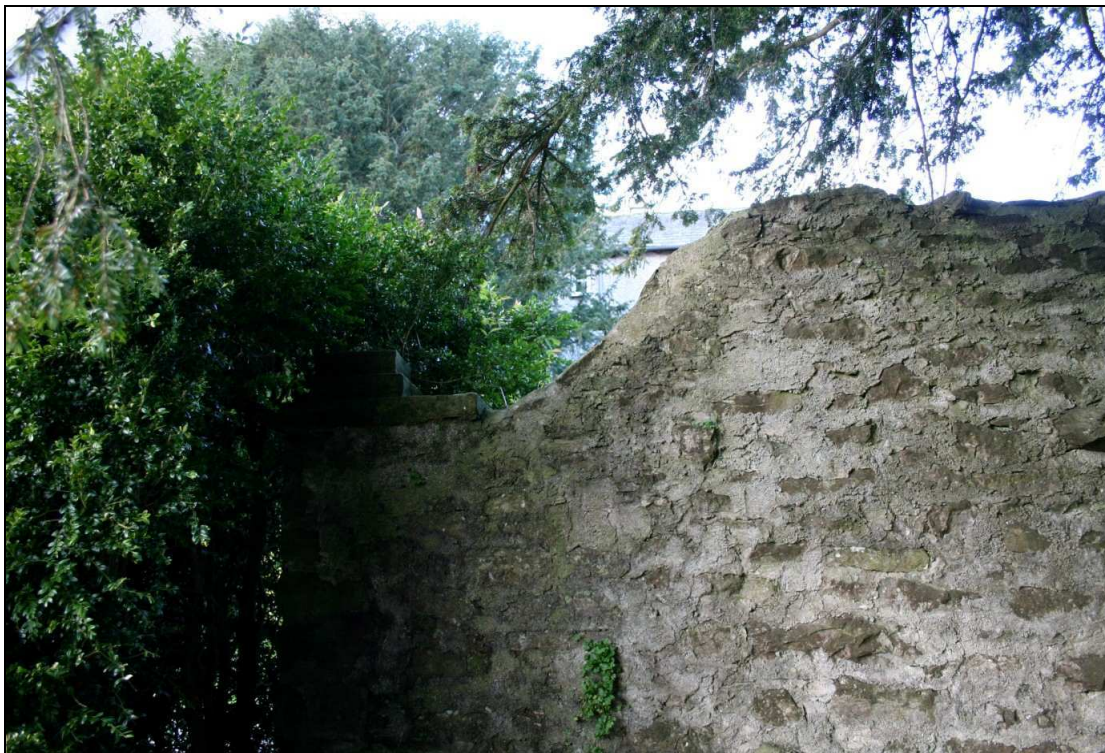
Plate 101: Gable-end of demolished building on north-east side of the terraced garden (NTSMR 181673)
