# LAND AT SPITAL ROAD, BROMBOROUGH, MERSEYSIDE

## Desk-Based Assessment and Evaluation

**United Utilities**

Issue No: 2007-8/677

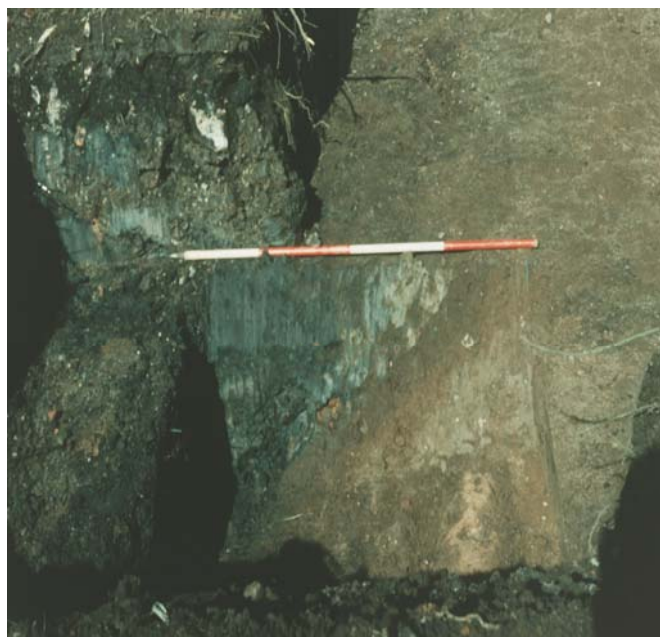
Plate 19: south-south-west-facing section of waterlogged feature *120*

The trenches also targeted areas of potential features relating to water management, such as the mill dam or any associated water channels. Although some waterlogged deposits were observed in Trench 3 that appeared to correspond to the edge of the mill pond, these appear to have formed following a demolition phase at the mill and there was no evidence of a retaining wall relating to the pond. Trench 1 was also positioned in order to encounter remains associated with the east/west road or track that was shown on the estate plan of 1755 and that crossed the River Dibben by Bromborough Bridge (Site **13**). No evidence of this routeway was observed.
