INTAKE FARM, CHEVIN END ROAD, GUISELEY

Archaeological Building Investigation

Oxford Archaeology North

Revised January 2007

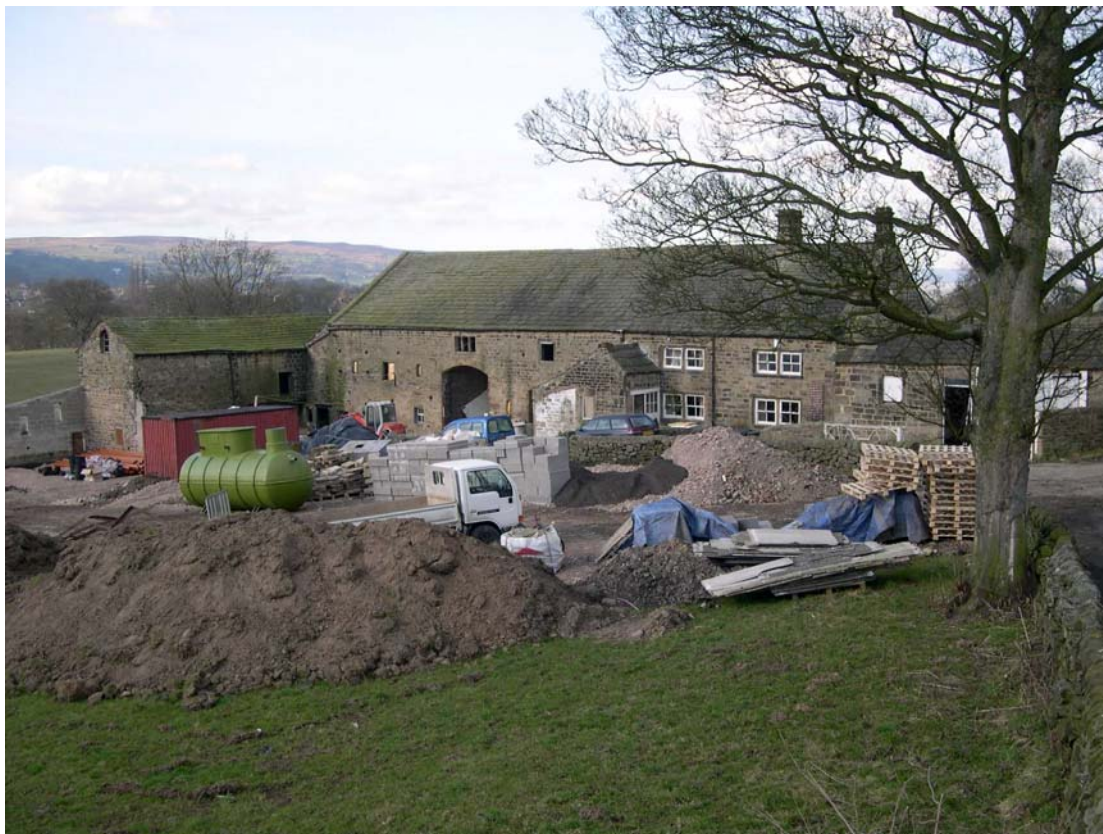
Plate 6: View of site from south-east

- 4.2.1 The barn, comprising five bays, is attached to the western end of the farmhouse (Plate 6). It is of local sandstone construction, roughly dressed and coursed on the external faces, and coursed rubble internally. The walls are of double-skin construction with a loose rubble core. In several places, a slightly wider-set foundation course was observed at the base of the external wall. This was not continuous around the structure internally, and was not visible externally. Much of the original lime and sand mortar was visible, but large expanses of later repointing were also observed. All external walls have rows of small (0.1m wide) sub-rectangular through-sockets, located just above first floor level on the long elevations (Plate 19), with further rows in the visible western gable. Their position at first floor level only, suggests that they are vents for hay stored at this level, but larger rectangular vents (Plate 19) throughout the barn may suggest that these small features represent put-logs.

- 4.2.2 The roof is of sandstone flag, pinned with mainly iron nails (although a few wooden pegs were observed), with a sandstone ridge and cast iron rainwater goods (Plate 6). The roof appears to have been re-laid, probably several times, with plastic sheeting above the rafters of the northern pitch.

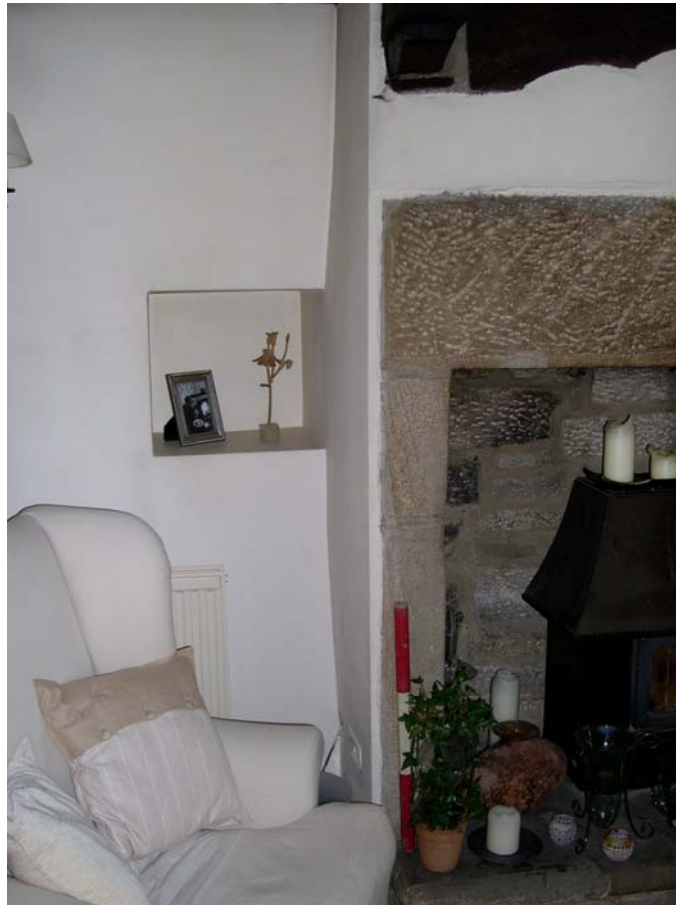
Plate 10: Spice cupboard to north of fireplace

- 4.1.4 Internal inspection revealed that the building originated as a two unit structure, probably as a single-, or one-and-a-half-storeyed, cottage. The central, north/south aligned wall has back-to-back fireplaces in projecting chimney breasts, both with simple sandstone surrounds and slightly projecting stepped hearths (Plate 9). A doorway between the two units at the southern end of the cross-wall appears to be in its original position. A spice cupboard/keeping hole, or possibly a small bread oven was observed, to the north of the fireplace in the western room (Plate 10).

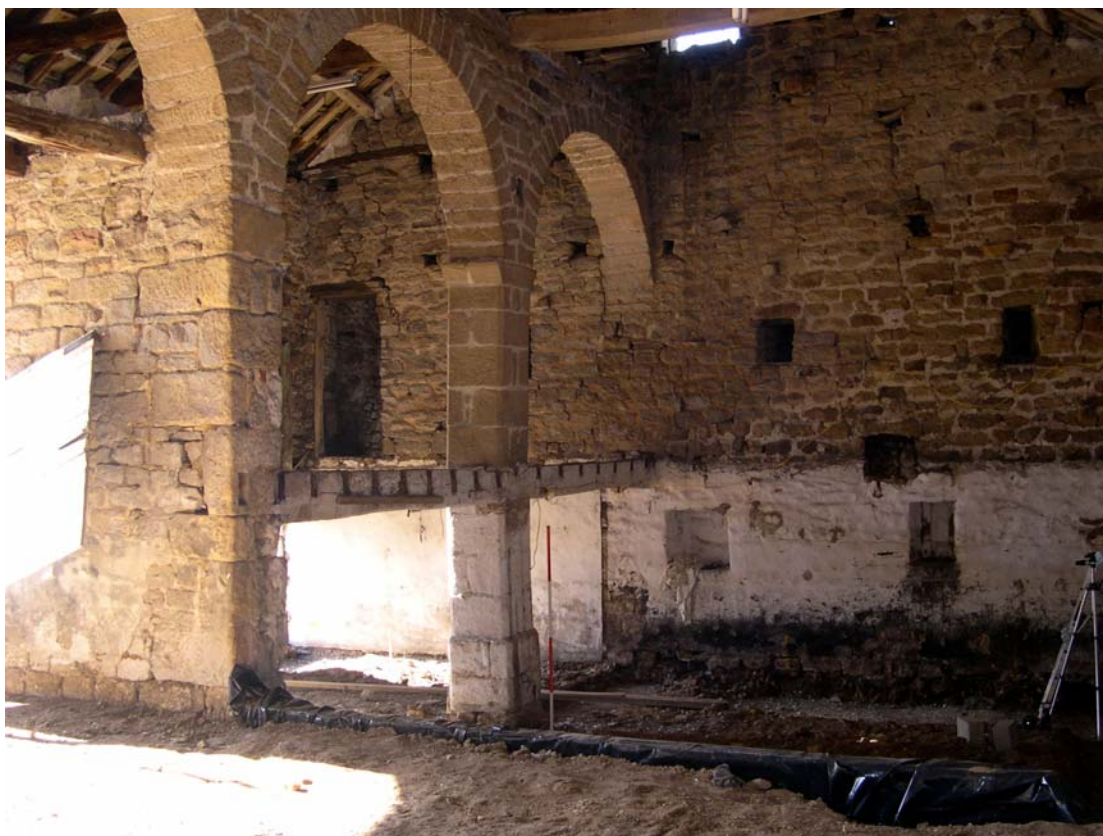
Plate 22: Arcade within the barn

- 4.2.7 The arcade is carried over the cow-house on two arches, supported by a central column (Plate 22). The column sits on a large 3' x 32" (0.92m x 0.82m) sandstone pad below 13" (0.33m) of foundation courses. The column is dressed above original floor level, with 1½" (0.04m) deep chamfers to all faces. It is 22"² (0.56m), with a chamfered plinth set 2" (0.05m) wider for the lowest 2' (0.61m) above floor level (Plate 26). The springing point of the arches is marked with a chamfered impost, flush with the north and south faces of the column (Plate 27). Both arches are rubble-built above roughly-dressed arch stones, which are continuous through both faces of the arcade. The arcade is generally of the same height as the long elevations, and capped with a timber arcade plate on the northern face, although it is one course higher, above the arcade plate, in the western bay. At its western end the arch of the arcade is built into the western gable. It is keyed into the wall, using similar pale sandy lime mortar with large lime inclusions, and there is no evidence to suggest it is anything other than a contemporary build. A tiered buttress on the western face of the gable wall (Figs 8 and 9; Plate 28), however, appears to butt the gable, and is constructed of more finely-dressed sandstone blocks than the arch or columns within the barn see *Section 4.3.3* below).

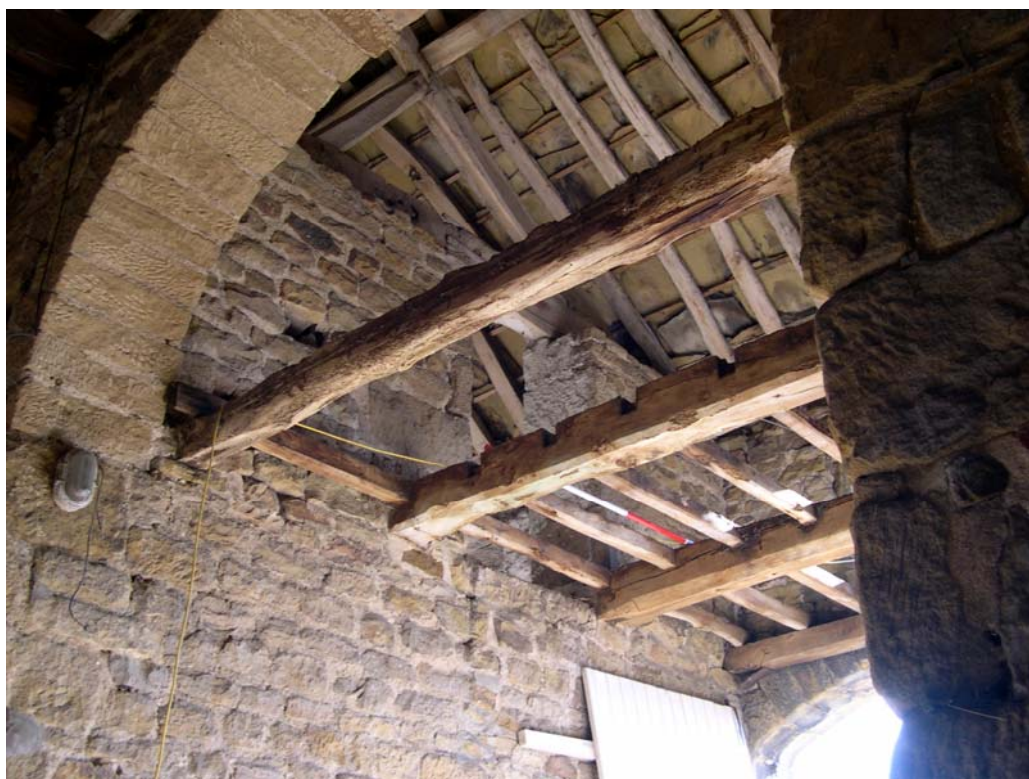
Plate 29: Re-used beams supporting floor joists in the barn porch

- 4.2.11 Within the southern porch were four beams supporting floor joists (Plate 29). The central beam was a re-used tie-beam with deep-tongued chamfers and two triple pegged mortices on the soffit (Plate 30), showing it was inverted in its re-use. Joists survived *in-situ* either side of this beam on 19" (0.49m) centring. The room formed above had a three-light chamfered stone-mullioned window in the southern elevation (Plate 21) and doors in both of the porch walls. The remains of what appeared to be steps were observed within the wall thickness of both doorways, and the western doorway also appeared to have been narrowed (Plate 31).

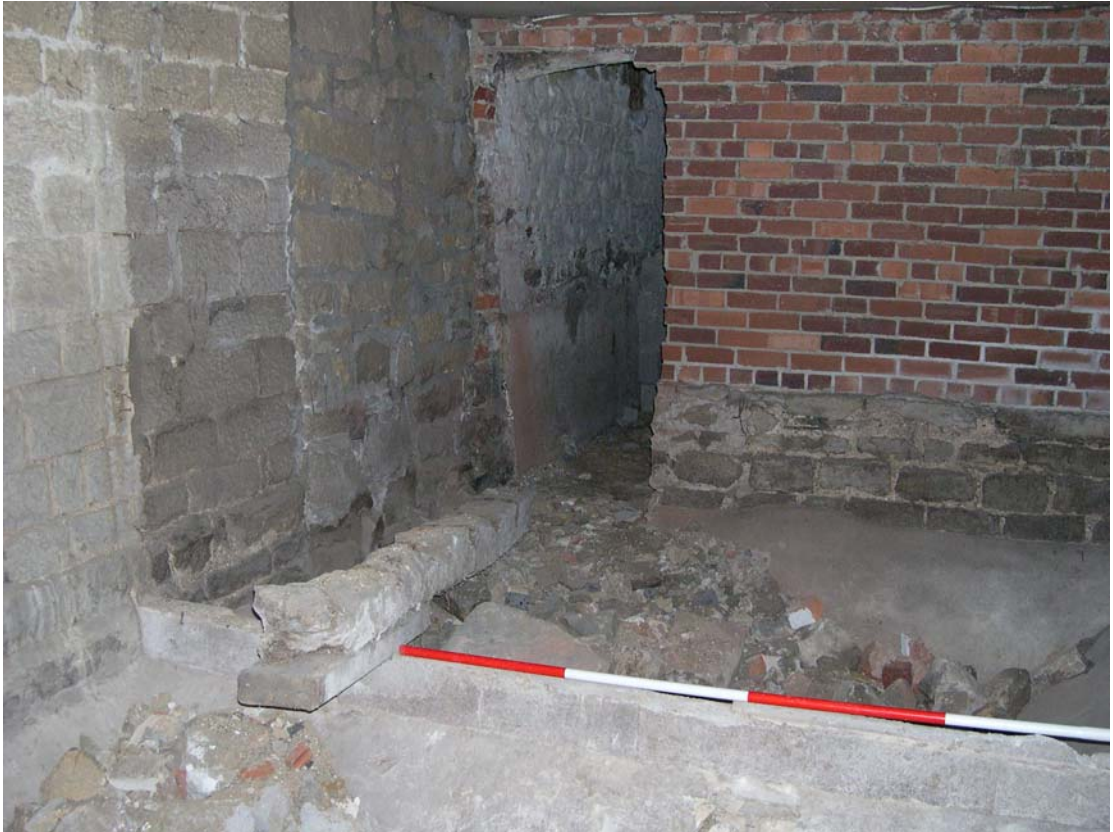
Plate 34: Eastern bay of the barn, showing phased stonework

- 4.2.15 Whilst it was not possible to observe any evidence of the arcade within the eastern bay, because of the presence of a late plasterboard ceiling, a low wall was observed below its position (Plate 34). This spanned the bay, and was later cut at the eastern end for the insertion of a doorway into the southern part of the bay. It is unclear whether the wall survives to its original height, or was reduced in height prior to the construction of a brick wall above it in English Garden Wall bond. This brick wall forms the southern wall to two large grain hoppers, only the concrete drains of which survive. Access to the northern chamber was by a door in the northern elevation, subsequently blocked to form a hatch, with the southern part accessed via a porch, which spanned the junction of the house and barn. The junction between house and barn on the southern elevation is stepped, with the barn projecting c0.1m to the south, beyond the coped kneeler of the house.

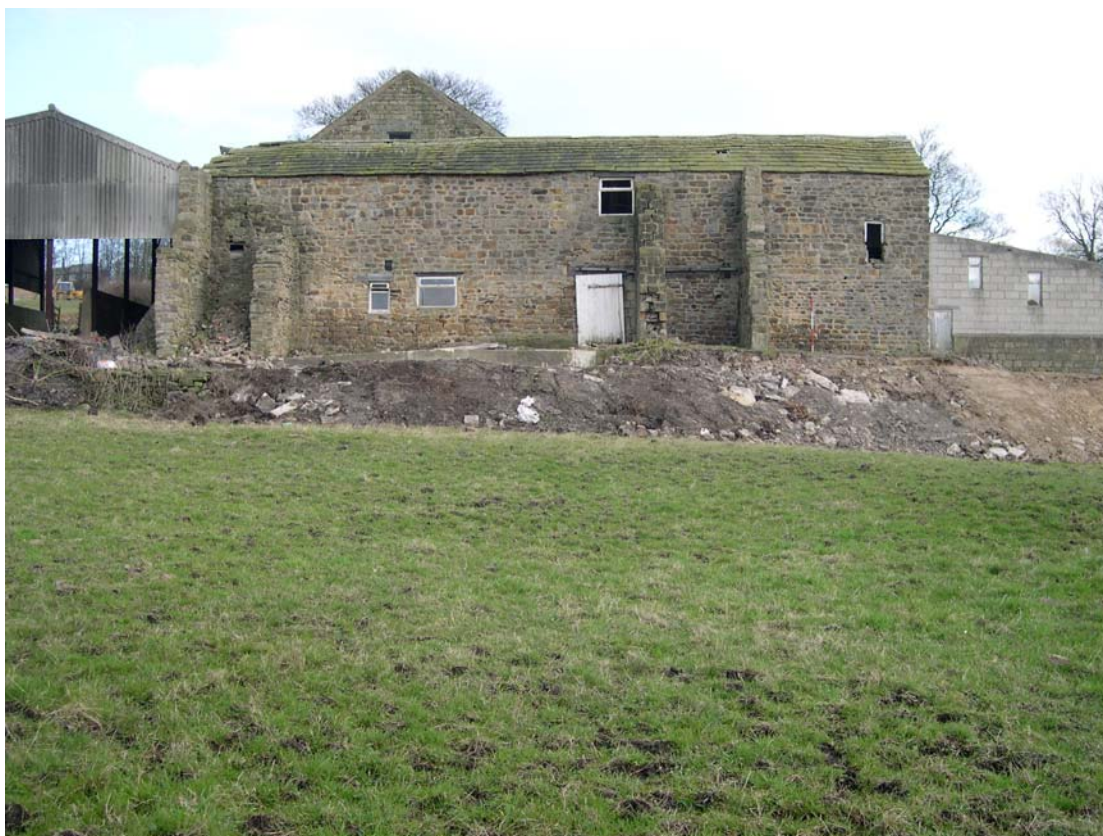
Plate 40: Buttresses on external western elevation of attached cow-sheds

height only, not extending into the loft above. It appears to be the eastern end of the southern of two buttresses on the external western face, the northern of which probably represents the north wall of a structure to the west. The barn also has two raking buttresses on the external face of the north elevation (Plate 39). These are both of rubble construction and appear to have been added to stabilise the structure. Several further late buttresses were also observed on the western elevation of both cow-houses (Plate 40)

- 4.3.4 The upper storey has a doorway at the eastern end of the north elevation (Plate 39), allowing access into the loft from the north side of the farm/fields, and a door inserted into the original barn at the south end of the eastern elevation. A partially blocked 2'8" (0.81m) wide aperture in the western elevation, 2' (0.61m) from the north elevation, was most probably a pitching hole. The roof-space is open at the southern end into the barn to the south. Two interesting roof-scars were observed at the northern ends of both the east (Plate 41) and west elevations. These appear to have been for a 13' (3.96m) wide single storey pitched roof. The southern elevation also appears to have been rebuilt around the western gable of this structure. A lower roof-scar on the external west face relates to a later addition on the western side of the present barn (Plate 40).

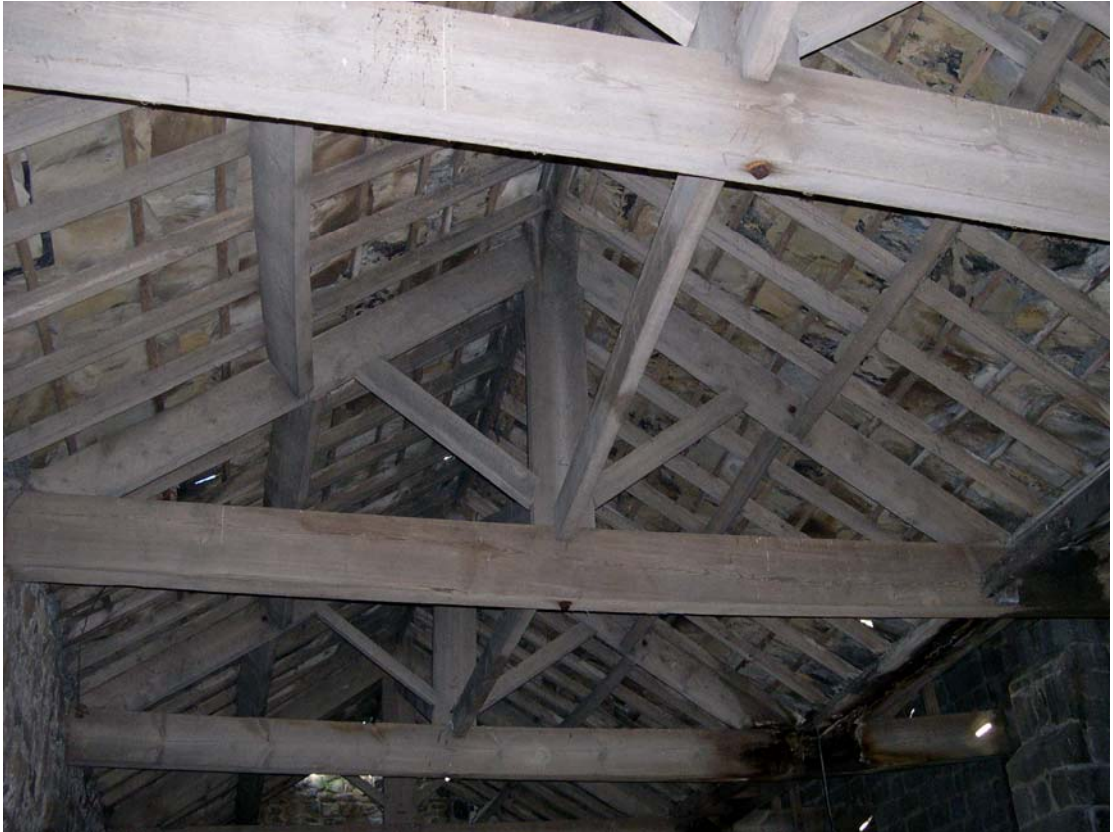
Plate 44: Roof trusses in attached cow-houses

- 4.3.7 Both barns now have one open eight-bay roof-space. This comprises braced king-post trusses, with longitudinal bracing between trusses at the base of each king post (Plate 44). The timbers are circular sawn softwood, tenoned and bolted together, with a single butt-purlin on each pitch and a clasped ridge board, all typical of a late nineteenth century roof. Chiselled assembly marks 'VII' were observed on the northern truss, further suggesting that the present roof relates to a re-roofing of both barns. The northern four bays are 7' (2.14m) wider, with the longer tie-beams cut into the west elevation of the main barn to the east. The trusses are the same as to the south, but with additional valley boards trenched into the tie-beam and principal rafters to the east elevation, forming a single pitch to the higher barn to the east.
