Bicester Heritage Hotel

Archaeological Evaluation Report

August 2018

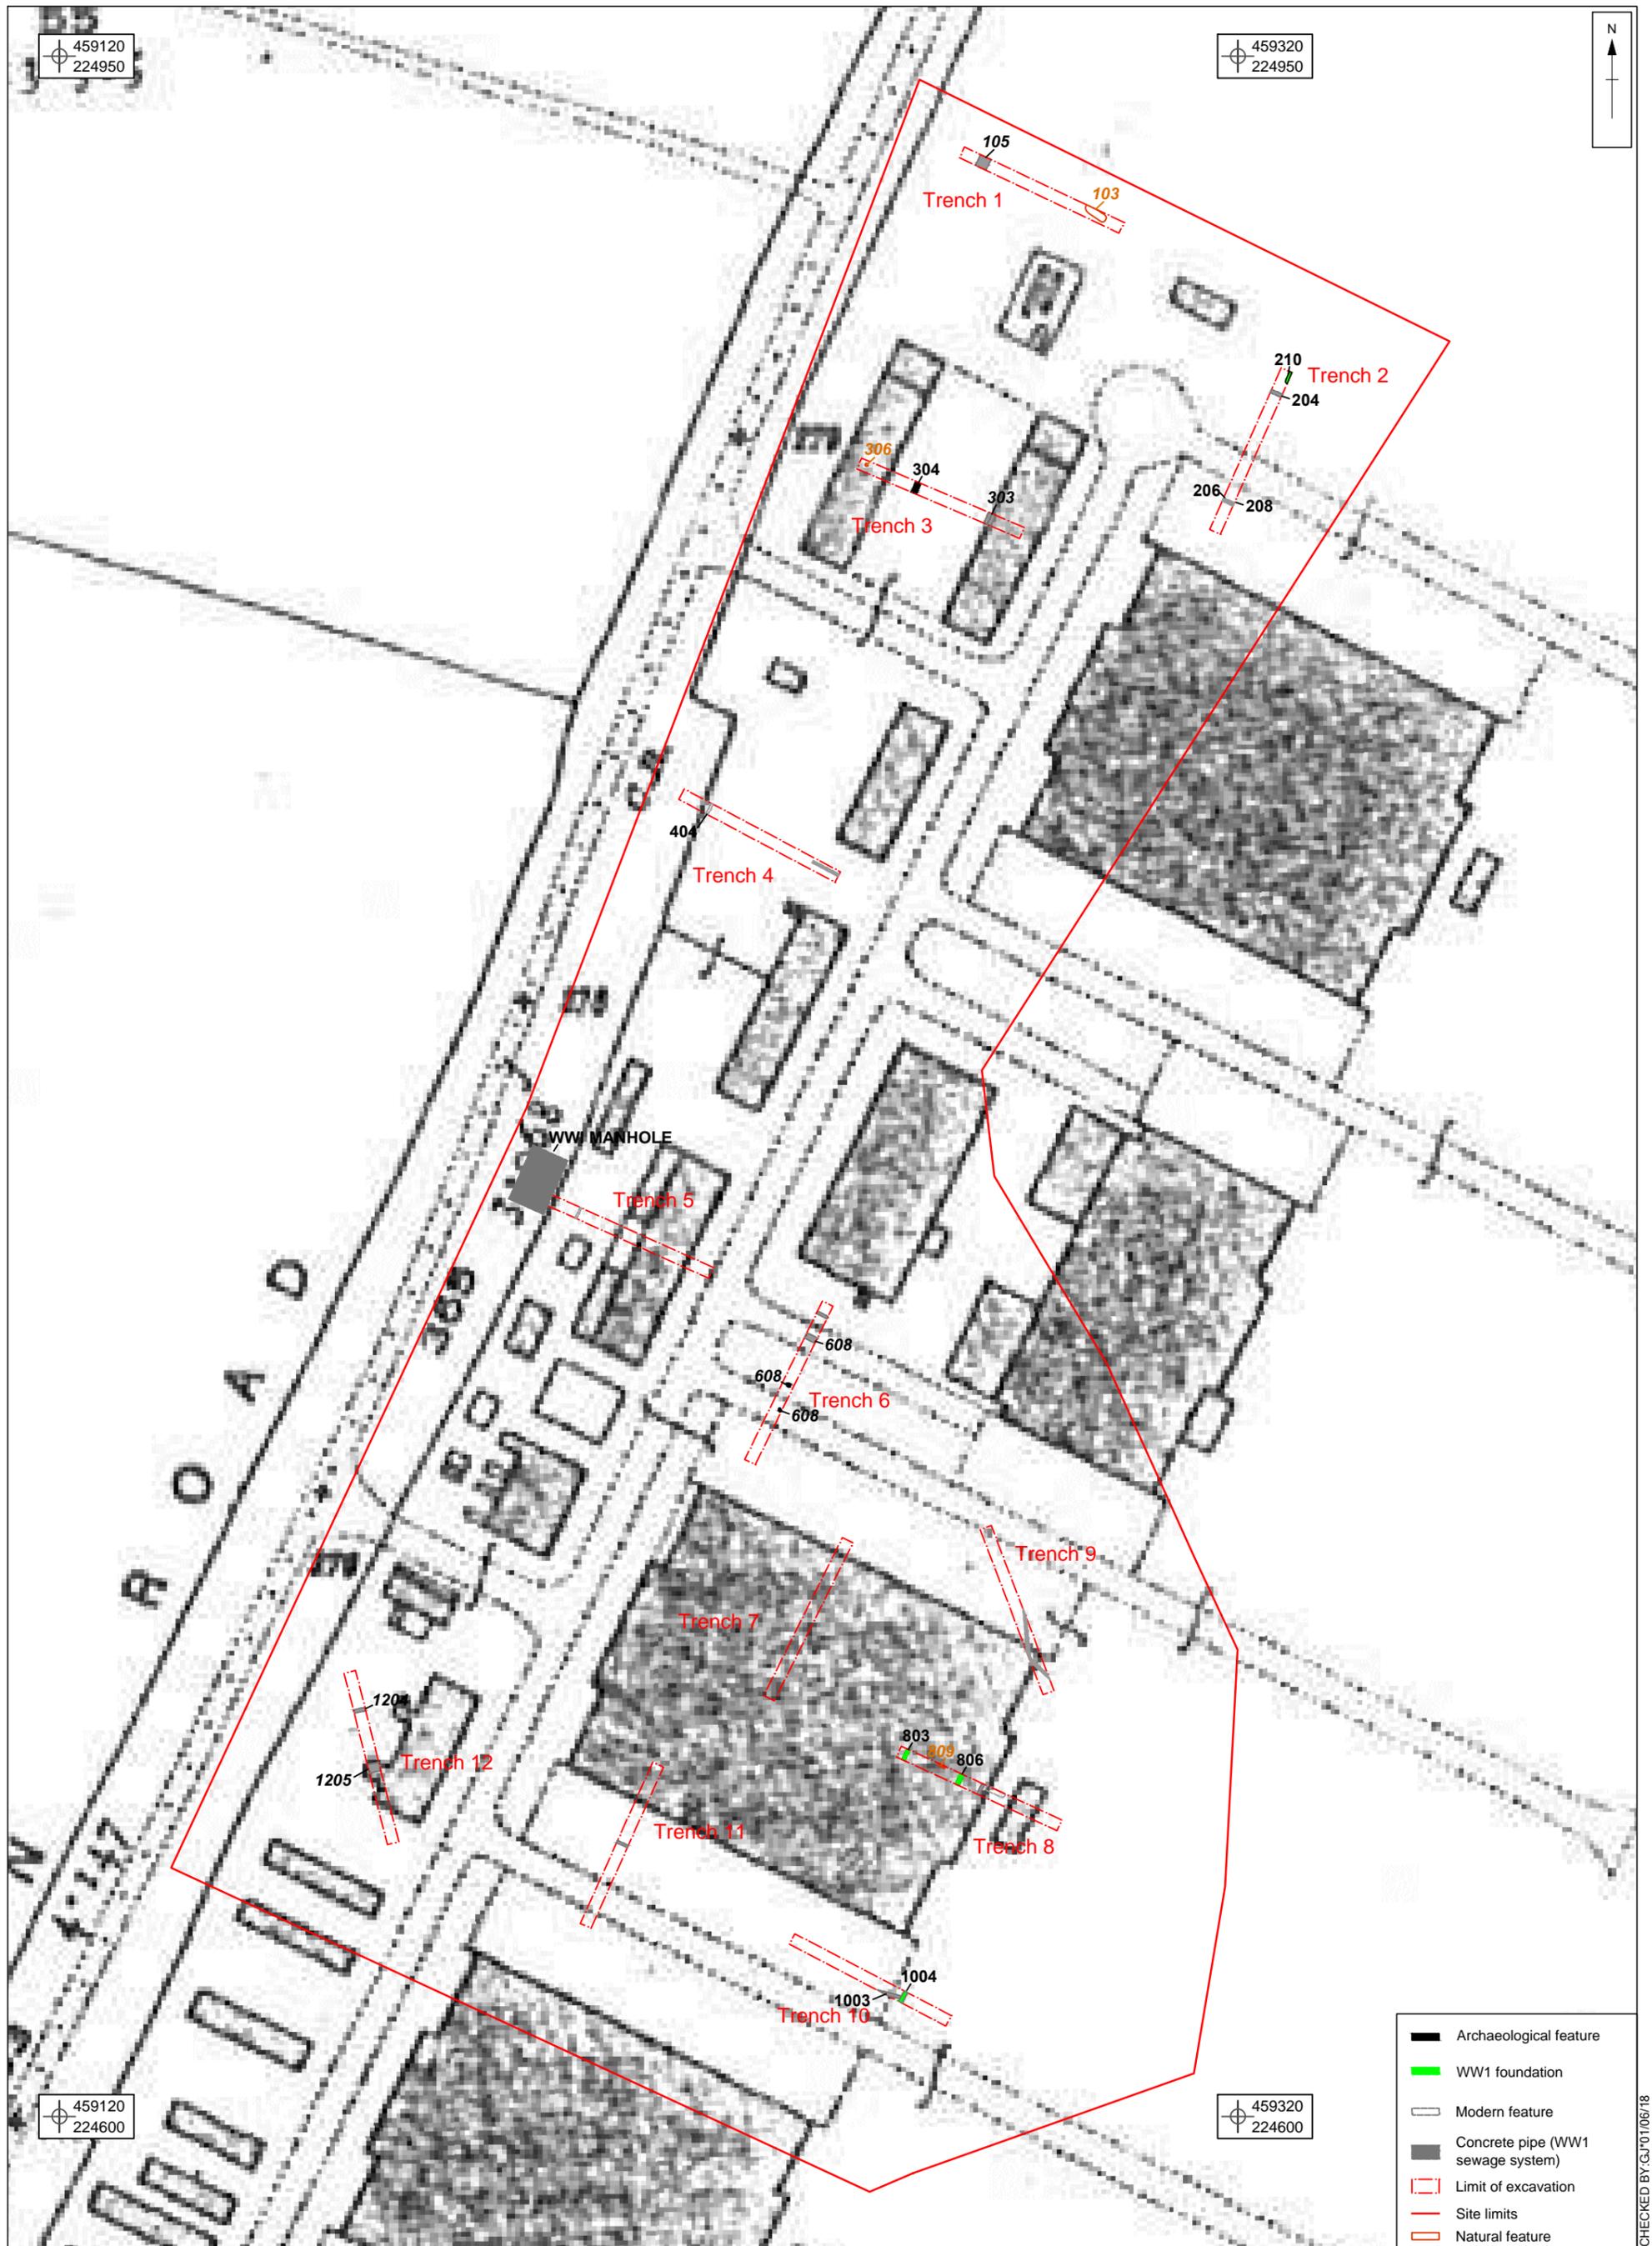
Figure 2: Trench location plan

2.2.1 Twelve trenches measuring 30 x 2m were laid out as shown on Figure 2 using a GPS with sub-50 mm accuracy. The trench location was scanned using a Cable Avoidance Tool both prior to and during the machine excavation. The trenches were excavated using an appropriately powered 13T mechanical excavator fitted with a toothless bucket under the strict supervision of an archaeologist. Spoil was stored adjacent to, but at a safe distance from, the trench edges. Machining was continued in spits down to the top of the undisturbed natural geology or the first archaeological horizon, depending upon which was encountered first. The exposed surface was sufficiently cleaned to establish the presence/absence of archaeological remains. A sample of each potentially significant archaeological feature was excavated by hand and recorded. Samples of each modern features found in trenches 1, 2, 3, 4, 5, 6, 8, 9, 10, 11, 12 were also excavated by hand and recorded.

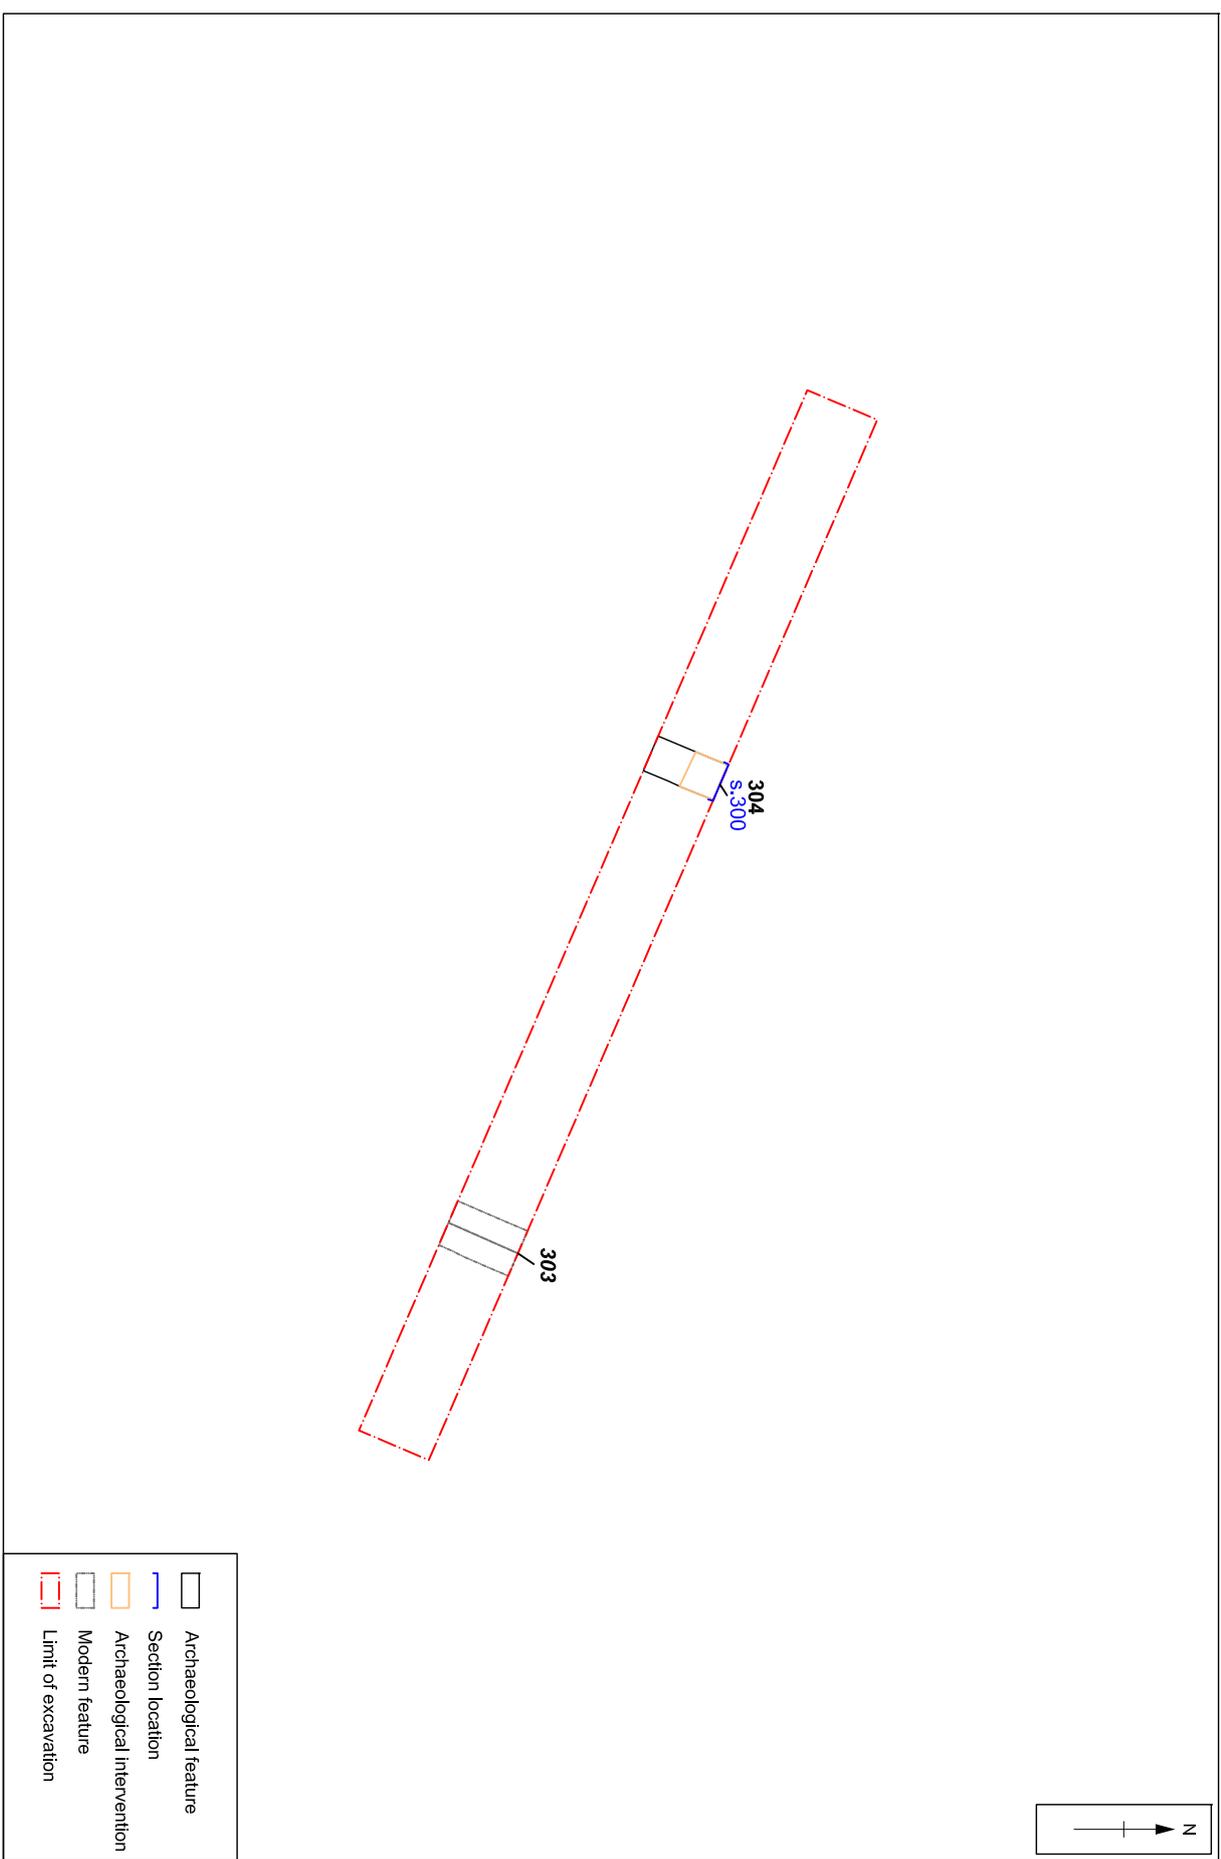
Figure 3: Trench 3

- 3.6.1 Trench 3 was excavated in the northern part of the site and was oriented WNW-ESE. The trench contained one levelling layer (308), one natural feature (306), one modern pipe trench (303, not excavated) and one Roman ditch (304).

- 3.6.2 Ditch 304 (Fig. 5, section 300) extended on a NNE-SSW alignment parallel to the Alchester-Towcester road. It contained a single fill 305, a soft, mid dark orange brown, sandy silt. One small fragment of pottery, dating to the late Iron Age/early Roman (c 50 BC-50 AD), was recovered from the fill.
- 3.6.3 Layer 308 was the remains of a levelling layer for a footpath between the technical buildings of the First World War RAF base.

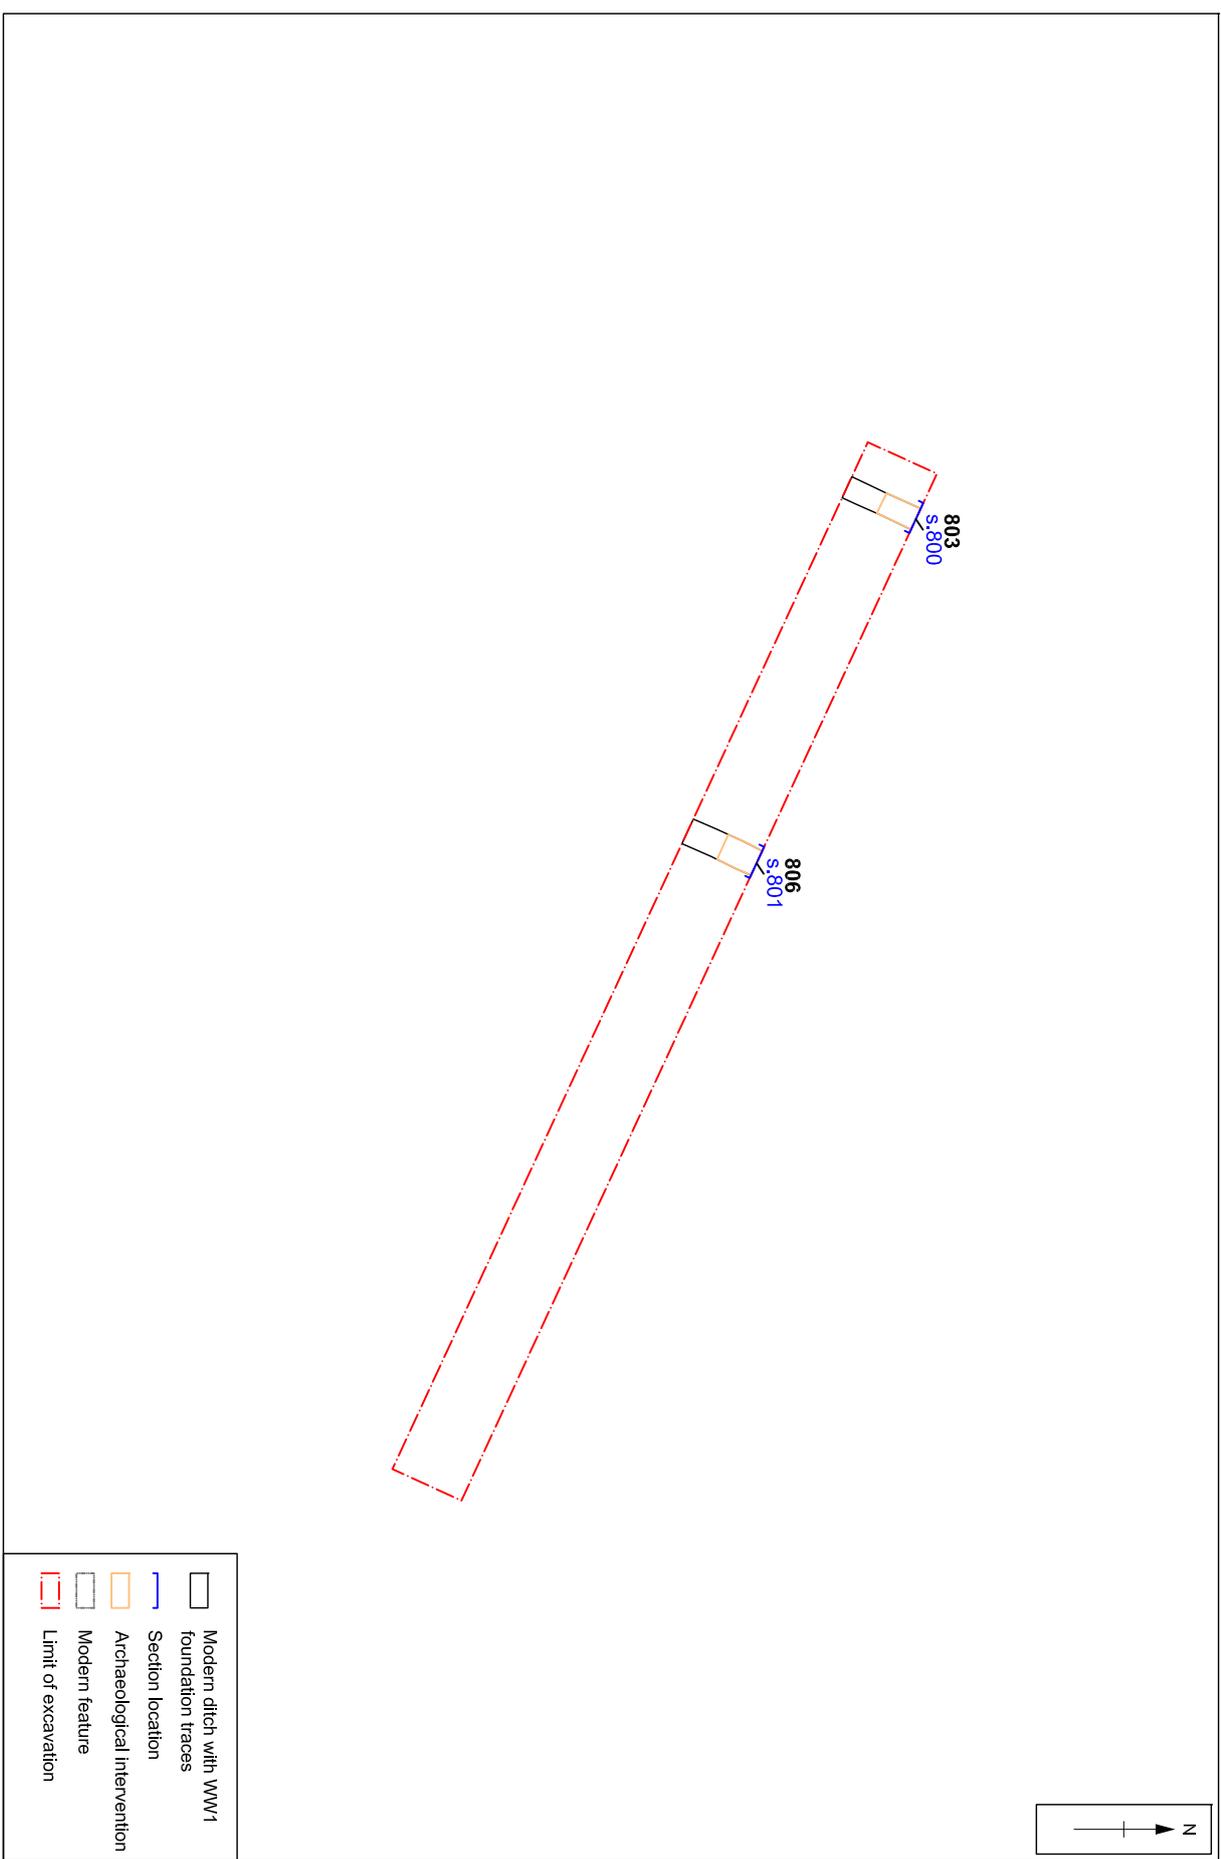
Figure 4: Trench 8

- 3.10.1 Trench 8 was excavated in the south-eastern part of the site and was oriented WNW-ESE. The trench exposed one tree-throw hole (809), a modern pipe trench (not excavated), the foundation of a technical building (803) and the foundation of a hangar (806).
- 3.10.2 Ditch 803 (Fig. 5, section 800) had vertical sides and a flat base and contained traces of a concrete strip foundation, above which were fills (804, 805) that contained four pieces of 20th century CBM. It corresponded with a workshop shown on the Ordnance Survey map of 1922 (Fig. 2).
- 3.10.3 Ditch 806 (Fig. 5, section 801) had a similar profile to ditch 803 and similarly contained traces of a concrete strip foundation, overlain by a fill (808) that contained a piece of 18th/19th century pottery and five pieces of 20th century CBM. It corresponded with a hangar shown on the Ordnance Survey map of 1922 (Fig. 2).

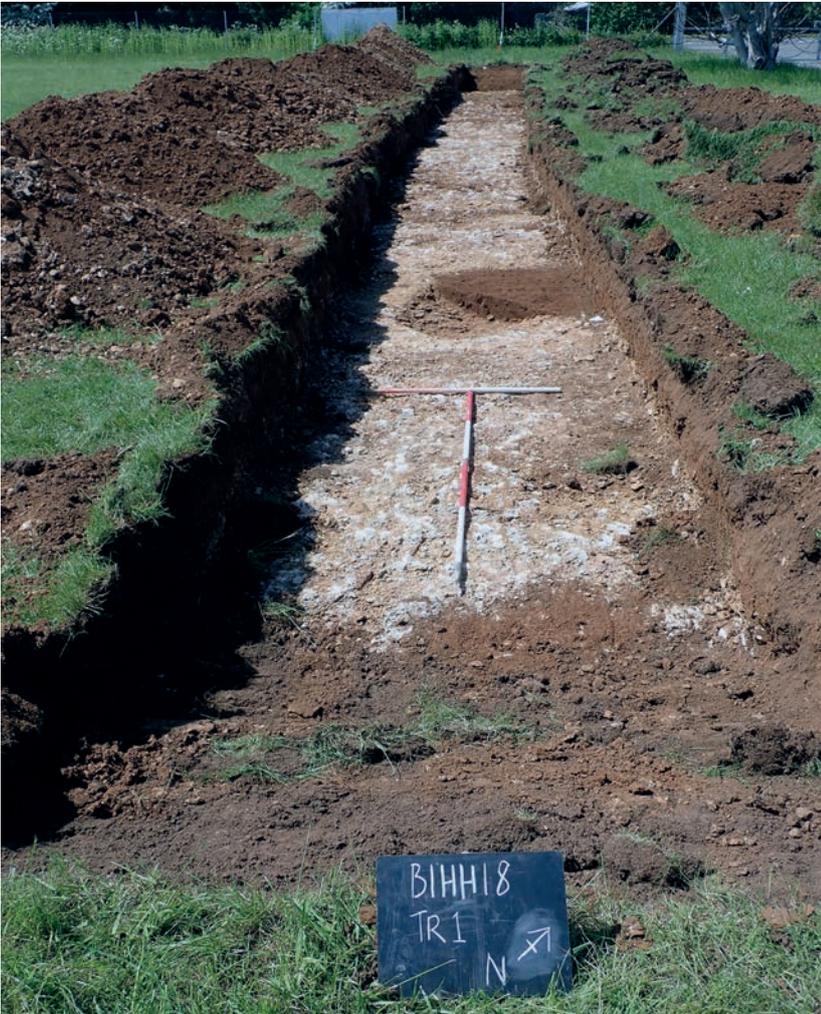
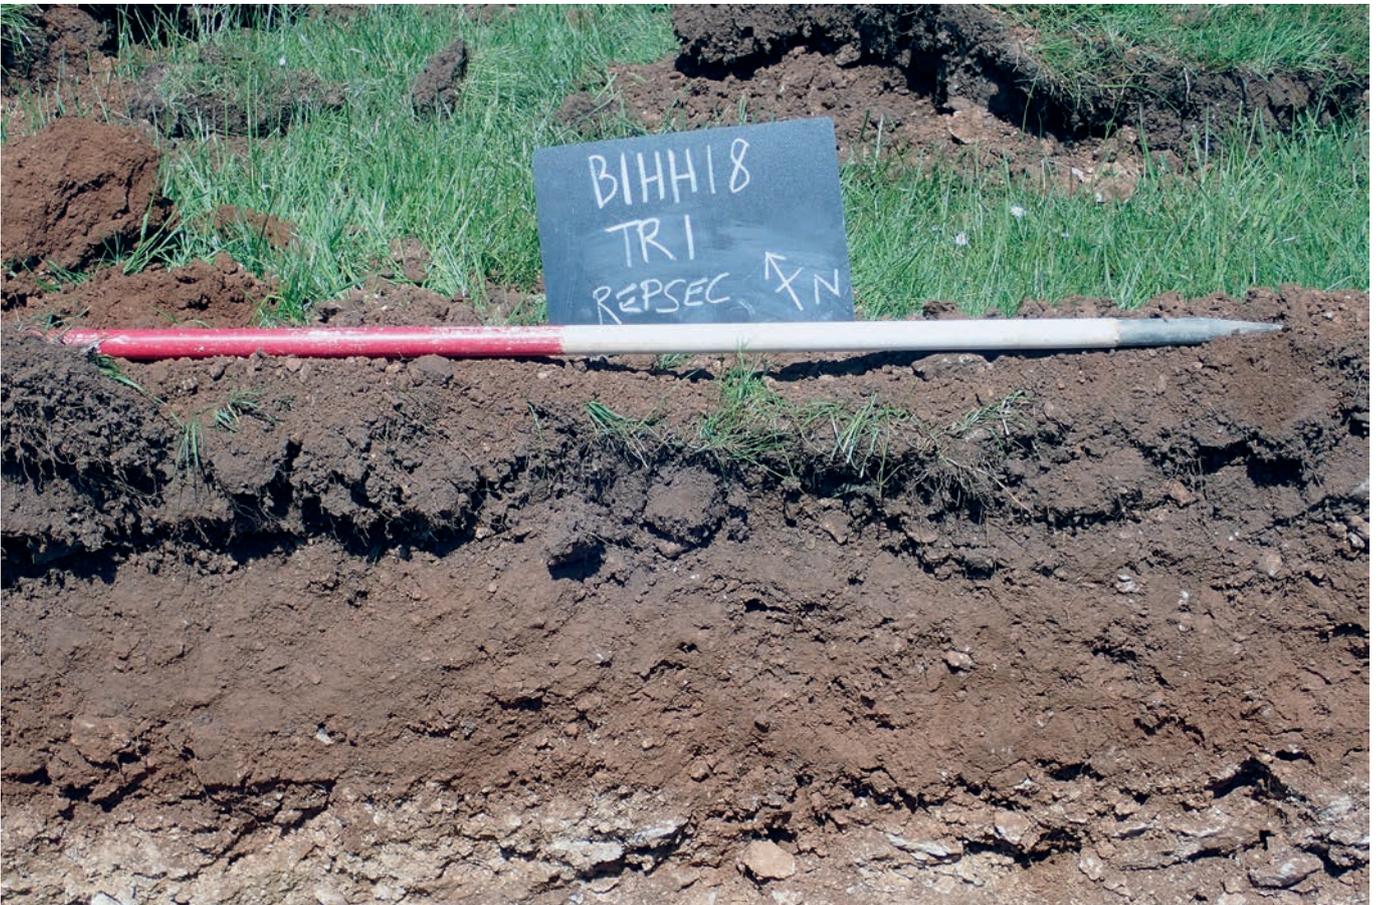
- 3.4.1 Trench 1 was excavated in the northern part of the site and was oriented WNW- ESE. The trench contained one tree-throw hole (103) and one modern pipe trench (105, not excavated).

Plate 1: Trench 1, general view

Plate 2: Trench 1, representative section

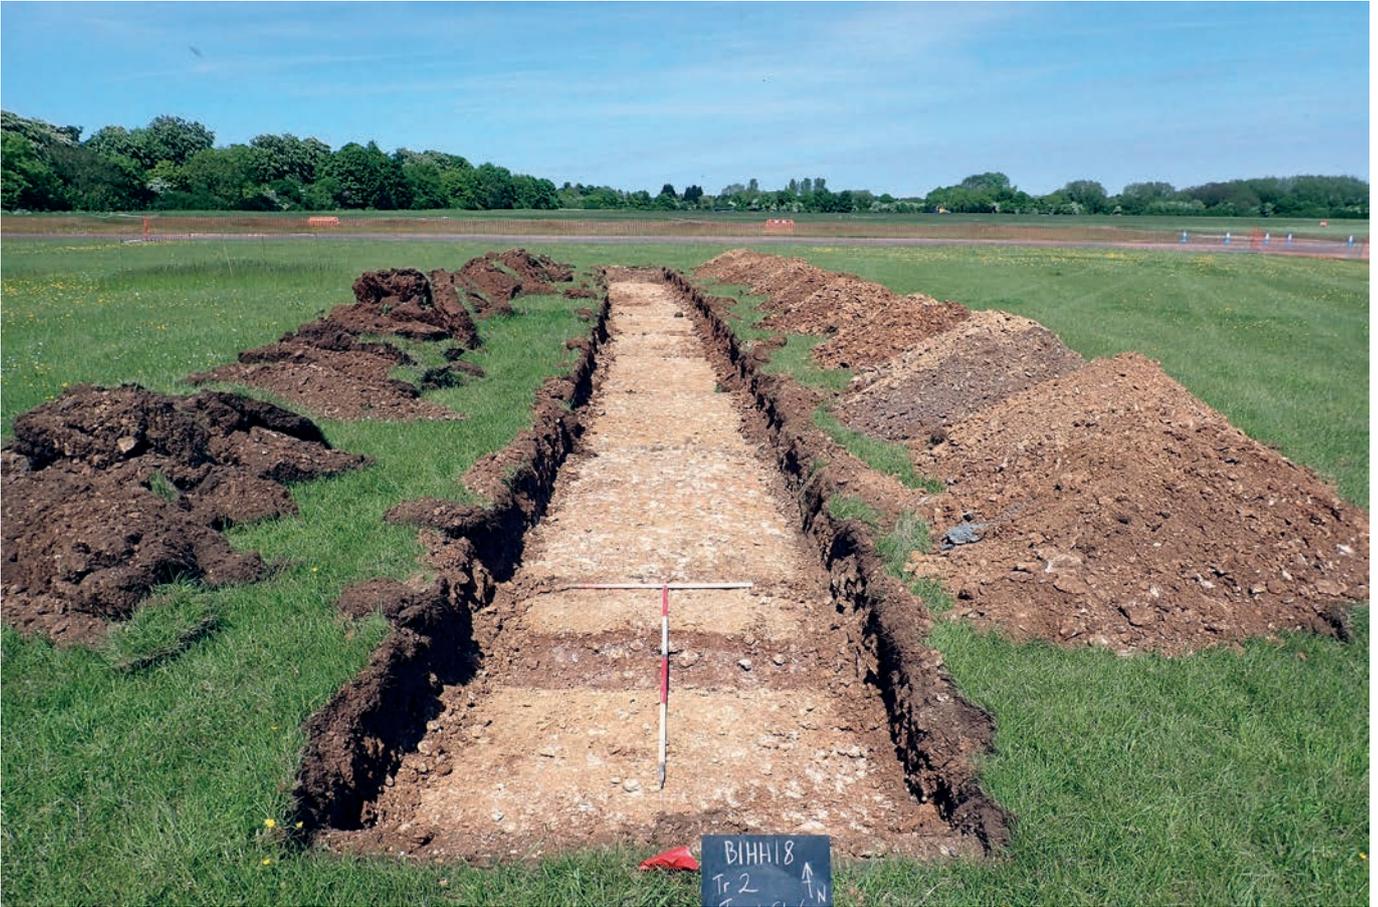
- 3.5.1 Trench 2 was excavated in the northern part of the site and was oriented NNE- SSW. The trench exposed one levelling layer (203), three modern (WNW- ESE) drain trenches (204, 206, 208) and one modern feature containing the remains of a concrete strip foundation (210), probably the base of one of the former hangars or an associated structure.
- 3.5.2 Ditch 206 was cut by ditch 208, from which a fragment of cast iron was recovered, possibly from a stove of 19th-20th century date.
- 3.5.3 Layer 203 was situated in the centre of the trench, between ditches 204 and 208, and represented the remains of a taxiway constructed during the First World War.

Plate 3: Trench 2, general view

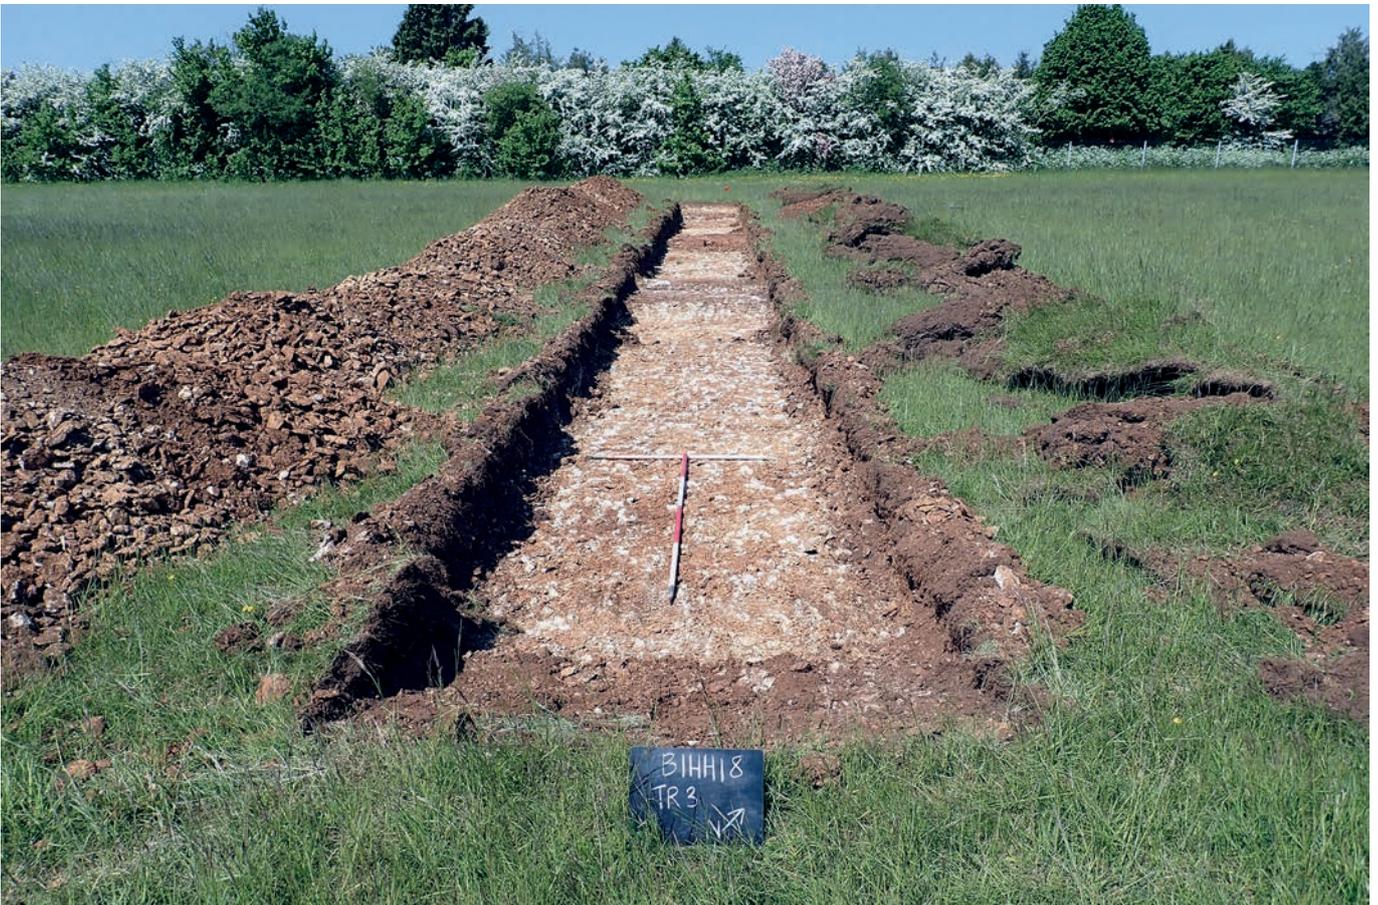
Plate 4: Trench 3, general view

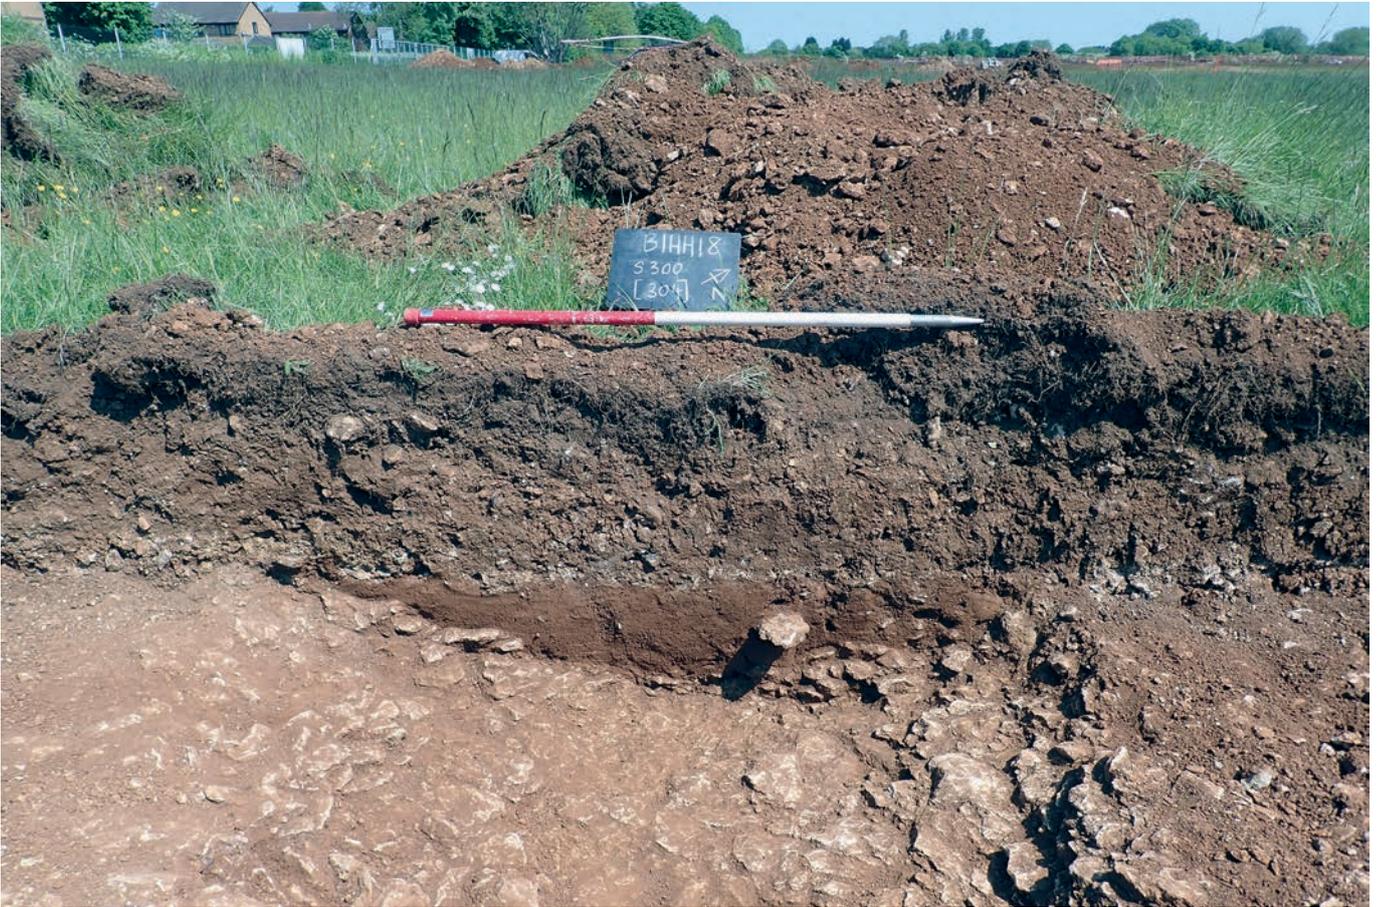
Plate 5: Trench 3, section 300, ditch 304

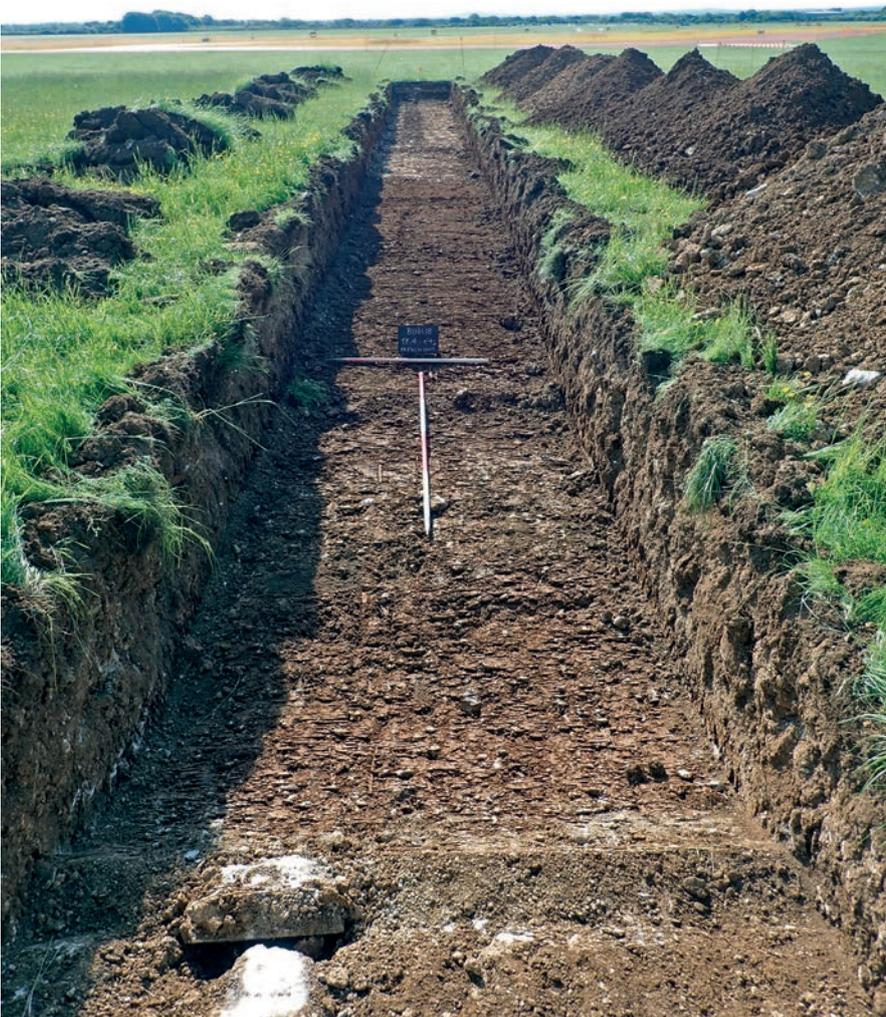
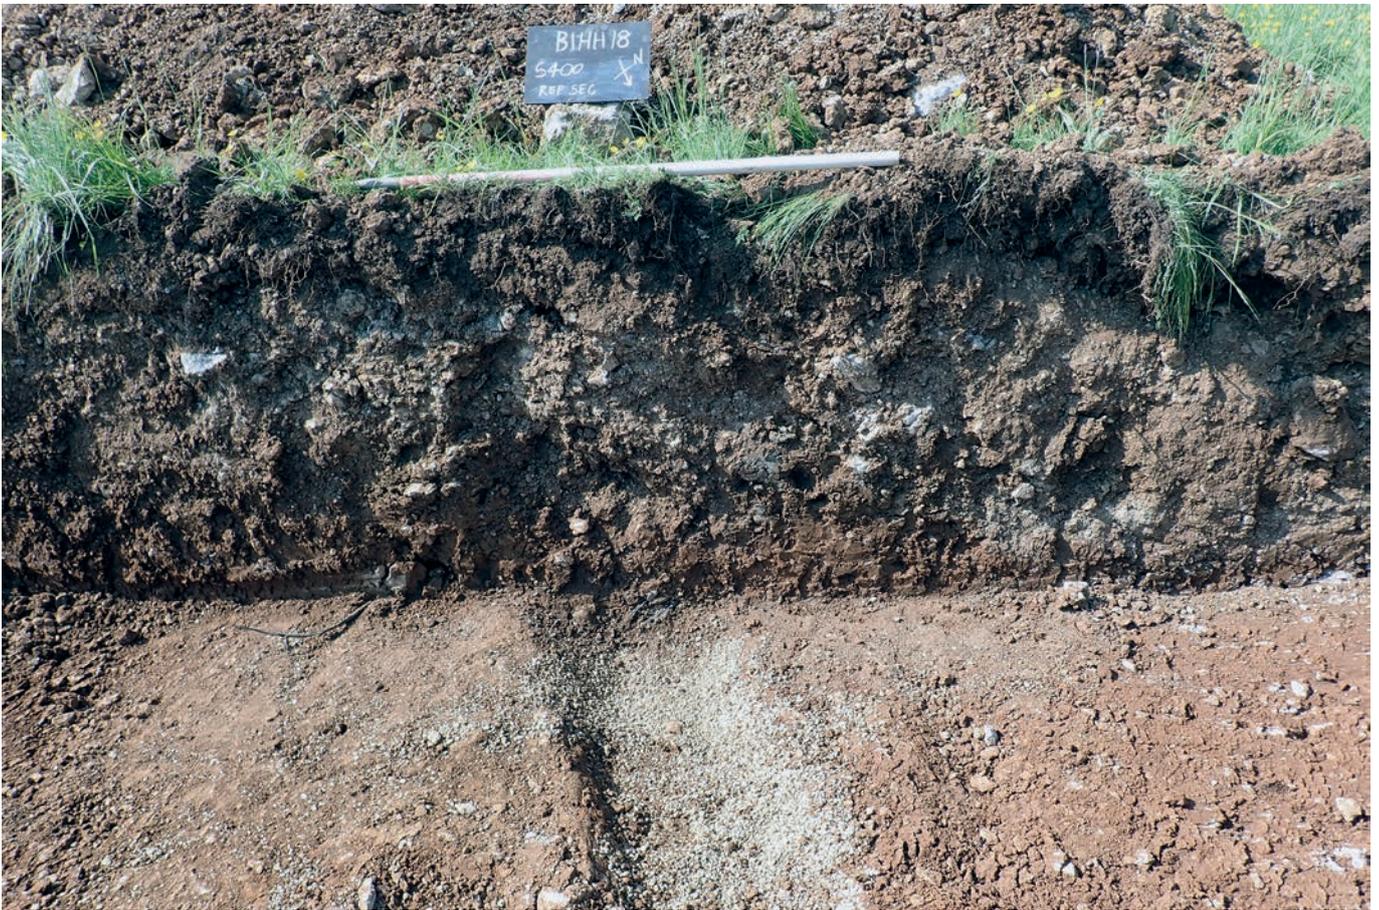
- 3.7.1 Trench 4 was excavated in the centre of the site and was oriented WNW-ESE. The trench exposed an electricity cable trench (404) and a pipe trench (not excavated).

Plate 6: Trench 4, general view

Plate 7: Trench 4, representative section

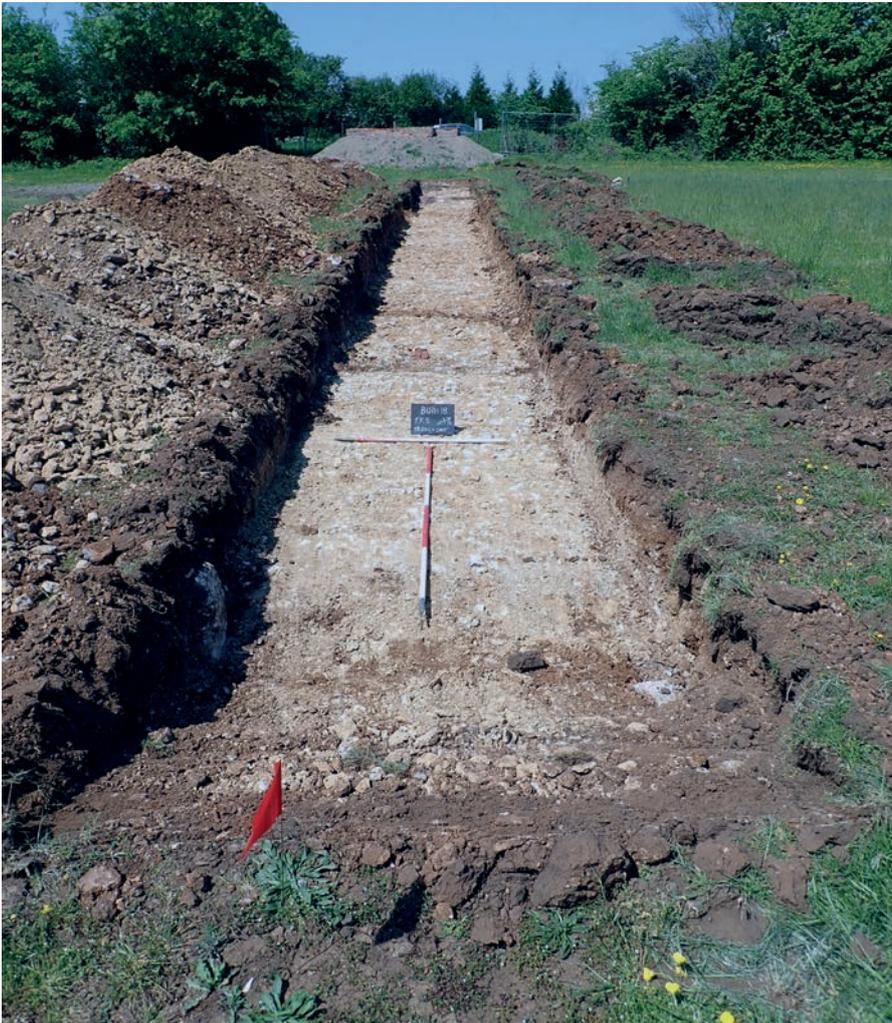
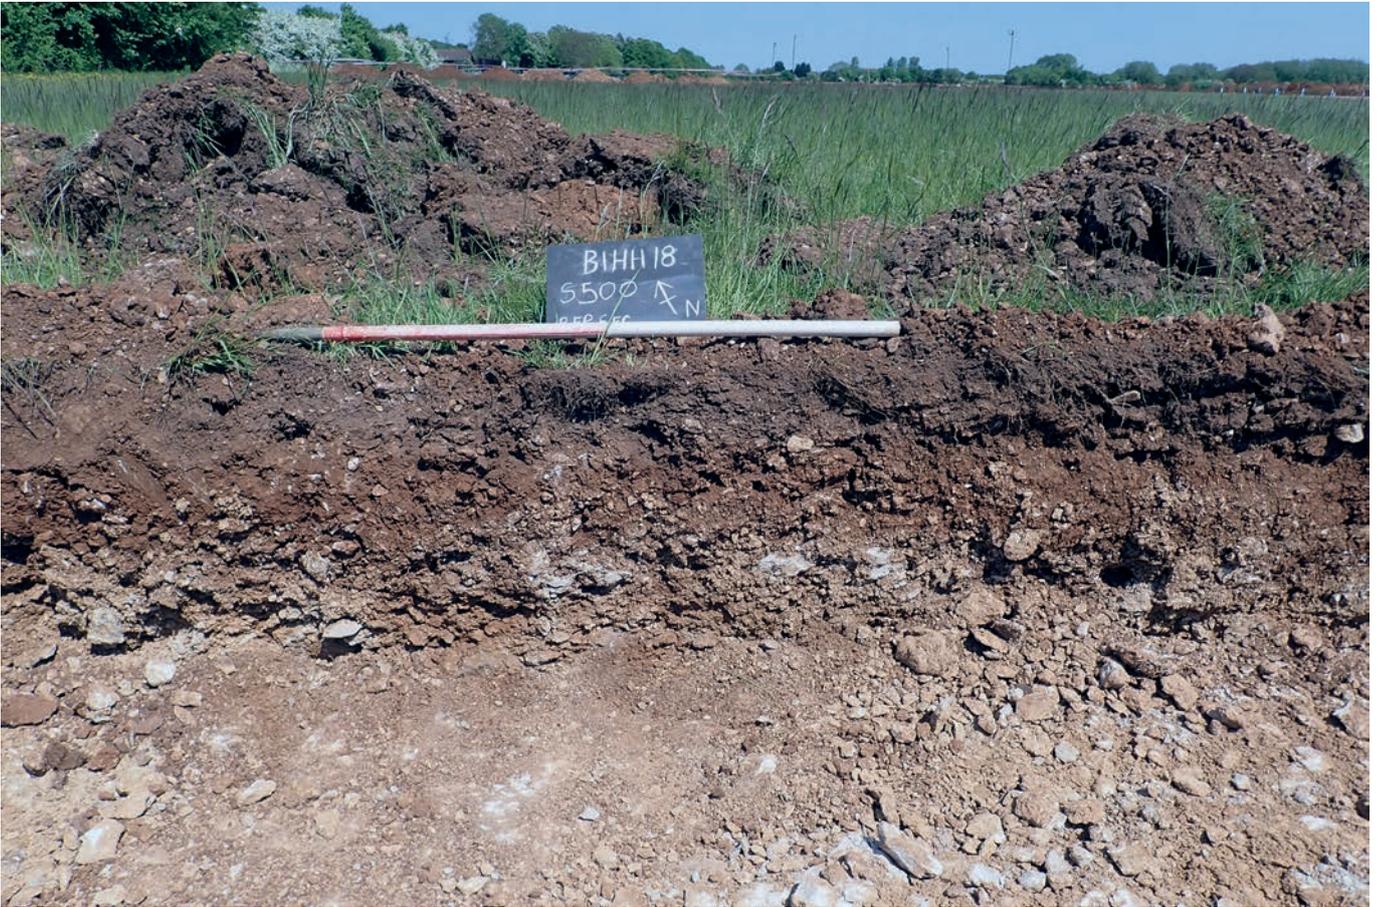
- 3.8.1 Trench 5 was excavated in the centre of site and was oriented WNW- ESE. The trench contained one modern electrical cable trench (not excavated).

Plate 8: Trench 5, general view

Plate 9: Trench 5, representative section

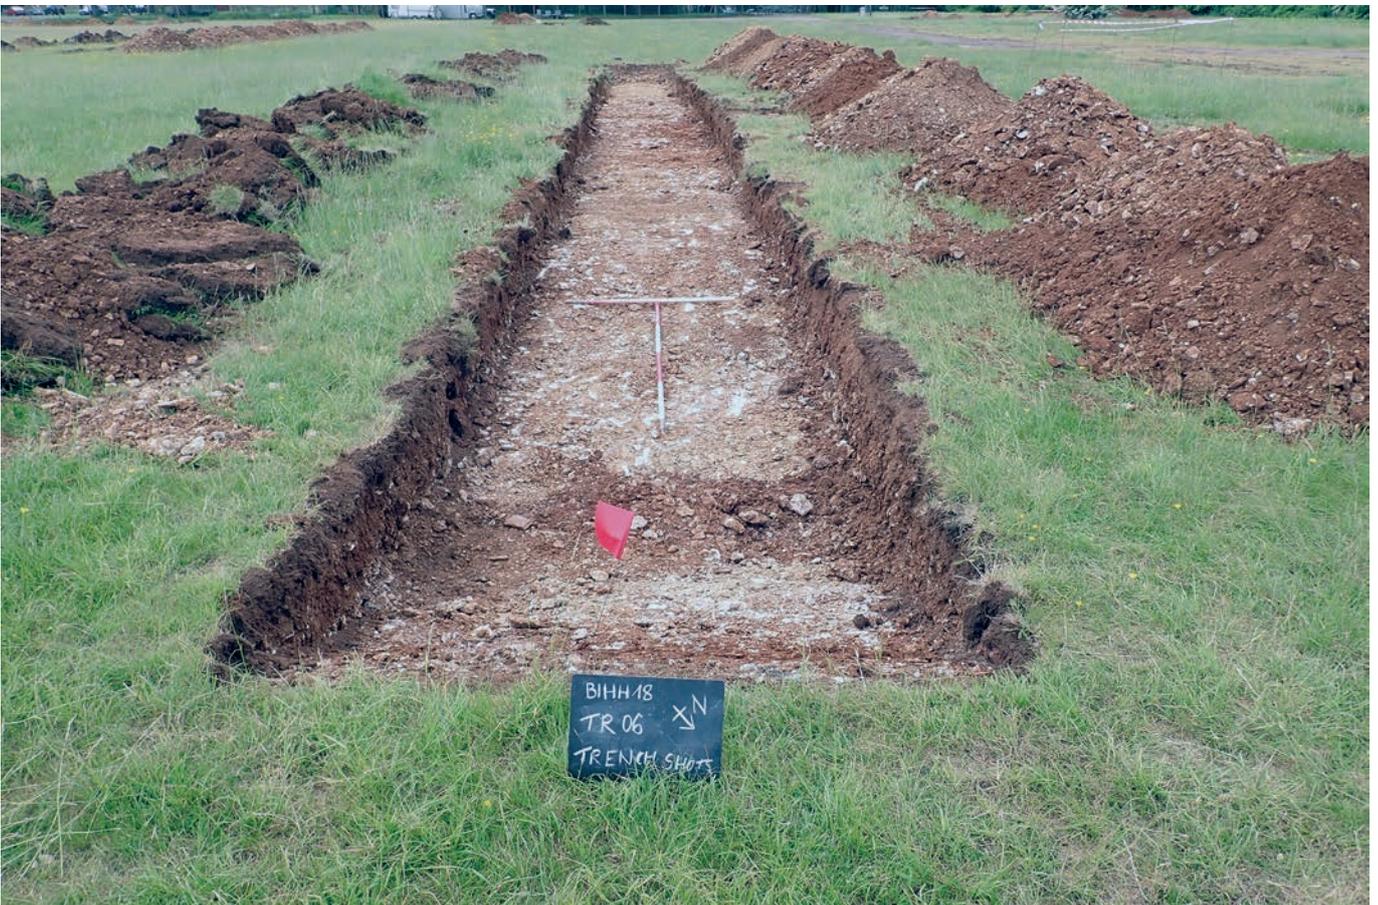
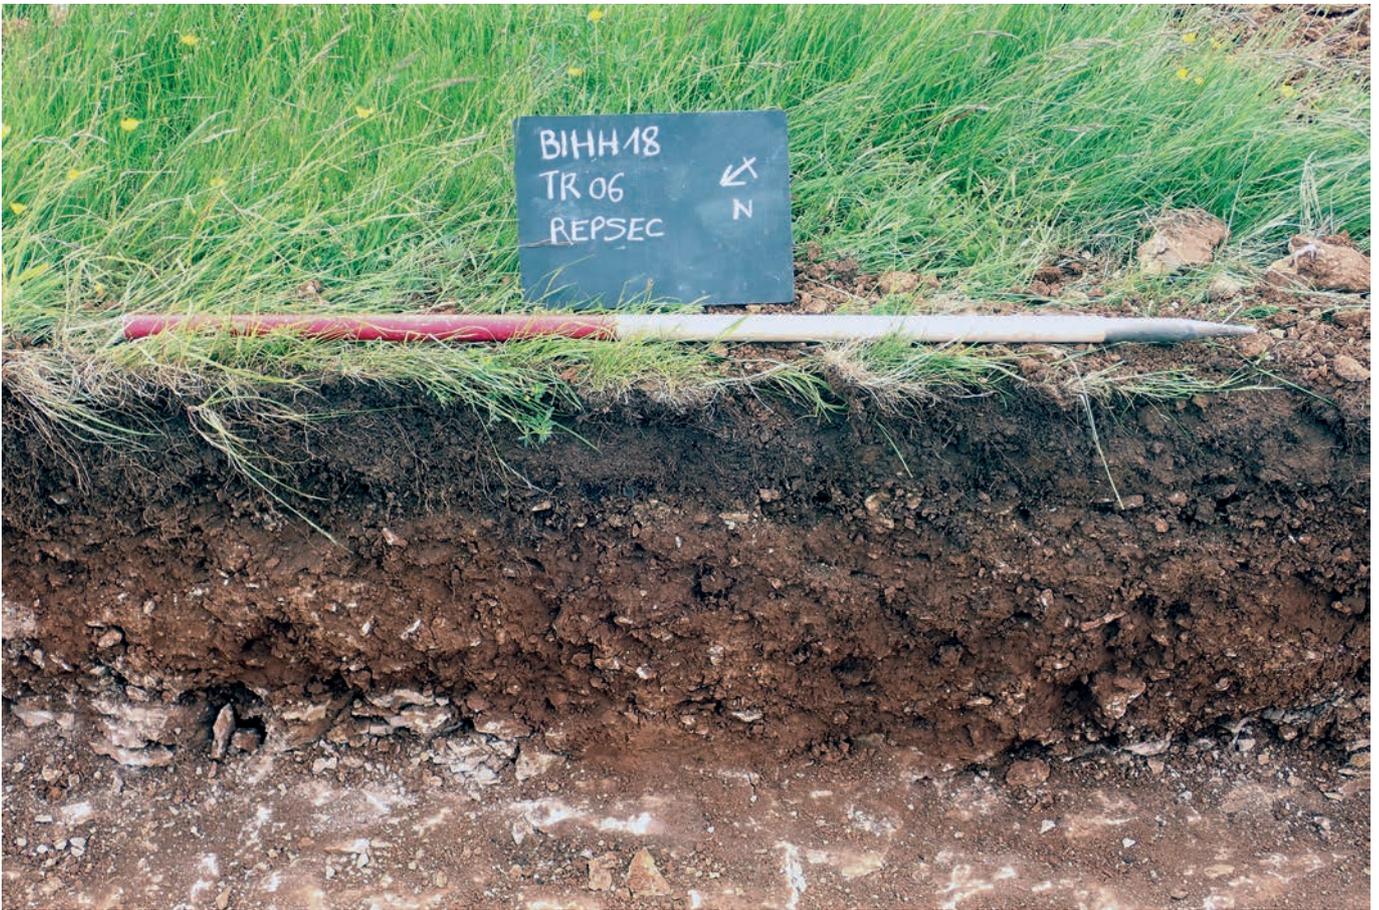
- 3.9.1 Trench 6 was excavated in the centre of the site and was oriented NNE-SSW. The trench contained one levelling layer (606), two postholes (602, 604) and two modern pipe trenches.
- 3.9.2 Posthole 604 was located in the middle of trench and posthole 602 was located in the southern part. The postholes were shallow cuts with sloping sides and flat bases. The function of the postholes is unclear.
- 3.9.3 Layer 606 was recorded in section in the southern part of the trench and represents the remains of the taxiway constructed for Training Station Depot and RAF base during the First World War.

Plate 10: Trench 6, general view

Plate 11: Trench 6, representative section

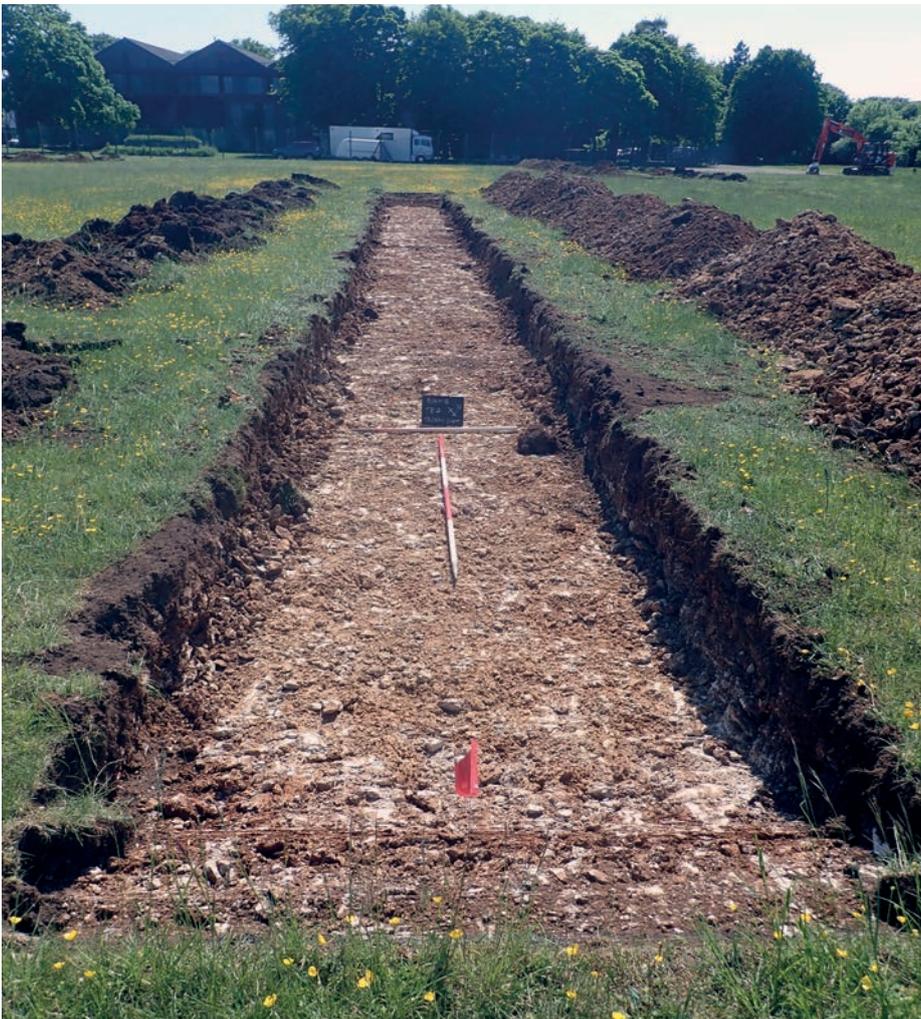
Plate 12: Trench 7, general view

- 3.3.1 The only archaeological feature pre-dating the WW1 airfield was a Roman ditch in Trench 3. Modern features associated with the airfield were present in Trenches 1, 2, 3, 4, 5, 6, 8, 9, 10, 11 and 12. Trench 7 (Plates 12 and 13) was completely devoid of archaeological or modern features and is not described further.
