Bicester Heritage Hotel

Archaeological Evaluation Report

August 2018

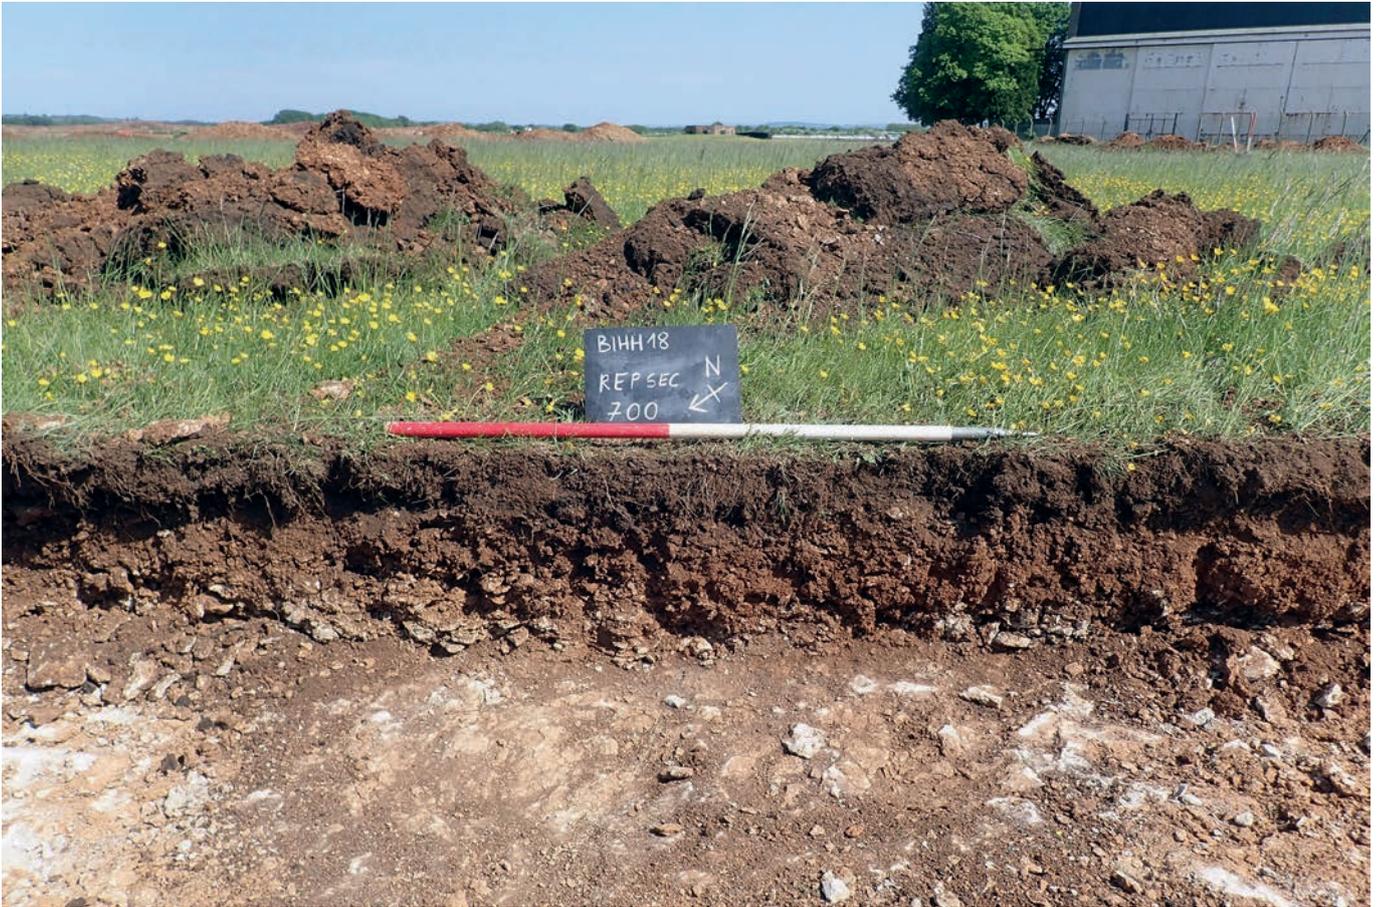
Plate 13: Trench 7, representative section

- 3.3.1 The only archaeological feature pre-dating the WW1 airfield was a Roman ditch in Trench 3. Modern features associated with the airfield were present in Trenches 1, 2, 3, 4, 5, 6, 8, 9, 10, 11 and 12. Trench 7 (Plates 12 and 13) was completely devoid of archaeological or modern features and is not described further.

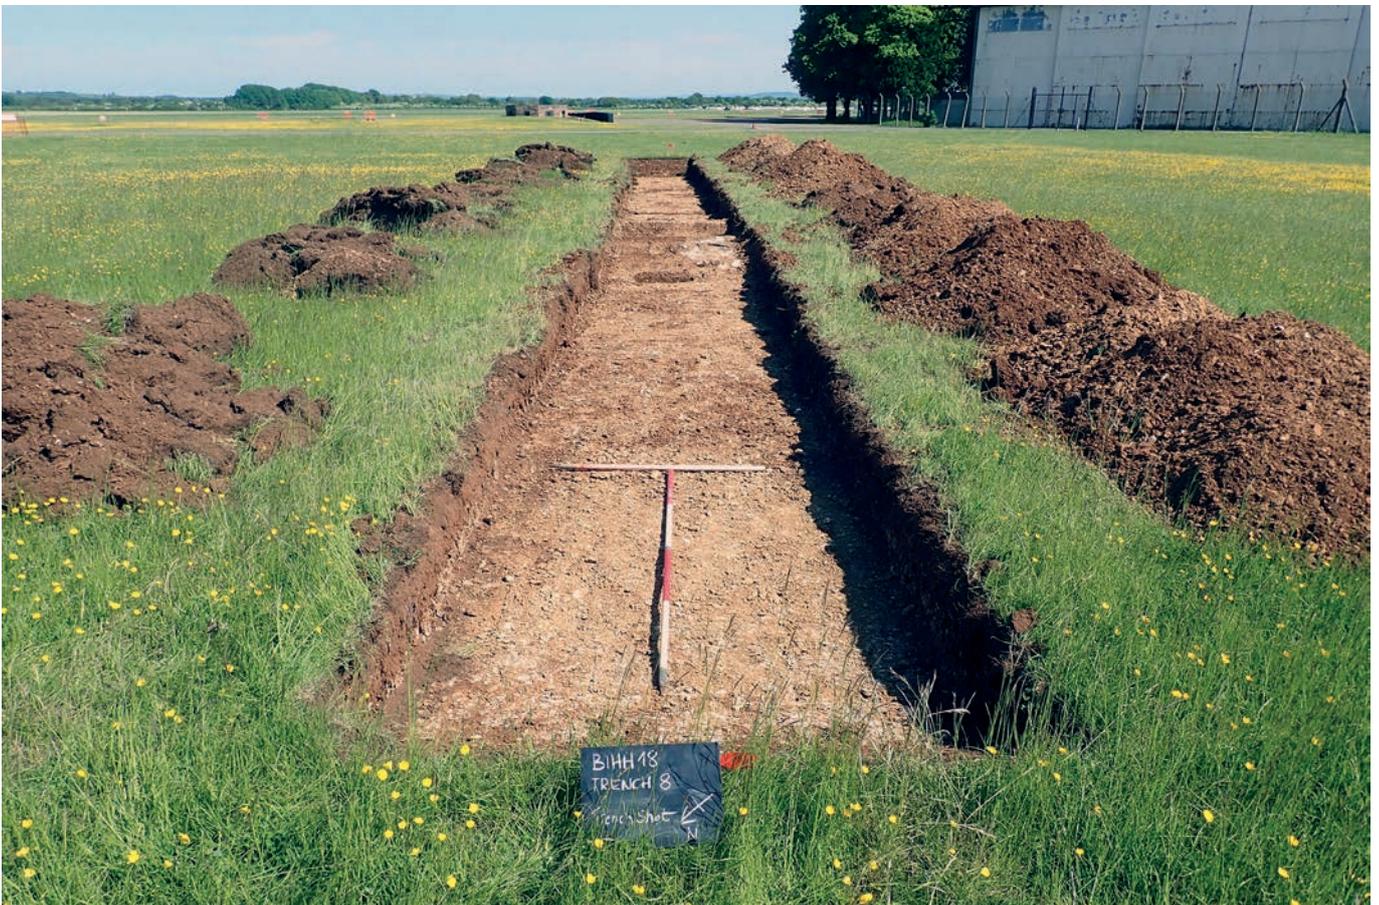
- 3.10.1 Trench 8 was excavated in the south-eastern part of the site and was oriented WNW-ESE. The trench exposed one tree-throw hole (809), a modern pipe trench (not excavated), the foundation of a technical building (803) and the foundation of a hangar (806).
- 3.10.2 Ditch 803 (Fig. 5, section 800) had vertical sides and a flat base and contained traces of a concrete strip foundation, above which were fills (804, 805) that contained four pieces of 20th century CBM. It corresponded with a workshop shown on the Ordnance Survey map of 1922 (Fig. 2).
- 3.10.3 Ditch 806 (Fig. 5, section 801) had a similar profile to ditch 803 and similarly contained traces of a concrete strip foundation, overlain by a fill (808) that contained a piece of 18th/19th century pottery and five pieces of 20th century CBM. It corresponded with a hangar shown on the Ordnance Survey map of 1922 (Fig. 2).

Plate 14: Trench 8, general view

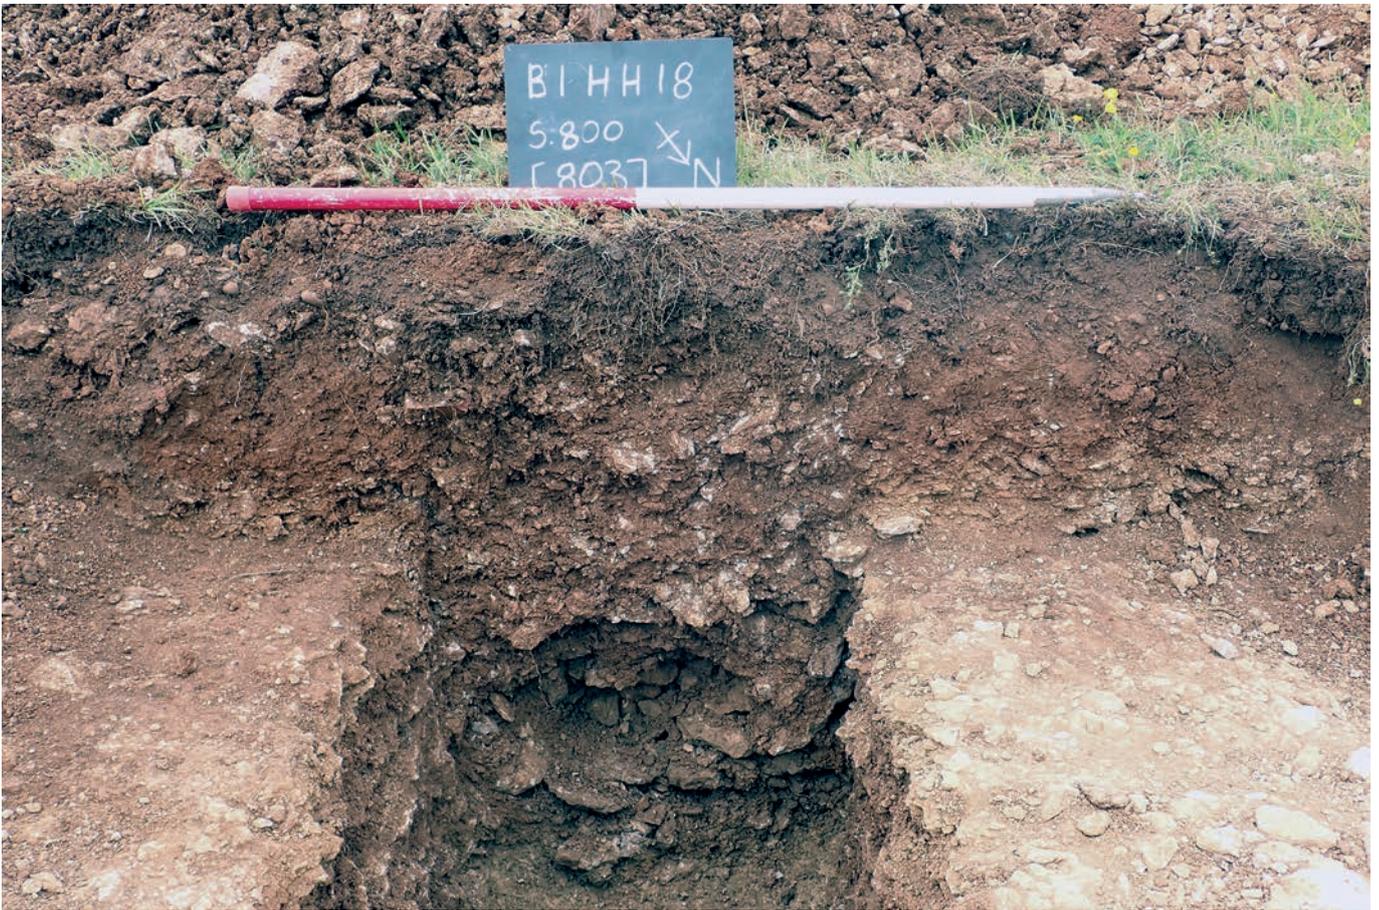
Plate 15: Trench 8, section 800, foundation 803

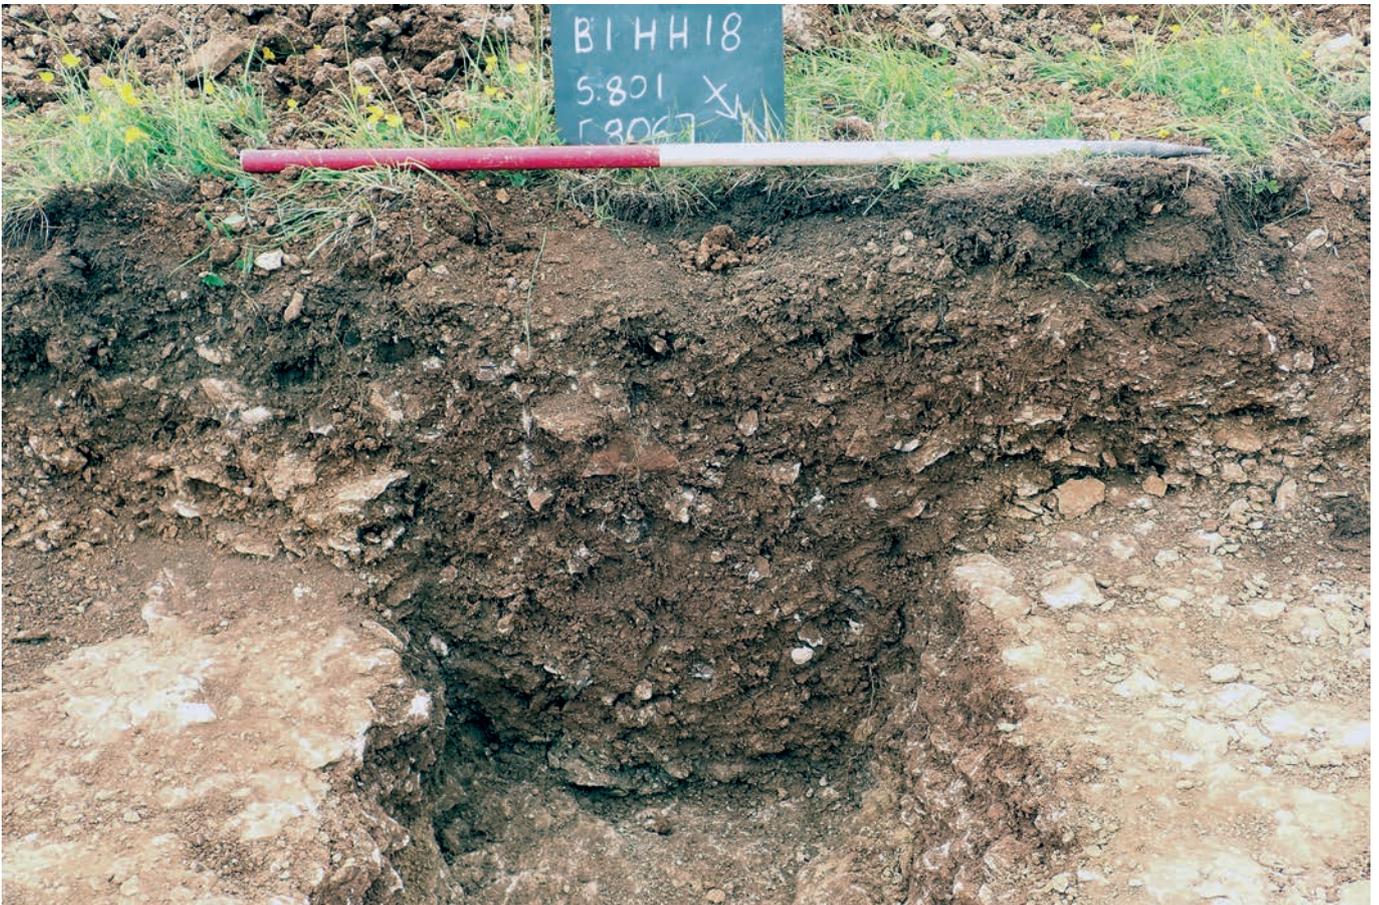
- 4.3.4 Trenches 8 and 10 exposed three shallow trenches containing traces of concrete strip foundations (Features 803, 806 and 1004). These appear to correspond with a hangar (806, 1004) and a workshop (803) shown on the Ordnance Survey map of 1922 (Fig. 2).
- 4.3.5 Trenches 2 and 6 had thickened soil sequences which correspond with taxiways constructed for the RFC Training Station Depot, as shown on the 1922 OS map (Fig. 2).
- 4.3.6 Trenches 3 and 12 contained levelling layers 308 and 1203, probably base layers of footpaths between the technical buildings marked on the 1922 OS map (Fig. 2).
- 4.3.7 In 1920 the RFC Training Depot Station buildings were demolished and returned to agriculture. Remains of the hangars appear to have been thoroughly cleared from the site, as only buried features such as service trenches and foundations survived.

Plate 16: Trench 8, section 801, foundation 806

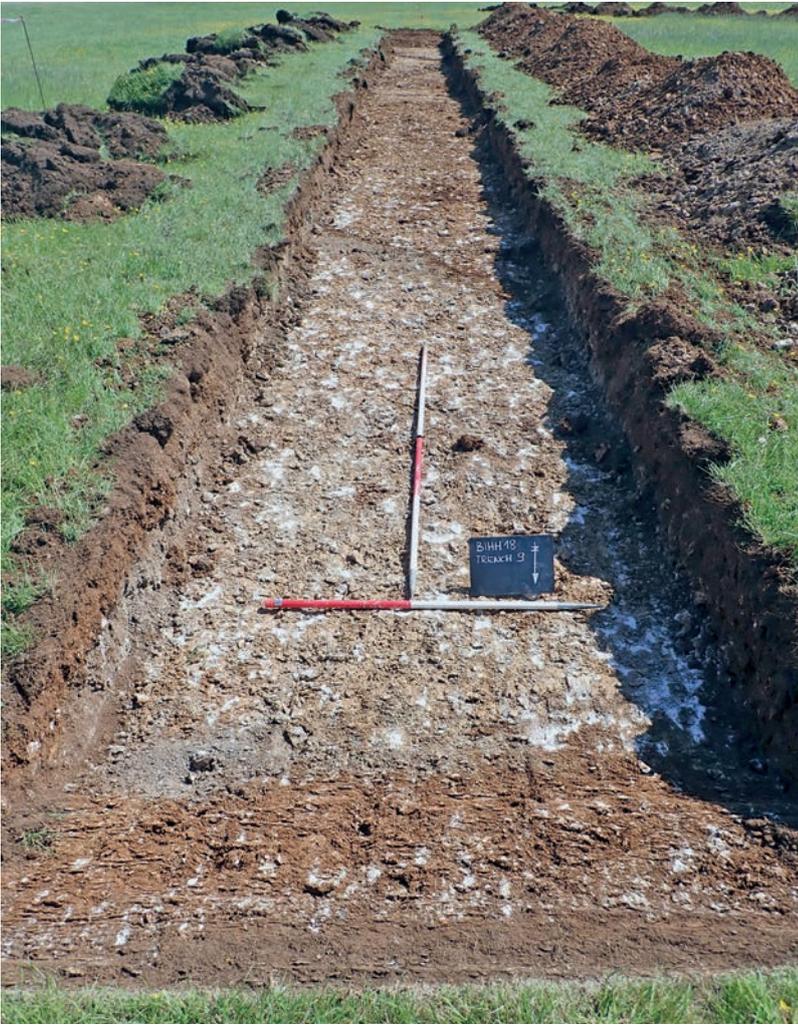
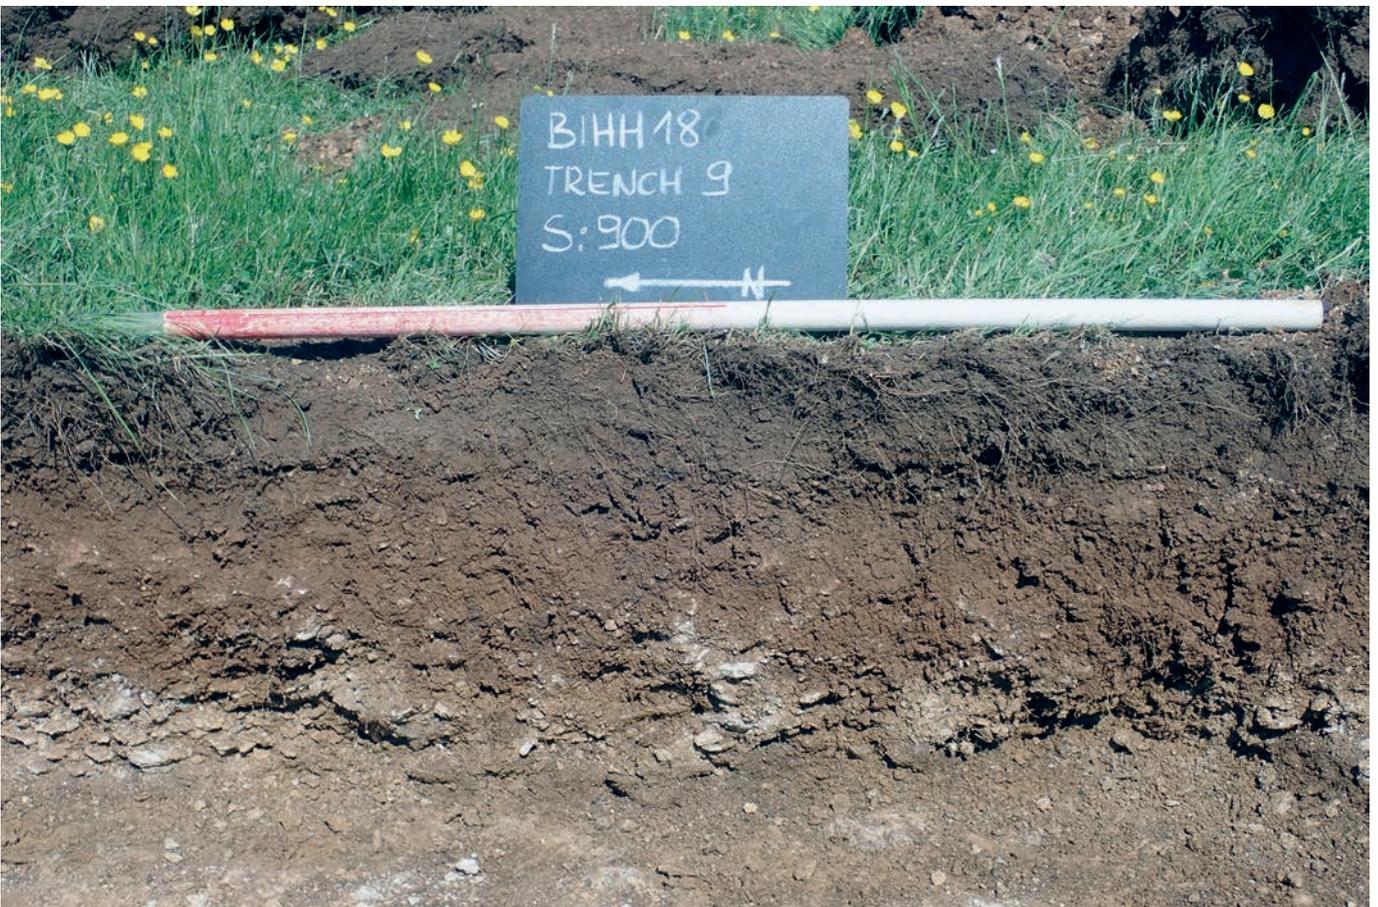
- 3.11.1 Trench 9 was excavated in the south-eastern part of site and was oriented NW- SE. The trench contained two modern pipe trenches (not excavated). The ditches contained asbestos tiles so were not excavated.

Plate 17: Trench 9, general view

Plate 18: Trench 9, representative section

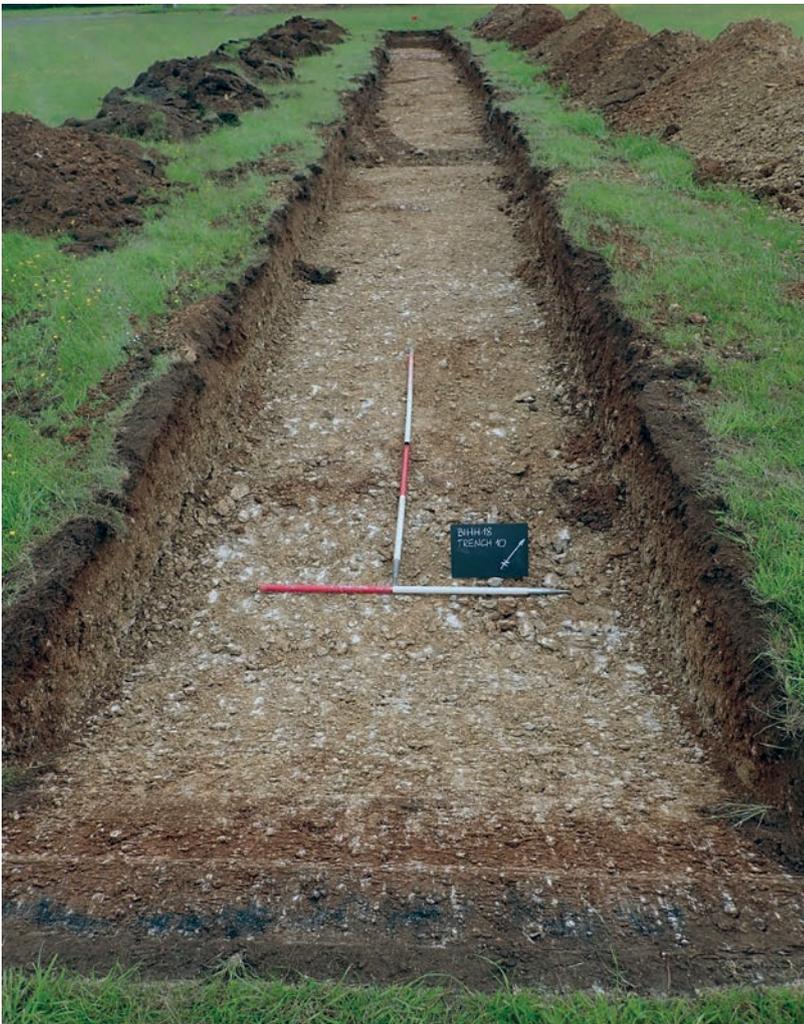
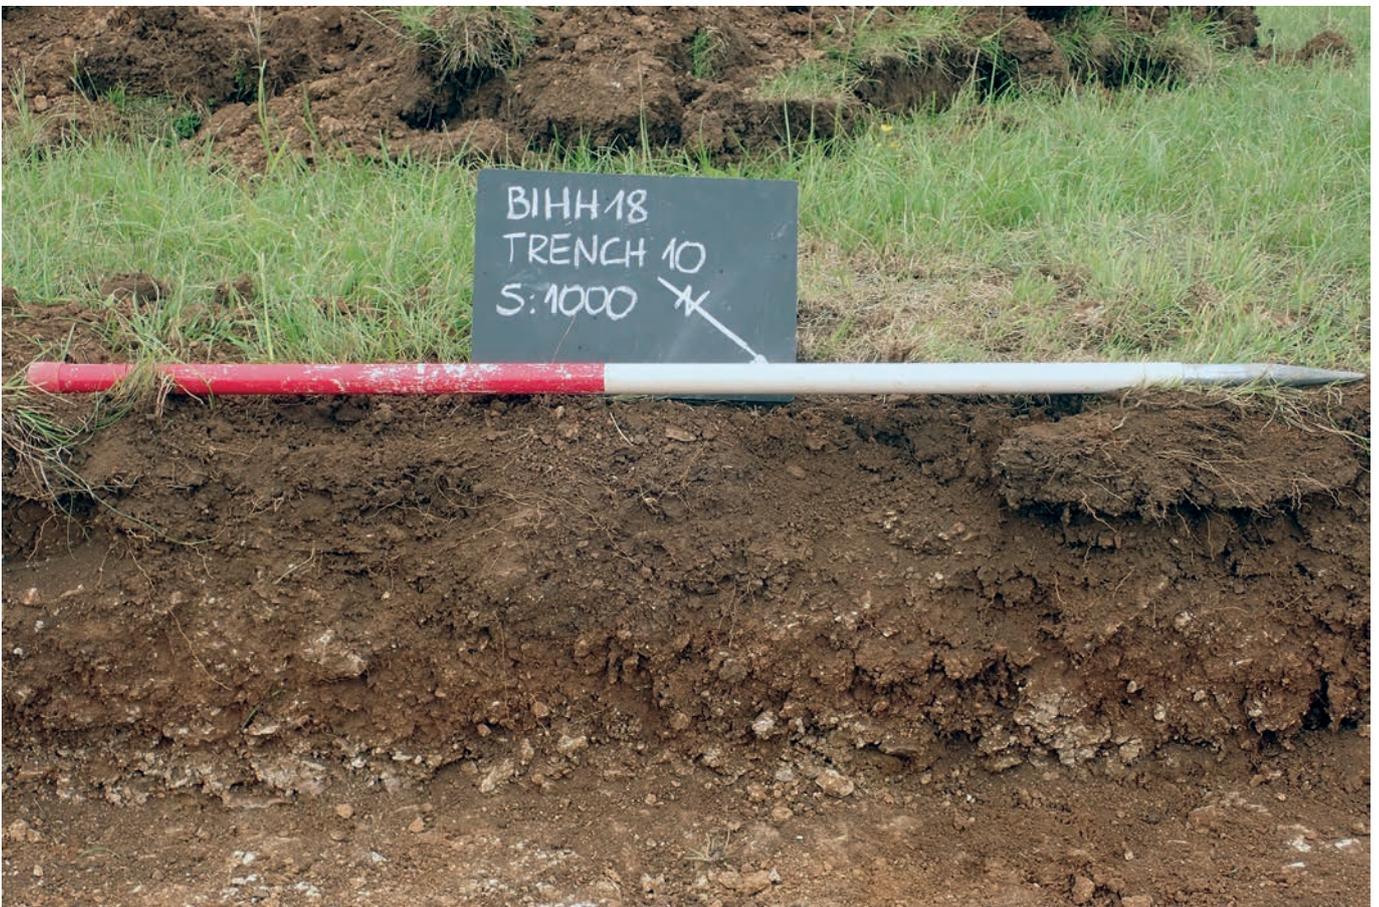
- 3.12.1 Trench 10 was located in the southern part of site and was oriented WNW- ESE. The trench exposed a pipe trench (not excavated) and the foundation of a hangar (1004), and the remains of a concrete structure (1003).
- 3.12.2 Ditch 1004 appeared to correspond with a hangar shown on the Ordnance Survey map of 1922 (Fig. 2) and may be a grubbed-out foundation trench. The shallow trench containing traces of concrete strip foundation.
- 3.12.3 Concrete structure 1003 was exposed in the northern face of the trench and had a large metal spring of unknown function.

Plate 19: Trench 10, general view

Trench 20: Trench 10 representative section

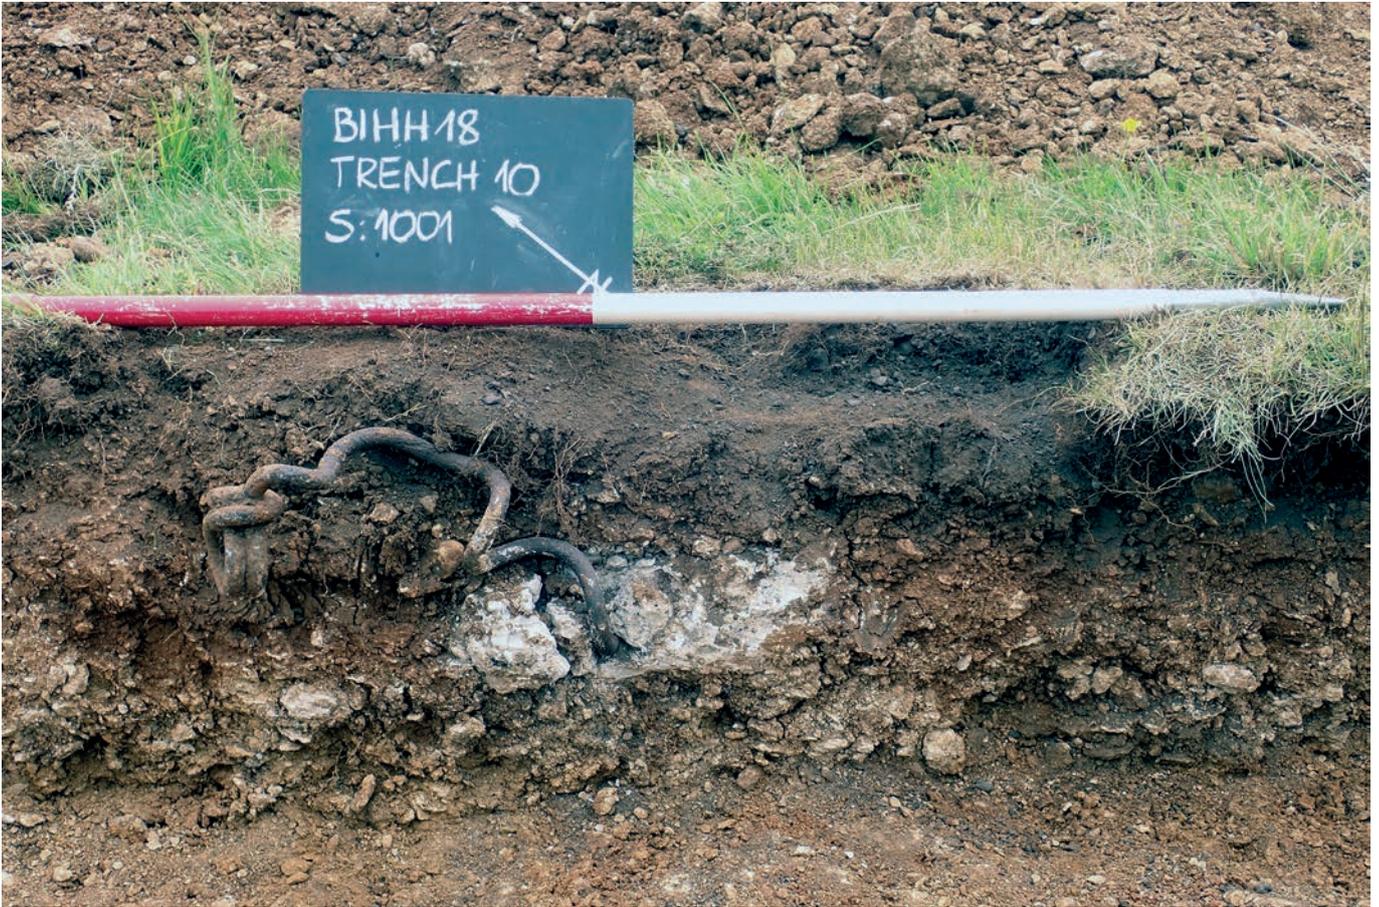
Plate 21: Trench 10, section 1001, concrete structure 1003

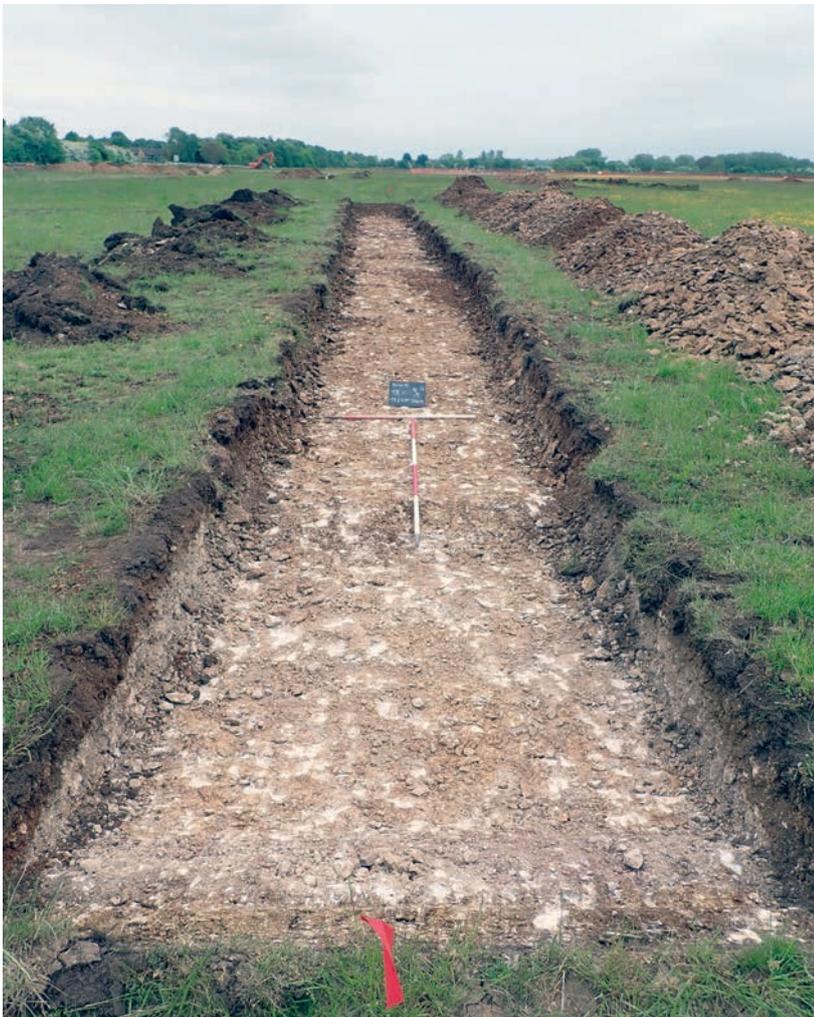
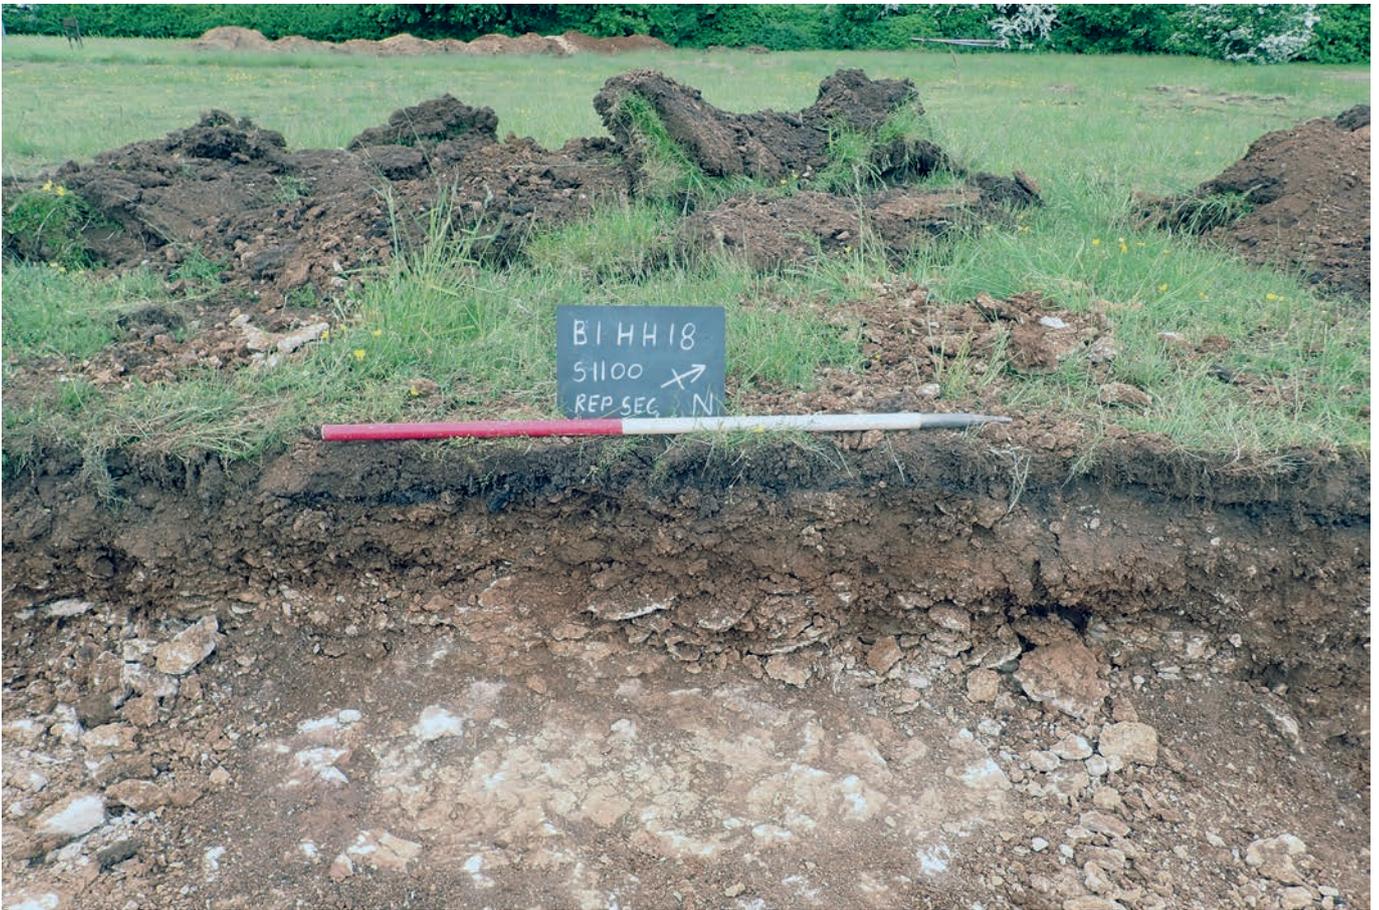
- 3.13.1 Trench 11 was excavated in the southern part of the site and was oriented NNE-SSW. The trench exposed one modern service pipe trench, which was not excavated.

Plate 22: Trench 11, general view

Plate 23: Trench 11, representative section

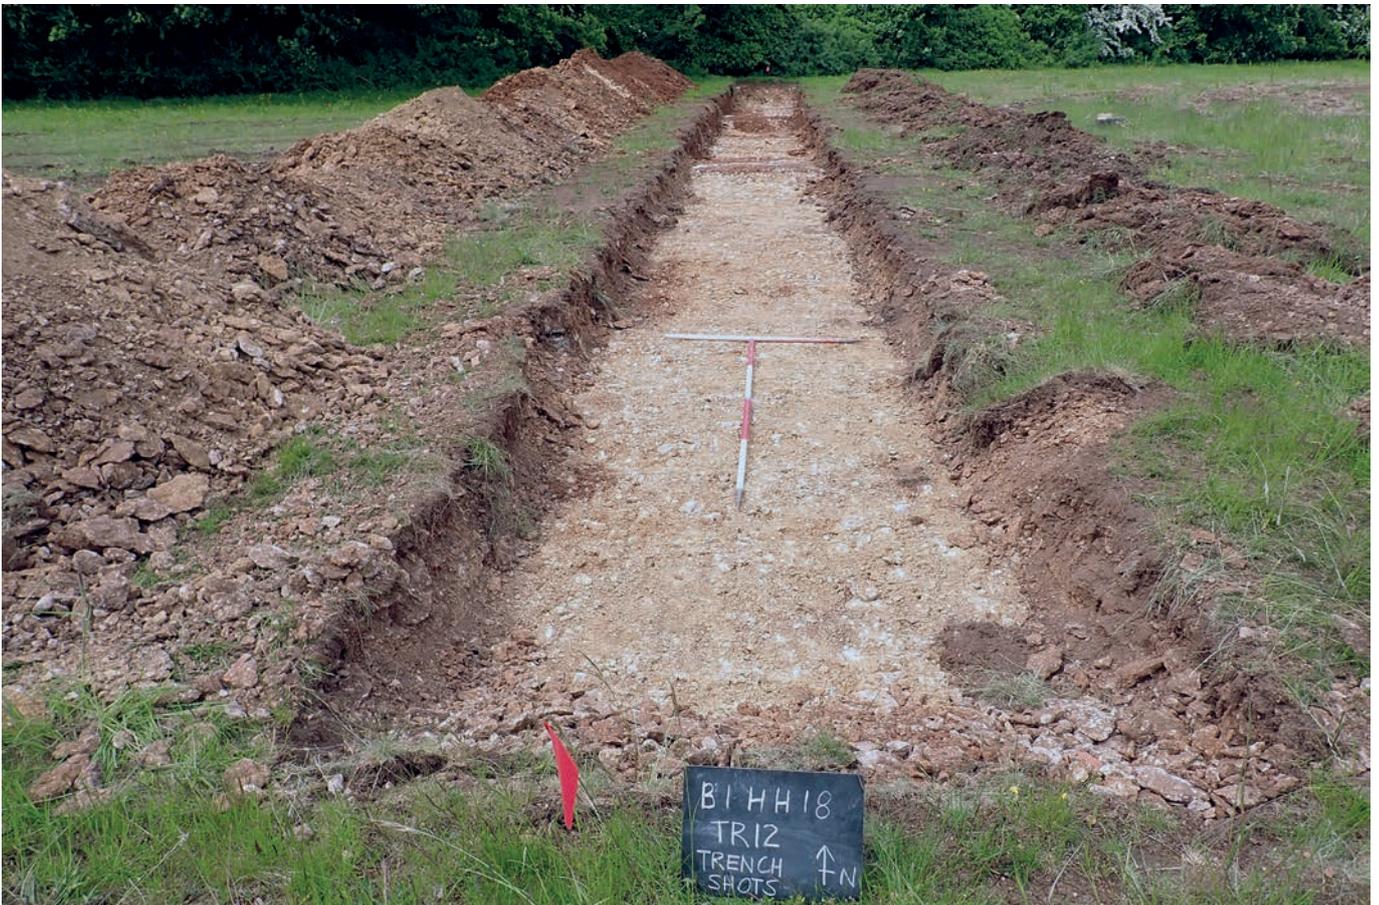
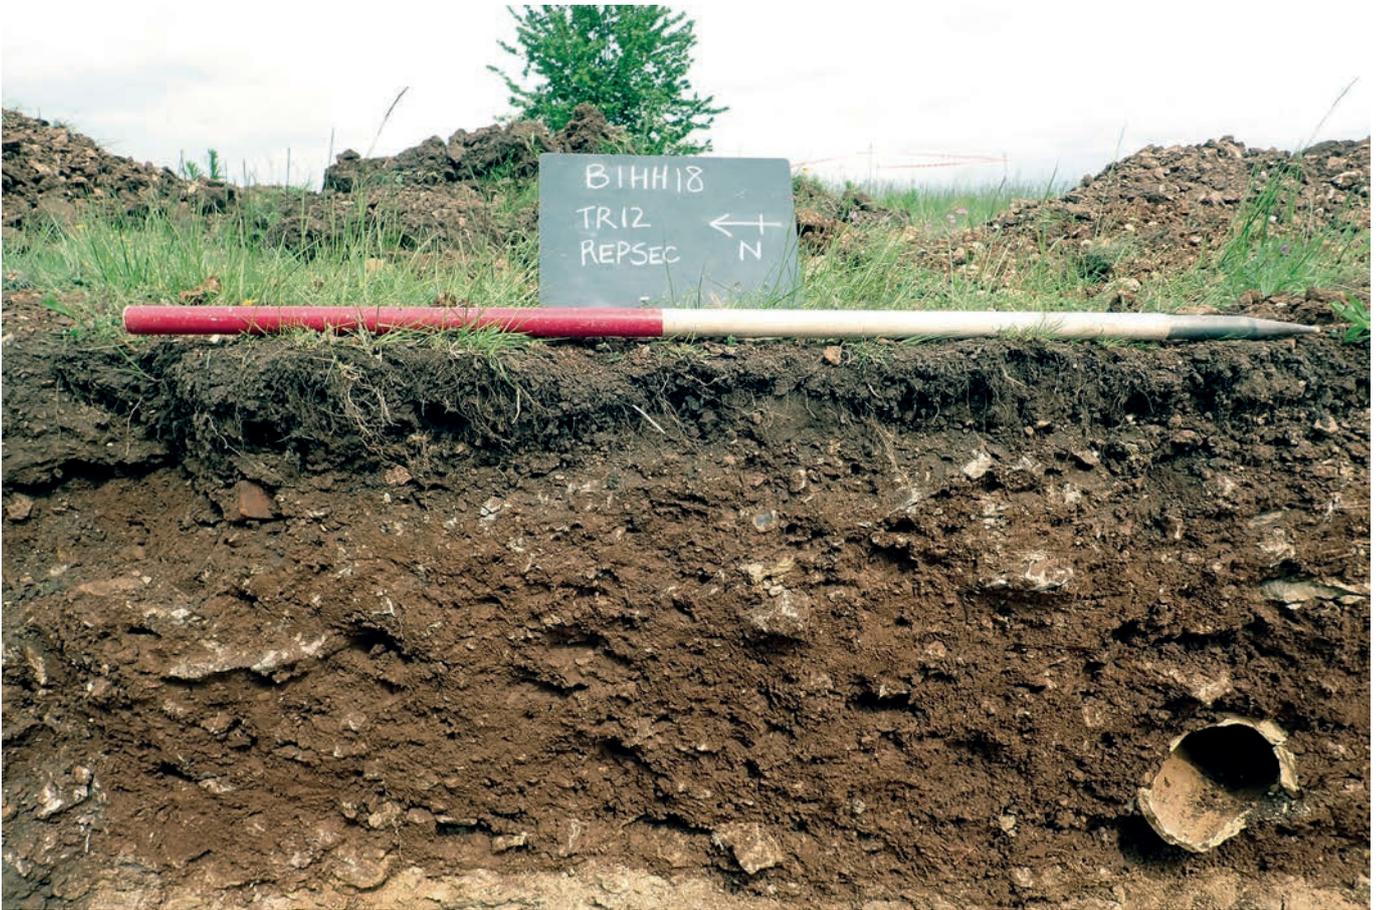
- 3.14.1 Trench 12 was excavated in the southern part of site and was oriented WNW- ESE. The trench contained one modern levelling layer (1203) and two modern pipe trenches (1204, 1205), which were not excavated.
- 3.14.2 Layer 1203 was located in the centre of the trench, between the ditches, and represented the remains of a levelling layer for a footpath between the technical buildings of the RAF base.

Plate 24: Trench 12, general view

Plate 25: Trench 12, representative section
