# KING CHARLES II MONUMENT BLACK DUB

**Archaeological Fabric Survey**

September 2002

**Document Type:** Fabric Survey Report

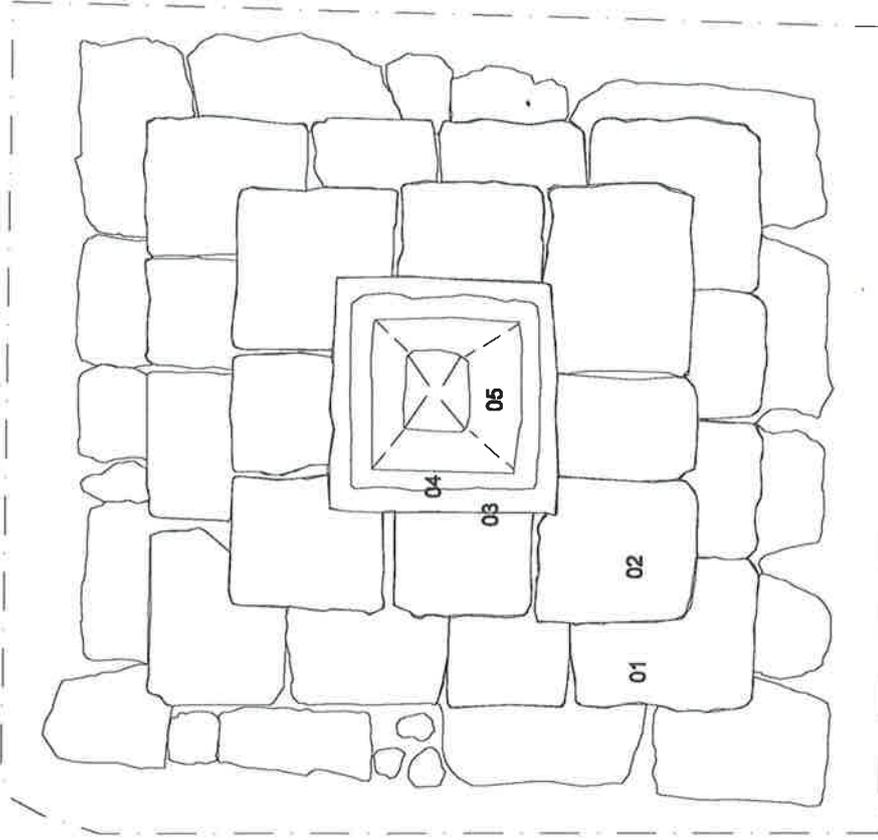
**Figure 2 : Black Dub Monument Plan**

- 3.1.2 The needle stone, **05**, is 1.2m tall and has a basal width of 0.47m, tapering to 0.3m before coming to an abrupt point (Fig 2). The decorated stone cube, **04**, is 0.56m x 0.56m; three faces have been decorated in bas-relief and the fourth, the north face, has the inscription to King Charles II (Plate 4). The east face has a crown carved onto it, and the south face has a recumbent lion with a possible Egyptian-style cartouche (Plate 3). The west face has a circular recess with a male profile bust, presumably of Charles II, in the style of a Roman emperor (Plate 2).

- 3.1.4 The base was exposed by hand digging a trench, 0.25m–0.3m wide, around the monument. This revealed a rough undressed stone foundation, **06**, in a similar construction style (Fig 2). The thickness of the base was 0.40m.

2.2.1 The record consists of a full description, annotated with dimensions, and a scale drawing of the monument in plan view (Fig 2). A full professional archive has been compiled in accordance with current IFA and English Heritage guidelines (English Heritage 1991). The archive will be deposited with the Cumbria Record Office, Kendal, and a copy of the report will be sent to the Cumbria Sites and Monuments Record.

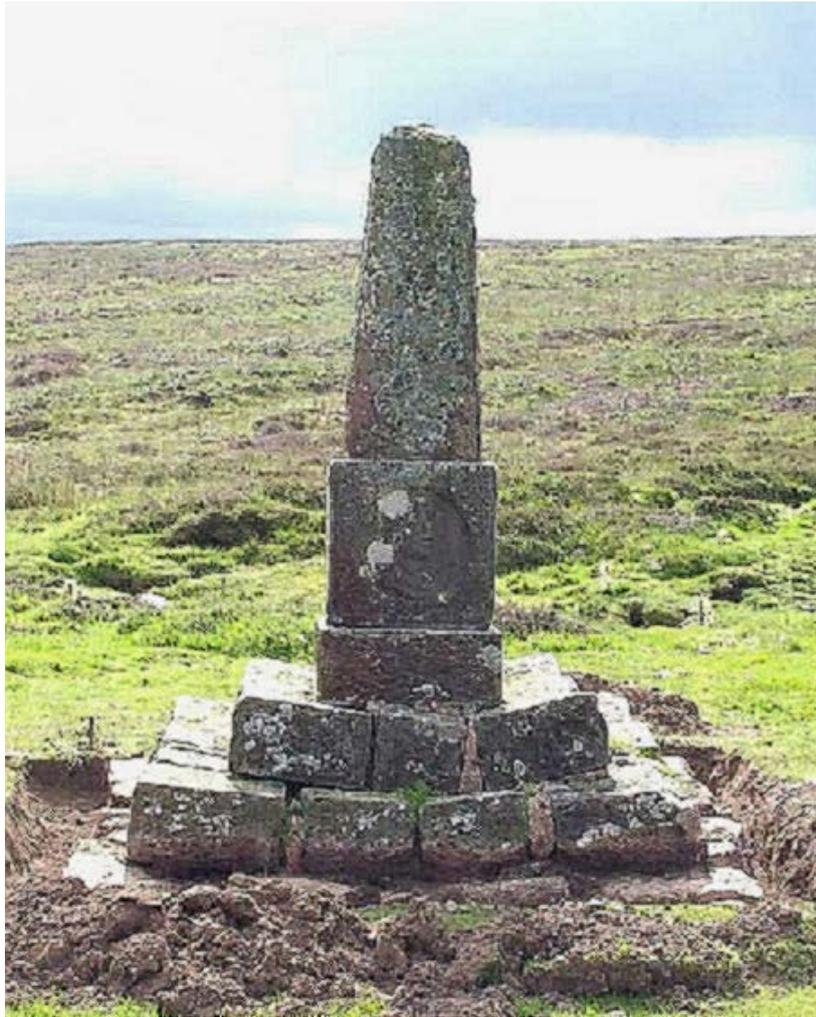
Plate 1: General view of the monument looking east

- 3.1.1 The monument (Plate 1) is constructed of ashlar blocks which have been finished to create a pecked appearance forming two plinths, a rectangular base stone, a decorated cube stone, and a needle capstone. The overall height is almost 2.90m, but the tip of the needle is weathered and eroded to less than its original height. The base of the monument is 2.2m x 2.2m square, with an average stone thickness of 0.40m.

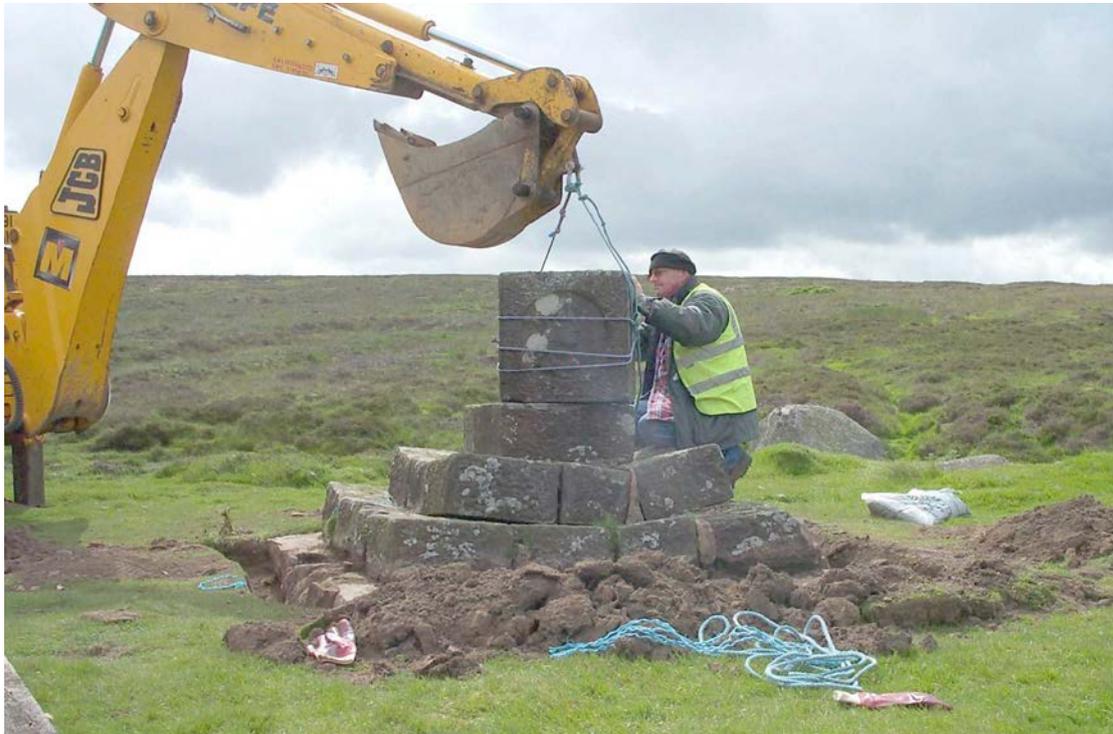
Plate 4: Removal of the decorated stone cube

- 3.2.1 The needle stone was lifted using a JCB and rope harnesses, as was the decorated stone cube, **05**. The single base stone, **03**, was lifted by hand. The stones of the plinths were numbered and located before removal so as to facilitate replacement in their original siting; they were then removed by hand.
- 3.2.2 The removal of the decorated cube revealed that the single base stone was not solid, but had a rectangular hole through it 0.33m long by 20m wide (Plate 5). This exposed the monument's core, **07**, which consisted of loose, irregular sized stones, the interstices of which were penetrated by much dark soil and modern

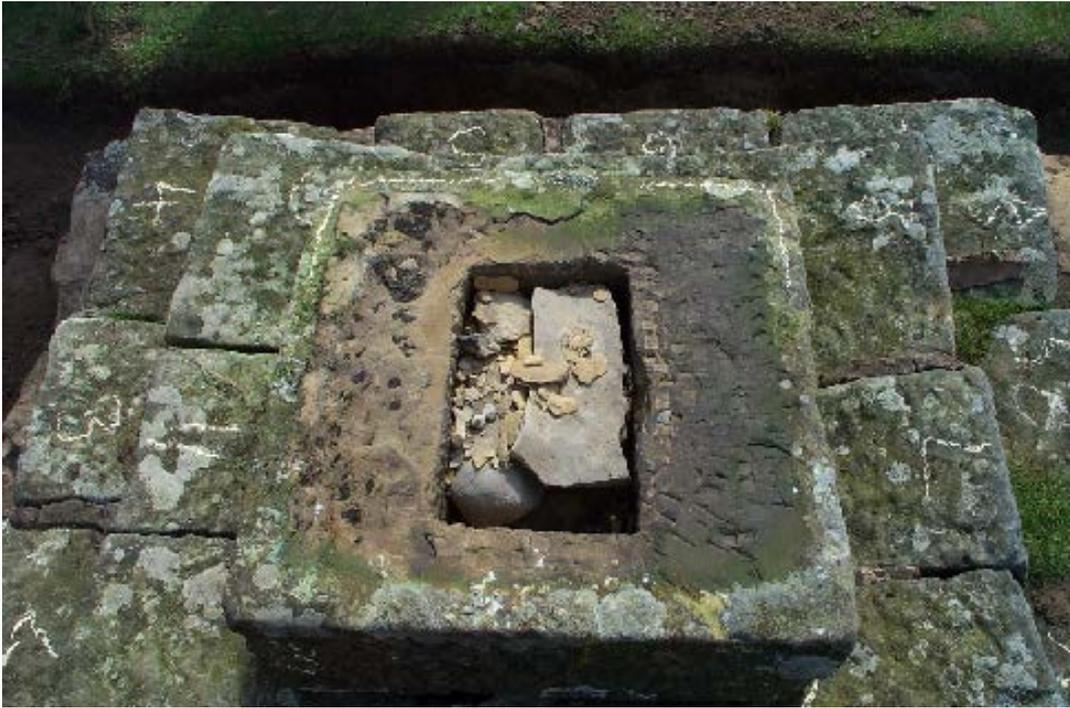
Plate 5: Rubble core through the hollow pillar base

debris. It became apparent that the collapse of the monument was due to this loose rubble core giving way under the weight of the central needle.

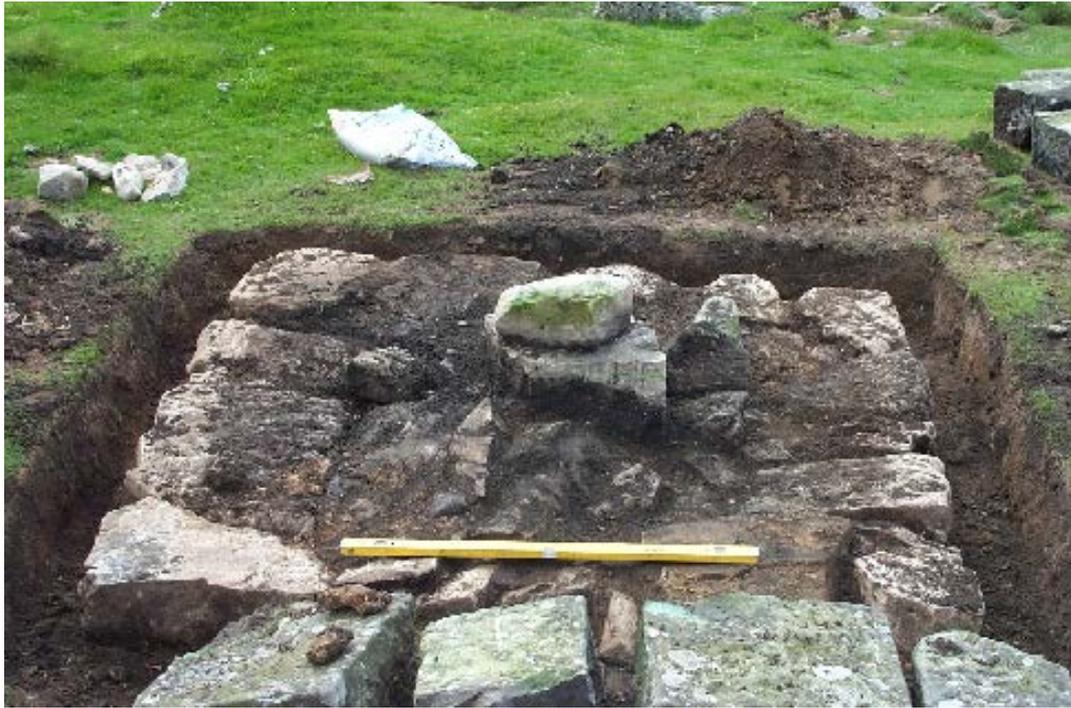
Plate 7: The foundations and internal stone pillar of the monument

- 3.2.3 The removal of the upper plinth showed yet another internal structural element, a rough stone-built central pillar, **08**. This was mortared into place with coarse lime mortar of a different type to that used externally. As this was exposed, and the loose rubble removed, it was also found that the base of the monument was formed by an external skirt of stone rather than a solid stone platform. Within this skirting was a solid mortared-in rubble base, **09**, with the rough stone support pillar protruding from the centre (Plate 6). This was found not to have sunk or moved and was still a solid and structurally sound foundation platform, demonstrating that the problem was not caused by the settling of underlying soft ground.

- 3.2.4 Having established that the cause of the slumping of the monument was the internal collapse of the loose rubble core and not the sinking of the foundations, the strategy for consolidation was altered. There was no need to remove the foundations or cause any further disturbance to the ground. As a result the foundations were repointed and consolidated *in-situ*. A new supporting core for the plinths was constructed and the original dry-stone work was placed back into the original position.
