SEWINGSHIELDS WOOD, NORTHUMBERLAND

Archaeological Evaluation Report

Oxford Archaeology North

October 2002

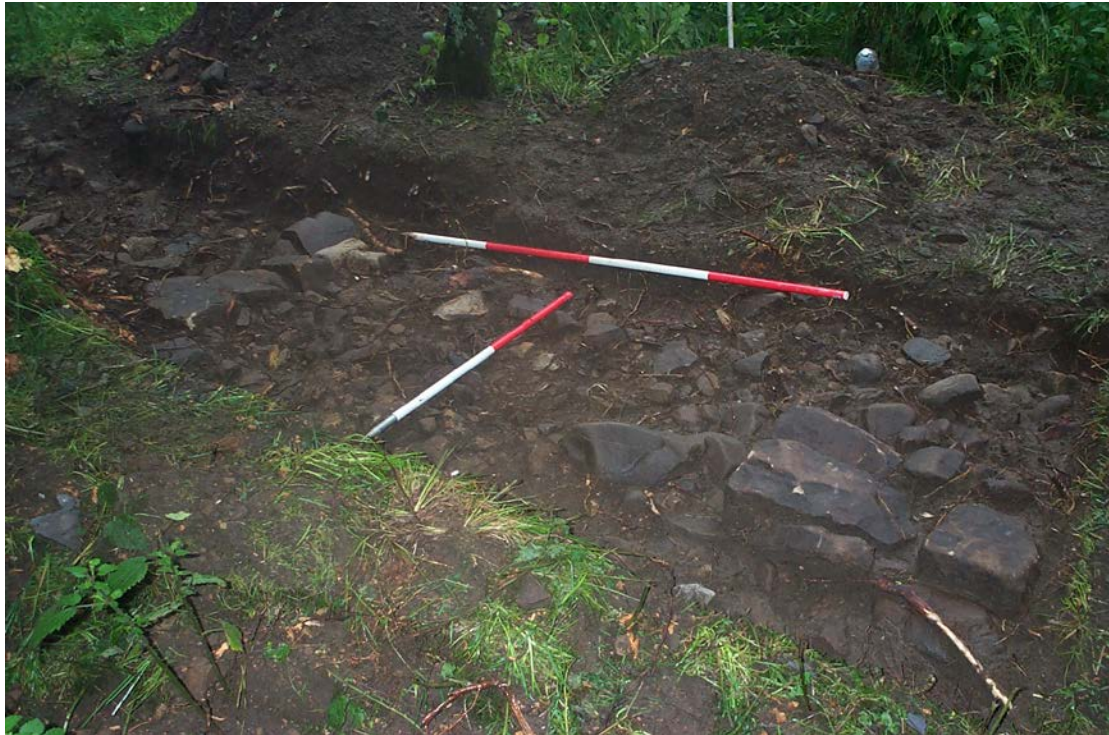
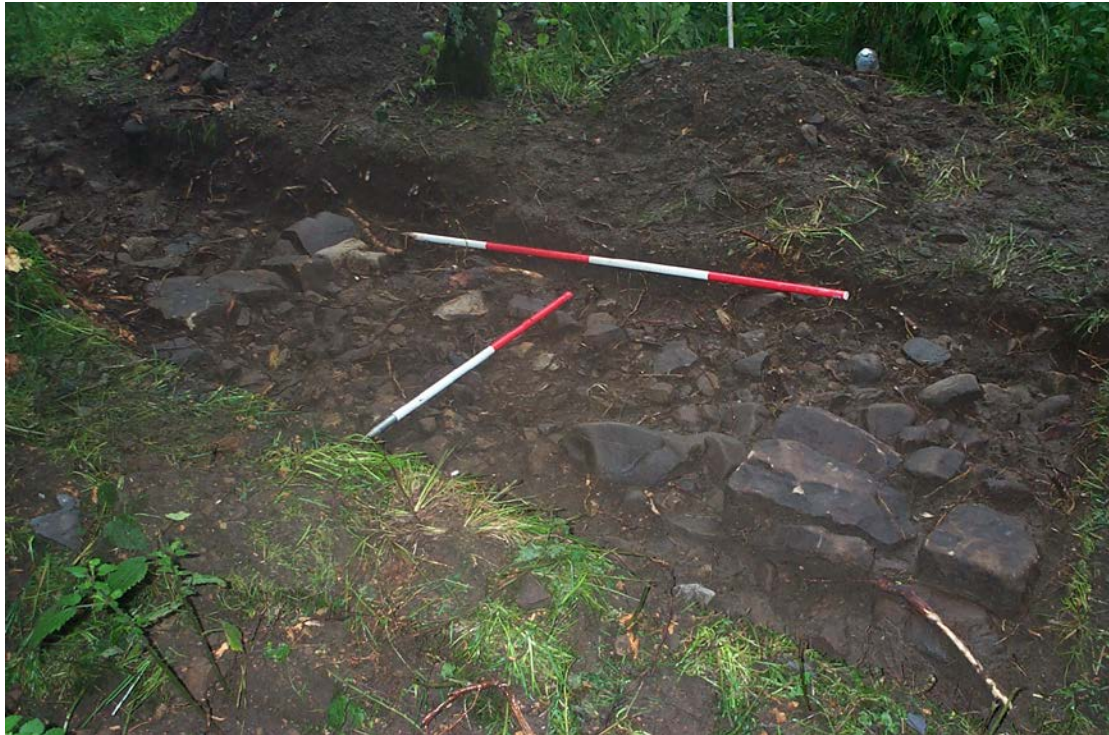
- 3.1.1 Trench 1 was placed adjacent to a well-established permissive path at the eastern side of the outbuildings north of Sewingshields Farm (Fig 2). Aligned approximately north/south, the trench measured 6.7m by 1.5m, and was excavated to a maximum depth of 0.41m (Plate 1).

Plate 1: General view of Trench 1, looking north-east

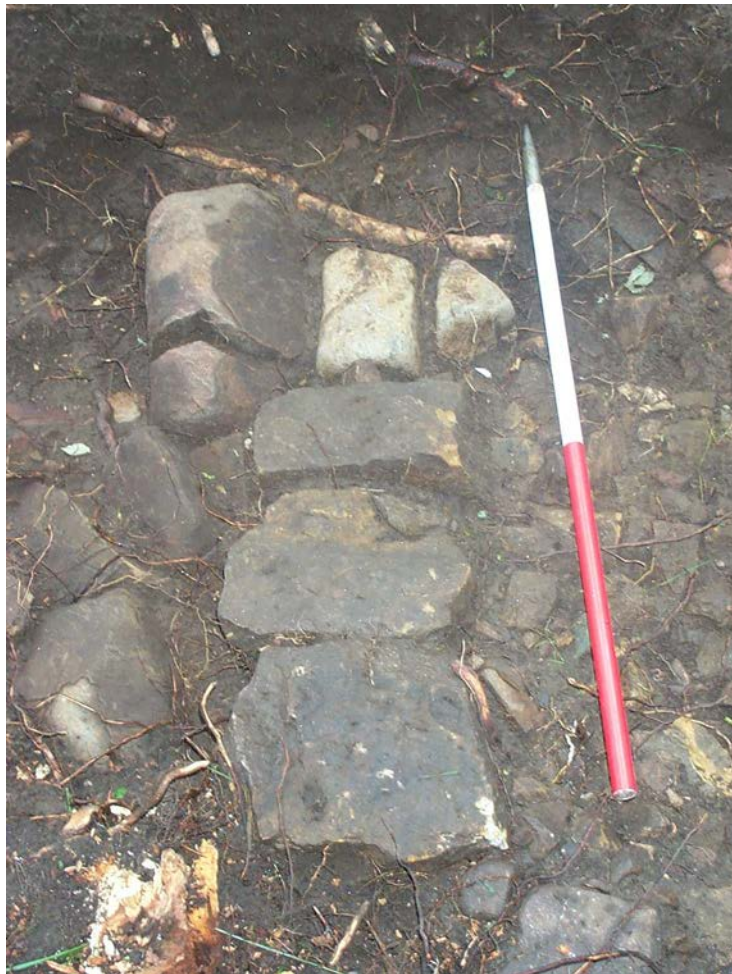
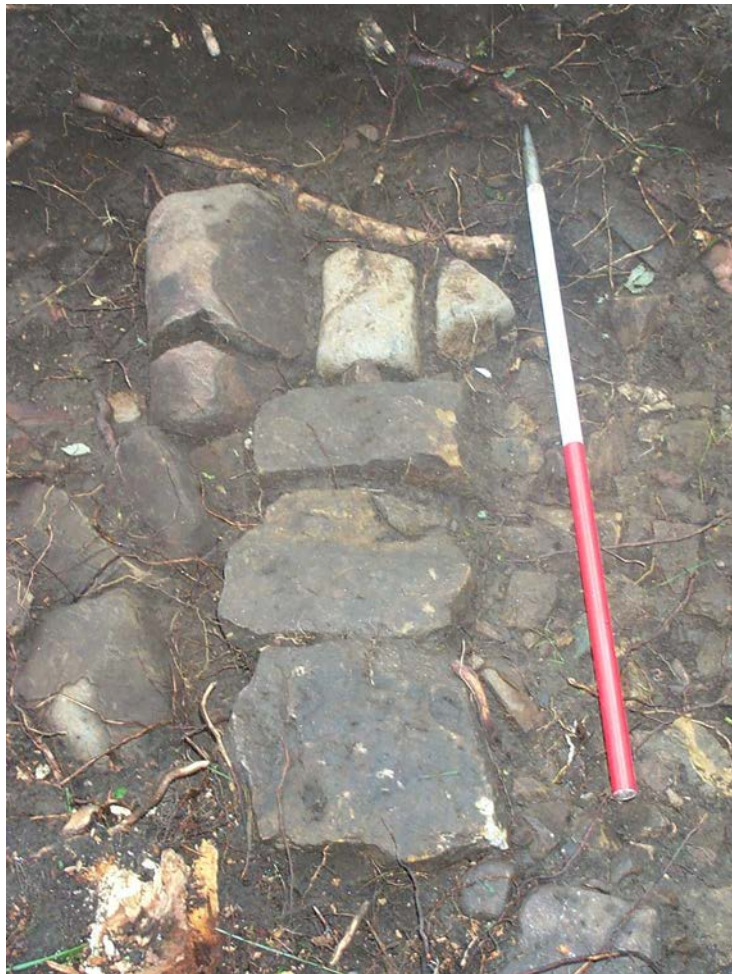
- 3.1.3 A second linear grouping of stones (**52**) was exposed at a distance of 2.45m to the north, and at a depth of 0.19m. This alignment was similarly orientated east/west across the trench, and comprised large freestone blocks, at least three of which appeared to be *in situ* (Fig 3). The size, shape, and distribution of the blocks indicated that, like stones **54**, they were also the remnants of Hadrian's Wall (Plate 2). Limited investigation along the northern edge of **52** revealed that the blocks were only a single course deep, suggesting that they were the foundation course of the north face.

Plate 2: North ashlar face 52, Trench 1, looking east

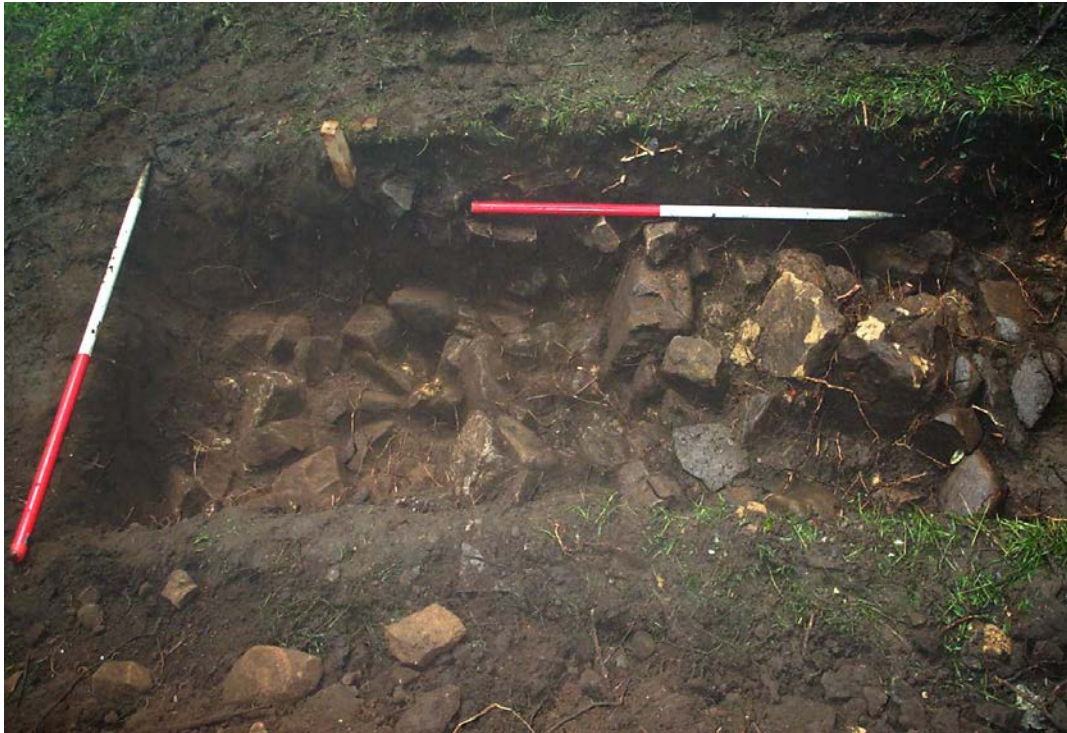
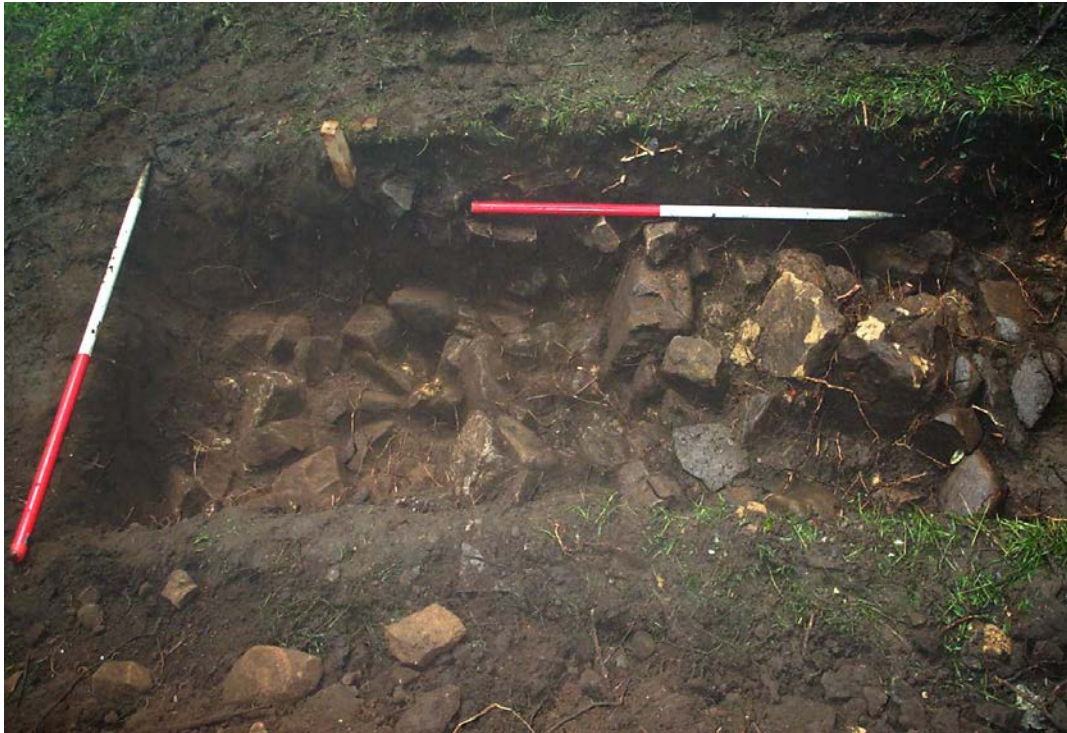
- 3.2.1 Trench 2 was placed across the projected line of the Wall, some 7.3m to the west of the outbuildings at the approximate centre of Sewingshields Wood (Fig 2). Aligned approximately north/south, the trench measured 3.7m by 1.3m and was excavated to a maximum depth of 0.60m (Plate 3).

- 3.2.4 Deposit **59** was overlain by rubble spread **57**, which comprised stones of all sizes and configurations, although it did not incorporate any facing stones. The stones formed c85% of the deposit, and were set randomly in a sandy-silt matrix. Spread **57** was exposed along the entire trench, although the most dense concentration of stones occurred at the southern end. Towards the southern end of the trench, the uppermost surface of the spread was exposed at a depth of 0.02m, whilst at the northern end, **57** was not encountered above a depth of 0.24m. Limited excavation of spread **57** revealed it to have a thickness of approximately 0.4m. The distribution of stones within this deposit suggested that it most probably represented the material discarded during stone robbing.

- 3.2.5 Situated above spread **57**, and therefore deposited at a later date, were three large freestone blocks (**56**), which were clearly Wall face components. The distribution of these facing stones (Fig 3) suggested that they represented tumble from the northern face of the Wall, as opposed to stones discarded during robbing activity. It may thus be suggested that **56** represented genuine *in situ* collapse of what remained of the Wall subsequent to robbing activity.

Plate 3: Looking east across Trench 2, showing rubble spread 57 and collapse 56

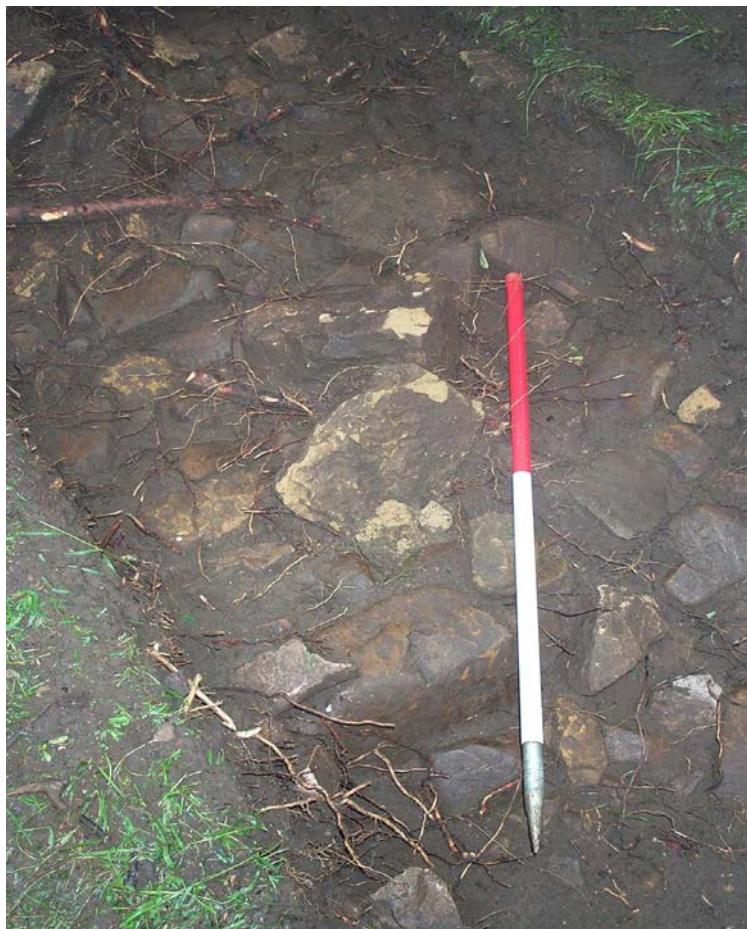
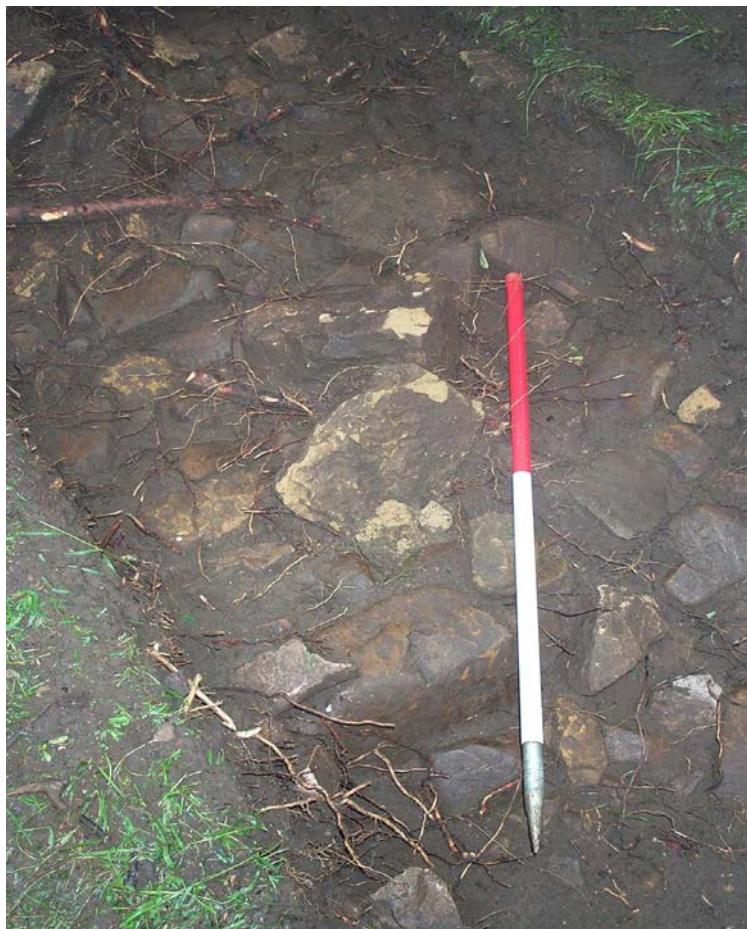
- 3.2.2 In stratigraphic terms, the earliest feature encountered within Trench 2 comprised two large freestone blocks (**58**), which were exposed at a depth of 0.3m, and formed an alignment orientated east/west across the approximate centre of the trench (Fig 3). The stones were laid bed-on and were seemingly *in situ*, although there was no clear trace of any bonding material between the stones (Plate 4). The northern face of each stone was dressed and each had been cut to a uniform thickness of c0.25m, which is consistent with the dimensions of facing stones recorded in excavations at the eastern end of Sewingshields Wood (LUAU 1999). Limited investigation along the southern edge of stones **58** revealed that they were only a single course deep, suggesting that they represented the foundation course of the north face.

Plate 4: North face 58 and rubble spread 57, Trench 2

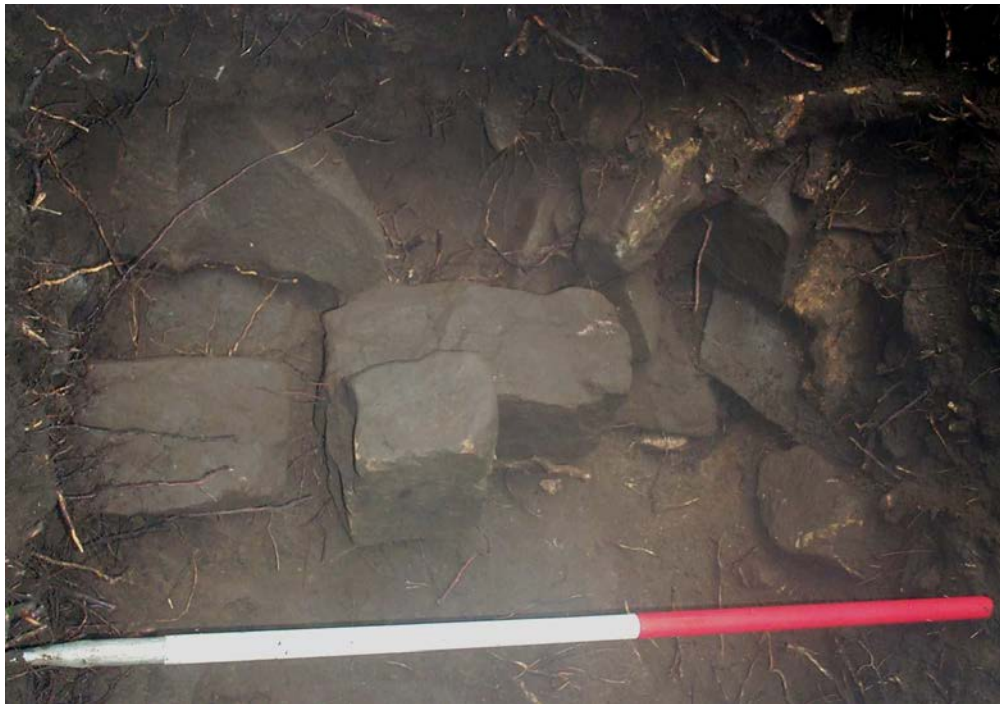
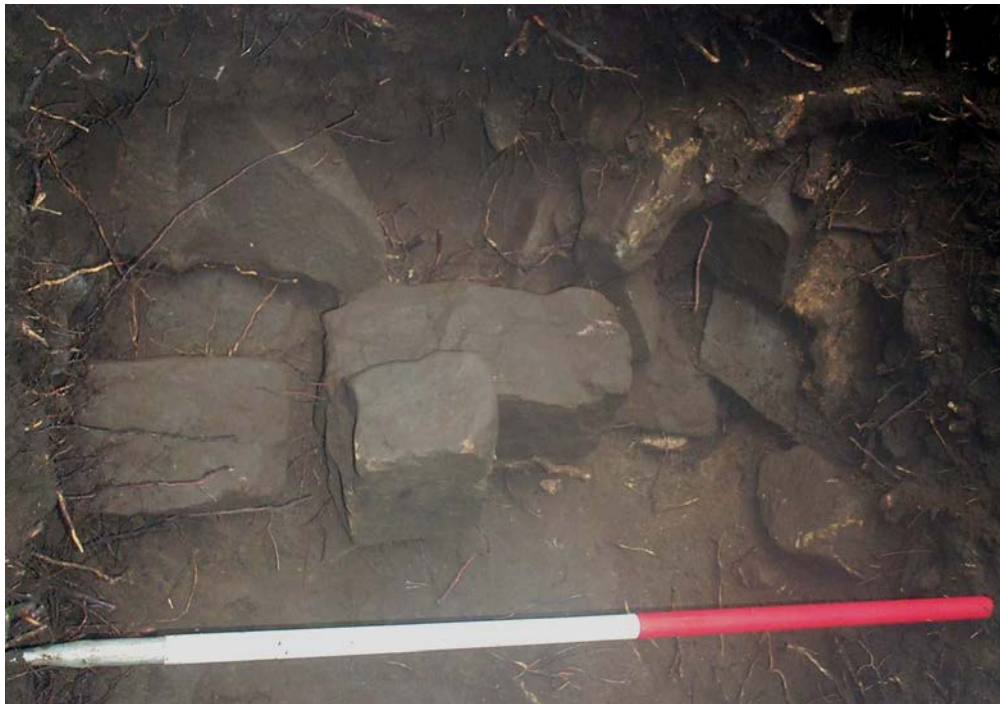
- 3.3.2 An alignment of large, freestone blocks (**62**) were exposed at the northern end of Trench 3, and were orientated east/west across the trench. Some of the component stones had clearly been disturbed, although at least two appeared to remain *in situ*. The uppermost *in situ* stone was revealed at a depth of 0.32m, and appeared to have been laid upon another stone, which was offset to the north by c0.2m. This may have represented the foundation course of the north face, with the upper stone representing the first course of the Wall. In contrast to Trenches 1 and 2, firm evidence for the use of mortar was produced from Trench 3, where it was seen to adhere to the southern edge of component stones of **62**.

Plate 6: North face and foundation **62**, Trench 3
