Northfield Filton Airfield Bristol

Historic Buildings Recording

January 2012

Document Type: Historic Building Investigation and Recording
Issue Number: 1

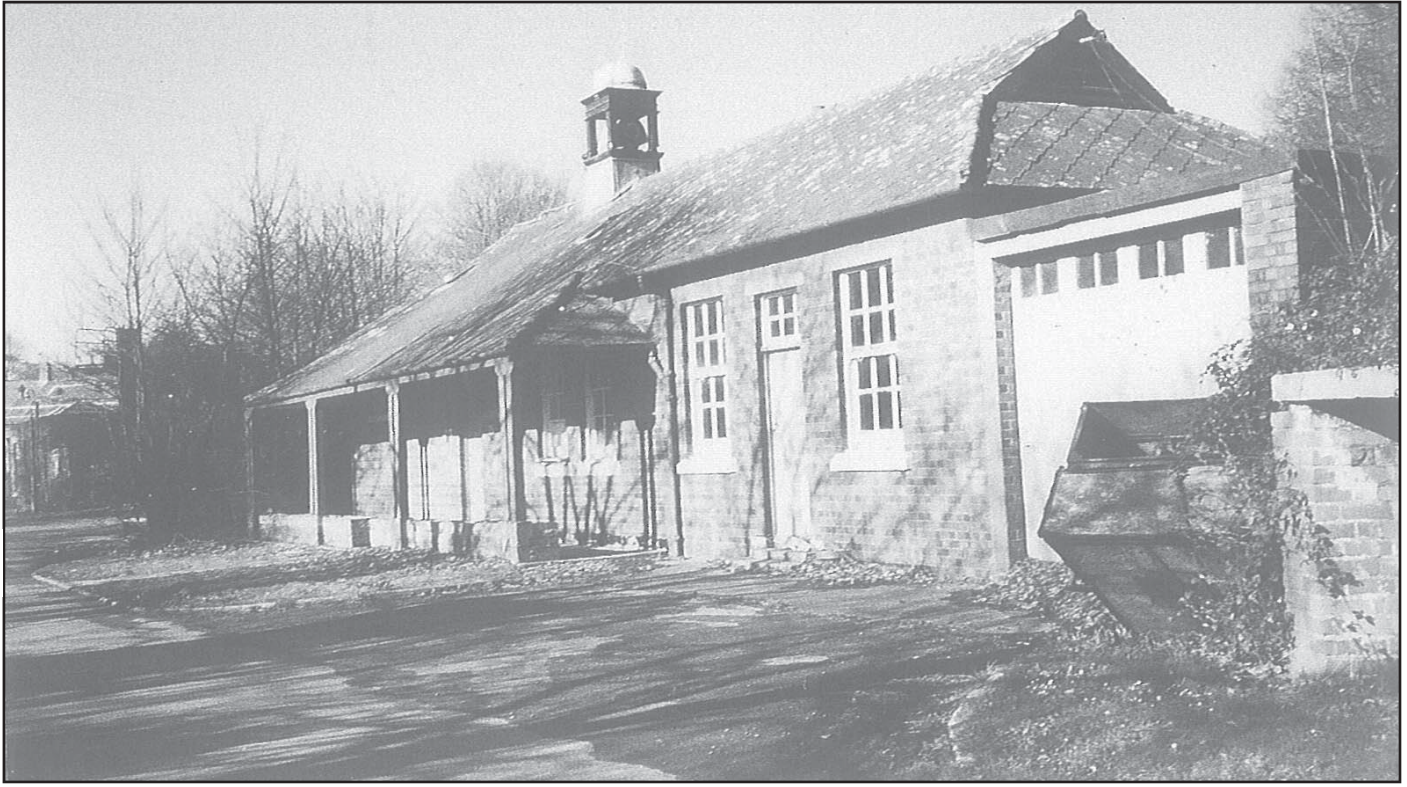
Site 25 Plate - Guardhouse (after Hall, 1995)

The photograph in *British Military Airfield Architecture* shows that the guardhouse at Filton was a single storey, rectangular plan range with a gabled roof covered in asbestos-cement tiles in a diamond pattern. There were sash windows, a projecting bell tower on the roof ridge and an overhanging cat-slide roof which would have provided cover while visitors were processed. The walls were of brick and adjoining to the north-east side of the building was a further building which provided accommodation for the fire party.

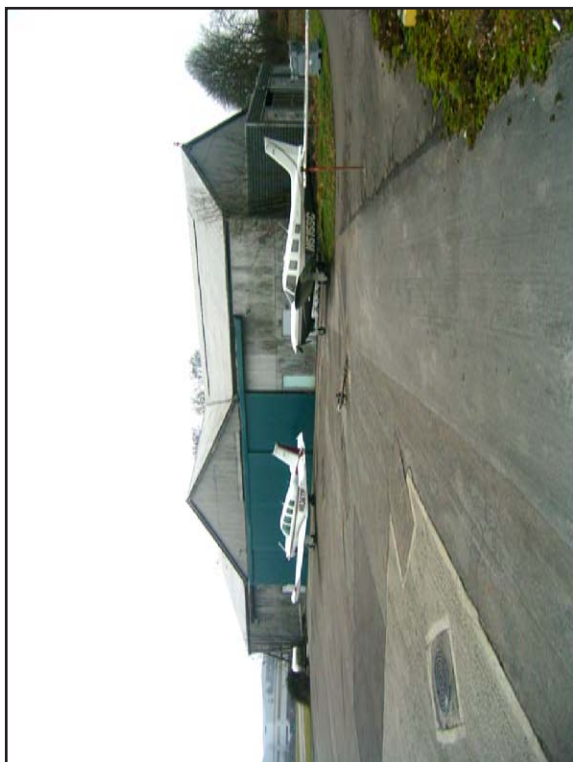
Site 52 Plate 1

The Side Opening Hangar is a single storied building with a linear (north-south) plan and gabled roof. It is clad in corrugated sheeting (partially secondary replacement) but it retains some original windows and cladding. The structure is a timber framework but this has not been inspected or recorded in the current works. At the centre of the east elevation is a set of full height, sliding (side-opening) doors to allow planes to be transferred in and out of the hangar and above this is a gabled pediment. To the rear (west) is a lean-to range for offices, workshop and stores with metal casement windows and a chimney. Small modern extensions have been added at the north end of the building and at the south end of the lean-to projection on the west side.

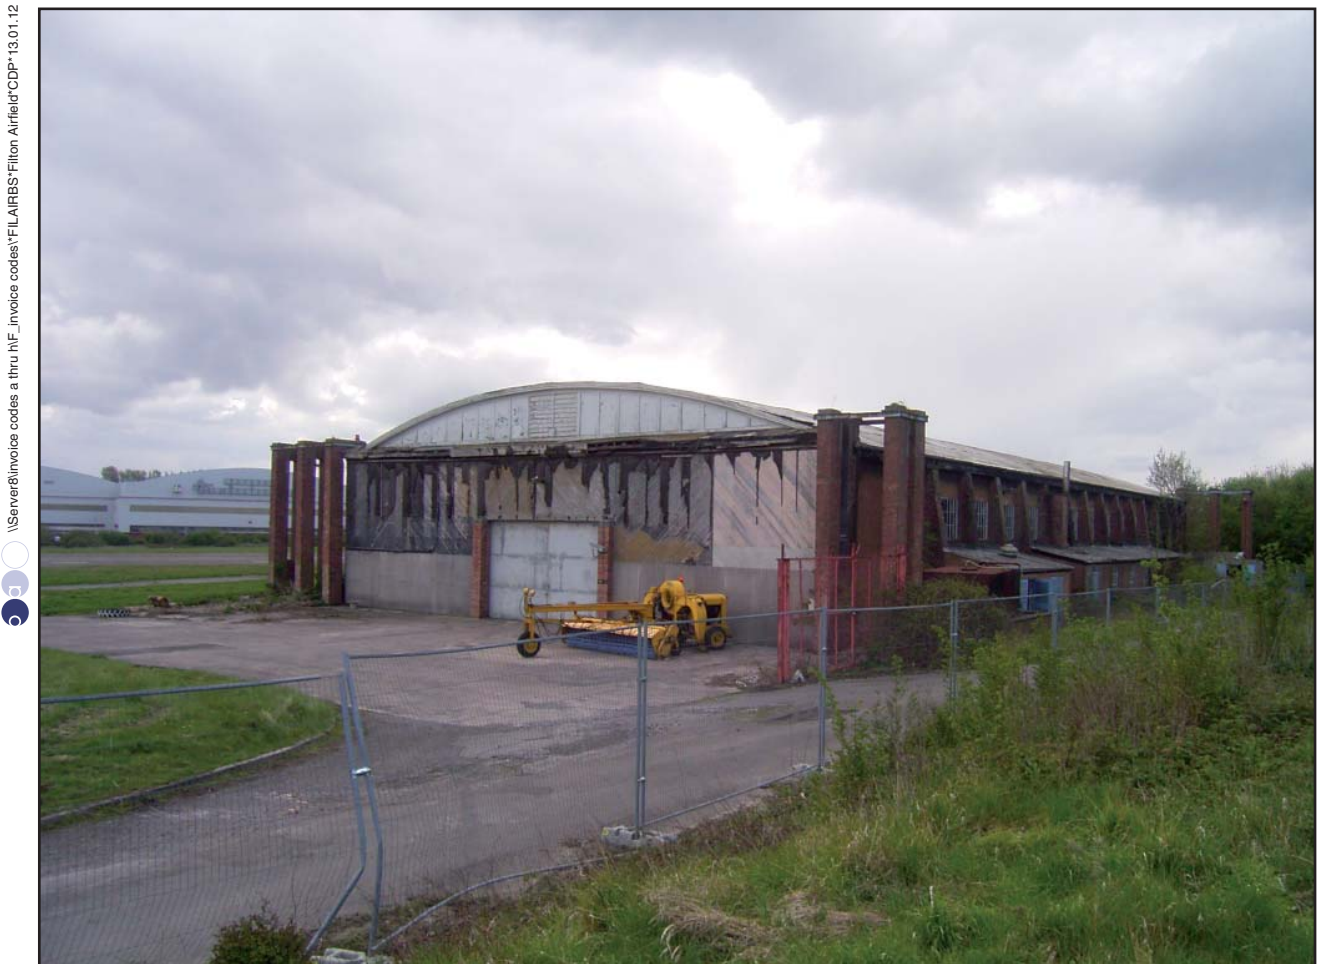
Site 75 Plate 1

This large hangar is c.52 m x c.26 m in plan and is a single bay wide. It opened at the eastern end and had buttressed brick sides supporting a shallow arched roof. The shed is lit by rows of windows along the side. Timber "Belfast Truss" girders, with the distinctive criss-cross latticed effect support the roof. Along the northern side of the building is a row of adjoining subsidiary rooms (probably offices, workshops etc) and along the south side is a further shorter lean-to.

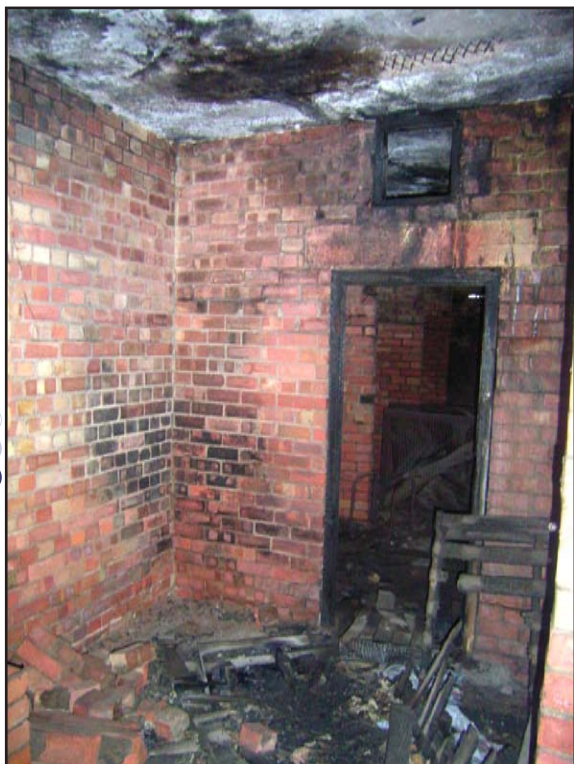
Site 115 Plate 1

The northern shelter has a number of cracks in its walls and similarly to the western shelter it has clearly suffered from fires or arson attempts.

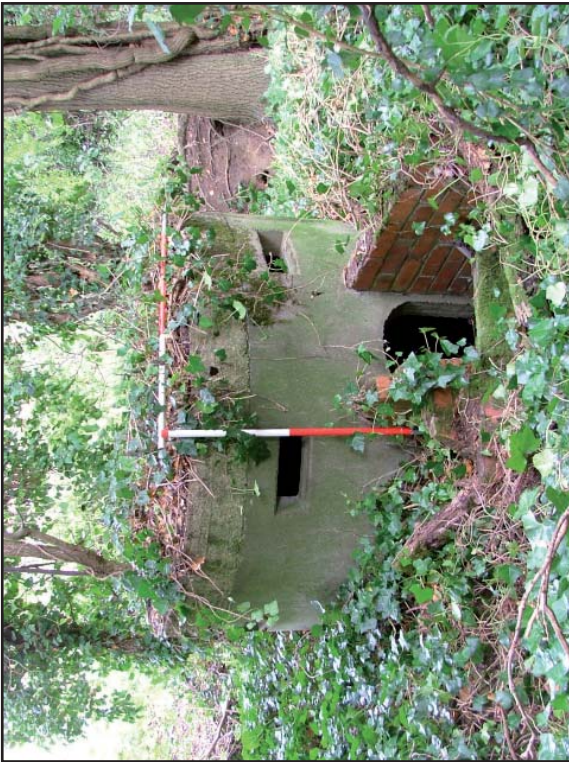
OA6 Plate 1

The pillbox, which is of the Air Ministry Norcon type, survives in good condition and covered the entrance to the farm with interlocking fields of fire with other defence posts along the west and north sides of the airfield perimeter. The Air Ministry Norcon type pillbox was a pre-cast reinforced concrete cylinder with six loopholes and small entrance. It measured 2.04 m Ø x 1.2 m and 0.24 m thick and was set on a six course high brick circular base. This was set 1.4 m in the ground with a partly covered brick lined trench entering it at right angles from the west. The pillbox had a 0.24 m thick concrete cast roof and floor with a 4" ceramic pipe drain from floor into boundary ditch.

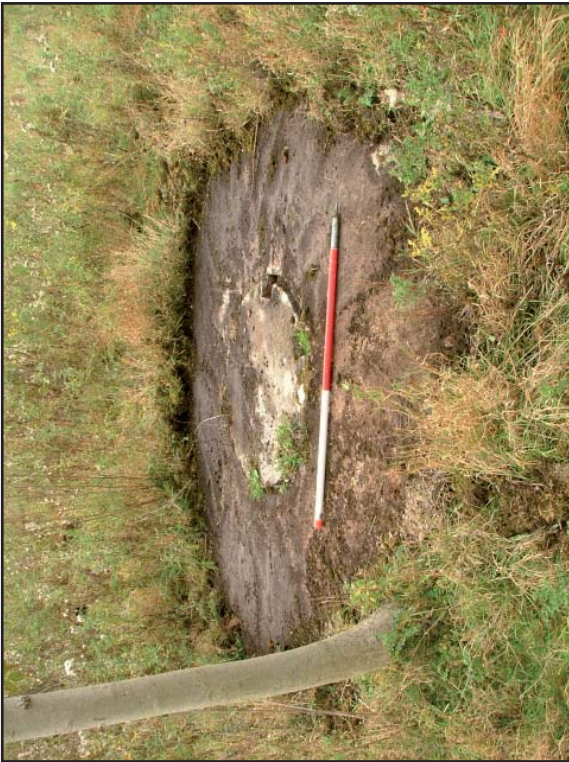
OA7 Plate 1

The two similar pads found within the main RAF base were located towards the western end of the technical area, and they appear to have been southern two from a group of four similar pads. The four were shown on the 1945 map and aerial photographs. They were 2.6 m square and 0.10 m thick with a 0.02 m raised centre, 0.85 m Ø with six 0.10 m square socket holes around it. These were 0.10 m in depth and for a mount possibly and aerial or mast.
