## Chapter 5: The Town: Detailed Studies of Sites Within the Late Saxon and Medieval Town

*Edited by Anne Dodd with contributions by Fr Jerome Bertram and Julian Munby*

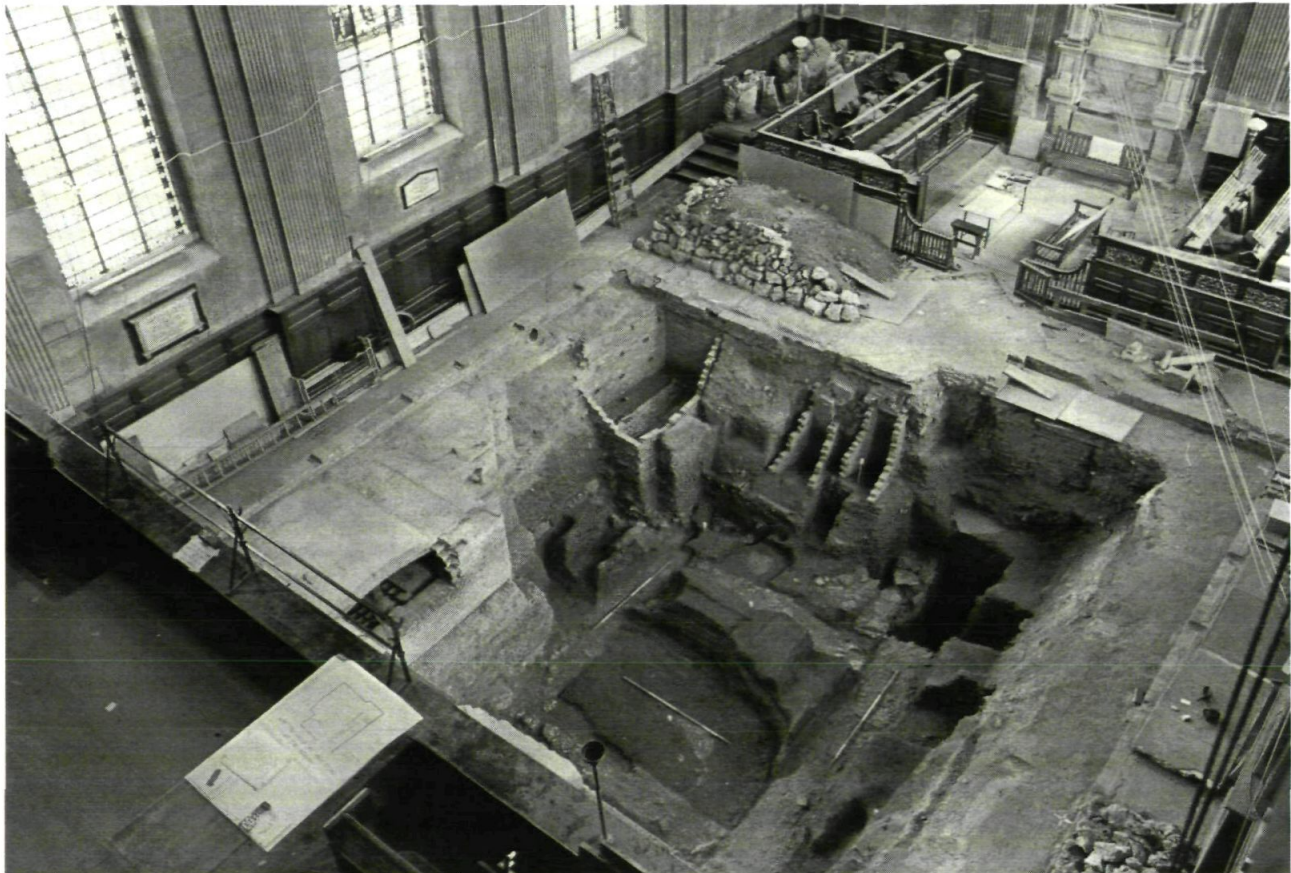
Plate 5.1 All Saints Church, general view of excavation, from the SW.

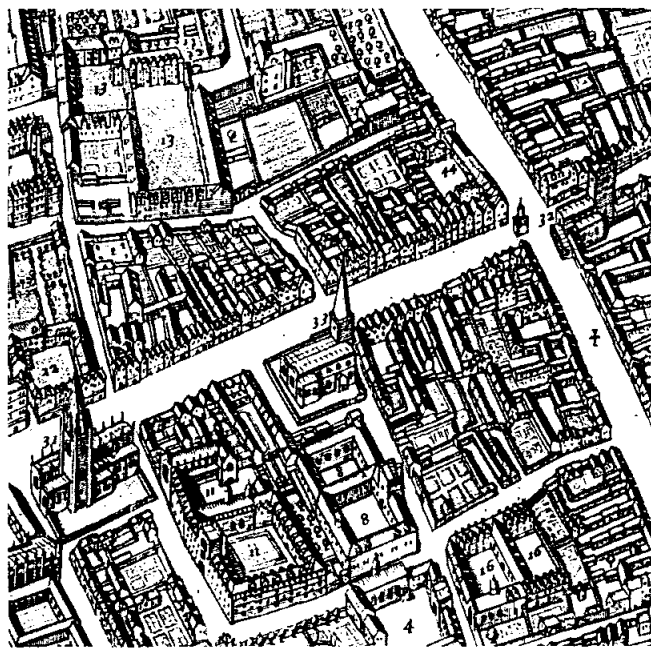
Figure 5.4 Loggan's bird's-eye view of Oxford, 1675 (detail), showing All Saints Church (No. 33) and St Martin's Church at Carfax (No. 32) looking south.

Although not shown on Salter's *Map* (Fig. 5.5), there was a road round the back of All Saints cemetery serving a series of tenements facing the churchyard, of which the eastern arm still survives. In the 16th century it was known as 'Rotten Row' (Green 1979, 39n), and it is clearly shown on Loggan's map of 1675 (Fig. 5.4). Many of the properties facing

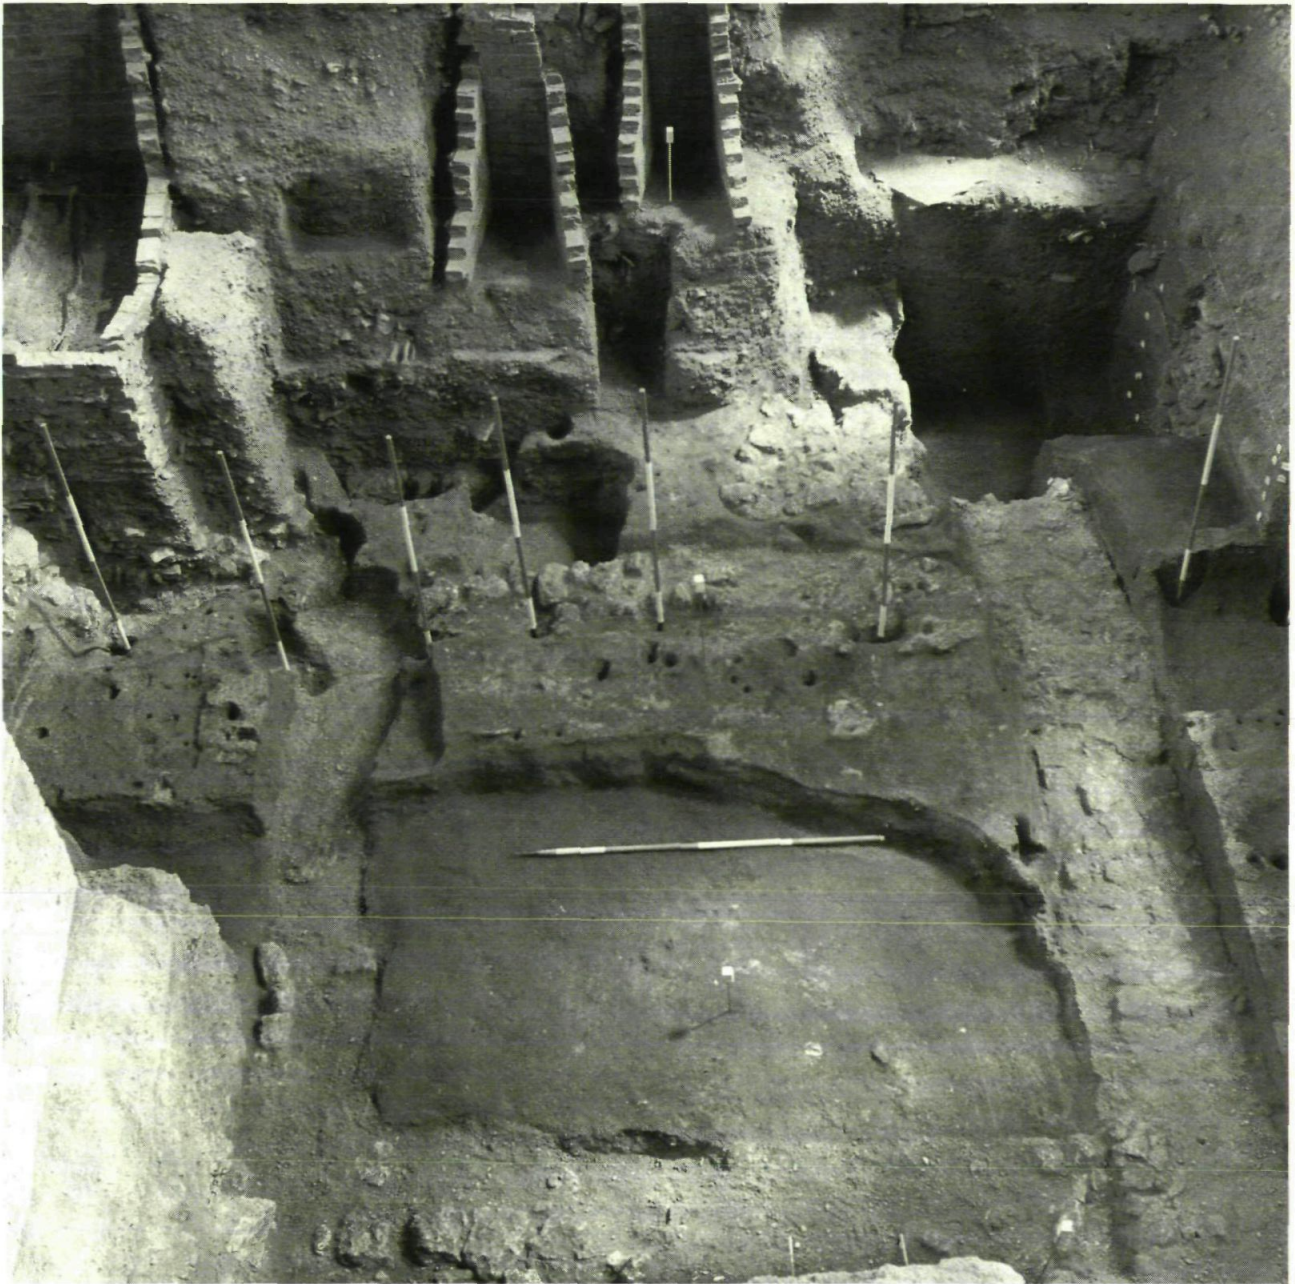
*Plate 5.2 All Saints Church, view of Phase 2a buildings, with the posthole alignment marked by the ranging rods, and the unexcavated cellar pit in the foreground; from the W.*

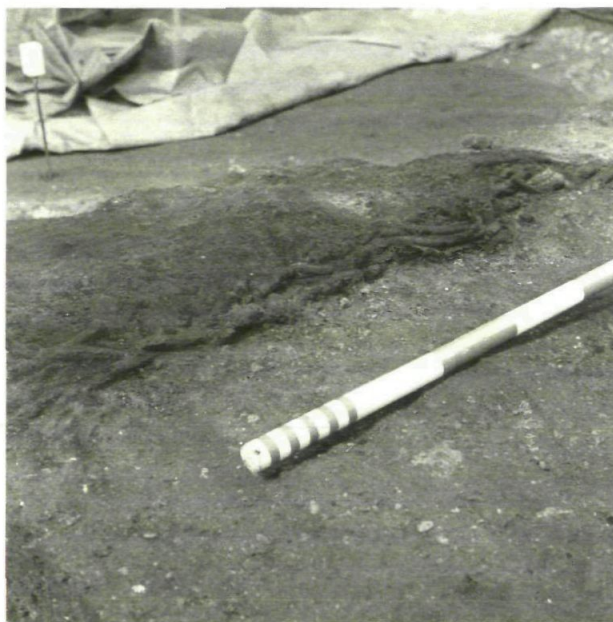
Plate 5.3 All Saints Church, the best-preserved section of charred fence AS118.

The best-preserved stretch was AS118, which was of woven wattles (Plate 5.3). The upright posts were relatively substantial pieces of oak (see Robinson, Chapter 7), and the wattles were mostly hazel rods. A rather heavier timber, AS124, was associated with the

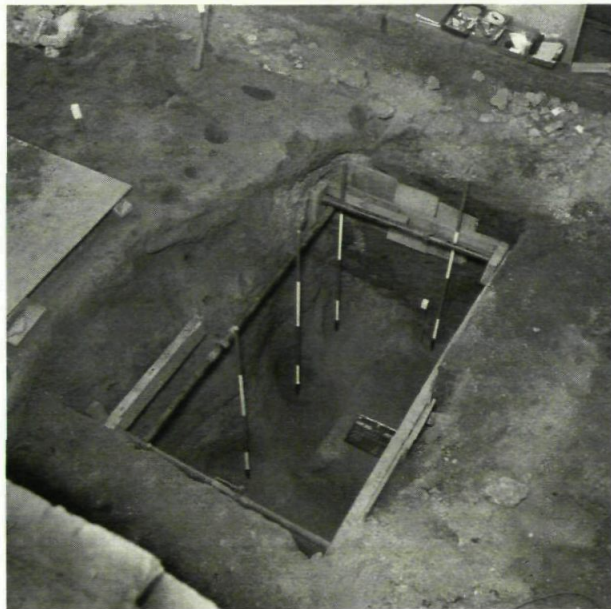
Plate 5.4 All Saints Church, the Phase 3 cellar pit under excavation, with the post settings marked by the ranging rods, from the N.

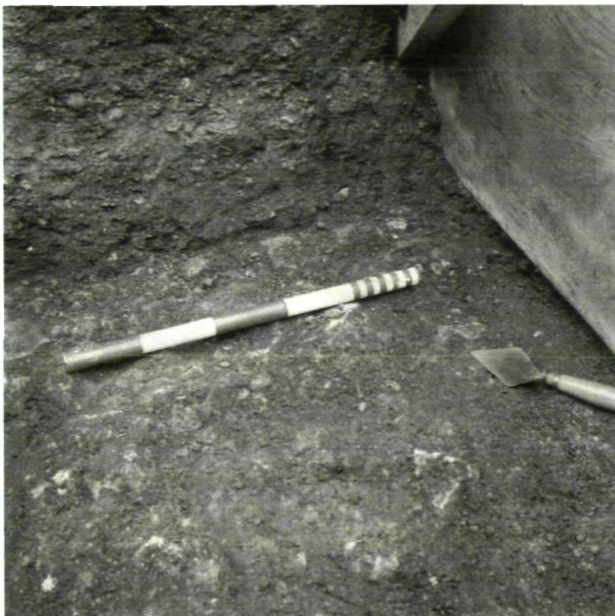
Plate 5.8 24 New Inn Hall St, primary street surface observed in contractors' trench with a coin of Edward the Elder (SF 24N.501) pressed into its surface.
