Pembroke College, Oxford: LV Distribution Upgrade Archaeological Watching Brief Report

March 2020

Watching Brief Report **Document Type:**

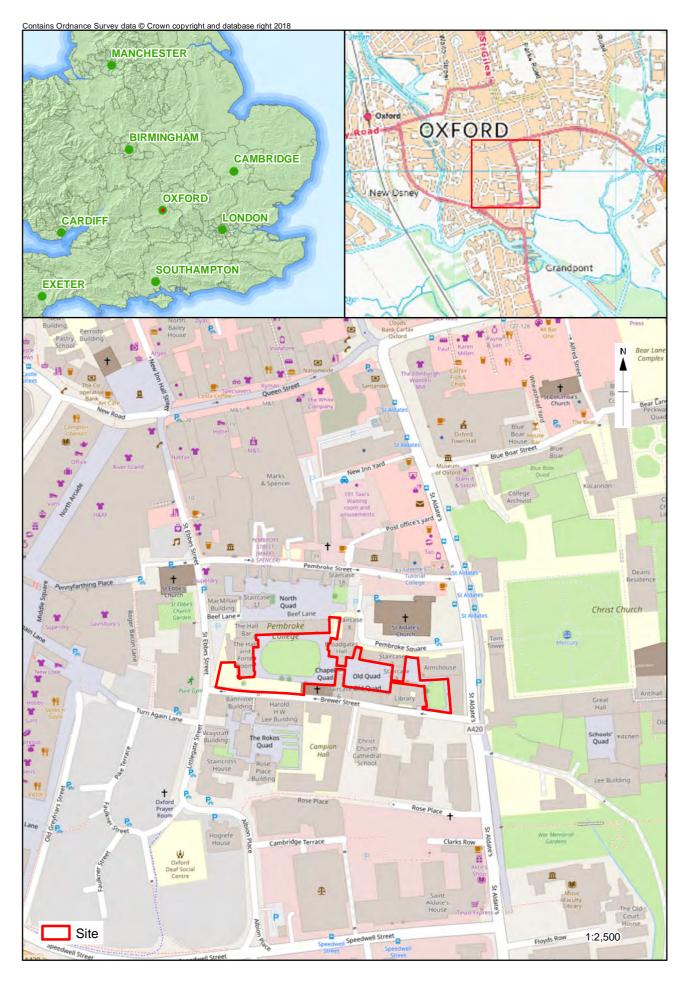
Figure 1: Site location

Figure 2: Location of proposed service trenches in the Library Courtyard and Old Quad

Figure 3: Location of proposed service trenches in the Chapel Quad

- 2.2.2 The scheme required hand excavation along the route of the new submain cabling and directly outside and inside the staircases in order to provide a route for the ducts through the stone walls (Figs 2 and 3). The service trenches were excavated across the centre of the Library Courtyard around the western, northern and southern sides of the Old Quad and around the northern, southern and eastern sides of Chapel Quad.

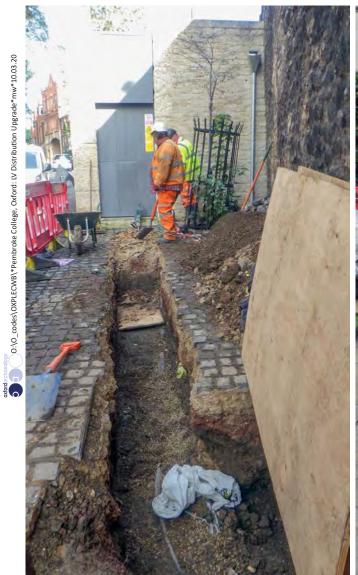
Plate 1: The trench in St Ebbes Road, looking Plate 2: The trench in the north side of the Chapel north. Quad, looking east

- 3.2.1 Hand excavation of the service trenches was undertaken cutting into the backfill of previous service trenches to a depth of *c* 0.5m below ground level. They were mainly opened underneath the paved quad paths (Plates 1-3). The general soil sequence underlying the paving stones comprised a *c* 0.25m thick layer of bedding sand, followed by a garden soil consisting of dark greyish brown sandy clay with inclusions of small stones, gravel and brick.

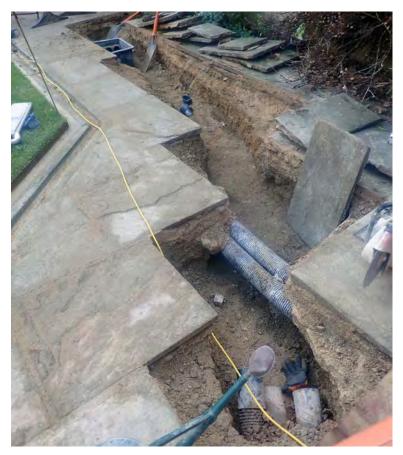
Plate 3: The trench in the south-west corner of Old Quad, looking south-east

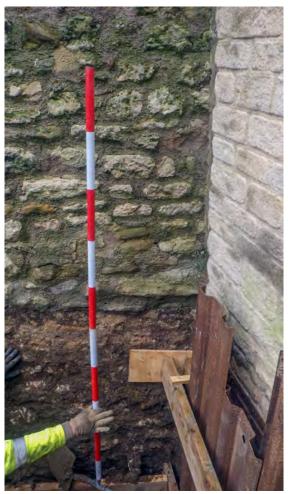
- 3.2.3 In the trench situated in Fellows Garden close to St Ebbes Street, the western perimeter wall of the College was exposed down to a depth of 2.7m below ground level (Plate 4). The trench was excavated through modern backfill and concrete structures supporting the perimeter wall were noted.

Plate 4: The College perimeter wall, looking east

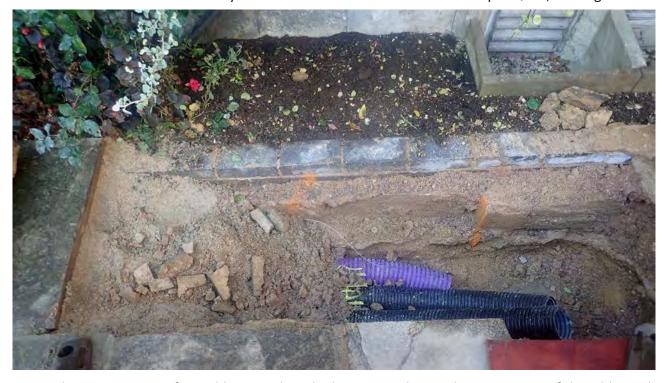
- 3.2.5 Large worked sandstones laid in pinkish red lime were recorded in the north-western part of the Old Quad (Plate 6). The stones appeared to have been reused as part of the underground foundation for a modern flower bed.

Plate 6: A course of possible reused worked stones in the north-west corner of the Old Quad, looking north
