Maids Moreton School, Buckinghamshire Archaeological Evaluation Report

OA Reference No: MAMS20

Maids Moreton School, Buckinghamshire

Archaeological Evaluation Report

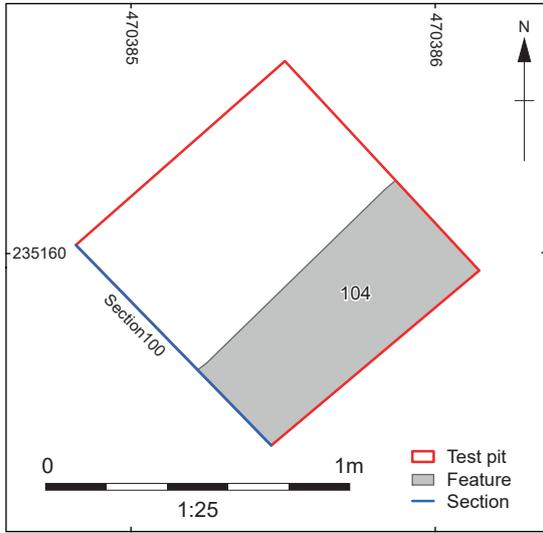
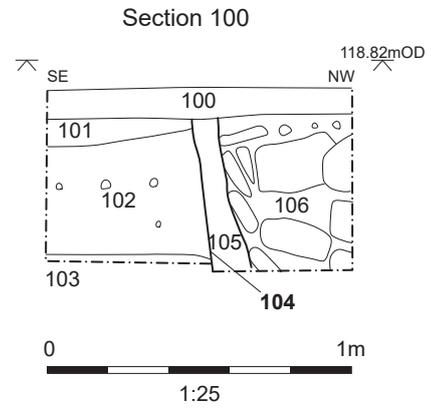
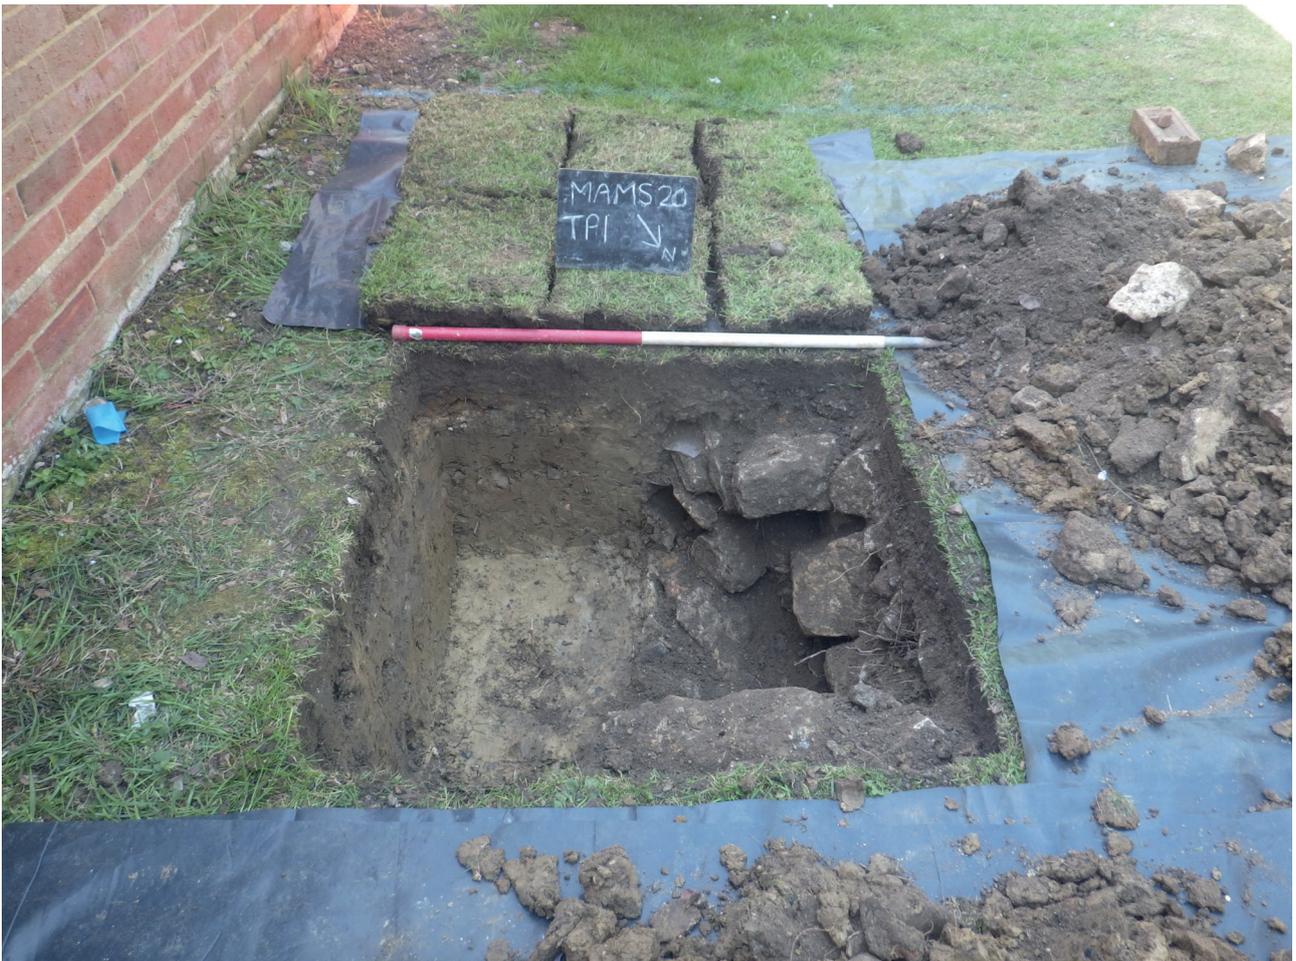
Figure 3: Test-pit 1

3.4.1 A single feature was recorded in Test-pit 1. The feature, 104, was only partially exposed within the test-pit and its true shape in plan is thus unknown but appears to be either linear or rectangular. The feature, which was aligned NE-SE, continued beyond all sides of the test-pit with the exception of the north-west. The feature measured over 0.56m in width and 0.6m in depth, and the one recorded side was near vertical.

3.4.2 The feature contained two fills, 105 and 106. The earlier fill, 105, was formed of redeposited natural clay. Given the near vertical interface between the two fills, fill 105 had either been applied to the edge of the feature to form a lining or, the later fill, 106, is the backfill of a later truncation. The later fill comprised predominately roughly hewn limestone blocks, slate and bricks in a loose dark grey silt. The bricks have been dated to the first half of the 20th century.

Test-pit 1, view to south-west

3.4.3 As well as truncating both the subsoil and the natural geology, the feature cut through a thin layer of made ground observed between the topsoil and the subsoil. The date of this deposit is unknown but it is thought to be associated with the construction of the school and suggests that even if fill 106 is indicative of a later truncation, the origin of the original feature and fill 105 also dates to the 20th century.

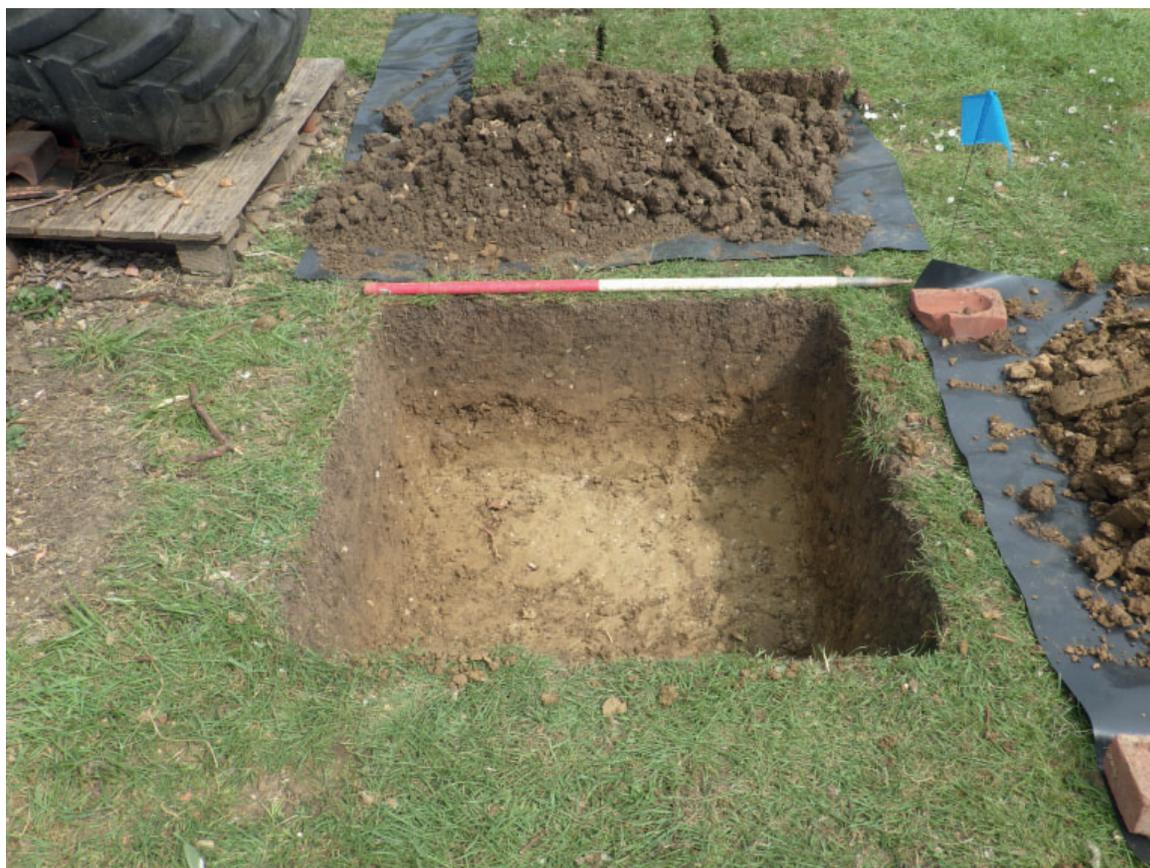
Plate 1: Test-pit 9, view to north-east

3.2.1 The soil sequence in the test-pits was fairly uniform across the site. The natural geology of clay with limestone inclusions was overlain by a silty clay subsoil, which in turn was overlain by topsoil. There was a change in the relative depths of subsoil and topsoil layers between the test-pits at the front and the back of the school, with those at the front having a much shallower topsoil (Plates 1-2 and Fig. 3).

3.2.2 At the back of the school, within Test-pits 5, 6, 9 and 12 there were areas of disturbed natural due to rooting activity from nearby trees.
