New Treatment Plant Bulstrode Park Gerrards Cross Buckinghamshire

Archaeological Watching Brief Report

April 2009

ARCHAEOLOGICAL WATCHING BRIEF REPORT

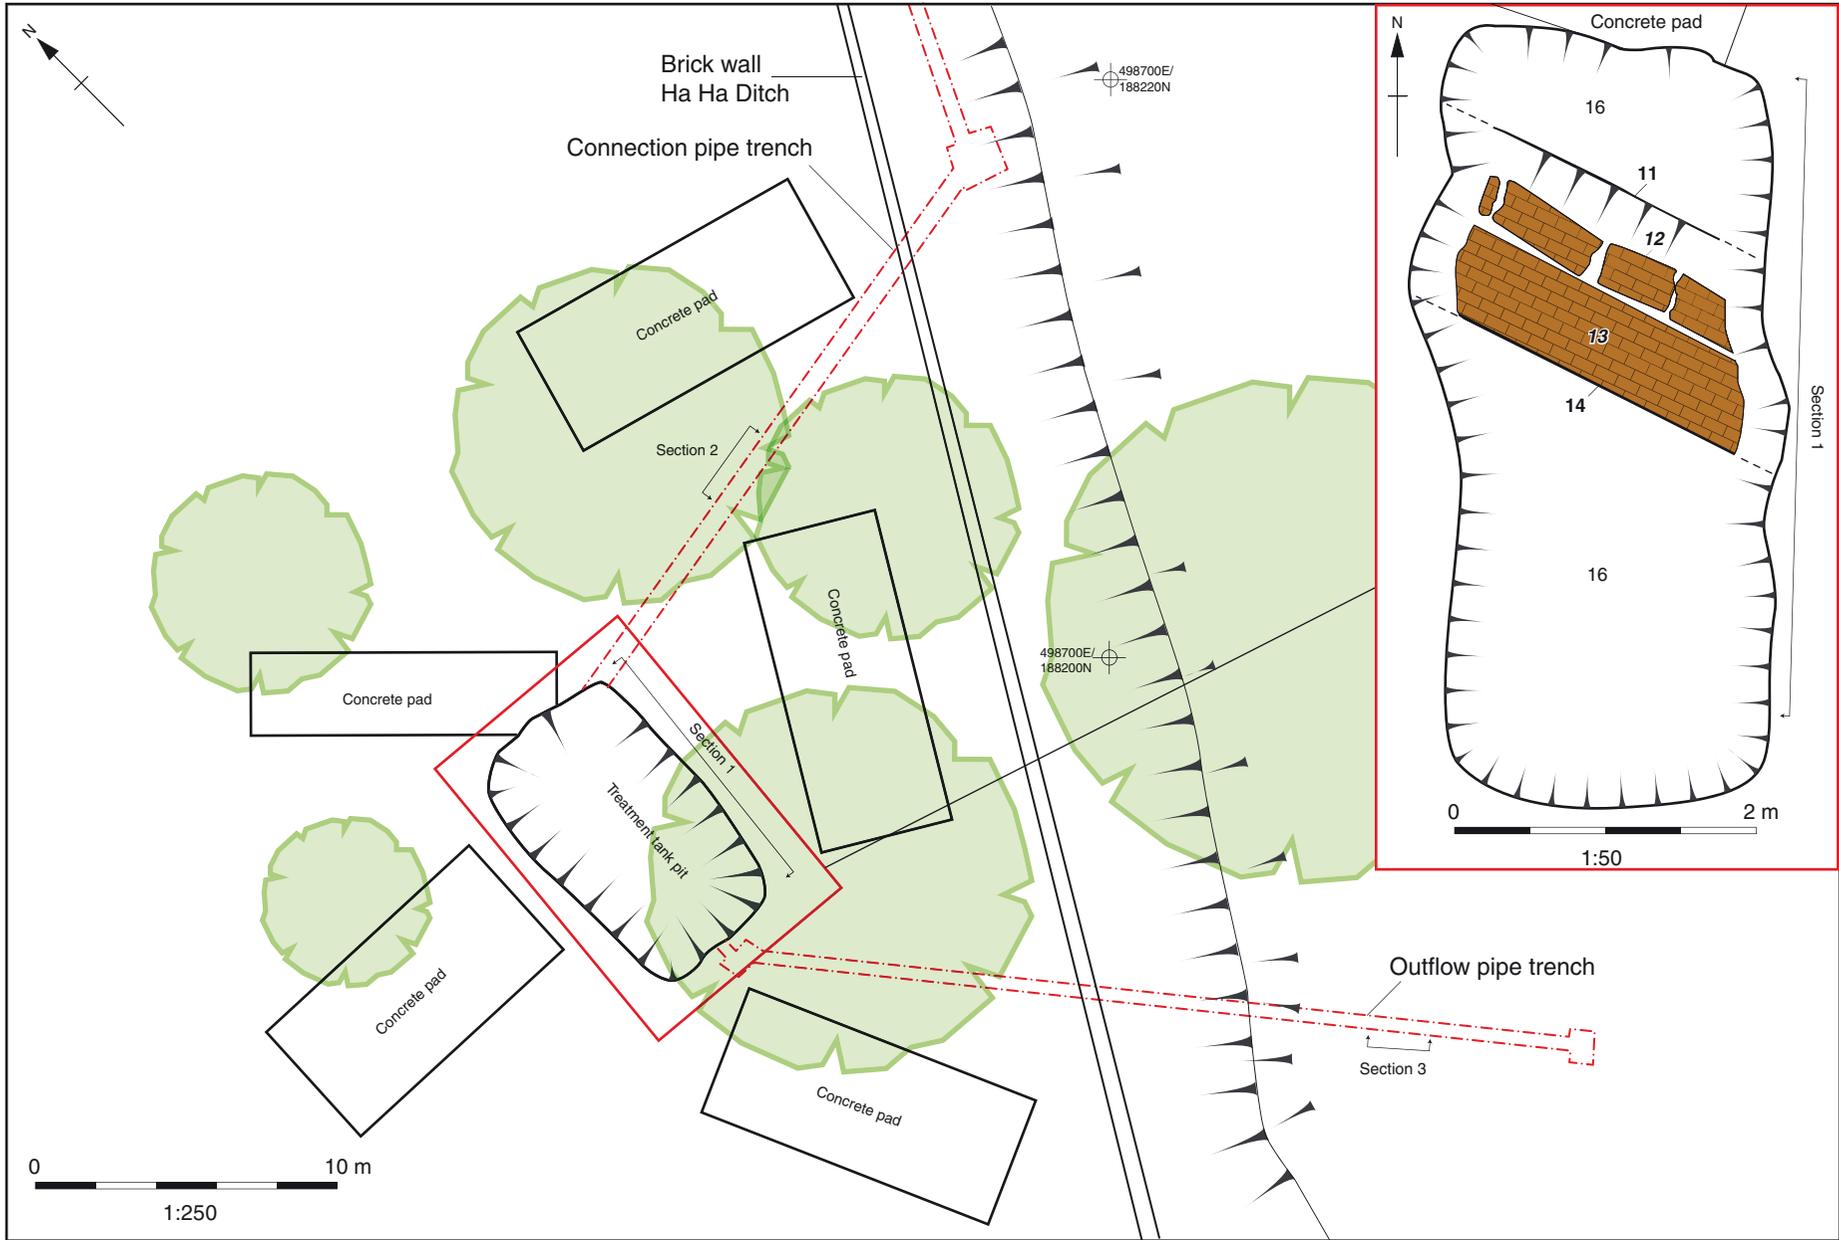
Figure 2: Site plan

- 3.1.1 This was situated on the eastern edge of the garden, on a gentle south-facing slope (Fig. 2). It was initially intended to measure 8.5 m long, 3 m wide and up to 4 m in depth. Due to the instability of the geology it was necessary to batter the sides leaving the footprint at the top of the excavation measuring approximately 10.5 m long by 6 m wide.

- 3.1.9 These works consisted of a 25 m length of trenching passing under the “ha-ha” wall and connecting to an existing access chamber. The excavations were up to 1.4 m in depth and 0.5 m wide (Fig. 2).

3.1.11 These works comprised a total of 25 m of trenching consisting of a 14 m length of trenching from the outflow of the treatment tank to the east side of the “ha-ha” and 11 m length of trenching across pasture to a second existing access chamber (Fig. 2).

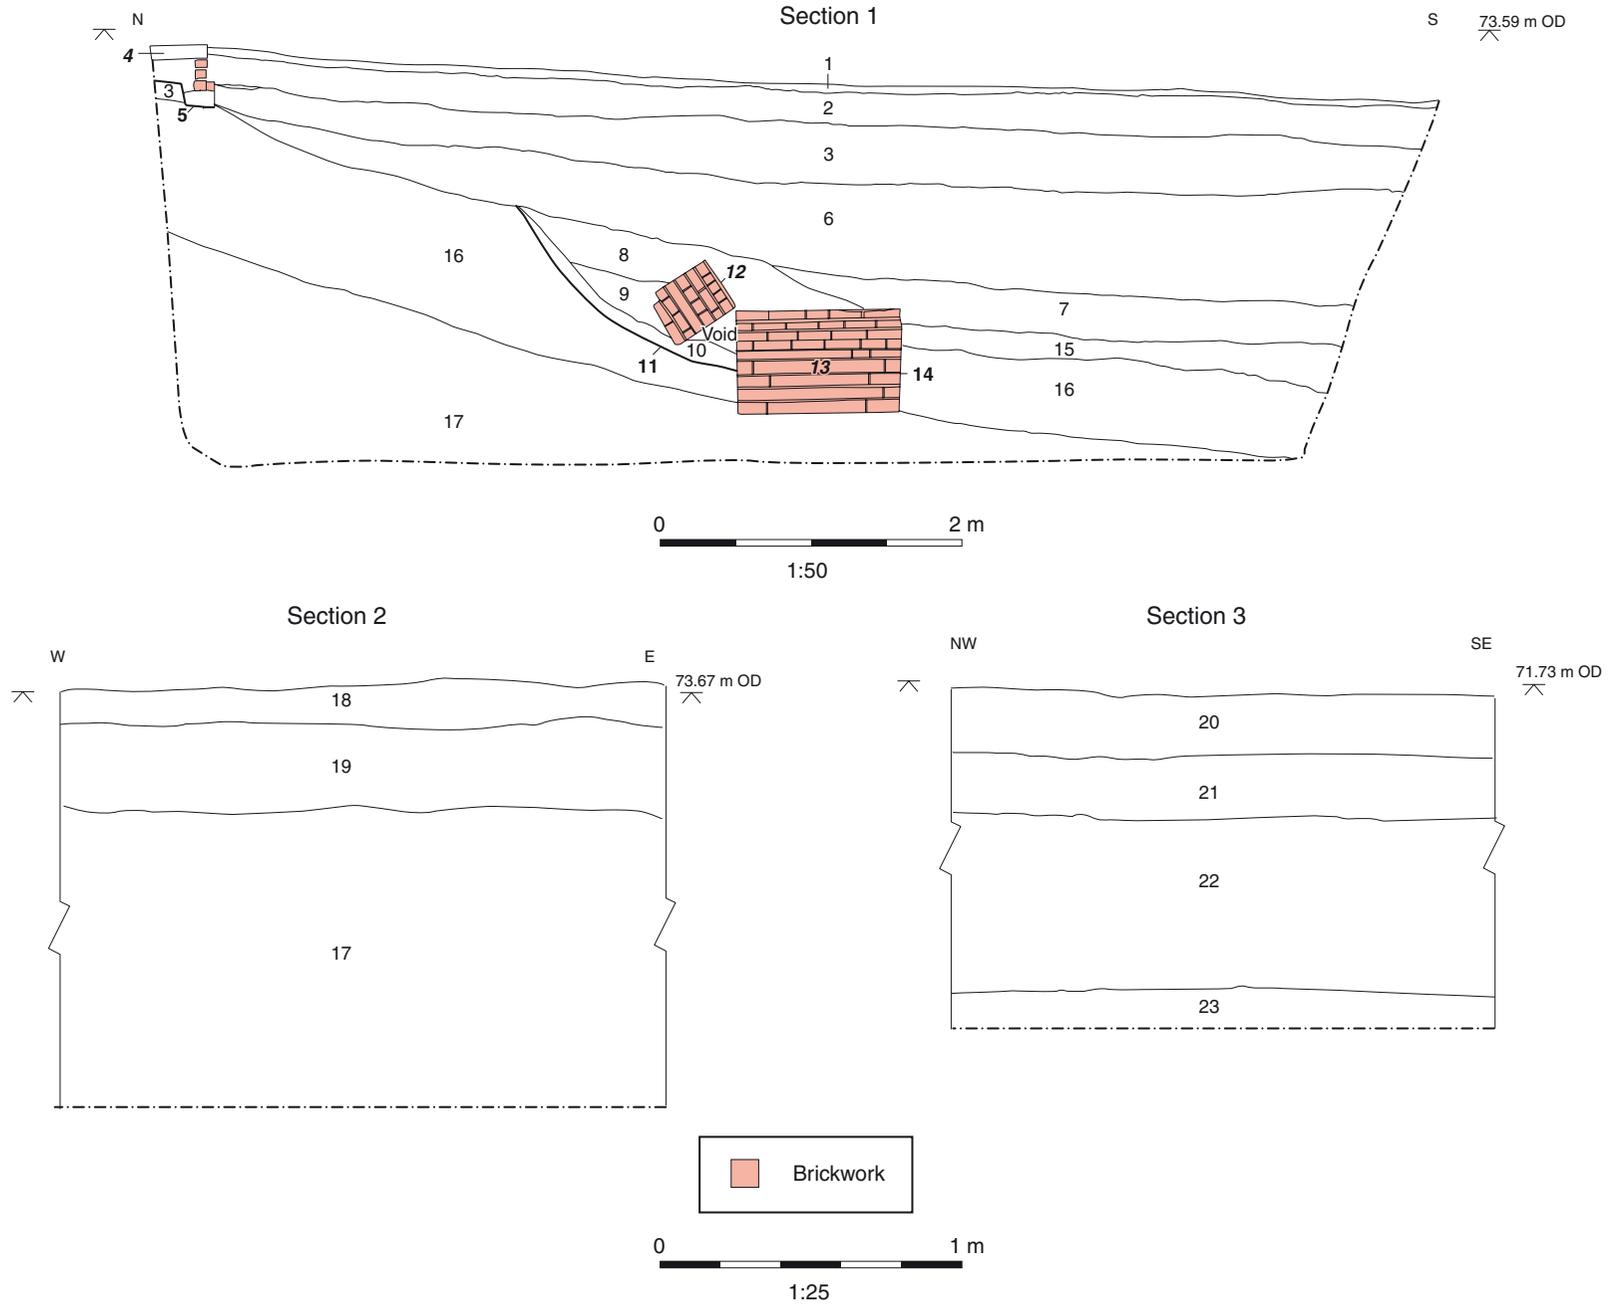
Figure 3: Section 1-3

- 3.1.2 A layer of natural orange-red sand (17) was encountered at a depth of between 1.2 m and 1.9 m below the current level of the lawns (Fig. 3, Section 1). This deposit sloped noticeably down to the south, much more steeply than the current gardens. Overlying this was a layer of red-brown clay silt (16) up to 0.9 m in depth. Within the southern half of the pit this was overlaid by a 0.15 m deep layer of grey-brown clay silt loam (15), which probably represents a buried topsoil horizon.

- 3.1.3 Cutting layer 15 was a 1.1 m wide by 0.6 m deep vertically sided, flat bottomed trench (14). This was aligned south-east to north-west, running roughly parallel to the

southern terrace of the main house. Built within this trench was a solid brick foundation (13), 1.1 m wide by 0.75 m high. This was constructed using hand moulded red bricks measuring 0.222 m x 0.103 m x 0.062 m.

- 3.1.4 Cutting layer 16 on the north side of this wall was a 1.5 m wide by 1 m deep ditch (11), running parallel to the wall. The base of this ditch was filled by a 0.15 m deep layer of dark red-brown silt clay (10), a probable silting deposit. Resting on top of this deposit and leaning against wall 13 was the remnants of a demolished wall (12). This measured 0.6 m in width, approximately 0.5 m high and was visible running the full width of the pit. It was constructed of identical components to wall 13 and it is probable that both walls 12 and 13 were part of the same structure. It would appear that after wall 12 was reduced in height it was pushed over into ditch 11.

- 3.1.5 Ditch 11 had then been partially backfilled with a 0.4 m deep layer of red-brown clay silt (9), leaving voids between walls 12 and 13. Filling the remainder of the ditch and running over the top of wall 13 was a 0.35 m deep layer of light yellow-brown clay silt (8). This contained numerous fragments of brick and much mortar flecking suggesting that it was composed of demolition debris and imported material.

- 3.1.6 Overlying this backfill, wall 13 and the original ground level 15 was a 0.3 m deep layer of red-brown clay silt (7), a landscaping layer of made ground. This was sealed by a layer of reddish orange-brown silt clay (6) measuring up to 0.8 m in depth, the depth increasing towards the south. This deposit contained numerous angular fragments of brick indicating that this was a layer of made ground. Overlying this was a 0.35 m deep layer of grey-brown clay silt (3). This contained similar fragments of brick as layer 6. Its composition suggests it was the final landscaping layer forming the topsoil of the landscaped gardens.

- 3.1.7 At the northern edge of the pit this layer had been cut by a 0.2 m deep construction cut (5). This was filled by a concrete and brick foundation supporting a concrete platform (4) measuring 12 m long and 5 m wide. This is associated with the military occupation of the park during WWII and probably forms the base for a “Nissan” hut or similar structure.

- 3.1.8 Overlying layer 3 and butting up to structure 4 was a 0.25 m deep layer of dark grey-brown silt loam (2). This deposit produced a quantity of modern (20th-century) building debris including plastic sheeting and paint cans. This was sealed by a thin skim of grey-brown clay loam (1), less than 0.1 m in depth representing a modern landscaping deposit.

3.1.10 A continuation of the underlying natural sand (17) was encountered at a depth of 0.4 m below the current ground level (Fig. 3, Section 2). This was overlaid by a 0.3 m deep layer of light grey-brown clay silt (19). This may be a buried soil horizon representing the original ground level. Overlying this was a 0.12 m deep layer of dark grey-brown clay silt loam (18), the present day topsoil and turf.

3.1.12 At the base of the trench a layer of grey-brown clay silt (23) was encountered (Fig. 3, Section 3). This deposit contained fragments of hand moulded bricks measuring 0.23 m x 0.105 m x 0.06 m suggesting that it represents a layer of made ground. This was overlaid by a layer of red-brown silt clay (22) measuring between 0.6 m and 1 m in depth. This layer produced many sub-angular brick fragments again suggesting a layer of made ground and is a possible continuation of deposit (6).

3.1.13 This was sealed by a 0.2 m deep layer of light grey-brown silt clay subsoil (21) similar to layer 19, which was overlaid by a 0.2 m deep layer of dark grey-brown clay loam (20), the present day topsoil and turf, similar to layer 18.

3.1.14 In the area immediately east of the “ha-ha” ditch this was overlaid by a lens of mixed red-brown silt clay and grey-brown clay loam (24), 3.6 m wide and up to 0.35 m in depth forming a rough bank following the length of the ditch. This represents material either excavated from the “Ha-Ha” ditch during its construction or material from its periodic cleaning.

- 4.1.1 Evidence for a major early landscaping feature in the form of an east-west running wall (structures 12 and 13) was encountered during the excavation of the pit for the installation of the treatment tank. The bricks used in its construction date to the early to mid 18th-century, which would fall within the period of landscaping of the gardens conducted by Henry Wise and Claude Desgots for the first Earl of Portland during the 1730s.

- 4.1.2 This wall consisted of a large foundation plinth (13) surmounted by a brick wall (12) that appears to run parallel to the front of the house. Ditch 11 is associated with this wall and possibly forms a “ha-ha” running cross the base of the gardens, although its orientation is the reverse of what would be normally expected (ie the ha-ha wall faces away from the house so as to be invisible). It is also possible that the wall actually represents a boundary wall demarking the limits of the garden landscaping during this period. A study of the Bowles engraving of the 1730s (Fig. 4) suggests that this structure may form part of the high wall and tower visible in the left-hand corner of the engraving. The location, alignment and size of the wall would support this hypothesis. The presence of the buried topsoil horizon, 15, indicates the original ground level in this area before the landscaping, while the absence of any made ground associated with this phase of landscaping banked up against the wall also suggests that the wall was in fact a boundary or ornamental wall rather than a terrace wall, again supporting the hypothesis that it is the wall shown in the Bowles engraving.

- 4.1.3 The wall appears to have been deliberately demolished as part of a later phase of landscaping. Wall 12 appears to have been reduced in height and the remainder toppled over into ditch 11. The ditch was partially backfilled by deposit 9 while successive layers of made ground 6, 7 and 8 were tipped over the demolished wall forming a smooth gradient running down to the base of the slope. The presence of large quantities of fragmented brick and mortar within layer 8 suggests it was related to the demolition of wall 12. Layer 6 contained a large amount of fragmented brick, but these were of a harder material and slightly larger than those used in constructing walls 12 and 13 suggesting a 19th-century date. This phase of landscaping is probably associated with that conducted by the Duke of Somerset’s son c1860. The house was also enlarged during this period and layer 6 probably represents material excavated from the foundations/and or cellars from this work together with construction debris in the form of brick fragments. By the time of the publication of the 1st edition of the Ordnance Survey map in 1875, the area is shown as open parkland with no structures visible, confirming that walls 12 and 13 had been demolished and buried by that time.

- 4.1.6 The excavations for the trench connecting to the existing sewer north of the tank showed that this area had not been subject to the same degree of landscaping with the presence of the subsoil (19) directly overlying the natural sand 17 suggesting that this area had been relatively undisturbed.

- 4.1.7 The excavations for the trench from the outflow of the treatment tank back to the existing sewer passed across land that had been heavily landscaped during the 1860s. West of the “ha-ha” the stratigraphy encountered was similar to that recorded within section 1. East of the “ha-ha” both layers 22 and 23 represent layers of made ground. The composition and the presence of 19th-century brick fragments within layer 22 suggests that it may be a continuation of layer 6.
