Dorset Visual Impact Provision

Archaeological Evaluation Report

October 2017

Client: National Grid

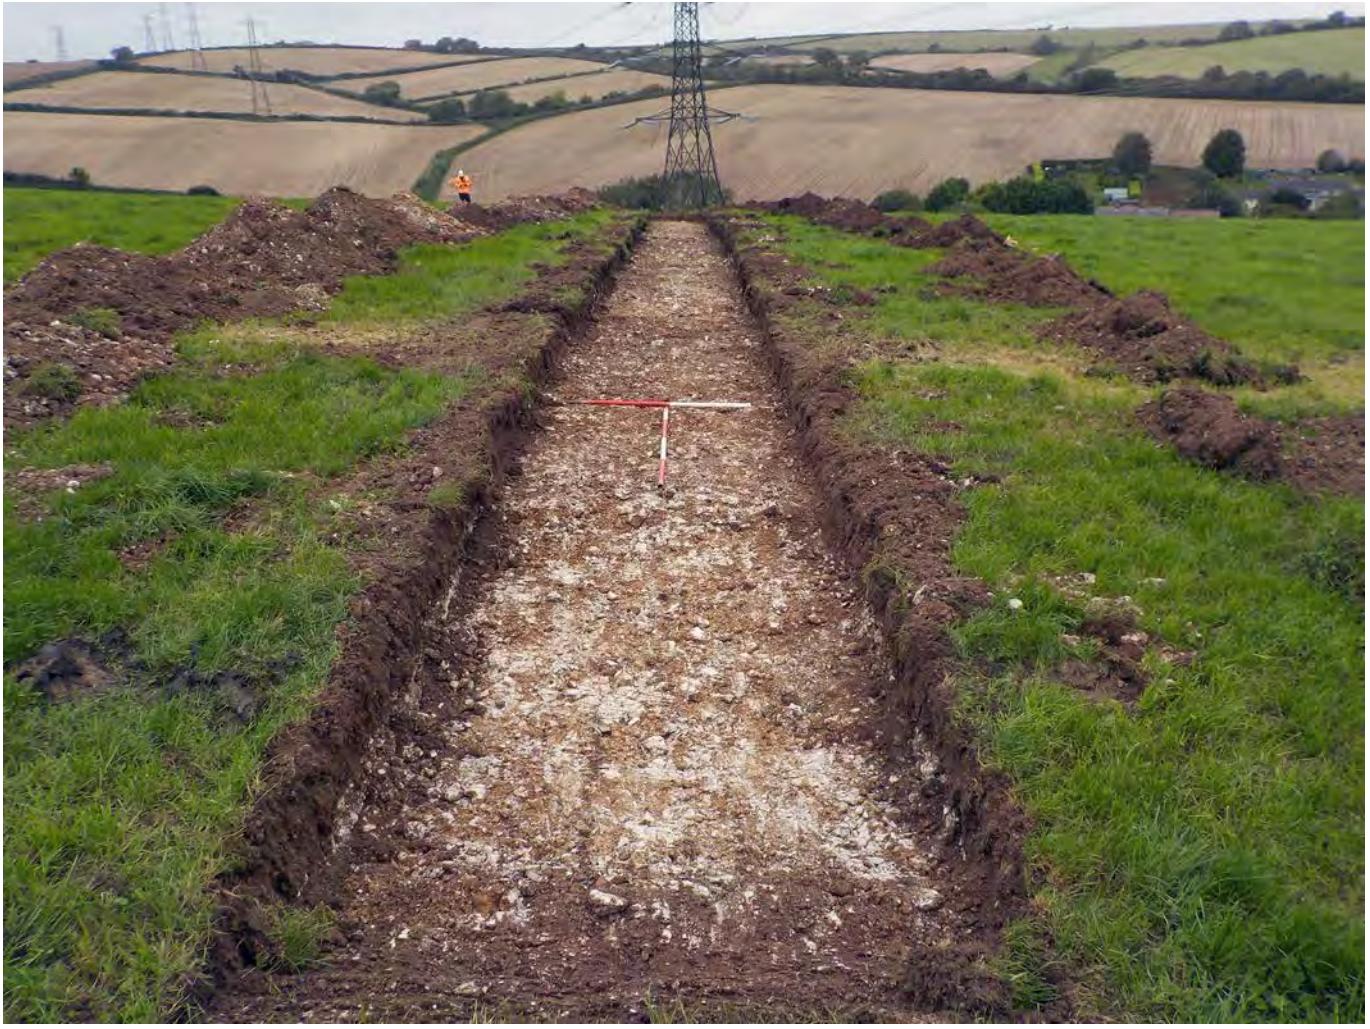
Plate 1: Trench 25 - view to N

Trench 25						
General description					Orientation	N-S
Trench devoid of archaeology. Consists of topsoil overlying natural geology of chalk.					Length (m)	50
					Width (m)	1.60
					Avg. depth (m)	0.30
Context No.	Type	Width (m)	Depth (m)	Description	Finds	Date
2500	Layer	-	0.30	Topsoil	-	-
2501	Layer	-	-	Natural, degraded chalk.	-	-

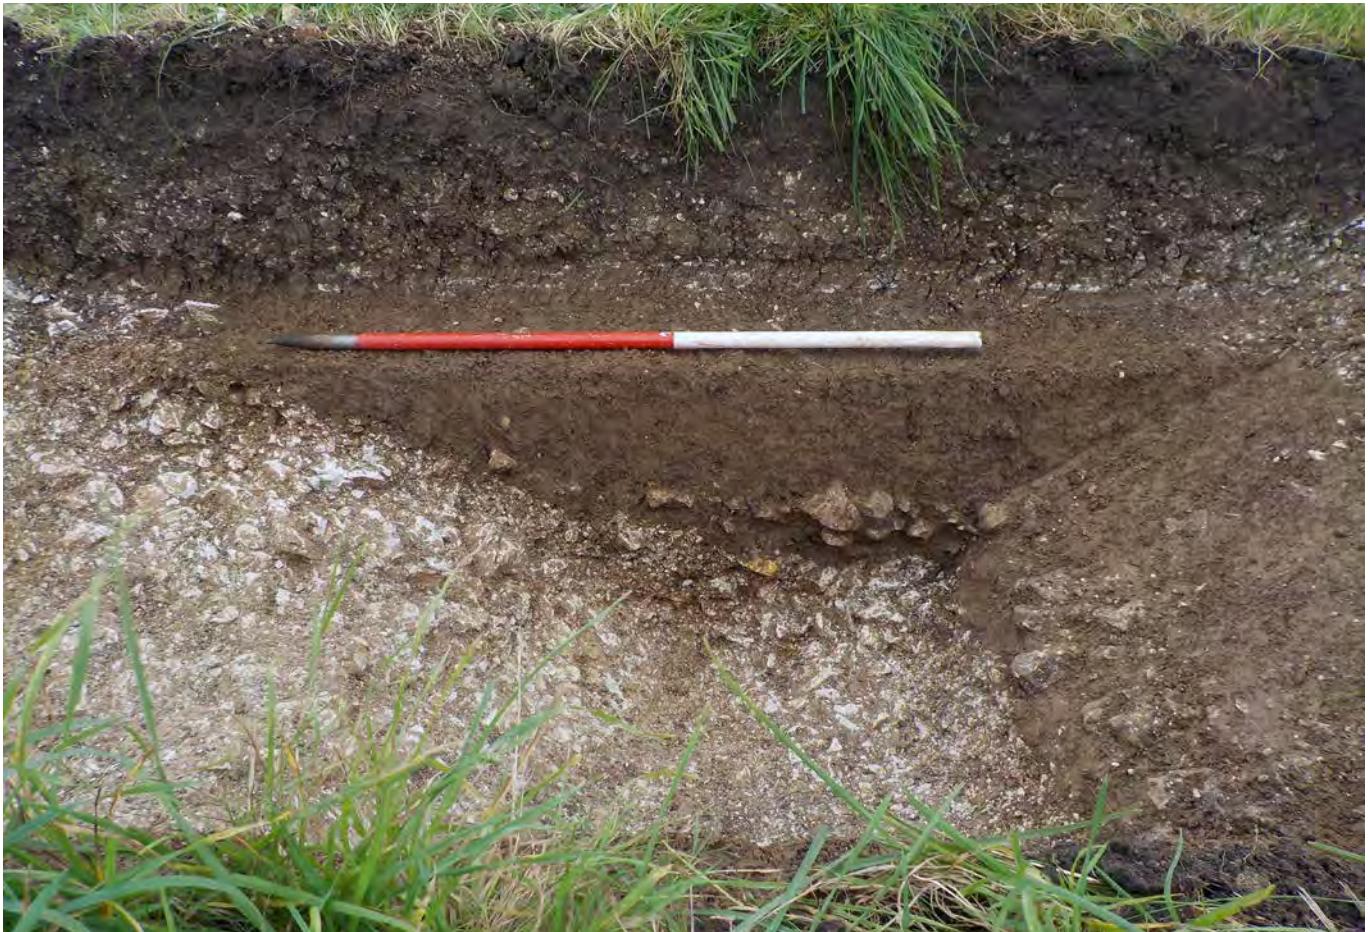
Plate 2: Trench 29 - ditch 2906, view to NW

Trench 29						
General description					Orientation	NE-SW
Trench contains seven ditches, the two largest probably form two sides of a barrow ring ditch c. 30m in diameter. Two small ditches suggest an internal smaller ring ditch. Another ditch was probably of post-medieval date. Consists of topsoil and subsoil overlying natural geology of degraded chalk.					Length (m)	50
					Width (m)	1.60
					Avg. depth (m)	0.40
Context No.	Type	Width (m)	Depth (m)	Description	Finds	Date
2900	Layer	-	0.40	Topsoil, dark grey brown, clayey silt.	-	-
2901	Layer	-	-	Natural, degraded chalk.	-	-
2902	Cut	0.96	0.17	Cut of small ditch. Shallow uneven sides, concave irregular base.	-	-
2903	Fill	-	0.17	Fill of 2902, dark grey, clayey silt, small chalk inclusions.	-	-
2904	Cut	0.84	0.14	Cut of small ditch. Even shallow sides, regular concave base.	-	-
2905	Fill	-	0.14	Fill of 2904, mid brown grey, clayey silt, small chalk inclusions.	-	-

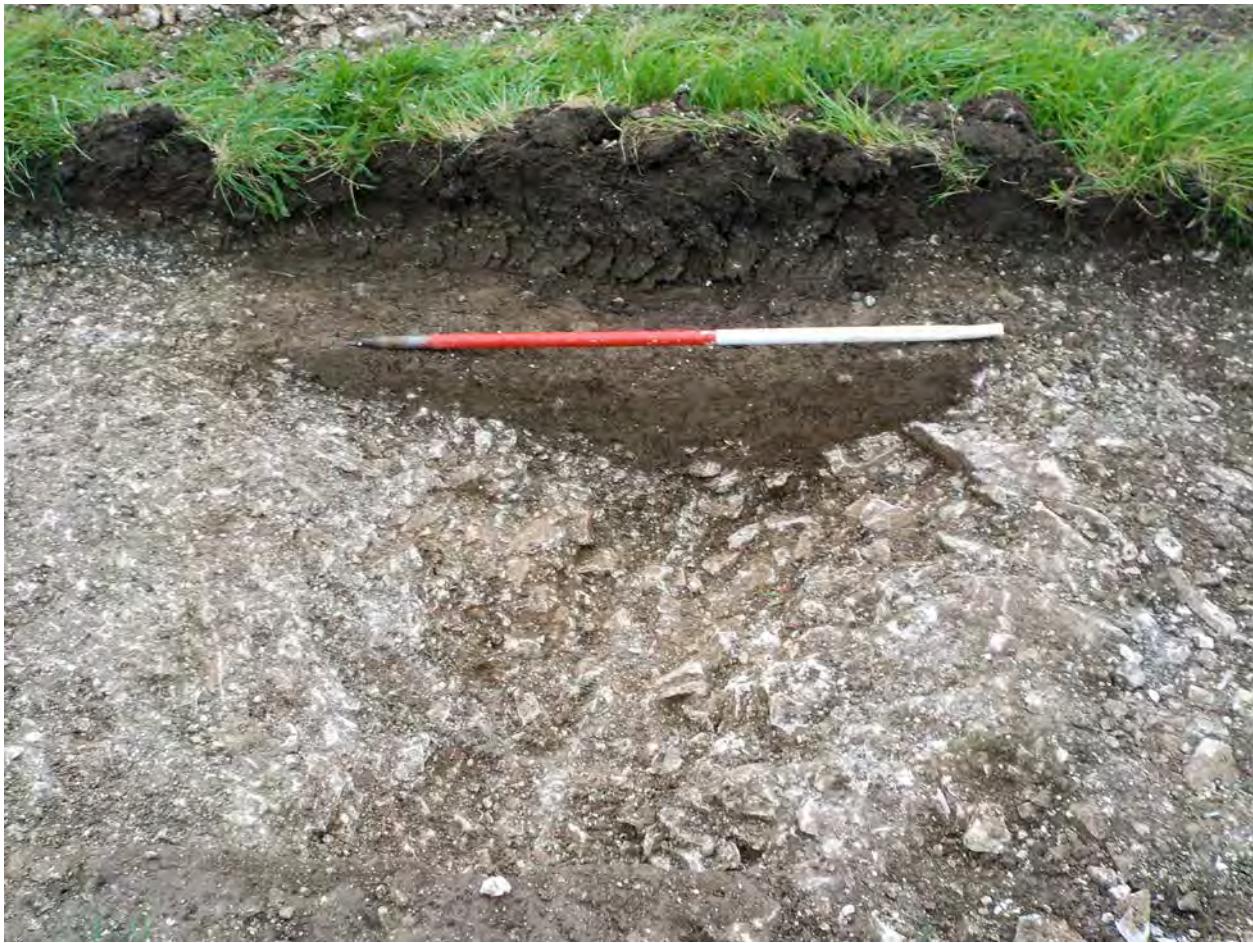
Plate 3: Trench 29 - ditch 2910, view to NE

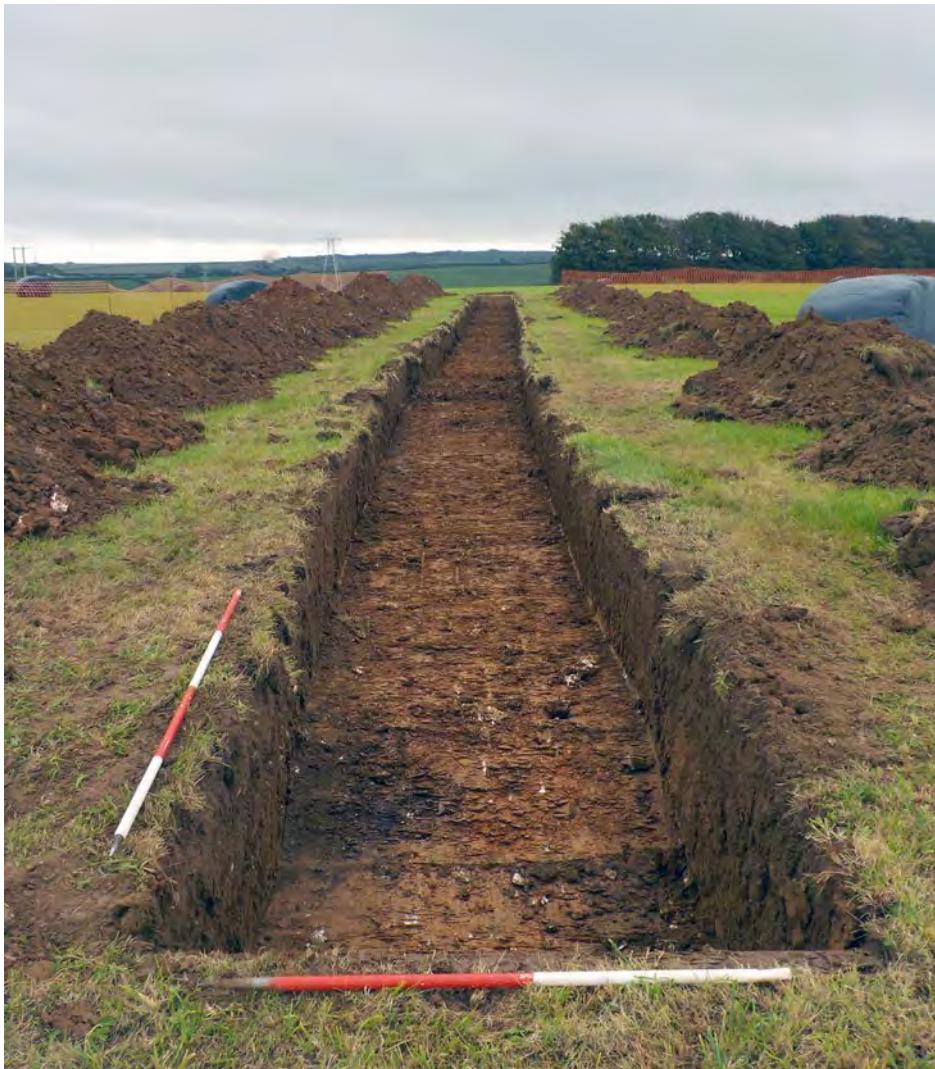
Plate 4: Trench 42 - view to S

3.7.1 In Trench 42 several probable archaeological features were cut into a plateau drift deposit and were not excavated due to health and safety constraints. Natural chalk had not been reached at a depth of 1m. The trench corresponds with an area of strong magnetic anomalies suggesting potential features or areas of burning identified by the geophysical survey (37).

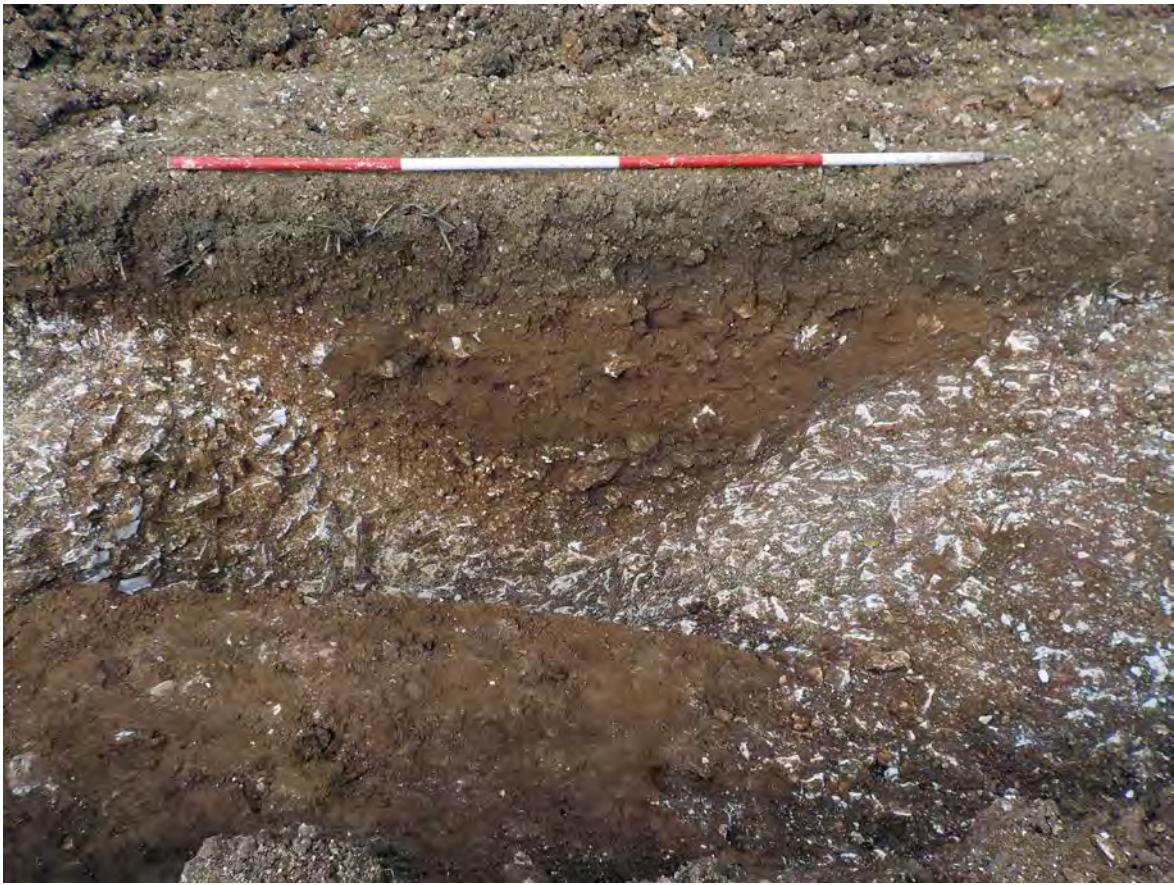
Plate 5: Trench 47 - ditch 4705, view to NW

B.2.5 Ditch 4705, fill 4706 also contained a significant assemblage with 41 pieces. This time the assemblage was more blade orientated with a high blade index of 33.33%. However, it is possible that much of this assemblage was redeposited as the flint is in worse condition than the material found in the ring ditch slots. The assemblage also lacked retouched forms and cores and can only be dated by thedebitage. The assemblage includes an odd mix with some very large irregular flakes as well as quite sturdy blade forms and it is likely to represent an accumulation of material from various ages including an early prehistoric element. While this assemblage may also originate from a scavenged barrow, it appears more likely that this feature was part of an enclosure and the large assemblage is probably a product of localised truncation of flint-rich deposits.

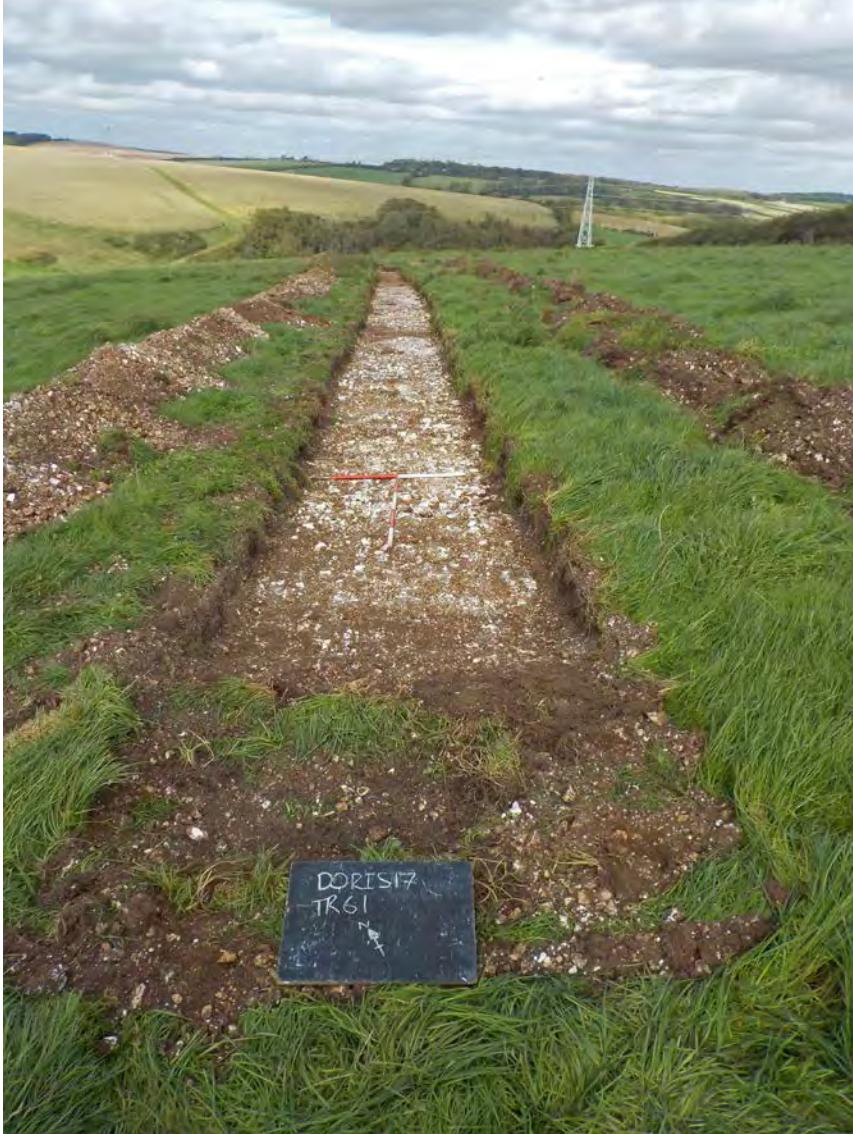
Plate 6: Trench 61 - view to NE

Trench 61						
General description					Orientation	NE-SW
Trench contained three ditches probably constituting part of a field system of unknown date. A pond was located in the corner of one of the possible fields. Two large postholes were located next to two of the ditches. A single smaller posthole was also found. Consists of topsoil and subsoil overlying natural geology of degraded chalk.					Length (m)	50
					Width (m)	1.6
					Avg. depth (m)	0.30
Context No.	Type	Width (m)	Depth (m)	Description	Finds	Date
6100	Layer	-	0.30	Topsoil, dark grey brown, silty clay.	-	-
6101	Layer	-	-	Natural, degraded chalk.	-	-
6102	Cut	0.30	0.60	Cut of posthole. Gently sloping upper part of sides, lower half very steep. Bottom not reached.	-	-
6103	Fill	-	0.60	Fill of 6103. Dark brown, silty clay, no inclusions.	-	-
6104	Cut	0.80	0.20	Cut of ditch. Sloping sides. Gently concave base.	-	-

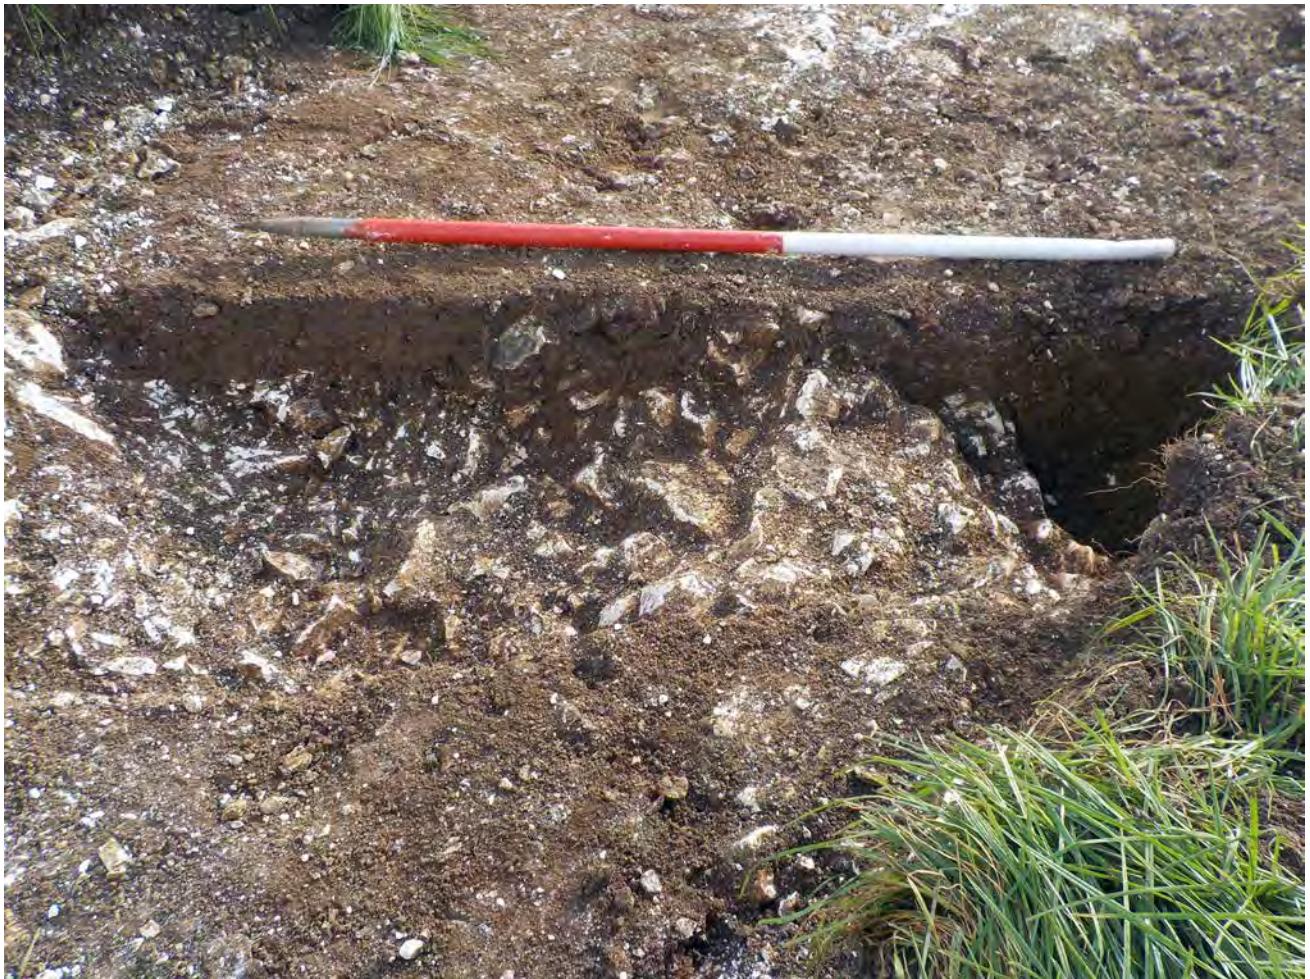
Plate 7: Trench 61 - ditch 6104 and pit 6106, view to S

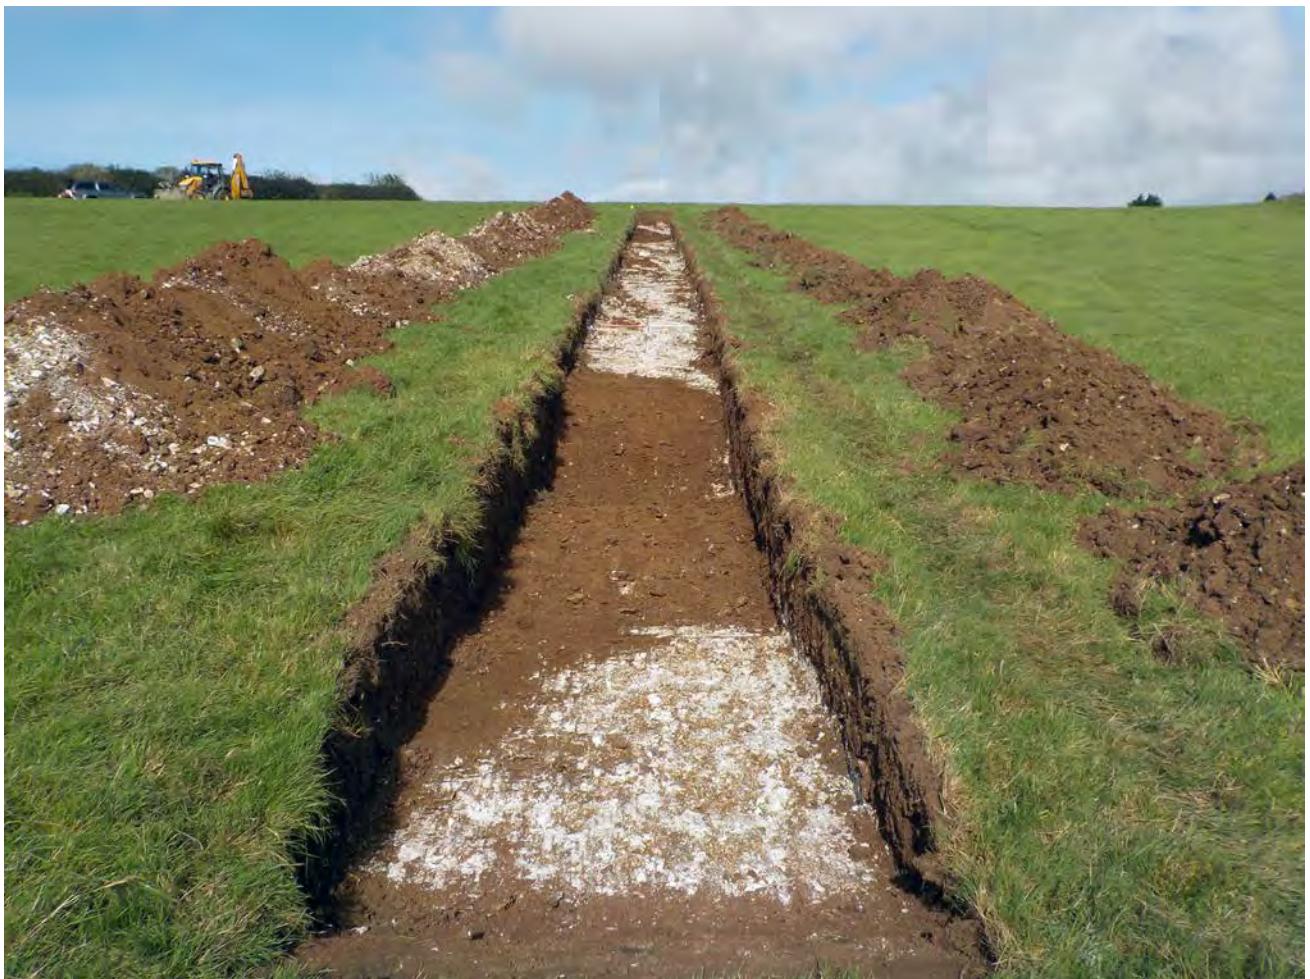
Plate 8: Trench 75 - view to NW

3.10.1 Trench 75 contained three large possible chalk extraction pits or sinkholes (7503, 7505, 7507) and correspond with one the area of large anomalies seen on the geophysics plan (65-72) estimated to be c. 6m in diameter. Those found in trench 75 were 5 – 6m in diameter and were not excavated but are likely to be deep.

Trench contains three large probably chalk extraction pits or sink holes. Consists of topsoil and subsoil overlying natural geology of degraded chalk.					Length (m)	50
					Width (m)	1.60
					Avg. depth (m)	0.50
Context No.	Type	Width (m)	Depth (m)	Description	Finds	Date
7500	Layer	-	0.30	Topsoil, mid grey brown, clayey silt, infrequent chalk inclusions.	-	-
7501	Layer	-	0.20	Subsoil, mid brown, clayey silt, infrequent chalk inclusions.	-	-
7502	Layer	-	-	Natural, degraded chalk.	-	-
7503	Cut	10.1	-	Cut of pit or sinkhole. Unexcavated.	-	-
7504	Fill	-	-	Fill of 7503. Mid brown, clayey silt, infrequent flint inclusions.	-	-
7505	Cut	5.04	-	Cut of pit or sinkhole. Unexcavated.	-	-
7506	Fill	-	-	Fill of 7505. Mid brownish yellow, clayey silt, infrequent flint inclusions.	-	-
7507	Cut	6.40	-	Cut of pit or sinkhole. Unexcavated.	-	-
7508	Fill	-	-	Fill of 7507. Mid brown, clayey silt, infrequent chalk and flint inclusions.	-	-

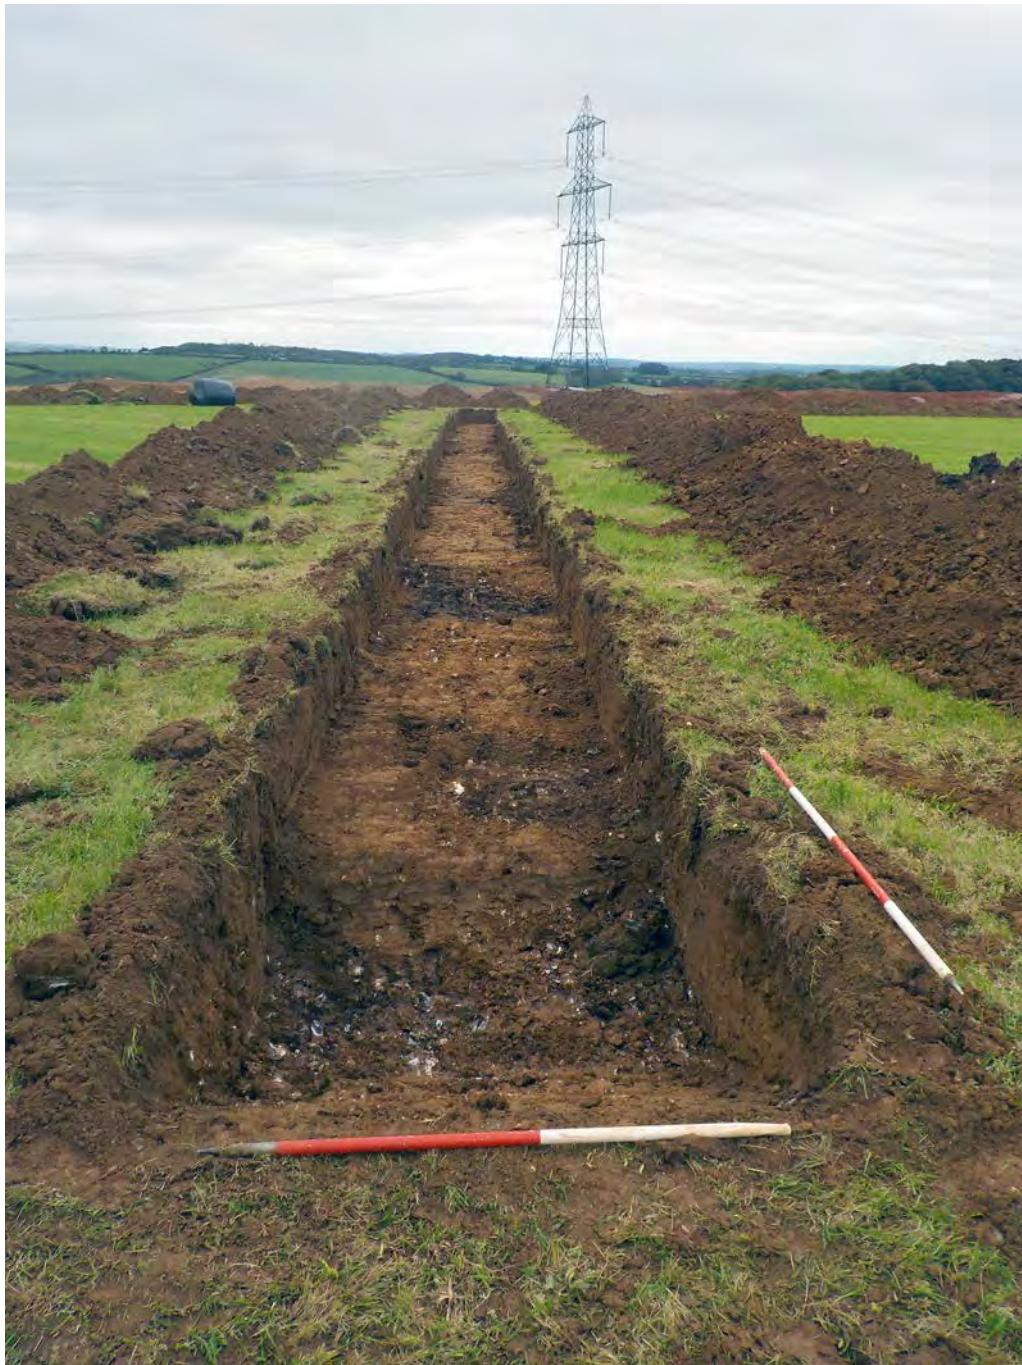
Plate 9: Trench 150 - view to NE

3.12.1 Features within Trench 150 truncated a plateau drift deposit, recorded approximately 0.65m below present ground level. A 1m deep sondage through the deposit did not expose natural chalk geology. Features within the trench were recorded but not excavated due to health and safety constraints (trench depth). The trench corresponds with an area of strong magnetic anomalies suggesting potential features or areas of burning identified by the geophysical survey (37).
