# Former Quaker Oats Factory Southall Ealing, Greater London Historic Building Investigation and Recording

June 2019

Client Name: Galliard Homes  
Document Title: Former Quaker Oats Factory, Southall  
Document Type: Historic Building Investigation and Recording  
Grid Reference: TQ13336 79722

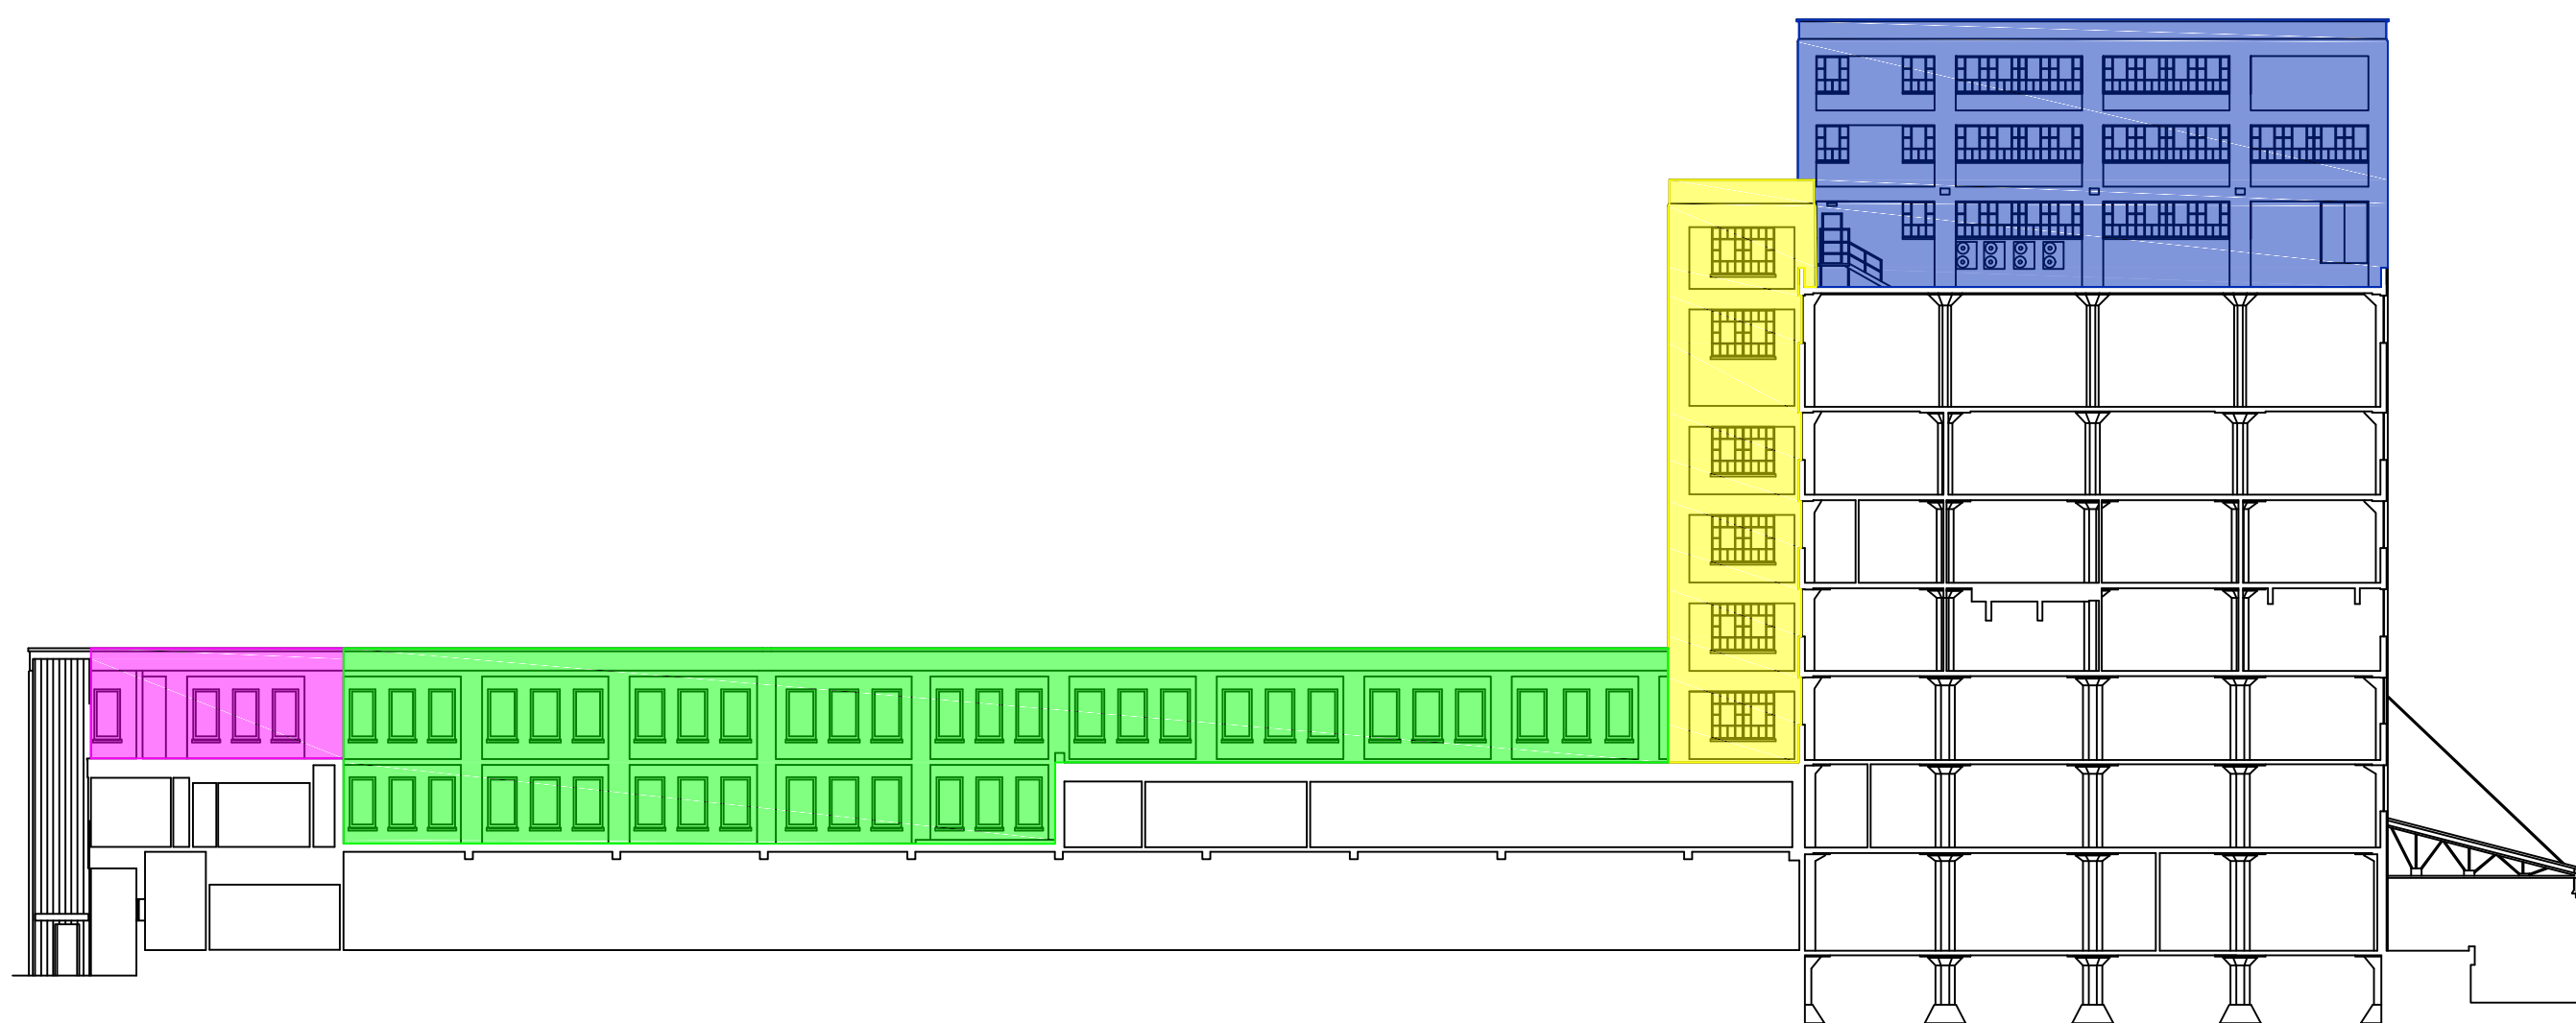
Figure 17: Section looking South and Section looking East

Building Chronology	
Block A1 (1936)	
Block A2 (1938)	
Block A3 (1970s-80s)	
Block B1 (1936)	
Block B2 (1938)	
Block B3 (1955)	
Block B4 (Early 1960s)	
Block D1 (1952-54)	
Block E (1956)	
Block F1 (1957)	
Block F2 (Early 1960s)

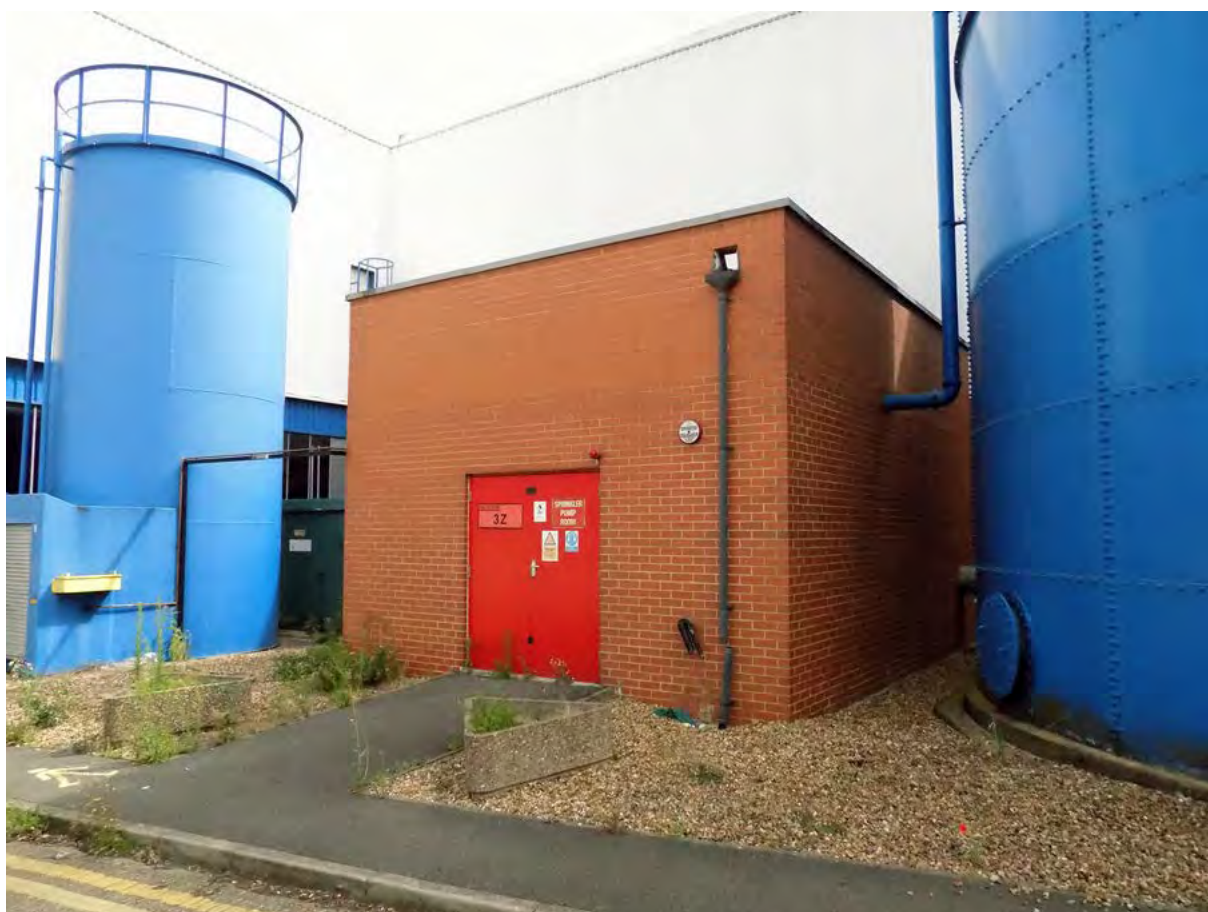
Plate 189: Sprinkler pump room on west side of new warehouse.

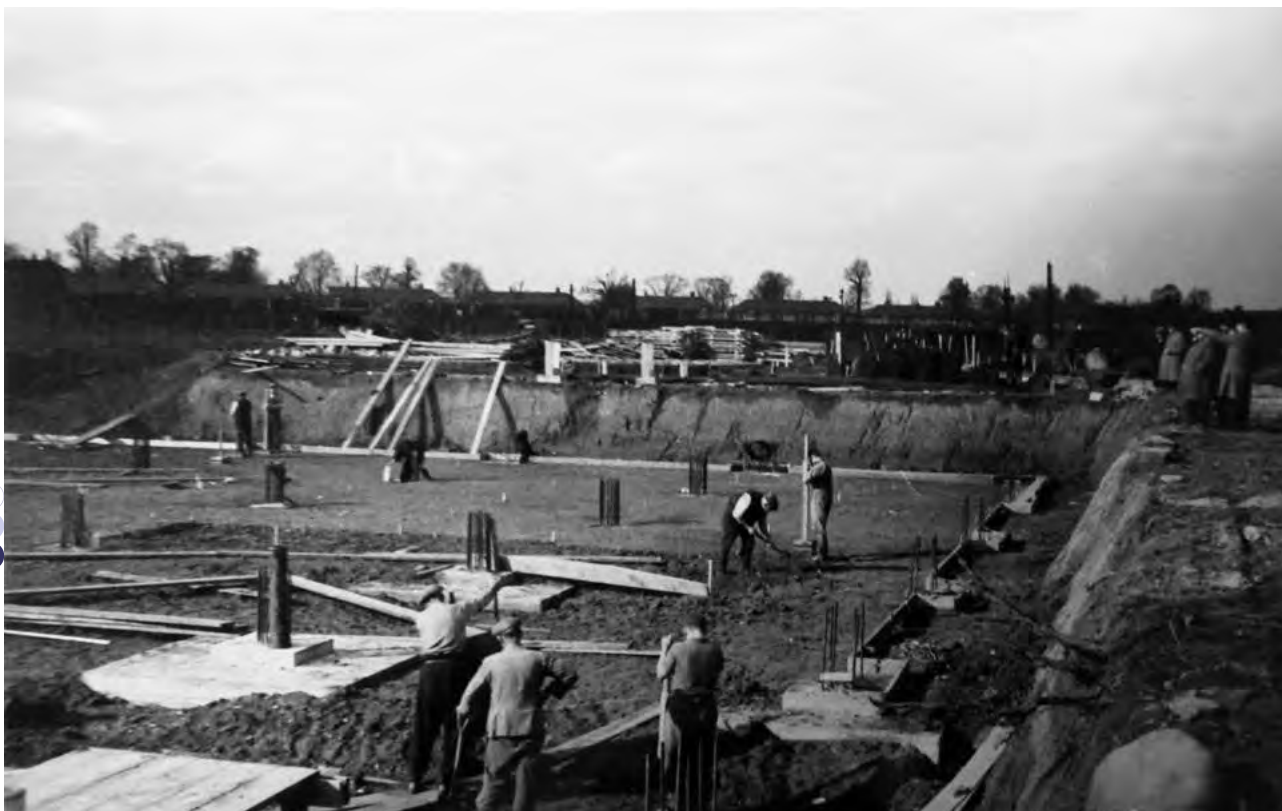
Appendix plate 3: View from the summer of 1936 showing the excavated basement for the new factory. Note column bases in the process of formation (from scrapbook of historic photographs found on site)

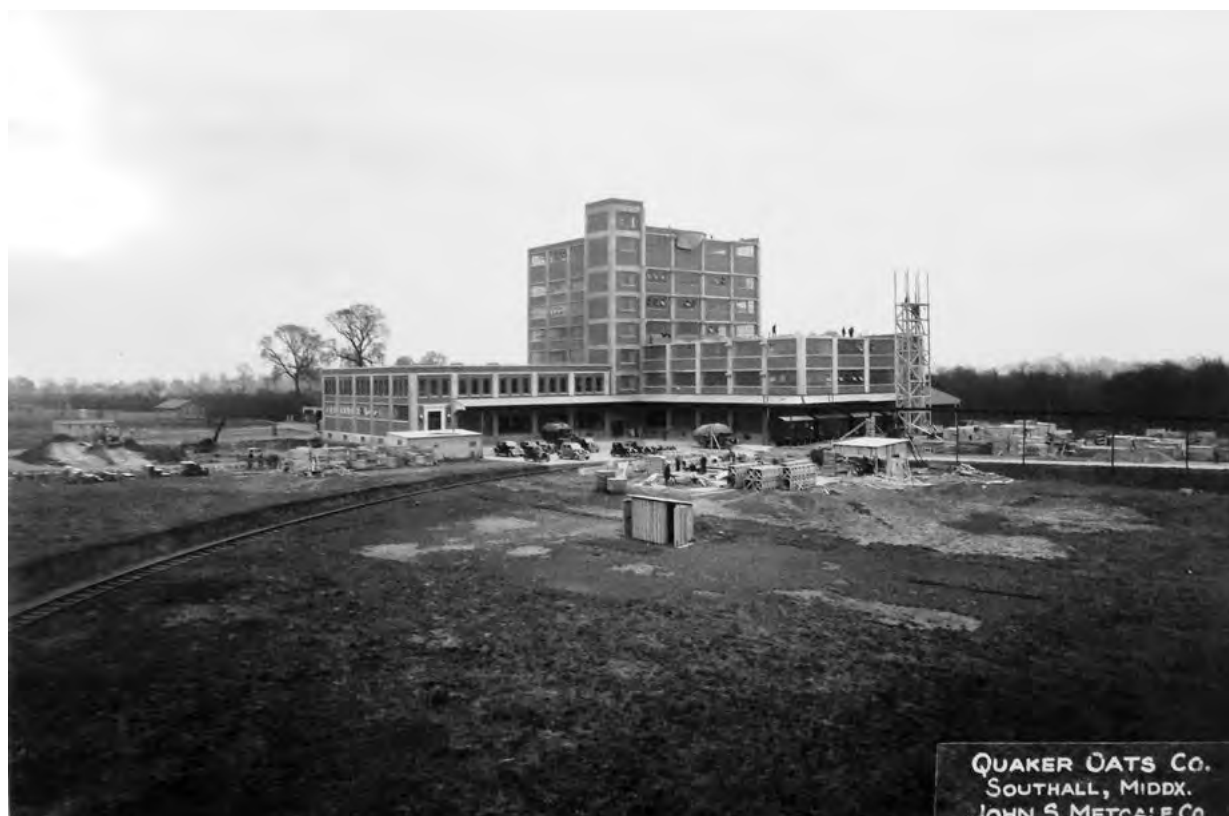
Appendix plate 5: View from north-west, dated 4 February 1938, showing the original form of Block A (centre and right) and Block B (left). The image also shows the start of works to raise Block A to seven storeys along its full length and to add a single storey extension to Block B (from scrapbook of historic photographs found on site)

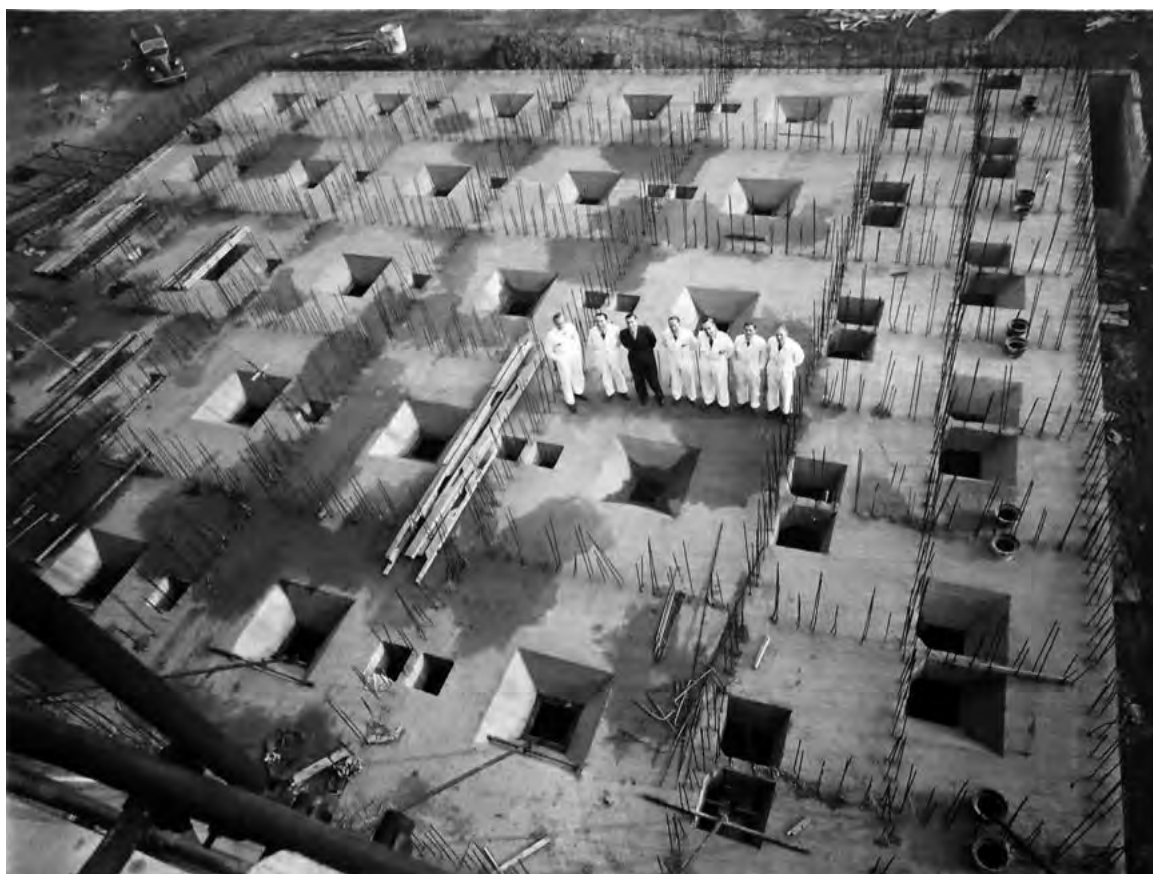
Appendix plate 13: View from May 1953 showing the base of the new silos range during its construction (from scrapbook of historic photographs found on site)

- 7.1.3 Several historic photographs were found in the building showing the silos under construction (Appendix Pl. 13-15, 24-25) in the 1950s as well as short newspaper clippings showing that the reinforced concrete was continuously poured, day and night (Pl. 16). An image from 1953 shows the bin slab of the original set of silos with each bin apparently comprising a main chute (upturned pyramidal form) and a smaller square opening in the deck. A similar image from 1956 of the silos extension under construction shows the silo deck (or base) with 20 square chutes (upturned pyramids).

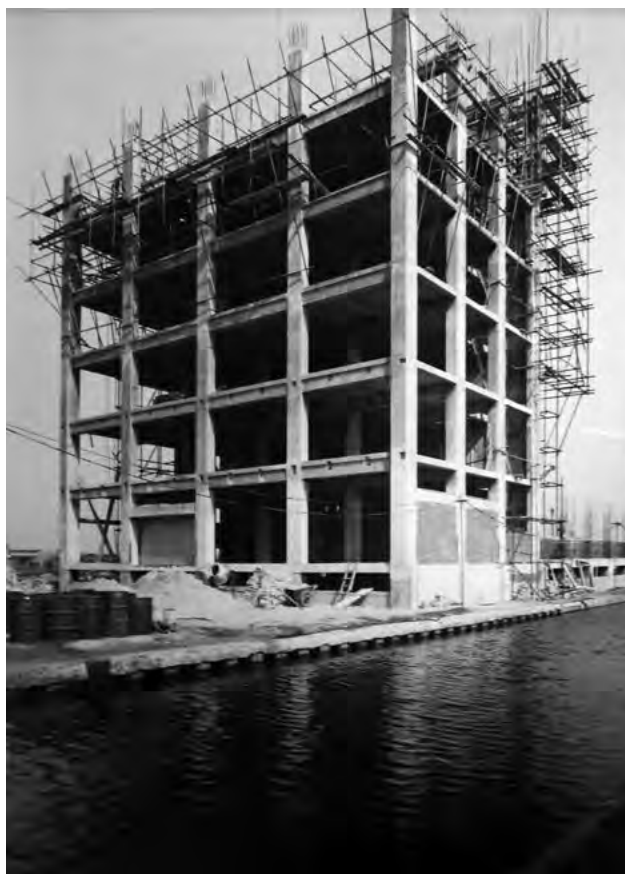
Appendix plate 14: View from south-west during construction of the new silo building in 1953 (from file of loose photographs found on site)

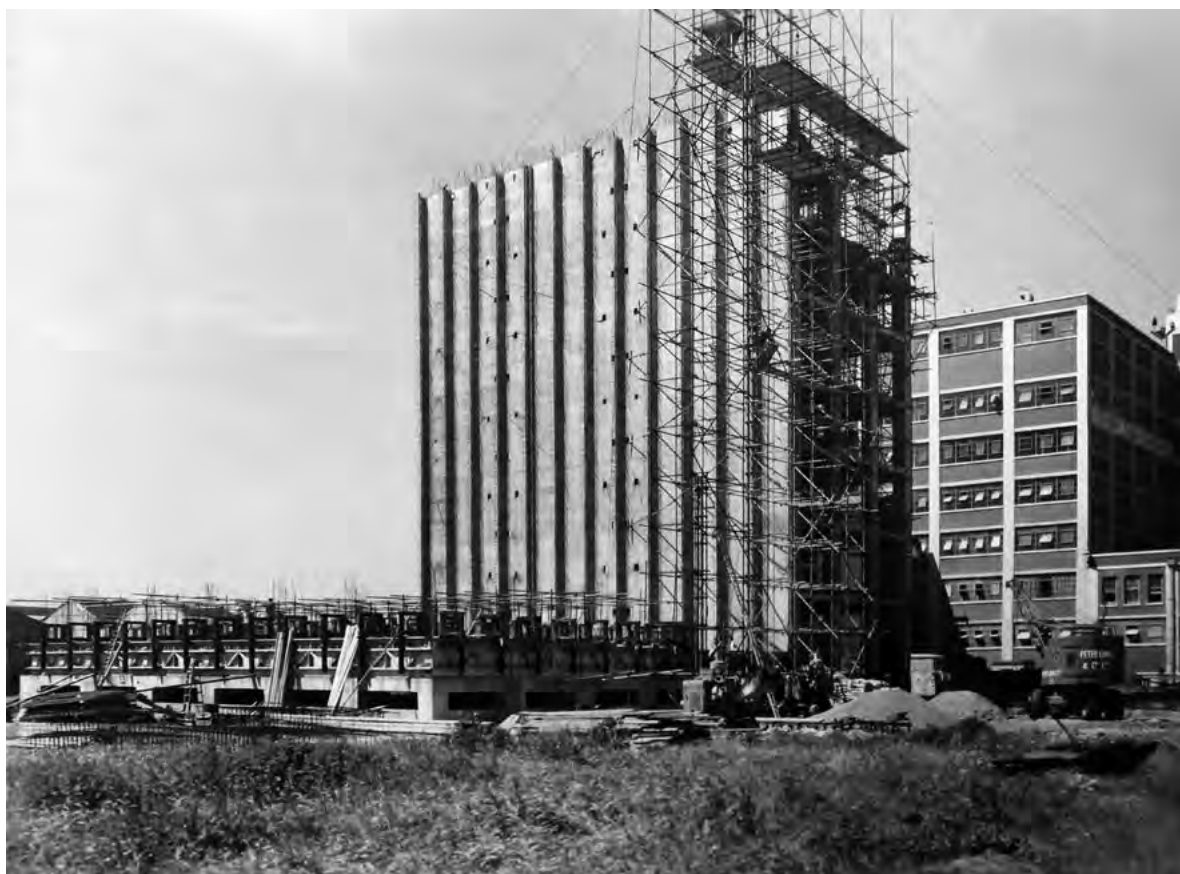
Appendix plate 15: View from June 1953 showing the new silos range under construction (from scrapbook of historic photographs found on site)

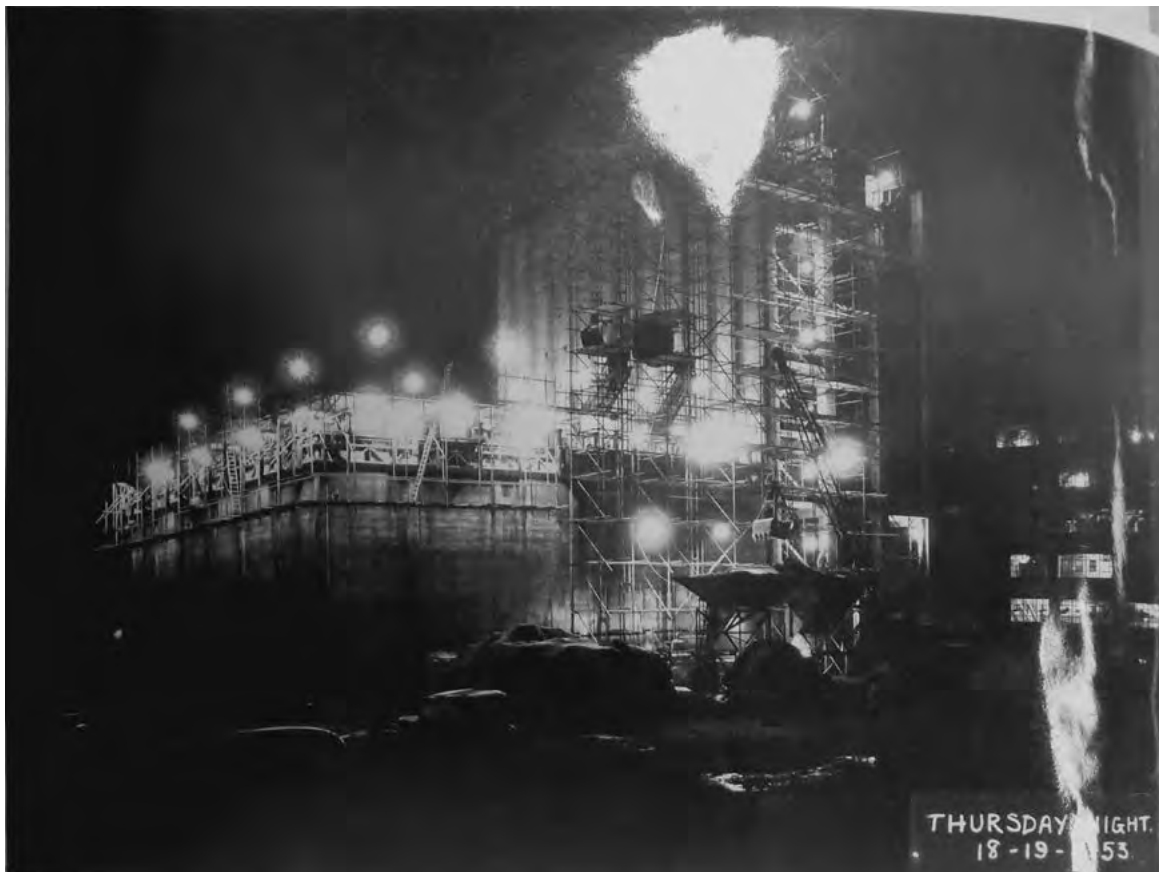
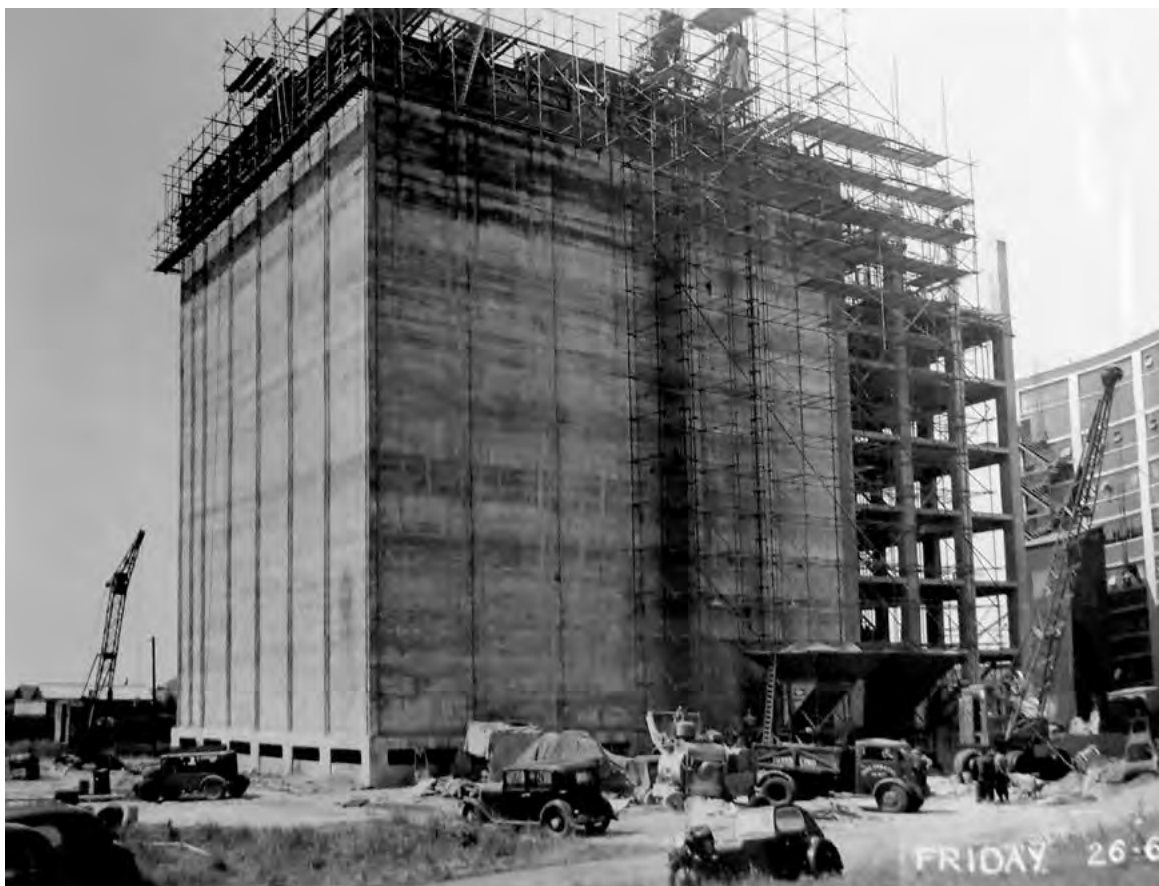
Appendix plate 16: Two images from June 1953 showing the continuous pouring process of constructing the silos (from scrapbook of historic photographs found on site)

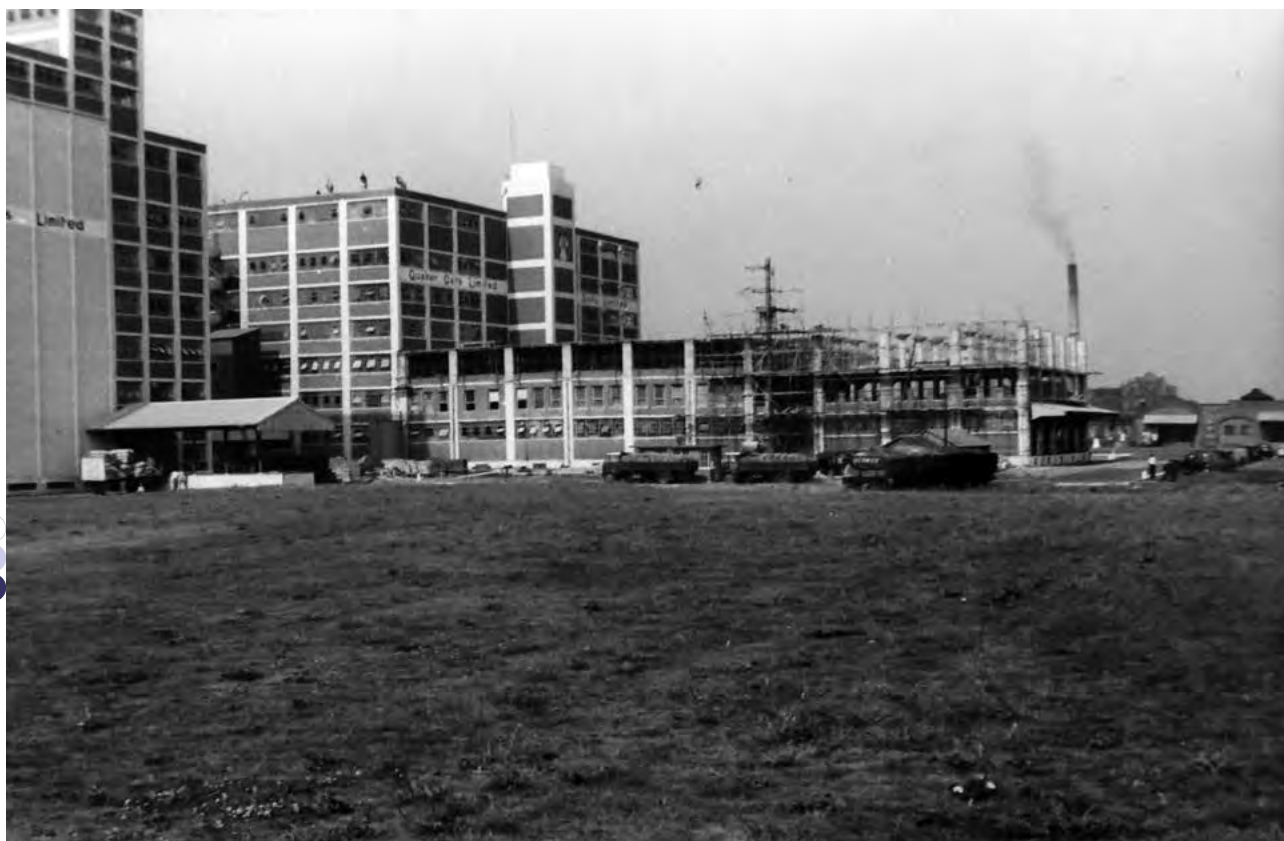
Appendix plate 19: View from July 1955 showing the extension of the office range (Block B). This raised the range to three storeys (from scrapbook of historic photographs found on site)

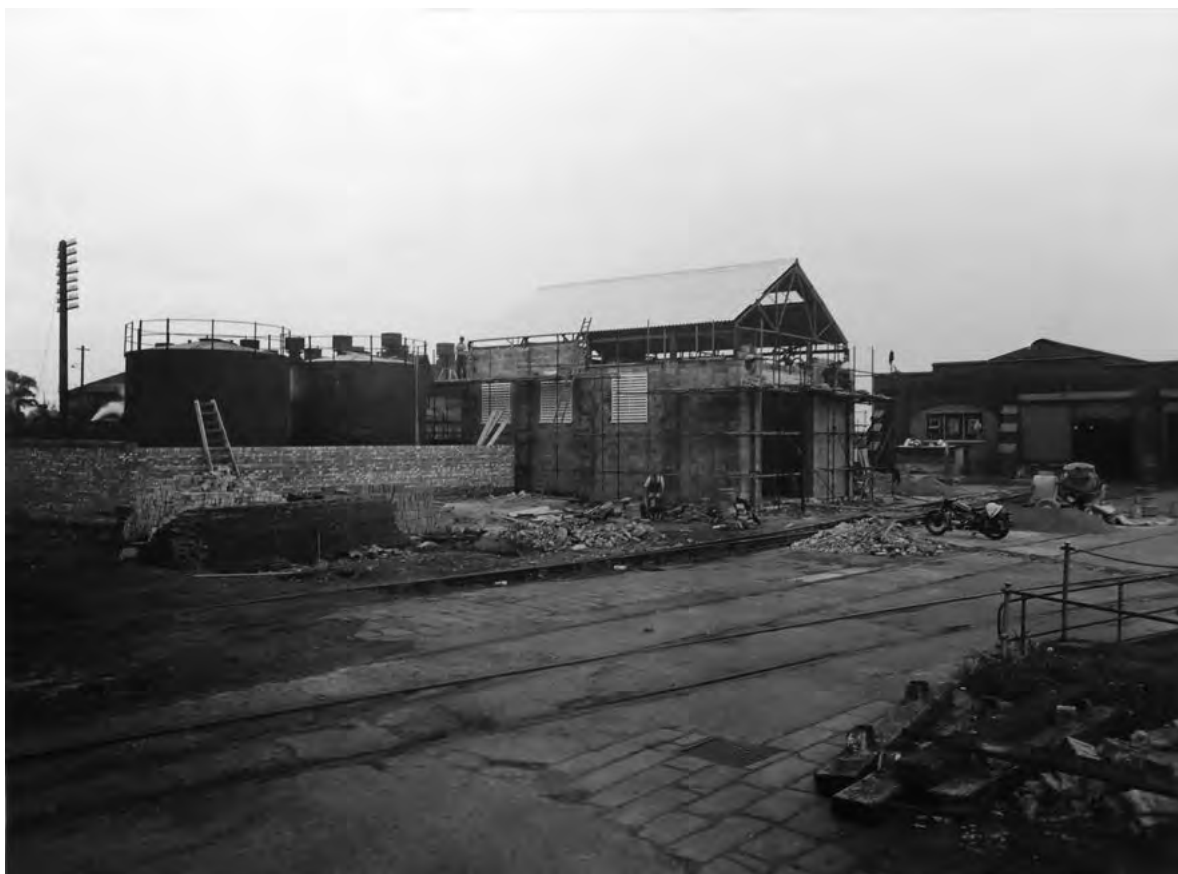
Appendix plate 21: View from 1955 showing the construction of a new boiler house. Looking west towards Building C (from scrapbook of historic photographs found on site)

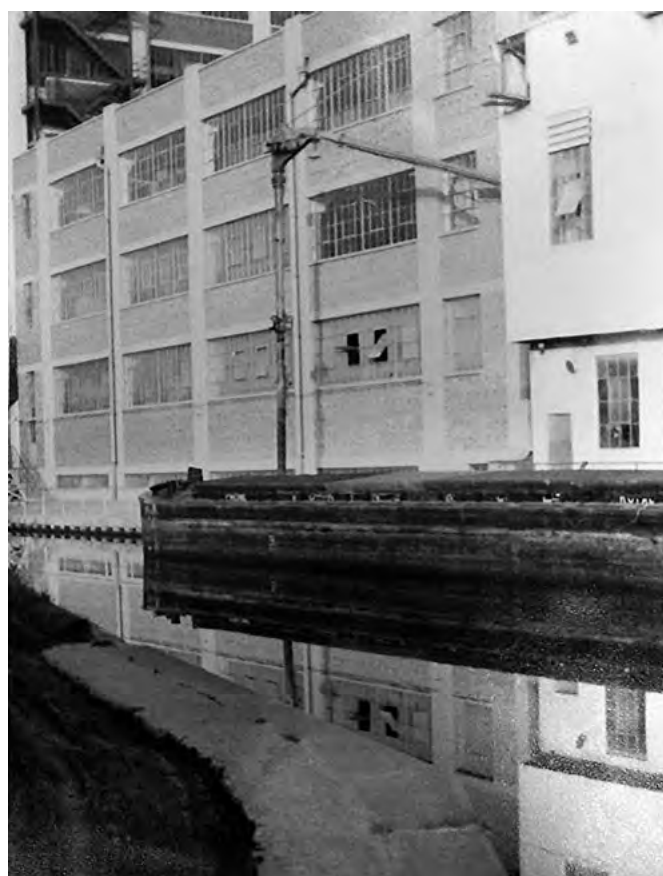
Appendix plate 28: View from south-east showing south side of Building F in Nov 1957. This was  
subsequently raised to seven storeys (from scrapbook of historic photographs found on site)

- 5.2.10 Bays 11 to 15 (Block F) are a later infill block constructed between the main mill and the grain silos (Pl. 1-3); the lower three floors were constructed in 1957 and then it was raised to seven storeys, probably in the early 1960s. The windows here are almost entirely PVC secondary replacements although the uppermost window in Bay 11 is original (metal framed). In Bay 14 there are PVC windows at 6<sup>th</sup> floor level but beneath this the historic arrangement has been recently replaced by crude plywood doors at the five floor levels above ground floor. These were not loading doors from when the factory was operational and instead they were installed as a temporary measure after the closure of the factory when the historic windows and panels were removed from this bay to allow for the removal of any reuseable plant from within the building (Rob Kinchin-Smith pers comm). Any internal walls near these were also removed at the same time.

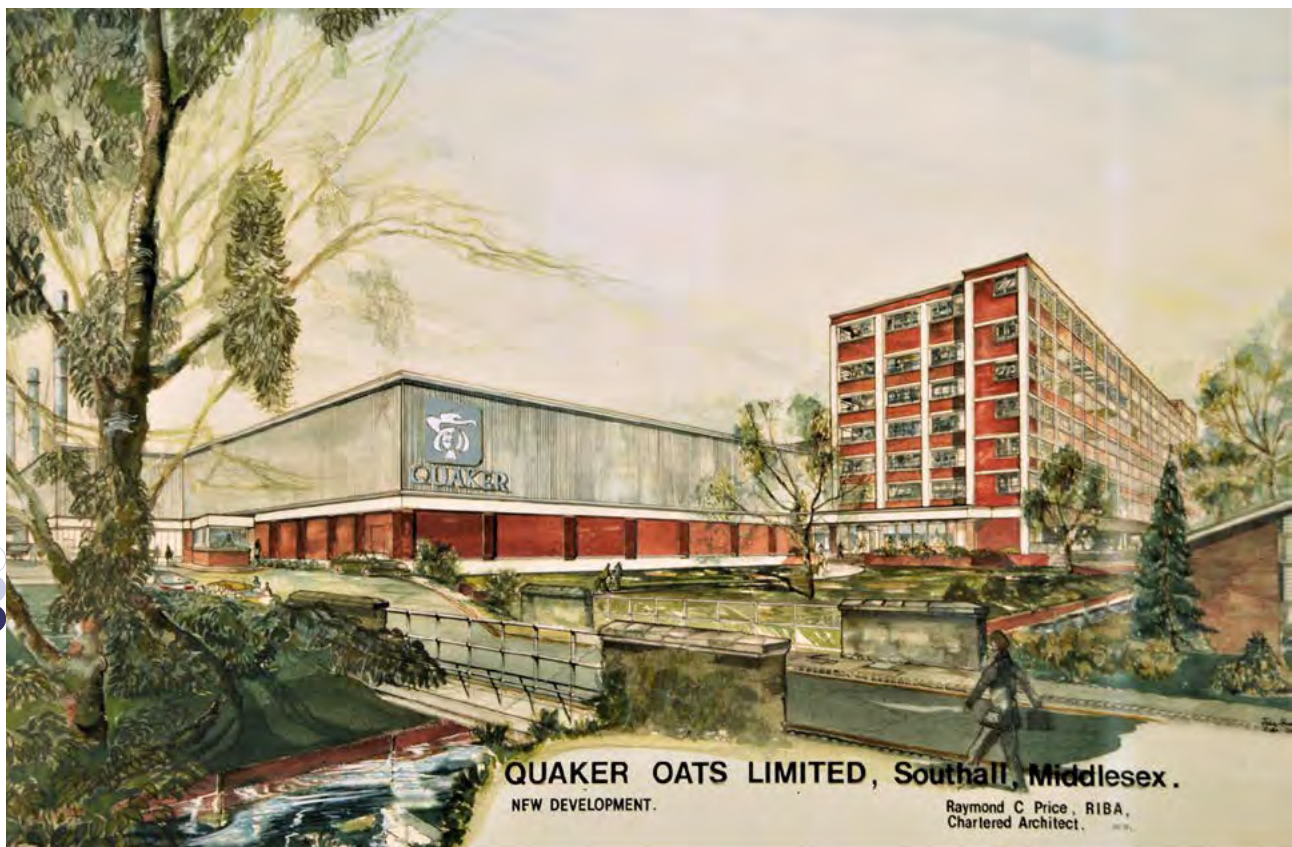
Appendix plate 31: Artist's impression of proposed warehouse on west side of factory, December 1980. The artist is John Sharp RIBA FISA and the architect of the new development is shown as Raymond C Price RIBA (framed drawing found on site)

8.1.2 The new warehouse was constructed c.1981 to the designs of the architect Raymond C Price, adjoining the north side of Block A and the west side of Block B. This was almost certainly undertaken in the same phase which saw the removal of all the rail facilities on the site and the move to road distribution by lorries. It also included the addition of the entrance foyer and stair projection at the west end of Block A and the freestanding boiler house. The date of the warehouse has recently been confirmed by an artist's impression found on site and dated Dec 1980 (See Appendix Pl. 31). Presumably this view was produced as part of the design process and therefore the main construction would have been undertaken in 1981.
