# Land east of Guilfords, Harlow, Essex

## Archaeological Evaluation Report

October 2022

Issue No: Version 1  
OA Report No: 2618  
NGR: TL 47682 12342

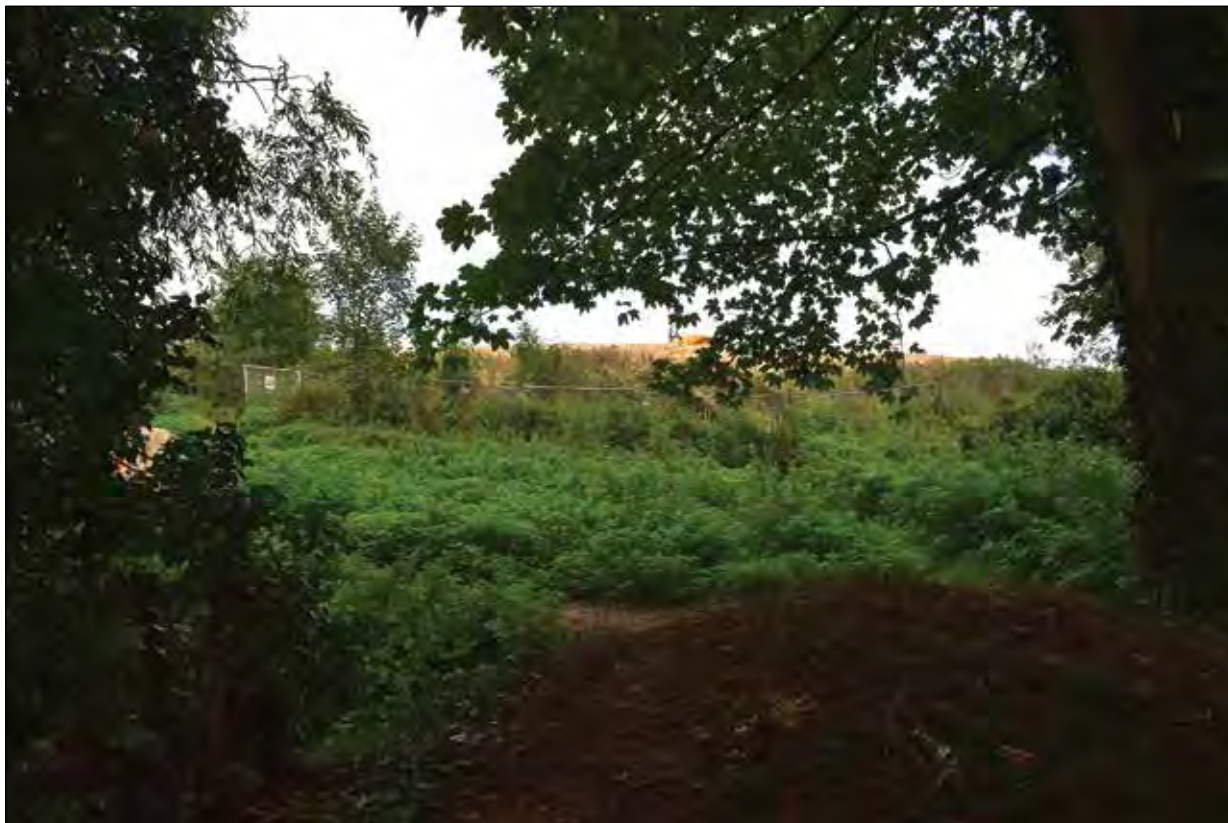
Plate 1: View towards the site of the Neolithic causewayed enclosure on the opposite side of Harlowbury Brook, looking north-east

working site (EHERs 14145, 14146, 14148), with subsequent evaluation and excavation of the site (Webb 2021; Fig. 2, HAGW17; Plate 1) uncovering the remains of a Neolithic causewayed enclosure. The enclosure encircled an area of pits and overlooked the southern end of the current site. This site produced over 50kg of Neolithic pottery and 9,000 worked flints, as well as significant burnt deposits. In addition, the remains of a possible Neolithic longhouse were uncovered to the east of the causewayed enclosure.

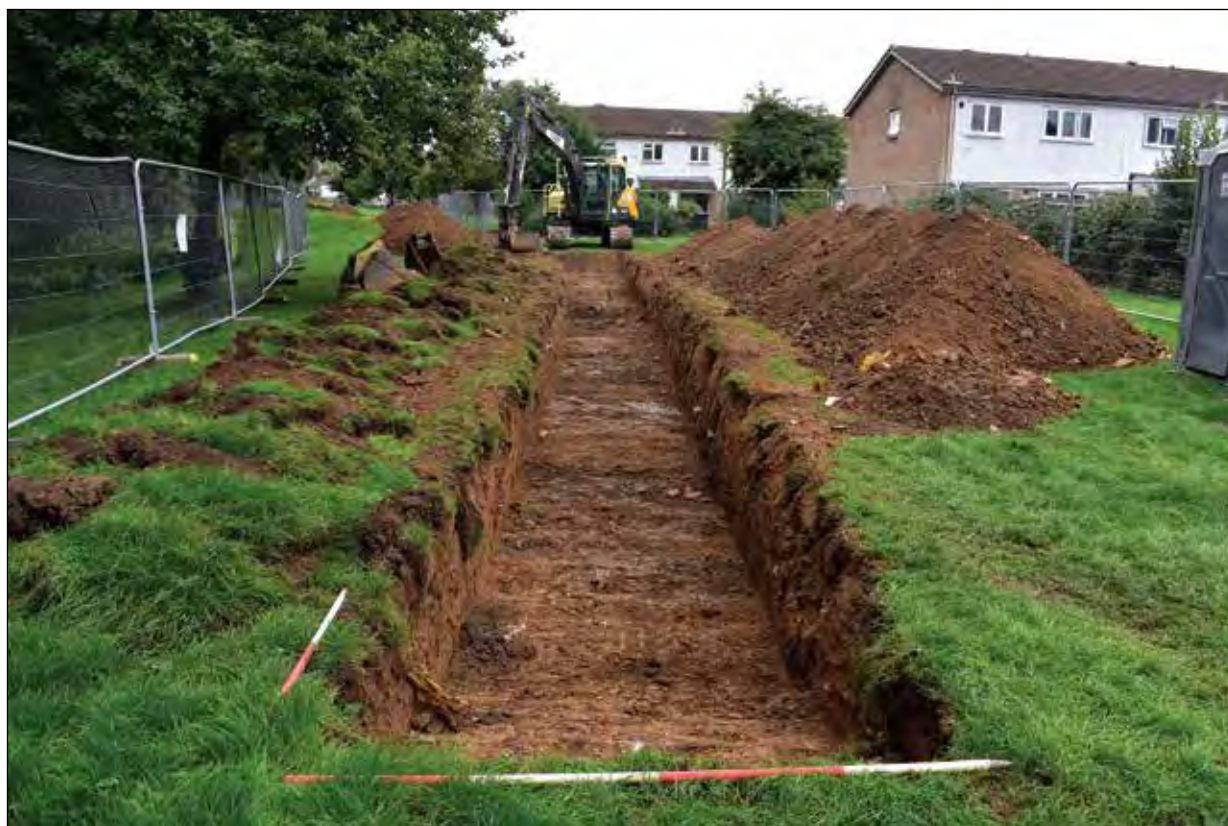
Plate 2: Modern levelling deposit (4) that spans the site, shown where it extends to a depth greater than 1m within Trench 1, looking south

- 4.2.3 It appears that the development of the Guilfords estate resulted in a deposit (4) containing modern refuse having been spread across the site. This layer was deeper in the north, towards the railway and river, where its thickness was not fully revealed by the 1m depth of Trench 1.

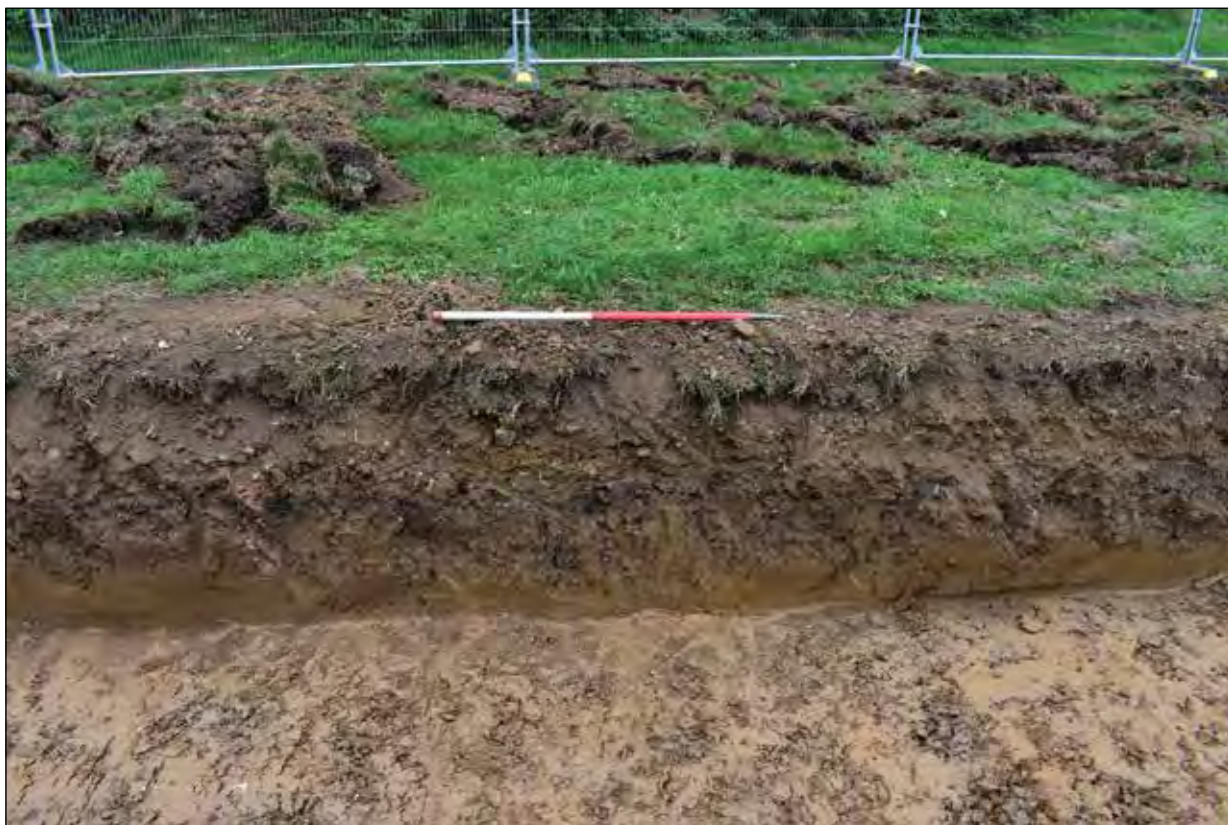
Plate 3: Alluvial deposit (2) in Trench 3, looking east

- 3.4.1 An alluvial deposit (2) covered a span of 22m in the middle of Trench 3 (Fig. 3; Plate 3). It measured up to 0.2m thick between the natural geology (1) and subsoil (3) and consisted of plastic mid reddish grey sandy clay. This deposit had a diffuse boundary with the underlying natural geology.

- 4.2.1 The evaluation succeeded in establishing the character, date and state of preservation of archaeological remains within the proposed development area. The alluvial deposit probably extended west from Harlowbury Brook and may correspond with alluvium identified in geoarchaeological boreholes at Gilden Way to the south which was interpreted as having been laid down on the floodplain during the Mid-Late Holocene (Young 2019, 9). Considering the scarcity of features on this site, the alluvium probably did not mask any further archaeological remains.

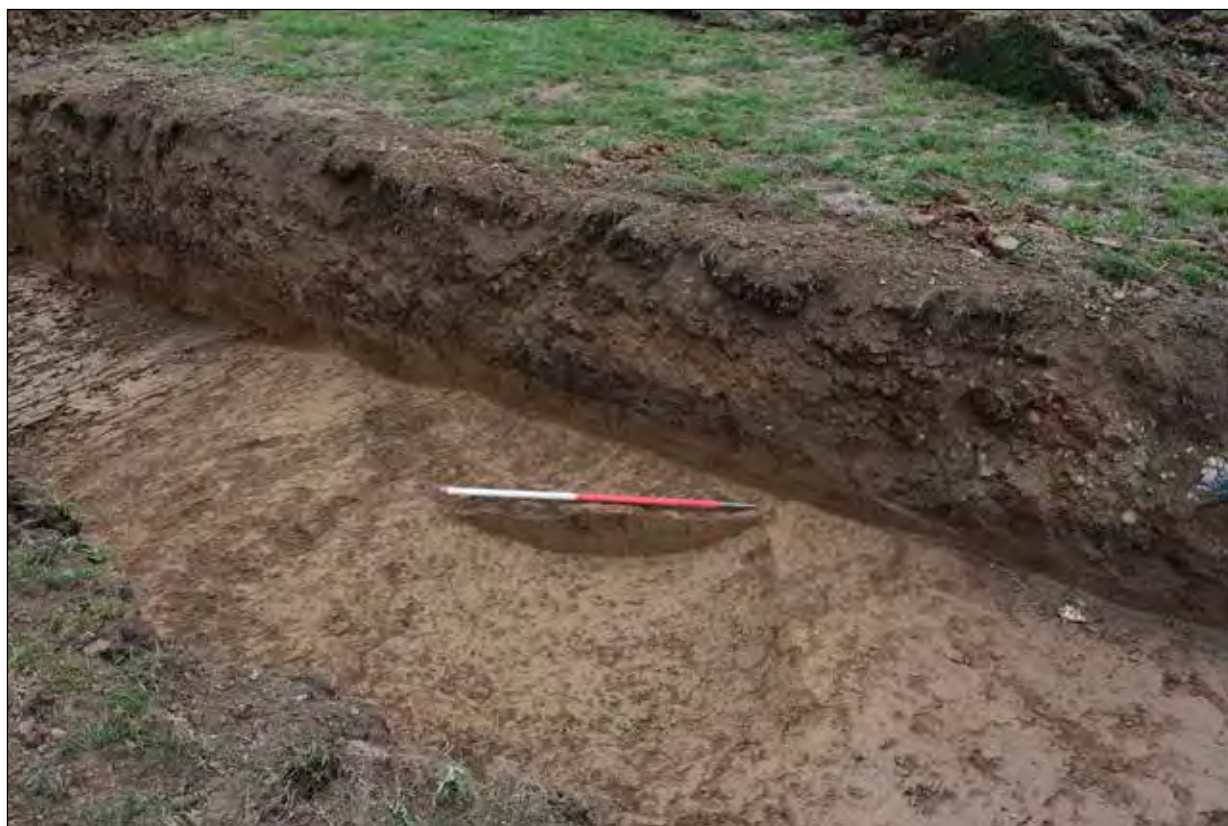
Plate 4: Ditch 6 in Trench 4, looking south-east

- 3.5.1 A linear ditch (6) was identified in the middle of Trench 4 on a north-north-west to south-south-east alignment (Fig. 3; Plate 4). This had gently sloping sides, a concave base and measured 1.24m across and 0.2m deep. It was filled by a deposit of a plastic mid reddish brown sandy clay (7) that contained no artefacts.

- 4.1.1 The ditch in Trench 4 was clearly visible as a paler strip against the natural geology when the trench was first opened. The alluvium was also clearly visible as a darker deposit beneath the subsoil. The site remained dry throughout the evaluation. Therefore, the results of the evaluation trenching are considered to have a good level of reliability.

- 4.2.2 The only archaeological feature on this was a shallow, sterile boundary ditch in Trench 4. The overall lack of archaeological features on this site suggests that the nearby prehistoric, Romano-British and post-Roman occupation remains highlighted in Section 1.3 was confined east of the brook.

- 4.3.1 No artefacts were recovered from the ditch in Trench 4 to aid its interpretation. However, both its differing alignment to nearby historic boundaries and its pale fill suggest it may have been a prehistoric boundary ditch in agricultural hinterland west of the previously identified areas of Neolithic, Bronze Age and Iron Age settlement east of the brook.
