ASH GROVE COTTAGE
NETHER KELLET
LANCASHIRE

Evaluation and Fabric Survey Report

Archaeological Evaluation and Fabric Survey Report

Report no 1999-2000/041/AUA8860

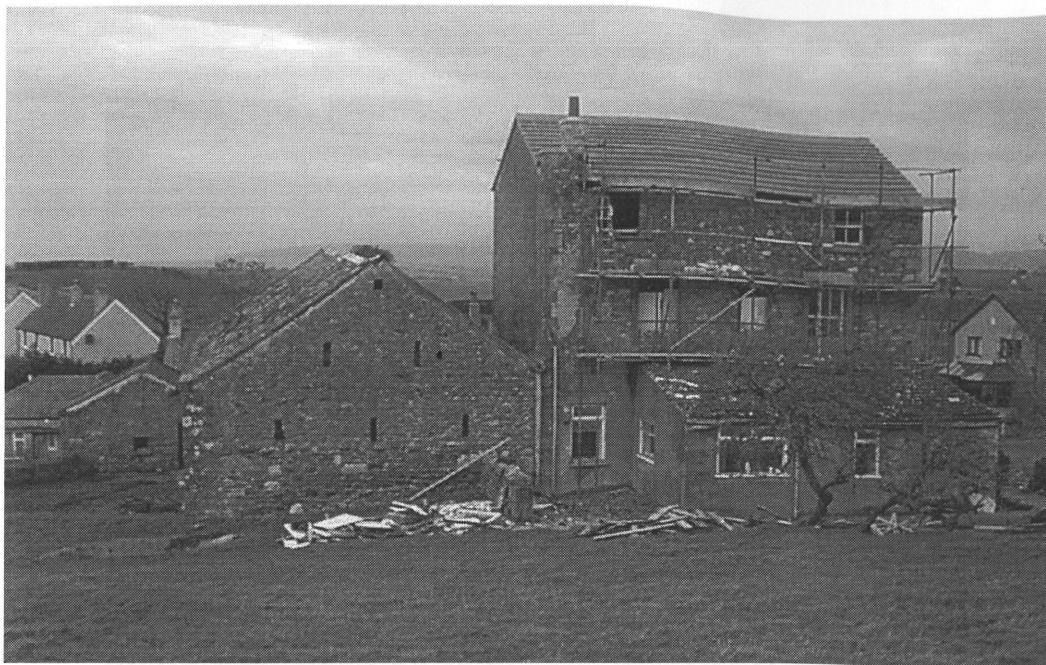
Plate 1 Cottage and Barn exteriors looking north-west

- 3.1.1 The assessment examined two structures a four storeyed farmhouse set into the slope, and an adjacent long barn which was set at a right-angle to the farmhouse, and its western end was also revetted into the slope. The principle entrances to the barn was on the northern side, facing into a courtyard, and the lowest ground floor of the farmhouse was similarly accessed from this courtyard and was used as cart sheds.

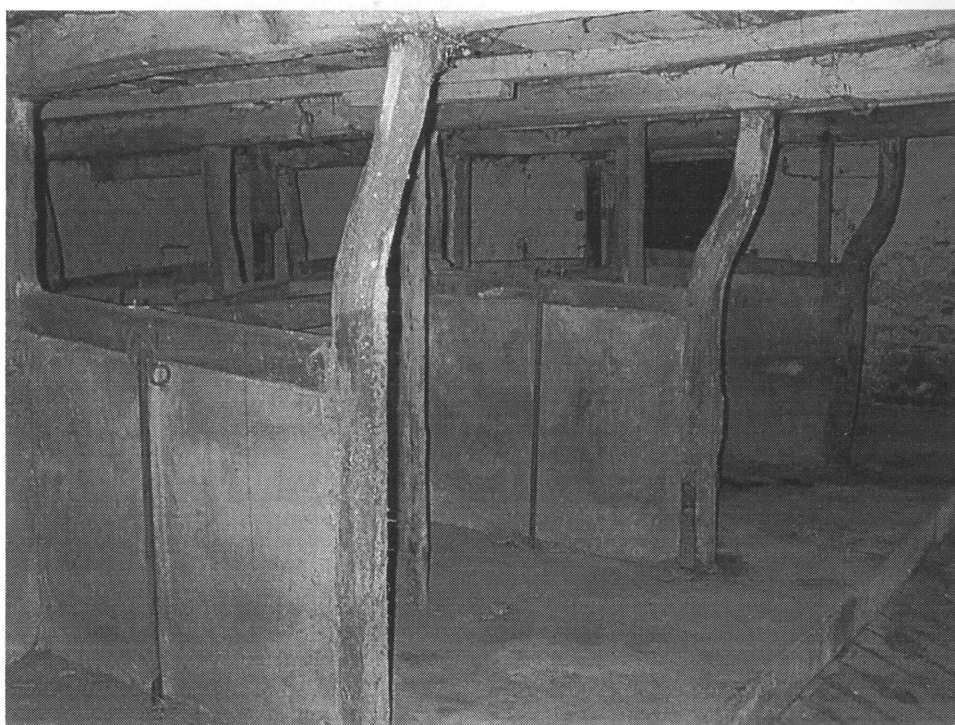
Plate 2 Cattle stalls within the western end of the barn

- 3.2.4 Internally the barn was little altered, except that the floor to the cow-house had been concreted. The cow-house comprised a central feeding passage with flanking manuring passages, each split into four double stalls (1.9m wide) with a central timber stanchion in each, as well as tether rings on the stalls. The area above was used as a loft. The eastern part of the building was a threshing barn with a flagstone threshing floor across the centre.

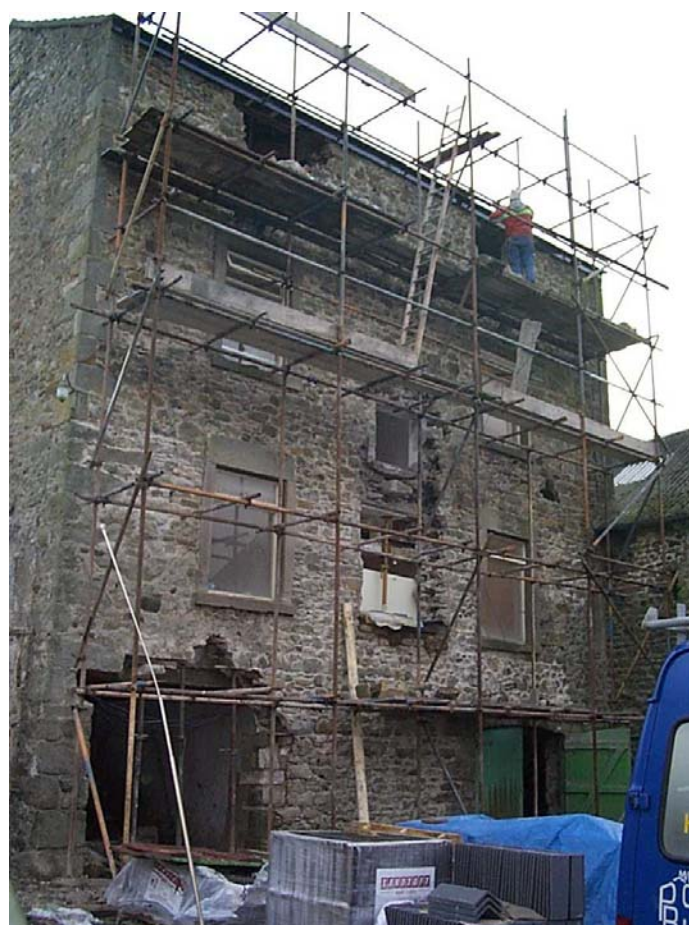
Plate 4 Western external elevation of the farmhouse

- 3.3.5 Externally, the house was quoined on all corners, with all original windows having stone lintels, sills and jambs. The southern elevation and part of the eastern elevation and outshut were rendered, and, although the quoin stones on the eastern elevation were continuous with the eastern elevation of the barn, there was a possibility of a rebuild *c* 1m to the south, suggesting that the barn may predate the main house. A mortar wall scar was also observed on the northern elevation of the house, suggesting that there was, at some point, a small structure attached to the lowest storey to the west of the main door.

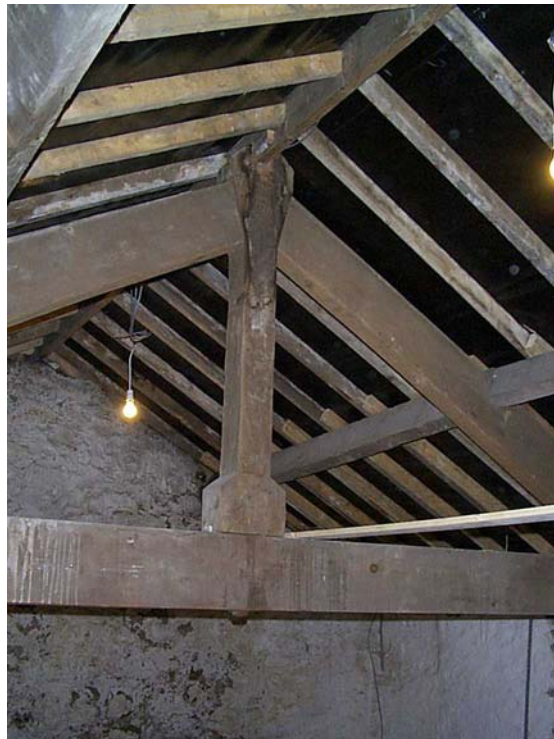
Plate 6 Kingpost truss within the farmhouse

- 3.3.4 The attic comprised a single room, with four windows at the top of the front and rear elevations. The entire roof had been replaced at some time during the twentieth century, probably at the time of the structural collapse of the upper two storey window lintels, but both king posts had been reused and the position of the trusses, on either side of the central staircase, remained the same. The roof sat directly on the wall tops without the use of timber wall plates. Both king posts had ornamental, but crude, chamfers, mimicking the earlier tradition of attaching the braces to the king post, though neither was socketed. It is probable that the original trusses had offset braces, as seen in the barn.

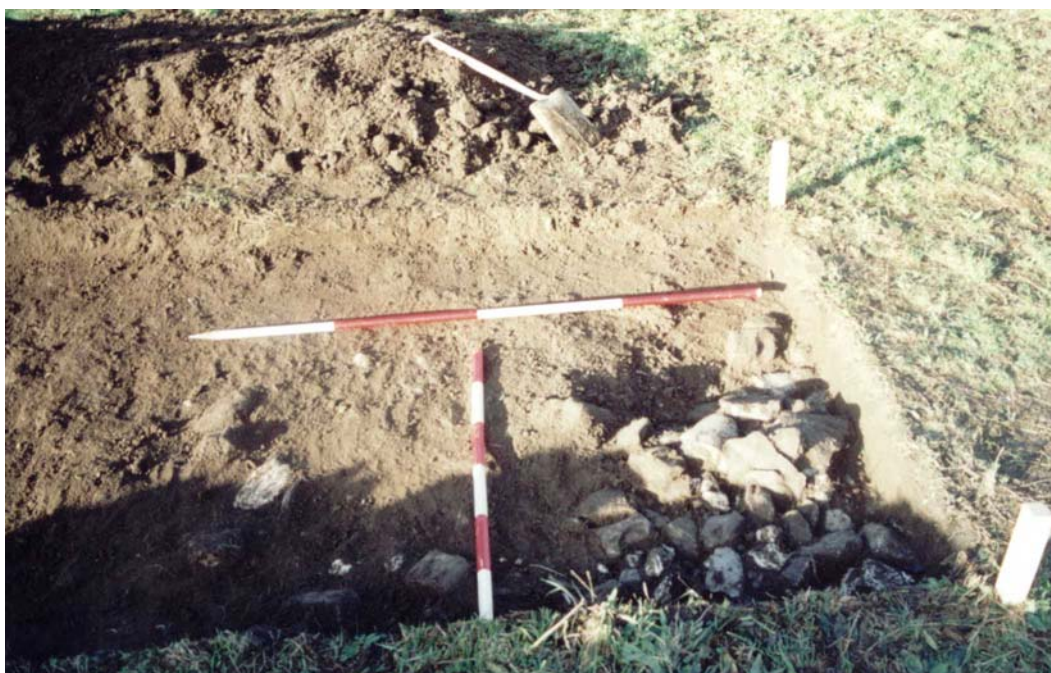
- 4.1.2 Removal of the turf [1] revealed a 1.7m x 1.2m spread [2] of angular and sub-angular stones in the south-eastern corner of the trench (Plate 7). In the rest of the trench, a uniform surface of mid-brown silty loam was exposed with occasional stones protruding from the surface. Excavation of the silty loam [3] in the south-western part of the trench showed it to be between 0.7m and 0.34m in depth, containing frequent small to medium-sized stones similar to those observed in the stone spread, overlying limestone bedrock.

- 4.1.3 The stones were randomly distributed, and did not appear to have been laid as a surface. The layer was excavated in two spits, with the surface being cleaned by hand in between; no evidence of any cut features was recorded.

Plate 7 Eastern end of Trench, showing localised stone spread [2] – Looking North
