# Cheltenham Minster Gardens, Gloucestershire

## Archaeological Watching Brief Report

November 2022

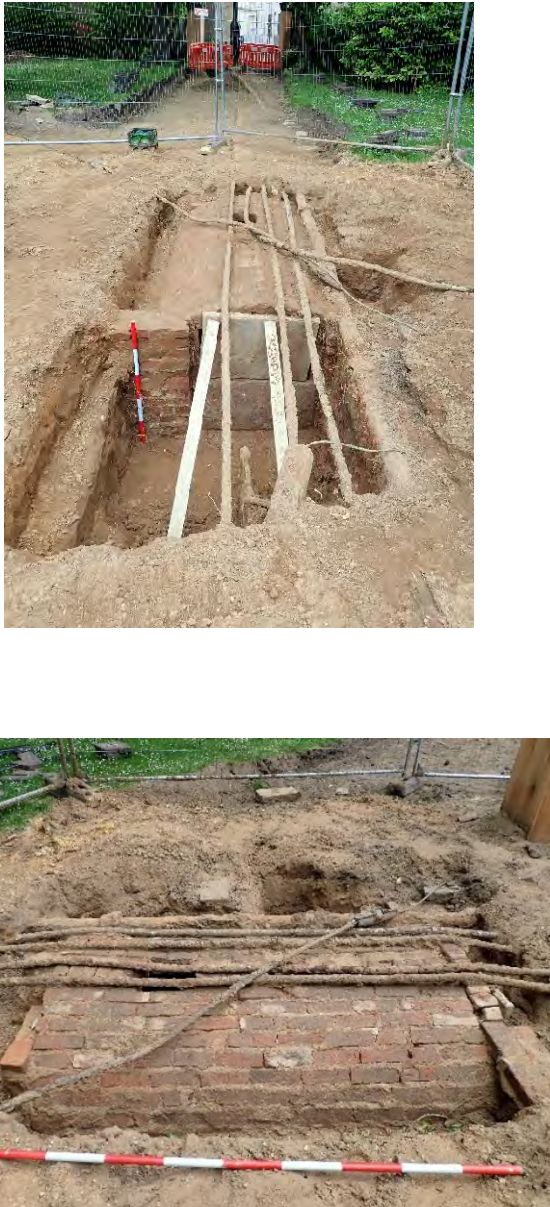
Structure Number	Photograph	Description
Vault 1

Brick vault containing coffins 2 and 3.

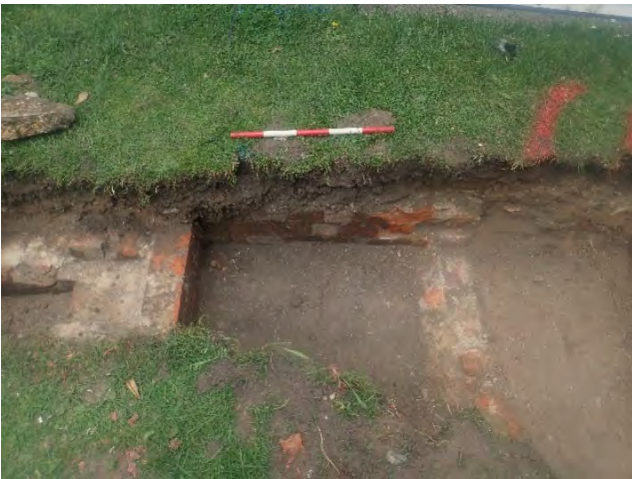
<p>Shaft grave 8</p>

<p>Brick built shaft grave. Brick dimensions 240mm x 111mm x 60mm. Roof removed or collapsed. Abuts shaft grave 9 to the south.</p>
<p>Shaft grave 9</p>

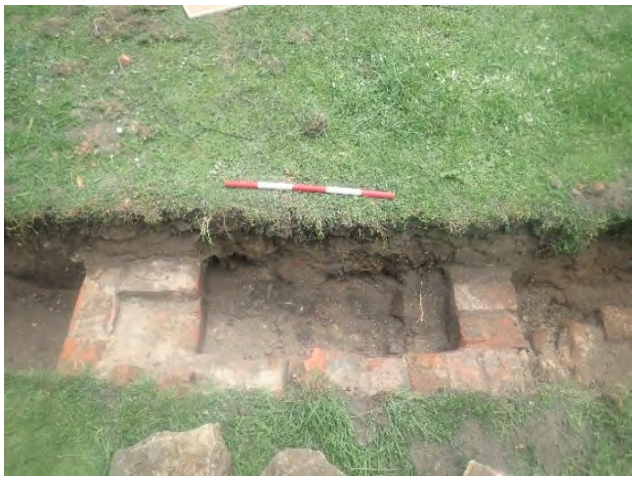
<p>Brick built shaft grave. Brick dimensions 240mm x 111mm x 60mm. Roof removed or collapsed. Abuts shaft grave 8 to the north.</p>
<p>Shaft grave 15</p>

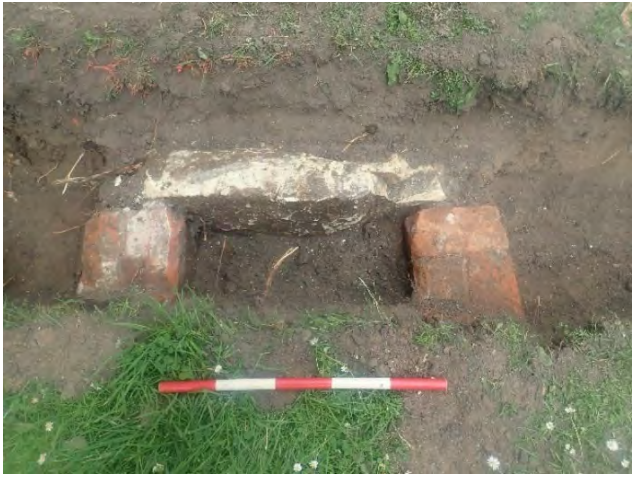
<p>Brick built shaft grave, with limestone slab at end, potential opening. Brick dimensions 240mm x 111mm x 60mm. Roof removed or collapsed.</p>

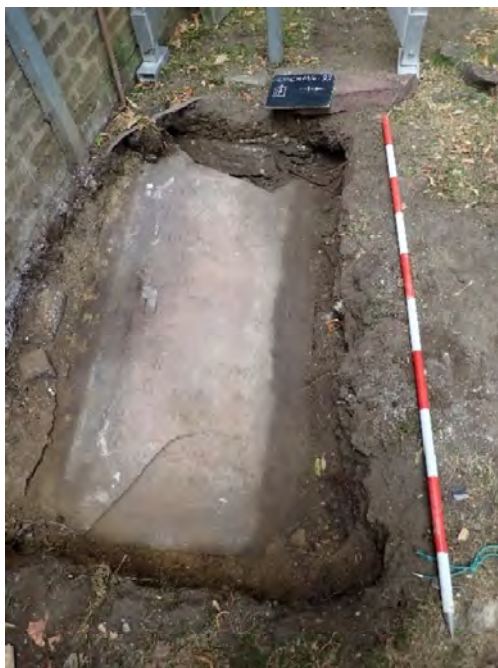
Ledger 17 (part of vault 65: Table Tomb 262)

Probably reused gravestone/ledger to construct table tomb. 1.9m x 0.9m x 0.09m. reworked around edges. Partial inscription

*"..Ann Wife of...  
... Middle...  
Died February 27  
Aged 30  
...Middle..  
...Dec 26<sup>th</sup> 18..  
...Aged 48..  
...ARD HULB...  
...1 Jan 6<sup>th</sup> 18..  
...ged 30 Yea..  
...RLA daughter..."*

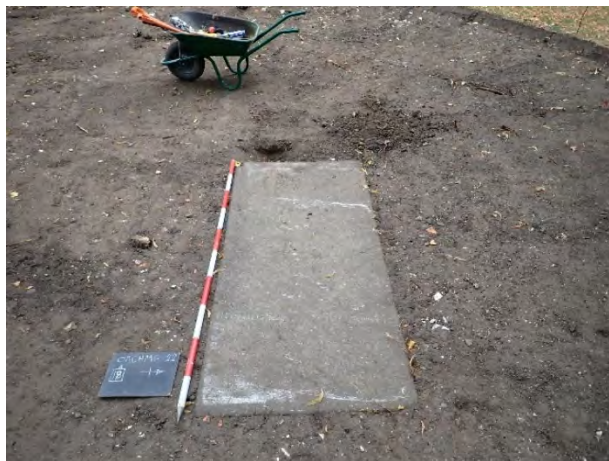
Stone 18

Blank sandstone slab. Possible part of tomb construction, no inscription on either side. 1.9m x 0.92m x 0.08m

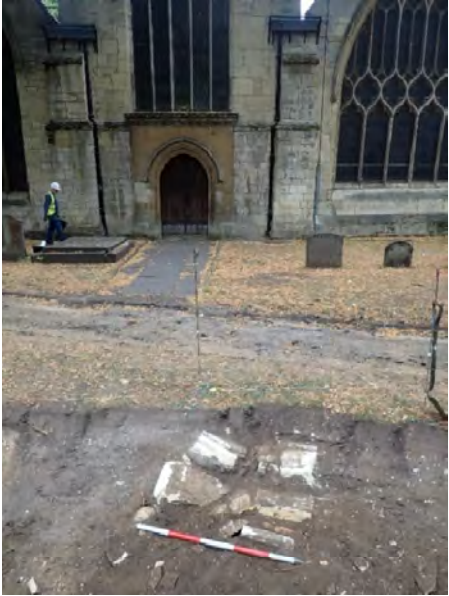
<p>Feature 19</p>

<p>Possible disturbed and broken capping stones or infill of shaft grave. Fragments of limestone and brick. 1.1m x 0.8m.</p>
<p>Structure 20</p>

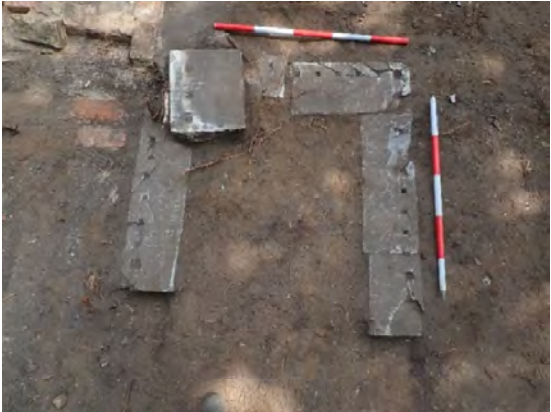
<p>Part of grave surround or reused element of other structure. Multiple recesses for iron railings. Possibly reused to form part of shaft grave. Hewn sandstone, 1.35m x 1.38m.</p>
<p>Structure 21</p>

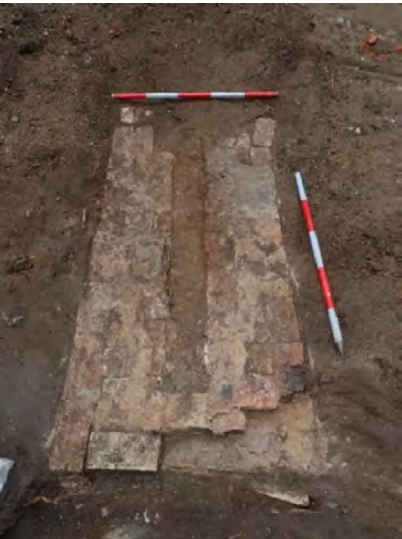
<p>Brick shaft grave with vaulted roof. Top course truncated away and infilled, dimensions 2.03m x 0.9m. Bricks 237mm x 114mm x 80mm.</p>

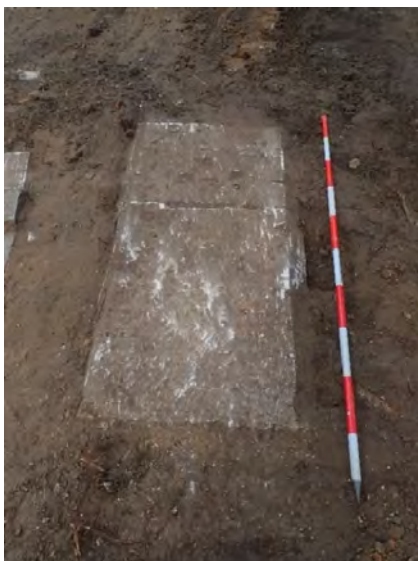
Structure 24, slab overlying capping stones 26

Sandstone slab 24 -  
overlying capping  
stones 26. Measured  
1.71m x 0.9m x 0.15m.

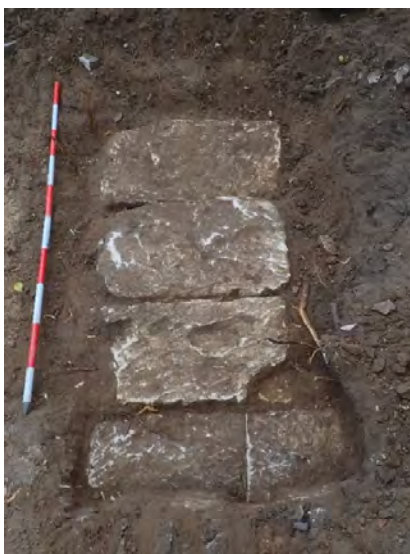
Capping stones 26 sealing shaft grave 27

Capping stones 26 -  
comprising four slabs  
of limestone overlying  
shaft grave 27.

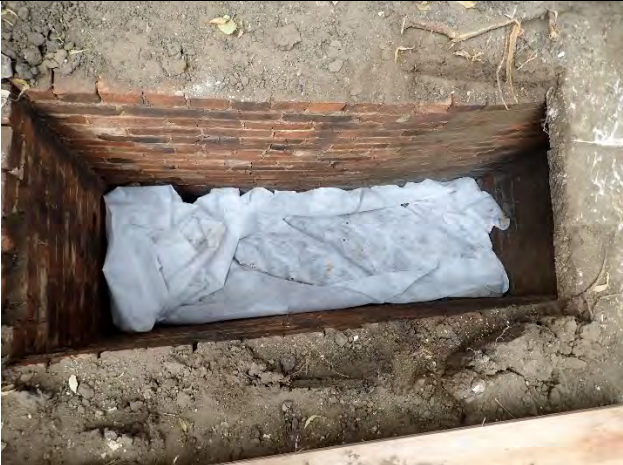
Shaft grave 27 -  
Contained  
disarticulated human  
remains and rubble  
collapse. Bricks  
237mm x 114mm x  
80mm. Structure  
measured 2.3m x 0.9m  
and 0.9m deep.

<p>Interior of shaft grave 27</p>	
<p>Shaft grave 28 (with stone capping 23)</p>

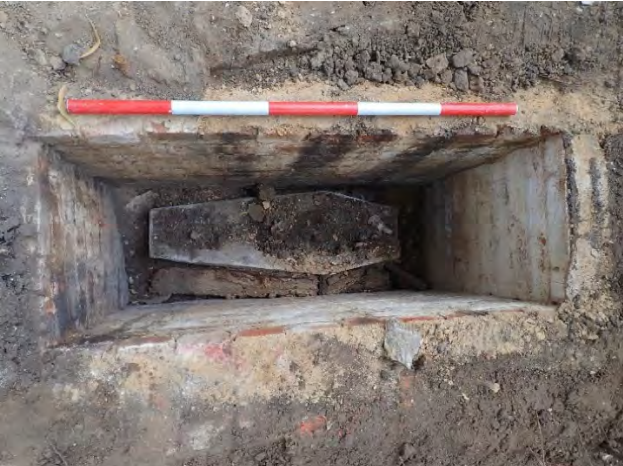
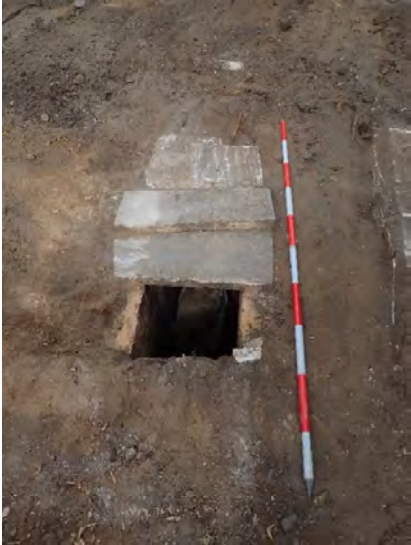
<p>Brick shaft grave with stone capping and limewashed interior. Bricks 230mm x 120mm x 70mm. Structure measured 1.4m x 0.7m.</p>

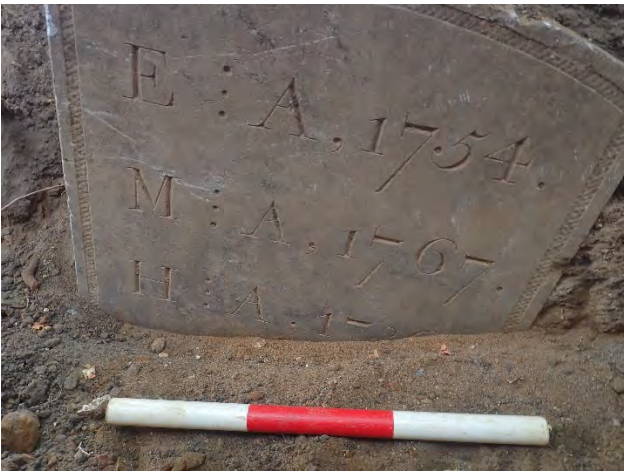
<p>Gravestone 29</p>

<p>Sandstone 0.39m x 0.032m x 0.55m. Potentially <i>in situ</i>.</p>
<p>Structure 30</p>

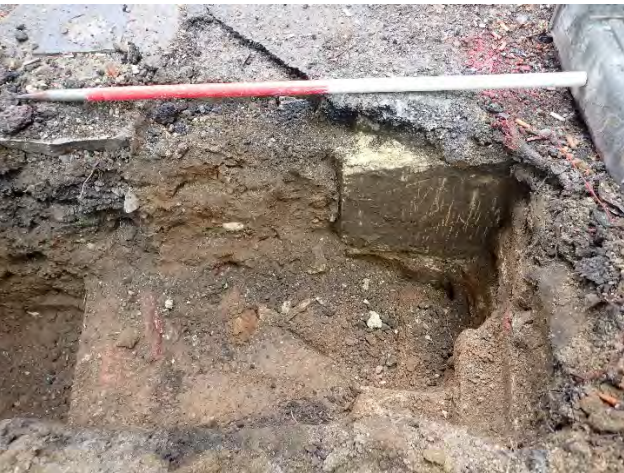
<p>Limestone block, 0.32m x 0.36m visible. Presumed foundation for pillar on western side of southeast entrance.</p>
<p>Gravestone 31</p>

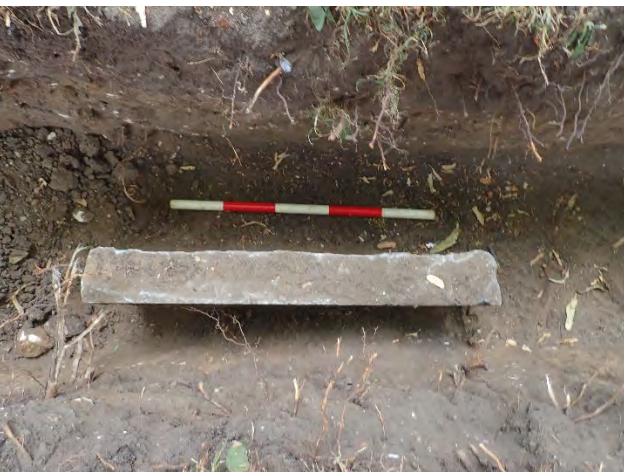
<p>Broken sandstone base, 0.62m x 0.2m x 0.08m. No inscription.</p>

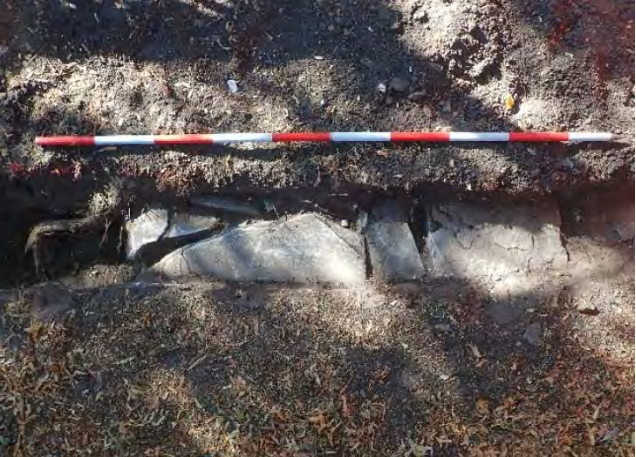
<p>Structures 32 and 33</p>

<p>Presumed capping stones for shaft graves (not exposed). Fragments of sandstone, interpreted as forming two separate structures.</p>
<p>Vault 34</p>

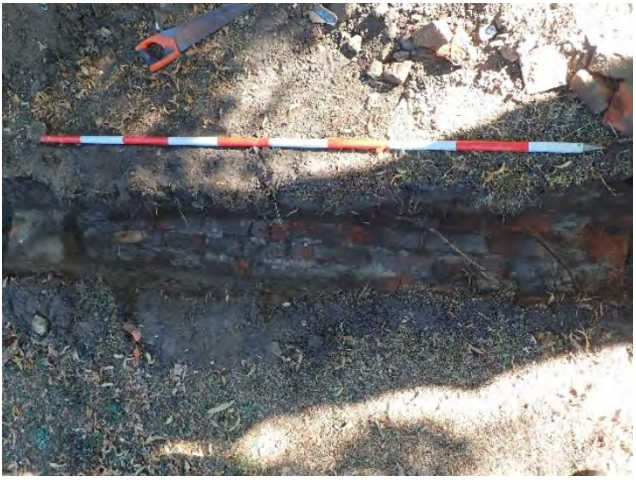
<p>Roof of vaulted shaft grave, 2.64m in length. Bricks 222mm x 111mm x 65mm.</p>
<p>Structure 35</p>

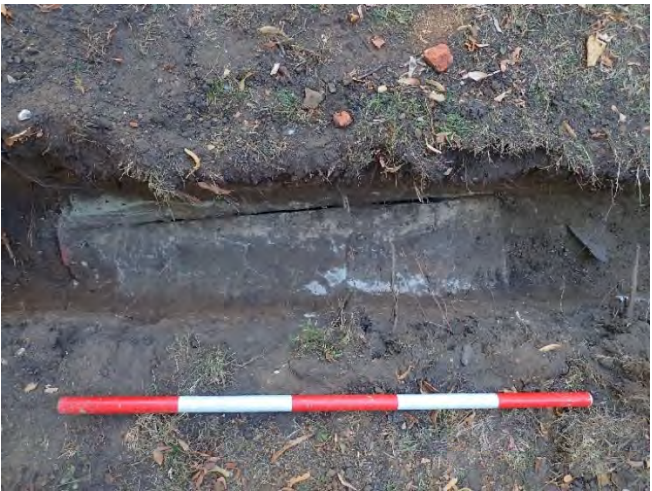
<p>Two sandstone slabs forming capping over shaft grave. Possibly a reused gravestone or ledger but no inscription. 1.18m wide.</p>

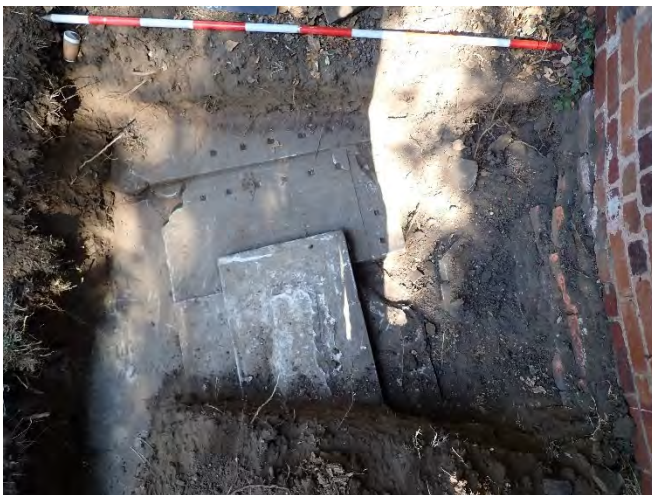
<p>Structures 36, 37, 38 and 39</p>

<p>Multiple sandstone slabs presumably lain as ledgers and part of monuments. Evidence of fittings for iron railings. Ledger 36 is visible at southern extent (left of photo). Partial inscription on ledger 36 reads  <i>“...of          ..RTS          ...ollege          ..e          ..his life          ...6 years”</i></p>
<p>Brick Vaults 40 and 41</p>

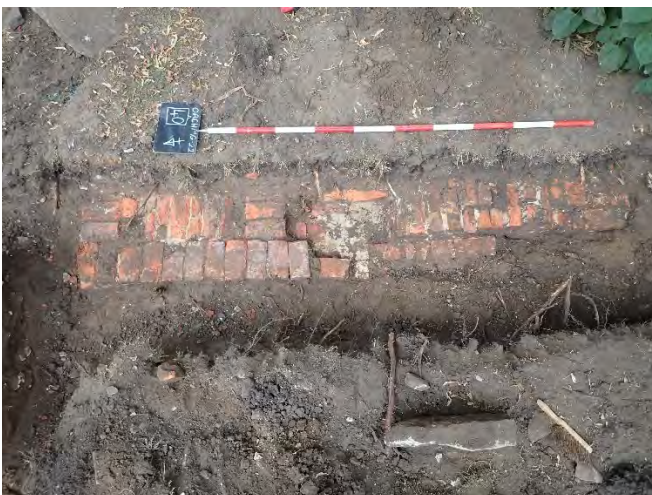
<p>Eastern end of two abutting brick shaft graves with vaulted roofs. Bricks 220mm x 106mm x 0.66m on both.</p>

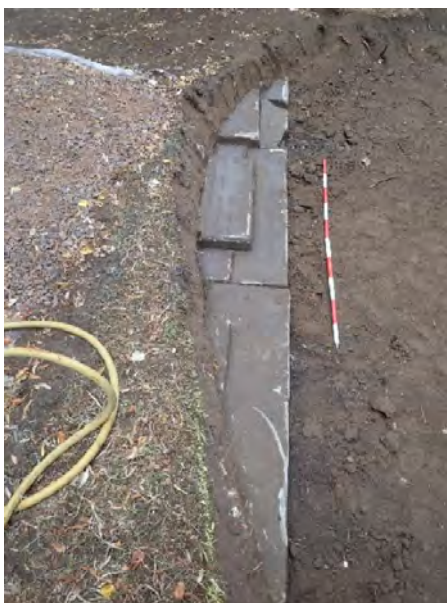
Structures 44,  
43, 22, 42 and  
45

Row of sandstone  
slabs supporting  
ledger stones 43, 22  
and 42 beneath extant  
bank.

Partial inscription of  
ledger 22 reads

Partial inscription of  
ledger 42 reads

*"...aged  
GARDNER"*

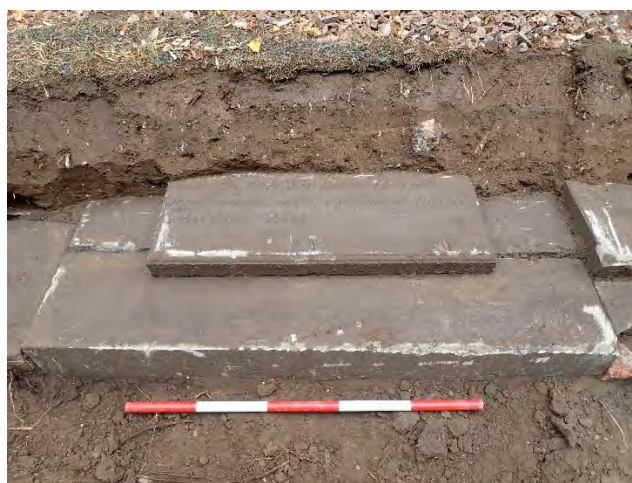
Detail of ledger 22 and supporting slabs.

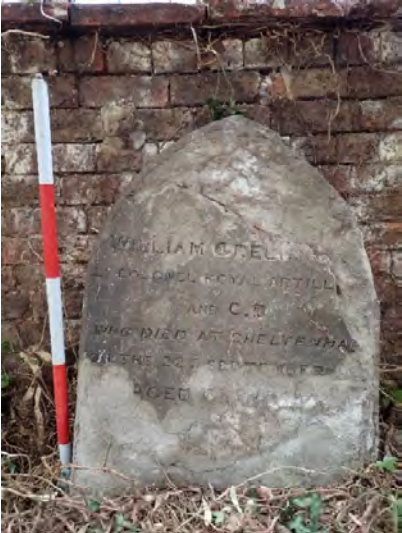
<p>Sandstone headstone revealed during vegetation clearance at western edge of the site. Unclear if <i>in situ</i>. Inscription reads:</p> <p style="text-align: center;"> <i>“WILLIAM GRELL...              LT COLONEL ROYAL              ARTILL...              AND C.D              WHI DIED AT              CHELTENHAM ON THE              22<sup>ND</sup> SEPTEMBER              AGED...”</i> </p>

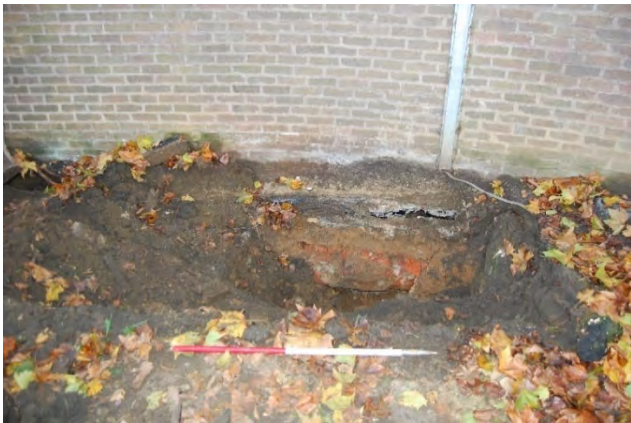
<p>Collapsed remains of brick shaft grave beneath ledger/slab 17. Most likely disturbed during construction of adjacent building. Bricks 240mm x 111mm x 60mm</p>

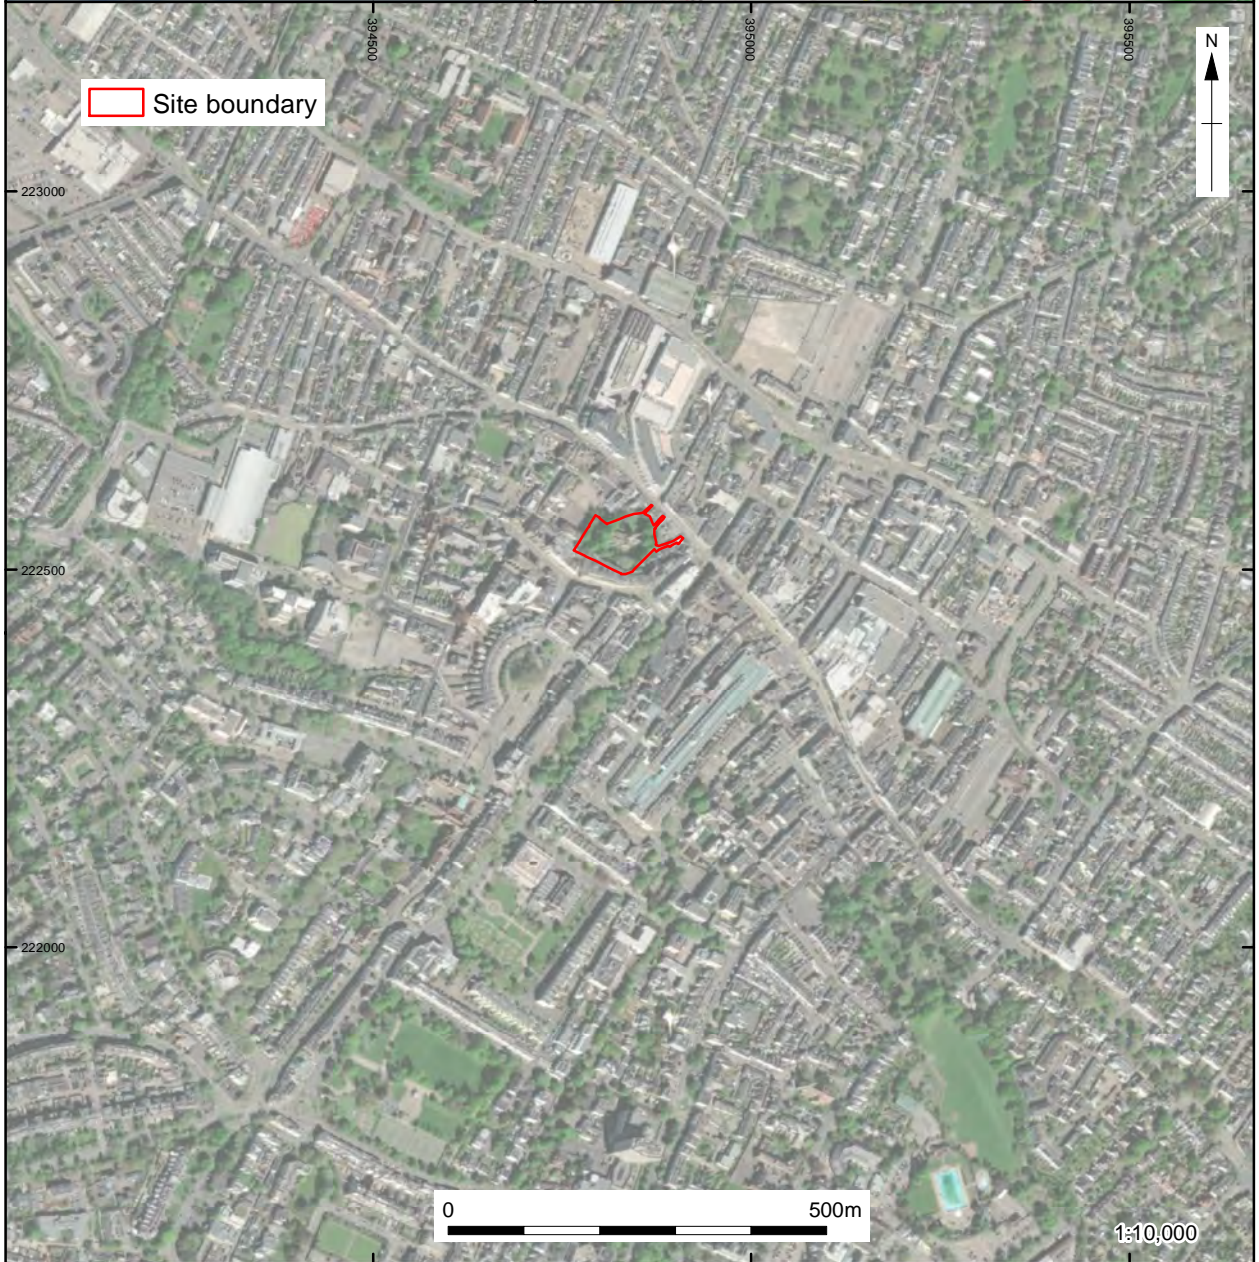
Figure 2: Extent of groundworks monitored and structures identified

4.3.1 In total 11 brick-built structures were recorded (Fig. 2). Five of these (1, 27, 28, 53 and 65) needed to be fully exposed to record them prior to backfilling to ensure that future collapse would not be possible. Where visible, the coffin fittings have been identified using the typology developed for Christ Church, Spitalfields (CCS), as part of the Spitalfields Project (Reeve and Adams 1993).

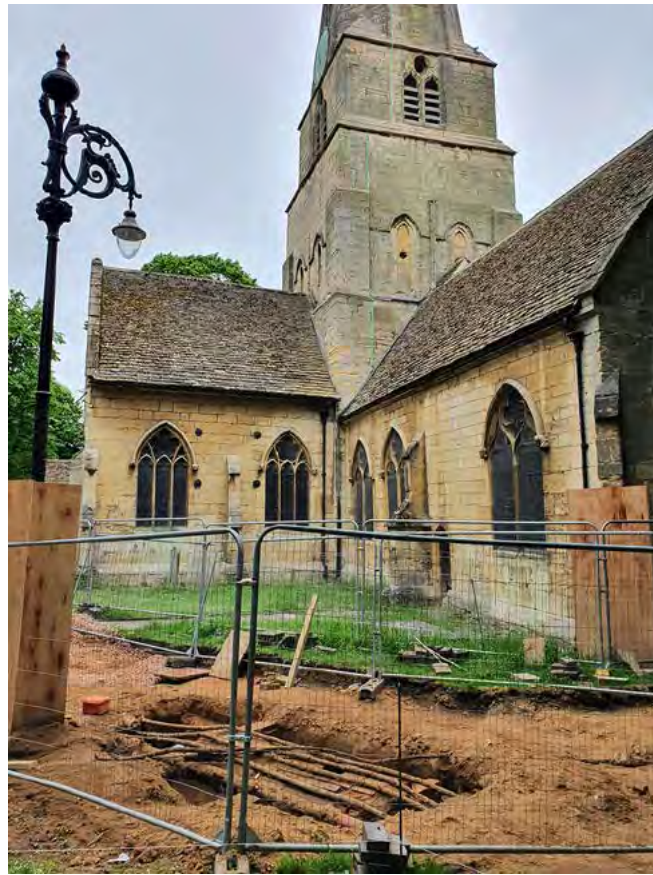
4.3.2 Tomb 1 was exposed beneath the footpath to the southeast of the Minster (Plate 1). The tomb was rectangular, aligned northeast-southwest with a vaulted roof. It measured 2.5m x 1.65m x 2.2m in depth. It was constructed from unfrosted bricks measuring 230mm x 140mm x 70mm. An entrance at its southwest end was blocked with two sandstone slabs (4 and 5) (Plate 2), measuring 0.76m x 0.53m x 0.035m and 0.86 x 0.46m x 0.04m. There was a hole in the roof which was probably damaged during the installation of electric cables which were laid directly on the roof of the vault.

Plate 4: General view of vault 1, revealed to the south-east of the Minster

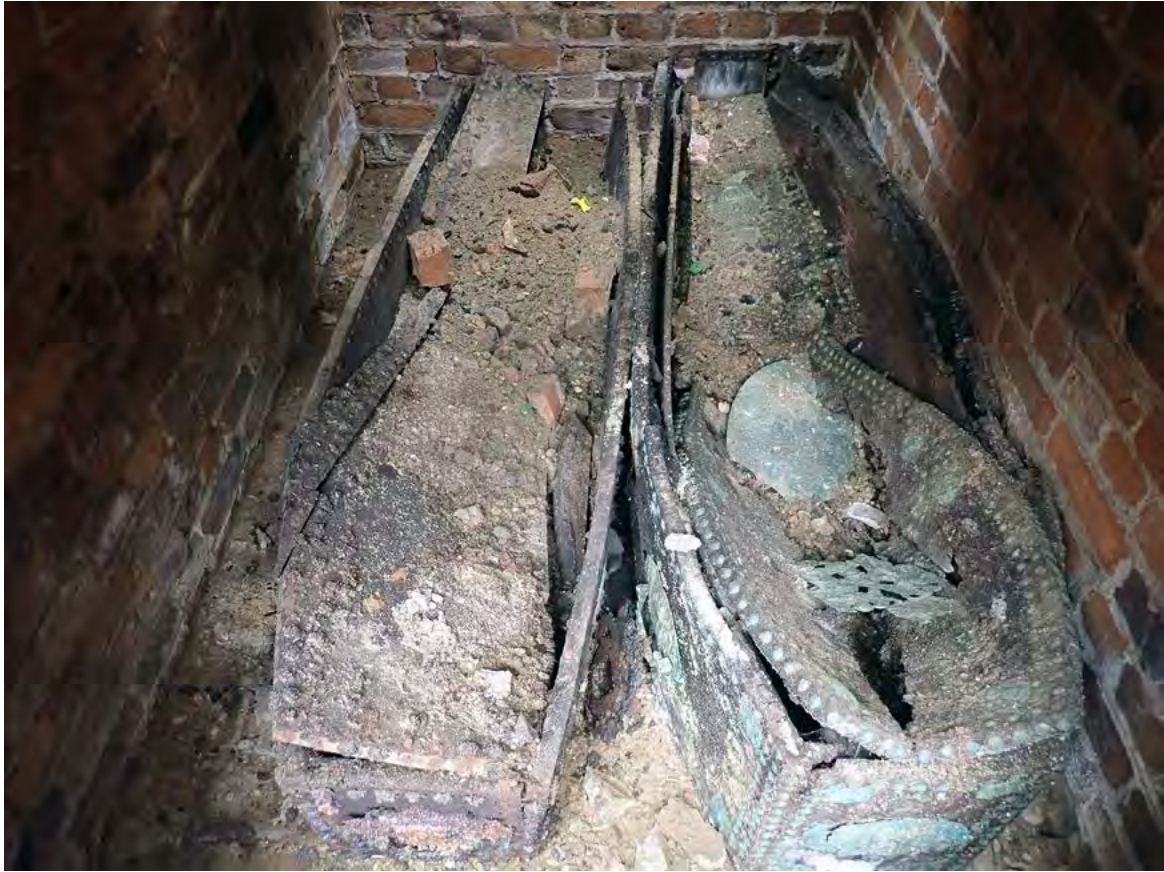
4.3.3 Vault 1 contained two adjacent coffins (2, 3). It was too hazardous to enter the vault and detailed recording was not possible, but both coffins were moderately well preserved, though had collapsed due to debris from the roof (Plate 3).

Plate 6: Coffins 2 and 3

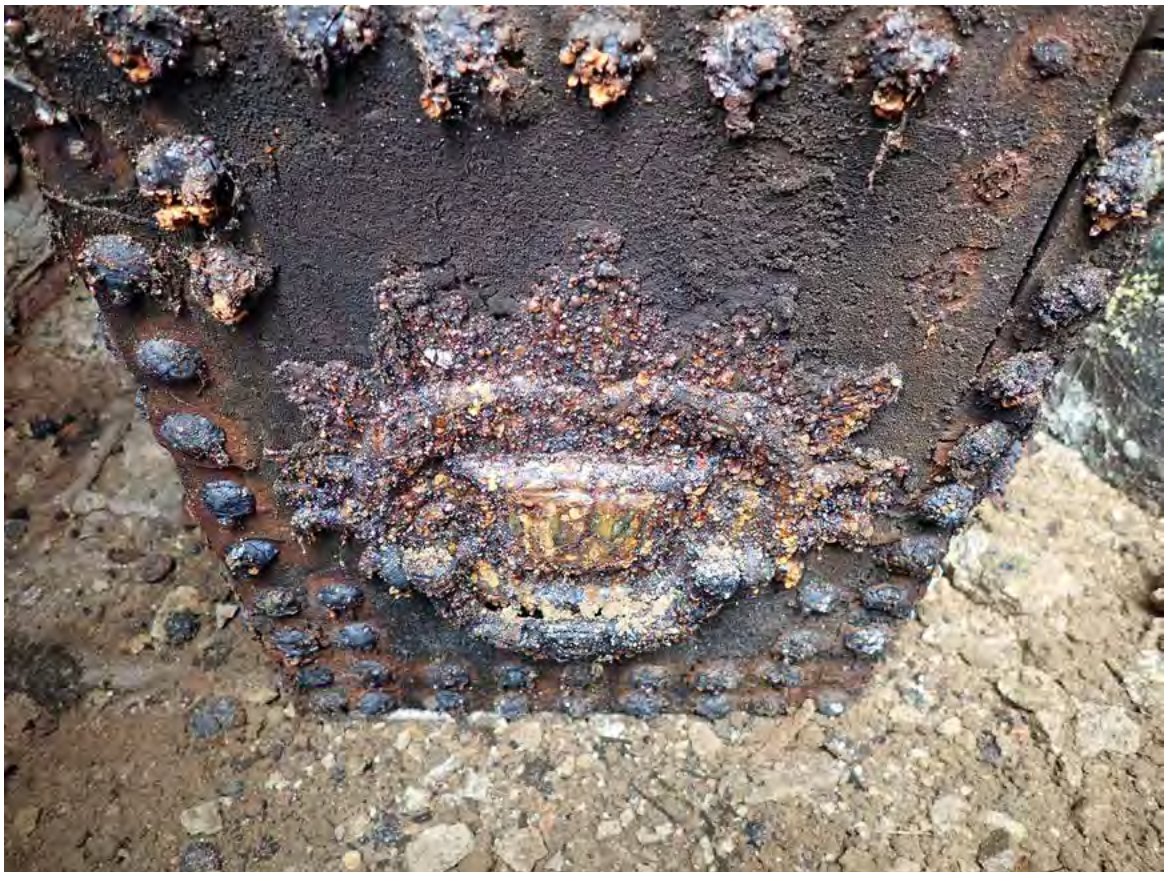
Plate 7: Grip plate on coffin 2

- 4.3.4 To the north, coffin 2 was tapered and constructed from a single layer of wood. It measured 1.86m x 0.46m x 0.36m. Two stamped iron depositum plates were visible on the lid. Typically there are three (head, breast, and foot), but in the case of coffin 2, the foot of the coffin had been obscured by fallen rubble. The head plate was in the same style as the grip plate, a sunburst (CCS type 12). A rectangular breast plate with an outer border floral motif was partially exposed. It was customary for the breast plate to have an inscription, which in this case may have been obscured by corrosion. Double rows of iron studwork were evident on the sides, lid, and west end of the coffin, almost certainly used to affix baize upholstery, which was preserved in a fragmentary state. The coffin also had iron grips (CCS type 6) and grip plates (CCS type 14) fixed to the sides. The grip and grip plate, although largely corroded had remnants of gold colored gilding (Plate 4). A further grip plate on the side of the coffin was evident, although had become detached.

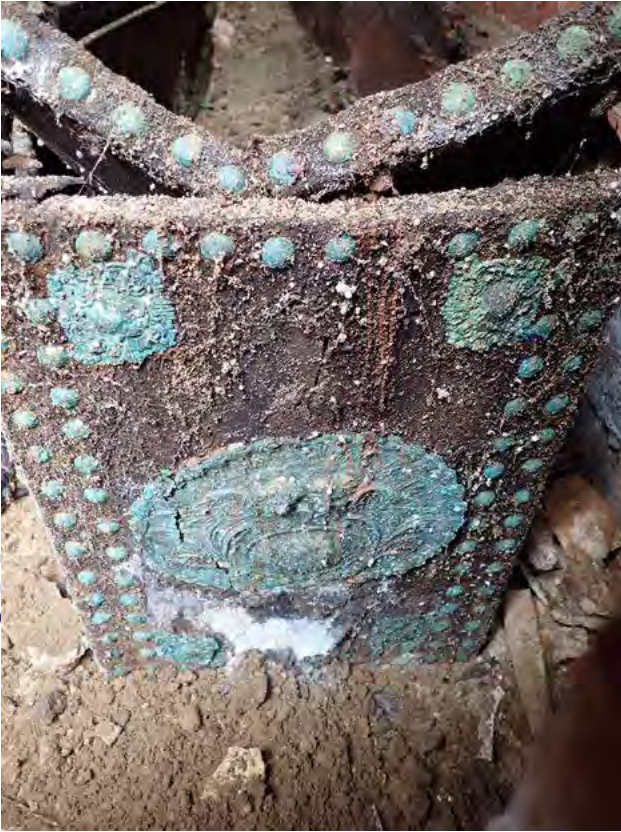
Plate 8: Grip plate, studwork and escutcheons on coffin 3

- 4.3.5 Coffin 3 was a smooth-shouldered coffin constructed with two layers of wood. It was slightly larger than coffin 2, measuring 1.86m x 0.57m x 0.4m high. It had a decorative pattern of gilt brass studwork in double rows across the lid and sides of the coffin (Plate 5). Fragments of baize were also visible and originally would have covered the exterior of the coffin. The end and lid of the coffin were decorated with gilt brass escutcheons in a floral design (CCS type 1). Two copper grip plates were visible, one on its end and one on the side, although more would have been present. The grip plate on the side of the coffin depicted two cherub heads (CCS type 3). The lid of the coffin had two gilt brass lid motifs. The head plate depicted two angels playing trumpets beneath a crown with a cherub praying between them. These did not match any of the styles recorded by Reeve and Adams (1993) and possibly represent a new type (Plate 6). The footplate was visible, though not accessible to record in detail, but appeared to depict an urn holding flowers. The breastplate was in the style of a shield with an inscription. The inscription read: *"Mary Bastin died Jan 13th 1811 aged 35 years"* (Plate 7).

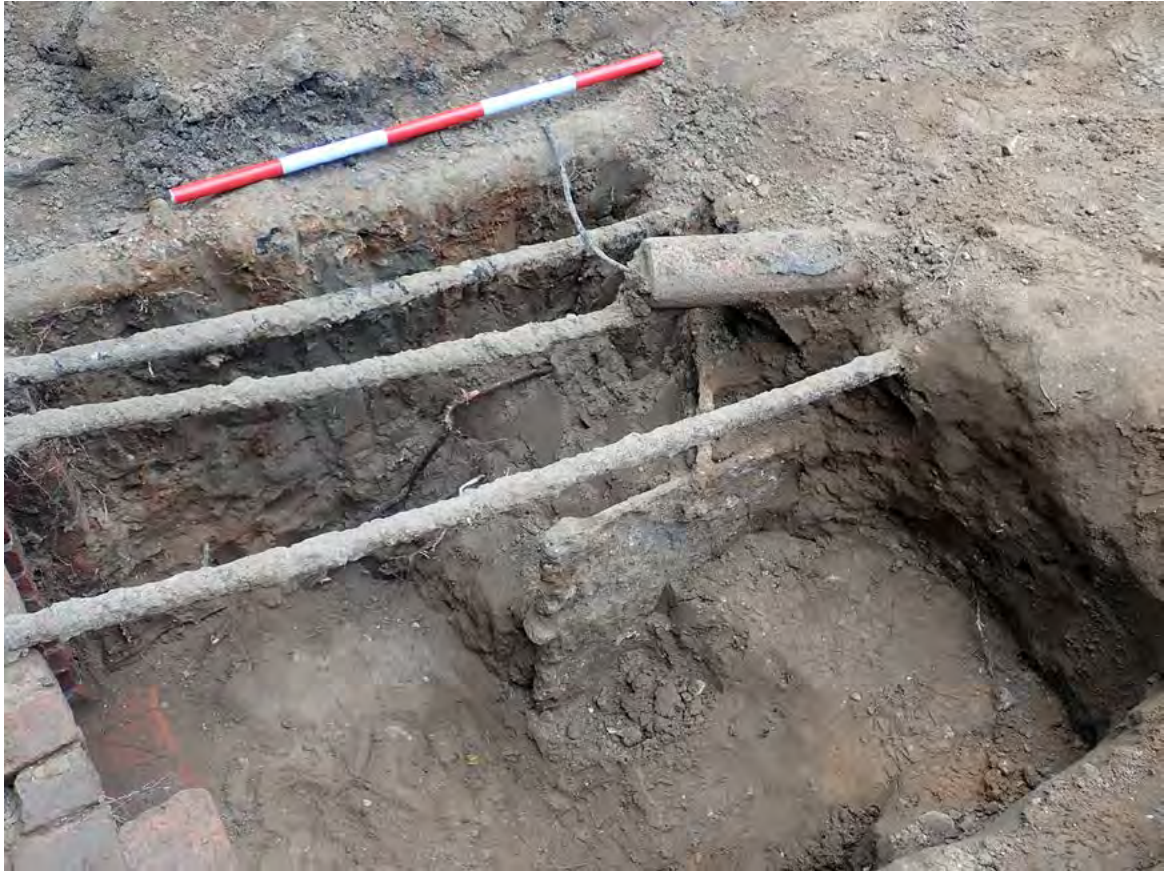
- 4.3.6 Just to the west of the entrance to the vault an iron object (6) was partially exposed. It comprised a large plate resting vertically in the soil, of which at least 0.57m x 0.55m was visible. Attached to the top of the plate and extending horizontally to the southwest was a corroded length of iron. Although the full extent of the object was not realised, it is likely to represent part of a mort safe, which would have been installed as a security measure against resurrectionists (body snatchers).

Plate 11: Mort safe (6) (view to south-west)

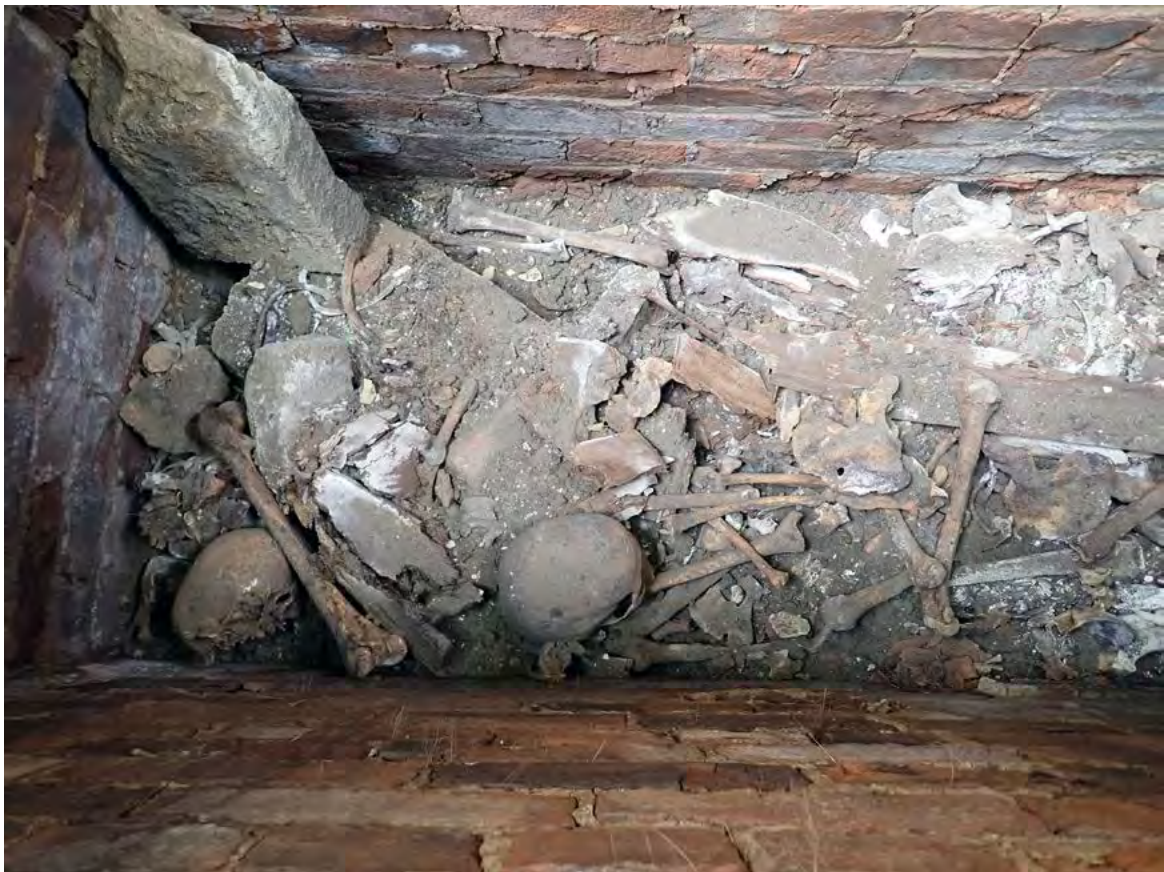
- 4.3.8 The grave was filled with disarticulated human remains (Plate 9) appearing to represent at least three individuals. Two largely complete skulls and a fragmented skull were visible, along with numerous long bones and other bones. A few fragments of decayed wood, presumably representing a coffin or coffins, were also evident. Three large, and numerous smaller sandstones have fallen into the grave, apparently causing damage to the remains. The origins of these later additions were not evident but were probably introduced during a phase of disturbance in the area.

Plate 12: Disarticulated human remains in shaft grave 27

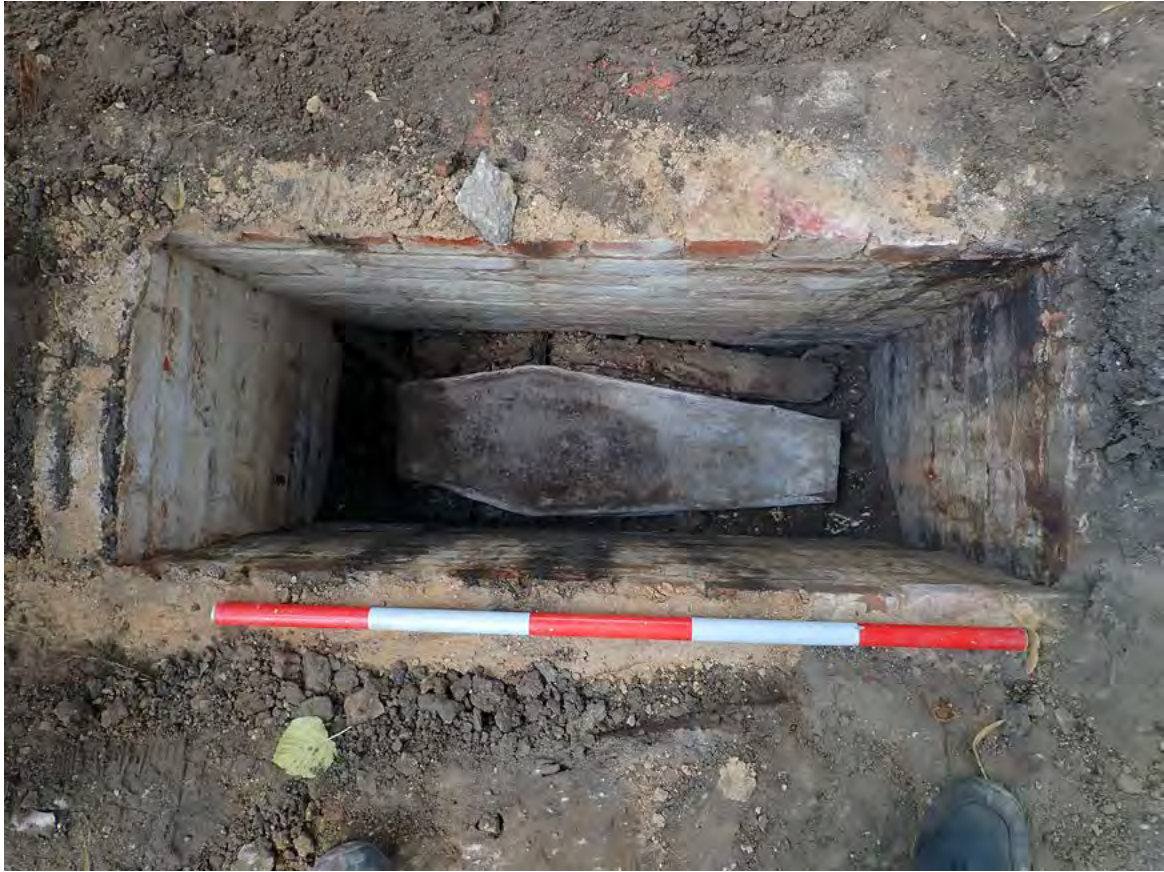
- 4.3.9 Shaft grave 28 lay immediately to the southwest of grave 27. It measured 1.4m x 0.7m in plan and 1m deep. It was constructed from unfrosted bricks measuring 0.23m x 0.12m x 0.07m, laid in an English garden wall bond. The grave was capped by four limestones of slightly variable dimension but overall measured 1.41m x 0.76. The thickness of the stones was between 0.09m and 0.15m.
- 4.3.10 At the base of the shaft grave was a shouldered lead coffin (25). The coffin measured 0.9m long and 0.31m wide and was estimated to be 0.2m high. The outer wooden coffin had largely disintegrated, leaving large fragments of wood with iron studs along the sides of the coffin (Plate 10).

Plate 13: Lead coffin within shaft grave 28
