LANCASTER
UNIVERSITY
ARCHAEOLOGICAL
UNIT

RUFFORD OLD HALL
LANCASHIRE

FABRIC SURVEY REPORT

Archaeological Fabric Survey

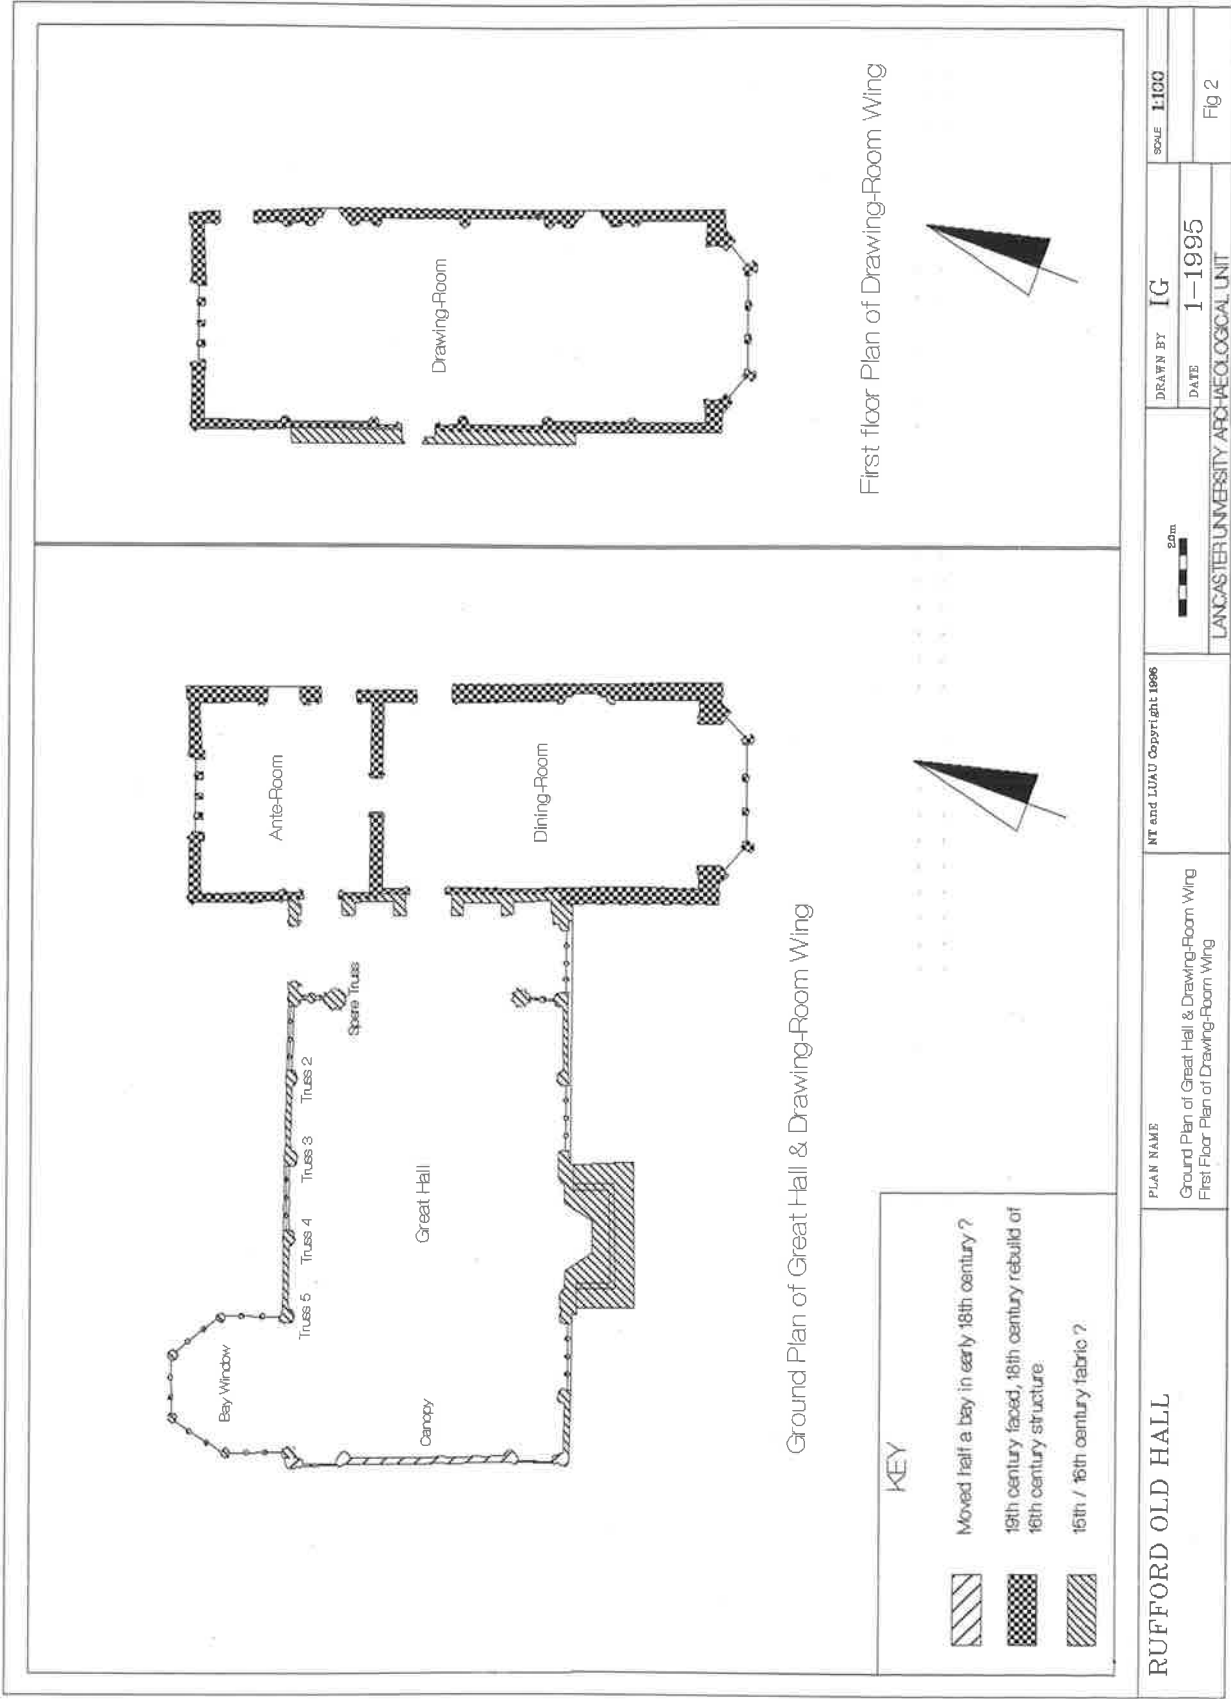
Fig 2: Ground Plan of Great Hall / Drawing-Room Wing and First Floor Plan of Drawing-Room Wing

- A ground floor plan of the Great Hall, Ante-Room and Dining Room at window-height (**Fig. 2**).
- A plan of the Drawing Room at window height (**Fig. 2**).

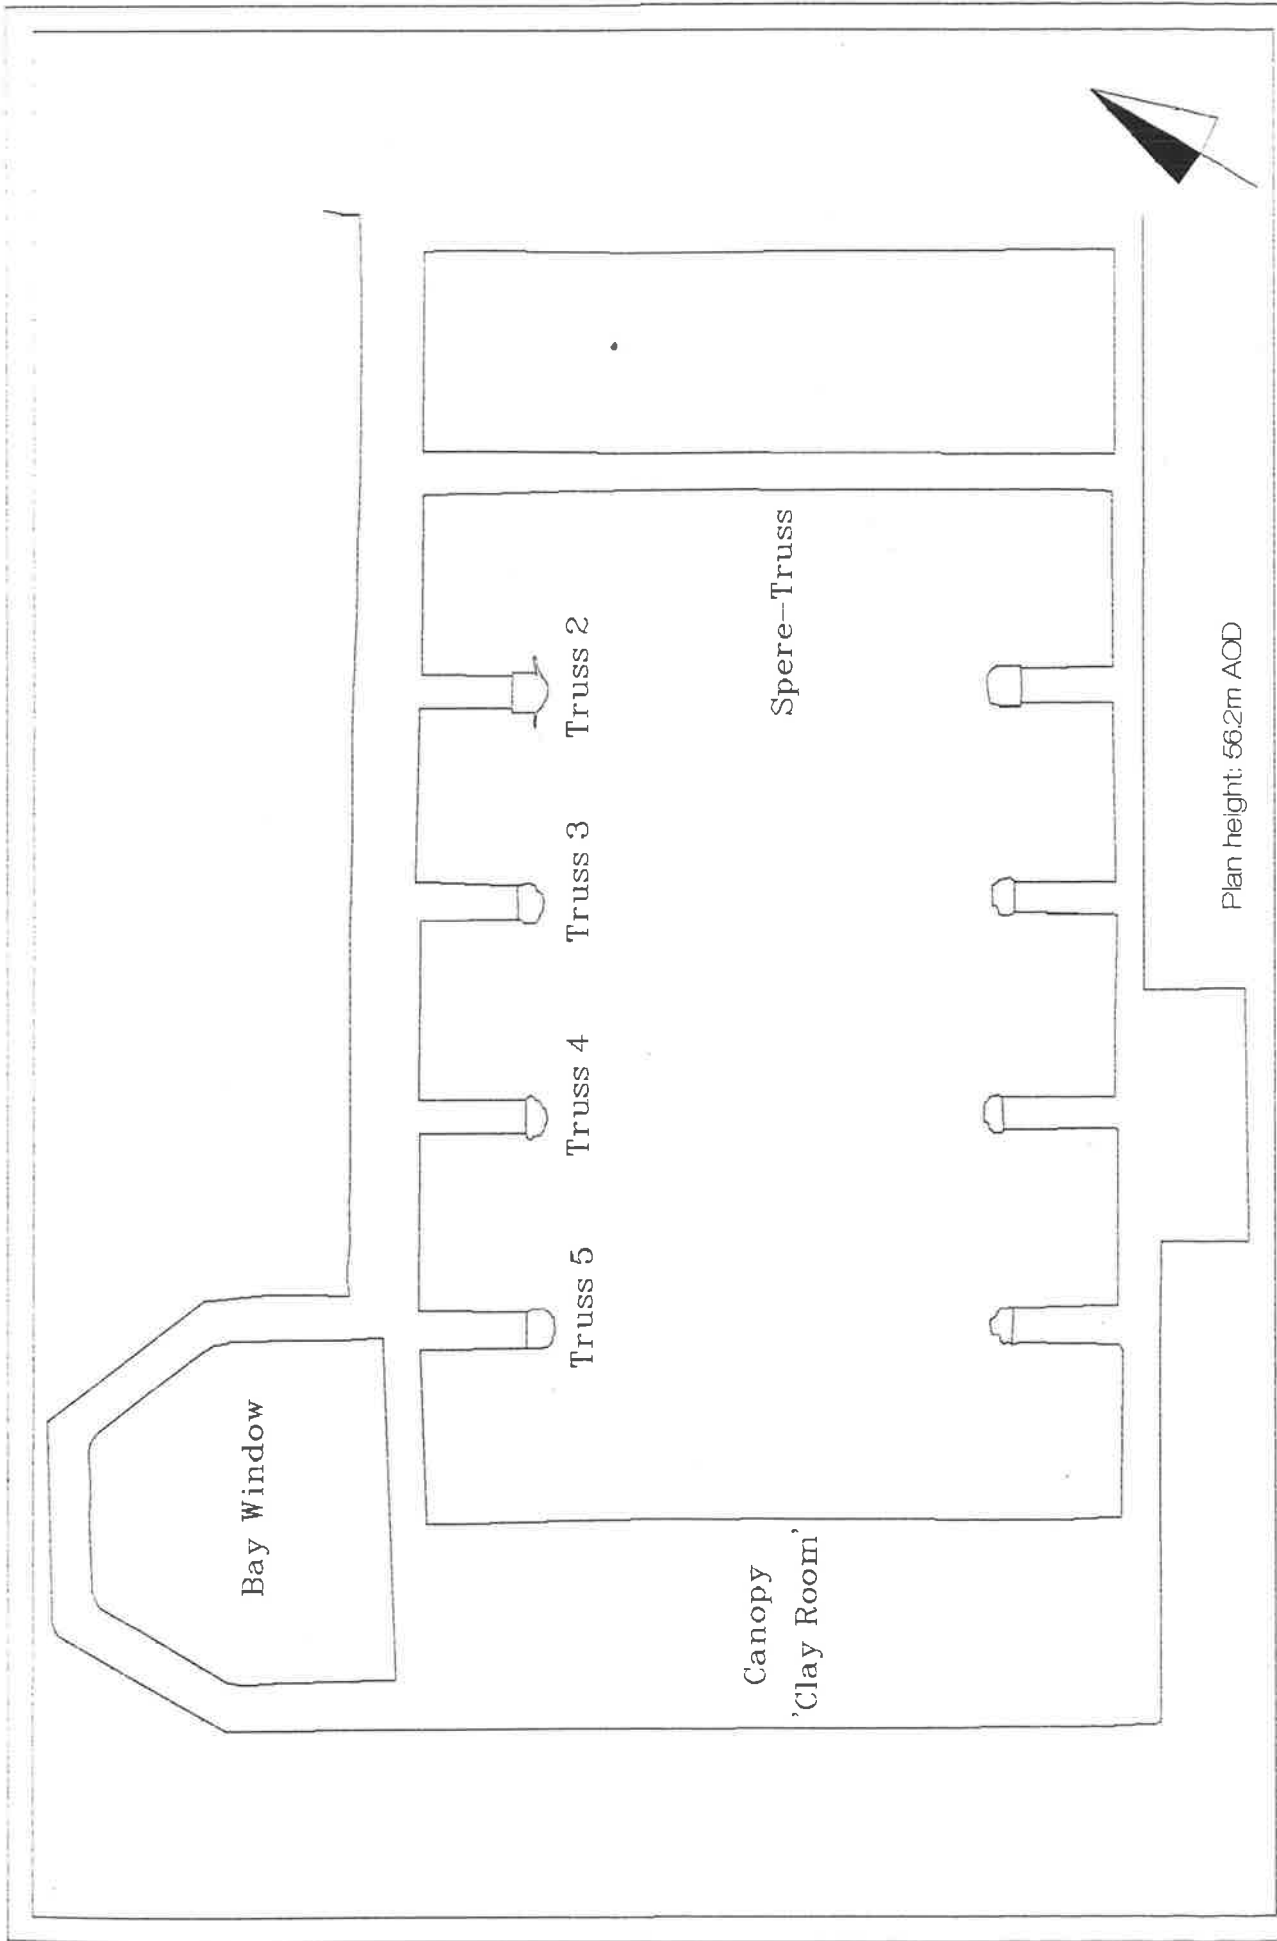
Fig 3 Great Hall Roof Plan

- A plan of the Great Hall at internal wall-plate level (**Fig. 3**).
- A cross-section through the long axis of the Great Hall and across the Drawing Room Wing, including the lantern in section (**Fig. 4**).

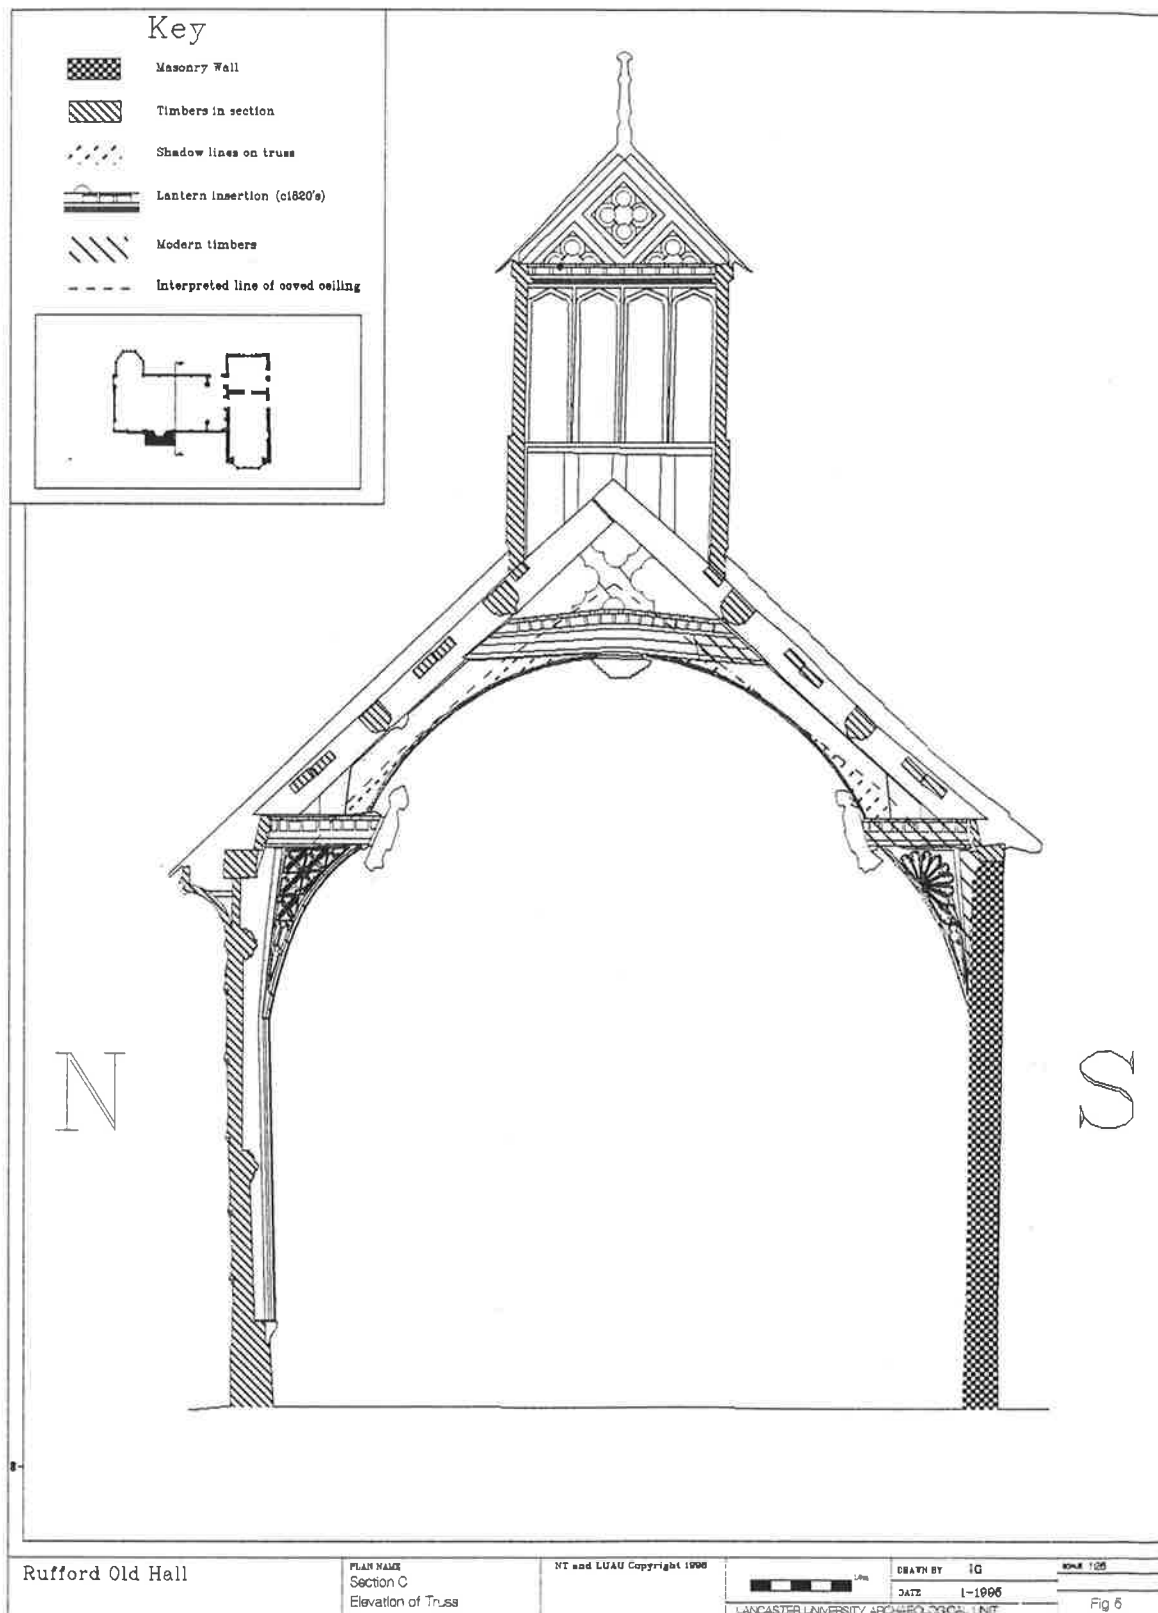
Fig 5 North/South Cross Section through Great Hall

- A cross-section through one bay of the Great Hall, showing a truss and the east side of the lantern in elevation (**Fig. 5**).
- A cross-section through the Drawing Room Wing (**Fig. 7**).

In the seventeenth century, a brick wing was constructed to the north-east of the Great Hall at right angles to it. J.T. Smith's analysis of the building concludes that this wing was never intended to communicate with the Great Hall, but formed the residence of an entirely separate social unit; the wing and the Great Hall were not united until the refurbishment of the nineteenth century (Smith 1971, 165) and the construction of the drawing room wing. This conclusion was reached by a study of the locations of doors, but is also suggested by the considerably lower floor level in the brick wing. In the eighteenth century, a new structure was built on the site of the former service rooms between the two buildings; this was a cross-wing fabricated from timbers salvaged from the sixteenth-century buildings of Holmeswood Hall, to the west of Rufford close to the former shores of Martin Mere. In the following century, after a long period of neglect and a variety of uses (including a period when it was used as a schoolroom), the whole of Rufford Old Hall was again inhabited on a permanent basis: this was marked by a radical campaign of renovation of the fabric, especially of the cross-wing, in a neo-Tudor idiom and the construction of a new block in brick to the east of the wing. It seems likely that the Great Hall was also refurbished at this time, with the removal of the coved ceiling (Section 3.11) and possibly also the replacement of several of the angel terminals to the hammer-beams. Most dramatic of the developments to this part of the building was the construction of the large lantern in the centre of the Great Hall roof, which is supported by Trusses 3 and 4 (figs 1 and 5).

The insertion of the lantern in the 1820's was fitted in the bay between trusses 3 and 4, and involved a significant alteration to the roof design to accommodate it (Fig 5). The tops of the principal rafters were replaced with new timber, along with the cusped braces above the collar beam. The upper purlins were left intact, although lantern timber supports were added.

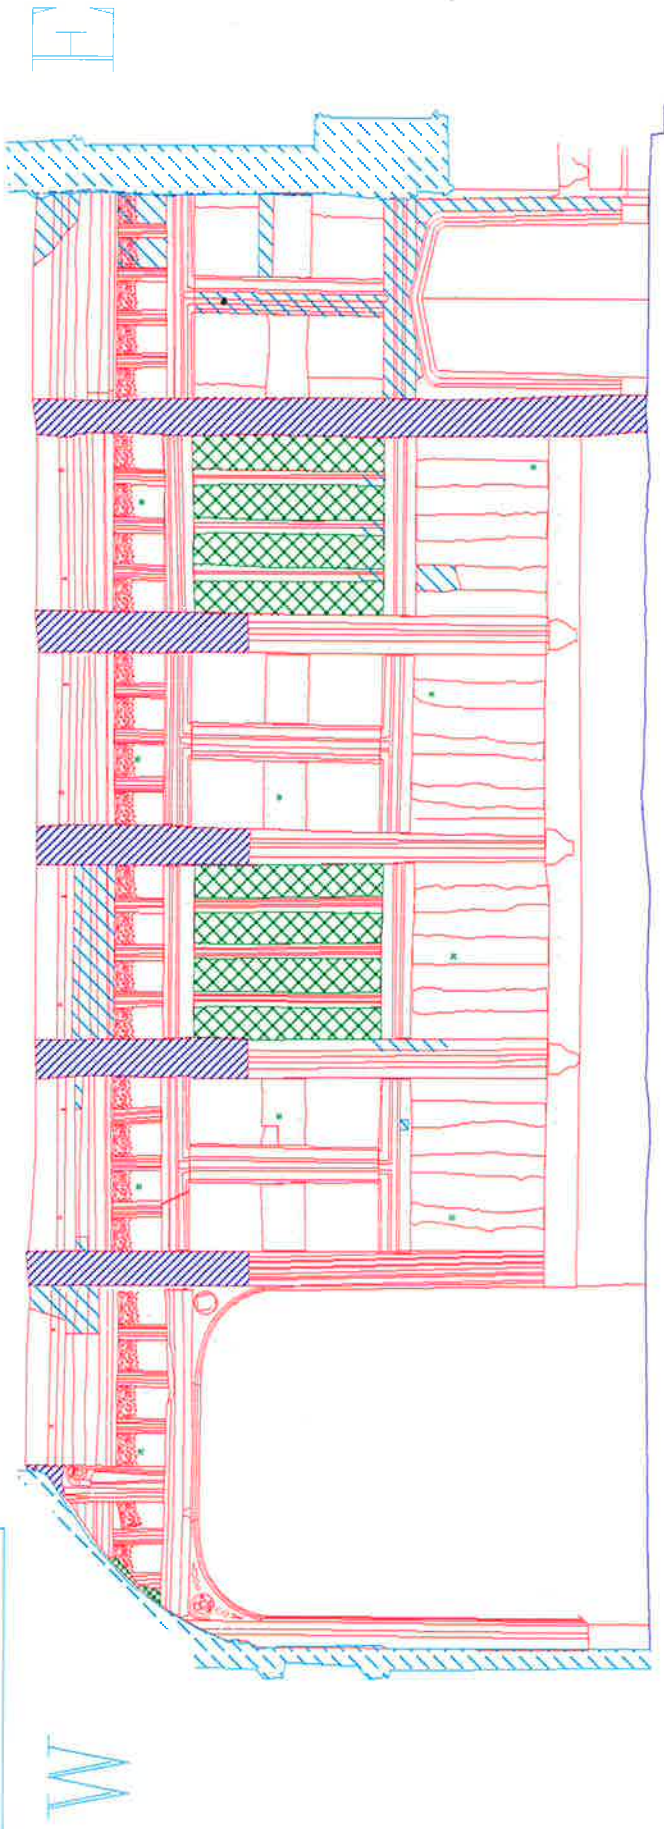
Fig 8 North facing internal elevation

- A drawing of the eaves detail (following removal of a small area of eaves covering)
- Internal elevations of the walls of the Great Hall (**Figs. 8, 9, 10 and 11**).

Above the opening of the bay window can be seen the top part of a moulded post, resting on the lintel of the bay window (fig 8); this now supports the bressumer of the canopy and is matched on the southern side by a post running down to the dwarf wall. Both of these posts bear figural carving and appear to be of similar profiles. In this interpretation, the south-western corner post has been lost. It is now felt that these posts formerly supported a roof truss of some form, marking this bay division.

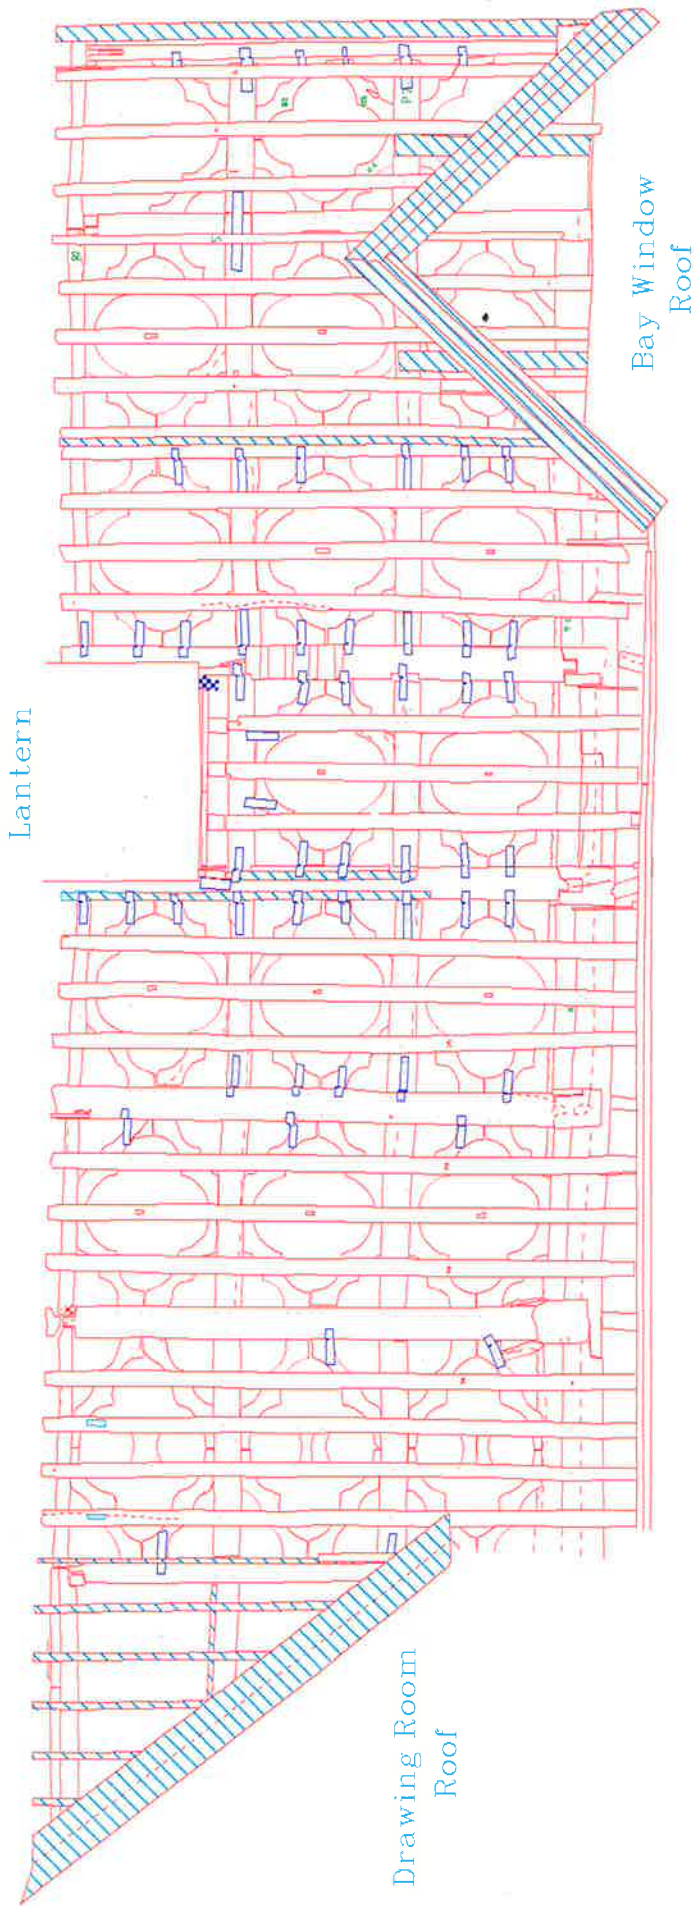
Fig 12 North facing external roof structure

- Drawings of the roof pitches of the Great Hall after removal of the roof covering (**Figs. 12 and 13**).
- An exploded diagram of one bay of the internal roof pitch, showing the arrangement of rafters, purlins and wind-braces (**Fig. 14**).

At the request of the National Trust, examination of the roof junction between the Great Hall and the Drawing Room wing was deferred until after the commencement of the main repair programme and the removal of the roof covering (figs 12 and 13). These works revealed that the rafters in this area are not from the original structure but are relatively recent in date; they are plain and of square section. However, peg-holes in the principal rafter of the eastern closed truss of the Great Hall showed that the purlins continued east of the hall, these purlins did not appear to be new timber and may have been the originals.

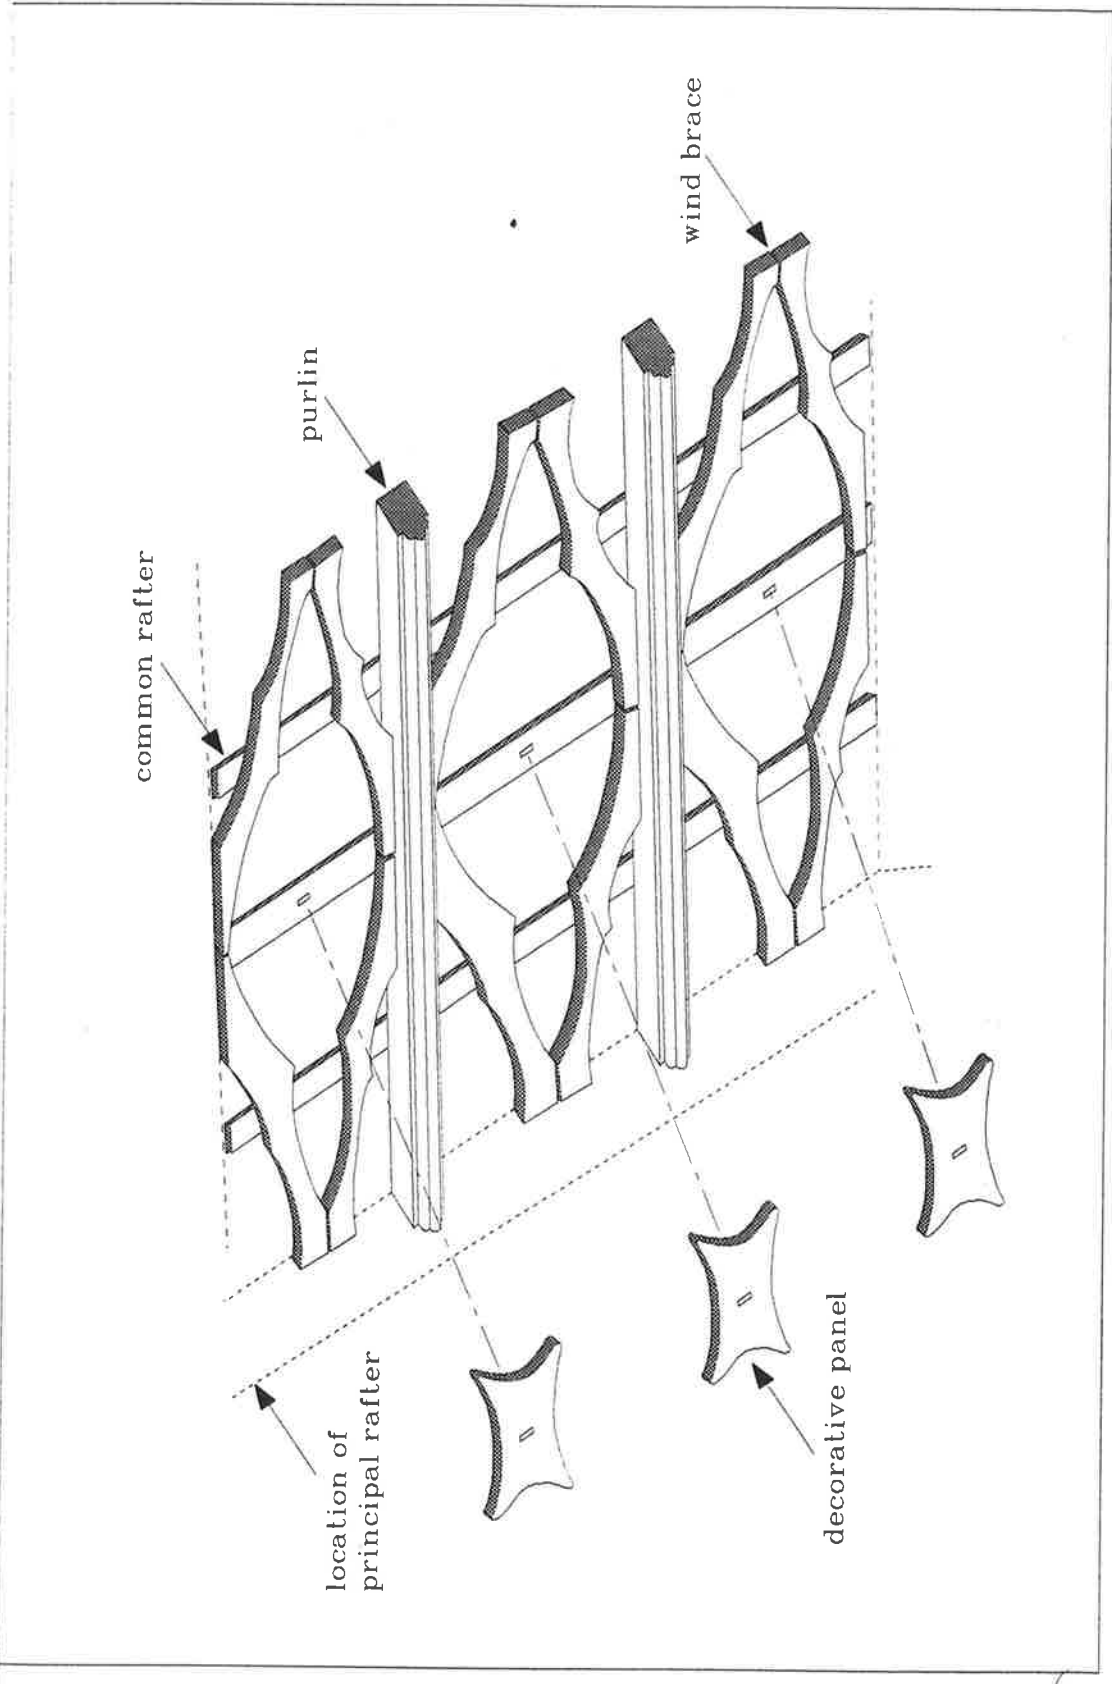
Fig 14 Diagram showing roof construction

<p>RUFFORD OLD HALL</p>	<p>DIAGRAM SHOWING CONSTRUCTION OF RAFTERS & WIND BRACES OF INTERNAL ROOF PITCH</p>	<p>COMMISSIONED & FUNDED BY: THE NATIONAL TRUST</p>	<p>NOT TO SCALE Fig 14 LANCASTER UNIVERSITY ARCHAEOLOGICAL UNIT</p>	<p>DRAWN BY: JFR. JA DATE: 04/96</p>
--------------------------------	---	---	---	--

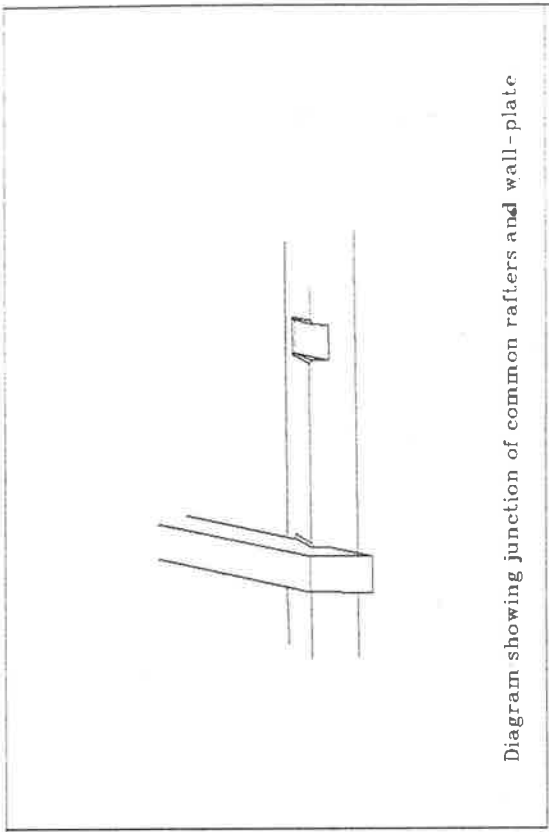
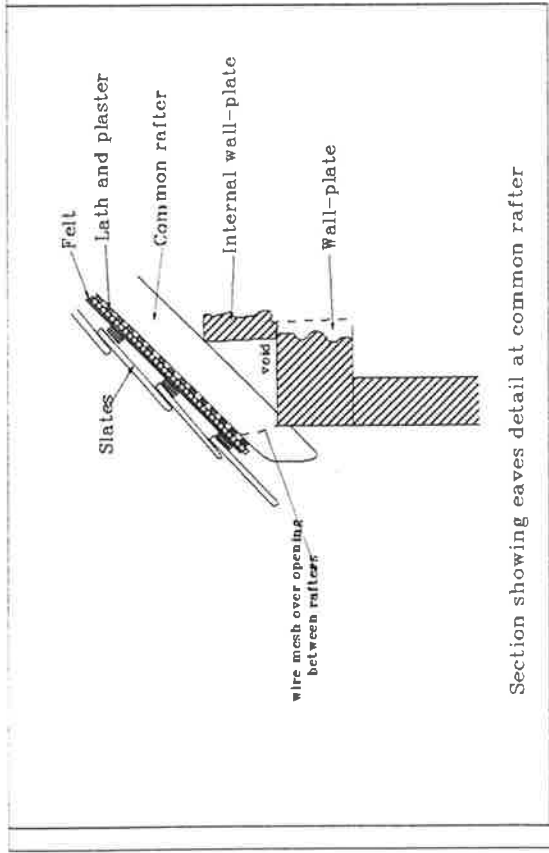
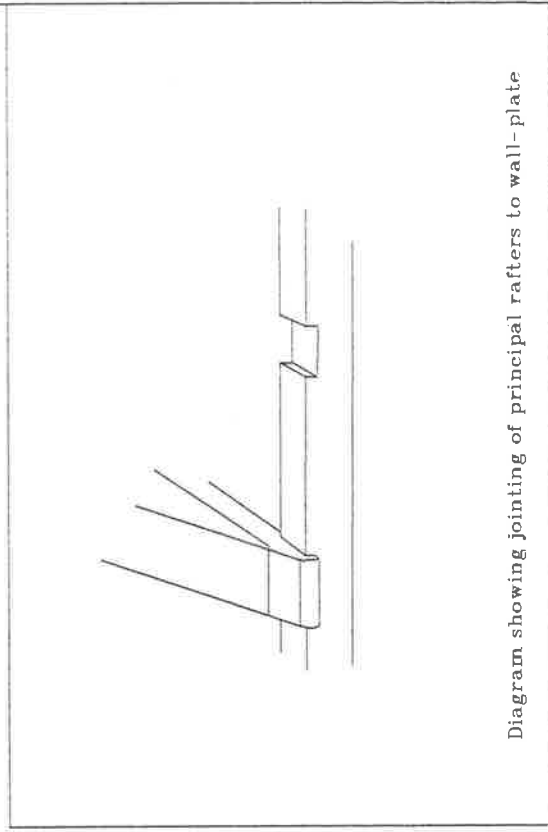
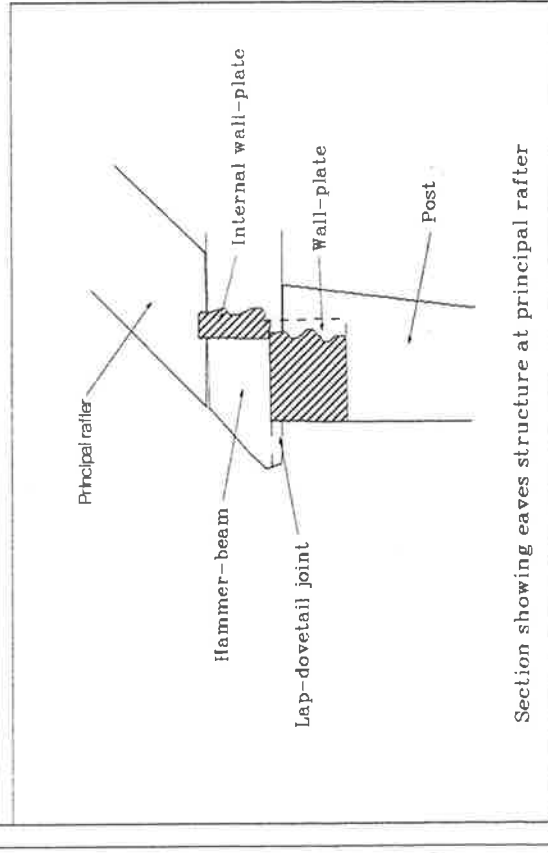
RUFFORD OLD HALL	DIAGRAM SHOWING CONSTRUCTION OF RAFTERS AND WALL-PLATE AT EAVES LEVEL		NOT TO SCALE Fig 15	DRAWN BY: JFR, JA DATE: 04/86
	COMMISSIONED & FUNDED BY: THE NATIONAL TRUST		LANCASTER UNIVERSITY ARCHAEOLOGICAL UNIT

Diagram showing junction of common rafters and wall-plate

Section showing eaves detail at common rafter

Diagram showing jointing of principal rafters to wall-plate

Section showing eaves structure at principal rafter

Following a request from the National Trust for an examination of the eaves detail, six slates were lifted from the area of the eaves on the south side of the Great Hall and the felt was pulled back from a small area. This indicated that the junction of the hammer-beam and the wall-plate is of the standard lap-dovetail type of assembly. In particular, the hammer-beams project slightly beyond the line of the wall-plate and the dovetailed soffits are clearly visible. The common rafters sit in shallow trenches cut into the upper outside corners of the wall-plate and also project slightly beyond the line of the wall.

This examination also revealed that the internal 'wall-plate' is not a structural feature but has more of a decorative function. Between the main (external) wall-plate and the internal feature is a void of approximately 300mm in width. The internal wall-plate sits on the edge of the main wall-plate and is jointed into the hammer-beams at the end of each bay, but does not completely close the gap between the wall plate and the underside of the common rafters or the laths of the roof. Since externally the spaces between the rafters are open to the elements (though wire mesh has been placed over these openings to keep birds out), the eaves of the great hall on the south side are relatively exposed to the elements.
