# New Sewer Box Vicarage Box Wiltshire

## Archaeological Watching Brief

**Document Title:** New Sewer, Box Vicarage, Box, Wiltshire

**Document Type:** Watching Brief

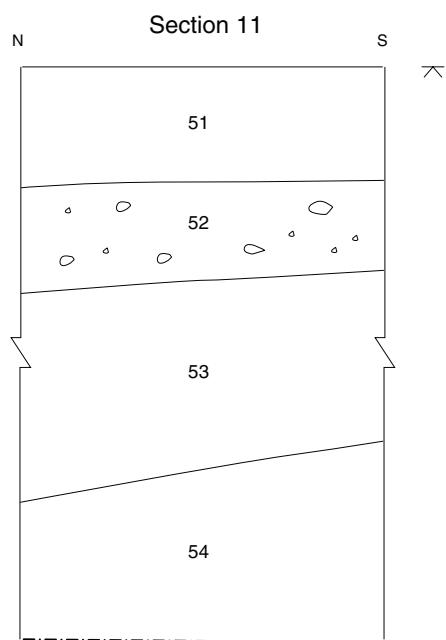
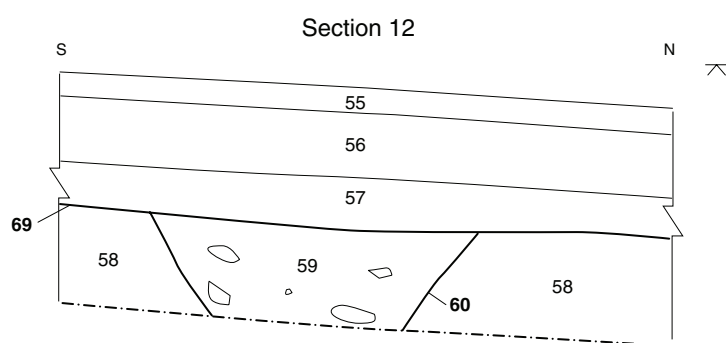
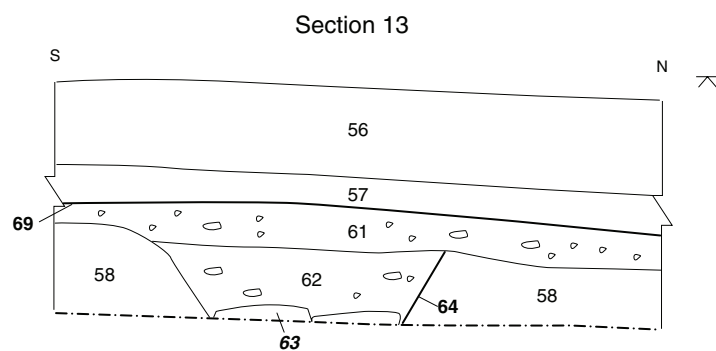
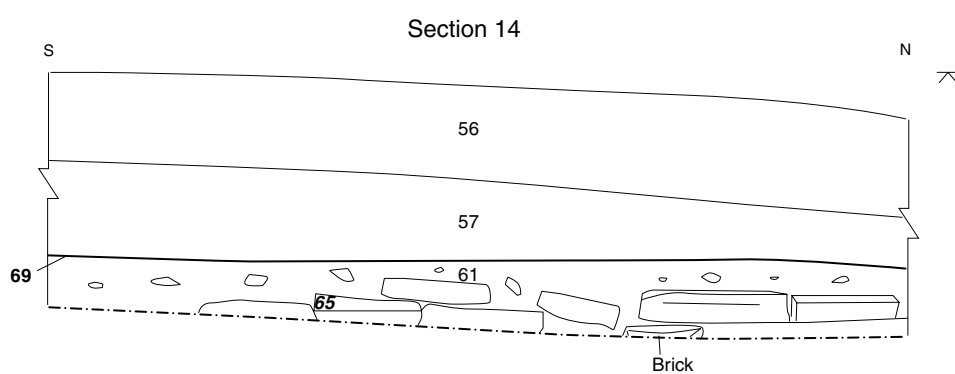
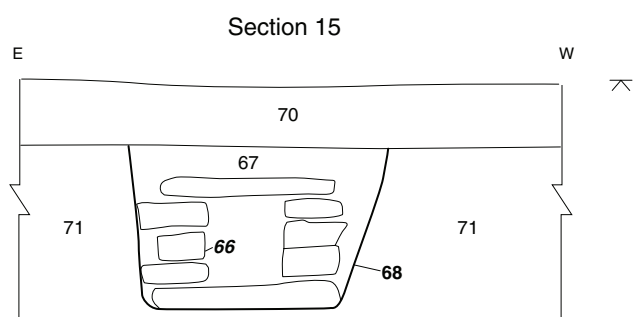
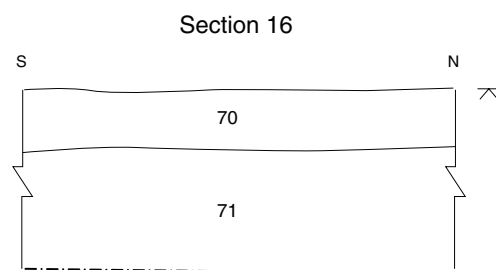
Figure 3 : Sections

- 3.1.1 At the northern end of the trench the underlying natural, a light grey silt clay (54) was encountered at a depth of 1.25 m below the current ground level (Fig. 3, Section 11). This was overlaid by a 0.5 m deep layer of dark grey clay silt (53), a probable layer of colluvium. This was sealed by a 0.35 m deep layer of yellow-brown silt clay (52), which also contained numerous small fragments of limestone and lenses of crushed stone. It is possible that this layer may represent a demolition layer associated with the Roman Villa, however the lack of dating evidence recovered suggest that it may equally be the construction layer associated with the garden wall. This layer was sealed by a 0.4 m deep layer of dark grey-brown silt loam (51), the current garden soil.

- 3.1.2 Approximately 2 m further south a layer of grey brown clay silt (58) was encountered at a depth of 0.5 m below the current ground level (Fig. 3, Section 12). This layer appeared very humic and produced some charcoal flecking suggesting it is a layer of worked soil, possibly a continuation of the buried soil horizon noted in the 2006 excavations. This was cut by a 1 m wide linear feature with steeply sloping sides, whose depth was in excess of 0.35 m (60). This was filled by a light grey silt loam (59) containing many small angular fragments of limestone. The feature was aligned east-west, consistent with the alignment of other features observed within the Roman site. The presence of the stone fragments suggest that this may represent a robber trench.

- 3.1.4 Layer 58 continued throughout this area and was cut by a second east-west aligned robber trench (64) a distance 6.8 m south of the robber trench 60 (Fig. 3, Section 13). This trench measured 0.9 m wide, had steeply sloping sides and measured 0.2 m deep. At the base of this feature the truncated remnants of a 0.6 m wide wall constructed of roughly dressed limestone blocks and lime mortar was encountered (63). The alignment and location of this feature suggests that it may be a continuation of Wall 5 exposed in Test Pit 1 of the 2006 evaluation. The remainder of the robber trench was filled with a light grey clay silt (62). Sealing this feature and overlying layer 8 was a 0.12 m deep layer of dark yellow-brown clay silt (61) which produced numerous angular fragments of limestone suggesting that it may represent a demolition layer. This layer had been truncated by trench 69 and overlaid with the pea gravel 57, which in turn was overlaid by layer 56.

- 3.1.5 Approximately 1.7 m south of Wall 63, a north-south aligned wall (65) was encountered running obliquely across the line of the trench (Fig. 3, Section 14). This measured 0.6 m wide with approximately 5.2 m length exposed within the trench. The wall consisted of 2 courses of roughly dressed limestone with occasional brick inclusions bonded with a lime mortar. The alignment of this wall suggests that it may form a return of wall 63, although the junction was not exposed. The wall was overlaid by a 0.15 m deep continuation of the layer of dark yellow-brown clay silt (61). This layer had also been truncated by service trench 69 and had been overlaid by a 0.25 m deep layer of the pea gravel 57, which in turn was overlaid by a 0.3 m deep layer of the redeposited garden soil 56.

- 3.1.6 As the trench excavation turned westwards the undisturbed garden soil (71) was encountered. This was a dark grey-brown silt loam measuring over 0.6 m in depth. Cut into this layer was a 0.85 m wide flat bottomed feature (68), 0.55 m in depth (Fig. 3, Section 15). This feature was aligned NW to SE running diagonally across the trench. Built within this cut was a stone built culvert (66). This was constructed using a stone slab as its base with 3 courses of stone laid on either edge and capped with a stone slab leaving a 0.3 m x 0.2 m void. Upon removal of this culvert within the line of the trench a fragment of 18th/19th century creamware was recovered from underneath the base slab suggesting that the culvert was of post-medieval construction, possibly contemporary with the construction of the vicarage. The culvert trench had been backfilled with a grey-brown silt loam (67), probably redeposited garden soil. Sealing the backfill was a 0.25 m deep layer of very dark grey silt loam (70), the present day topsoil and turf.

- 3.1.7 The stratigraphy within the remainder of the trench was similar, with the base of the trench exposing the top of Layer 71 overlaid by a 0.2 m deep layer of the current topsoil and turf 70 (Fig. 3, Section 16).
