Simpsons Maltings 45 The Vineyard Abingdon Oxfordshire

Historic Building Report

Document Title: The Maltings, 45 The Vineyard, Abingdon, Oxfordshire

Document Type: Historic building recording
Issue Number: 1

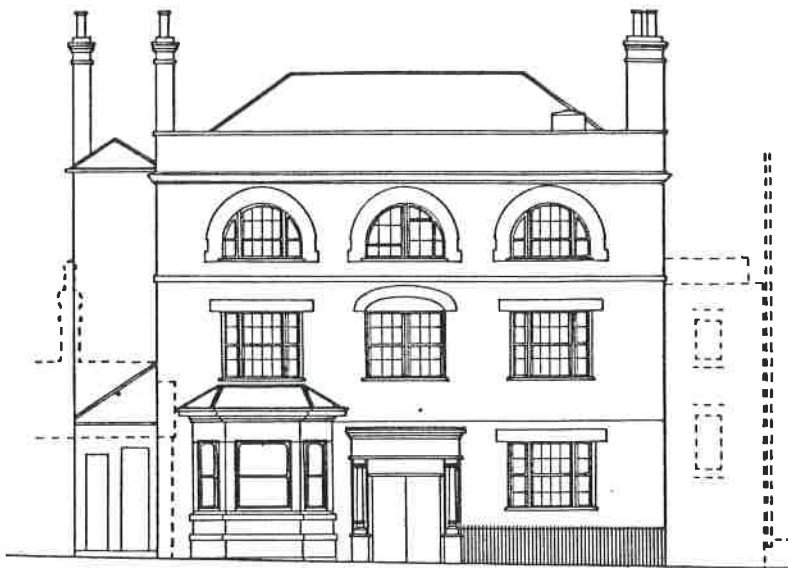
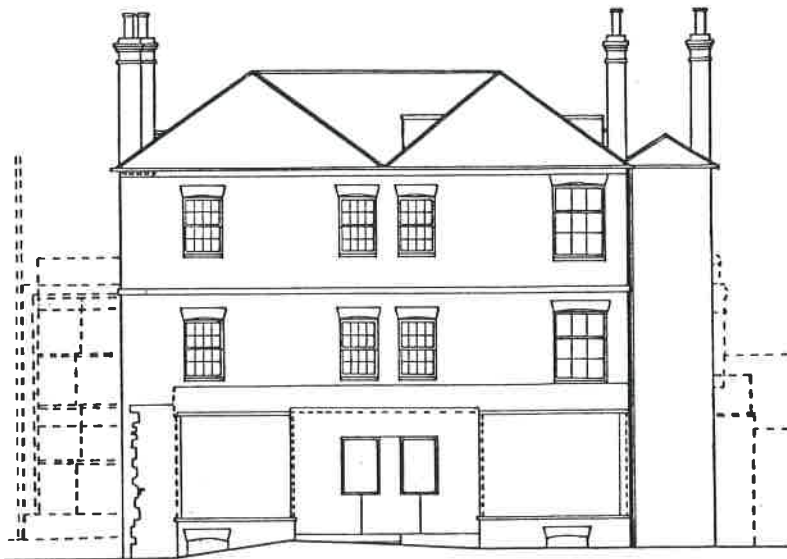
Scale: 1:100 at A2, 1:200 at A4 Figure No: 17

North Elevation

East Elevation

South Elevation

West Elevation

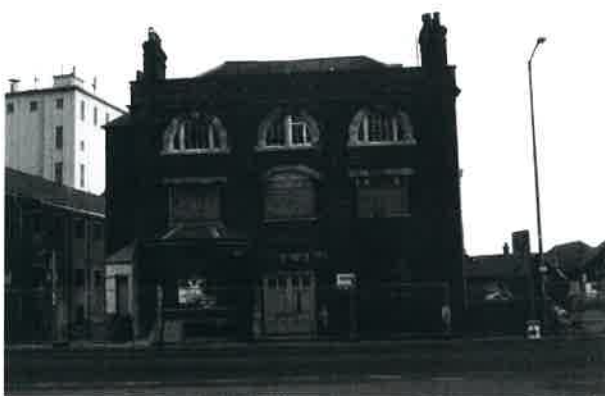
Plate 5: North elevation of 45 The Vineyard

- 3.3.4 The *north elevation* fronts onto the street and is the most architecturally impressive face of the building. It is of red brick with a parapet that partially hides a hipped roof. On the ground floor there is a central pair of doors (6-panels with upper two glazed) within a projecting porch with two stone columns supporting a simple stone entablature. This appears to be shown on the 1874 OS map (Fig. 7) and at that time was presumably a shared doorway to the two separate properties. To the east of the doorway is an attractive bay window with brick piers and stone detailing. This feature is again shown on the 1874 map but stylistically it appears to be a mid 19th-century addition. To the west side of the doorway is a primary sash window with two softwood mullions and margin lights. There are three first floor sash windows; the central one is beneath a shallow stone arch and has a central mullion while the two side windows match the ground floor window with two mullions and margin lights. There are three second floor Diocletian windows each of which is beneath a stone semi-circular arch. The two side windows have two mullions and margin lights while the central window has a single central mullion. There is a projecting string course at second floor level.

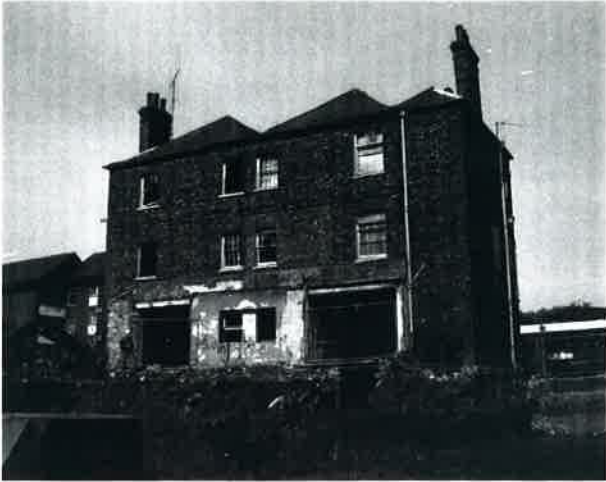
Plate 7: South elevation of 45 The Vineyard

- 3.3.5 The *south elevation* (rear) is again largely of brick but is plainer than the north elevation and there is an area of uncoursed stonework within the wall towards the west end of the ground floor. The stonework is likely to survive from an older building. The ground floor now consists of two large openings created to link the primary building with two small extensions (now demolished). There are four sash windows to both first and second floor each one beneath a brick lintel with square top and cambered underside. The three windows to the west at each level have 16 small lights while the easternmost window at each level has only nine lights but is a larger window. The small extension on the east side of the elevation is of 19th-century brick similar to the main building but there is a clear straight joint between the two sections of wall.

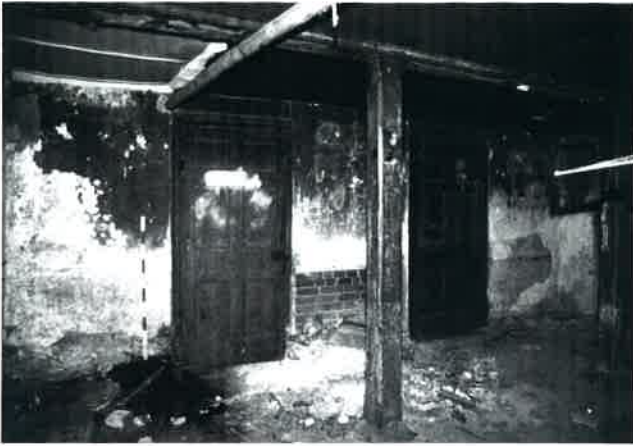
Plate 13: Cellar, B/1.0 from North-west corner

- 3.3.10 *B/1.0* is the main room in the western part of the basement and is likely to have acted as a cool room and pantry. Its floor is covered with quarry tiles and its ceiling is supported by a principal joist (N-S) itself supported by two square posts (Pl. 13). The walls are plastered and there are two large cupboards against the east wall each accessed by 19th-century 6-panel doors. In the north wall of the northern cupboard there is a tall thin window formed within a previous wider arched opening which would have extended beneath the pavement.

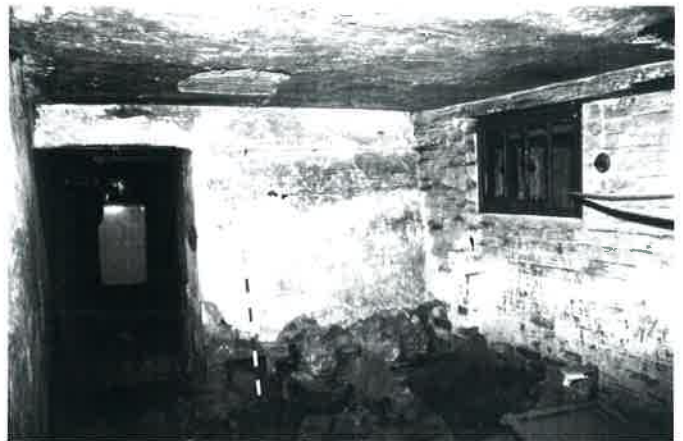
Plate 16: B/2.0 from South-west

- 3.3.11 *B/2.0* is a small room at the south-west corner of the basement (Pl. 16, 17). Its walls and ceiling are plastered and its east wall is of 19th-century brick having been inserted to allow the construction of a staircase on the other side of the wall (Pl. 22). The room has a cement floor and from the trace of coal on the floor it appears to have served as a coal cellar.

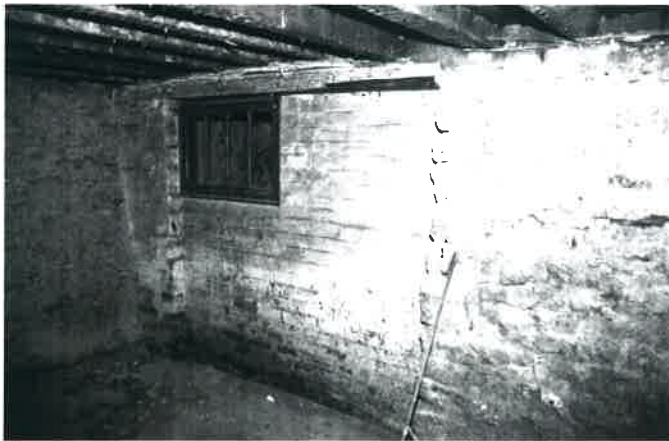
Plate 17: B/2.0 from South-west

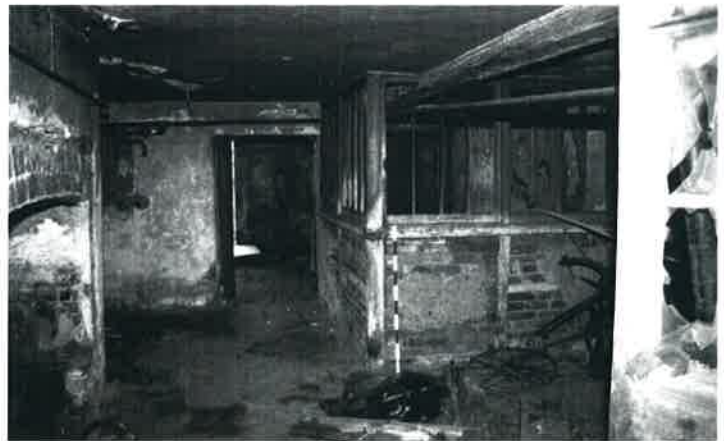
Plate 18: General view in B/3.0

- 3.3.12 **B/3.0** is the main room at the north-east corner of the basement and it appears to have served as the scullery of the house. Several smaller secondary rooms have been created in the larger room with partitions consisting of brick lower parts and glazed upper sections. The walls and ceiling are again plastered but much of it has come away, particularly from the secondary brick partitions. At the north-east corner of the room are the fragmentary remains of a former washing copper adjacent to a brick arched fireplace. Within the fireplace there is what appears to be a small former bread oven with a cast iron door (Pl. 19). The north wall of the room links to a vaulted coal cellar which projects beyond the front wall of the house and beneath the pavement. It comprises a brick vault on stone walls.

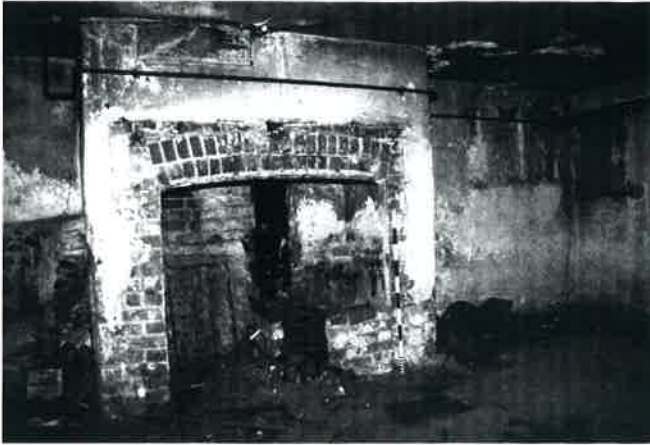
Plate 19: Fireplace in B/3.0

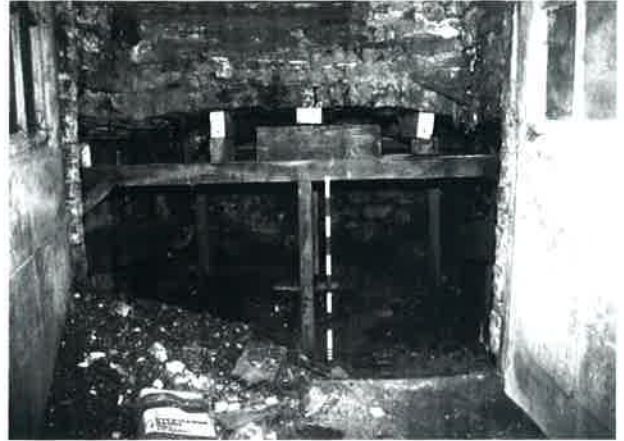
Plate 20: Vault B/3.1 in North wall of basement

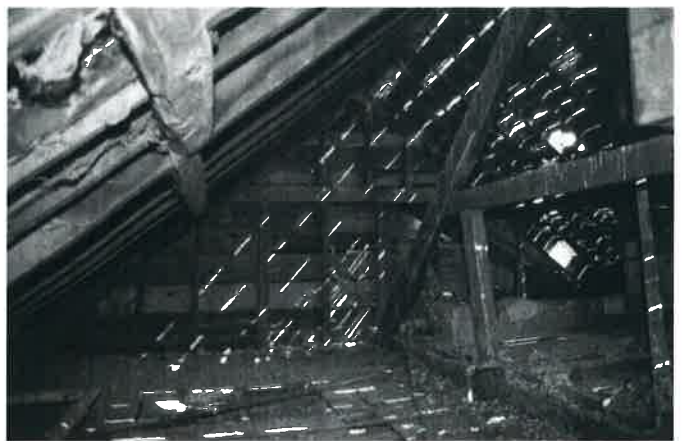
Plate 30: Queen post truss in roof

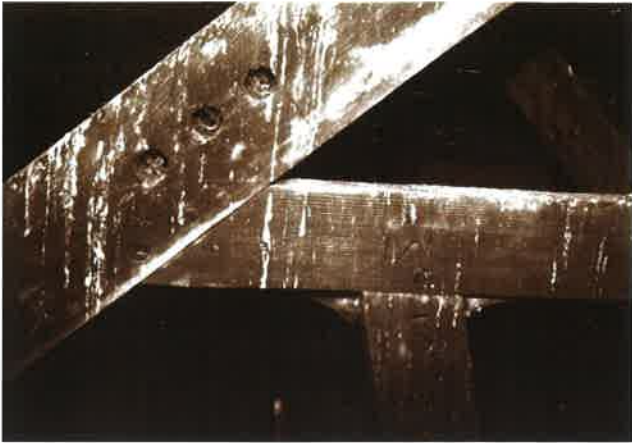
Plate 31: Truss detail showing queen post, collar and principal rafter

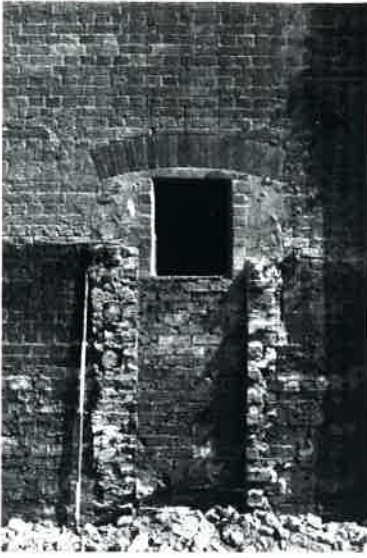
Plate 37: Blocked door in Bay 1 of West elevation of malthouse

- 3.2.3 The *west elevation* (facing the rear yard) consists of a series of windows and doors within the main block which would originally have had shutters or louvres to allow good control of the ventilation across the growing floors. It is usual at malthouses of this period for the windows to growing floors to be small and very regular but here the ground and first floor openings are slightly taller than usual and less regular. Each opening on the upper two storeys is beneath a concrete lintel and it appears likely that these openings have been increased in size from their original form. Those to the basement are beneath primary segmental blue-brick arches. The windows and shutters had all been removed prior to the current survey. Each bay is divided by a brick pilaster with simple blue-brick detailing towards the top and at the eaves. Towards the north end there is a double-width bay which reflects the internal location of the steeping tank and there is evidence of a small former blocked vent above every other ground floor window. The tower at the south end is slightly more decorative with three blue-brick string courses and blue-brick semicircular arches with stone keystone over the two second floor windows. These windows have vertically hung shutters and deep sloped sills formed of four courses of chamfered blue brick. There are two cast-iron plates at one of the blue string courses (just above second floor level) which are the ends of two iron joists that support the kiln drying floor.

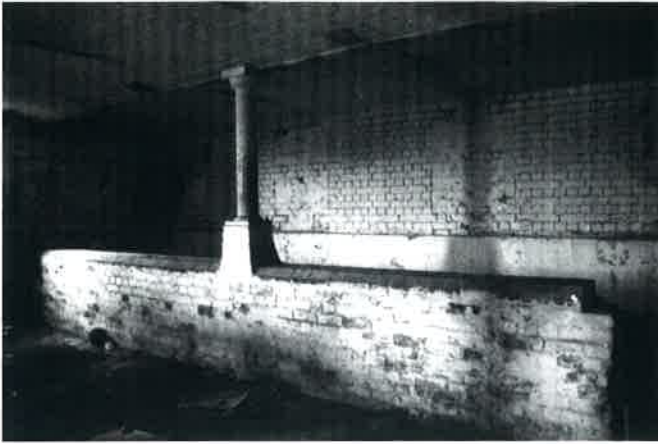
Plate 43: Steep in basement of malthouse

- 3.2.7 The *basement* consists of a long single room, which would have housed a growing floor, and a small separate kiln room at the south end. The former growing floor is divided by a central row of 11 circular cast iron columns with plain heads each one supporting an I-section iron joist (E-W) and shallow brick jack-arch ceiling resting on the lower flange of each joist. Each column rests on a stone foundation block (77 cm²) the tops of which are at approximately the same height as the current floor surface. Within the northernmost bay of the basement there survives the partially truncated remains of the steep, a large brick tank in which barley would have been soaked in water for up to three days to take on moisture in order to start the germination process. The steep extends the full width of the building and is 1.8 m wide by 80 cm deep. It is brick built and its internal faces are clad in tiles to make it water tight. The northernmost column is a shorter version of the other columns and it sits on top of the south wall of the steep.

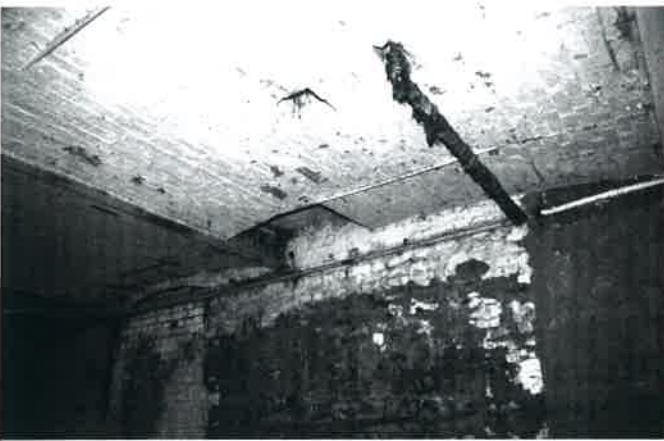
Plate 45: Brick-vaulted ceiling in basement of malthouse, note hatch

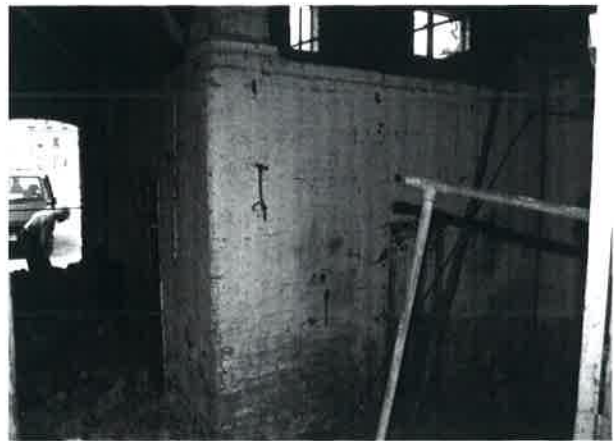
Plate 52a: View of kiln base

- 3.2.10 The kiln at the south end of the basement substantially survives. It comprises a square-plan brick base (c.3.1 m²) along the central line of the building with access space around each side of it. Within the base is a small brick lined chamber into which a fire box would have been inserted through an arched opening within the south wall. Anthracite would almost certainly have been the fuel used due to its high quality and relatively low smoke emissions. Two horizontally split cast iron doors survive in-situ which would have closed onto this opening. Infilled former openings survive in both side walls of the kiln base although in one (to the east) there survives a smaller iron door on a pulley which would have slid up to allow ventilation to the kiln. The firebox would have generated a moderate heat which would have risen up to the drying floor just above the highest floor (first floor) level (detailed below).

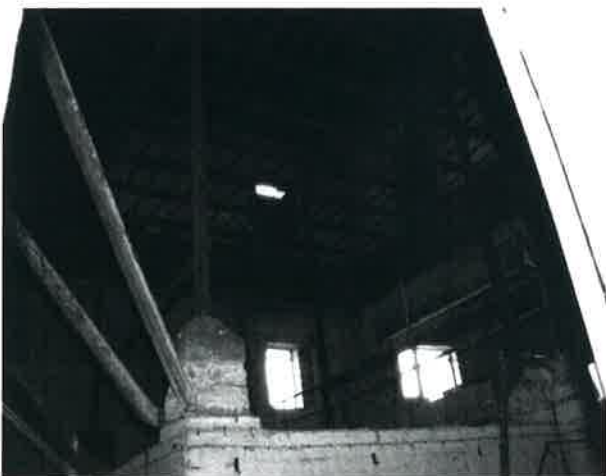
Plate 53b: View up towards drying floor above kiln

- 3.2.14 The principal feature of the kiln at this level is the drying floor which is c.30 cm above the height of the second floor. When the green barley had germinated as far as was necessary and had been moved up through the building along the drying floors it was passed onto the drying floor to be gently heated to stop the germination process. The floor consisted of an iron frame with two principal rolled joists (E-W), each one supported at its mid point by an octagonal iron column, supporting a series of smaller secondary joists (N-S) 31 cm apart. This frame held perforated ceramic floor tiles (31 cm² x 5 cm) typical for a maltings of this period which allow the heat generated in the kiln below to rise through the floor, through the grain and out through the up-turned hopper (or hood) above. The holes in the tiles are conical shaped so that the openings in the lower face are large but those in the upper face are small to prevent grain falling through. The walls of the kiln are vertical for c.2 m above the drying floor and above this the roof rises in a pyramidal shape to a small square opening at the apex. The upstanding chimney which formerly sat on top of the vent opening had been previously removed. There are two window openings in each of the four walls of the kiln, above the height of the drying floor. The windows in the three external walls have vertically hung shutters. The two openings in the north wall of the kiln (internal) would have been used to fill the kiln with green barley and to remove the kilned malt. The kilned malt would probably have been put directly into sacks from the kiln, and either dropped down to the ground floor through the hatch or through the adjacent door in the east wall which was originally accessed by a staircase. The malt would then presumably have been stored in another building or immediately transported away from site.

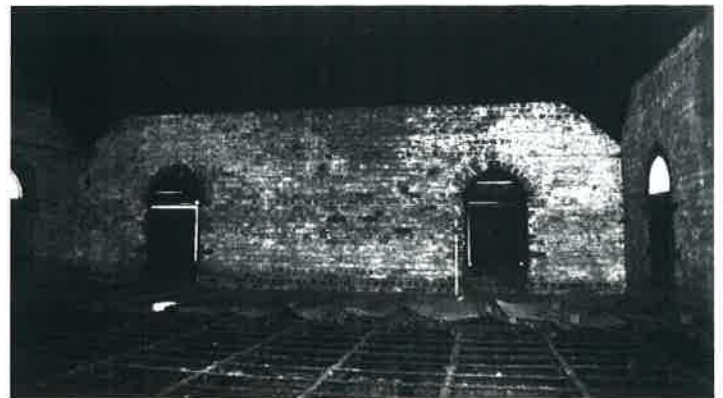
Plate 54: View across drying floor
