# Chapter 3: Junction 8 Northbound and minor sites to the north

## JUNCTION 8 NORTHBOUND

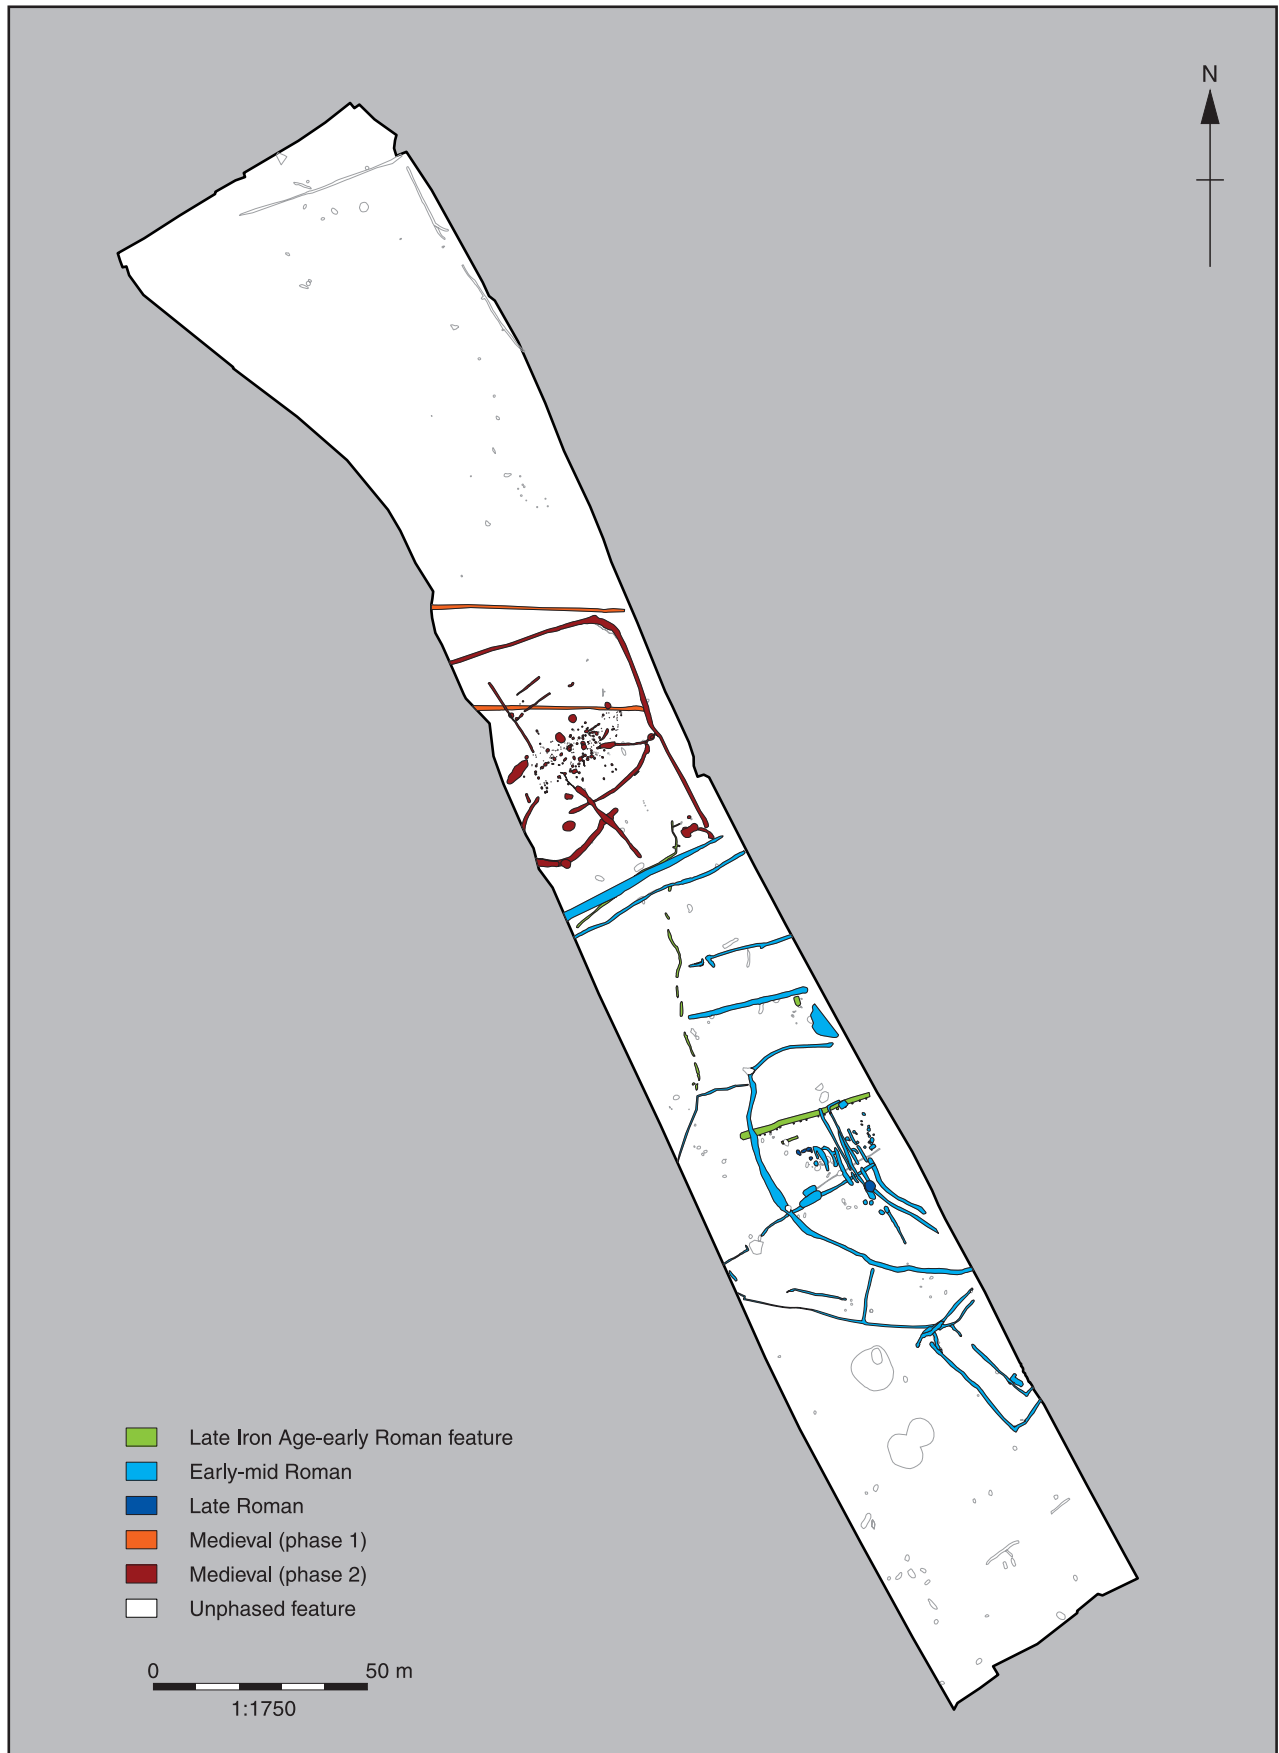
*Fig. 3.1 Junction 8N, plan of all features*

Evidence for settlement at Junction 8N may be divided into two broad periods, which also correspond to two geographically distinct parts of the road cutting. The earlier activity, belonging to the late Iron Age-early Roman and middle Roman periods, with scattered later Roman features, consisted of a series of enclosures occupying the south-eastern half of the excavated area. Immediately north-west of the Roman activity, occupying the north-western part of the site, was an area of medieval settlement, dating to the late 12th-13th centuries, and comprising a post-built structure, groups of pits and several enclosure gullies.

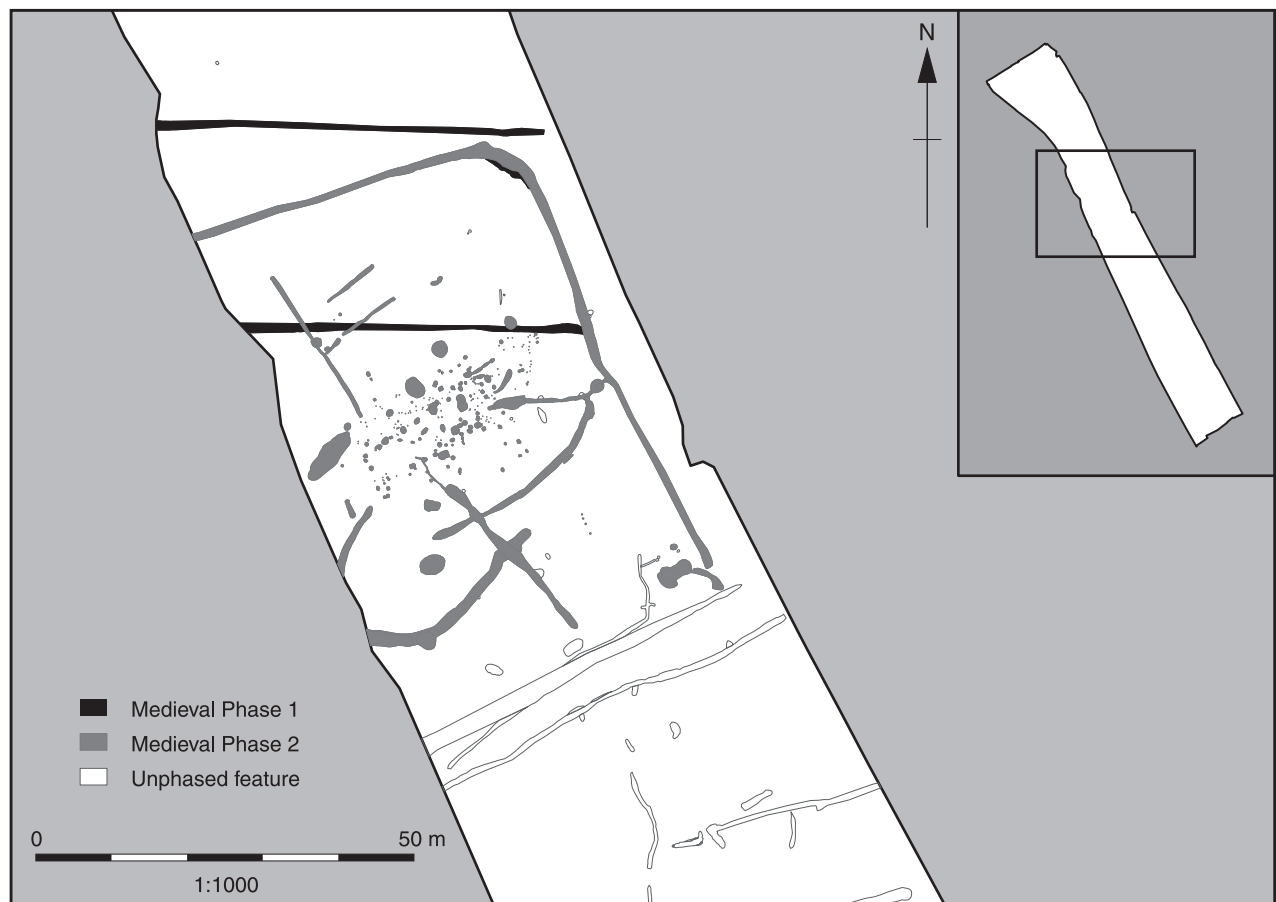
*Fig. 3.15 Junction 8N, medieval activity*

The medieval activity, most if not all of which dated to the late 12th-13th centuries, occupied the part of the site to the north of the early Roman trackway. It is divisible into two broad stratigraphic phases. Features assigned to the first phase comprised two east-west-aligned boundary ditches (6095 and 6449), set approximately 26m apart, and a small oven or kiln (6585). These features produced no secure dating evidence, but are believed to be medieval in date on the basis of their spatial relationship with the medieval settlement.

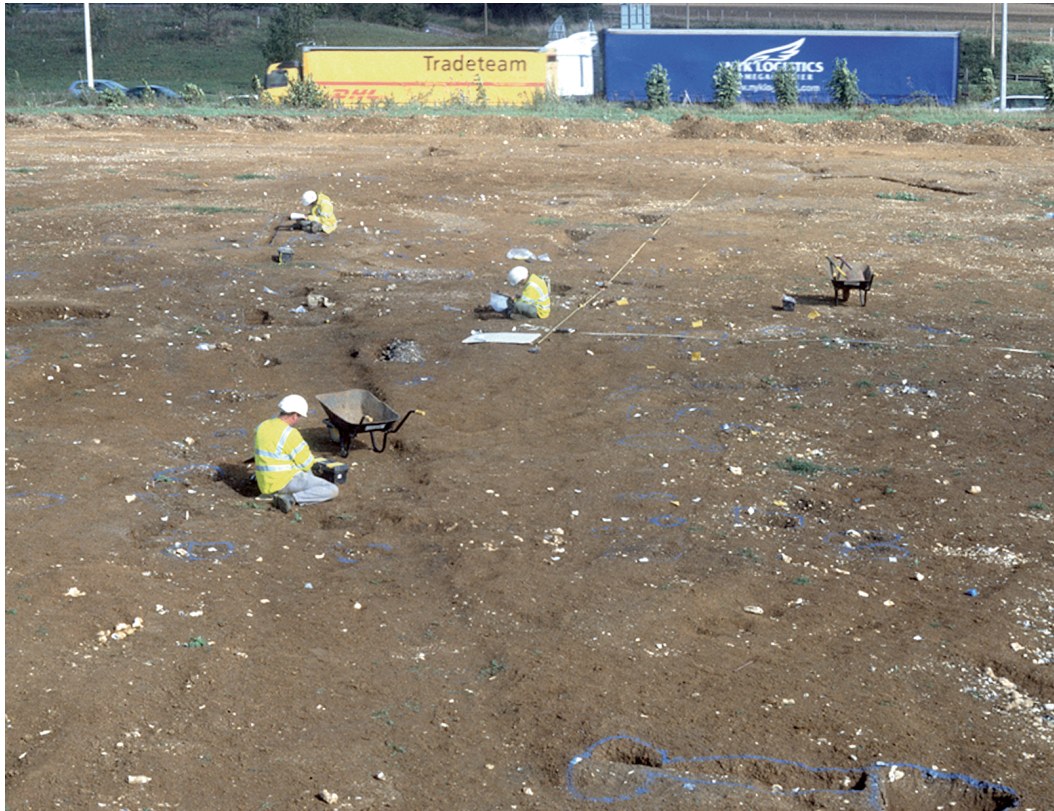
Fig. 3.21 Junction 8N, post-built structure 6961, looking north-east
